DEPARTMENT OF MINES
GEOLOGICAL SURVEY OF SOUTH AUSTRALIA

ENGINEERING GEOLOGY OF THE KANGAROO CREEK DAM

by
J. P. Trudinger
Assistant Senior Geologist

Bulletin 44

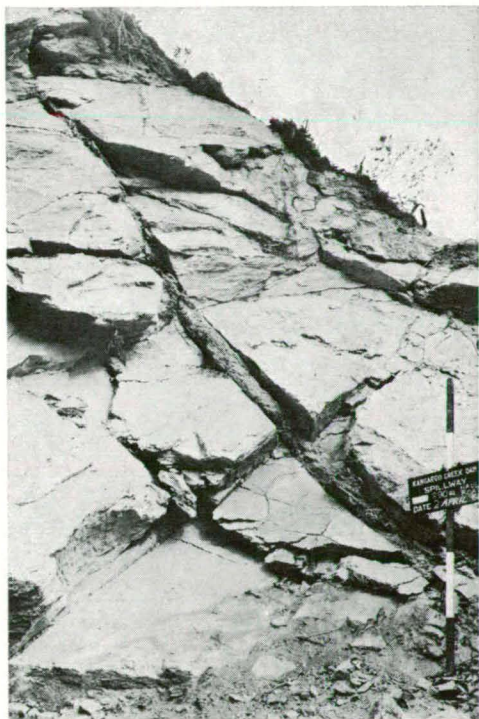
Fig. 17. Seam of infilled clay in a Set (2) joint which forms one side of a semi-detached wedge of rock.

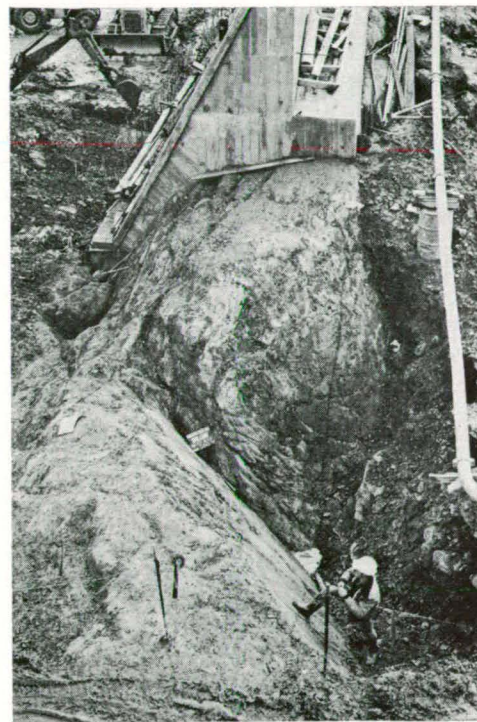
Fig. 19. V-shaped gully formed by sliding along Set (1) and Set (2) seams; spillway channel, north wall—foundation for block LH.

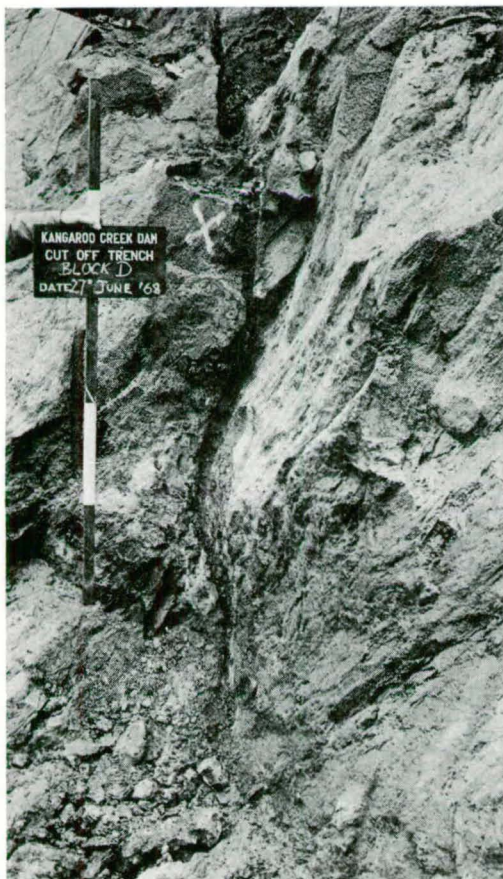
Dental treatment was carried out where soil seams more than 50 millimetres in width intersected the foundation surface. The purpose of this treatment was to guarantee an effective bond between the concrete and the foundation rock and to avoid water seepages along the interface which could result in erosion of the seam materials.

Fig. 32. Foundation for grout cap with infilled clay seam 5 cm wide before dental treatment.

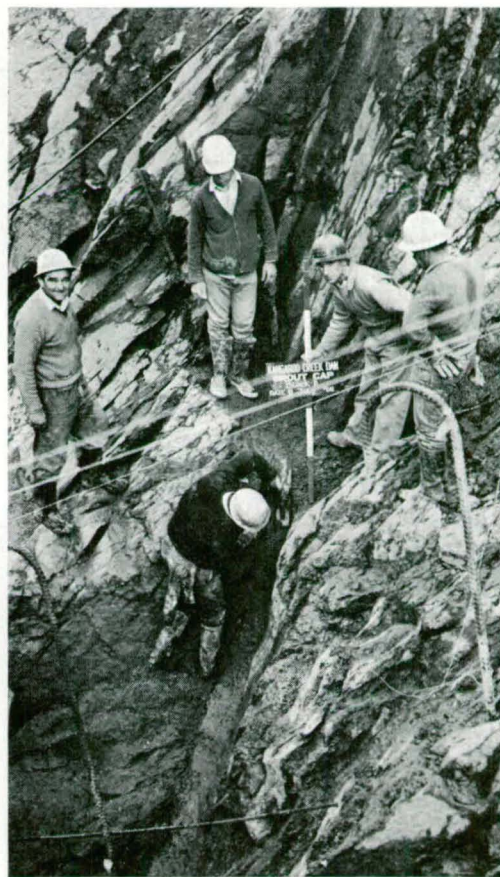
Fig. 33. Foundation for grout cap with infilled clay seam 5 cm wide after dental treatment.

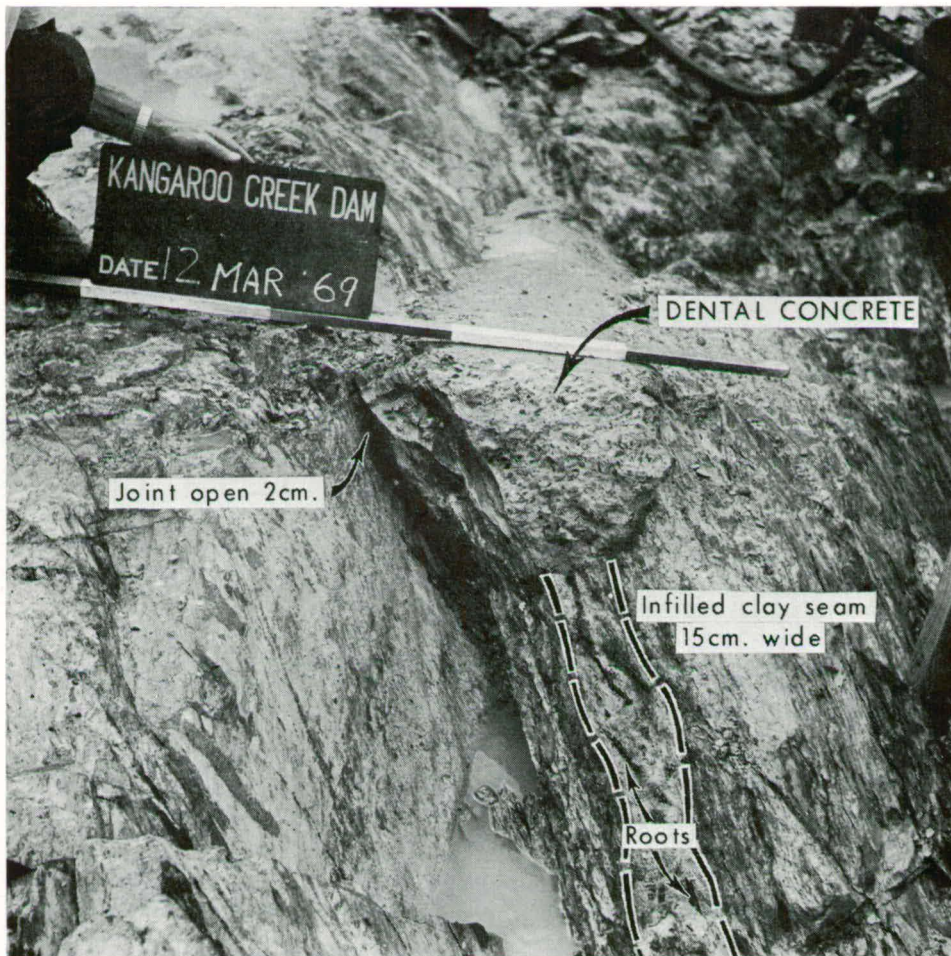
Fig. 34. Cut-away view of dental treatment of infilled clay seam in foundation for grout cap, block A.

This type of treatment was applied to seven seams all on the left bank, for which a total of approximately 40 cubic feet of concrete was used.

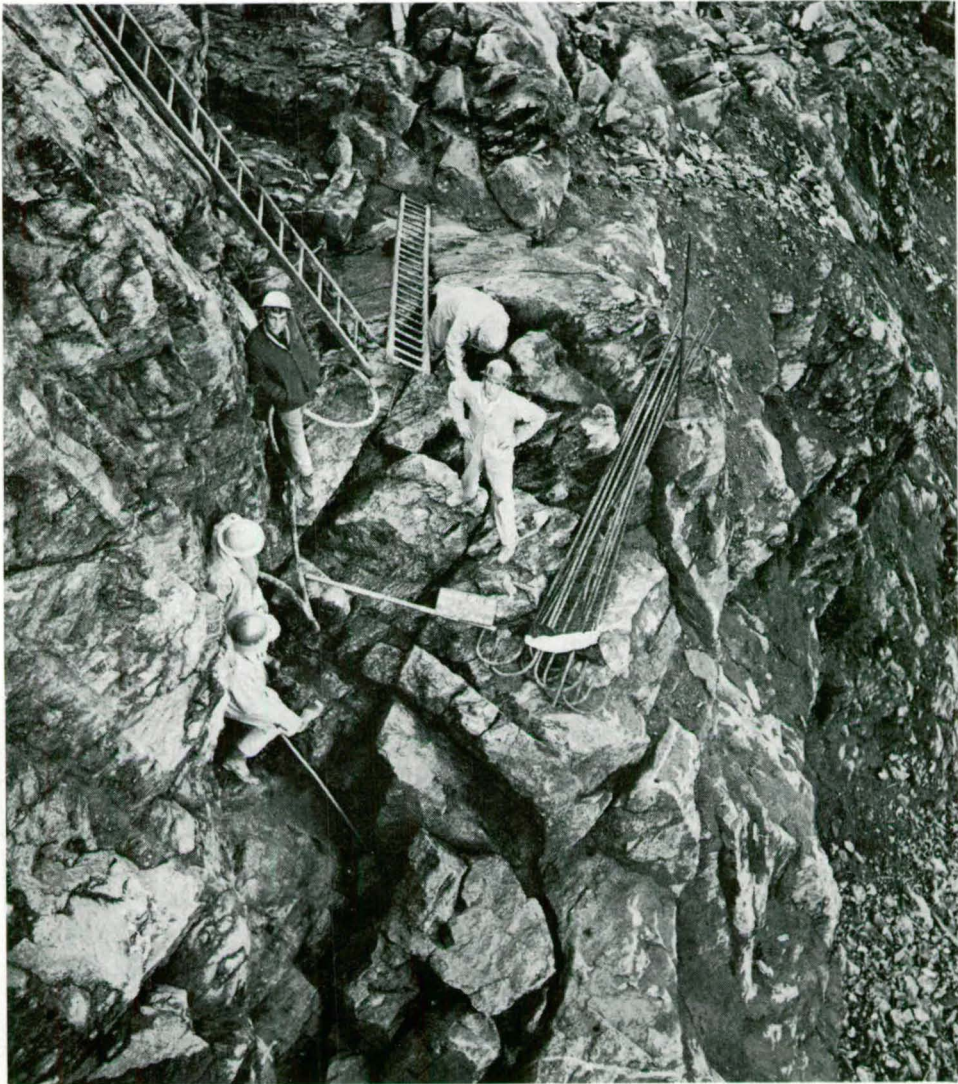
Fig. 36. Floor of right abutment excavation, with numerous gaping joints open up to 30 cm.

The excavation was mainly in fresh gneiss with some slightly weathered granitic gneiss. The rock mass in the north and east (upstream) batters and the upstream half of the floor has been only slightly affected by mechanical weathering, however the upstream part of the floor and part of the downstream wall are in the zone of severe mechanical weathering. Hand clean-up of the floor in this area revealed numerous near-vertical gaping joints (Figs. 30 and 36), open up to 15 centimetres and apparently extending to considerable depths.

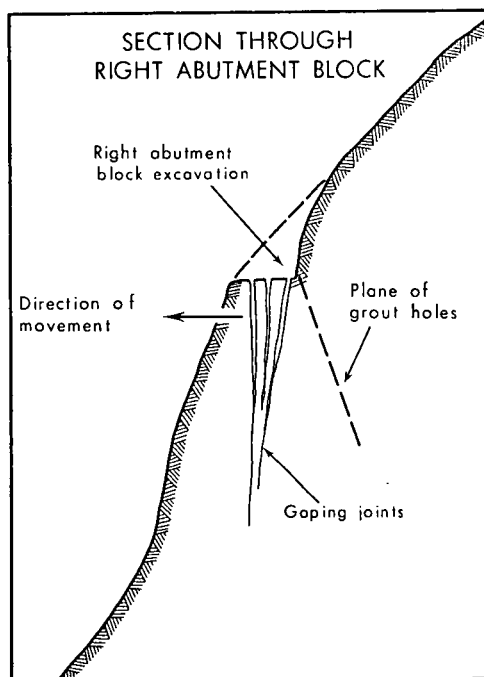
Fig. 38. Section through right abutment block showing direction of movement that caused opening up of joints.

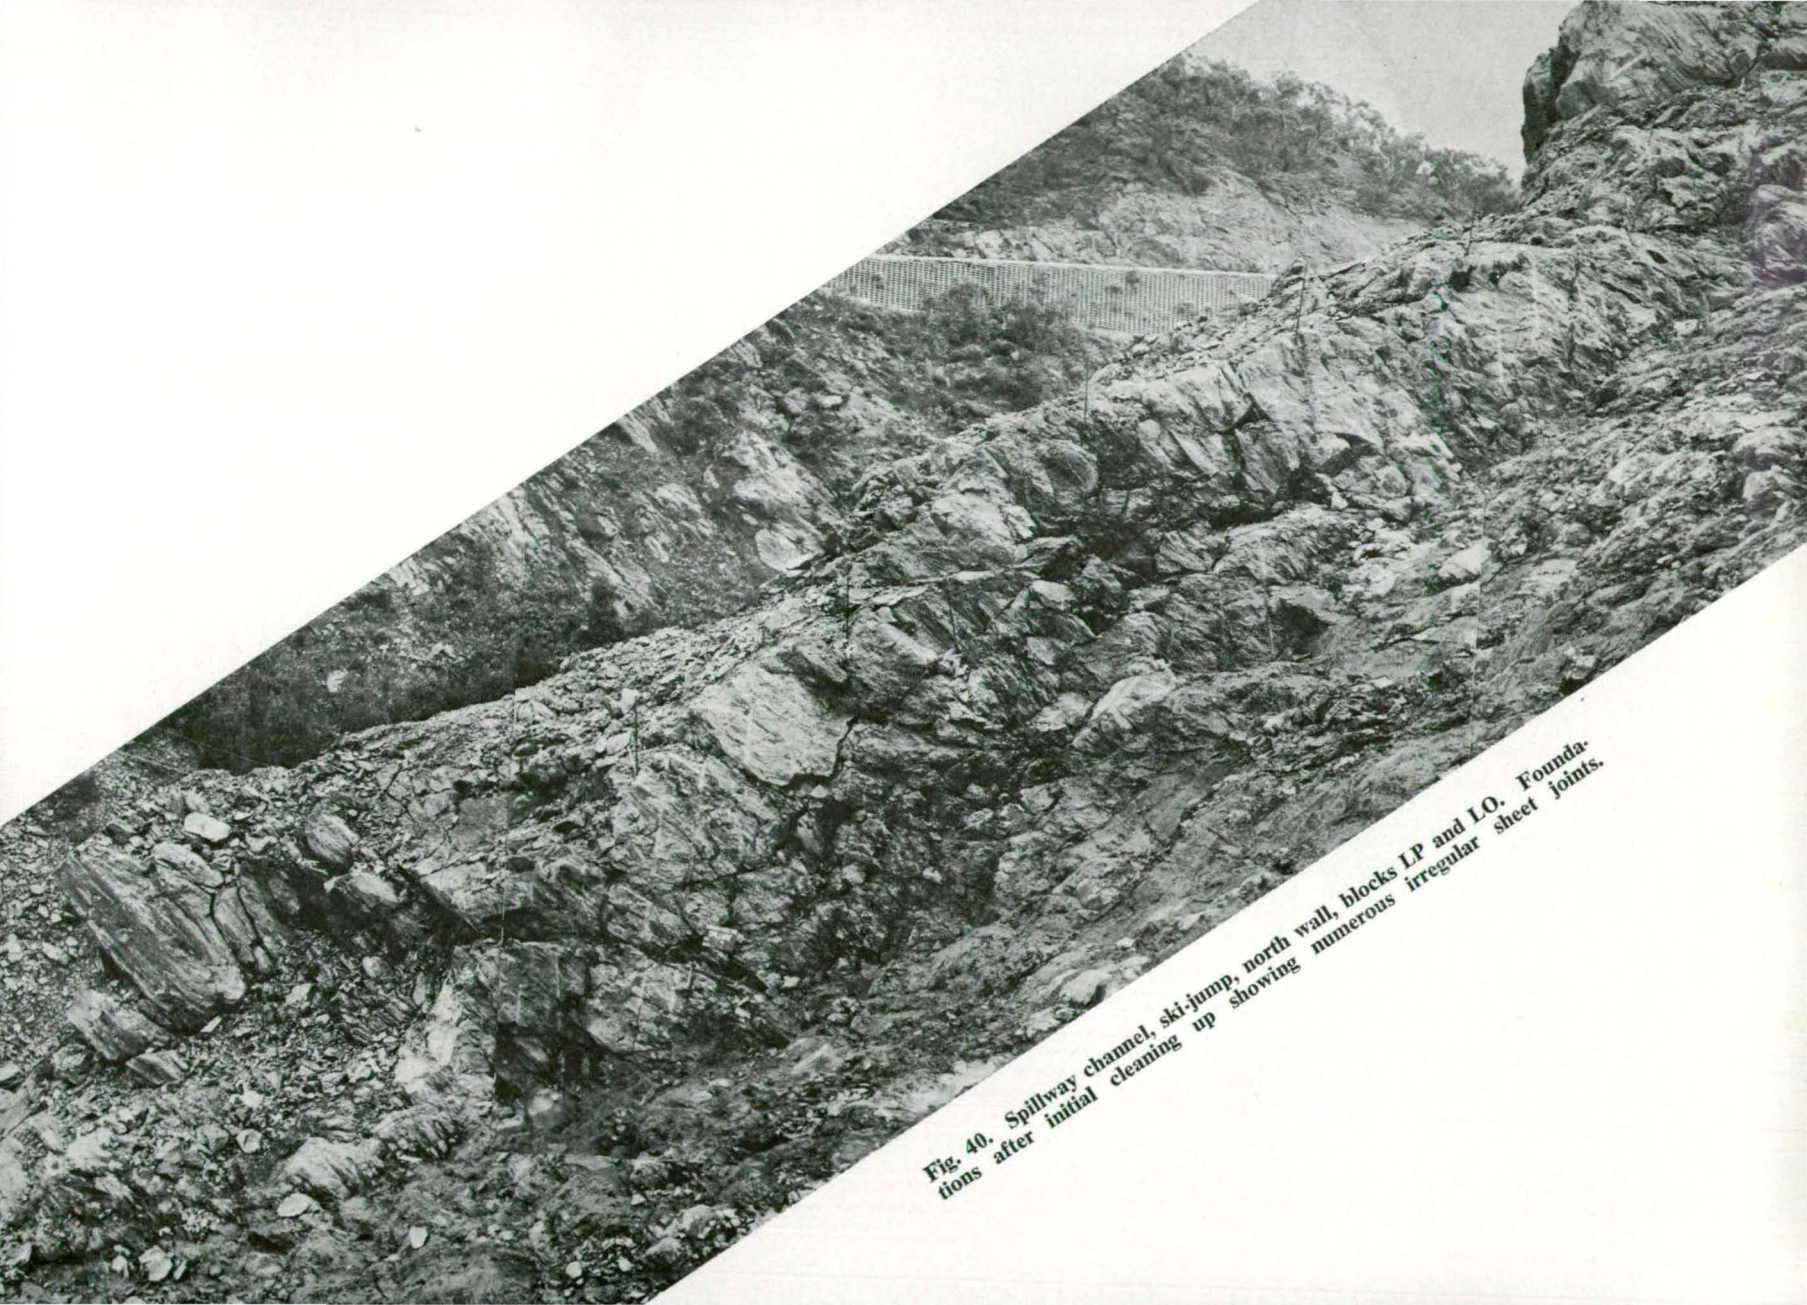
Fig. 40. Spillway channel, ski-jump, north wall, blocks IP and LO. Foundations after initial cleaning up showing numerous irregular sheet joints.

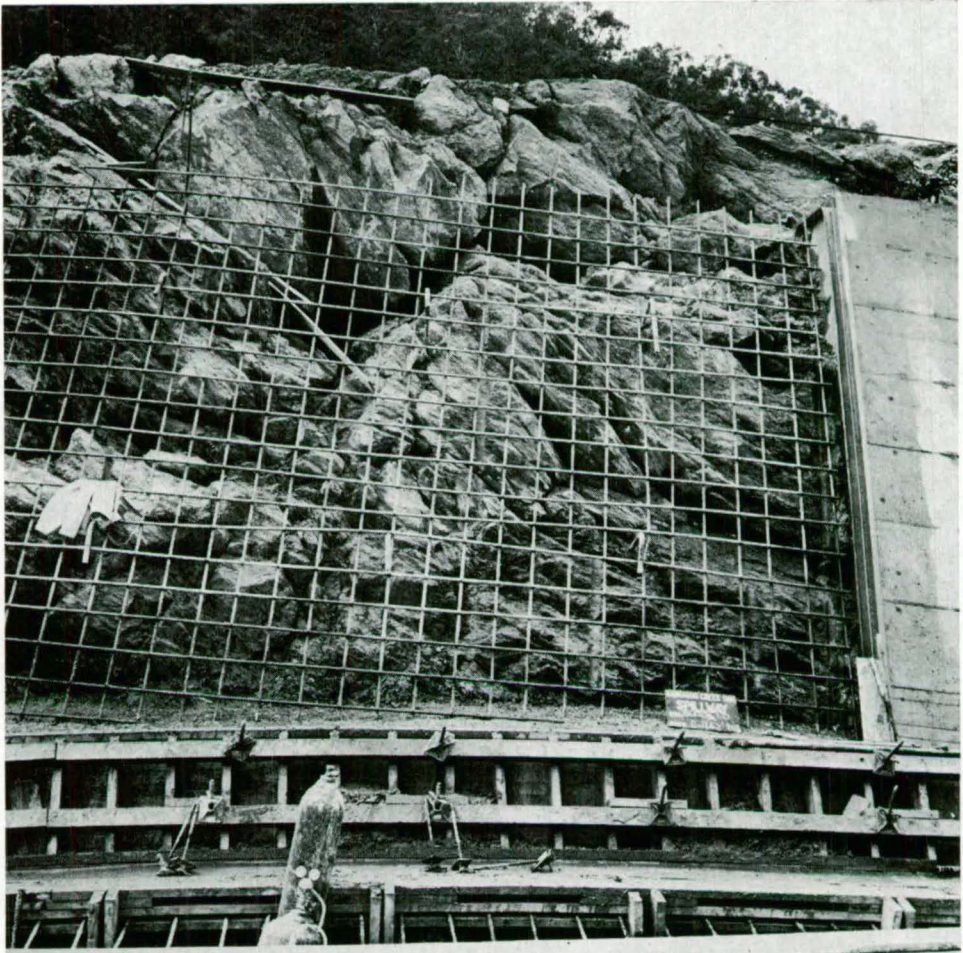
Fig. 41. Spillway channel, north wall, block LO, with disturbed wedge shaped block in upper part of foundation.

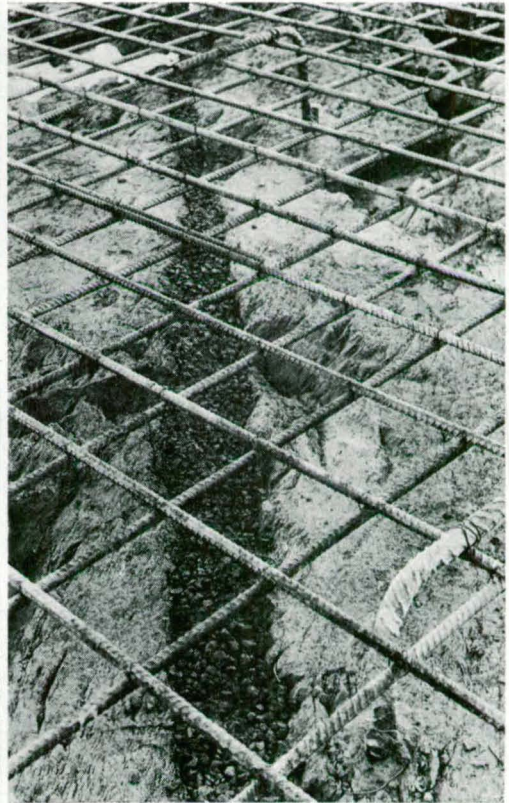
Fig. 43. Narrow crushed seam exposed in the floor of the spillway channel excavation after wet seam treatment.

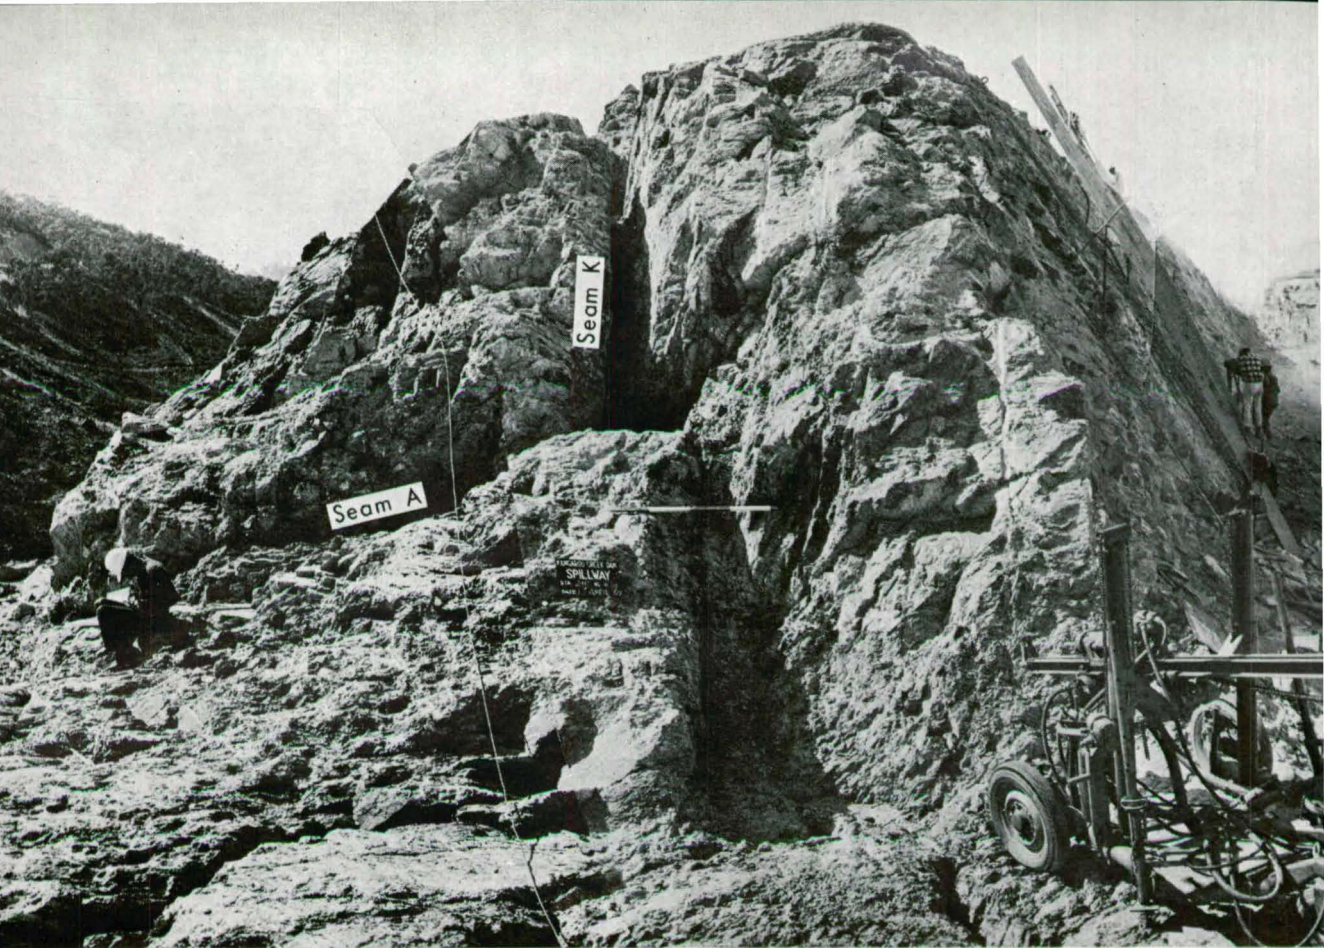
Fig. 46. Initial excavation for spillway block LE showing disturbed rock containing thick seams of infilled clay (seams K and A).

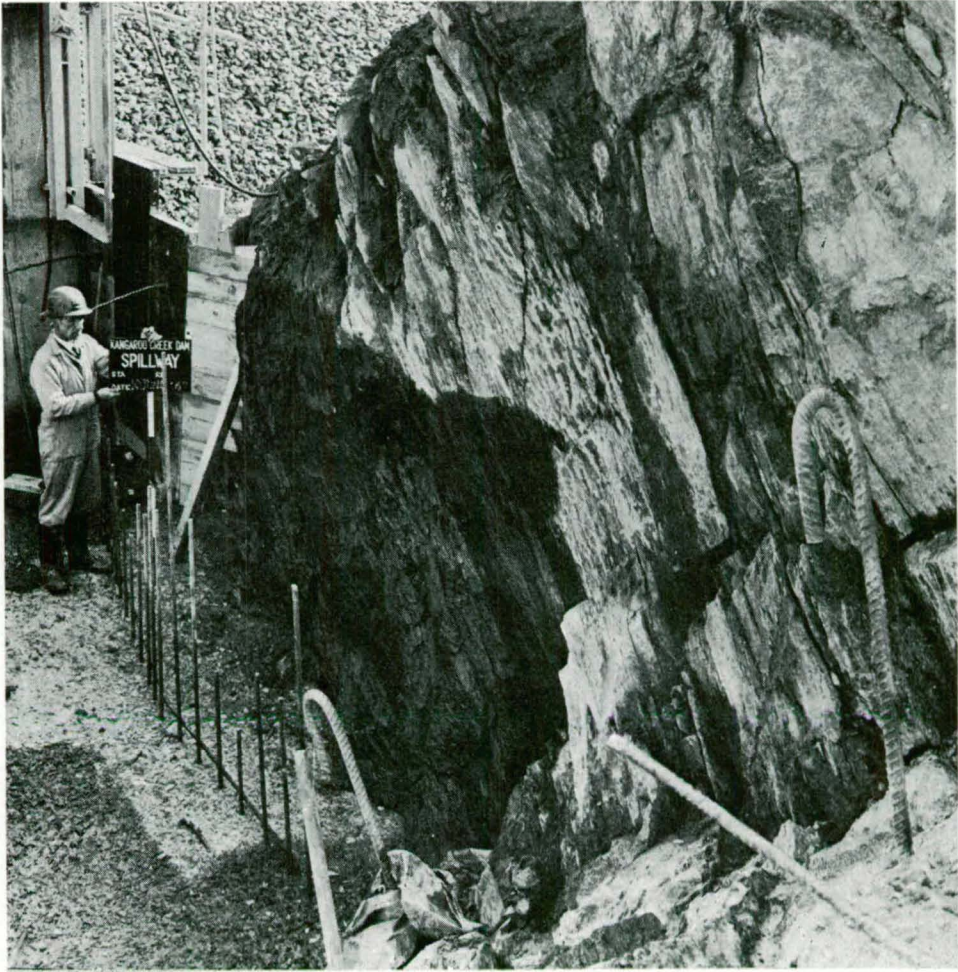
Fig. 47. Vertical batter of final excavation for spillway block E. The surface of the disturbed rock has been bitumen coated to eliminate bonding between rock and concrete.

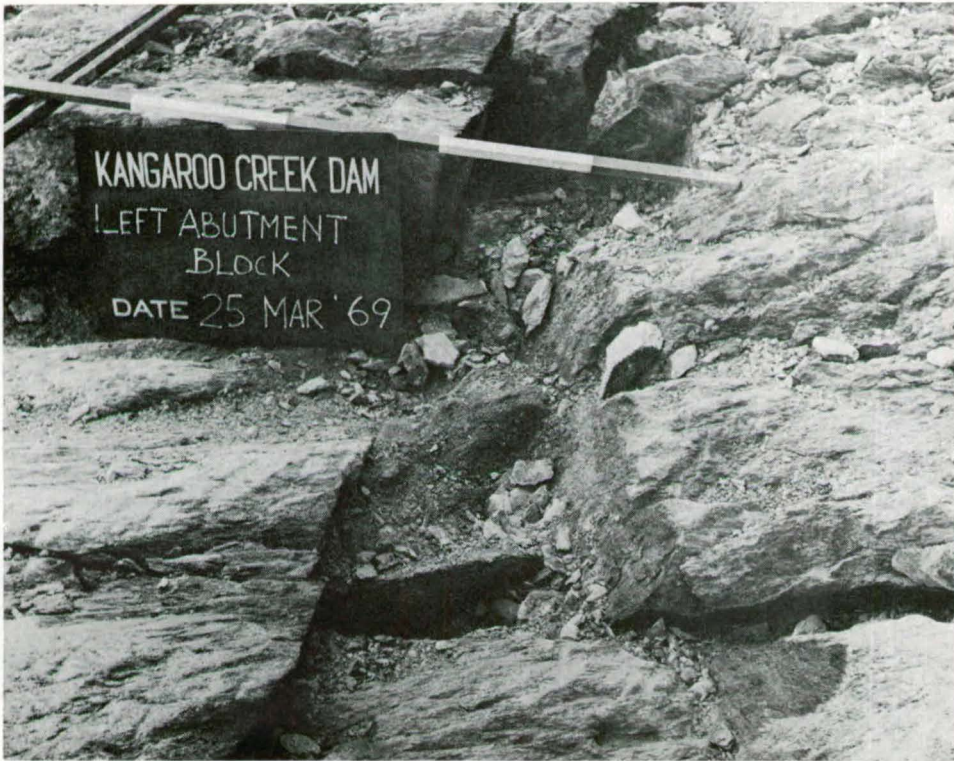
Fig. 49. Gaping joints exposed in foundation for left abutment block.

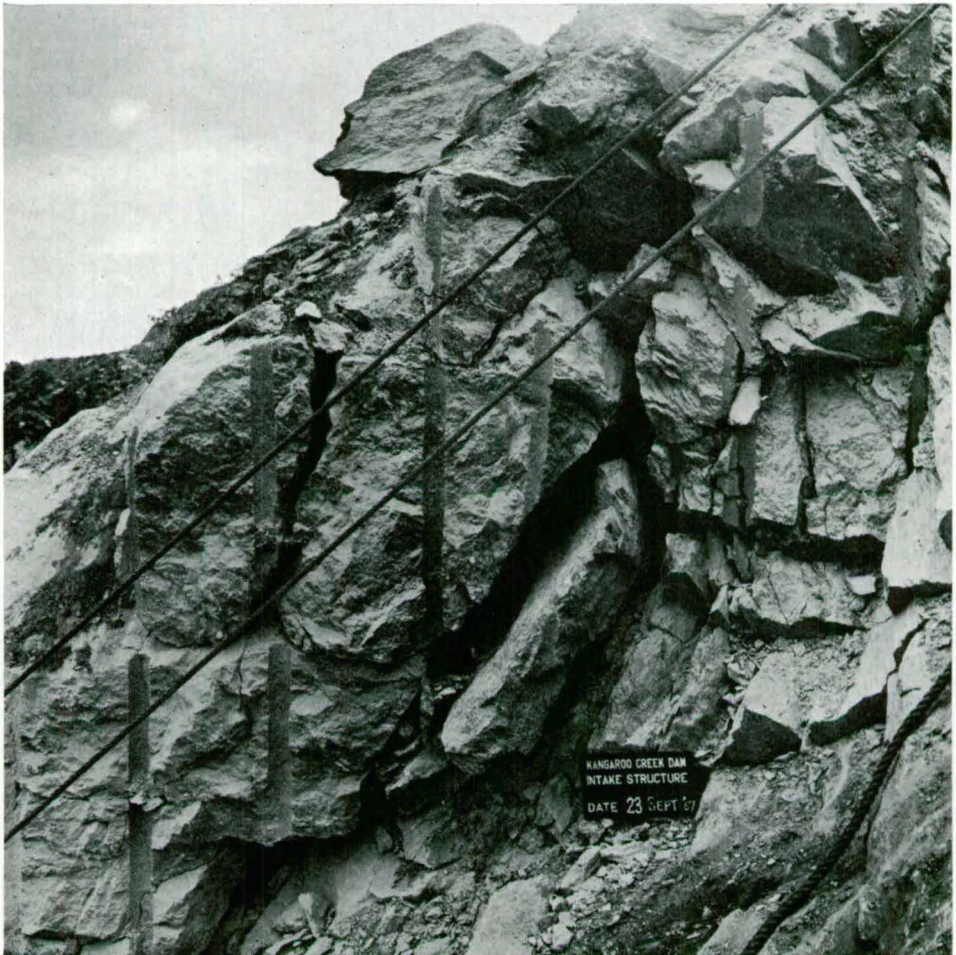
Fig. 51. Sheet joints gaping open to 20 cm in upper part of intake structure excavation, downstream wall.

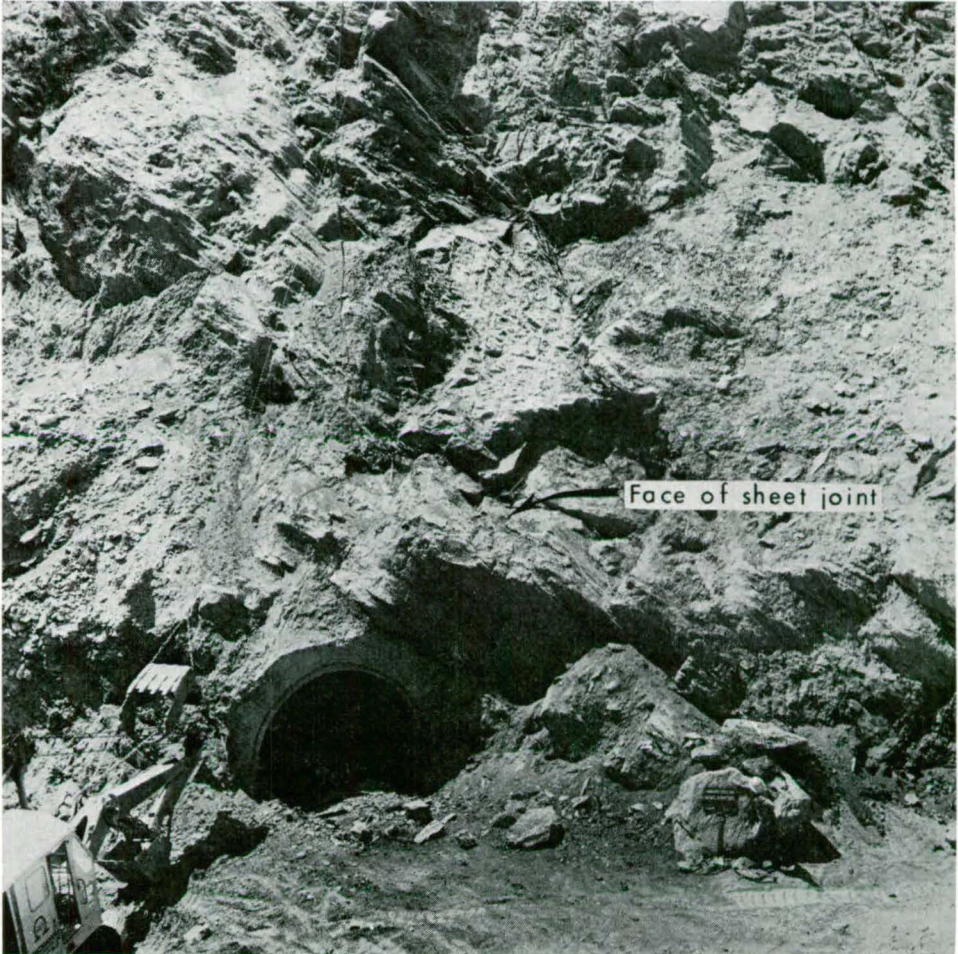
Fig. 52. Lower part of intake structure excavation showing pre-split floor, underlain by sheet joint.

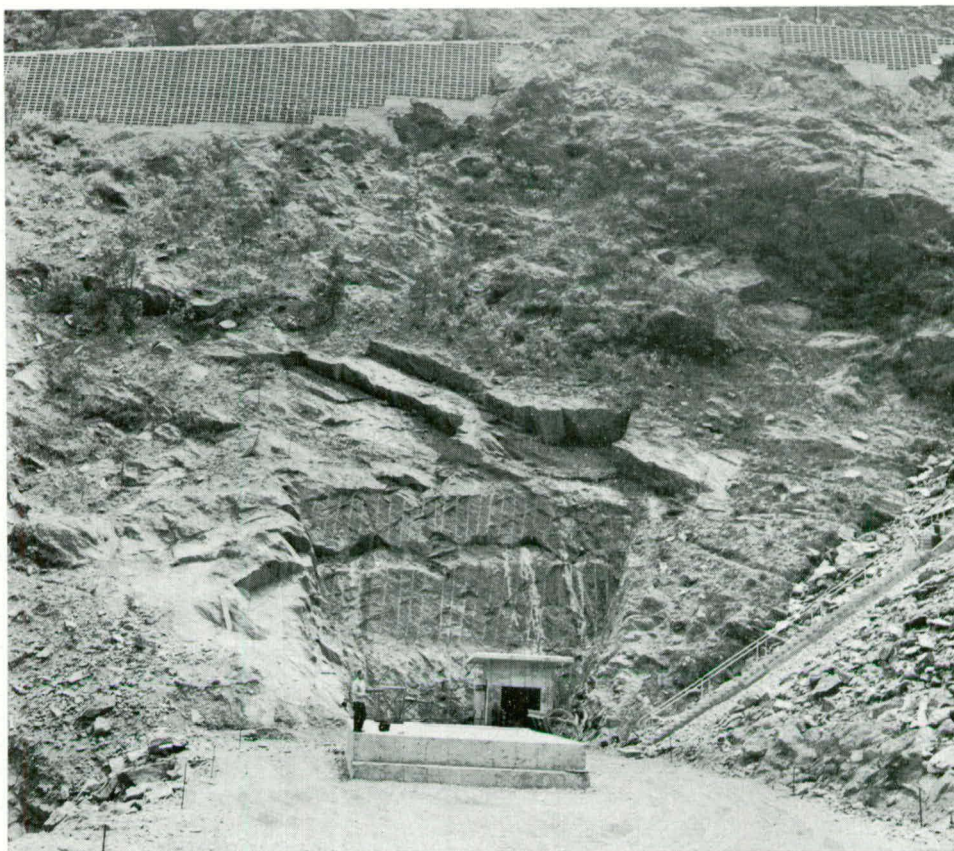
Fig. 69. A series of five near-parallel sheet joints exposed in and above the access shaft open cut.

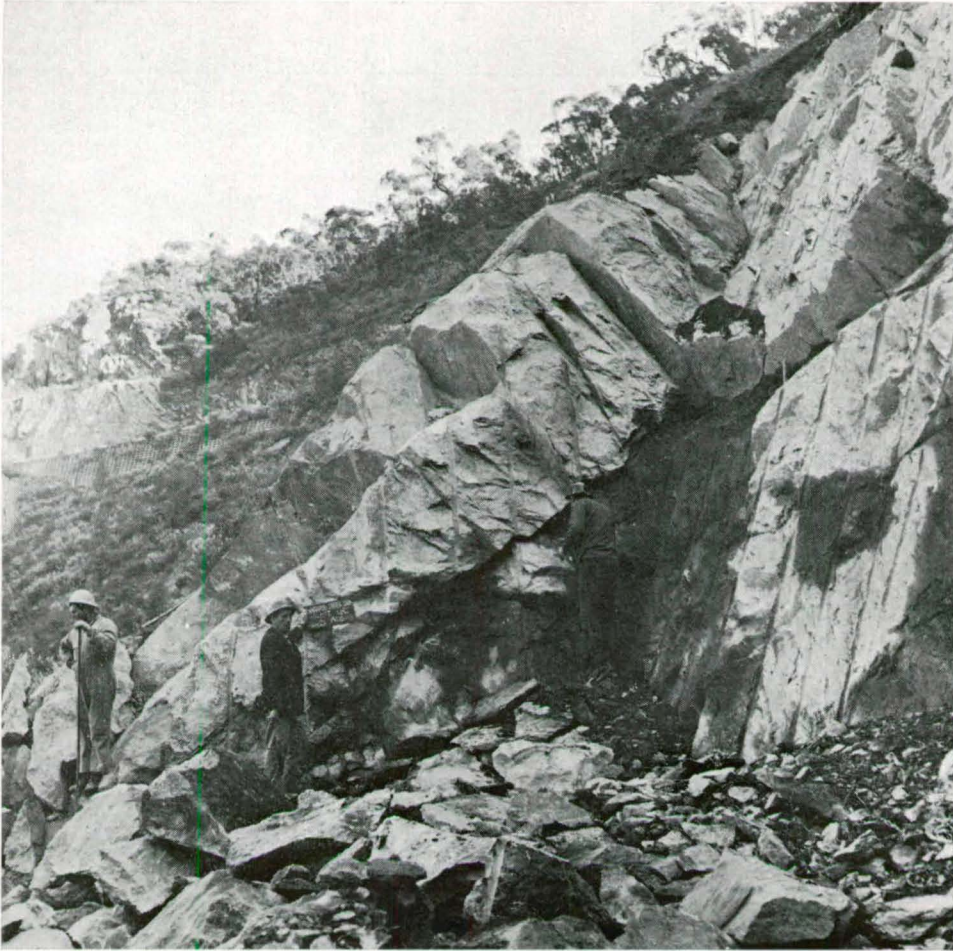
Fig. 70. Partly open sheet joints exposed in the downstream wall of the access shaft open cut.

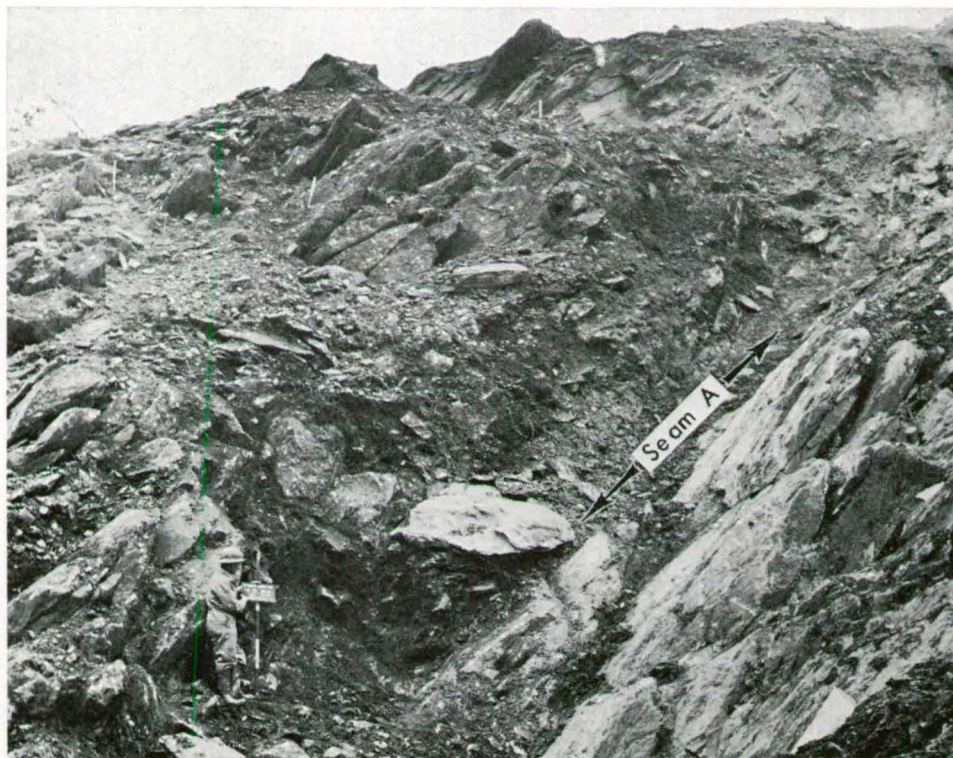
Fig. 73. Early stage in excavation for grout cap, block B through soil and disturbed rock—part of wedge mass No. 1.

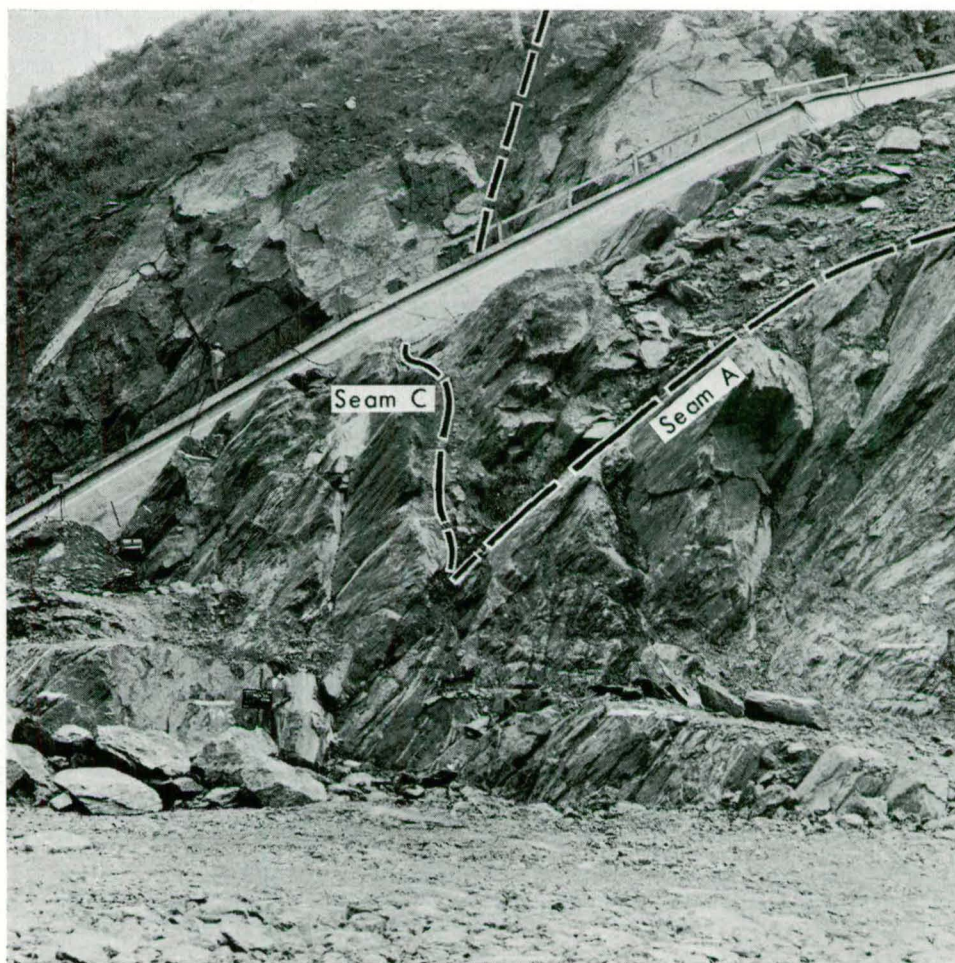
Fig. 74. Base of wedge mass No. 1 exposed in embankment foundation downstream of grout cap, block C.

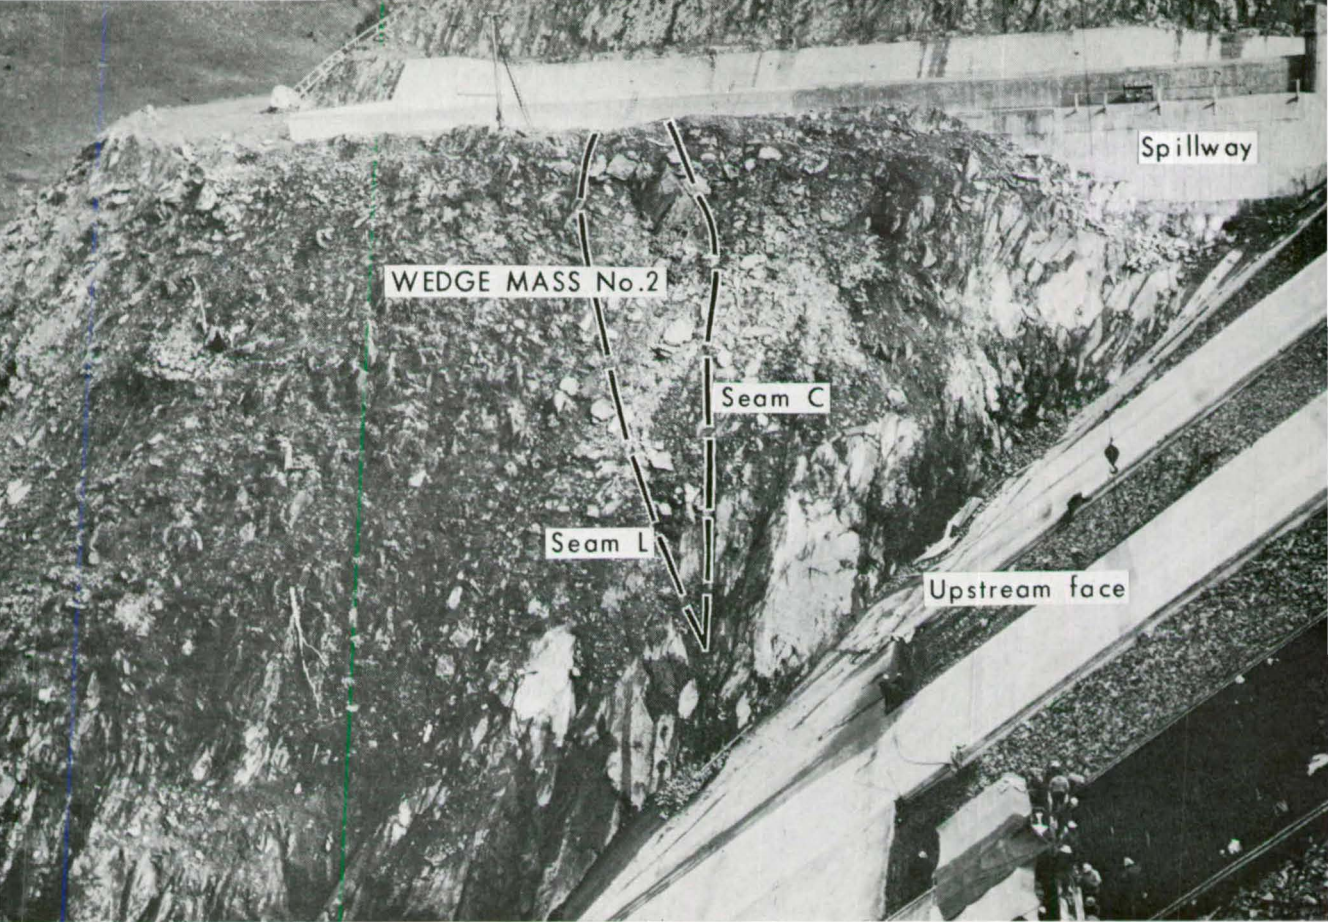
Fig. 75. View of left bank upstream of dam embankment. Wedge mass No. 2 is located between spillway block LB and grout cap, block C.

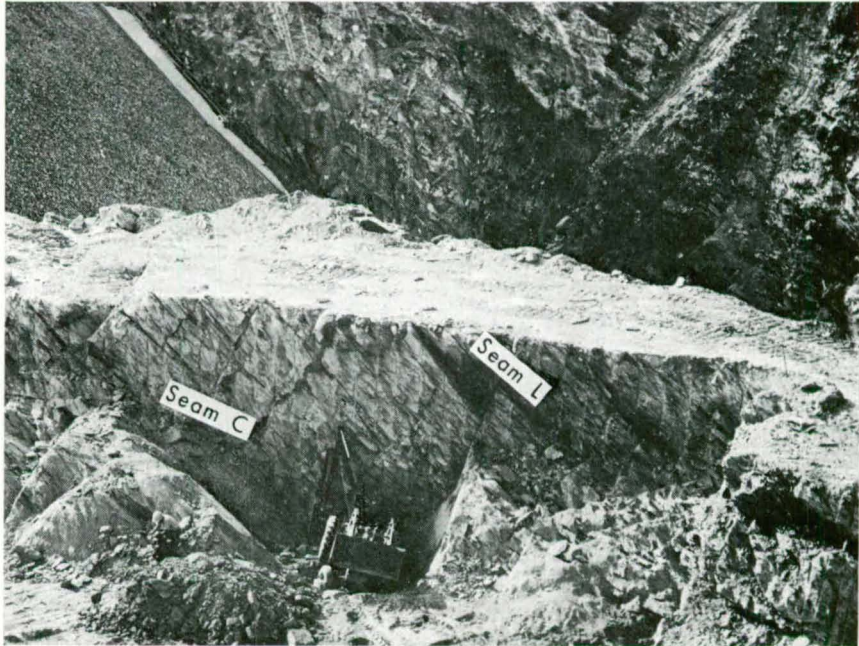
Fig. 76. Excavation of upper part of wedge mass No. 2 in foundation for spillway overflow lip, block LB.

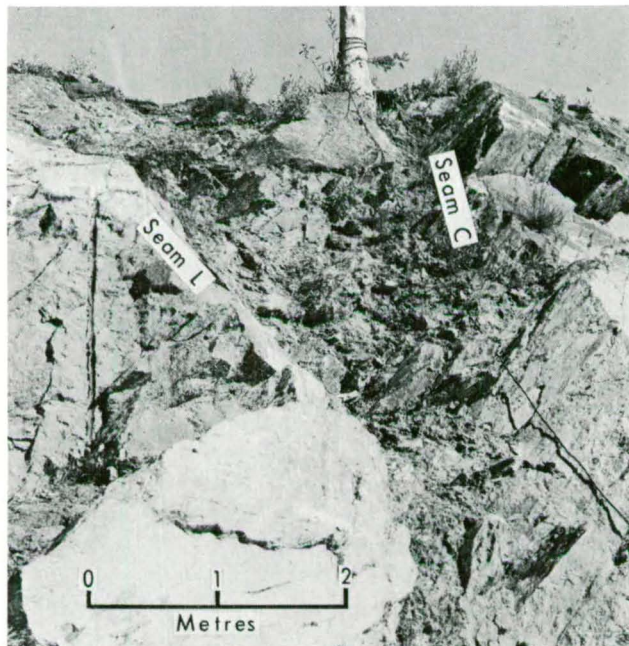
Fig. 77. Lower part of wedge mass No. 2 in grout cap excavation. The wedge toes out 15 feet above grout cap, block C.

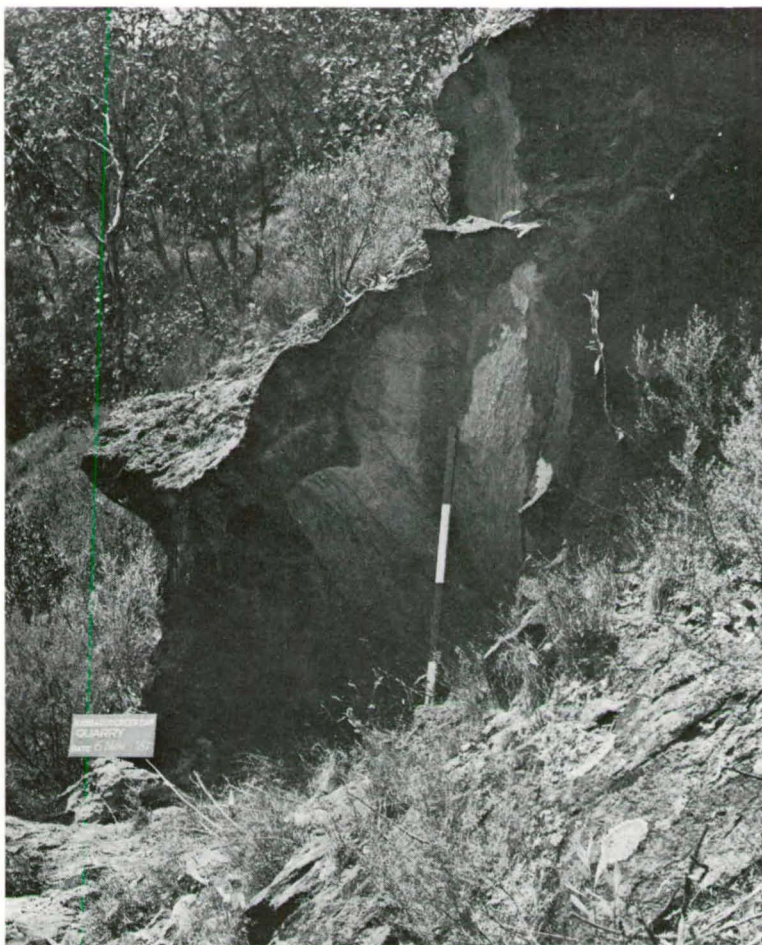
Fig. 80. Natural cave. Inner surface is actively fretting to sand and silt-sized flakes. Site of quarry No. 1.

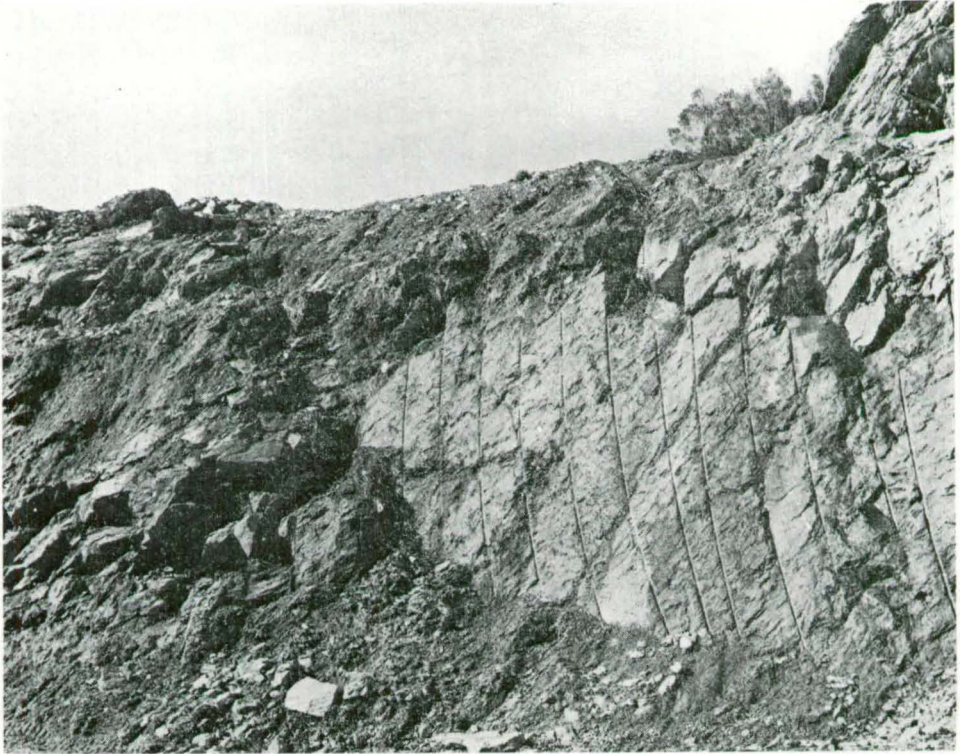
Fig. 86. Part of batter for quarry No. 1, bench 3. Pre-split is almost planar except towards the top of the batter where some overbreak has occurred.

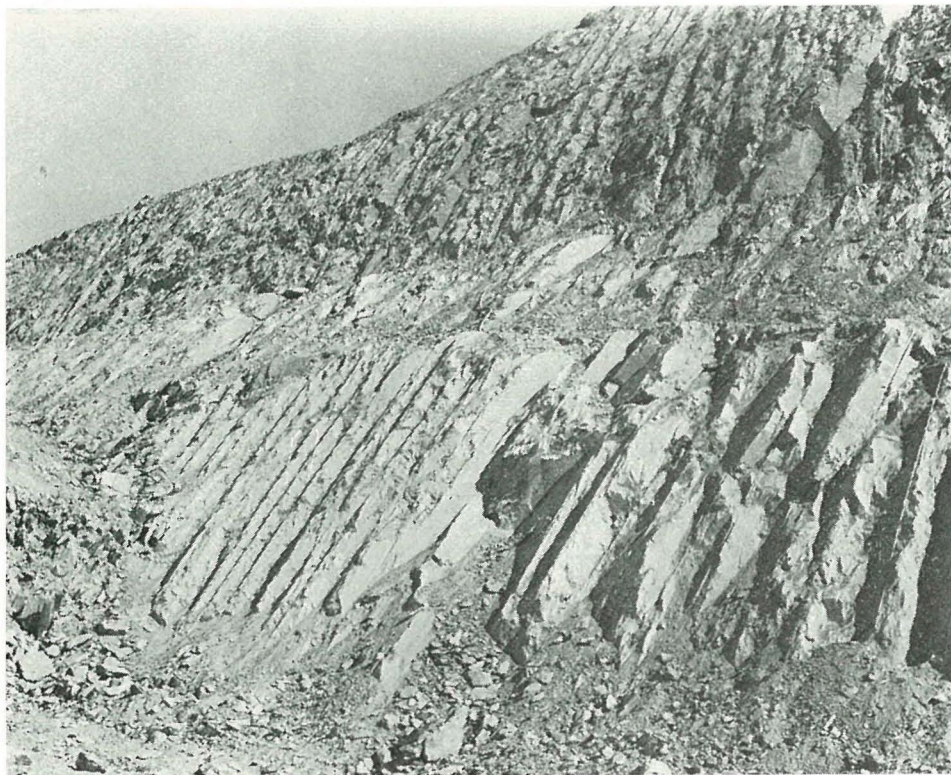
Fig. 87. Part of the upslope (south) wall of the spillway excavation. The pre-split surfaces are uneven, due partly to overbreak along joints and partly to V-shaped breakage between holes.

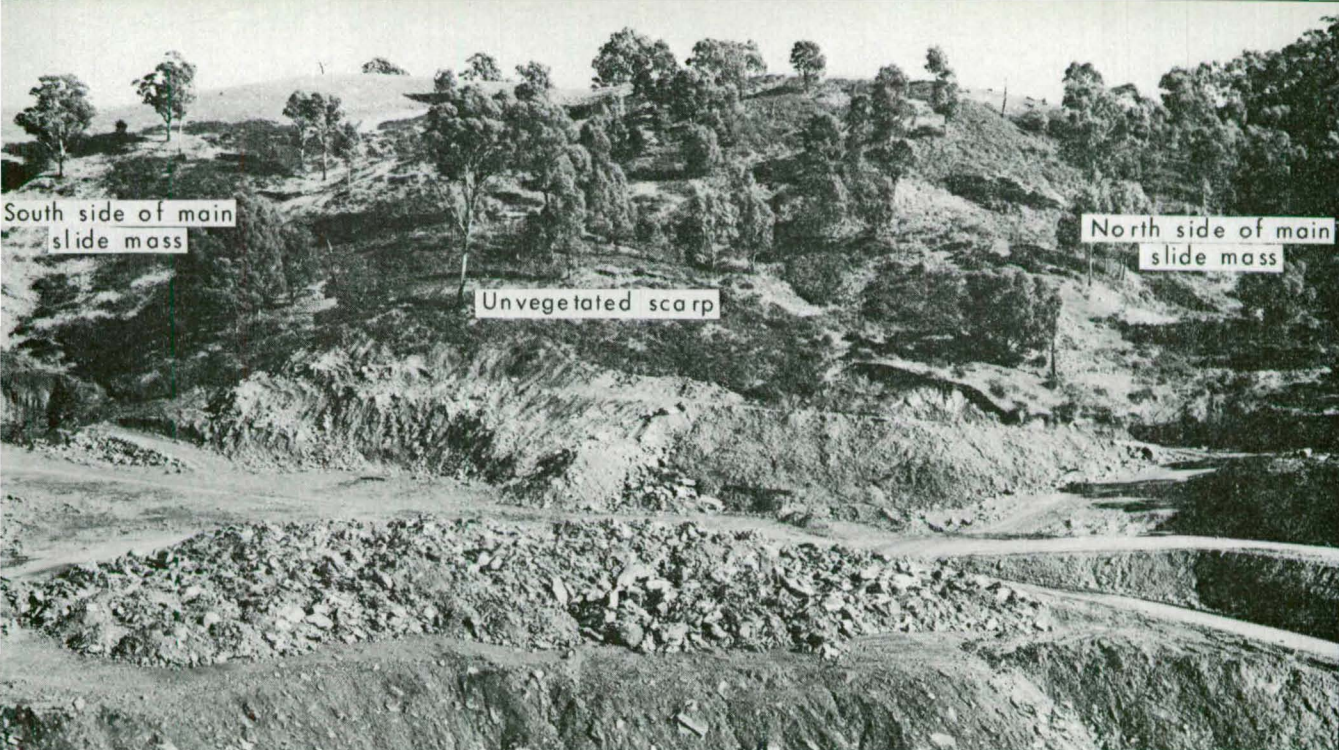
Fig. 89. Large landslide at the head of the gully to the south of the dam. The disposal area in the foreground is mainly above full supply level and supports the toe of the slide.
