Hydrogeological Report on NW Aboriginal Lands well monitoring – October 1998 to April 1999

REPORT BOOK 2000/00005

Department for Water Resources, Groundwater

FEBRUARY 2000

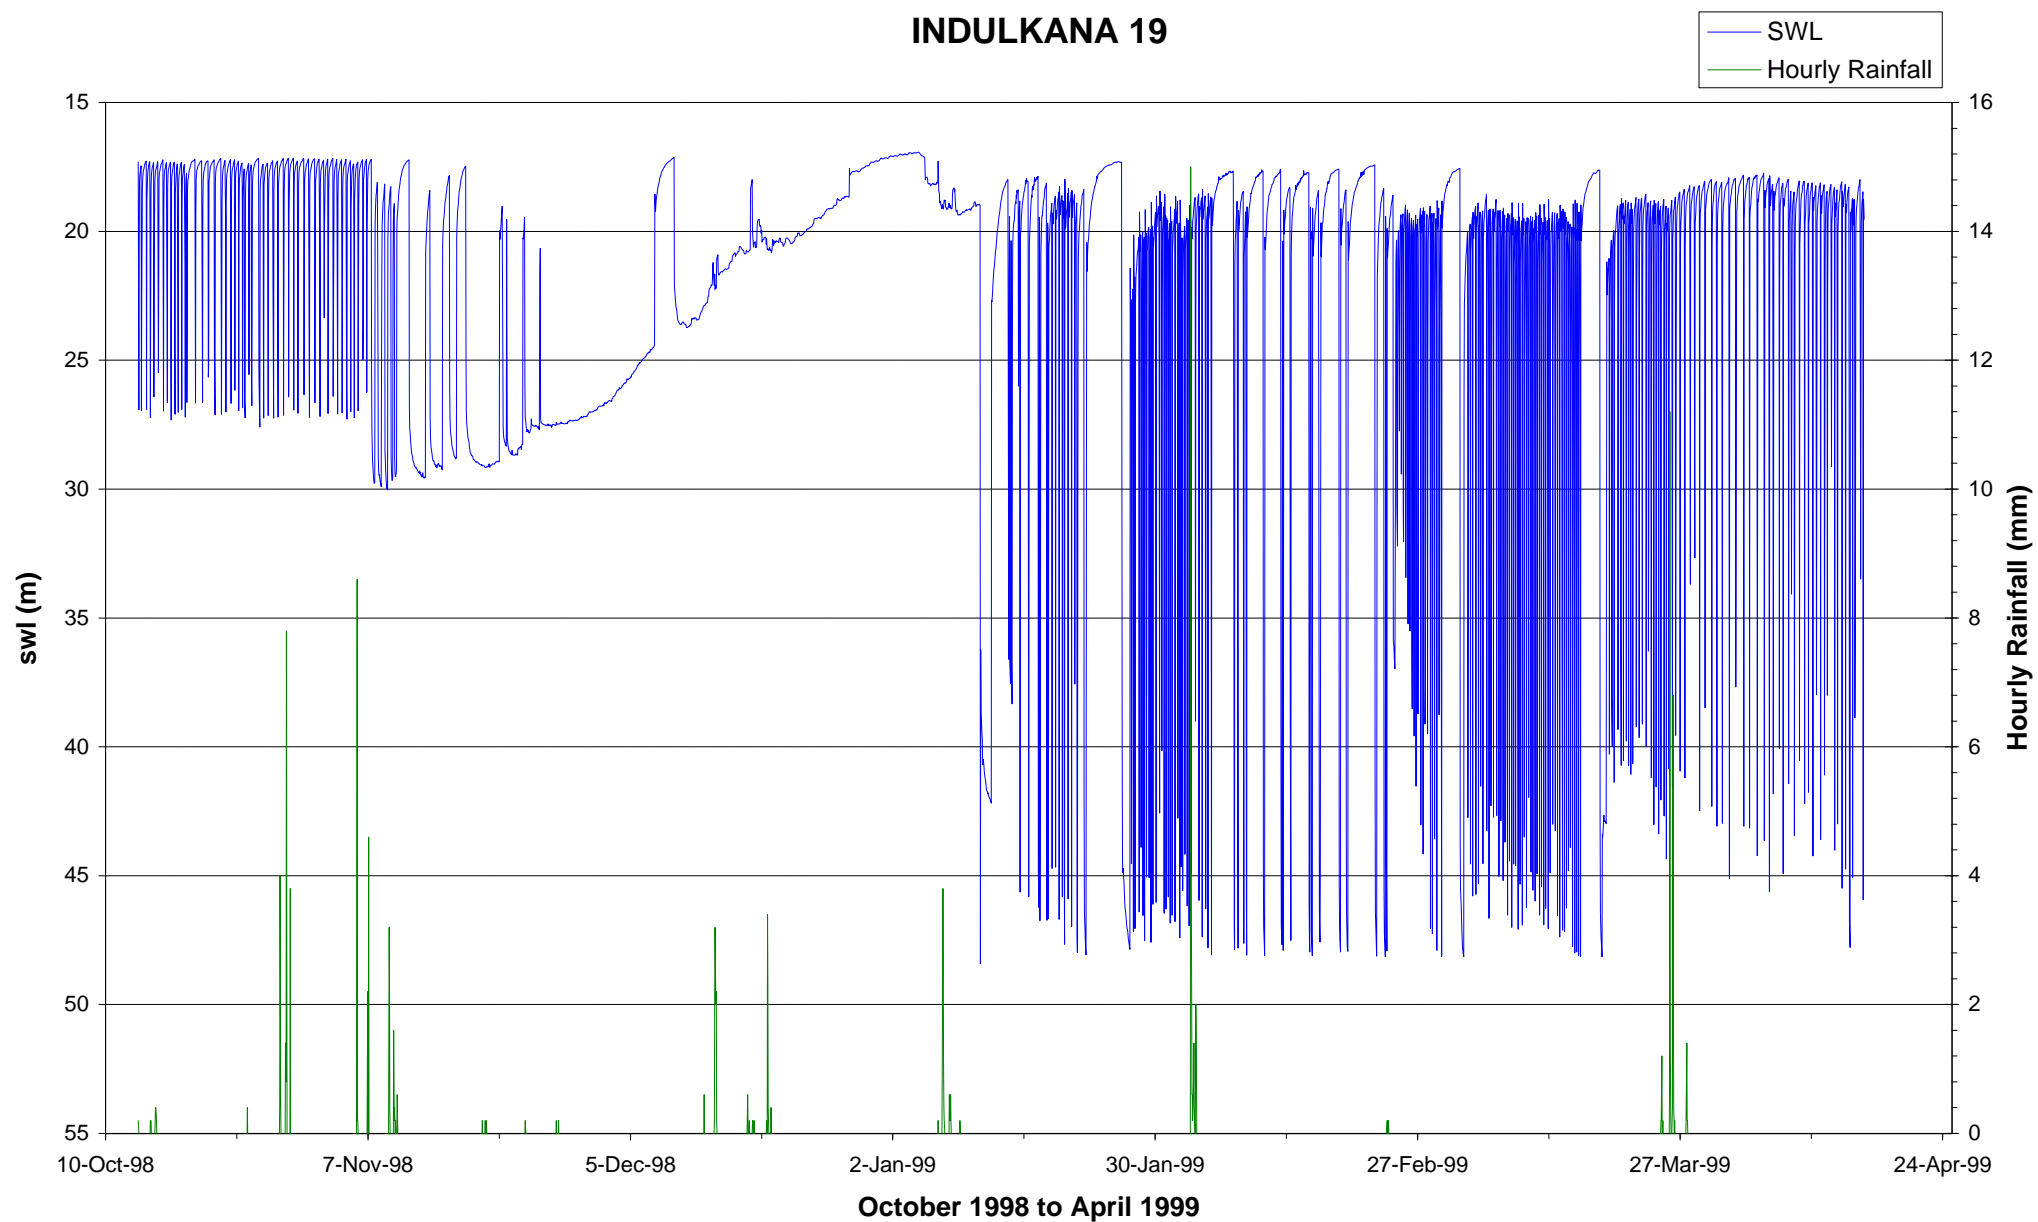
Figure 3 Indulkana Rainfall - October 1998 to April 1999

Rainfall. The rainfall gauge on 19 shows significant falls intermittently through this period, but no sustained periods of rain such as would be ideal for recharge. There is no obvious recharge indication in any well.

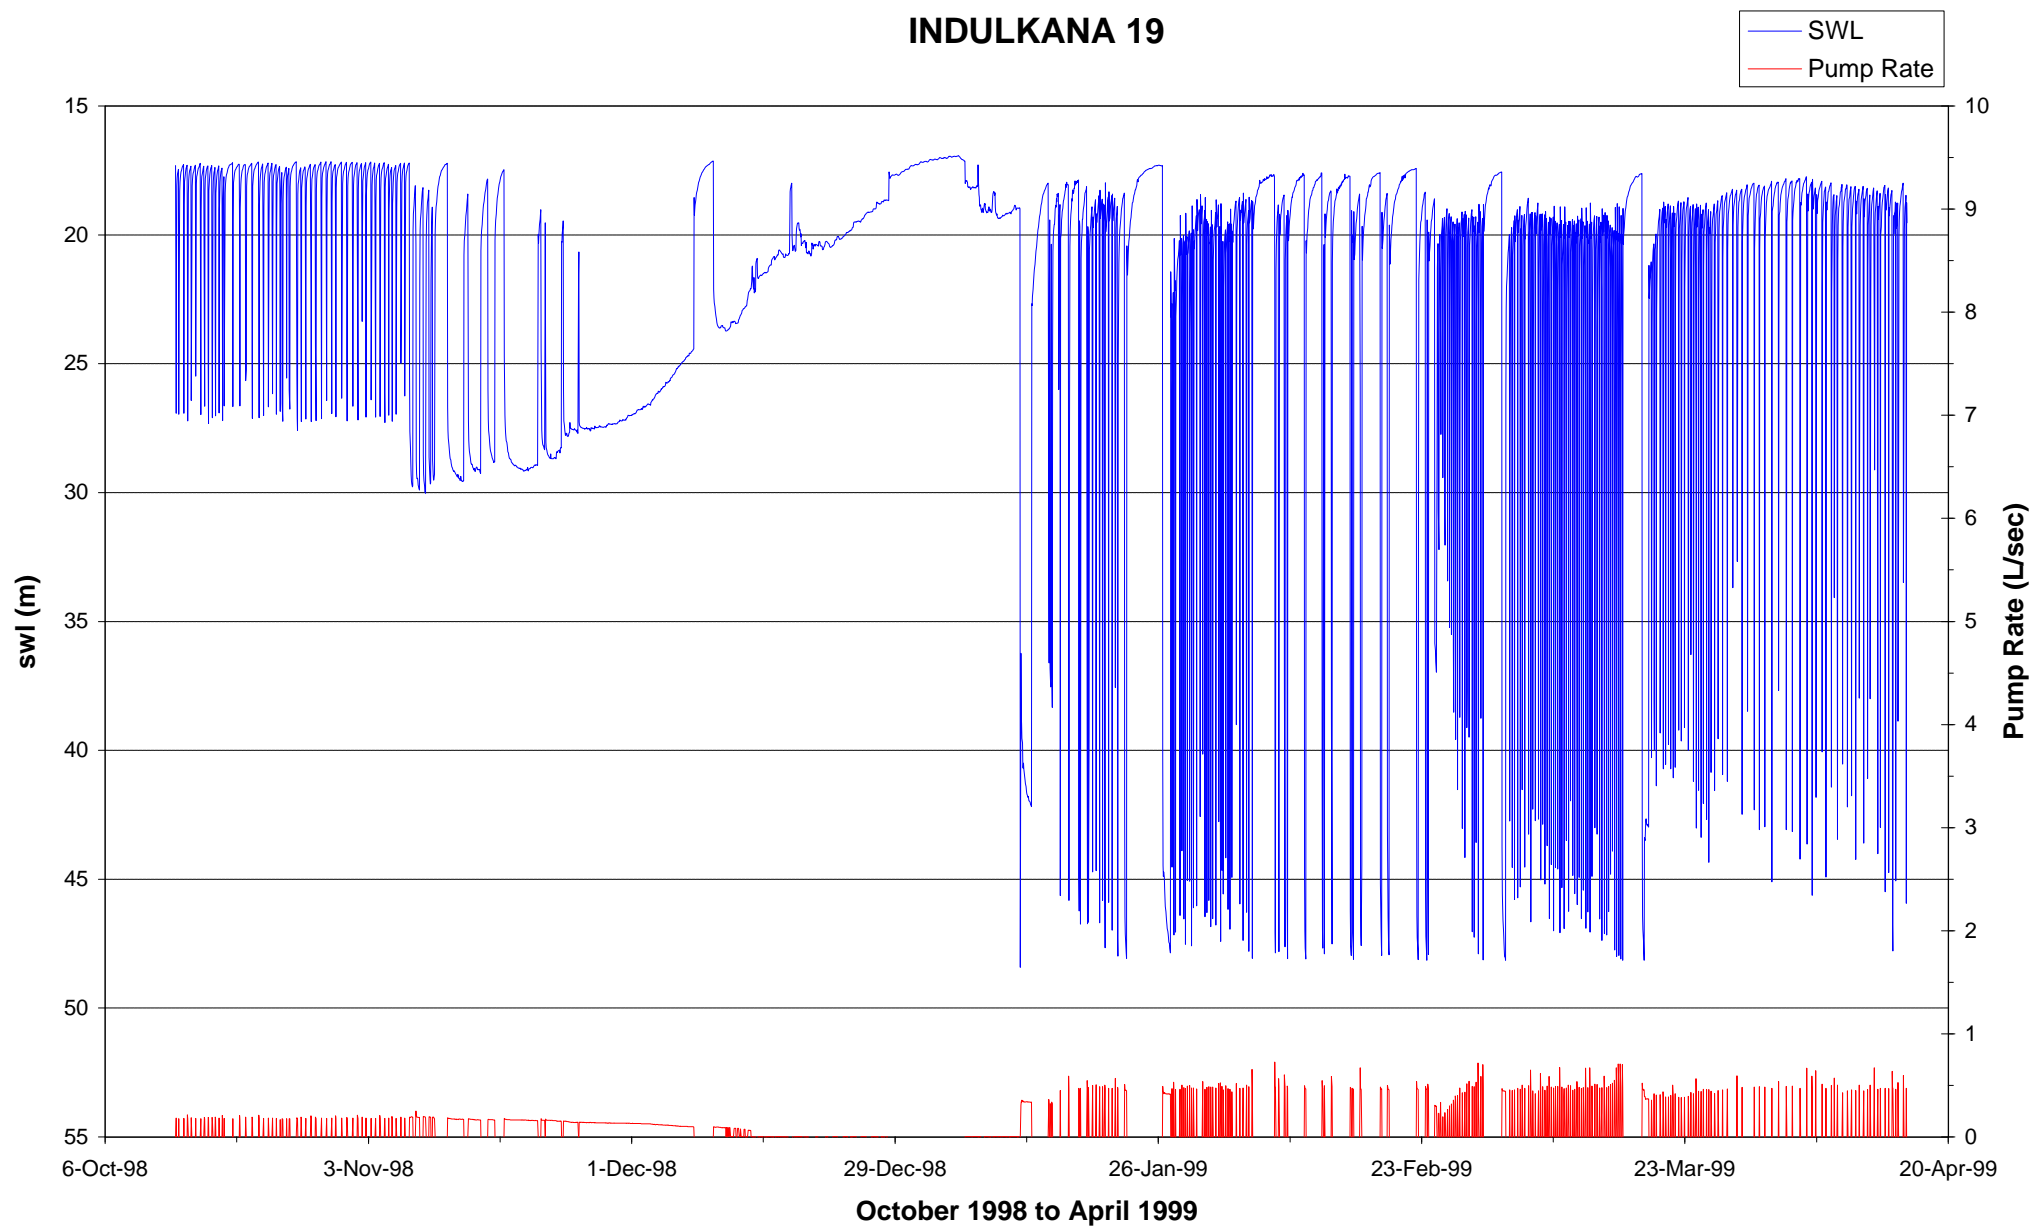
Figure 4 Indulkana IMB-19; Hourly SWL and Pump Rate

Well 19. While there is no indication of depletion in this period, the well is showing a high response to the pumping rate of ~0.6 L/s. This has long term implications. The slow recovery of the well in the second half of December is caused by pumping at such a low rate as to be invisible on the graph (0.001–0.002 L/s).

| BORE | SWL(Actual) | SWL(logger) | Flowrate | Accumulated Flow m ³ |
|---|---|---|---|---|
| 19 | 16.660 | 16.660 | 0.64 | 954.133 |

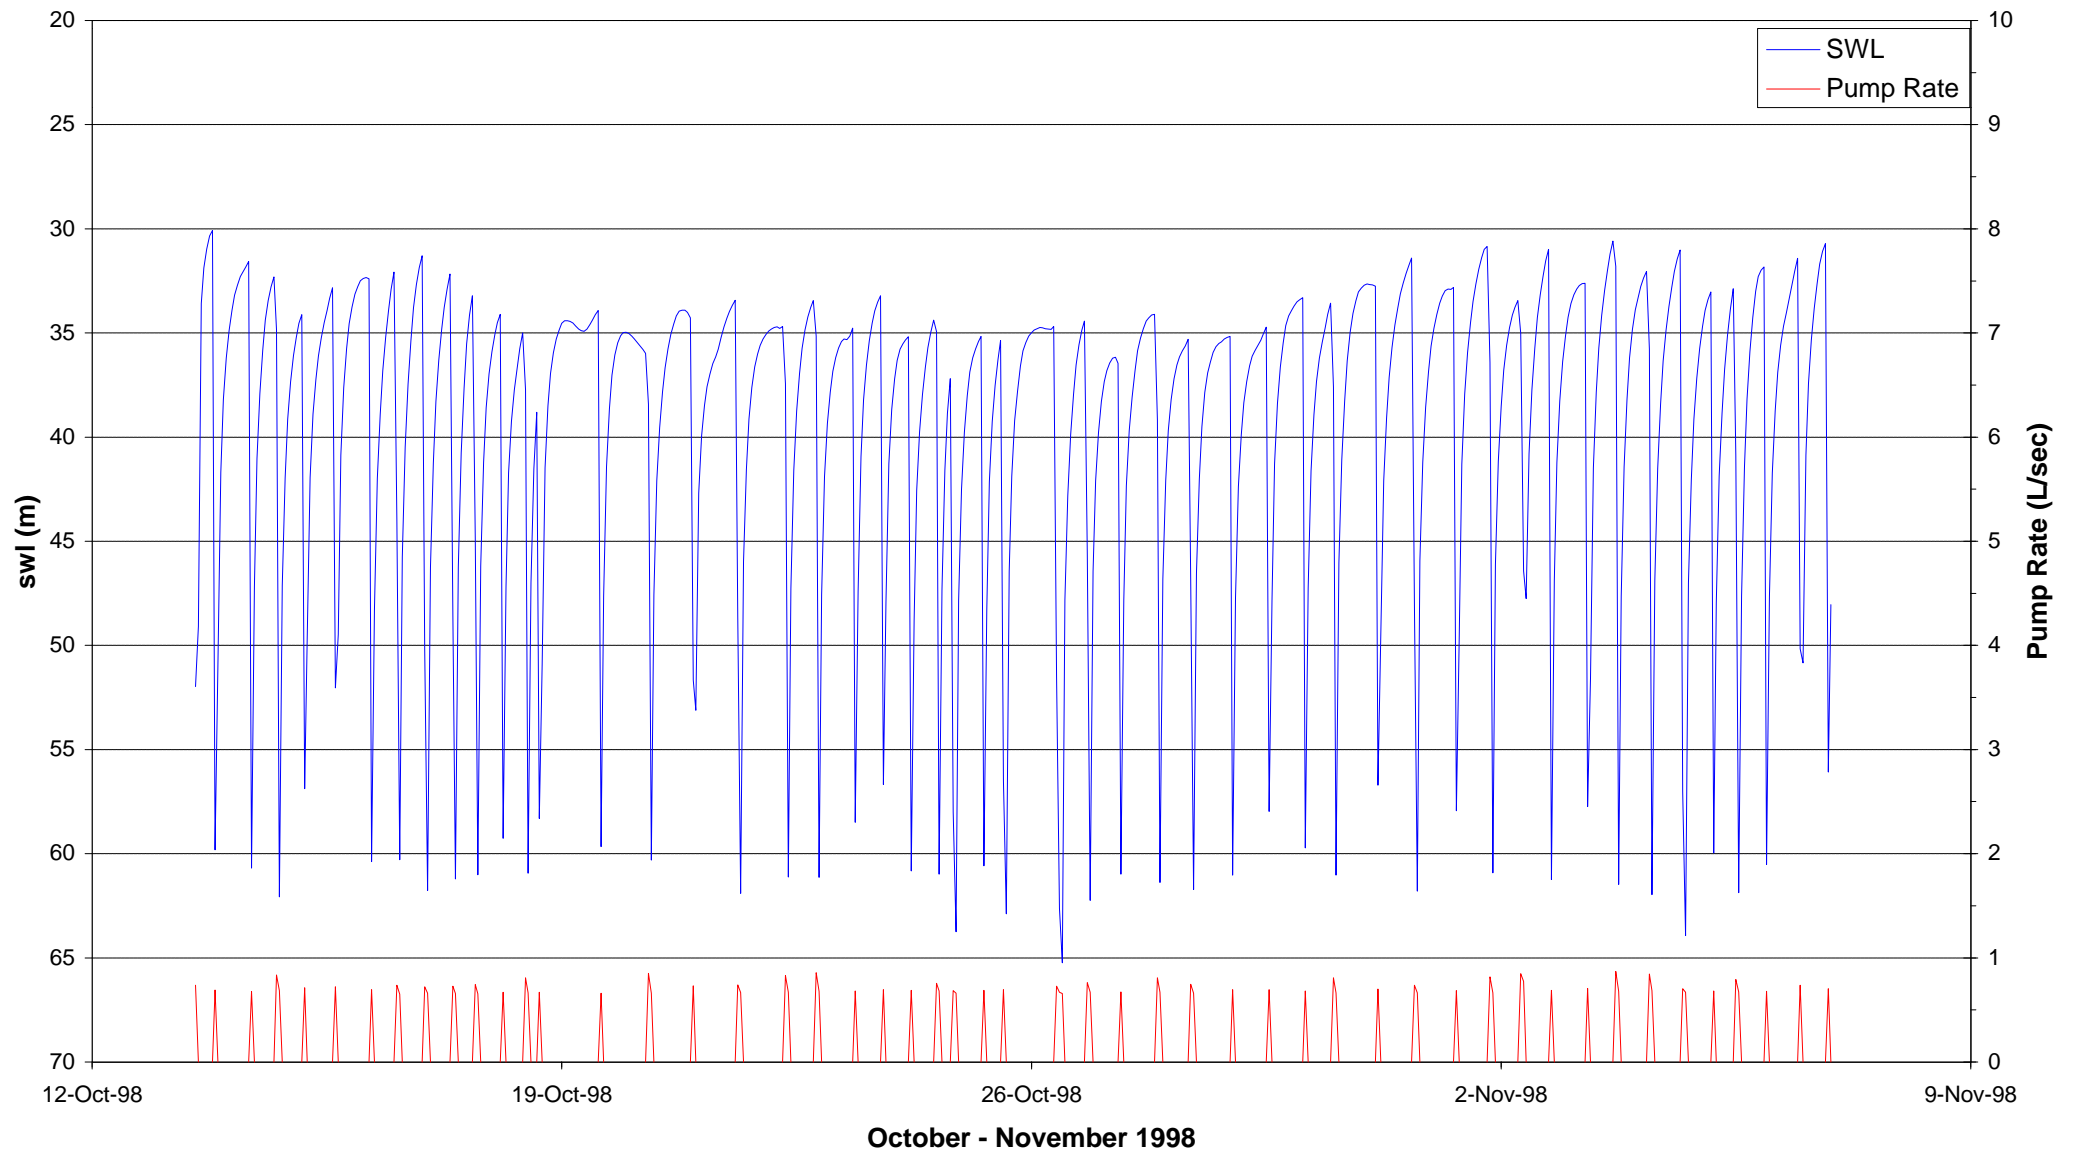
Figure 5 Indulkana IMB-19A; Hourly SWL and Pump Rate

Well 19A. The failure of the logger in November 1998 resulted in too small a data set to show long term trends. However, the well is evidently being pumped dry within two hours at the currently used rate of 0.8 L/s and never fully recovers in the intervening 12 hours. The long term effects of this may be evident in the next download of data over a full 6 months.

- 19A Data logger was unable to communicate. Data logger S/N 311183 was removed and replaced with logger S/N 311208.
 The flow meter was also faulty with no 4–20mA output. The faulty unit S/N A97–79248 was removed and replaced with spare S/N 912498 D.
 The data logger had stopped logging after 2200 hours on the 6 November 1998, this corresponds to the commencement of rainfall at bore 19 and may well have been caused by a lightning strike.

- Equipment failures resulted in some lost data at:
 - Indulkana 19A data logger required a replacement fuse, but the flow meter was removed and returned for repair, the failures were probably caused by a lightning strike.

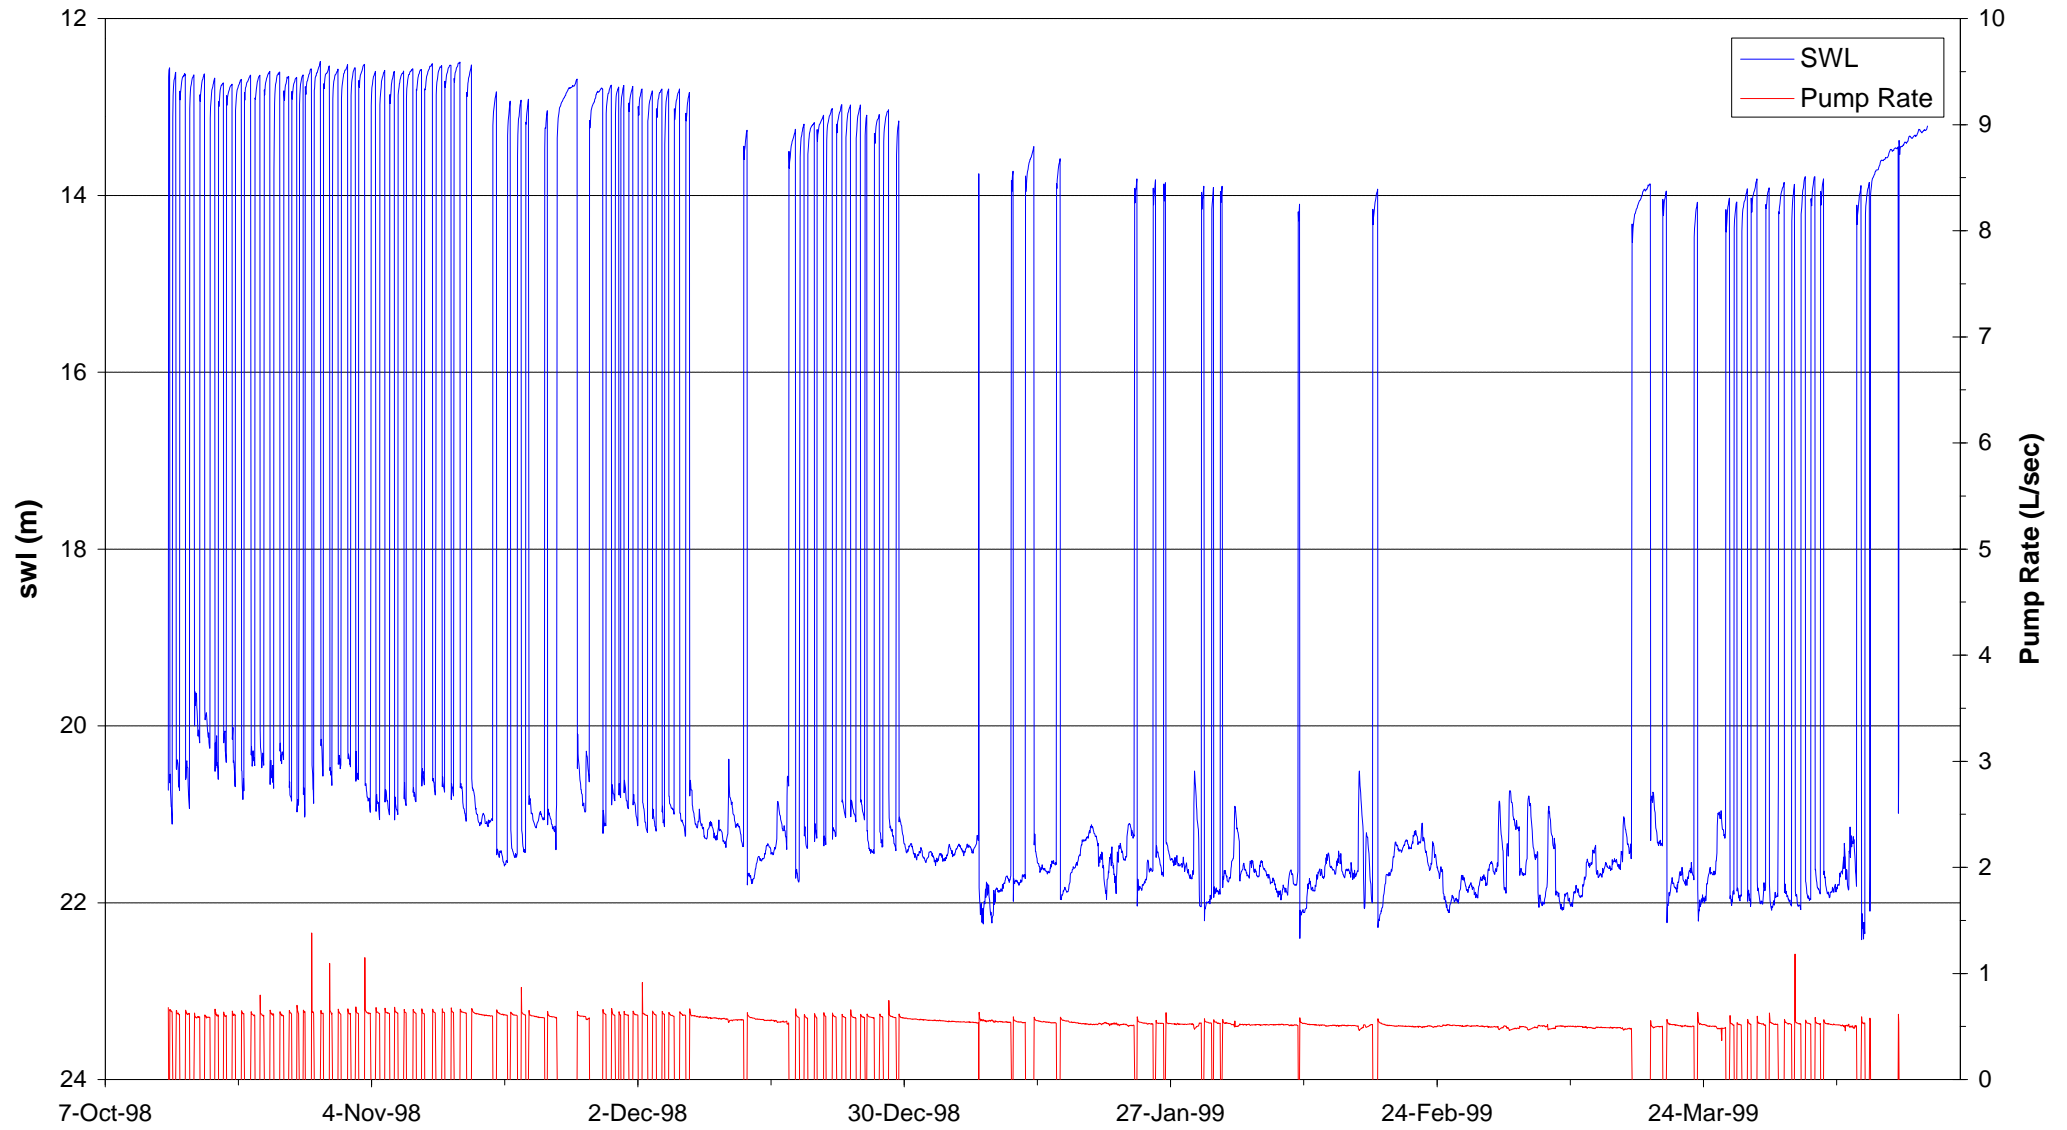
Figure 6 Indulkana IMB-25; Hourly SWL and Pump Rate

Well 25. This well, the major water supplier in the area, is showing evidence of slow depletion, but has stood up well to steady pumping. Prior to recovery in April 1999 in response to a week without pumping, the water levels had declined by over a metre for the period. The well appears capable of sustaining current pumping rates.

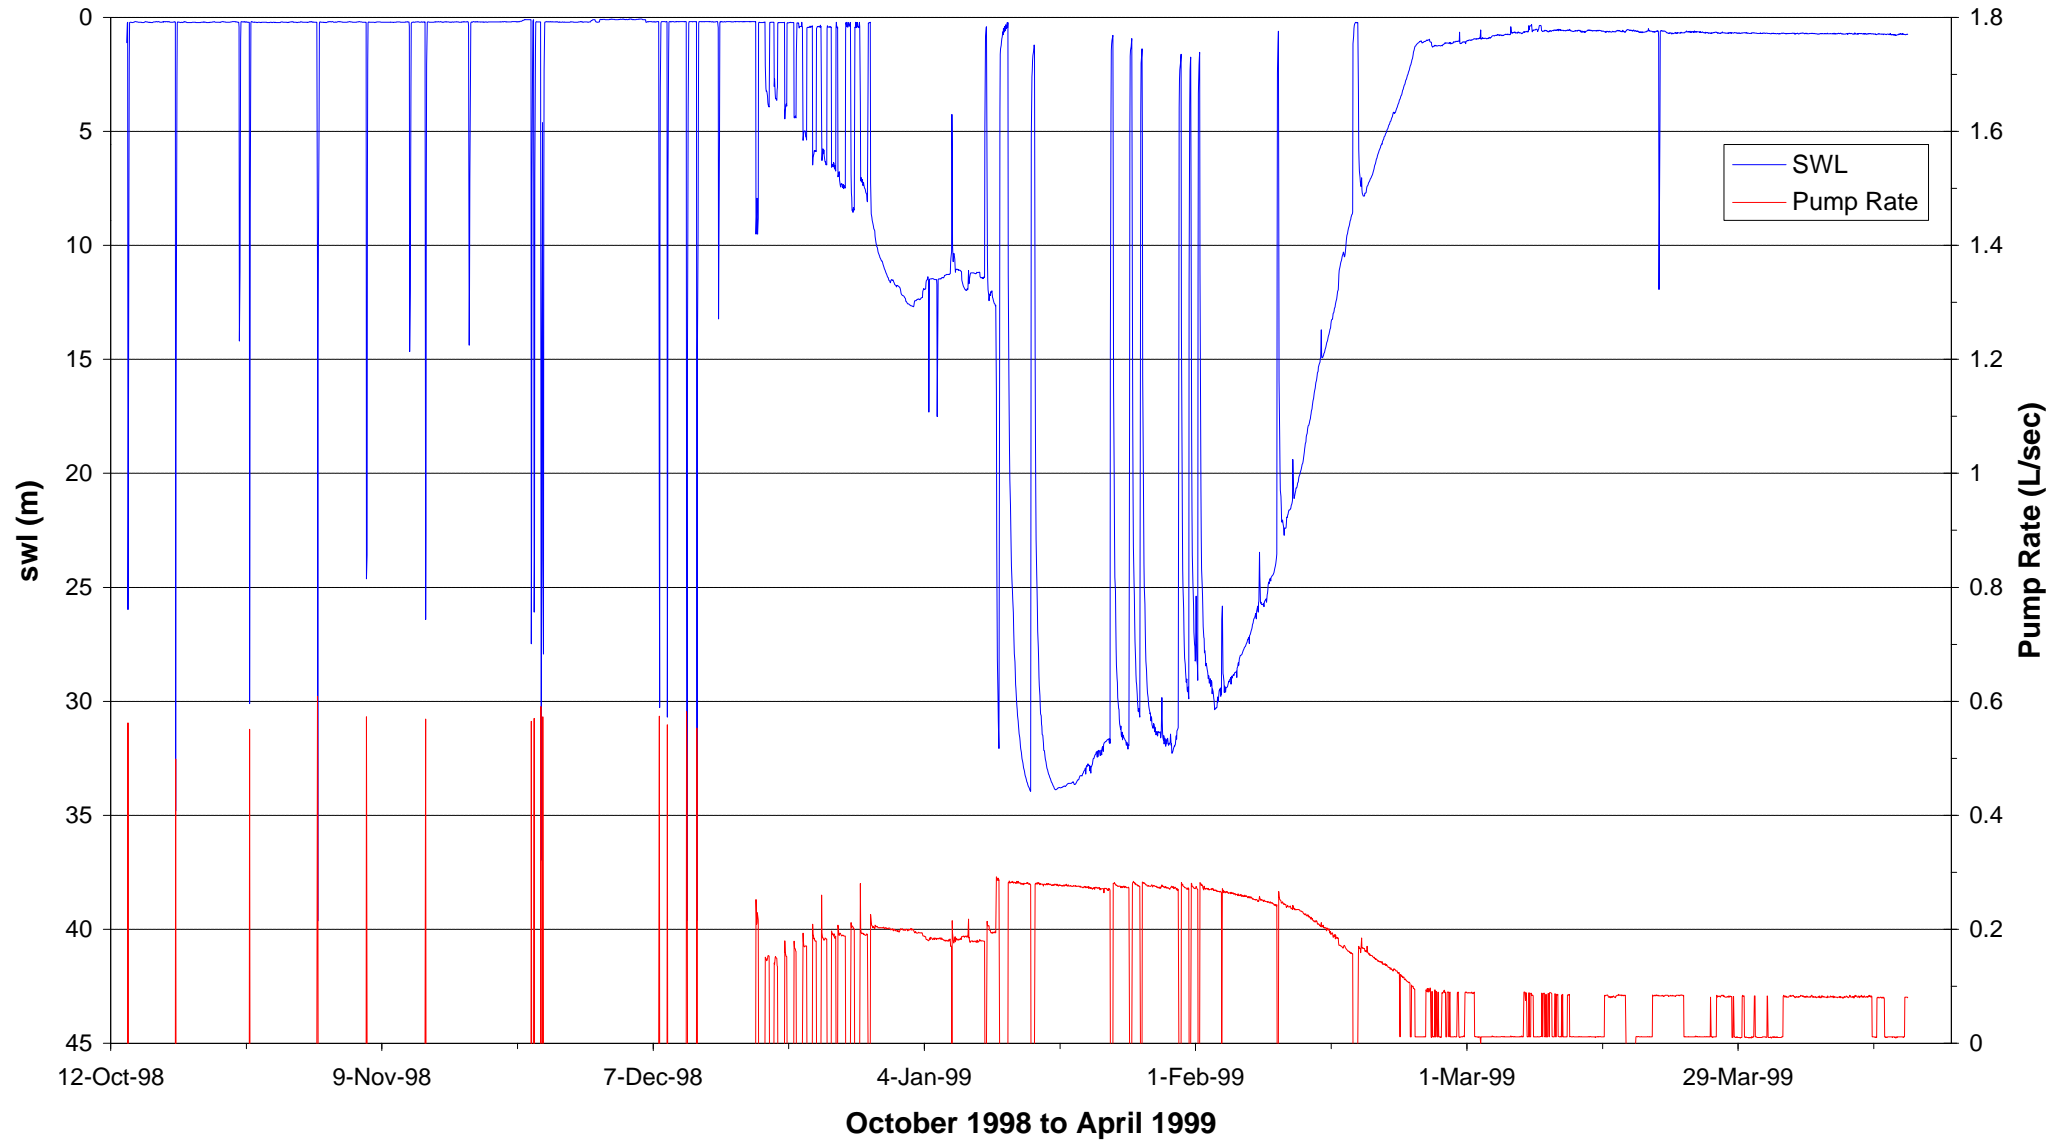
Figure 7 Indulkana IMB-26; Hourly SWL and Pump Rate

Well 26. No depletion; the well seems satisfactory so long as pumping rates are kept low. The well shows a high response to pumping rates of ~0.6 L/s, but minimal response to rates of 0.1 L/s.

- 26 SWL datum may have been set to 39.097 m, the set up of this bore will need to be closely checked at the next site visit. The pump in this bore has deteriorated substantially since February 1999 which can be seen by the drop off in flow rate. I understand the pump has recently been replaced.

- It appears that two sites may have had SWL datum set incorrectly due to operating errors and will also have to be checked during the next trip. Ernabella E44, and Indulkana I26 bores.

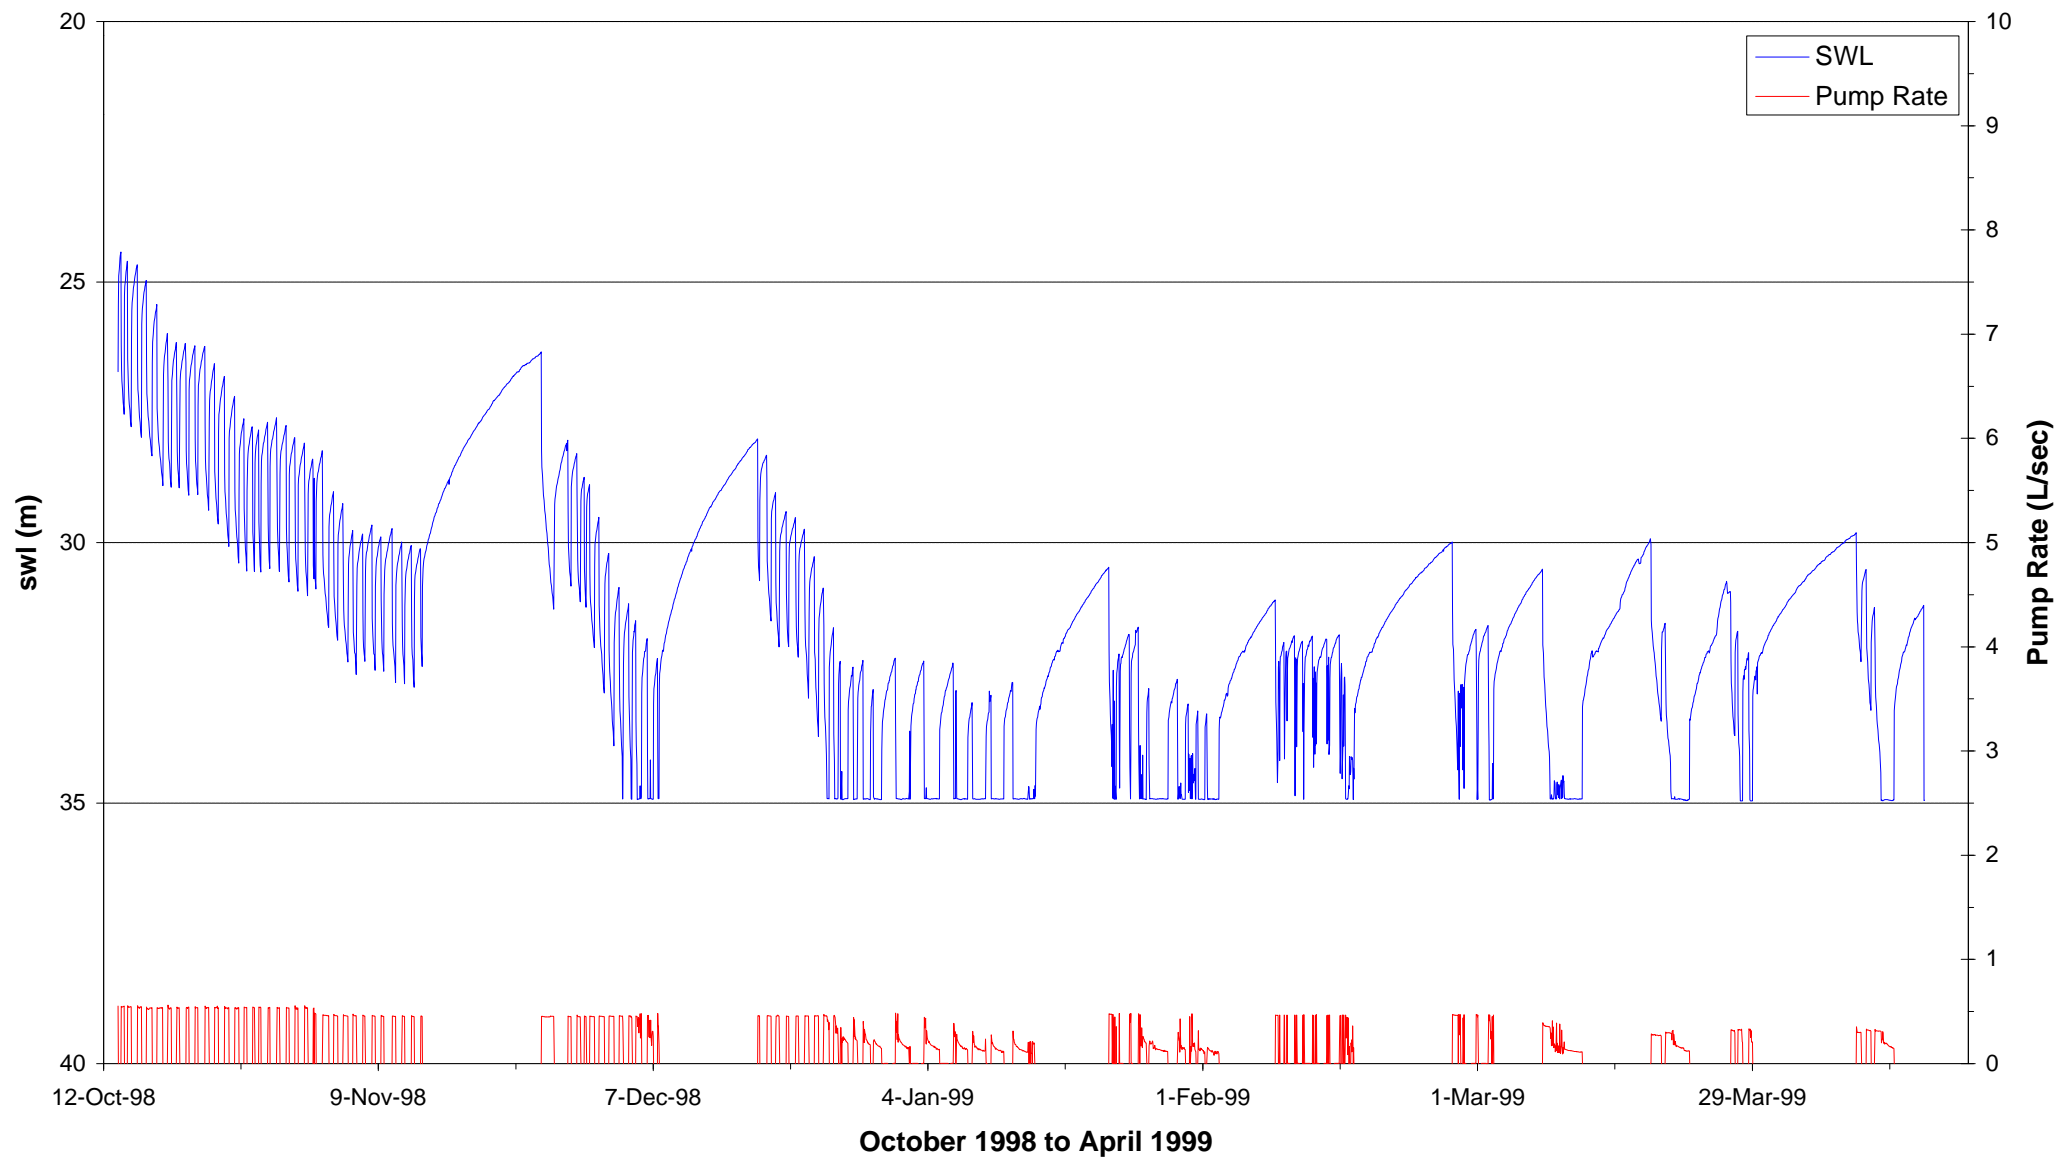
Figure 8 Indulkana IMB-27; Hourly SWL and Pump Rate

Well 27. The well is bottoming out in spite of low and intermittent pumping rates. The water level fell by over 5 m over the monitoring period.

- 27 SWL datum was reset by 0.045 m.
 It appears that this bore has been over pumped and should be isolated and given time to recover.
- IR1 The new bore Indulkana Range 1 SWL was measured but there is no monitoring equipment installed. The bore has a temporary power supply and pipe line to the community system.

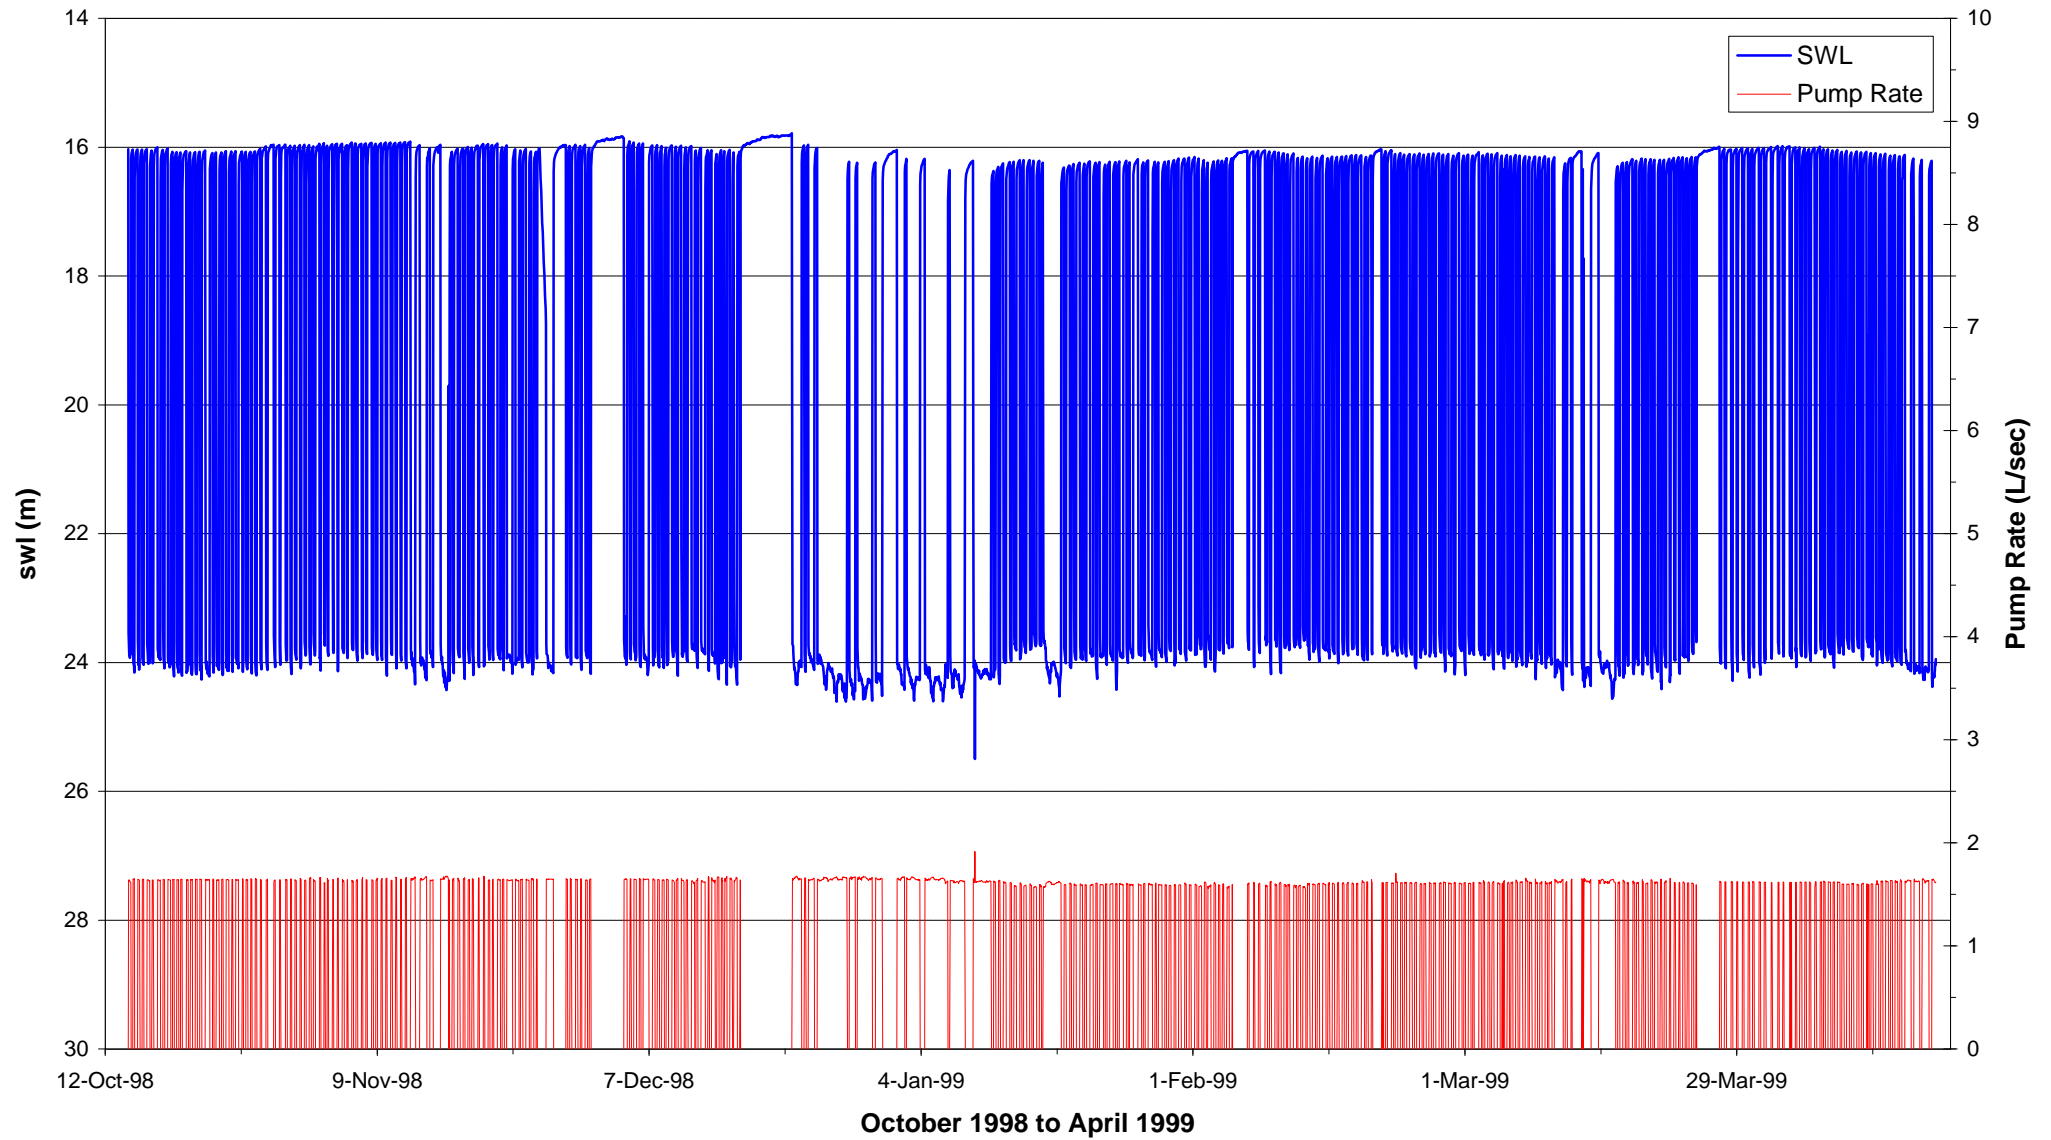
Figure 11 Mimili M-1; Hourly SWL and Pump Rate

Well M1. No sign of depletion at these pumping rates.

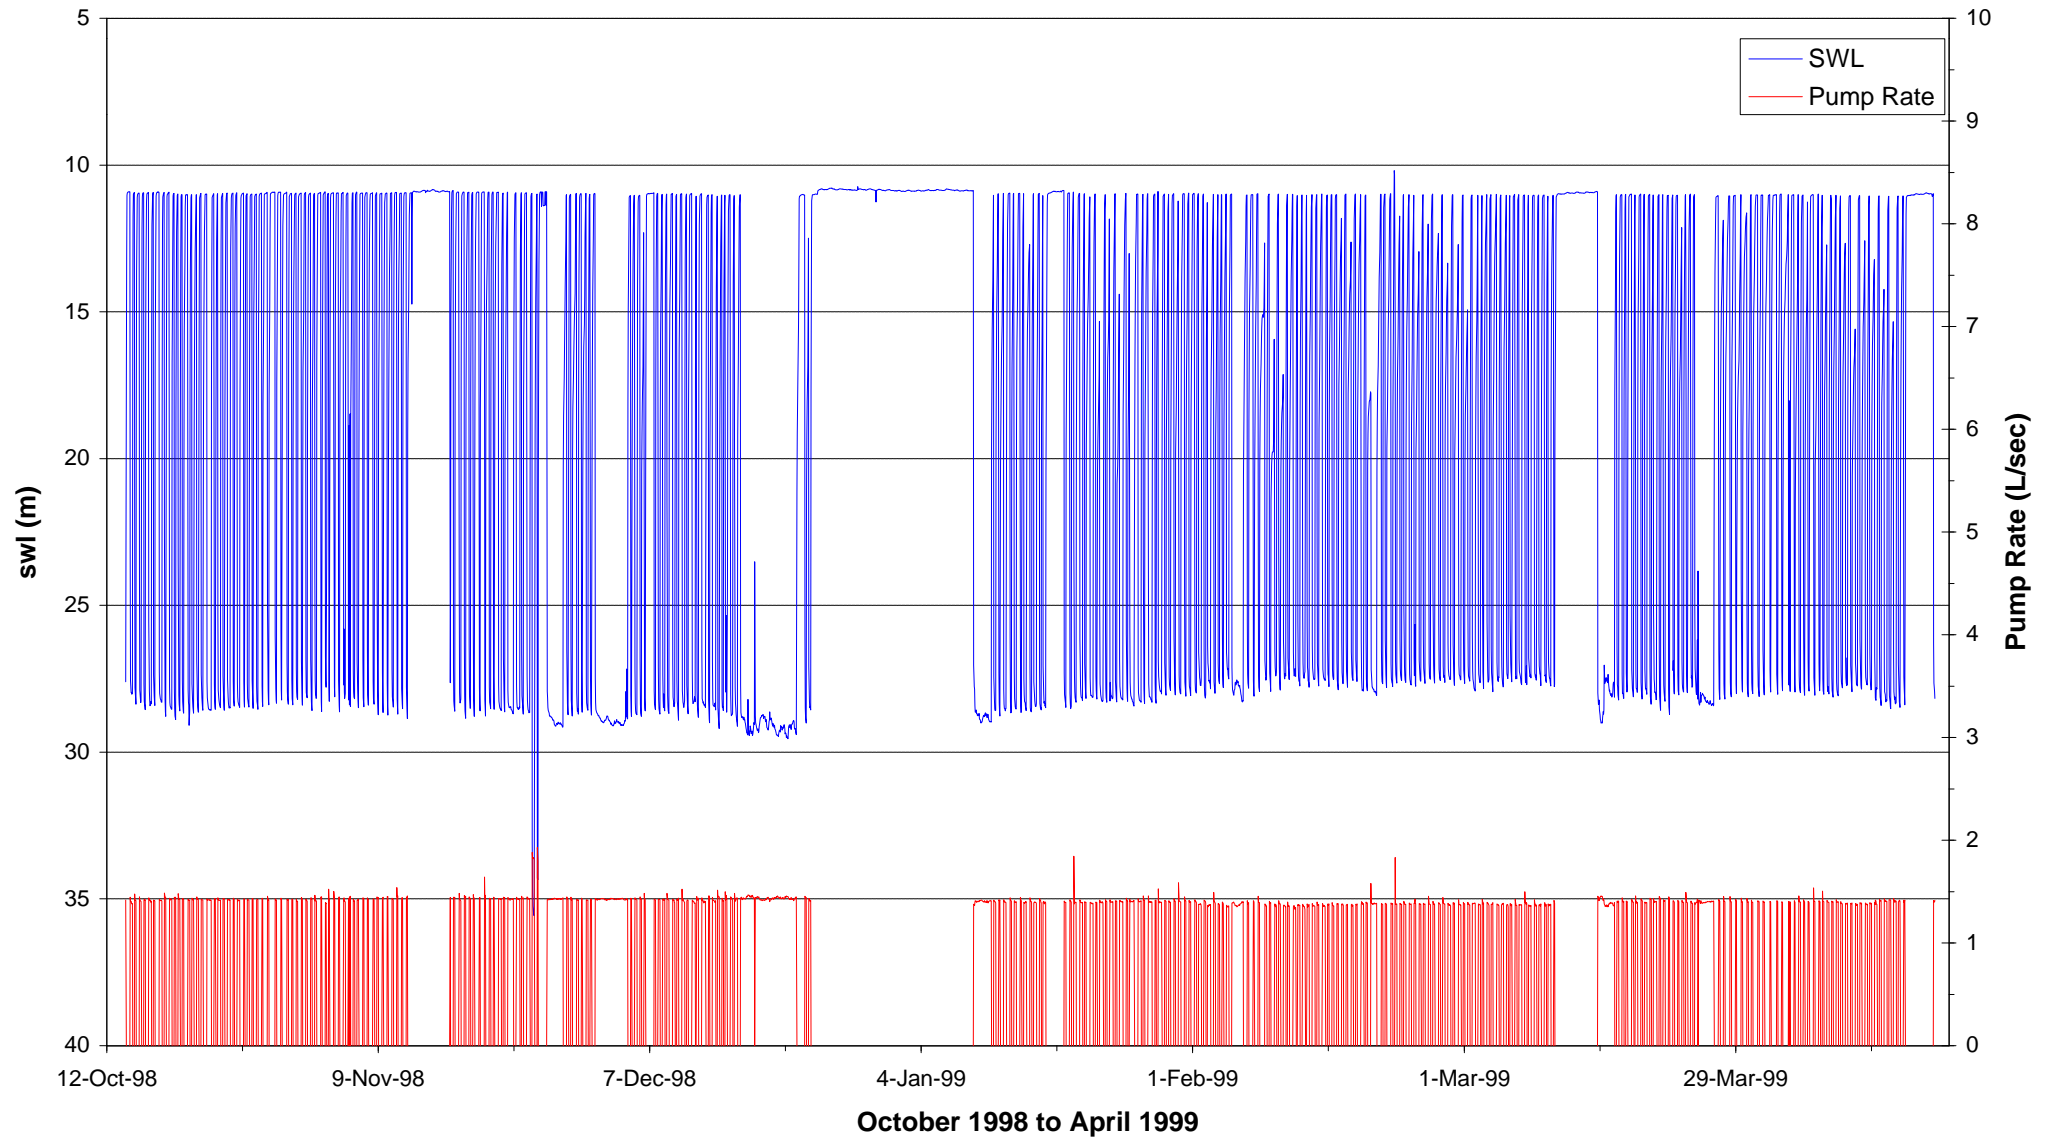
Figure 12 Mimili M-3; Hourly SWL and Pump Rate

Well M3. No sign of depletion at these pumping rates.

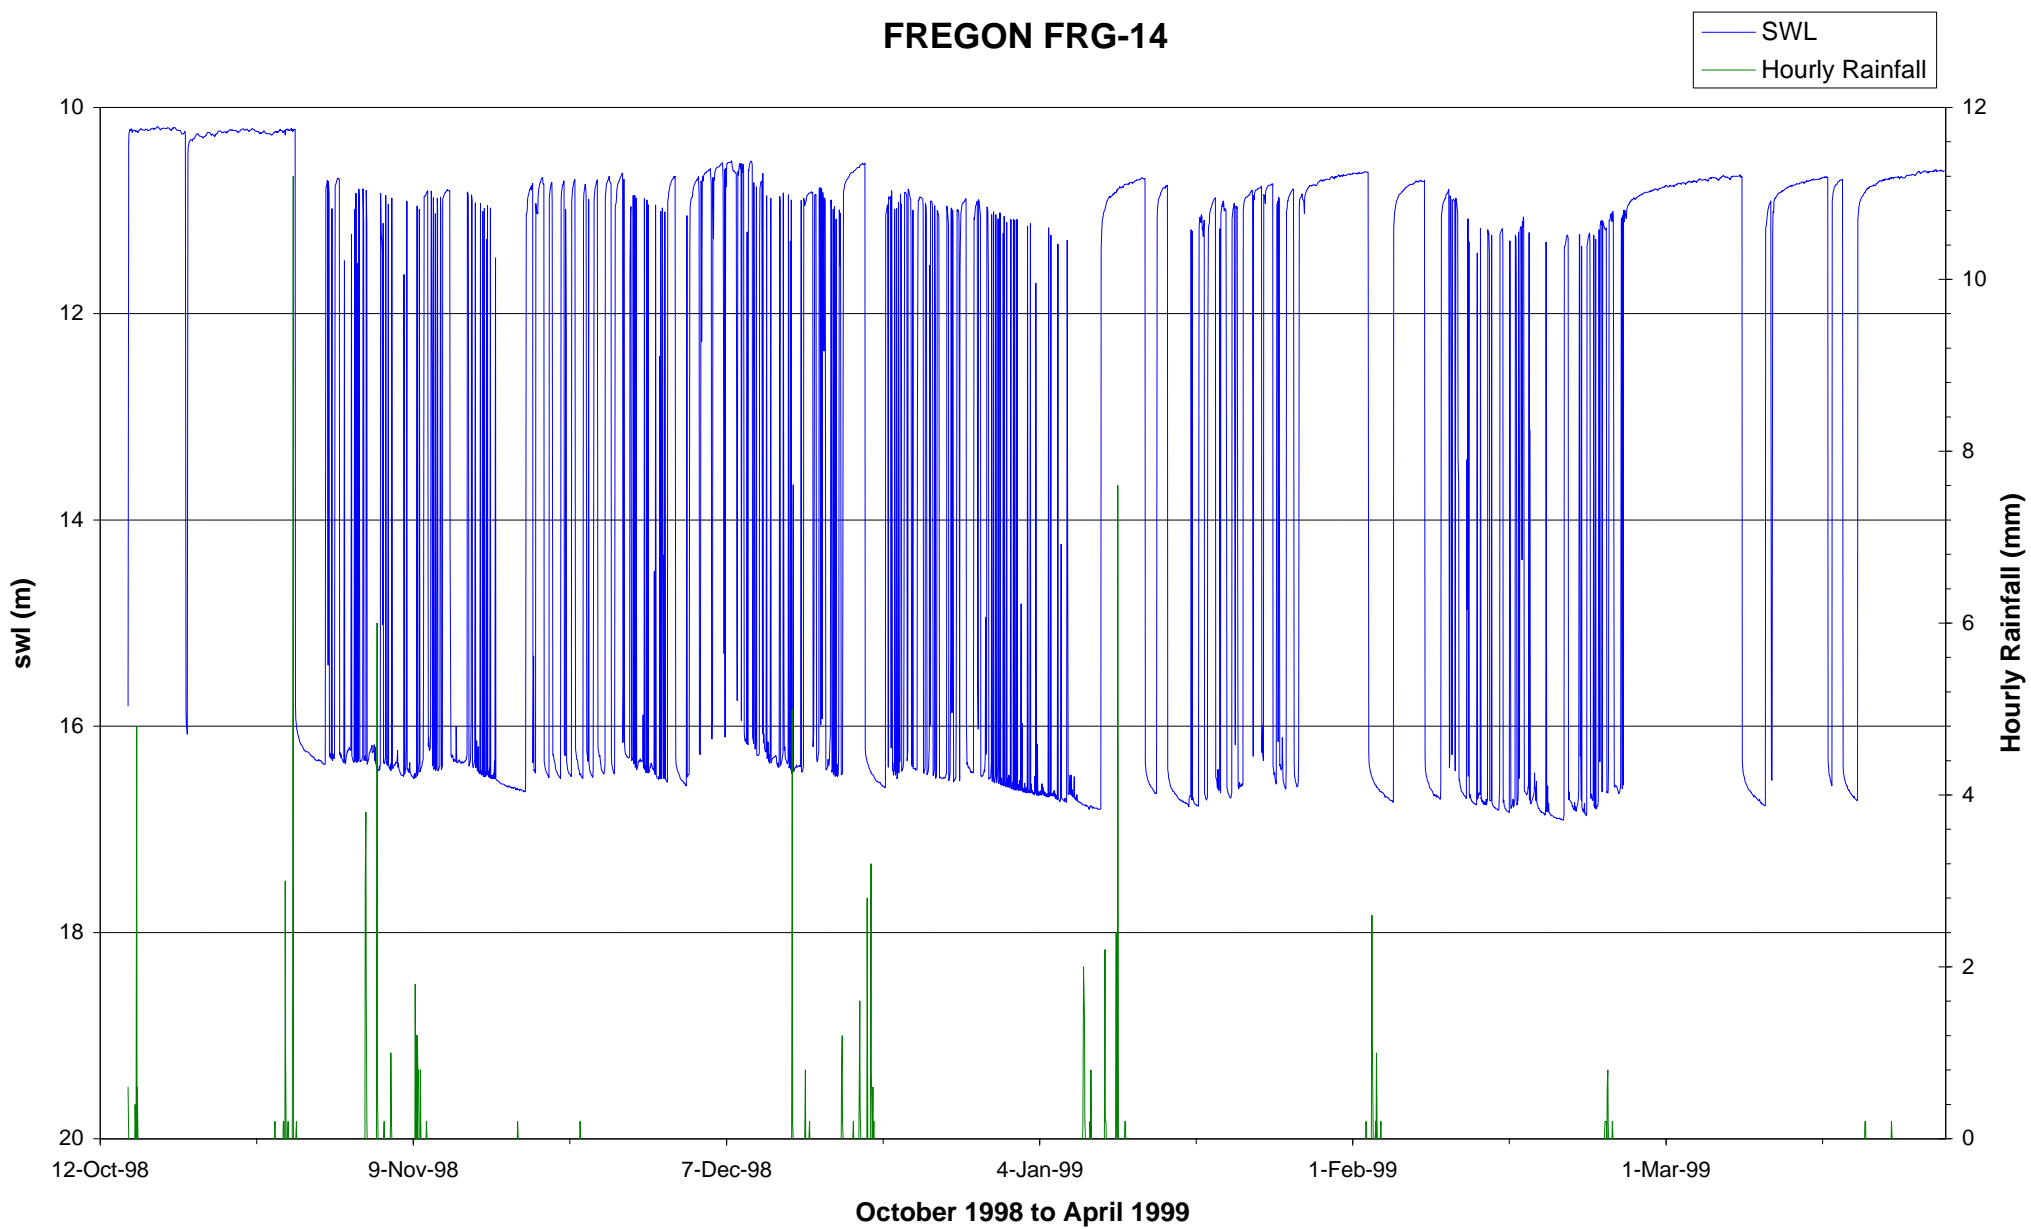
Figure 14 Fregon Rainfall - October 1998 to April 1999

Rainfall. There were intermittent falls in this period, but less than occurred at Indulkana or Mimili.

Rain gauge reading at bore FRG 14 was 97.2 mm from 14 October 1998 to 25 March 1999 when the logger failed.
