Hydrogeological Report on NW Aboriginal Lands well monitoring – October 1998 to April 1999

REPORT BOOK 2000/00005

Department for Water Resources, Groundwater

FEBRUARY 2000

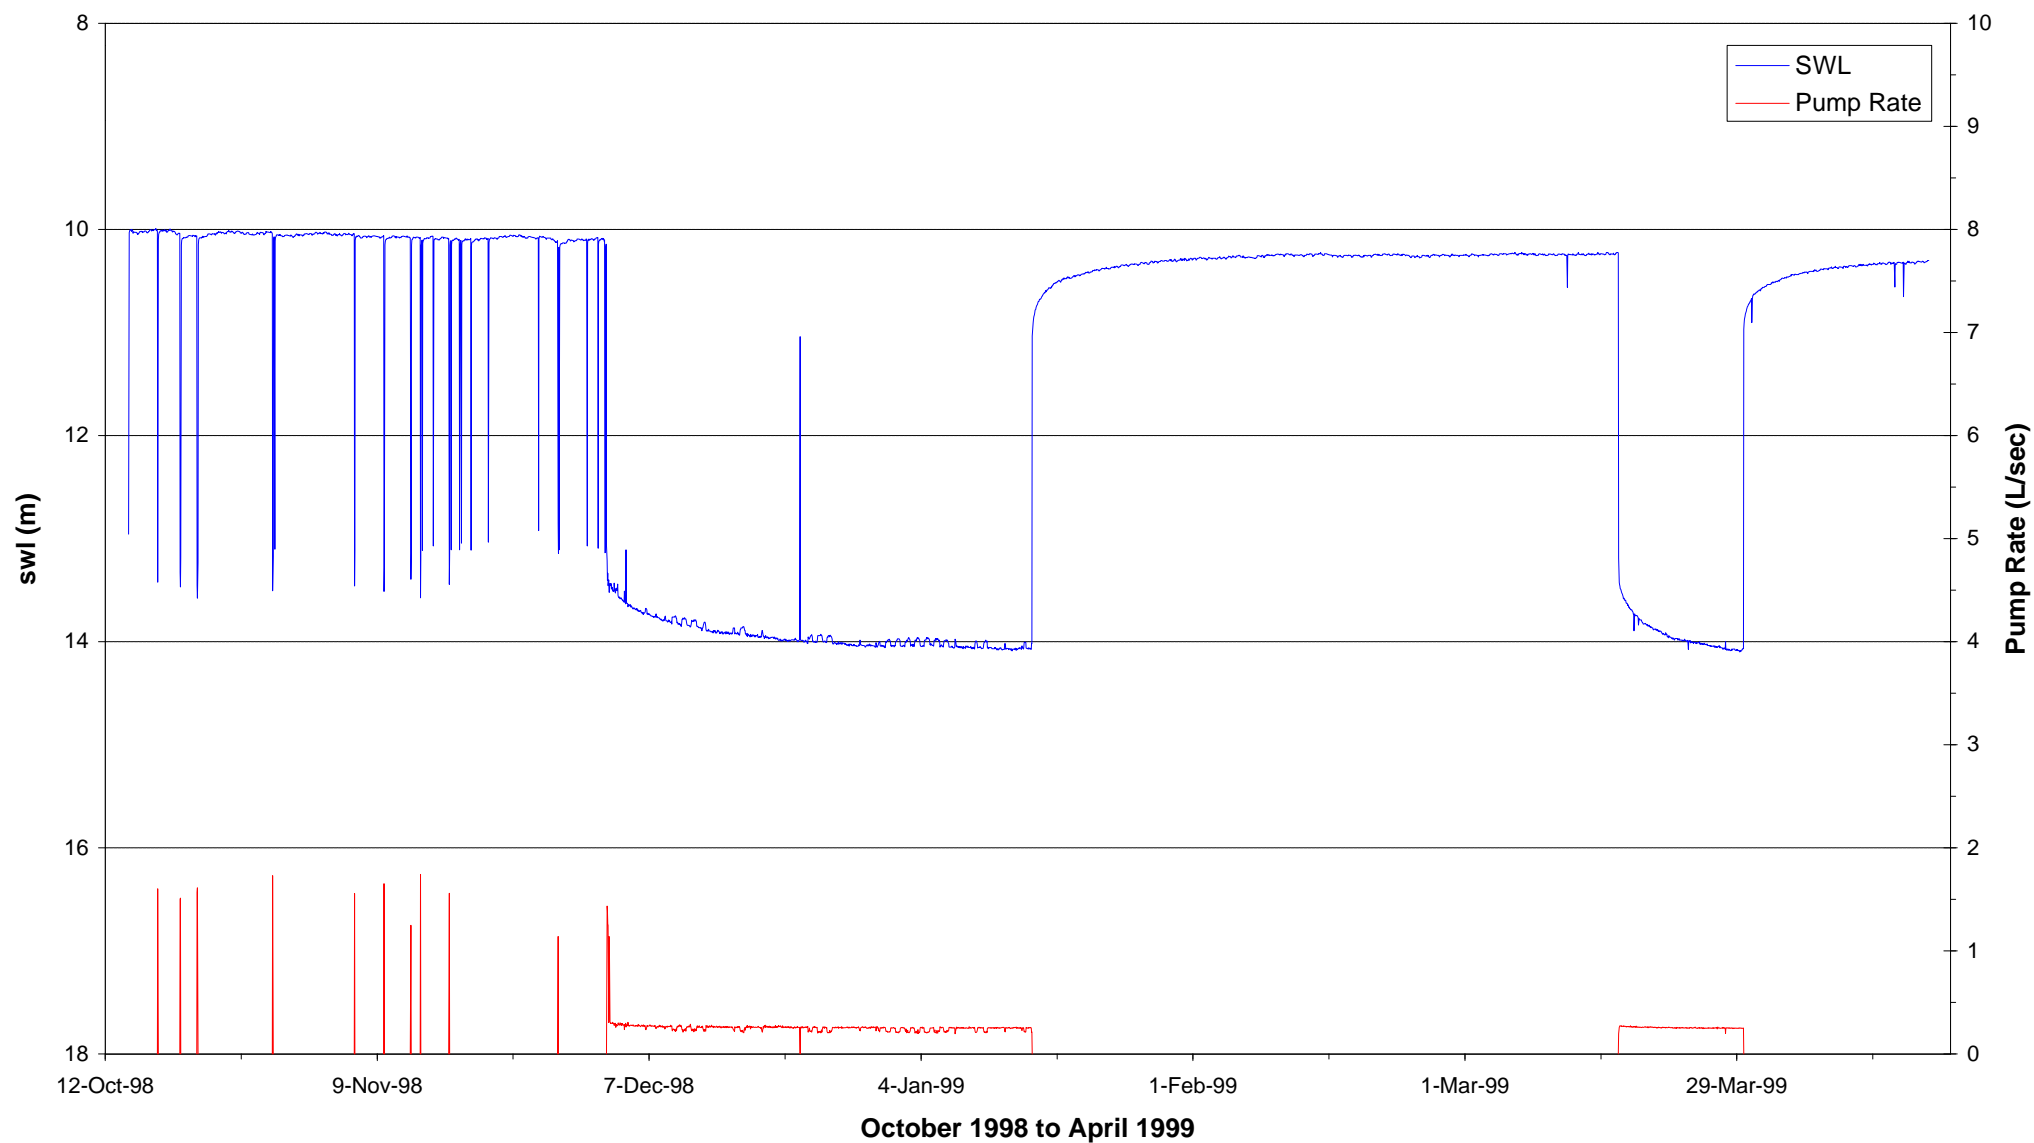
Figure 15 Fregon FRG-1; Hourly SWL and Pump Rate

Well 1. The well is gradually depleting, even at these low pumping rates and sparse intervals. The water level declined by 0.3 m over the monitoring period.

- FRG 1 Flow rate may have been read in error, the normal logged pump rate is 0.25 L/s, this will need a closer look at the next visit.
- FRG 14 Data logger was unable to communicate. Fault was found to be a blown fuse in the logger, after replacement the logger was successfully down loaded. The logger had been operational until the 25 March 1999, however after that date no data was recorded. There is no obvious reason which caused the logger to fail.
- FRG 7 The 2100P pressure transducer (S/N 210359) was found to faulty and was replaced with a spare unit S/N 210 435. From the data recorded it would appear that the pressure transducer began to fail during mid January 1999.

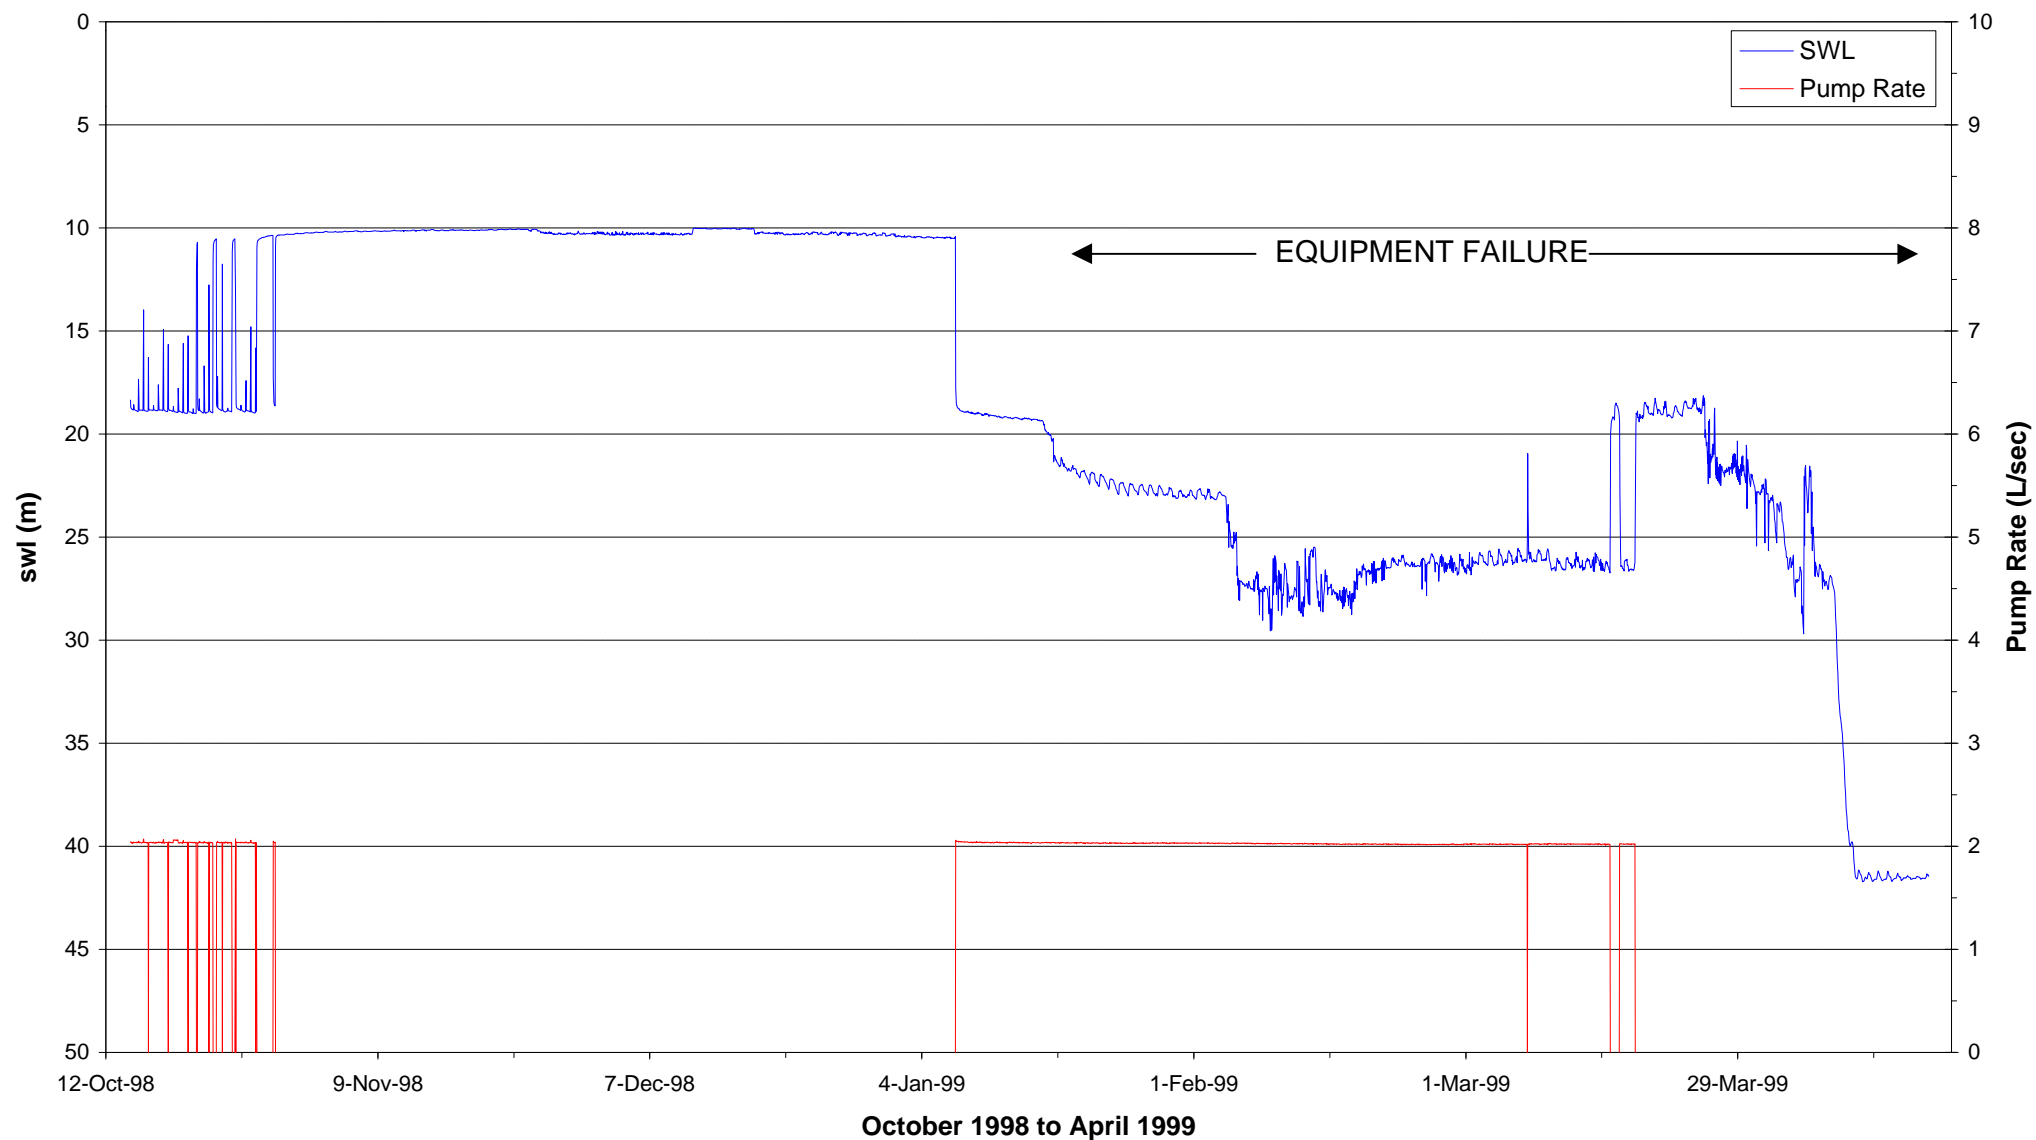
Figure 16 Fregon FRG-7; Hourly SWL and Pump Rate

Well 7. Only the first half of this record is valid, as the equipment failed in mid January. From the data available there is no sign of depletion.

- Fregon 7 were a pressure transducer failed and was found to have a significant amount of condensate in the 2100P. The unit has been returned for repair.

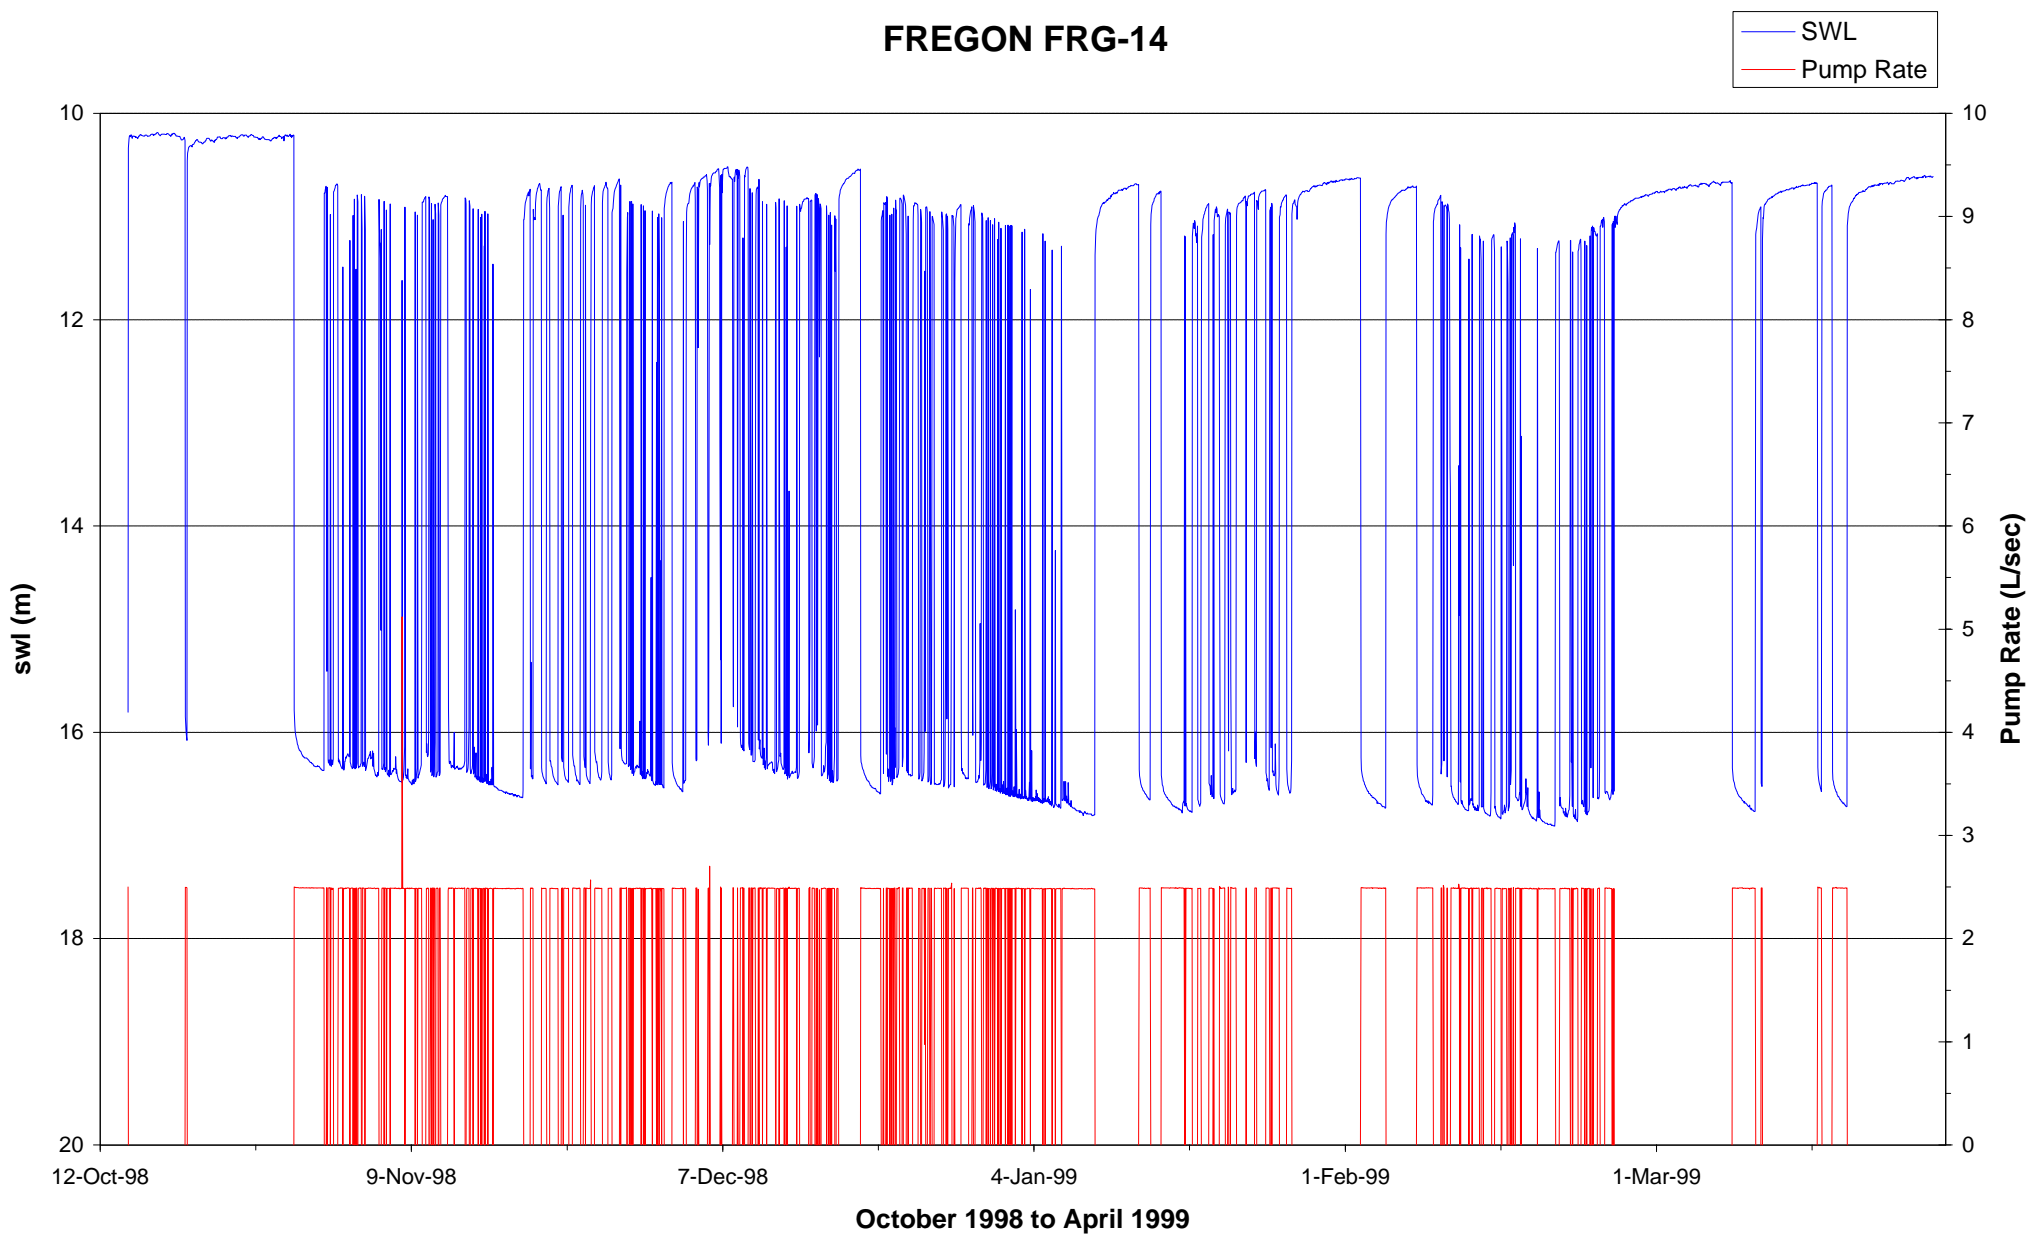
Figure 17 Fregon FRG-14; Hourly SWL and Pump Rate

Well 14. It does appear that this well is depleting, but the time span of the data and irregular pumping intervals make the conclusion unsure. Analysis of more data will clarify the picture. The water level fell by 0.4 m over the monitoring period.

- Fregon 14 were a logger stopped logging for no apparent reason, the fault was a blown fuse which was replaced.
 - Kenmore Park 6 were a pressure transducer appears to have failed for a period of time but corrected itself, possibly due to a sticking valve. No action taken at this stage.

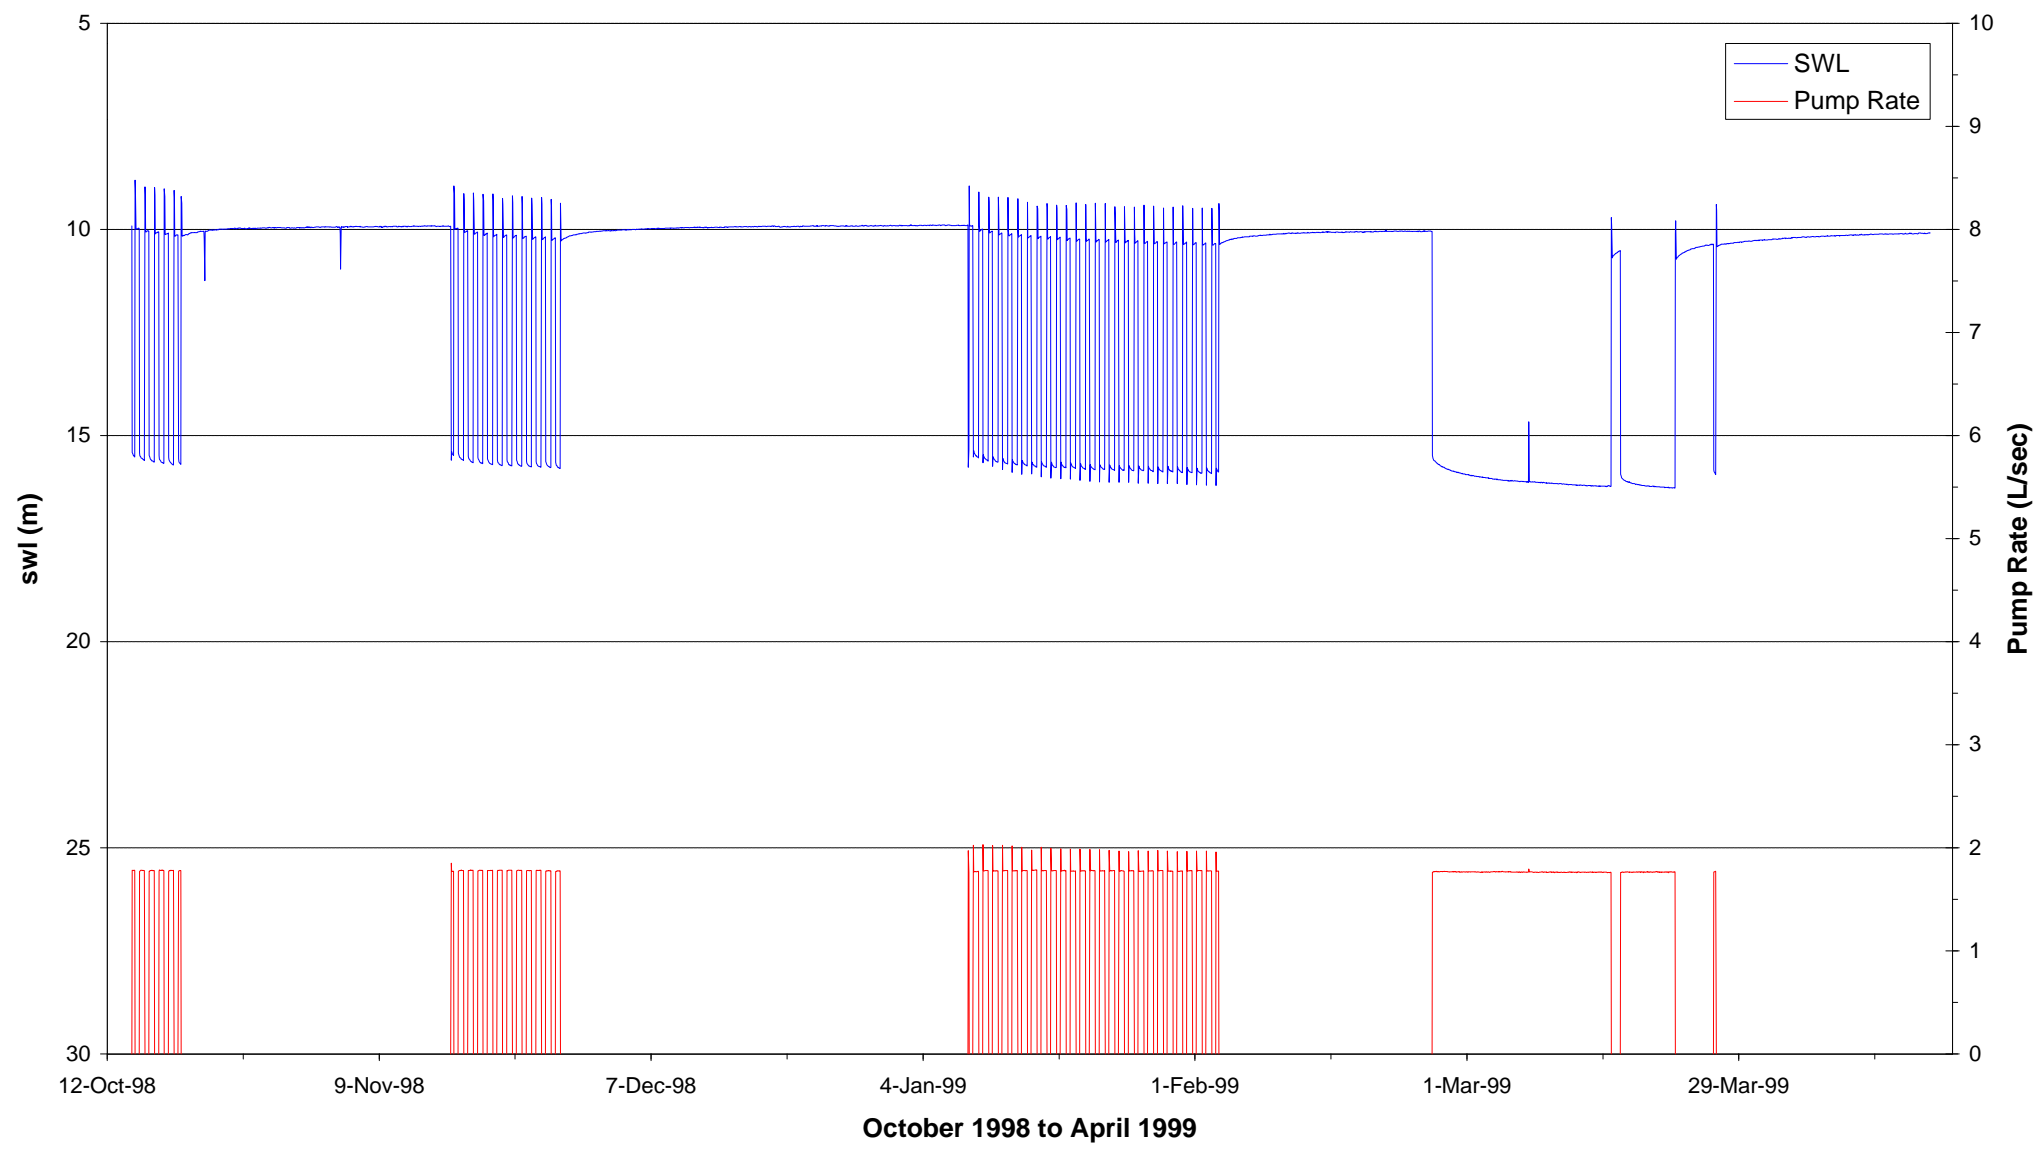
Figure 18 Fregon FRG-E4; Hourly SWL and Pump Rate

Well E4. Slow depletion appears to be taking place, as for well 14 above. The water level fell by 0.2 m over the monitoring period.

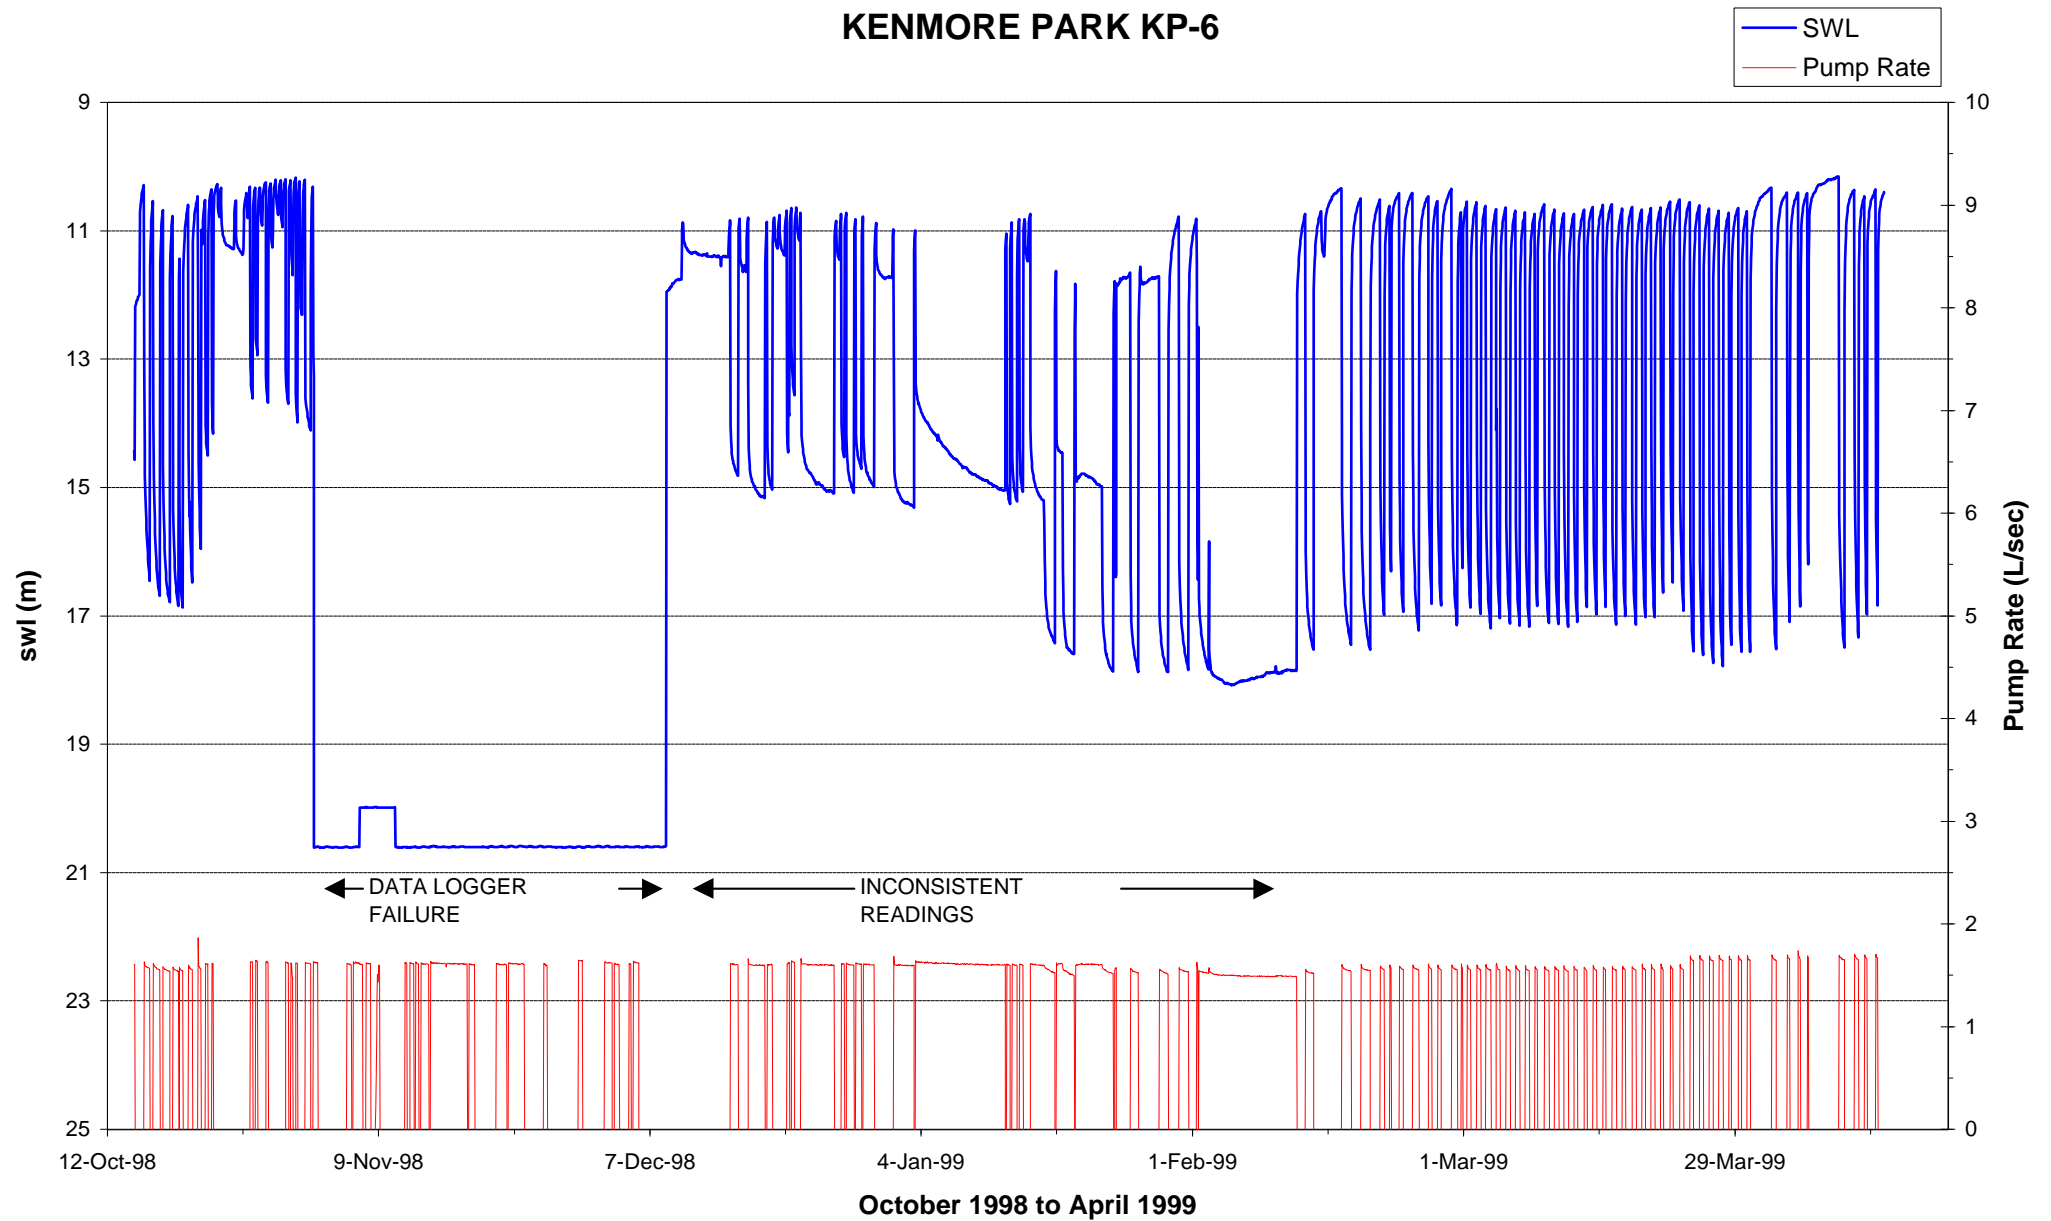
Figure 21 Kenmore Park KP-6; Hourly SWL and Pump Rate

Well 6. No sign of depletion, but SWL figures are evidently wrong at times (November-December), and look illogical at other times (January-February). While this data is not to be trusted, the later data between mid-February and April appears better and indicates that the well is capable of sustaining current pumping rates.

- KP 6 SWL reset by 0.250 m. The reading recorded for SWL for the period 2 November 1998 to 8 December 1998 are false. It appears that either the air line was disconnected or the valves in the 2100P transducer did not seal. The situation appears to have corrected its self but this will be reported to the manufacturer and the equipment checked at the next down load trip.
- KP98 473.89 hours at 13 April 1999
320.5 hours at 14 October 1998
153.39 hours total use.

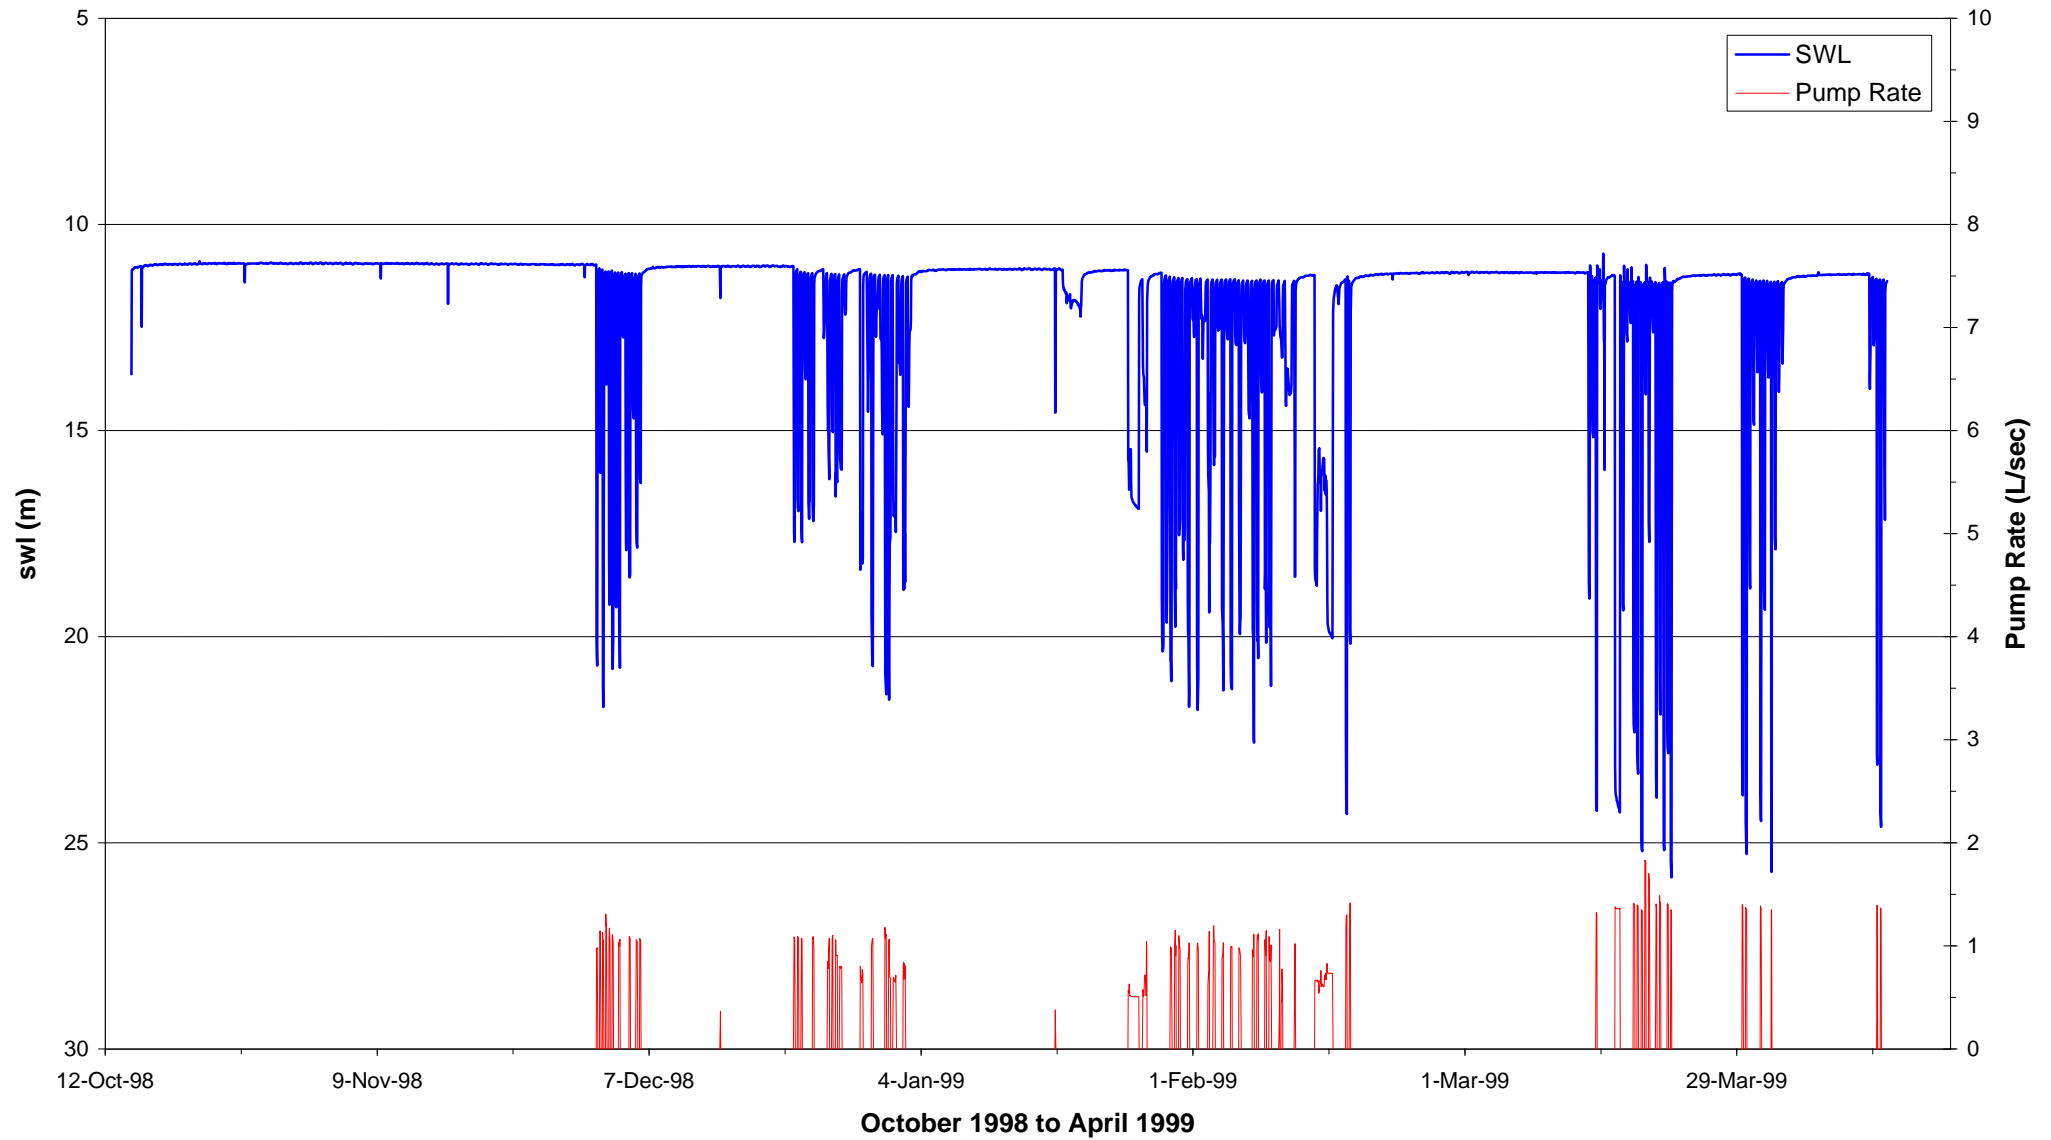
Figure 22 Kenmore Park KP-7; Hourly SWL and Pump Rate

Well 7. Pumping has been of short duration and the well appears to have a fragile supply. The water level has declined by 0.2 m over the monitoring period.

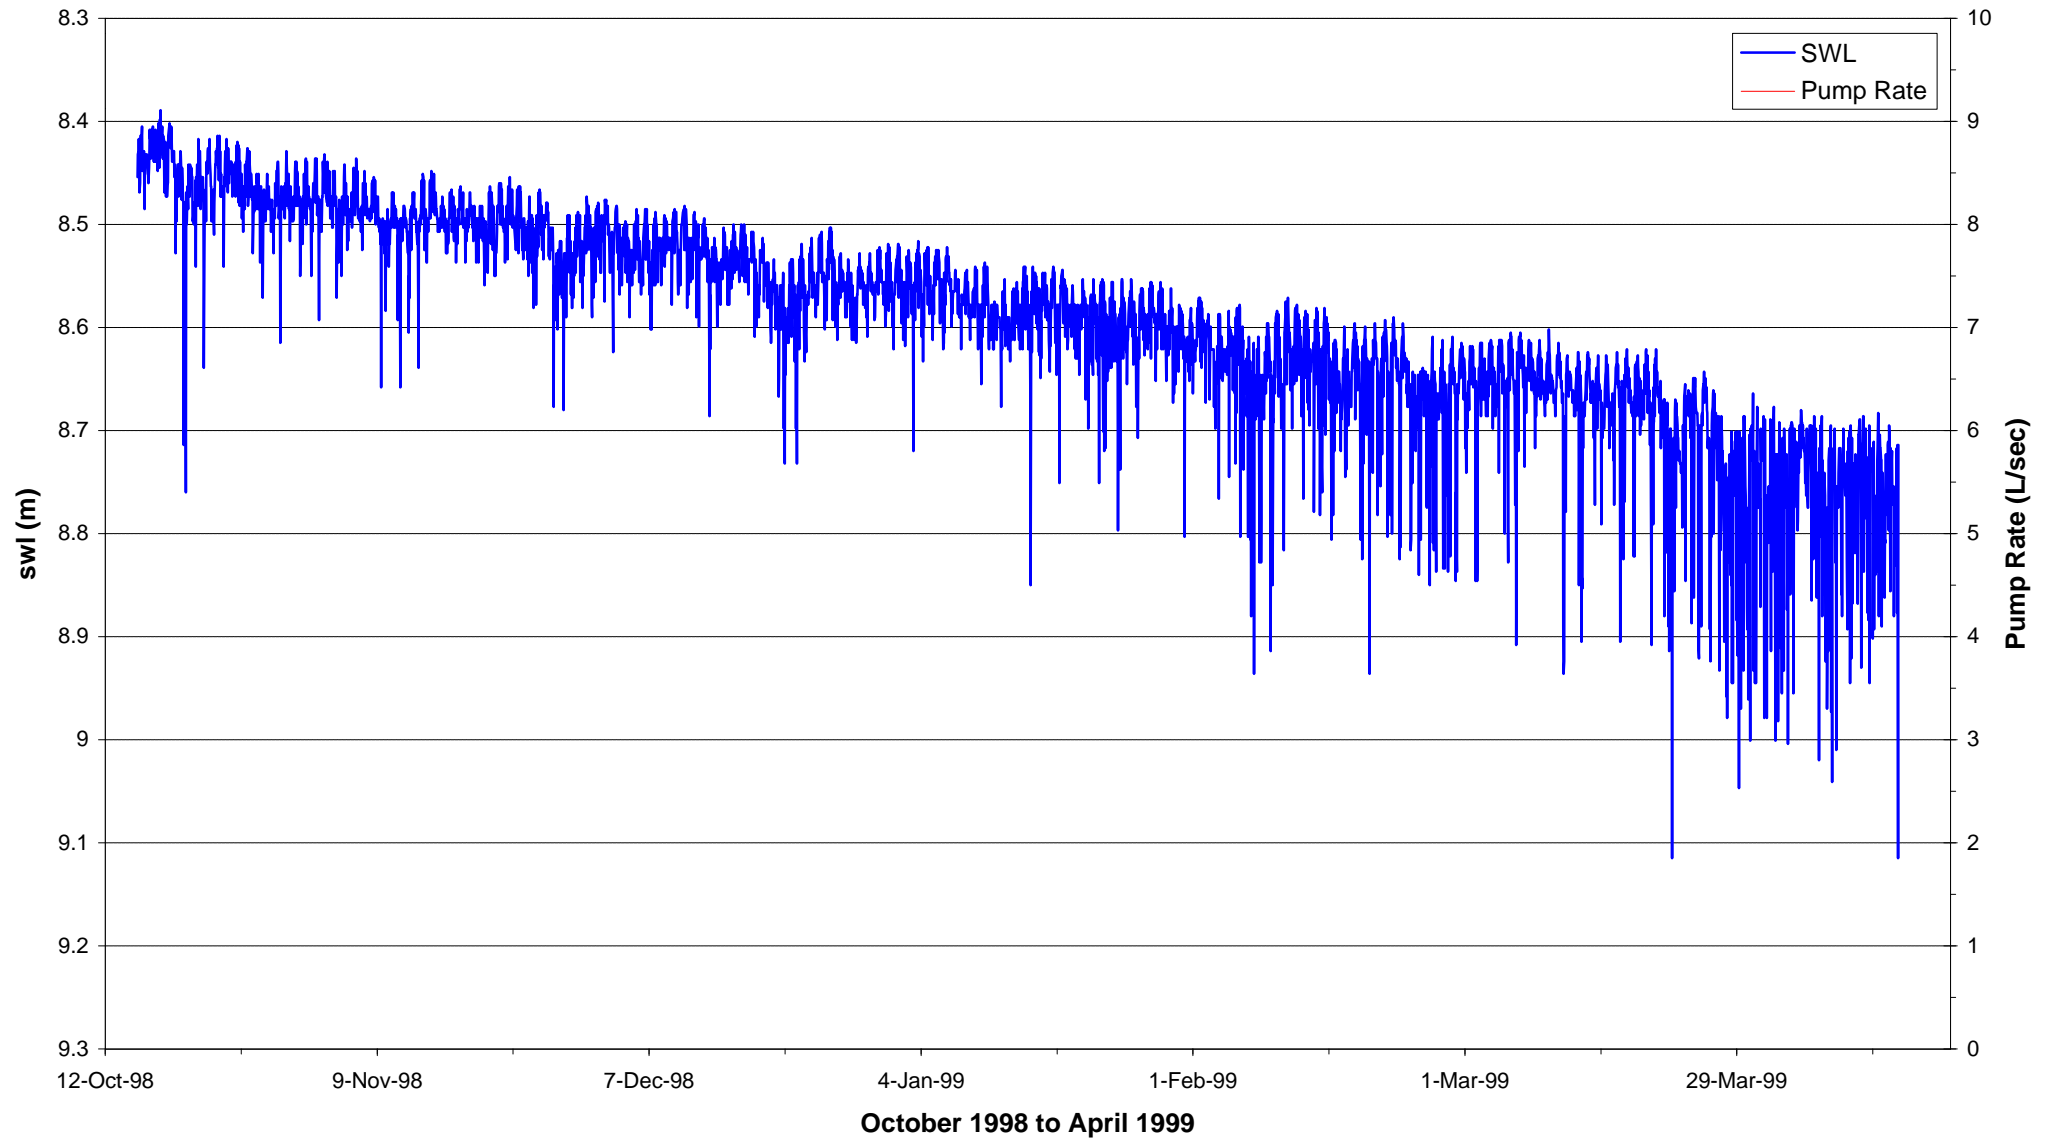
Figure 25 Pukatja E-1; Hourly SWL and Pump Rate

Well 1. In spite of the lack of pumping this well shows a steady drop of 0.3 m over the period, as a result of either pumping in adjacent wells or movement of water downstream. There is no evidence of recharge.

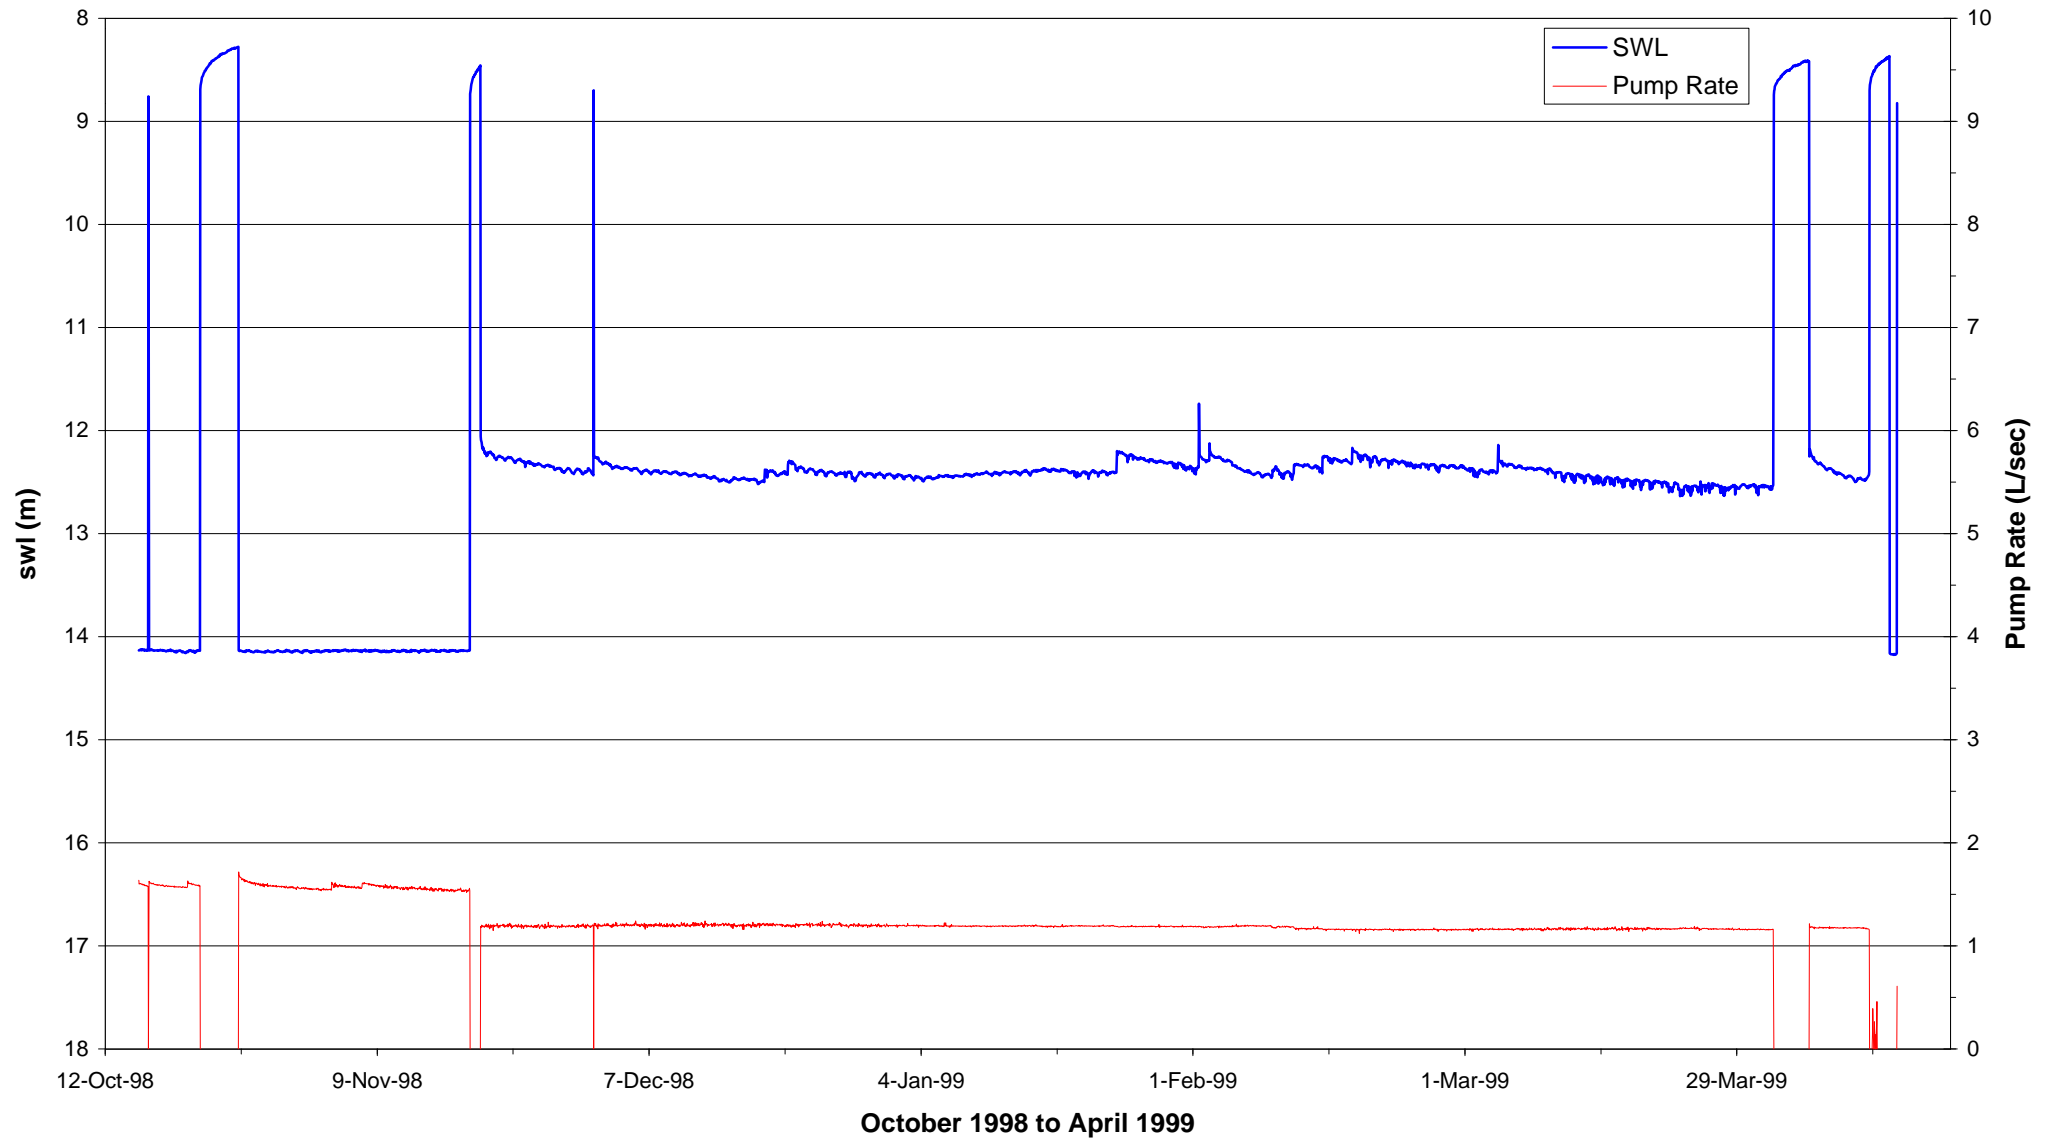
Figure 26 Pukatja E-12; Hourly SWL and Pump Rate

Well 12. The well was pumped well nigh continuously over the period with no sign of aquifer depletion.

- E01 SWL datum reset by 0.082 m. The bore has not been used for the monitoring period.
- E12 SWL datum reset by 0.315. Pump was running but no flow. It was found that the pump had broken away from the black poly pipe pump column. The data shows that the pump connection broke away after 1500 hrs. on 11 April 1999.
- E42 SWL datum reset by 0.057
- E44 SWL datum reset by 2.980. No flow data because the pump has not been replaced. This site will require a close check at the next visit as the SWL datum may have been in-correctly reset with the air tube out of water.
- E45 SWL datum reset by 0.062
- E97B New installation of equipment on 10 April 1999
- E97L New installation of equipment on 10 April 1999.

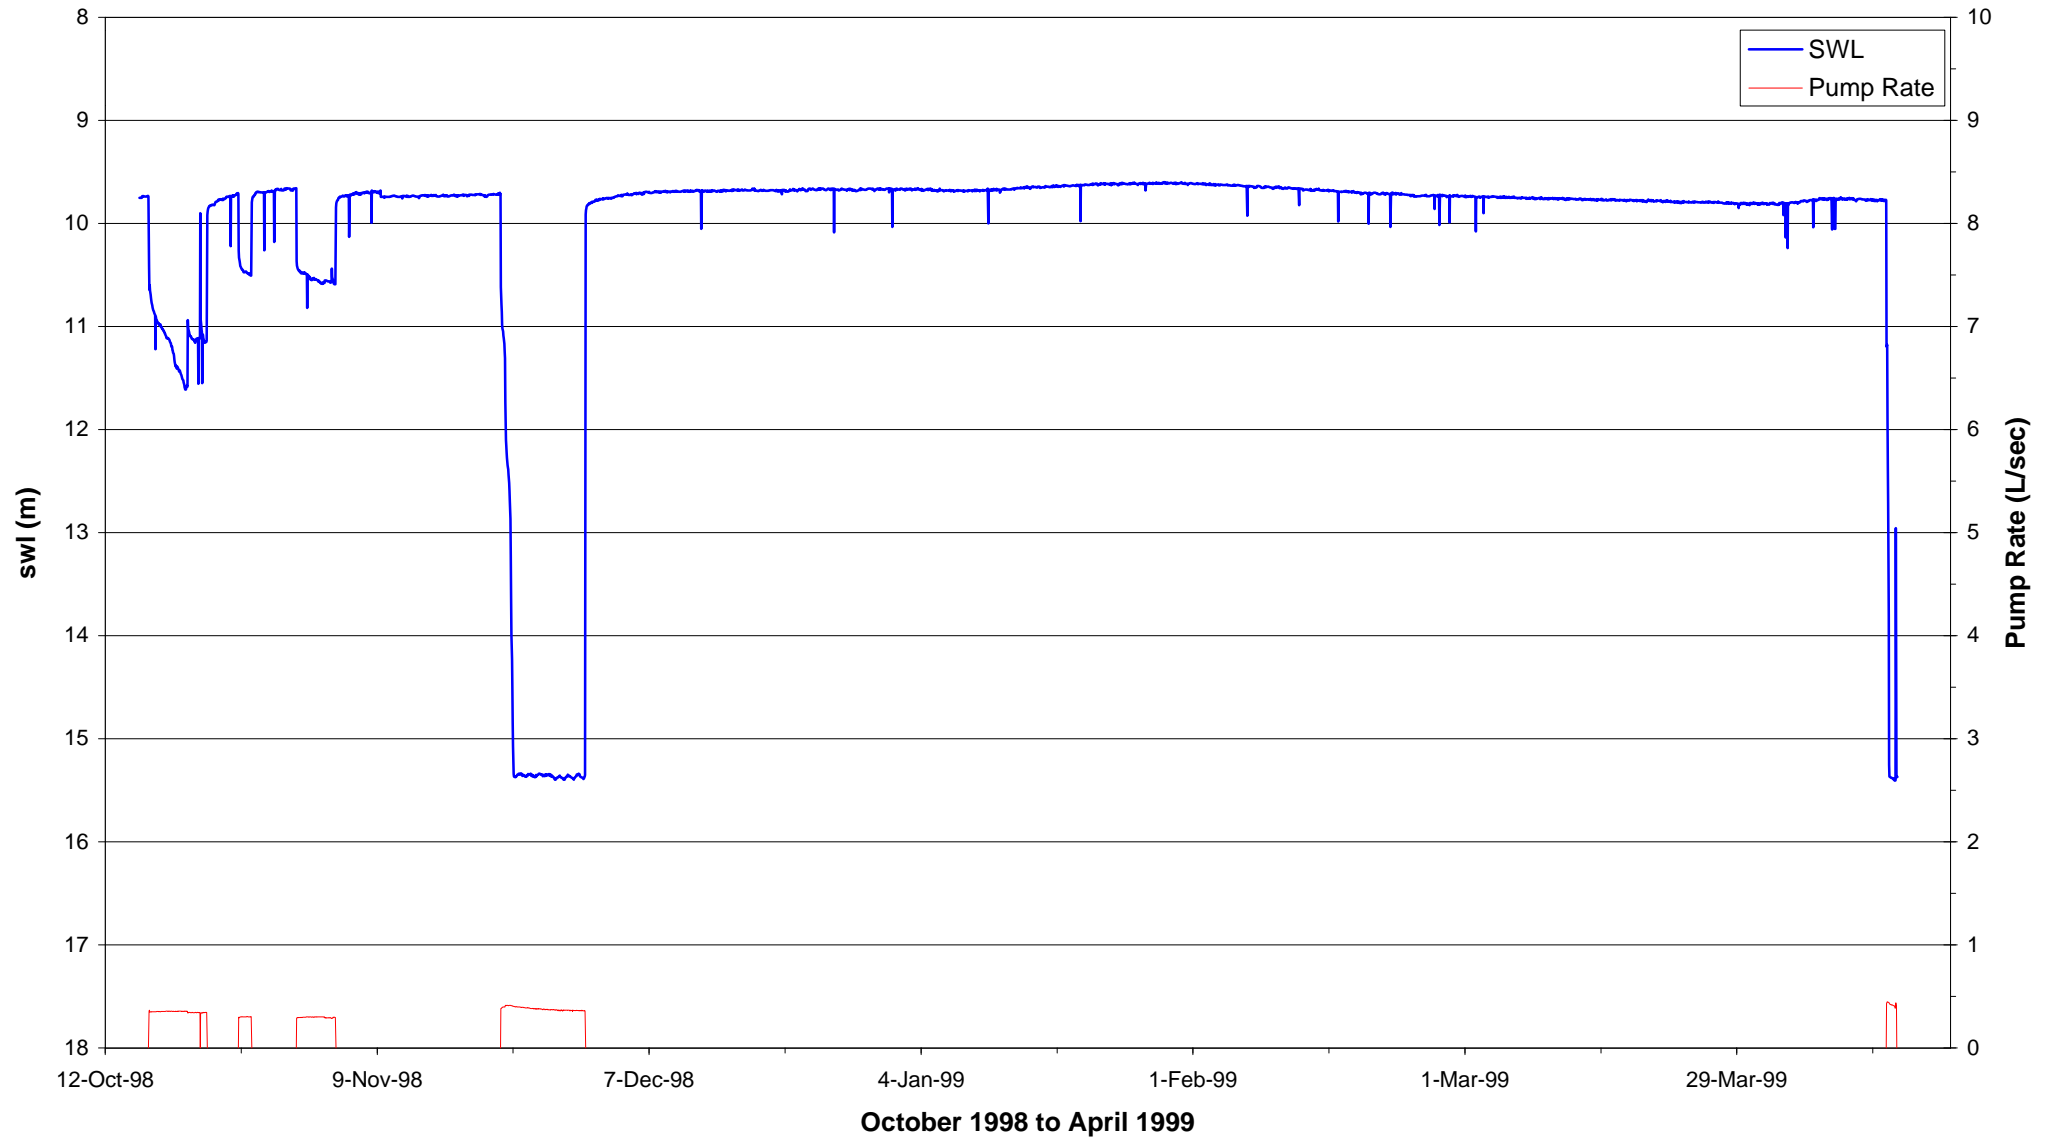
Figure 27 Pukatja E-42; Hourly SWL and Pump Rate

Well 42. This well was not pumped much in this period. In the absence of pumping the SWL shows a general drop of 0.2 m, but also some indications of rises that might indicate recharge, even though the correspondence with rainfall events is poor. The data warrants further study, especially when more data is available.
