Hydrogeological Report on NW Aboriginal Lands well monitoring – October 1998 to April 1999

REPORT BOOK 2000/00005

Department for Water Resources, Groundwater

FEBRUARY 2000

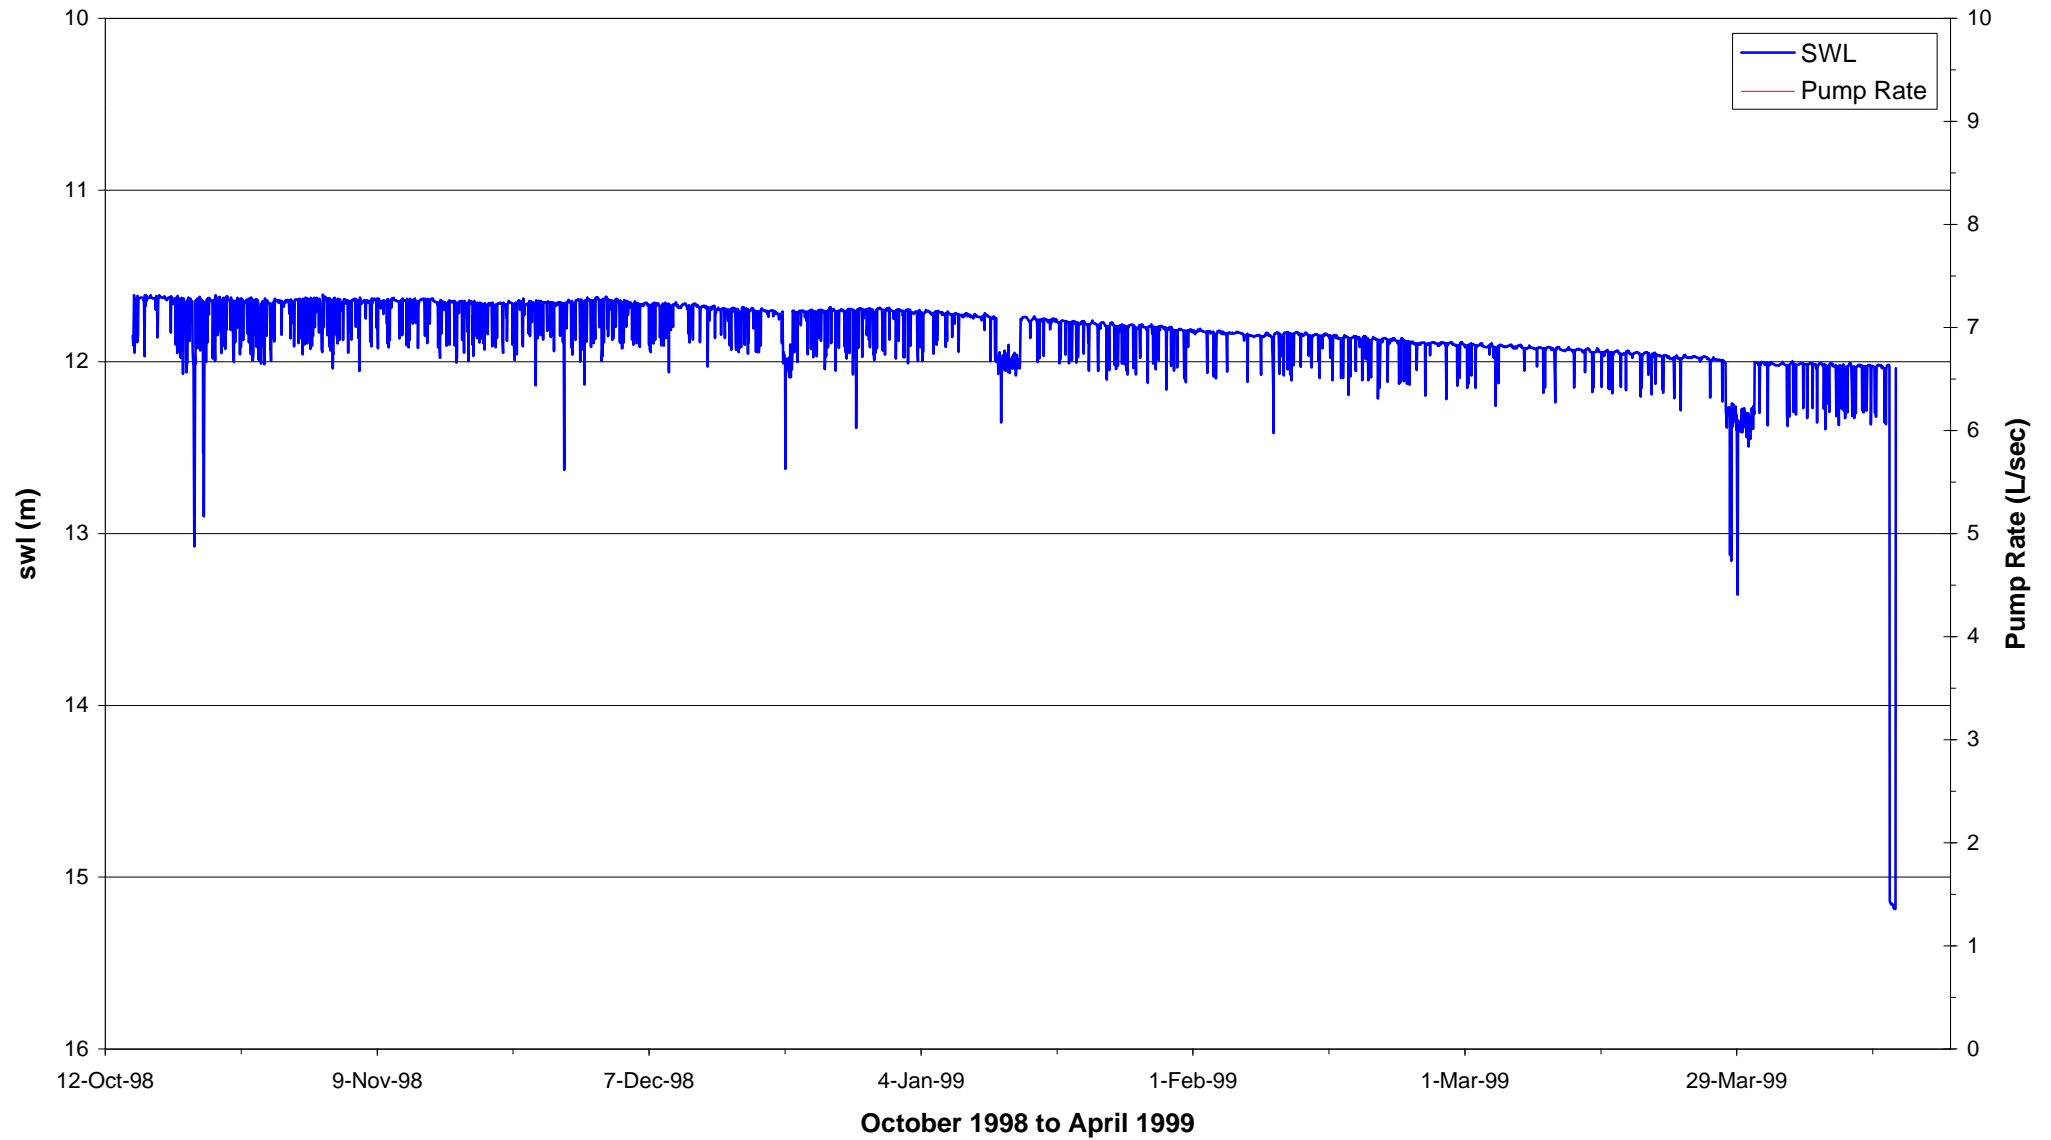
Figure 28 Pukatja E-44; Hourly SWL and Pump Rate

Well 44. Shows a steady drop of 0.4 m in the absence of pumping, as for well 1. No evidence of recharge.

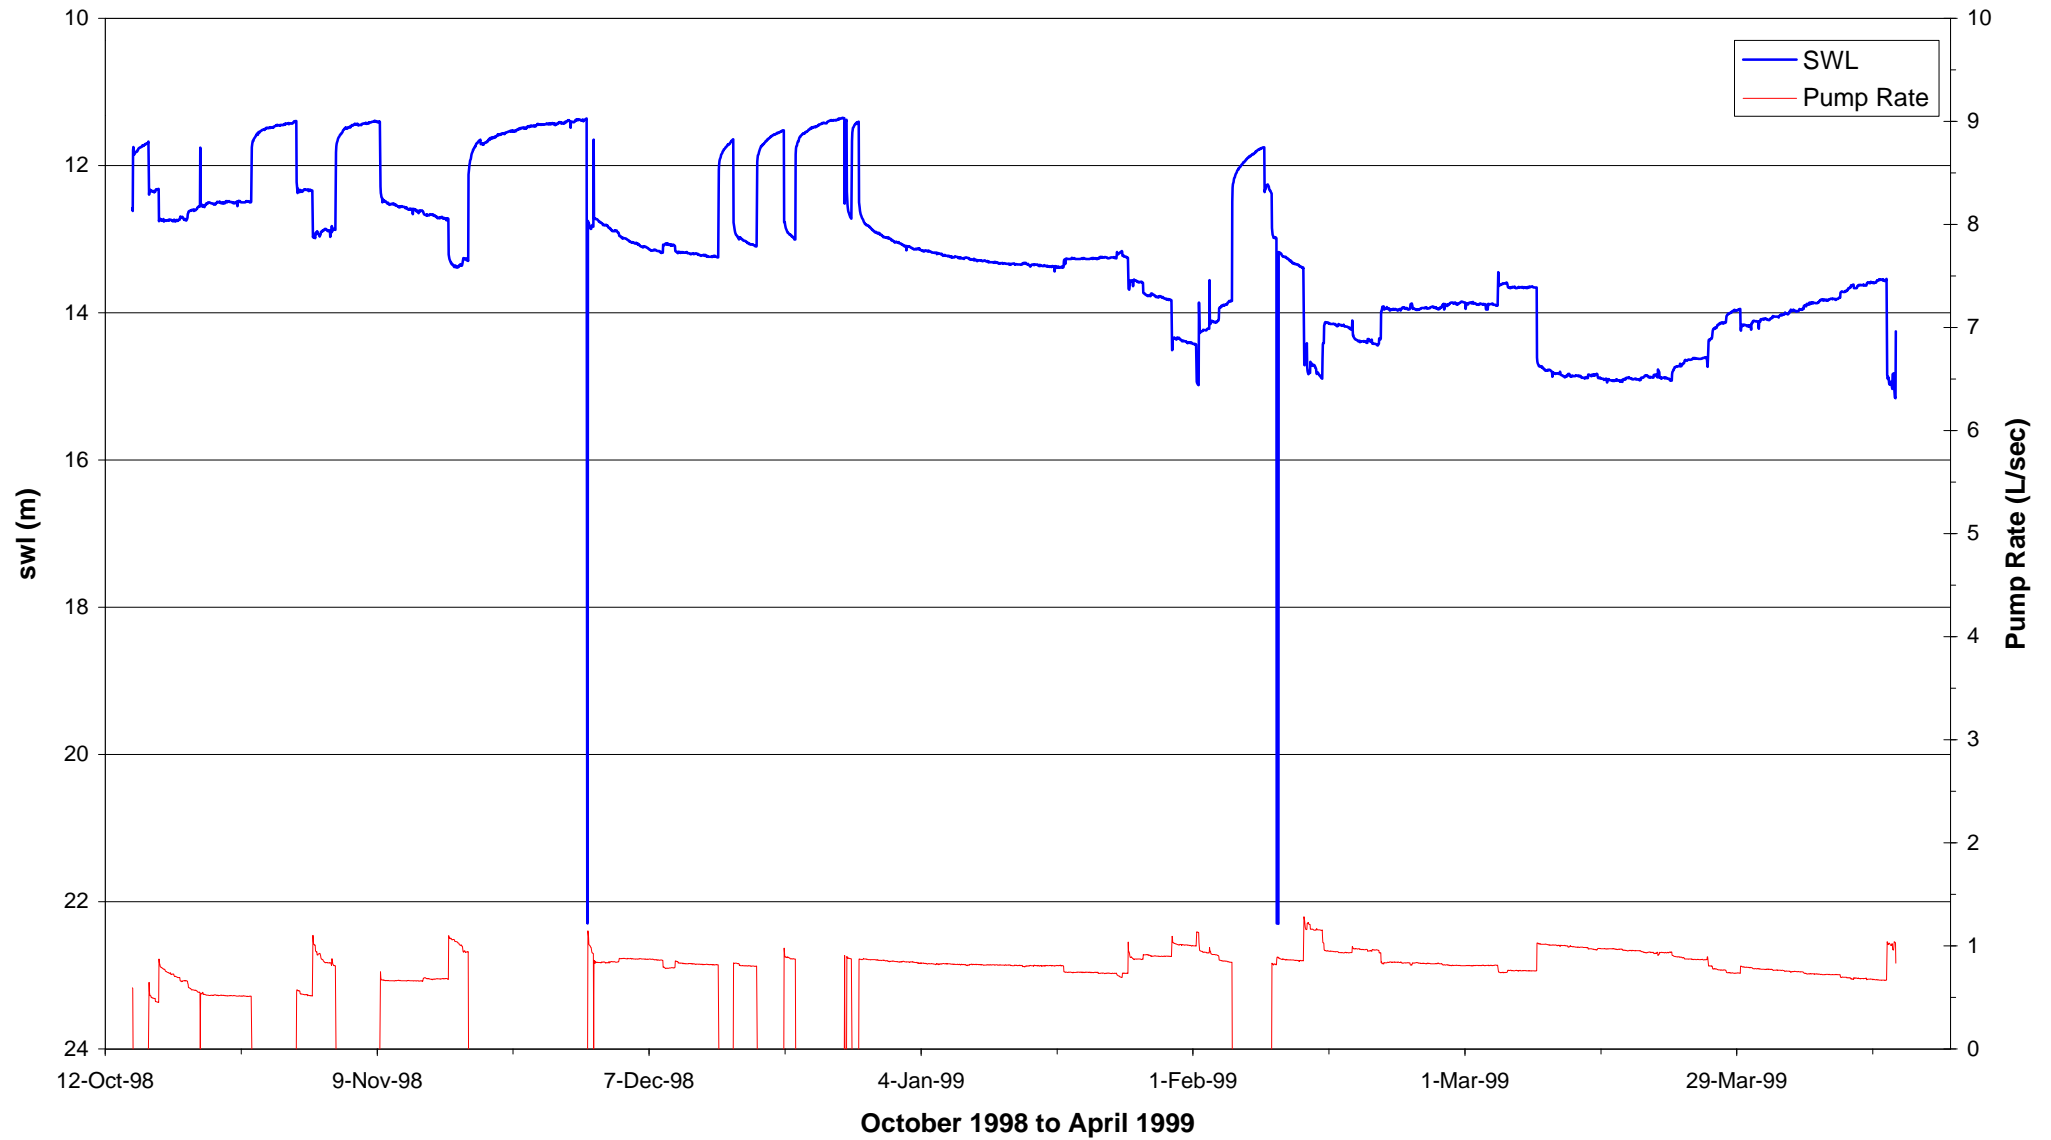
Figure 29 Pukatja E-45; Hourly SWL and Pump Rate

Well 45. While depletion seems to be taking place, the erratic pumping rates make accurate determination difficult. The SWL seems to have dropped about 2 m

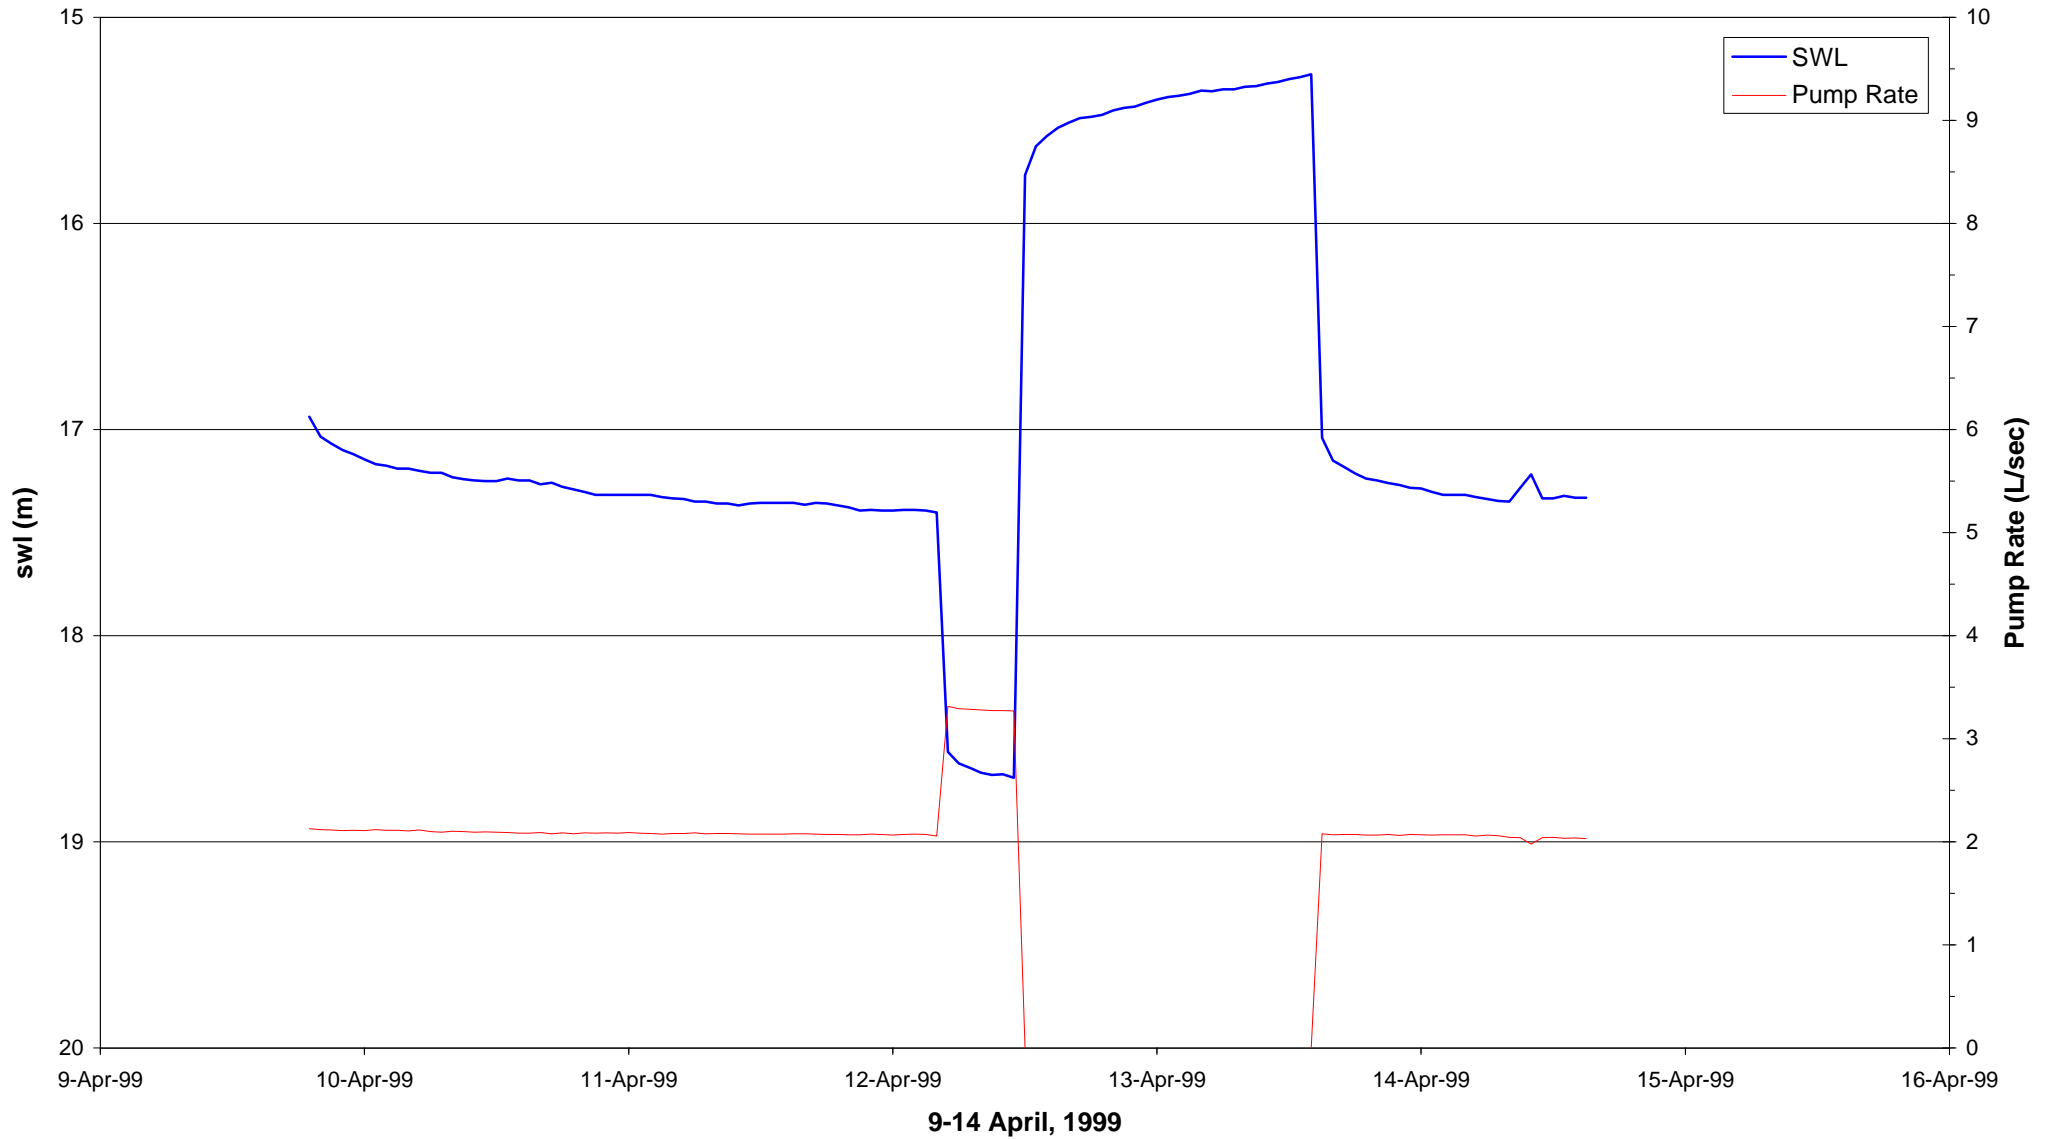
Figure 30 Pukatja E-97B; Hourly SWL and Pump Rate

Well 97B. Insufficient data.

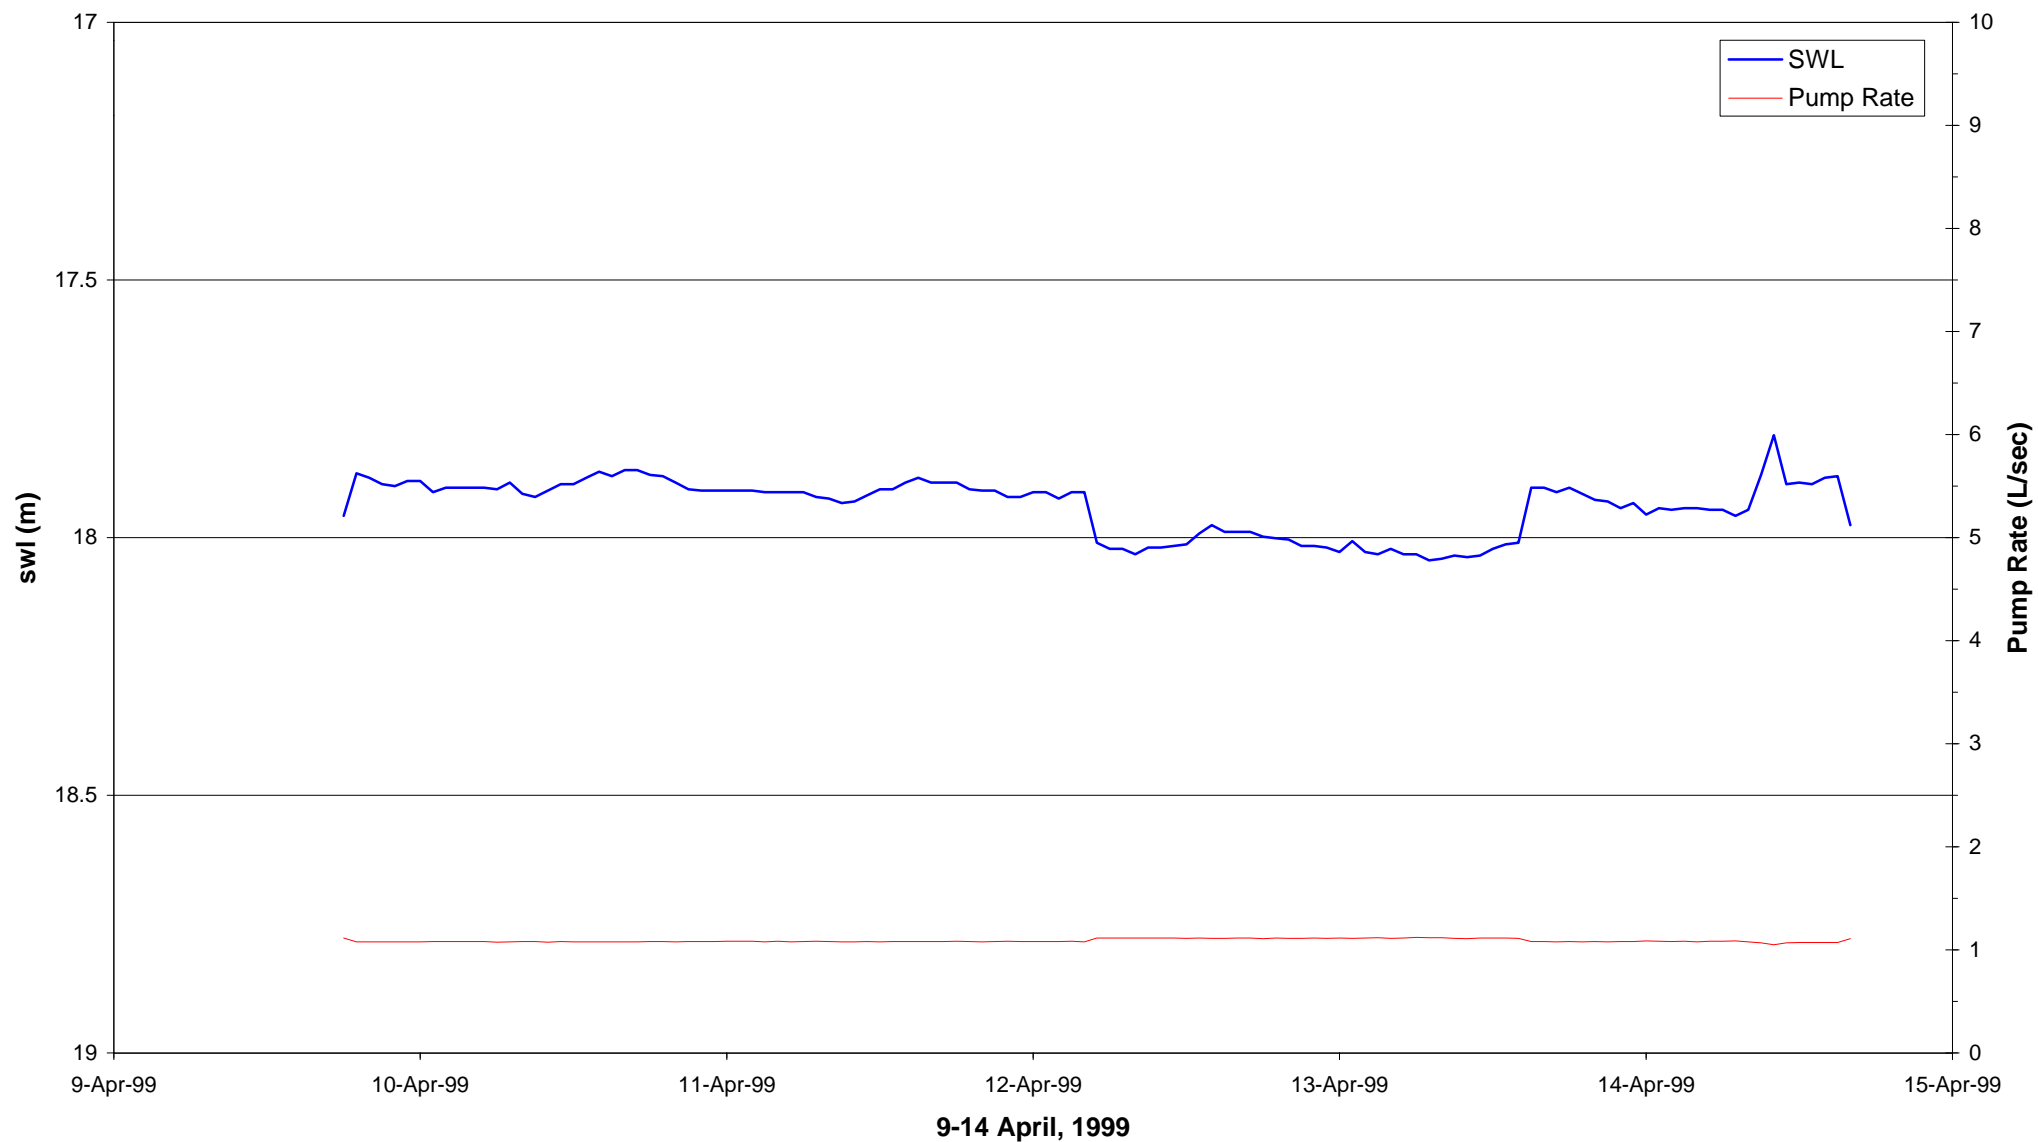
Figure 31 Pukatja E-97L; Hourly SWL and Pump Rate

Well 97L. Insufficient data.

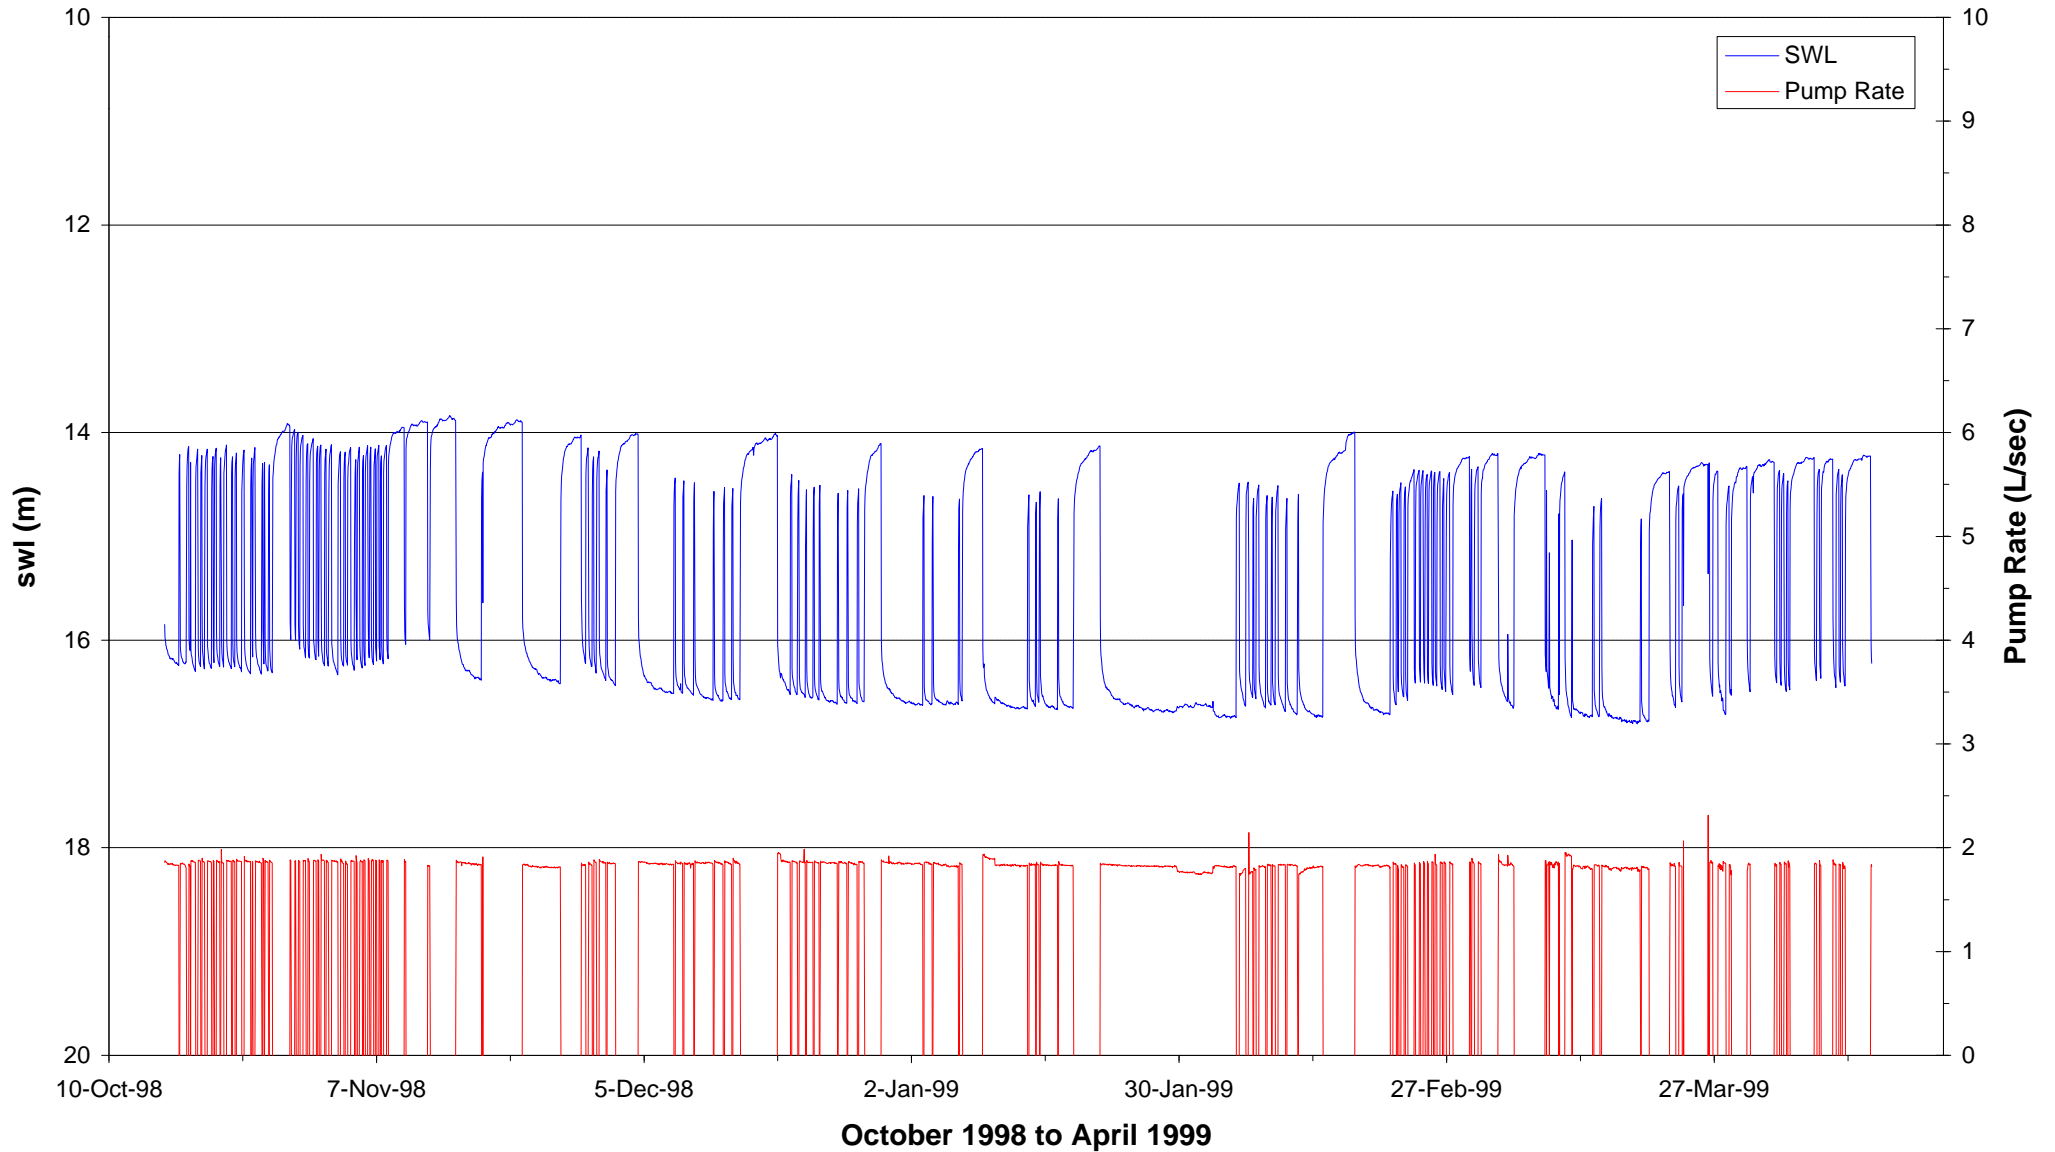
Figure 34 Amata A-15; Hourly SWL and Pump Rate

Well 15. There are possible indications of depletion, but these are somewhat obscured by variations in pumping rate and duration. A greater data time window will clarify it.

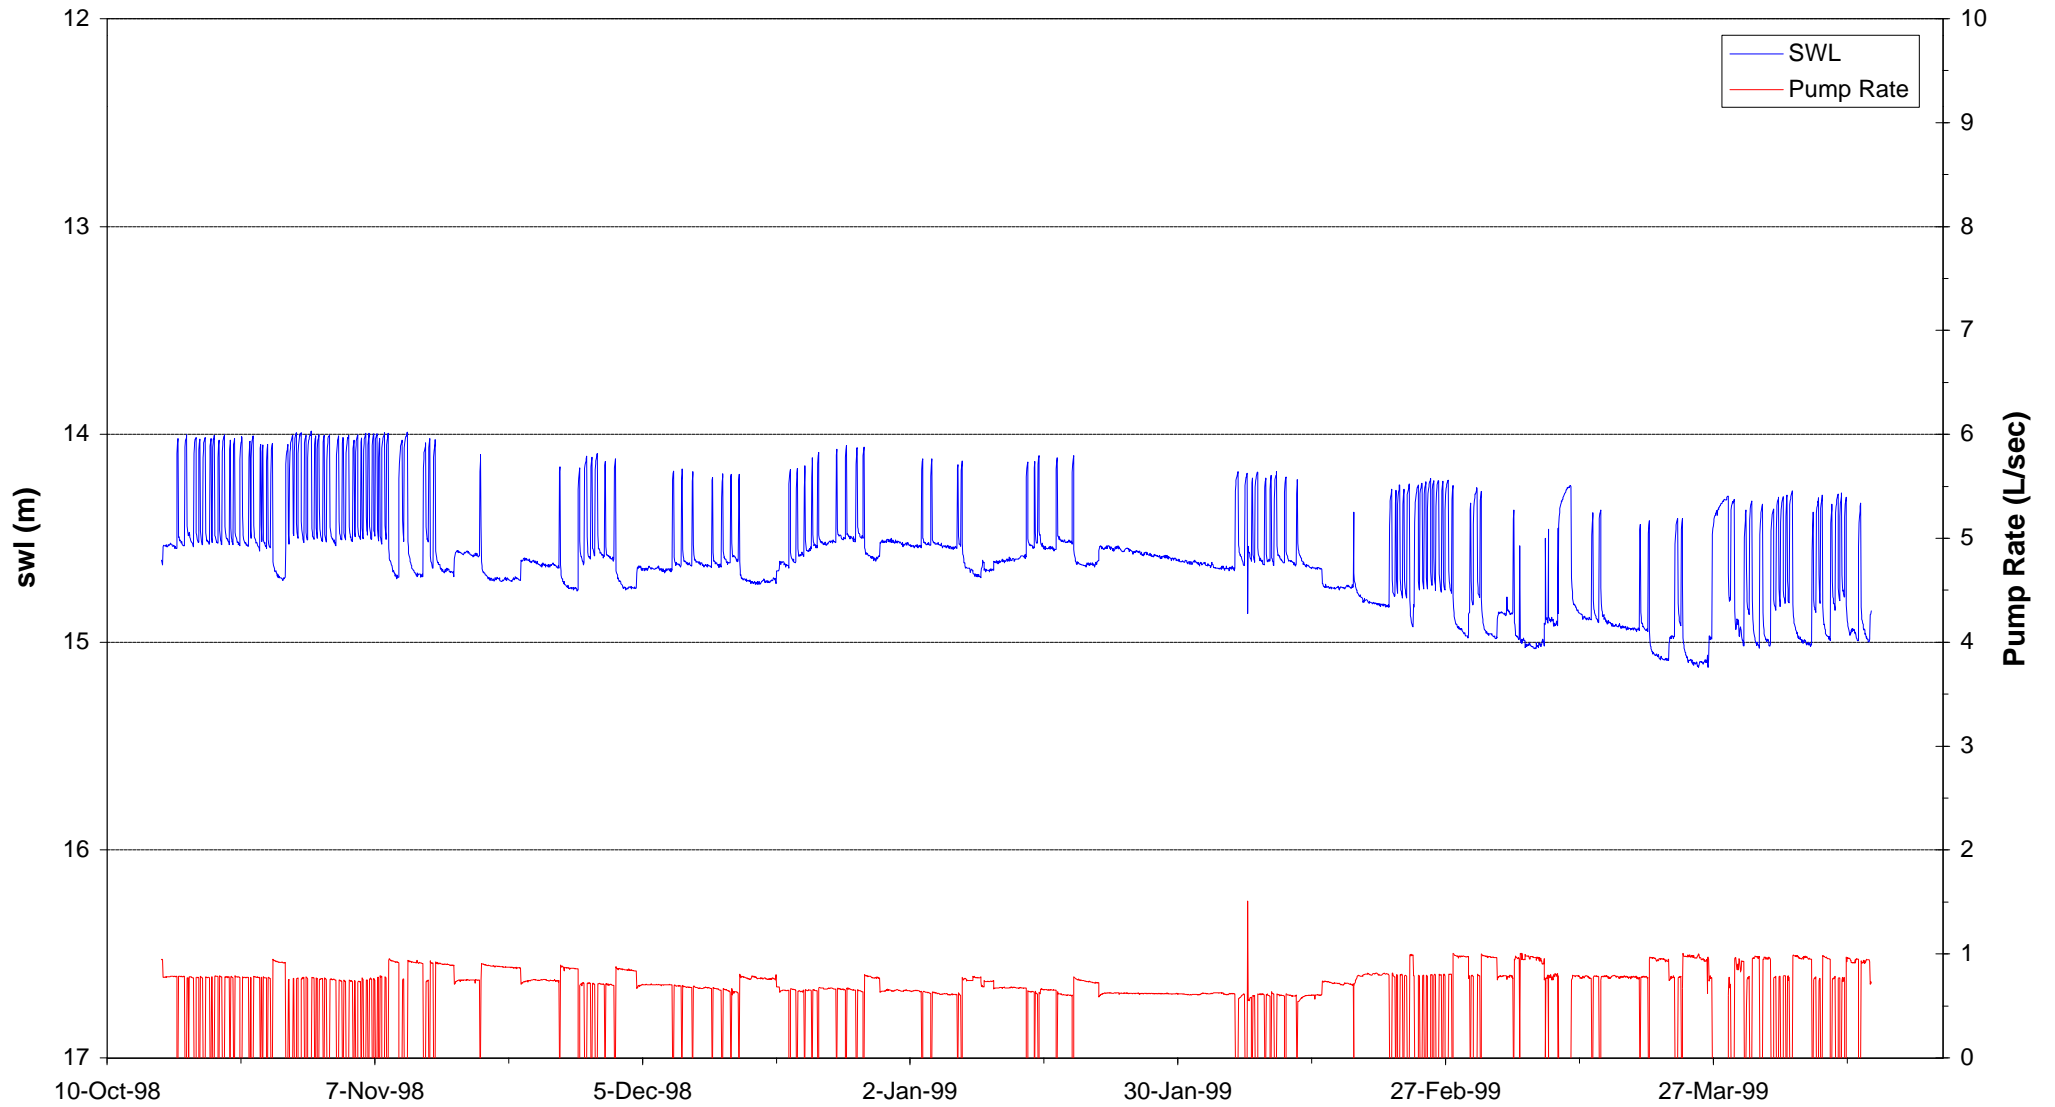
Figure 35 Amata A-17; Hourly SWL and Pump Rate

Well 17. As for 15. The best estimate is a decline in water level of 0.3–0.5 m.

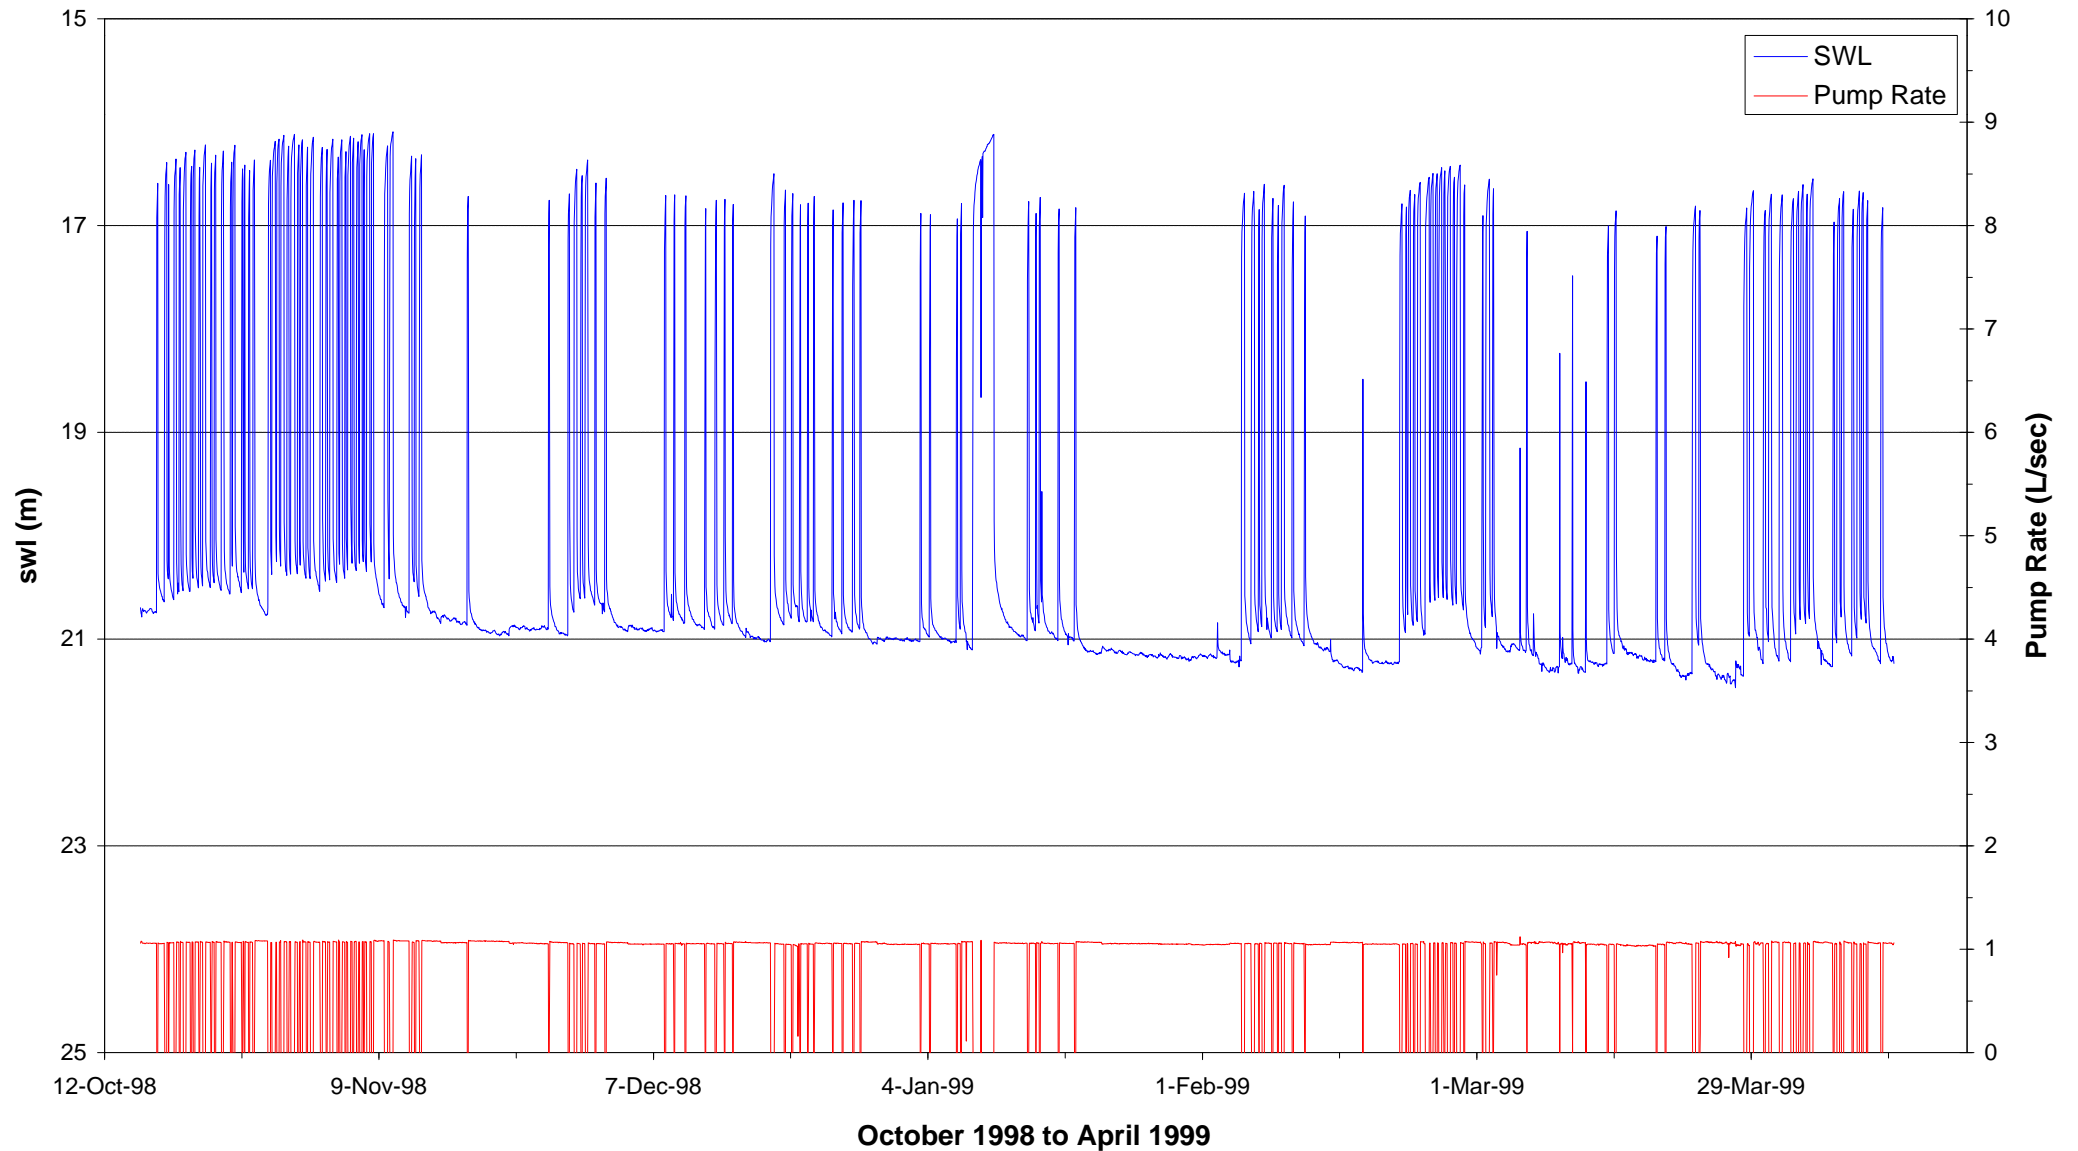
Figure 36 Amata A-26; Hourly SWL and Pump Rate

Well 26. The indications of gradual depletion are fairly clear but the rate is, again, slow.

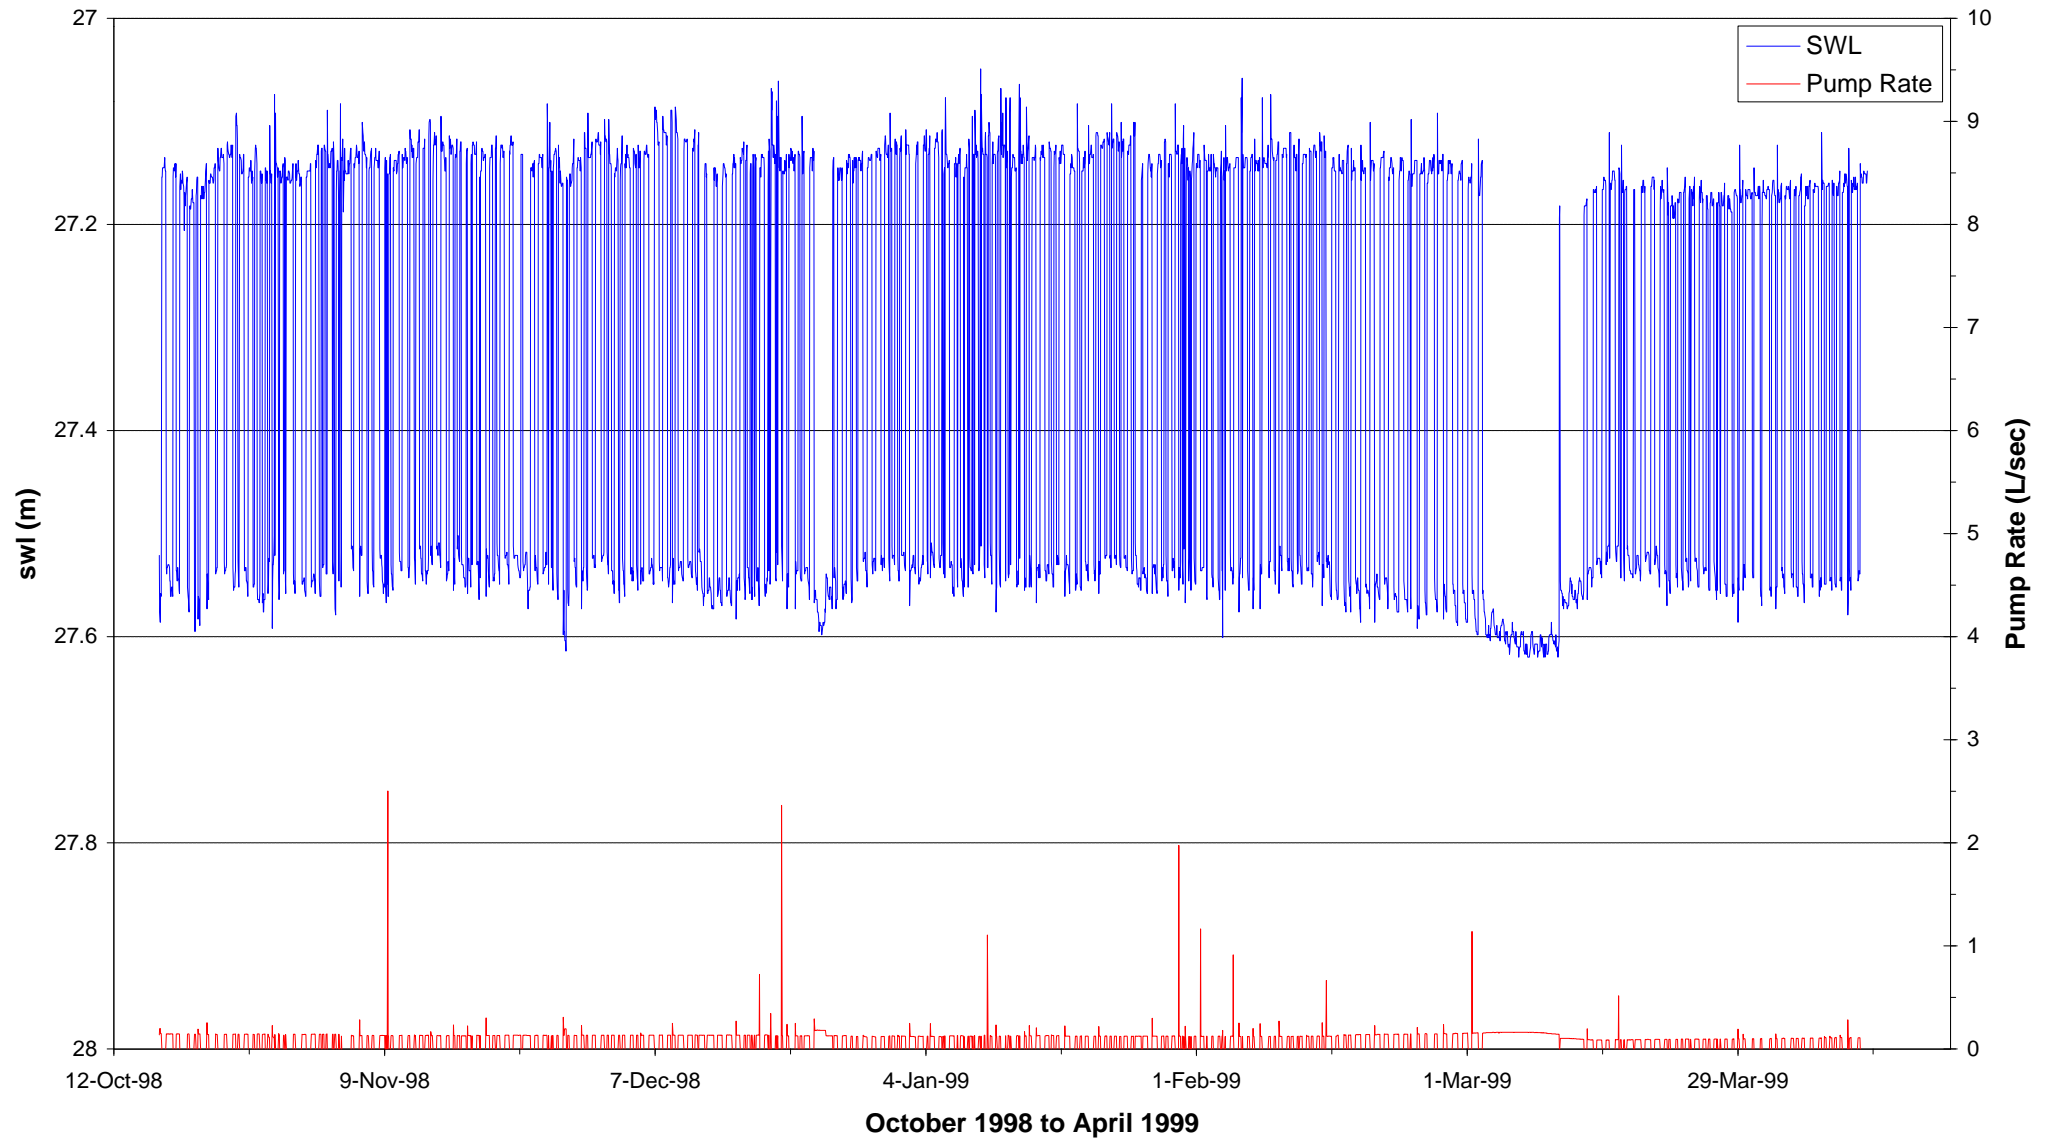
Figure 39 Kalka KA-1; Hourly SWL and Pump Rate

Well 1. No sign of depletion.

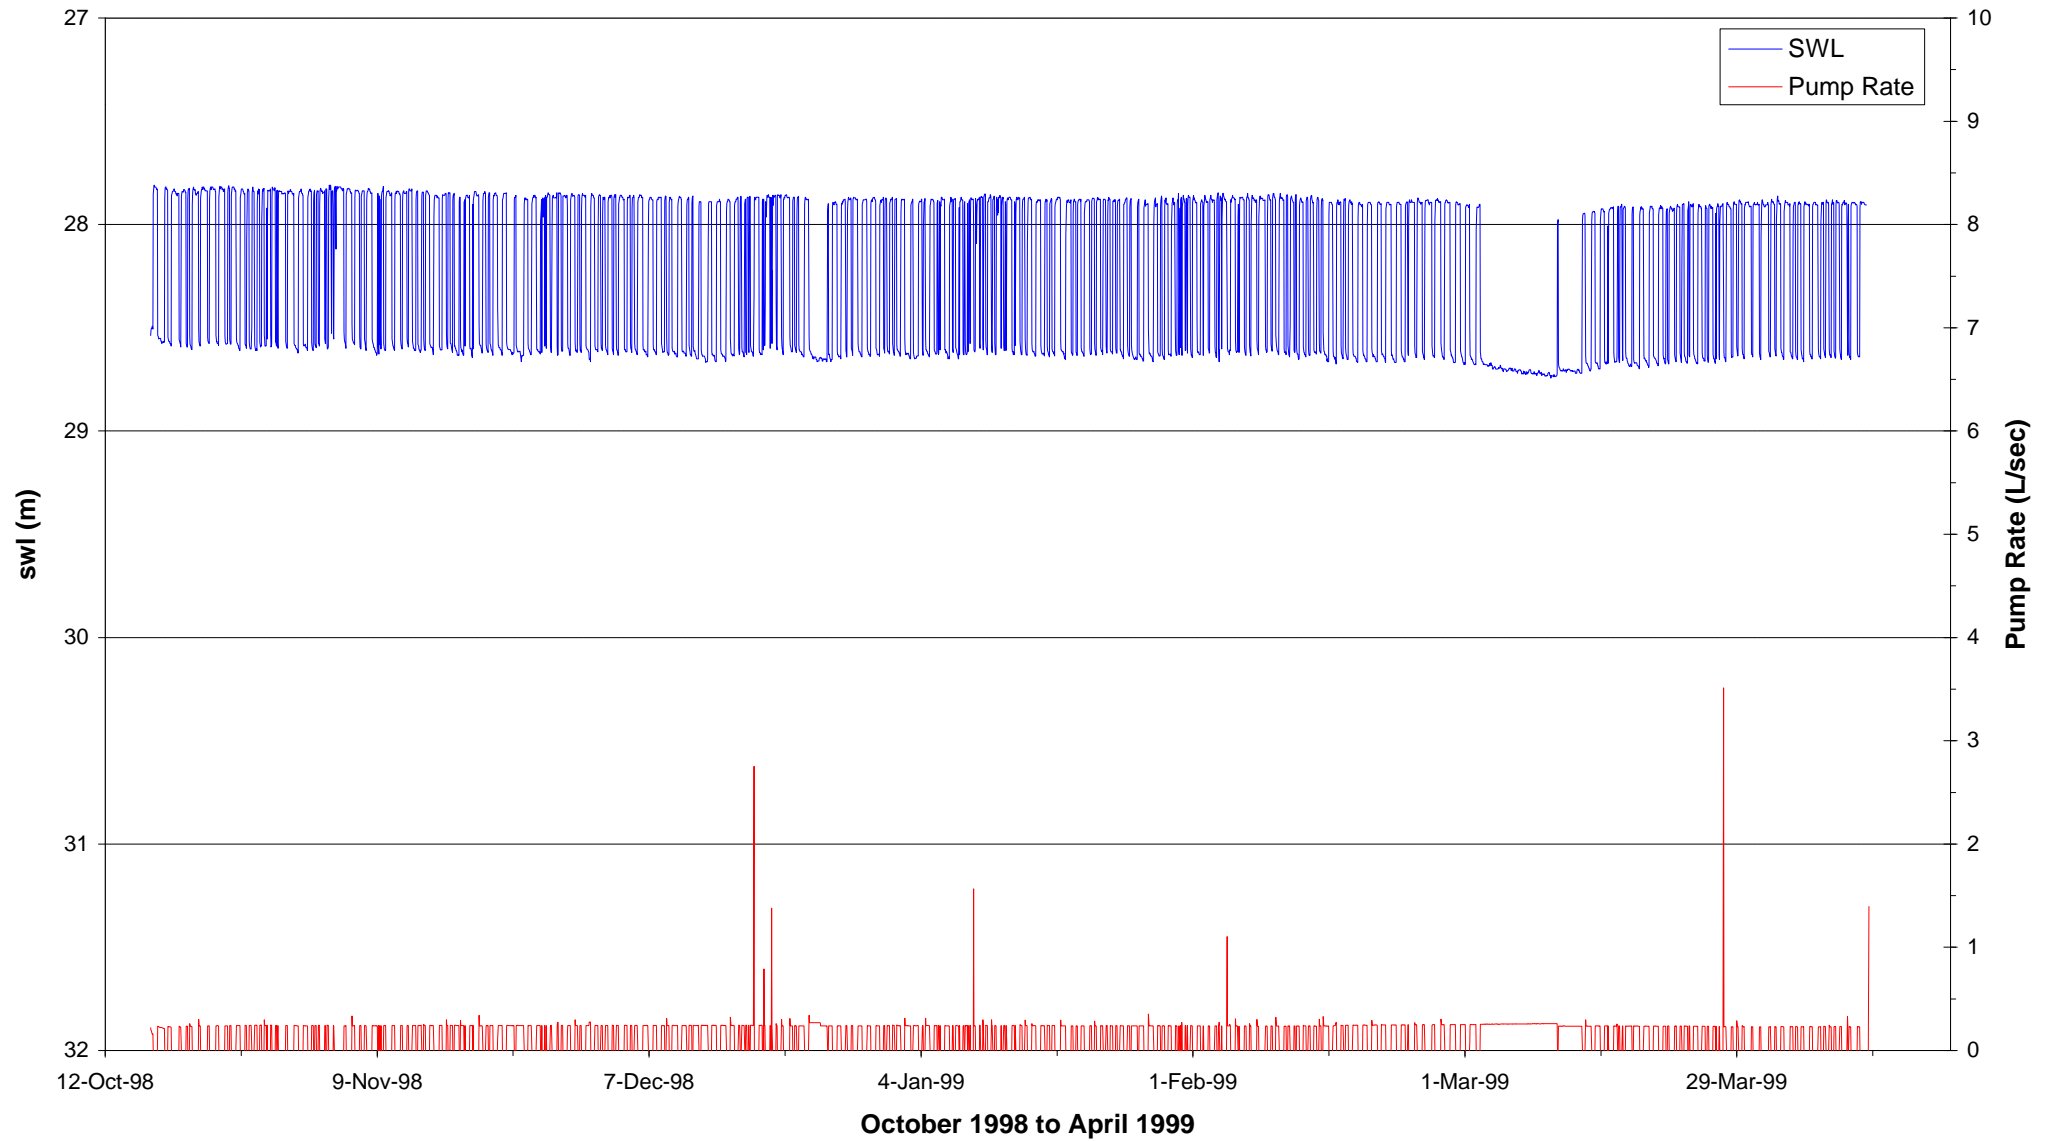
Figure 40 Kalka KA-2; Hourly SWL and Pump Rate

Well 2. No sign of depletion.
