Hydrogeological Report on NW Aboriginal Lands well monitoring – October 1998 to April 1999

REPORT BOOK 2000/00005

Department for Water Resources, Groundwater

FEBRUARY 2000

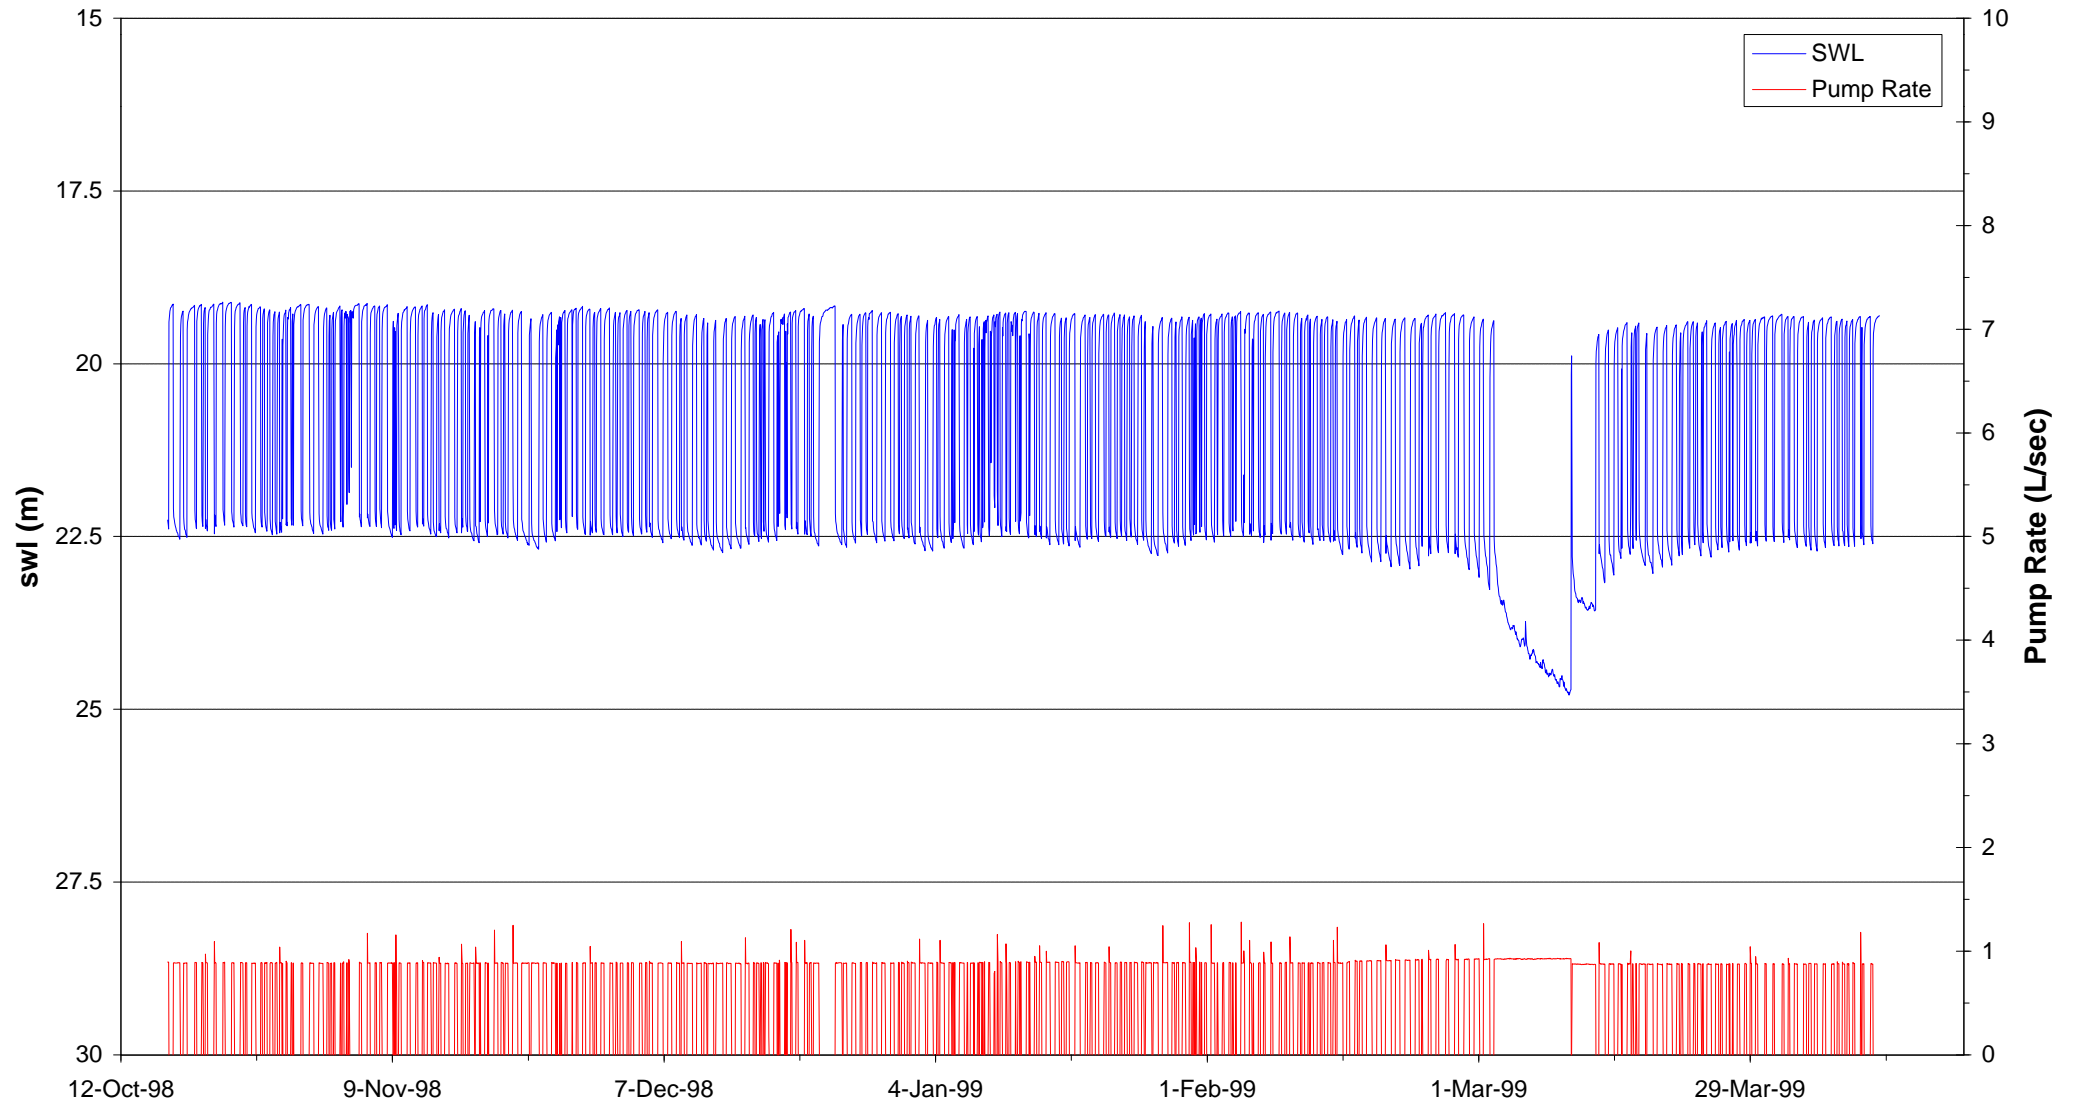
Figure 41 Kalka KA-3; Hourly SWL and Pump Rate

Well 3. No sign of depletion.

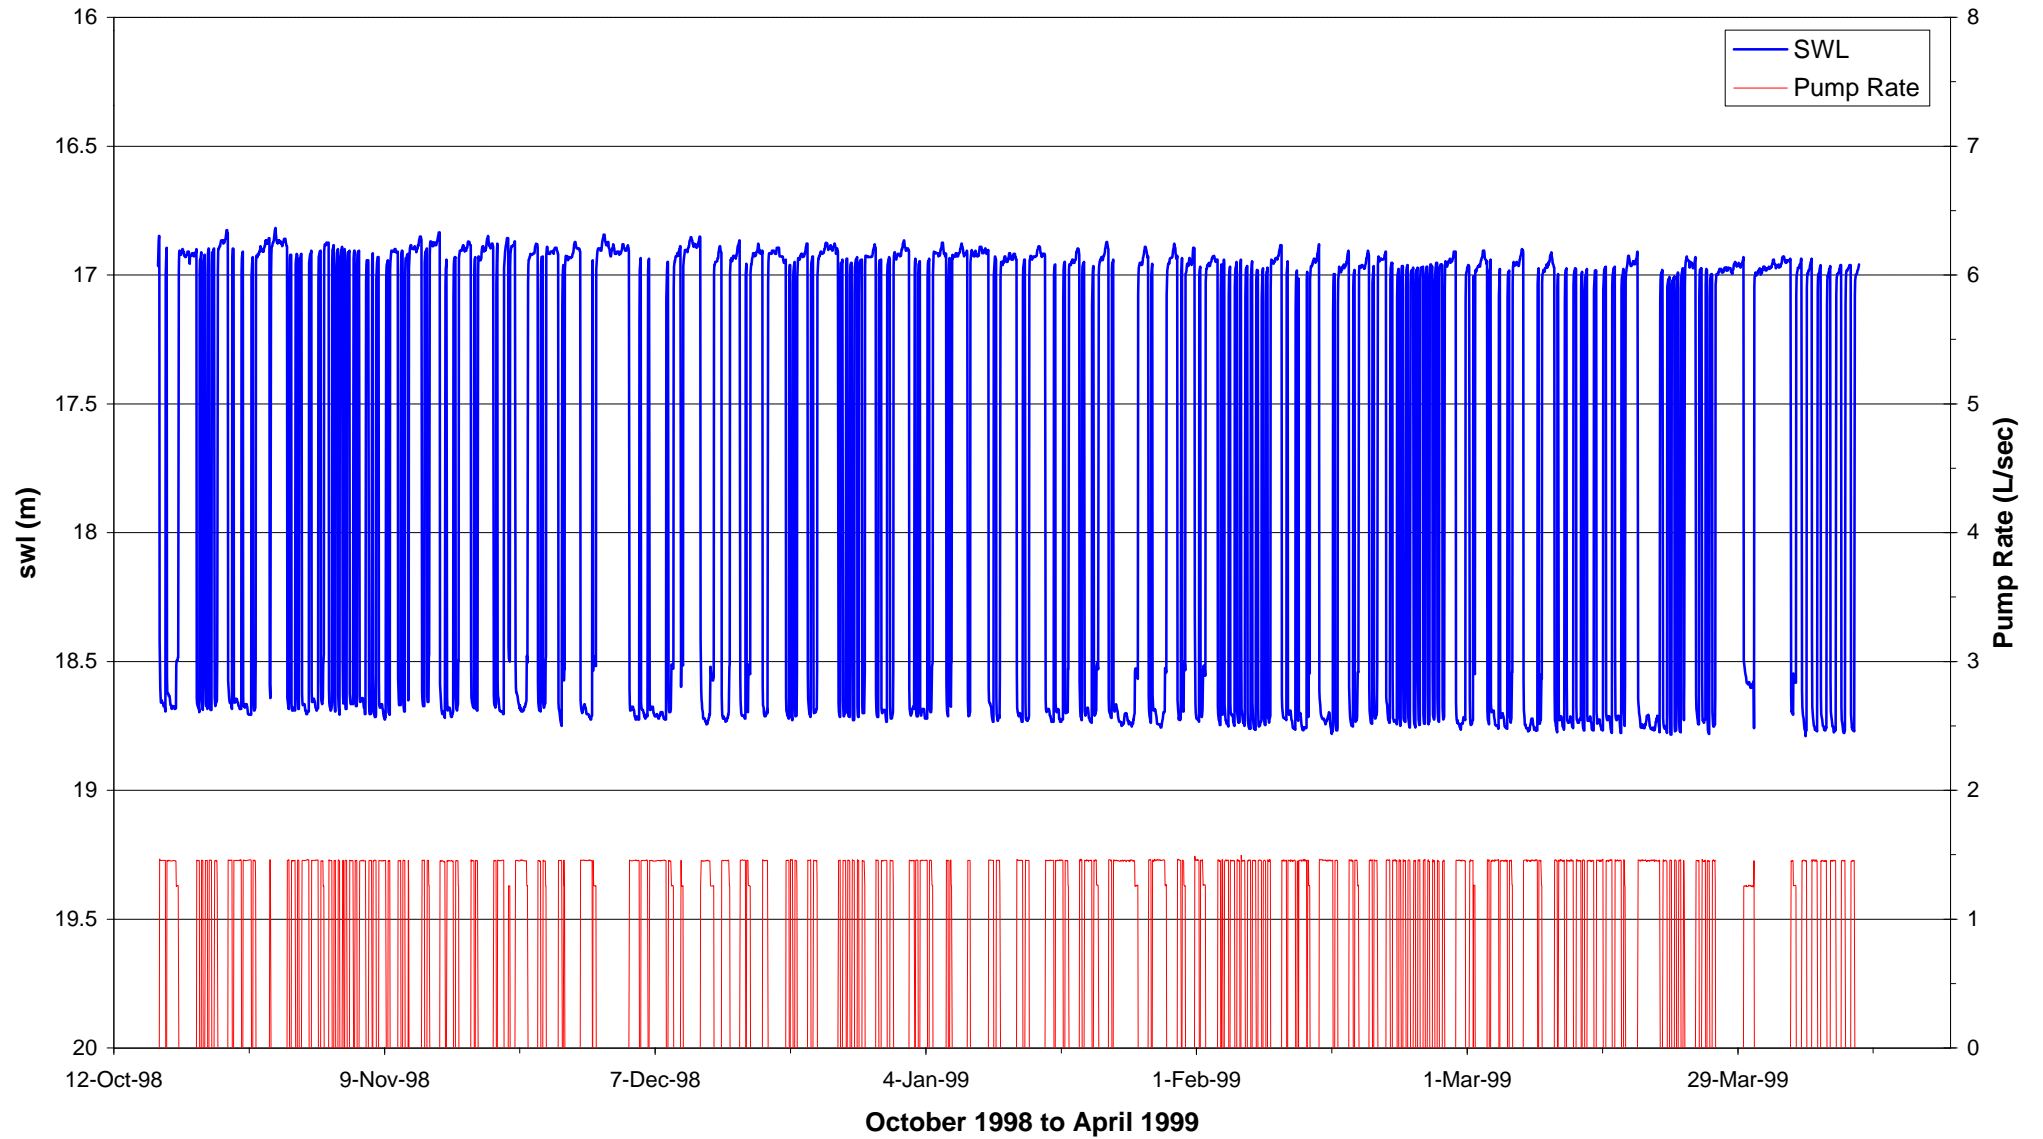
Figure 43 Pipalyatjara PIP-95; Hourly SWL and Pump Rate

Well 95. No sign of depletion.

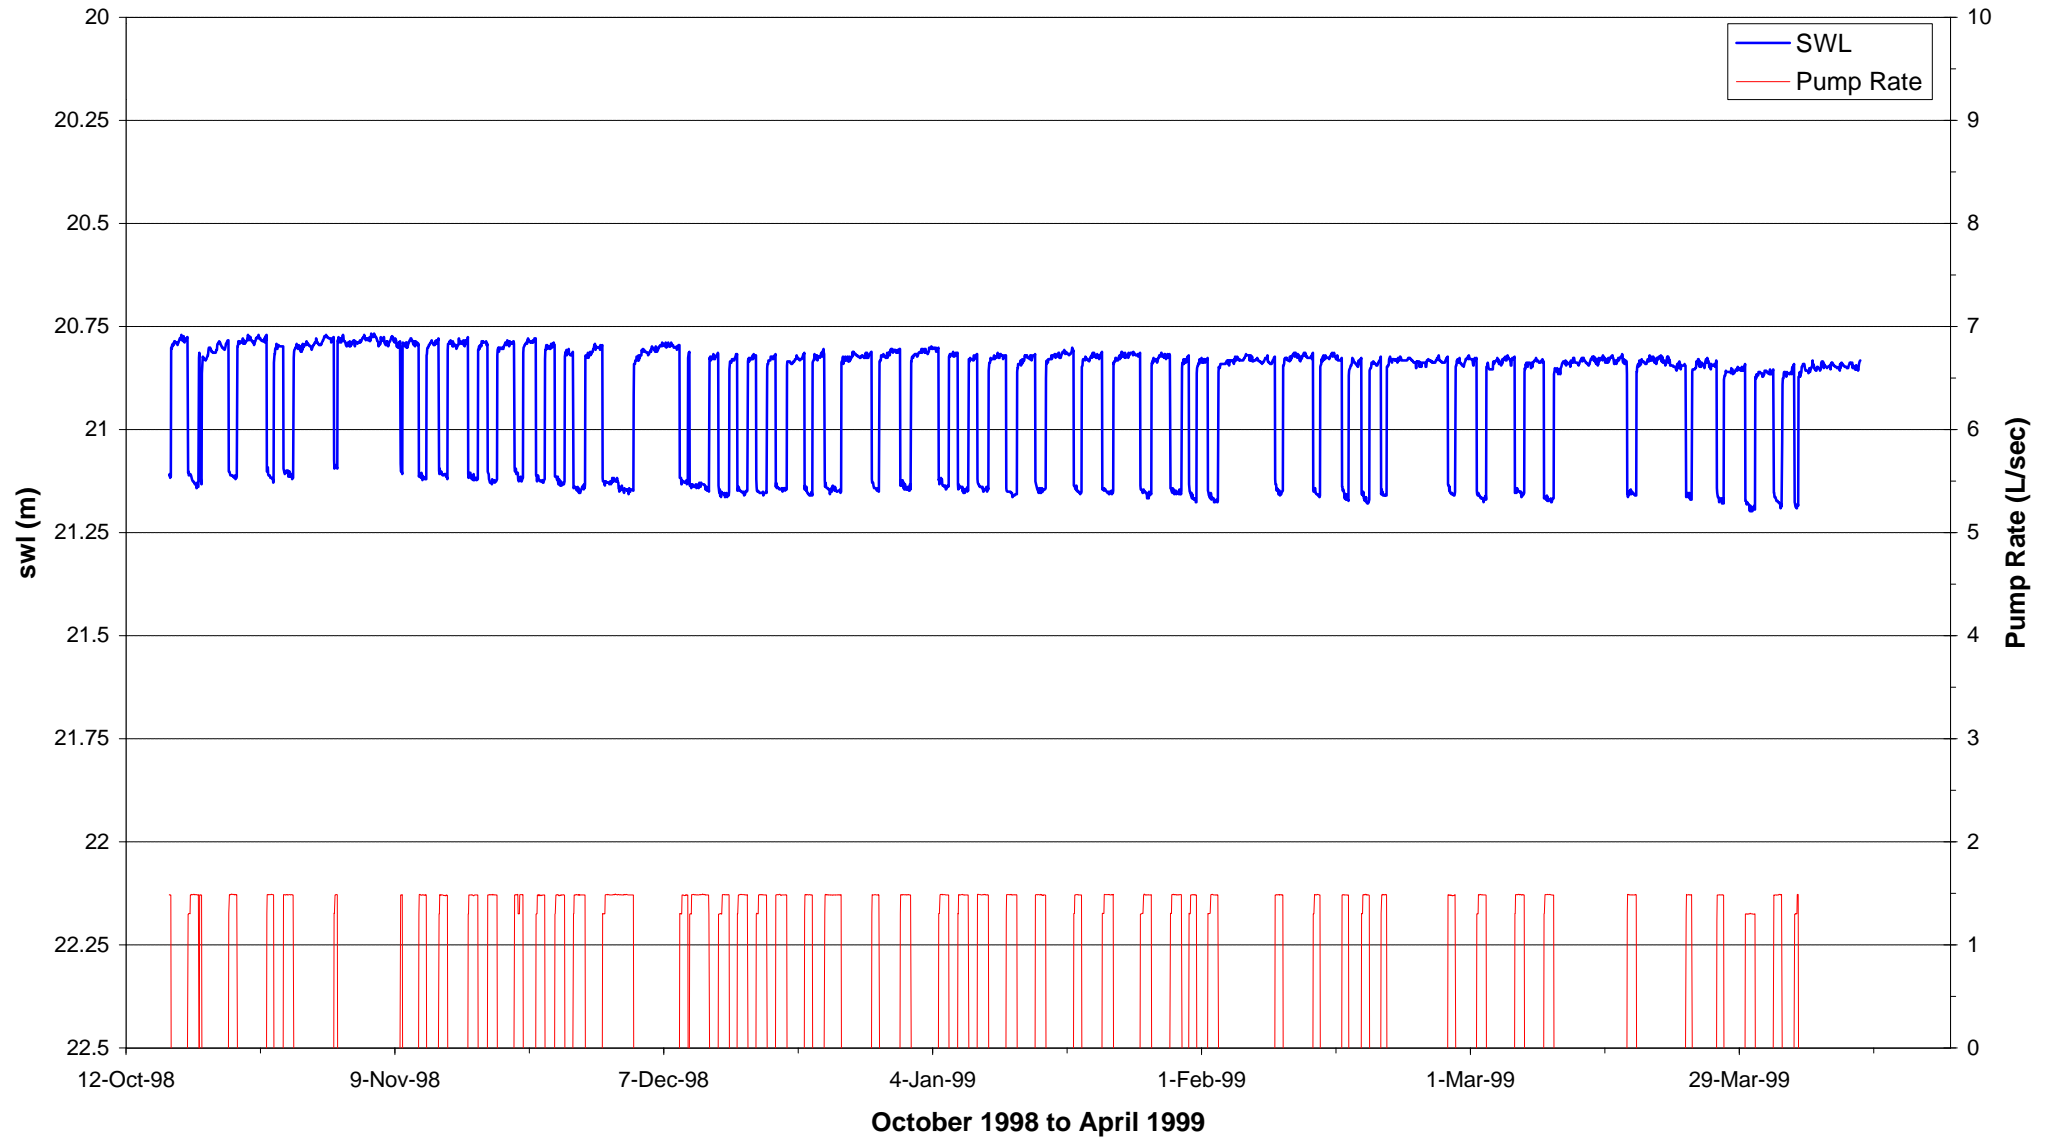
Figure 44 Pipalyatjara PIP-96; Hourly SWL and Pump Rate

Well 96. No sign of depletion.
