Hydrogeological Report on NW Aboriginal Lands well monitoring – April to October 1999

REPORT BOOK 2000/00007

Lloyd Sampson and Sandy Dodds

Department for Water Resources, Groundwater

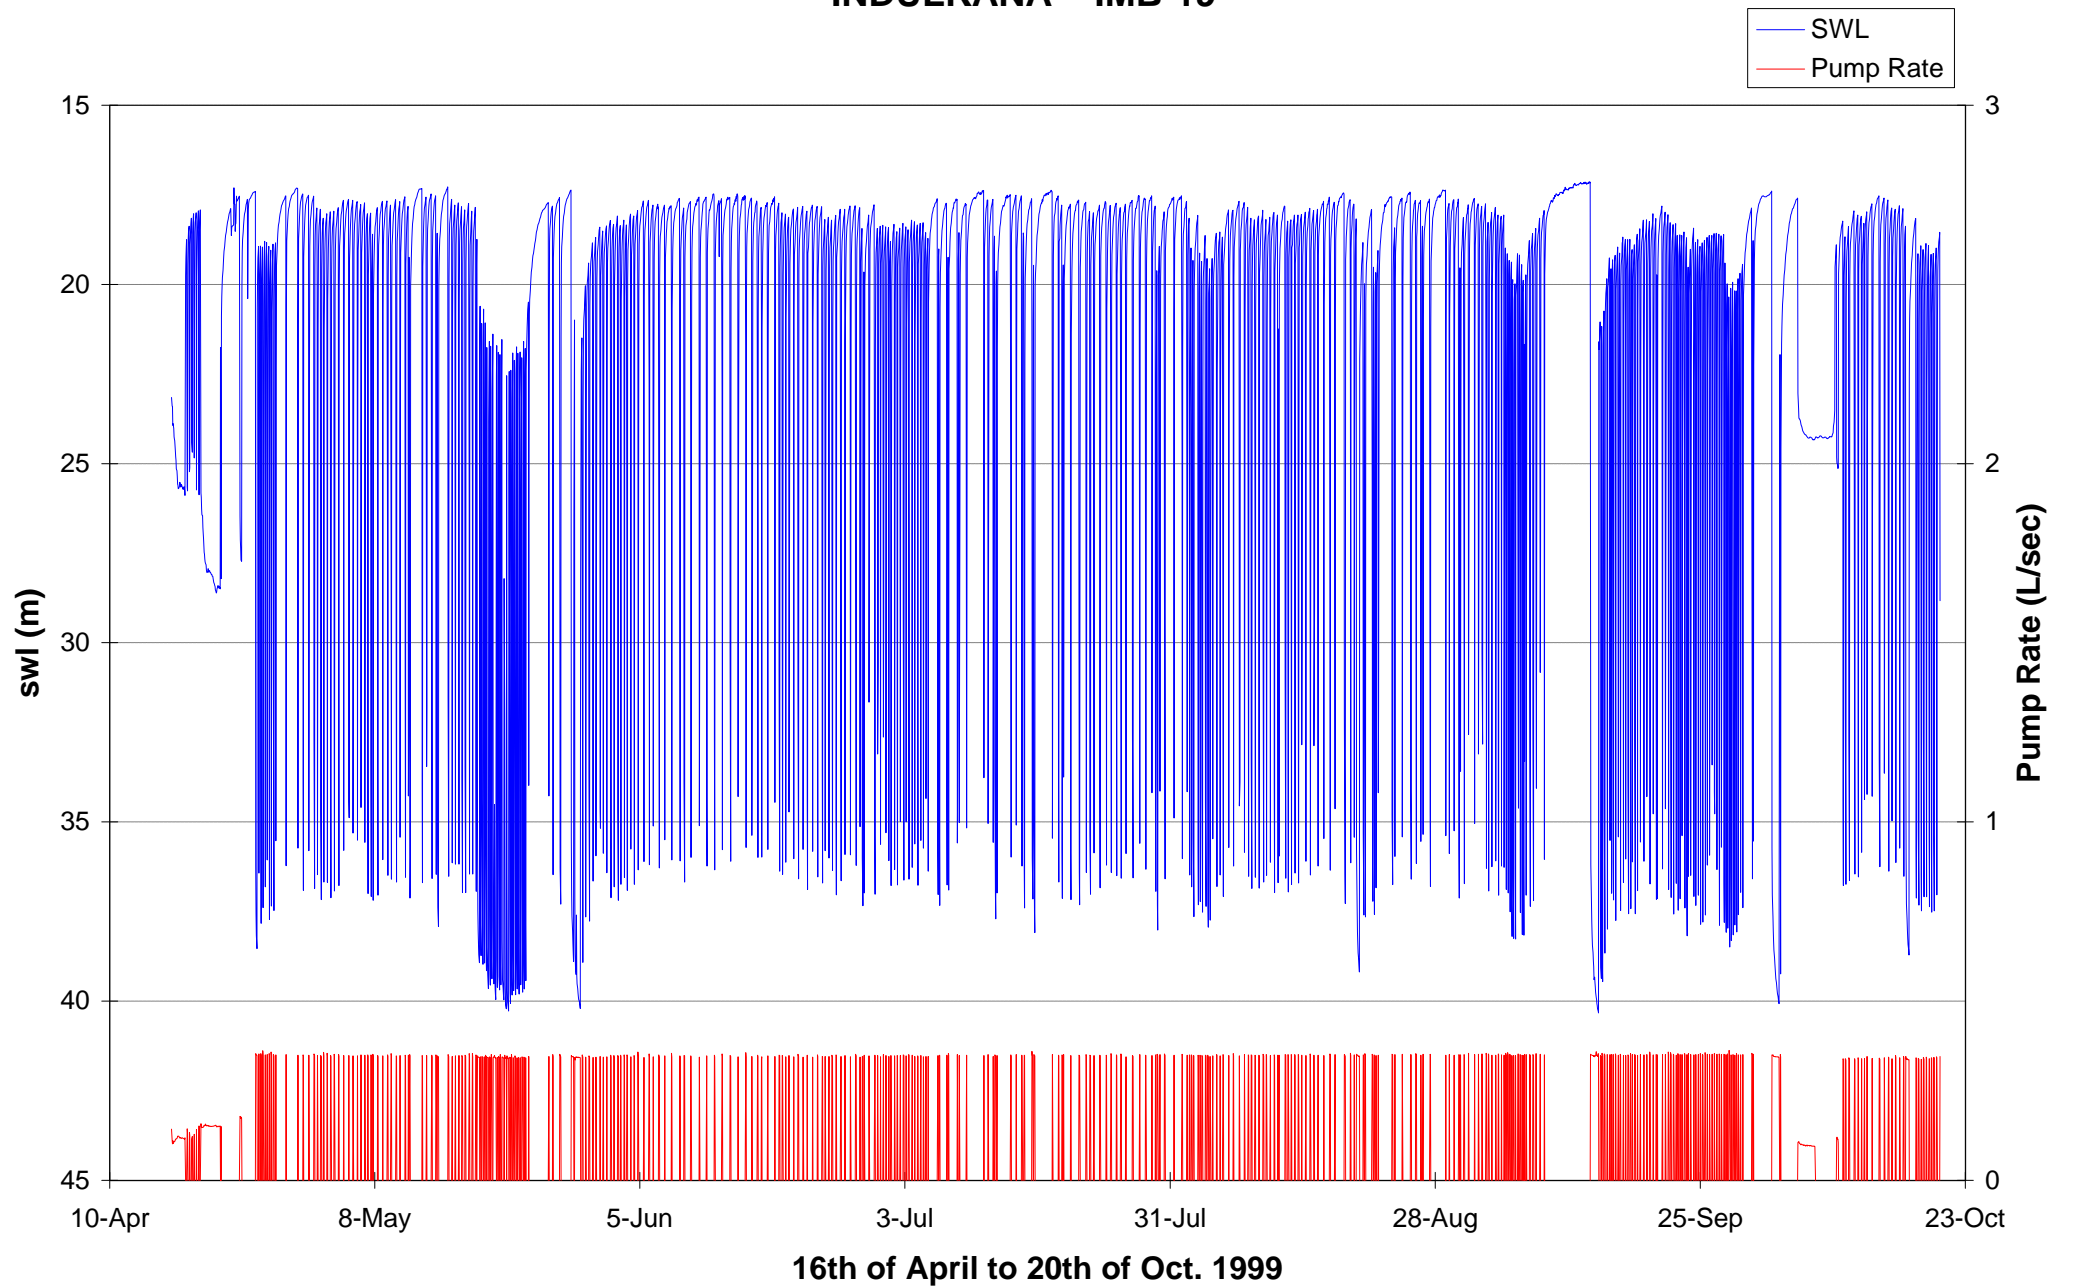
Figure 4 Indulkana IMB-19; Hourly SWL and Pump Rate

Well 19. The lower pump rate of 0.35 L/s (0.6 L/s in the previous period) has eased the stress on this well, but even at this rate the well cannot maintain supply for very long (Figure 4). A 21 hour spell of continuous pumping in September resulted in 4 m of additional drawdown to 40 m. An intensive intermittent pumping period during May resulted in a similar drawdown. While these drawdowns are not into the danger zone of 41–56 m where the aquifer lies, they are as close as is advisable.

The well recovers fairly quickly, and almost regained its original SWL of 15.6 m when rested for 5 days in early September (SWL 17.14 m). Similarly in May when the bore was not pumped for 2 days the SWL recovered to 17.72 m.

The well was pumped at 0.1 L/s continuously for 44 hours in early October with only very slow additional drawdown of 1 m, so it appears that this pump rate could be applied continuously for several weeks before the SWL would drop to the danger zone of 40 m.

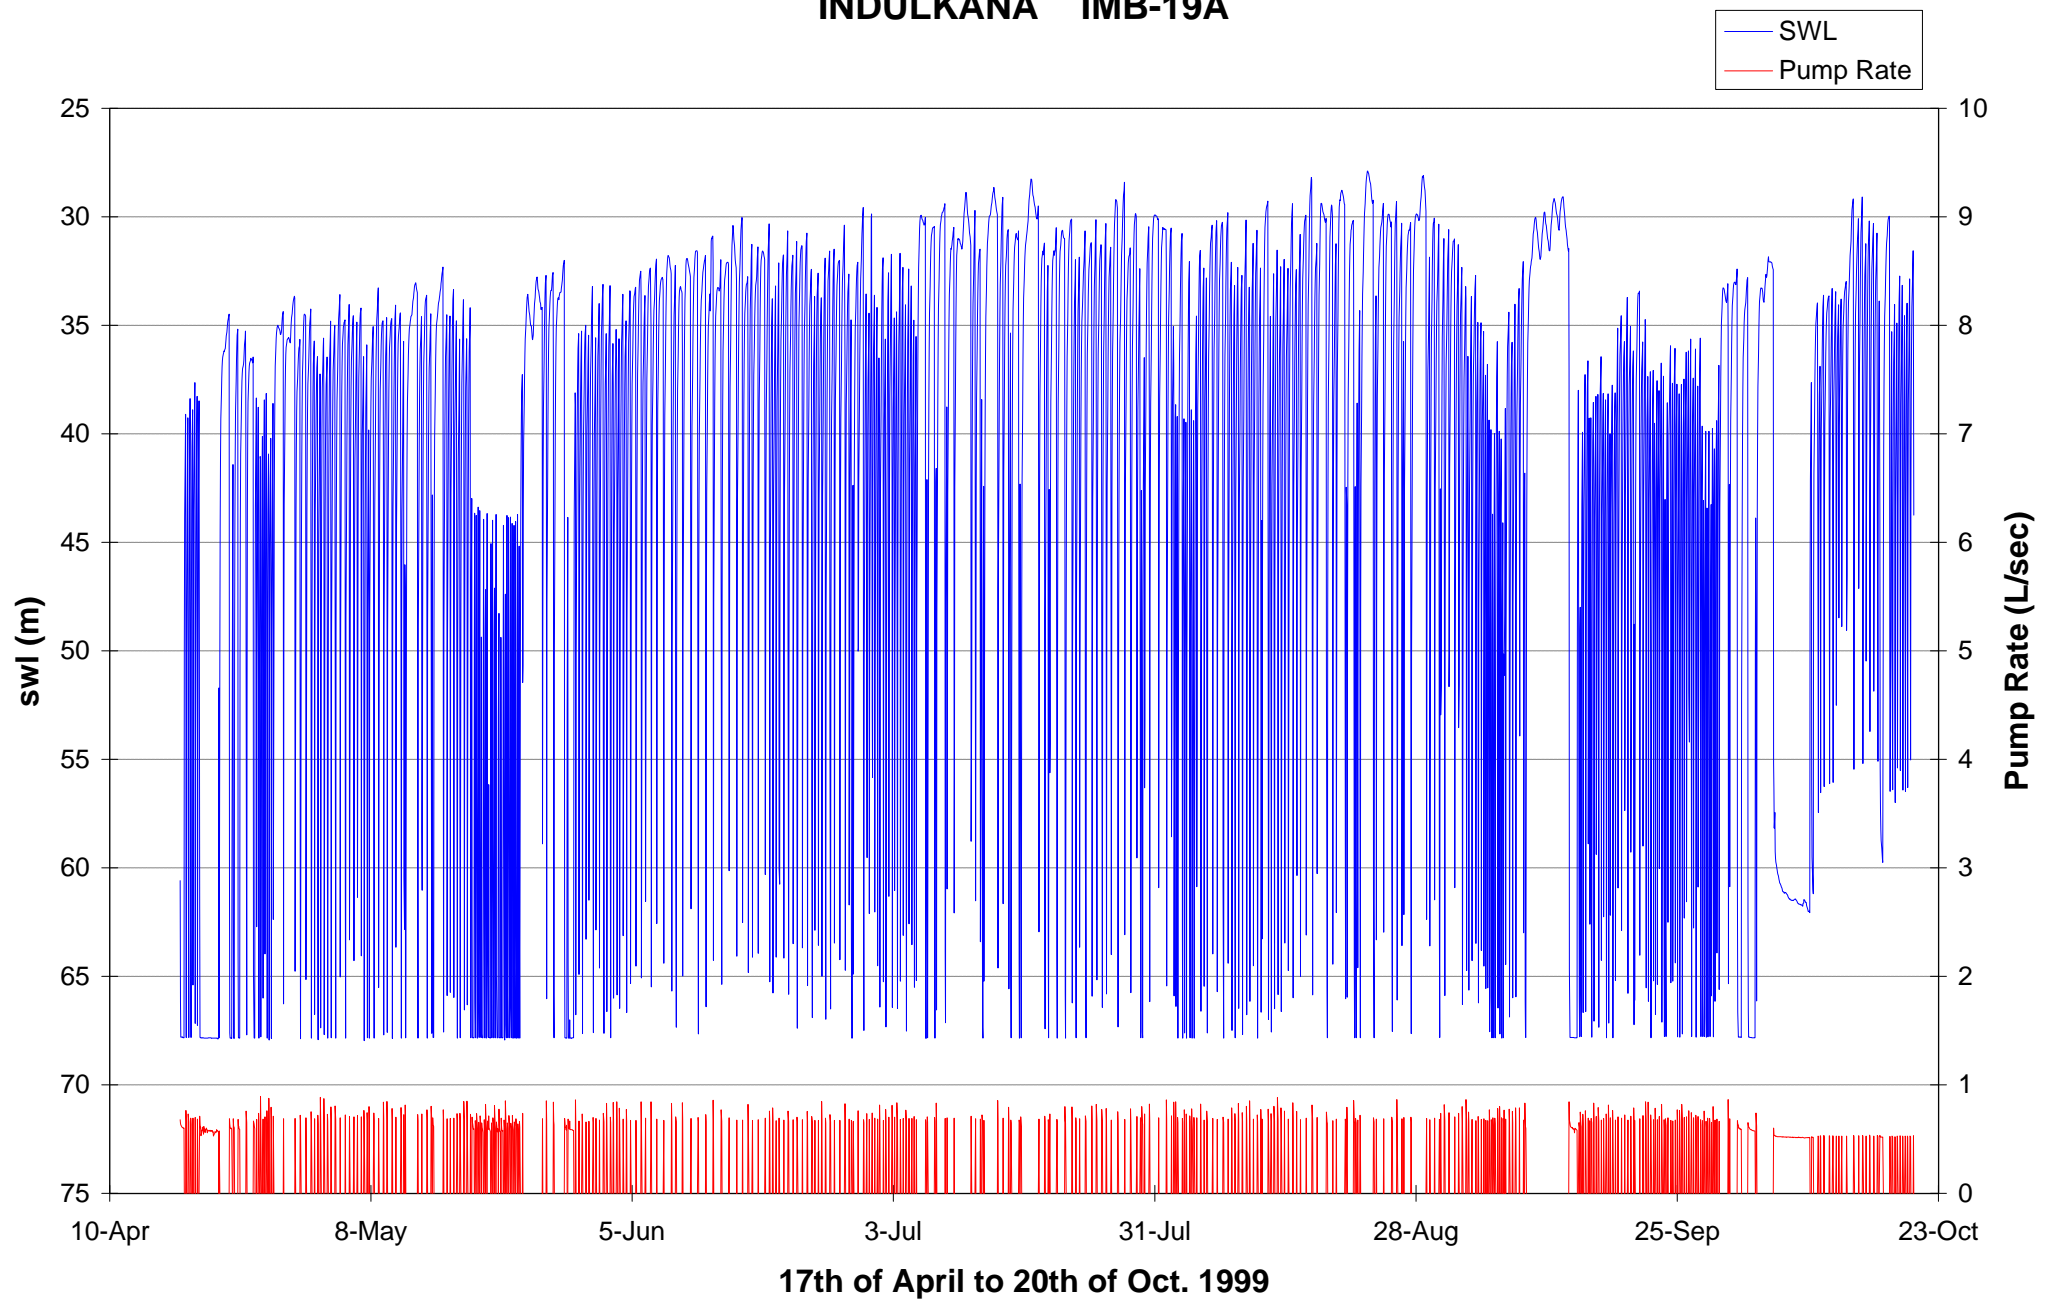
Figure 5 Indulkana IMB-19A; Hourly SWL and Pump Rate

Well 19A. The well is still being pumped dry within two hours at the currently used rate of 0.8 L/s and never fully recovers in the intervening 12 hours (Figure 5). In May, during an intensive pumping period water levels were not allowed to recover and

the SWL declined approx 10 m. However, in the long term the well appears to recover to near its original SWL of 28 m, if given time.

The well was pumped continuously for about 3 days in early October at the reduced rate of 0.5 L/s and sustained this fairly comfortably. The water level dropped at less than 1 m/day, indicating that the continuous pumping could have continued for a week or more in an emergency.

It is recommended that if a more continuous pumping regime is required then the pumping rate be reduced to 0.5–0.6 L/s.

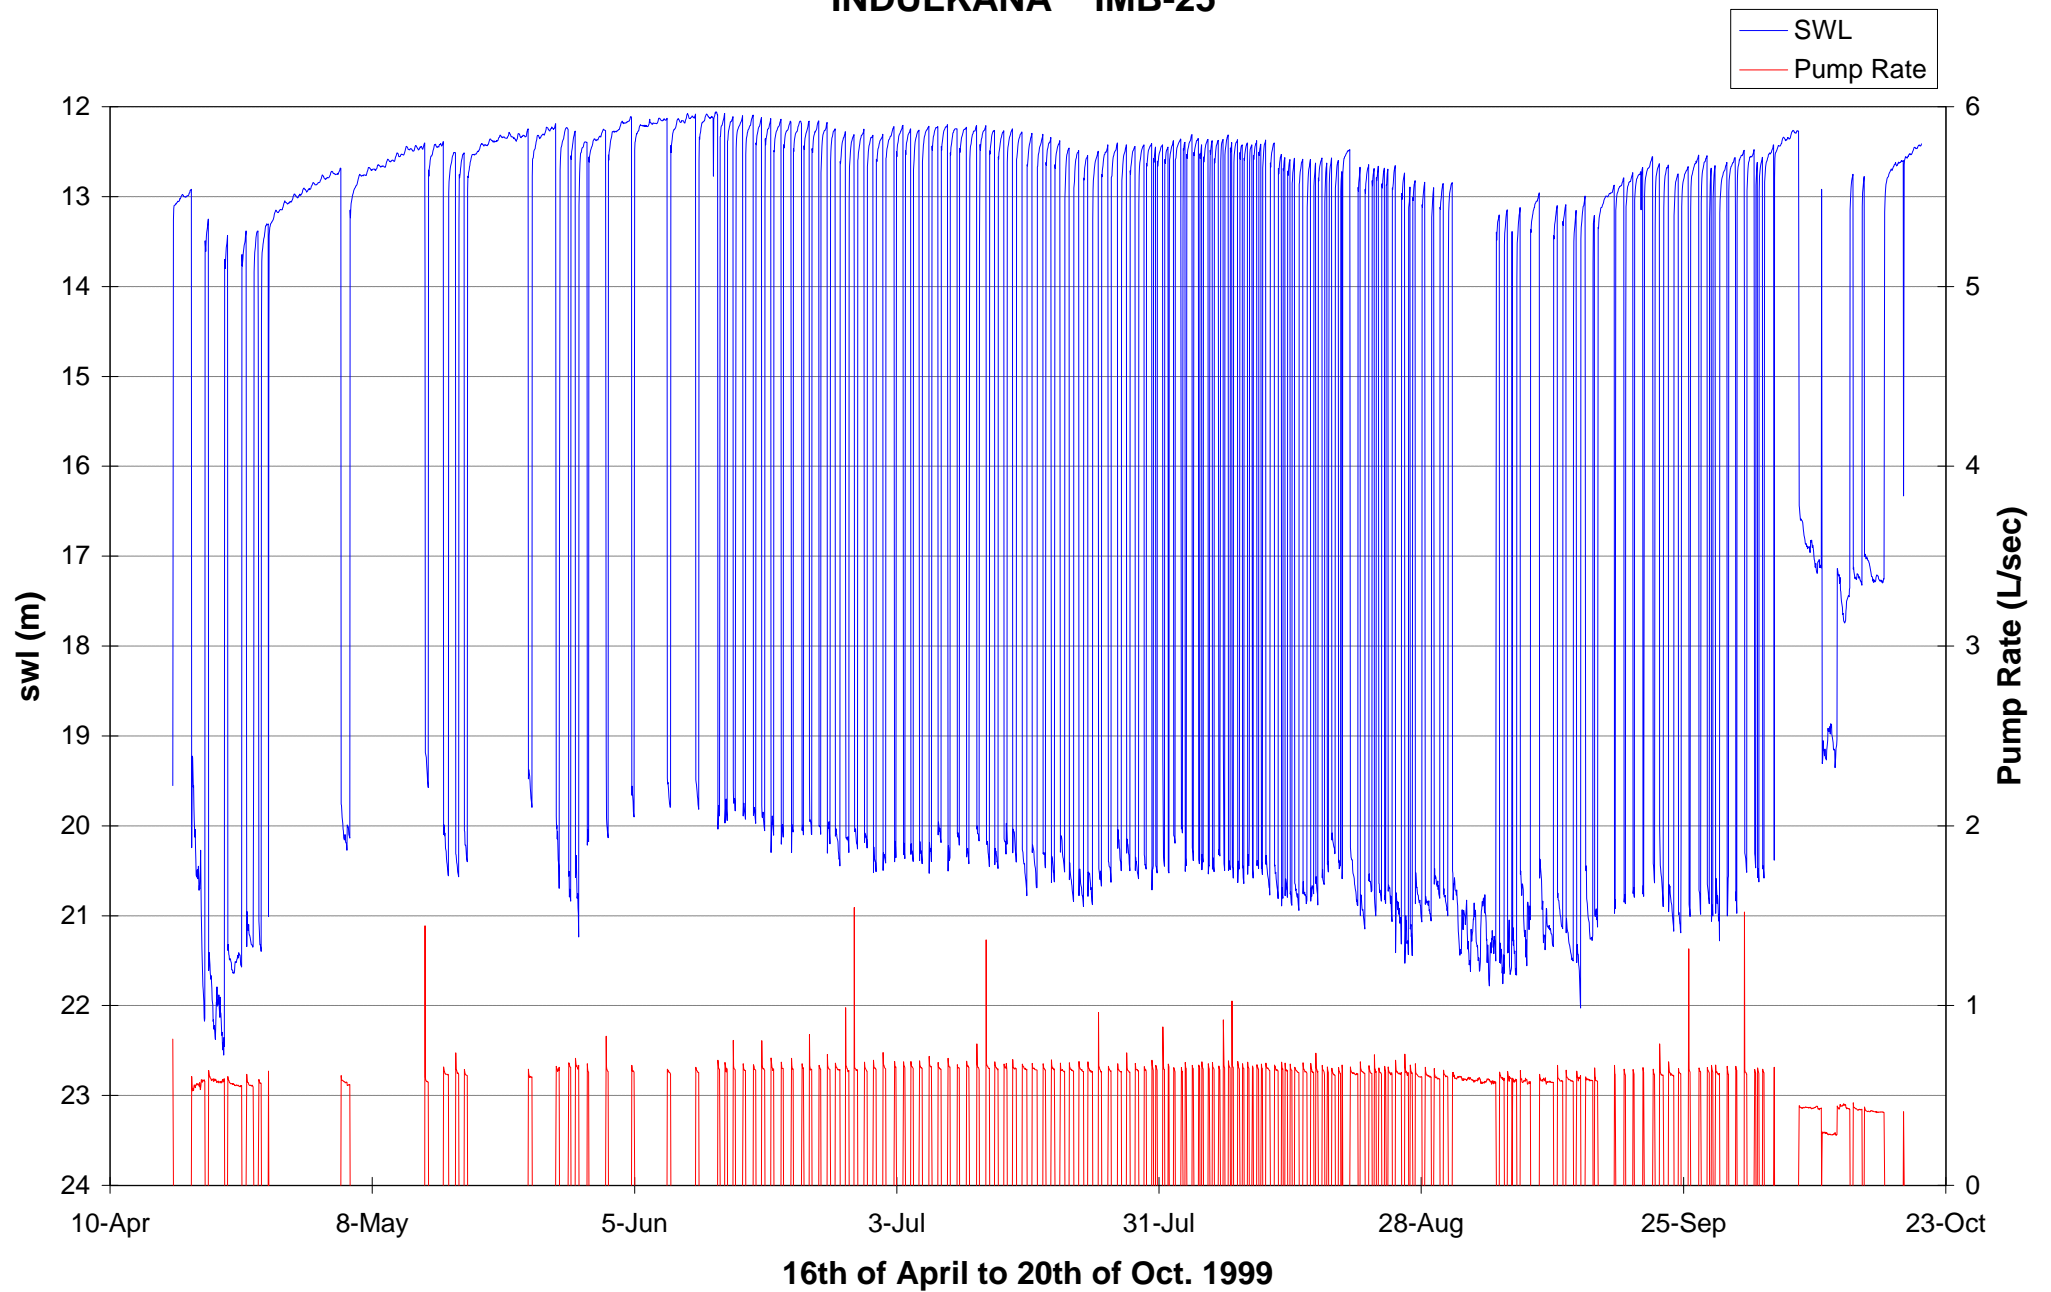
Figure 6 Indulkana IMB-25; Hourly SWL and Pump Rate

Well 25. This well has recovered significantly thanks to reduced pumping in May, with the SWL rising to 12 m, well above its 1995 level of 14.8 m (Figure 6). After a period of stability in June-July the SWL again dropped in August-September as a result of increased hours of pumping. It appears that the pumping rate for July of about 7 hours daily at 0.65 L/s (16 kL/day) is sustainable in the long term without depleting the aquifer.

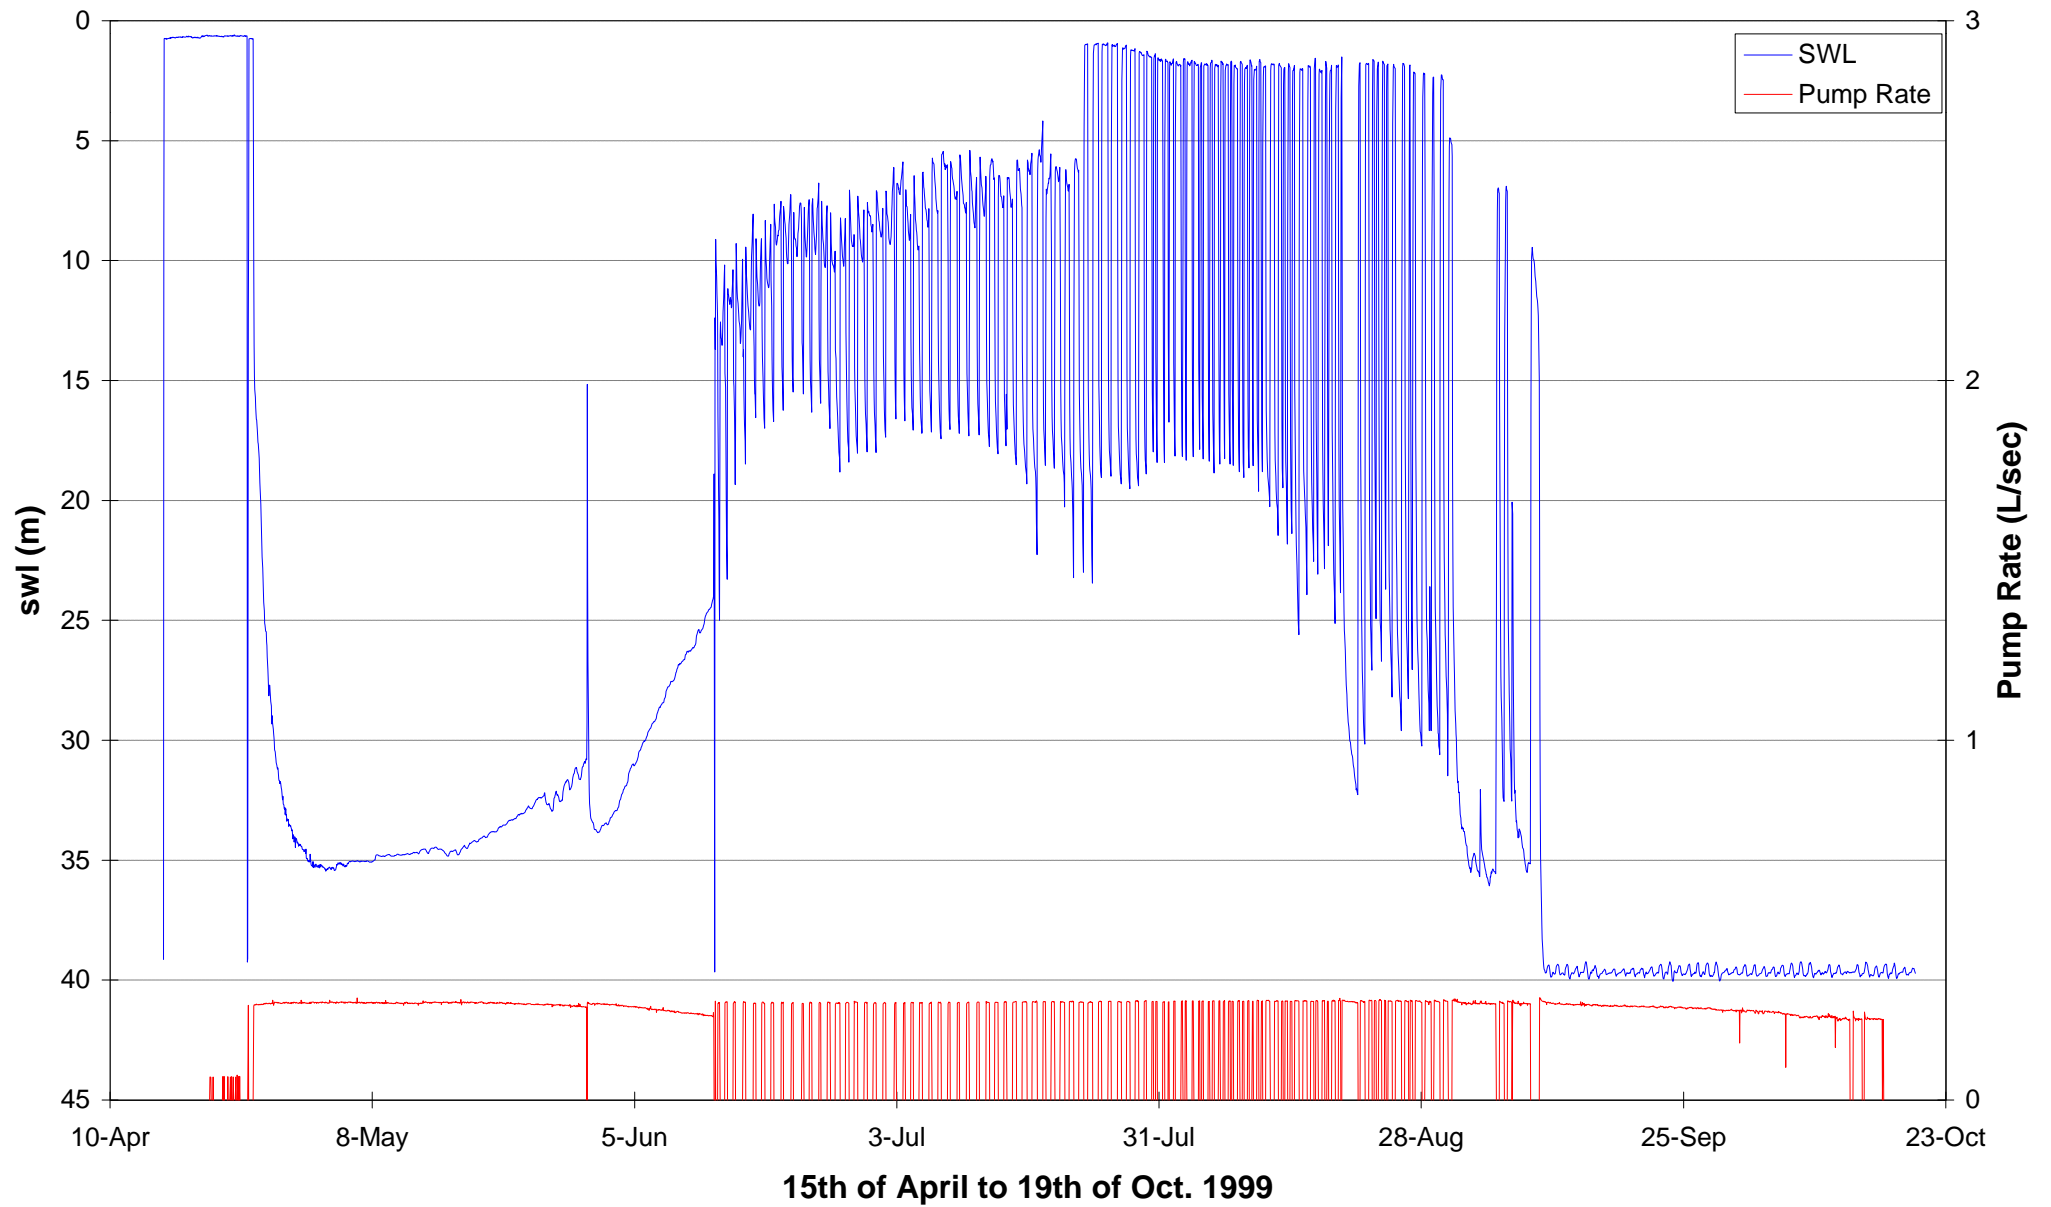
Figure 7 Indulkana IMB-26 - Hourly SWL and Pump Rate

Well 26. The failure of the SWL transducer in early September throws some doubt on the earlier data back as far as July, but it appears from the continuous pumping in May that the well can sustain a rate of 0.3 L/s for some time (Figure 7).

The pressure transducer 2100P was found to be faulty, reading 0.00 metres head of water.

S/N 210 362 failed on the 9 Sept. and was removed and replaced with S/N 210 359.

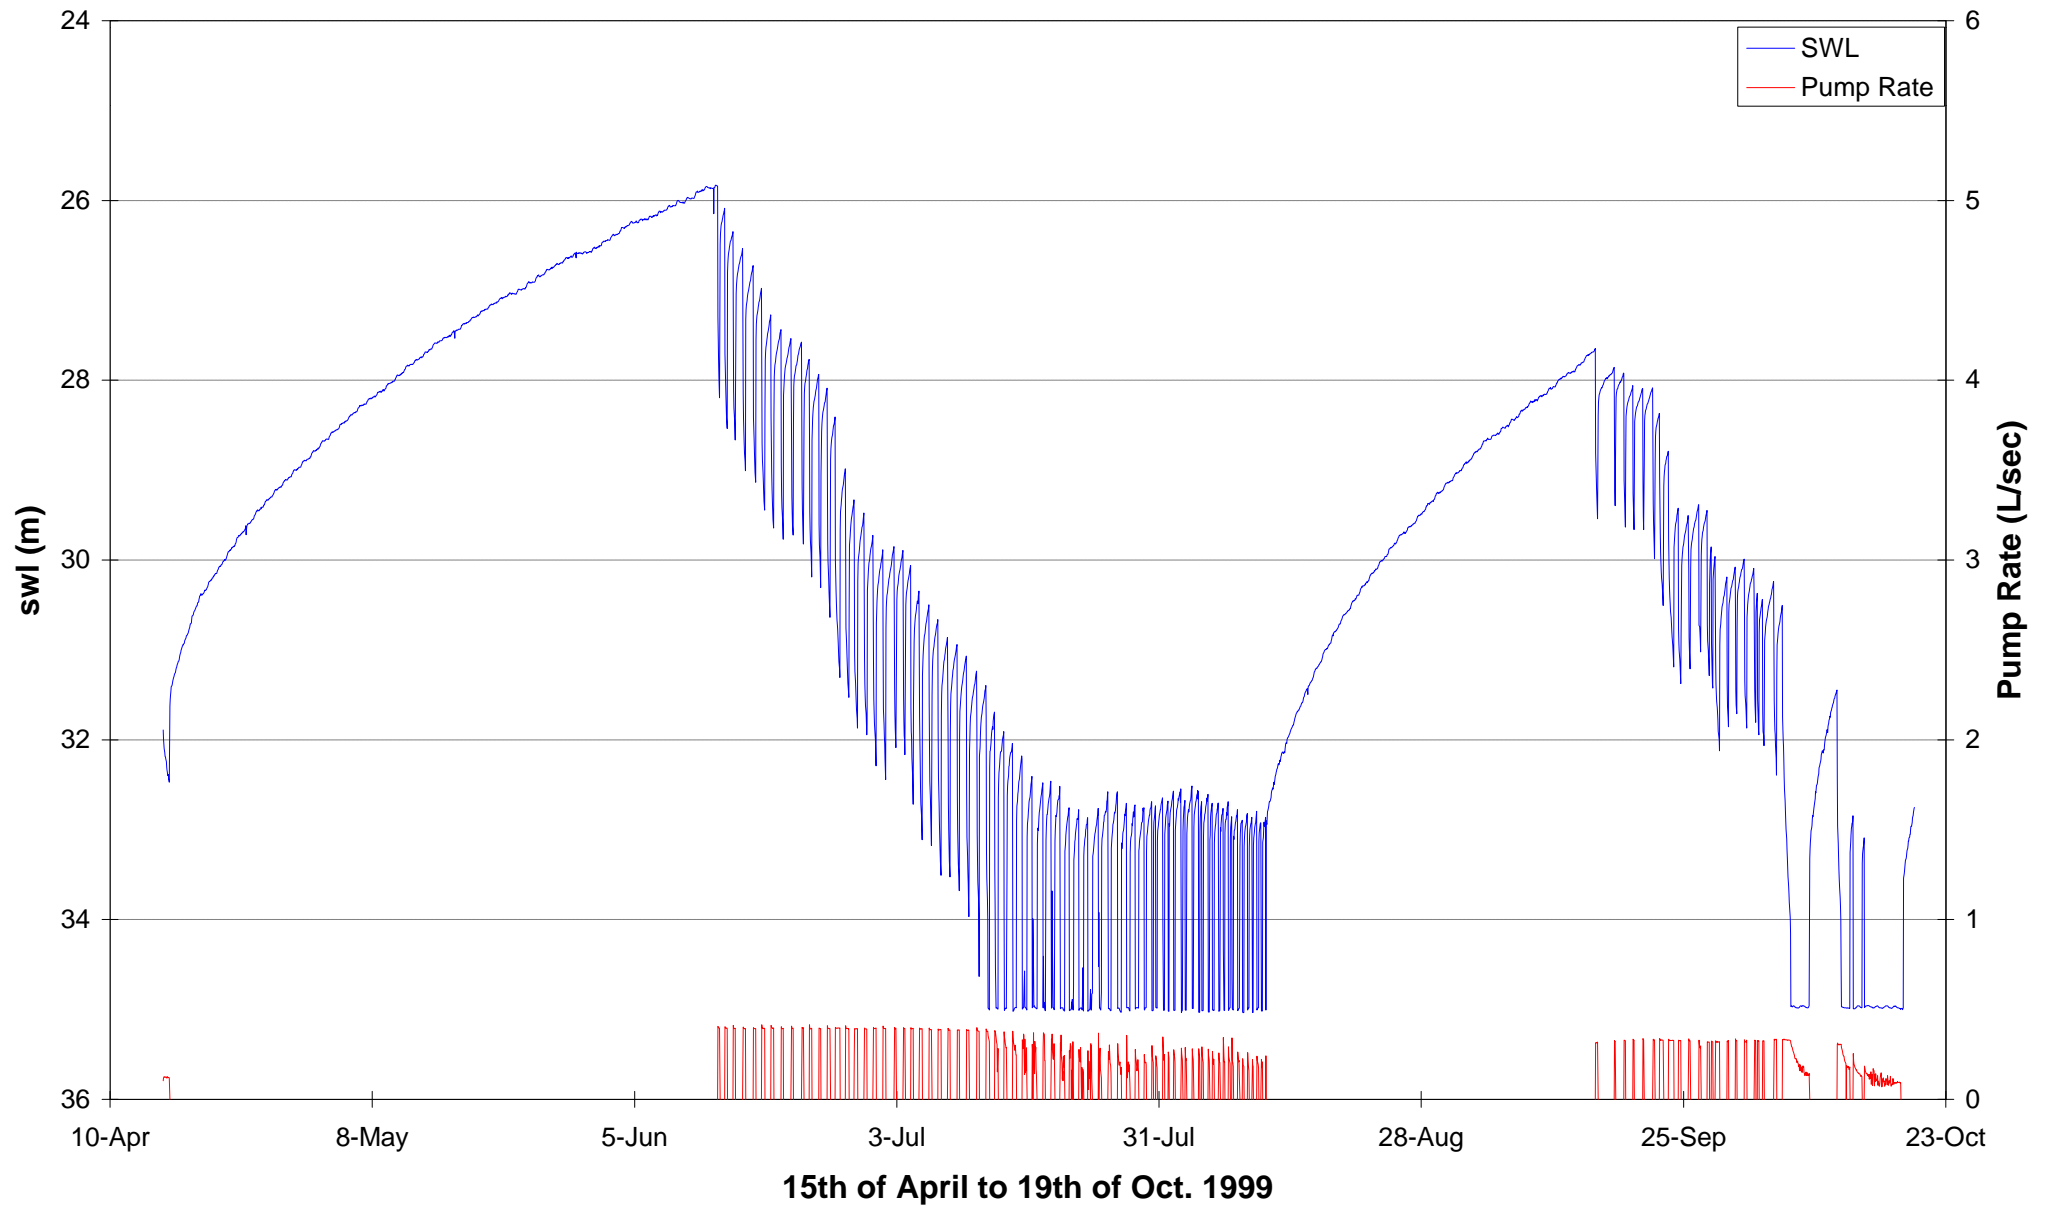
Figure 8 Indulkana IMB-27 - Hourly SWL and Pump Rate

Well 27. The well is bottoming out in spite of low and intermittent pumping rates (Figure 8). The very slow recovery rate indicates that this well, while possibly not depleting the aquifer, can never produce much water. It would be preferable to reduce the pump rate (currently at 0.4 L/s) in order to sustain longer term pumping.

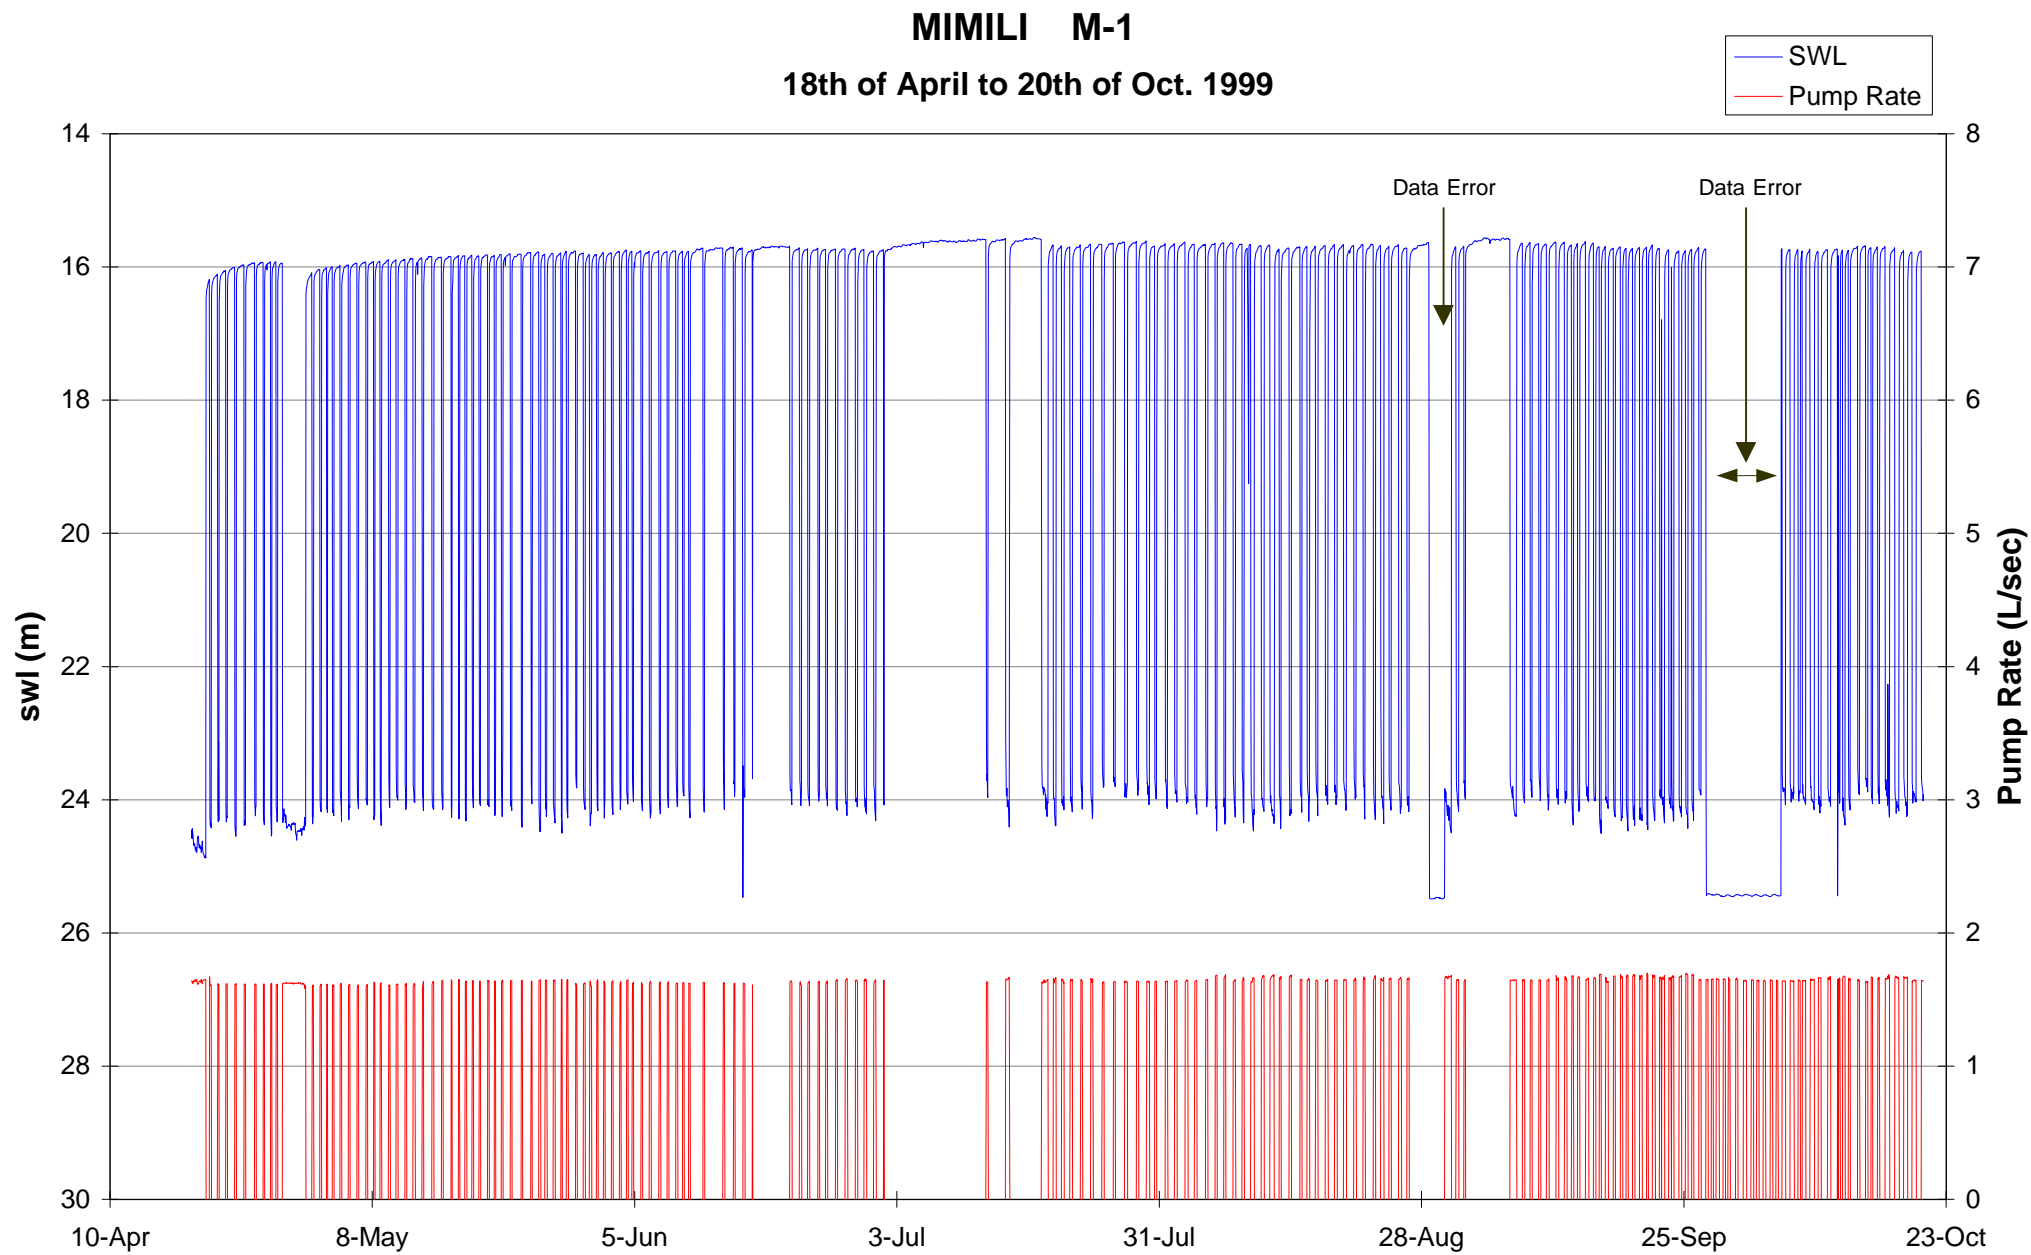
Figure 11 Mimili M-1; Hourly SWL and Pump Rate

Well M1. Two data errors in late August and early October relate to a meaningless shift in SWL (Figure 11). There is no sign of depletion at these pumping rates, with the SWL of 15.6 m comparing favourably with the 1978 figure of 14.7 m.

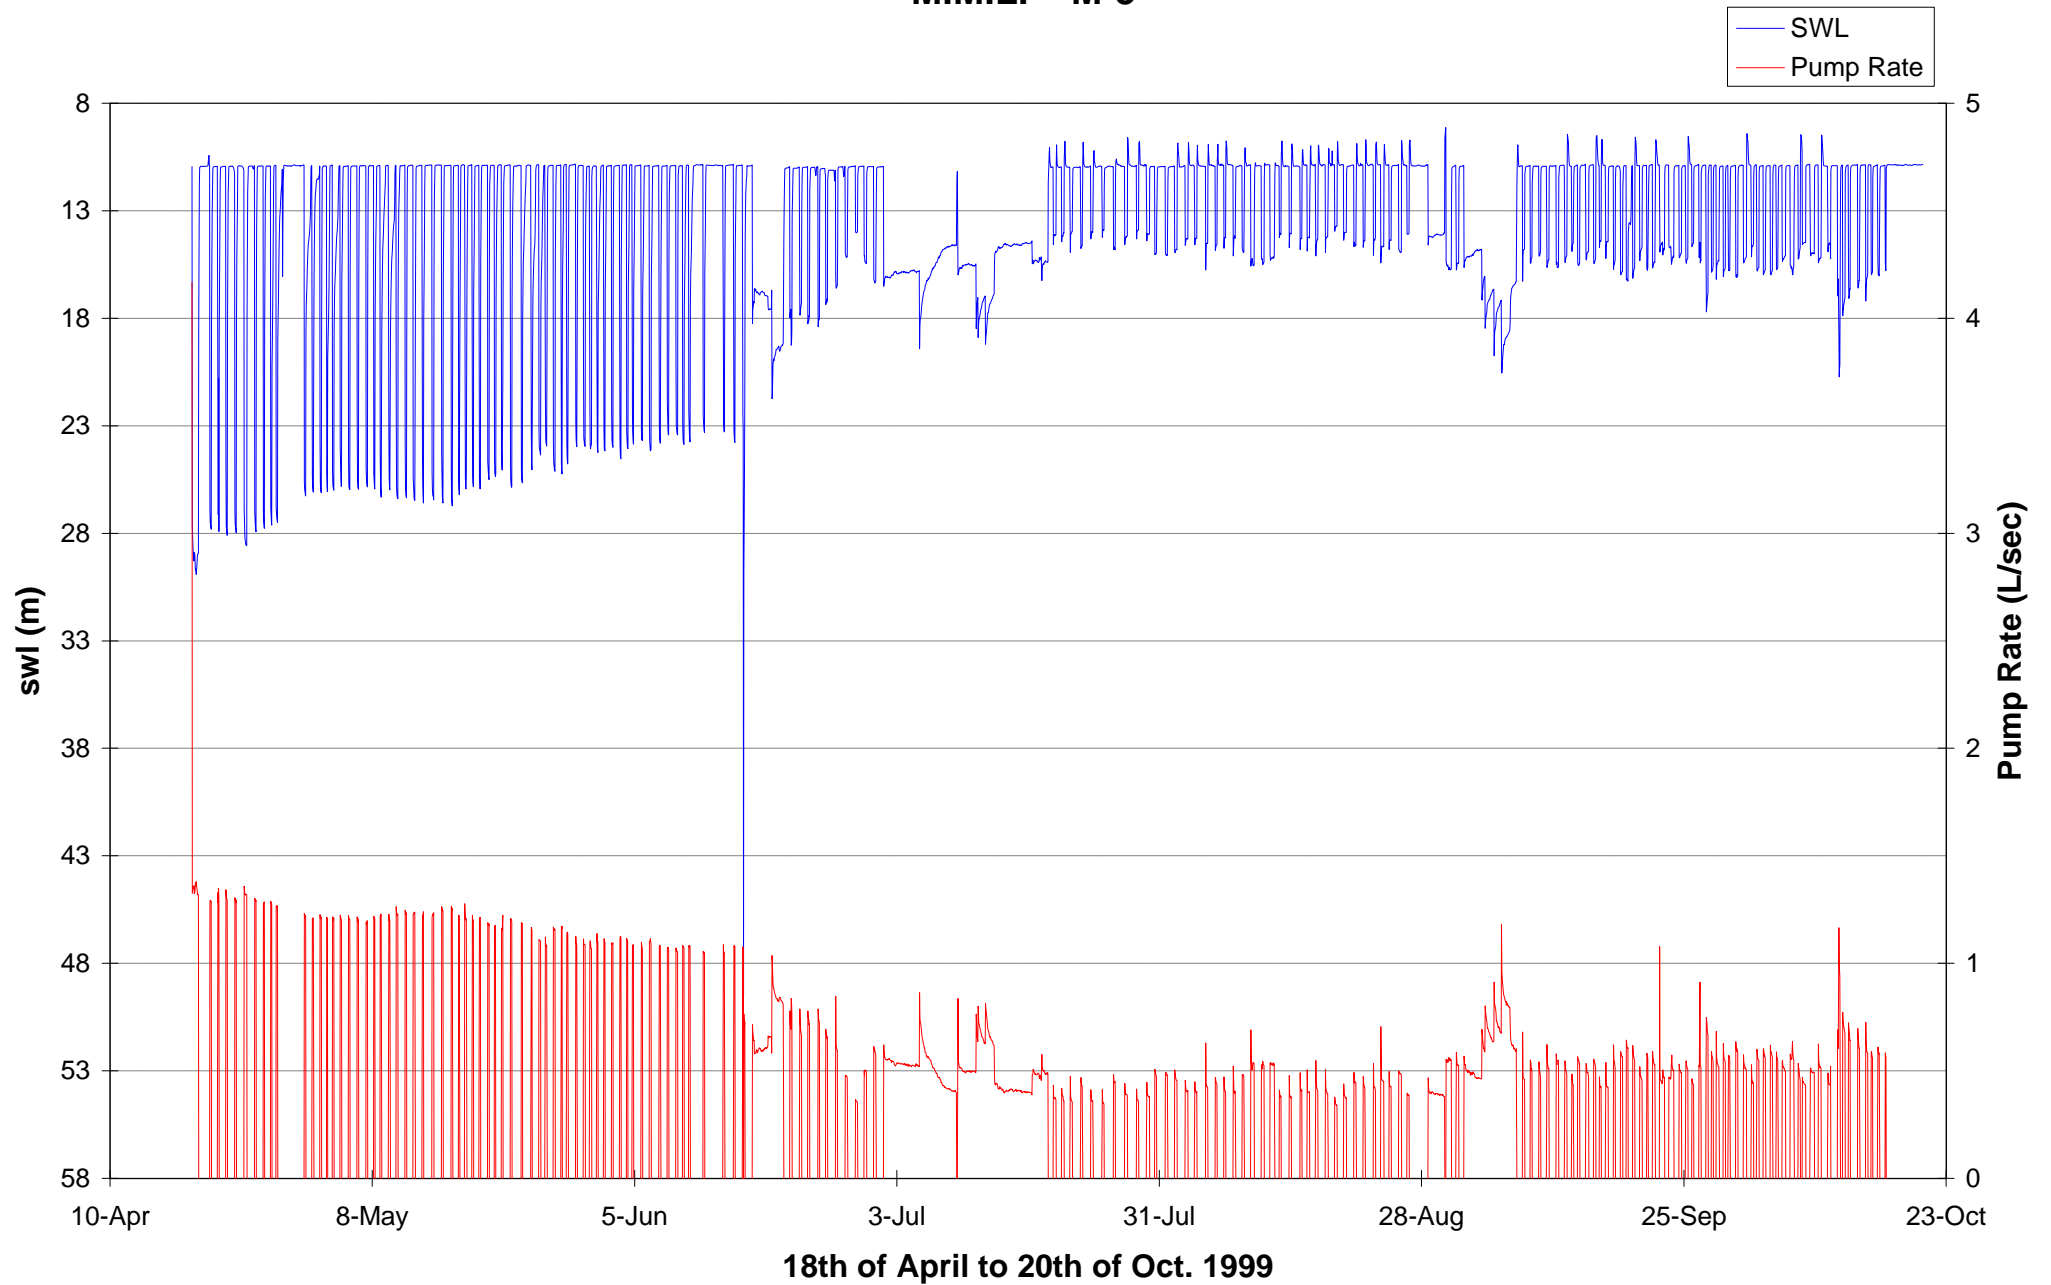
Figure 12 Mimili M-3; Hourly SWL and Pump Rate

Well M3. There is no sign of depletion at these pumping rates, the SWL having been about 10 m since 1995 (Figure 12). An overshoot in the SWL when the pump turns off, marked by a spike in the plot above the relaxed SWL of 10.9, may indicate water flowing back into the well from the distribution system through a faulty non-return valve.

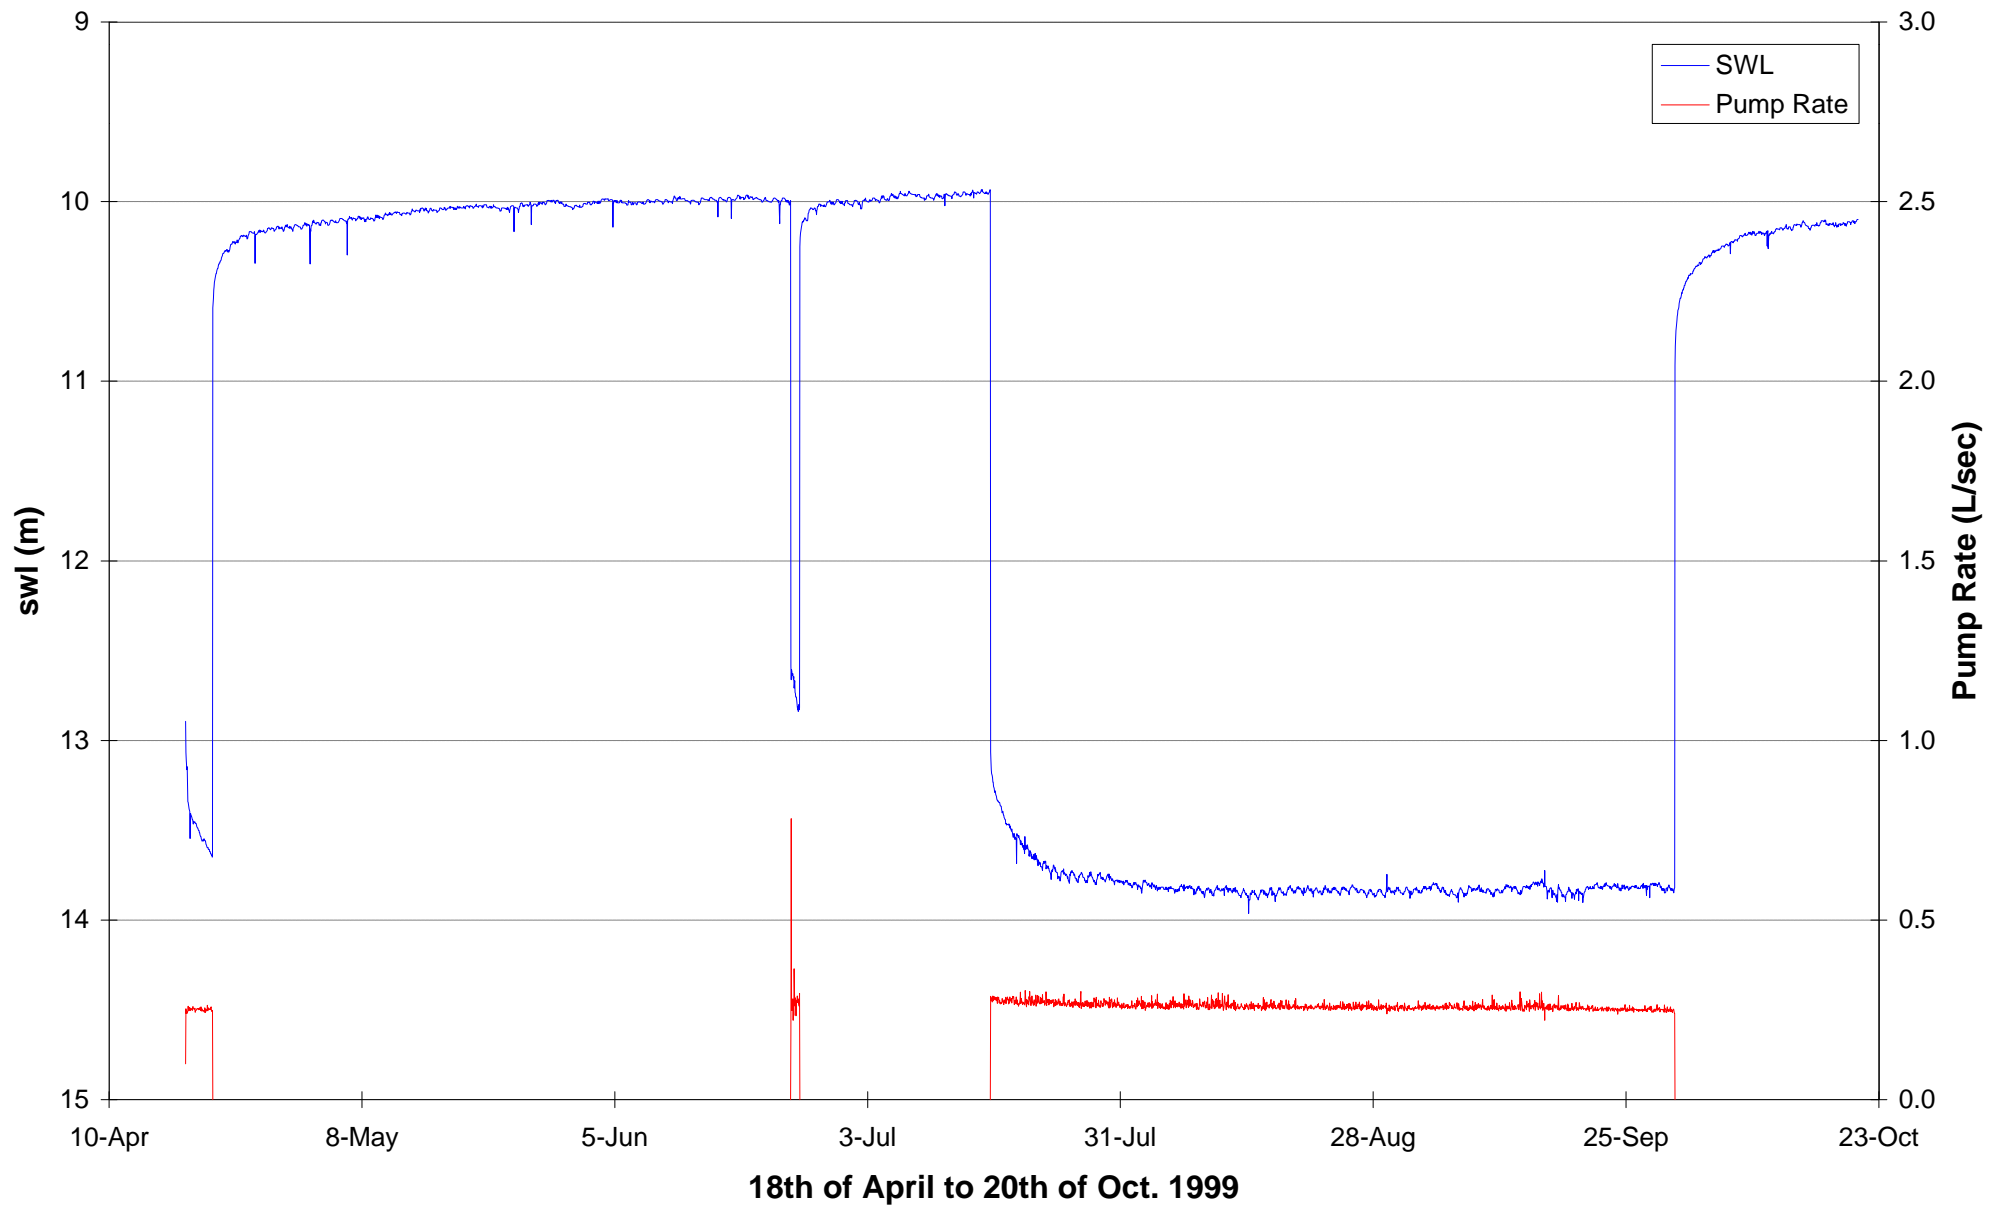
Figure 15 Fregon FRG-1; Hourly SWL and Pump Rate

Well 1. These results (Figure 15) contradict the indications of the previous period, in that the SWL has recovered to the level of 10 m. This level has been consistent since 1995 at least, there being no records previously. This well has been pumped at rates of 1.7 L/s in the past and has never shown consistent signs of depletion, but the available drawdown, with the bottom of the well at 18.6 m, is not great. It is recommended that the pump rate for this bore be maintained at 1.7 L/s.
