Hydrogeological Report on NW Aboriginal Lands well monitoring – April to October 1999

REPORT BOOK 2000/00007

Lloyd Sampson and Sandy Dodds

Department for Water Resources, Groundwater

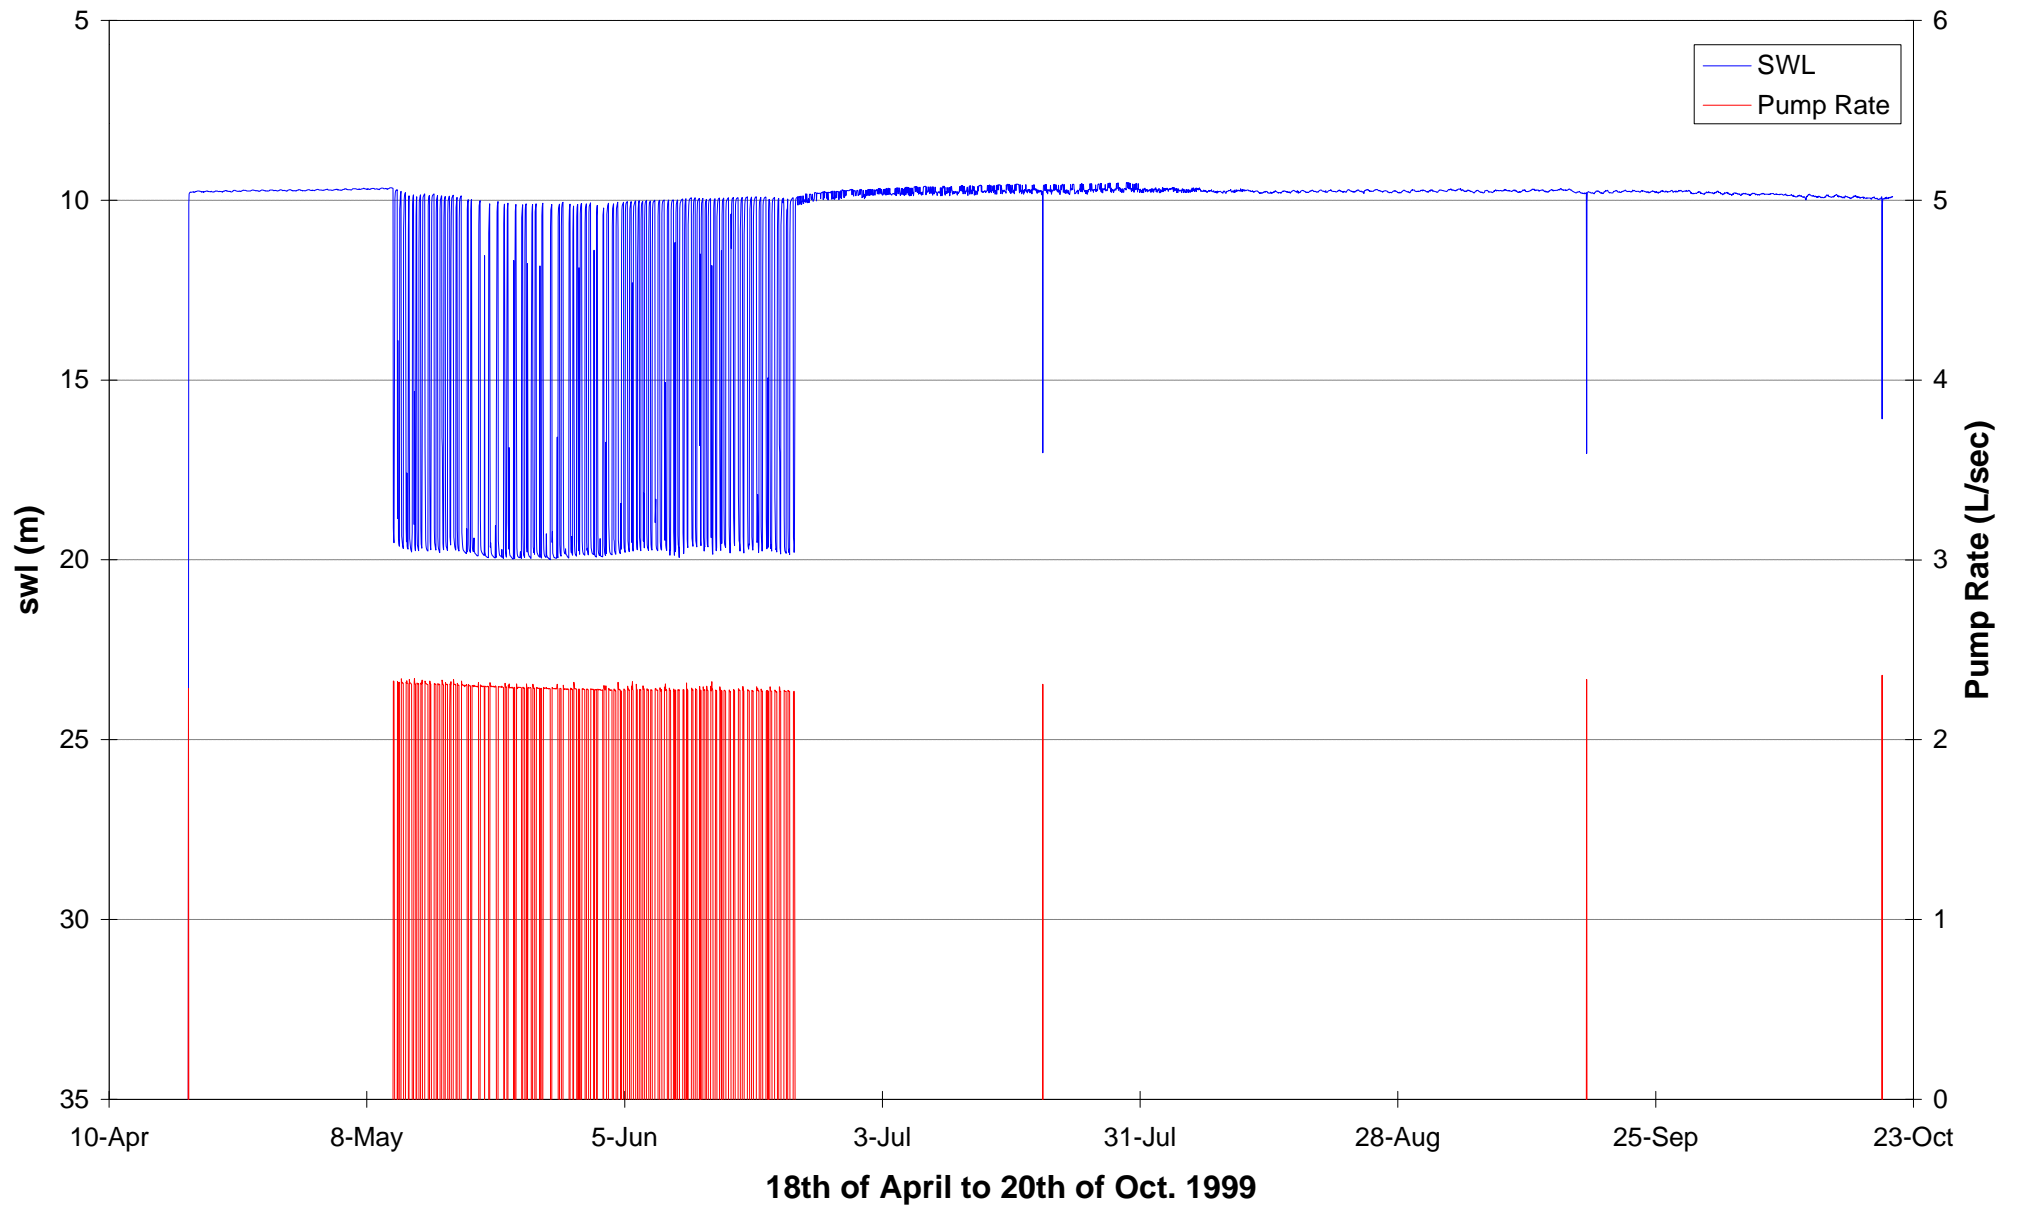
Figure 16 Fregon FRG-7; Hourly SWL and Pump Rate

Well 7. The well has been little used, and the SWL has been consistent at about 10 m for this period and since 1998 (Figure 16). It is actually higher than in 1983 (12 m) so there are no signs of dewatering. The pump rate of 2.3 L/s does not cause excessive drawdown, nor did the intensive production over the period May - June cause much deviation in the water level. The available drawdown is about 20 m.

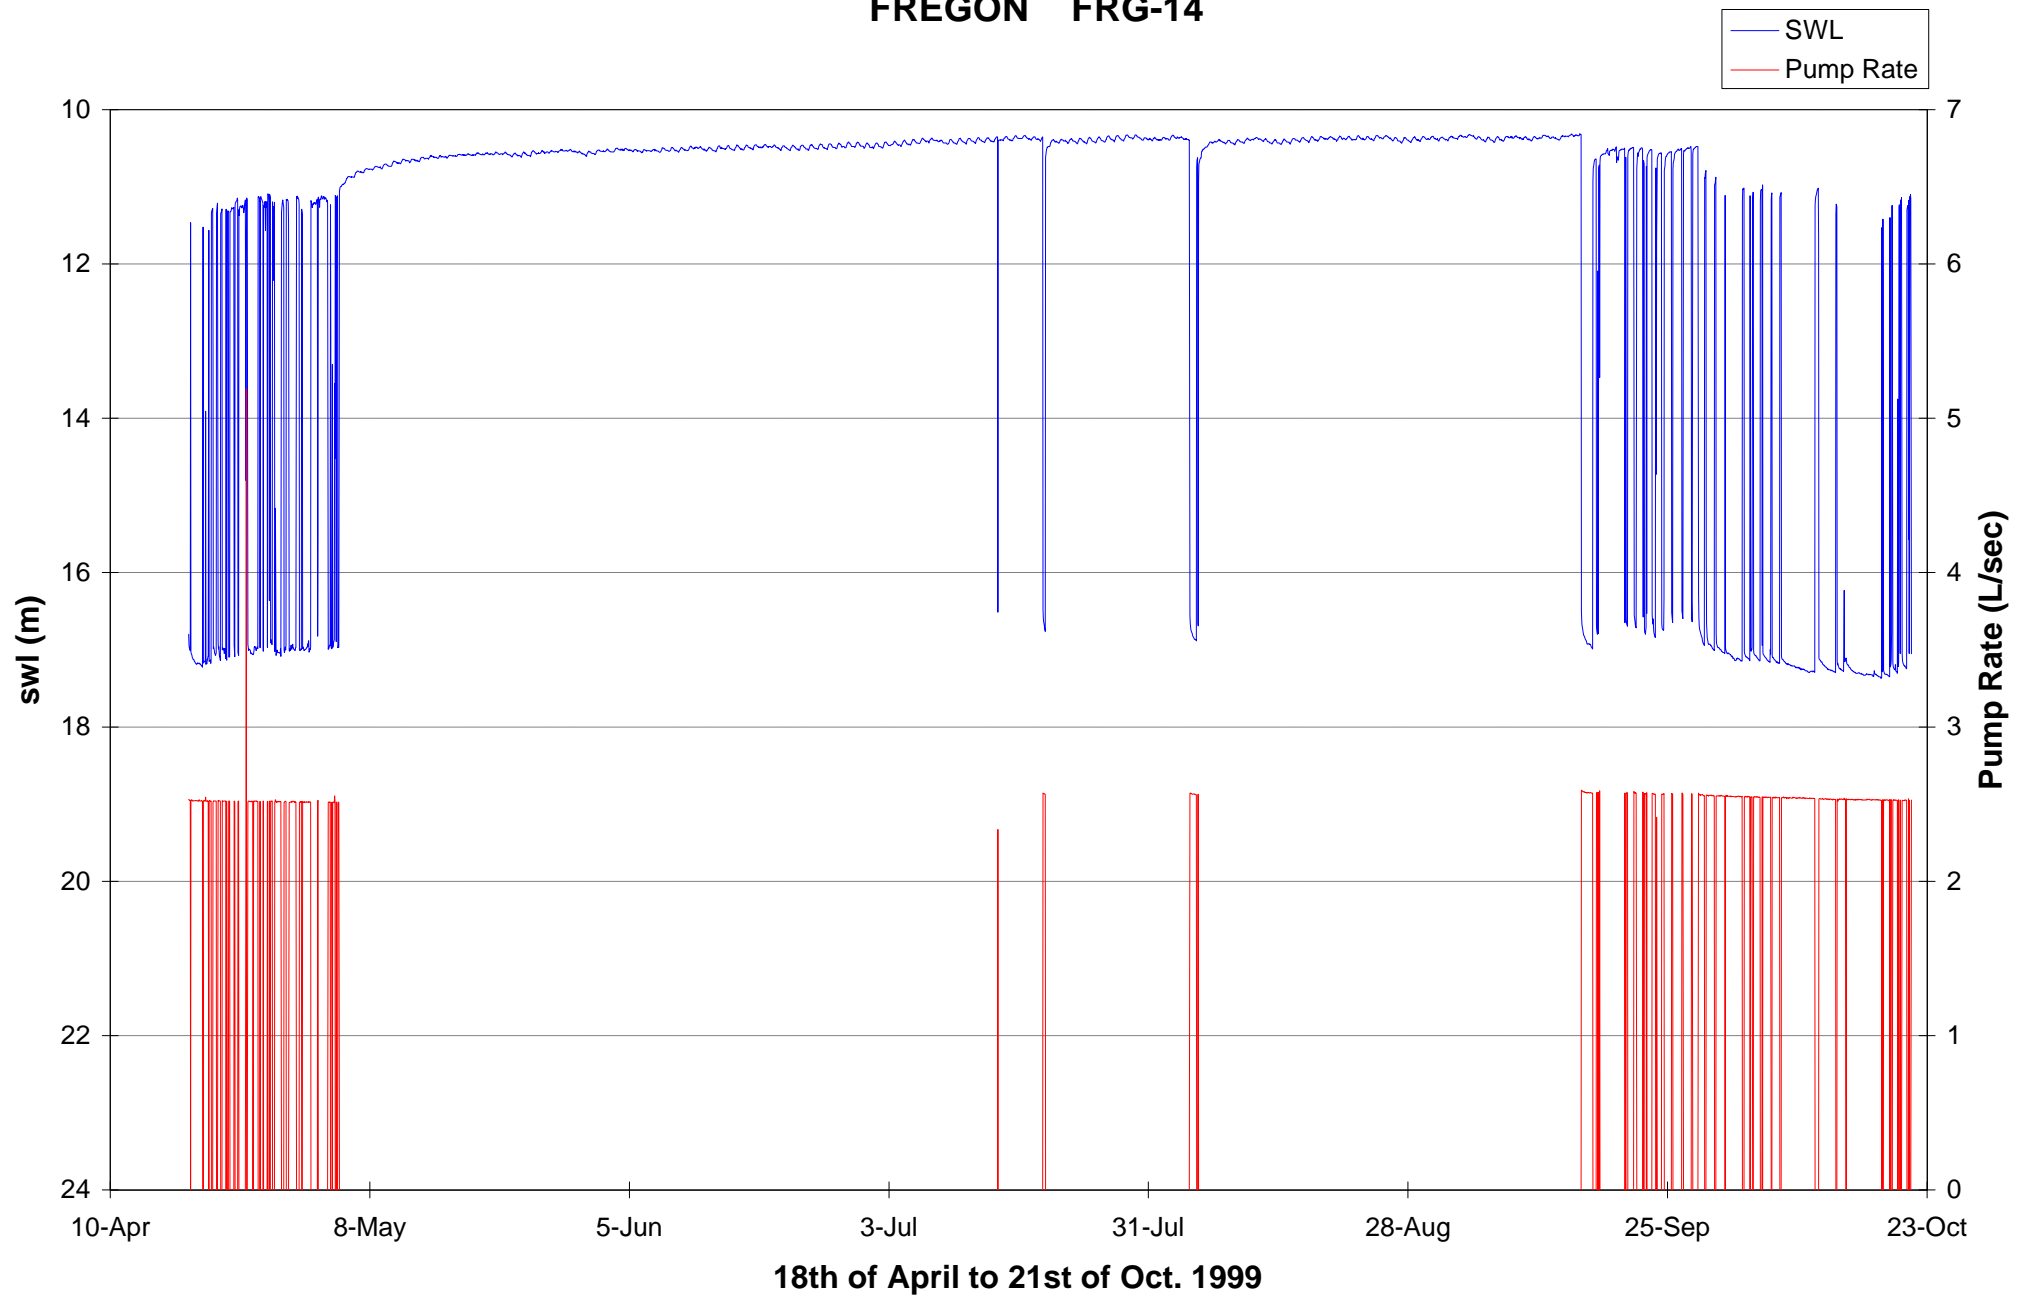
Figure 17 Fregon FRG-14; Hourly SWL and Pump Rate

Well 14. The well was pumped fairly lightly over this period, with a resulting recovery in SWL to 10.4 m (Figure 17). This is the same as the level in 1987, so there appears to be no dewatering problem. The well is slow to recover, which may limit the daily pumping rate slightly, and this limitation may be greater if the pumping water level drops below 18 m, which appears to be the top of the aquifer. Continual pumping over the period 7–10 October caused a decline in water level of 0.2 m to 17.3 m. A slight reduction in the pumping rate to, say, 2.0 L/s might be advisable if extended pumping times are anticipated.

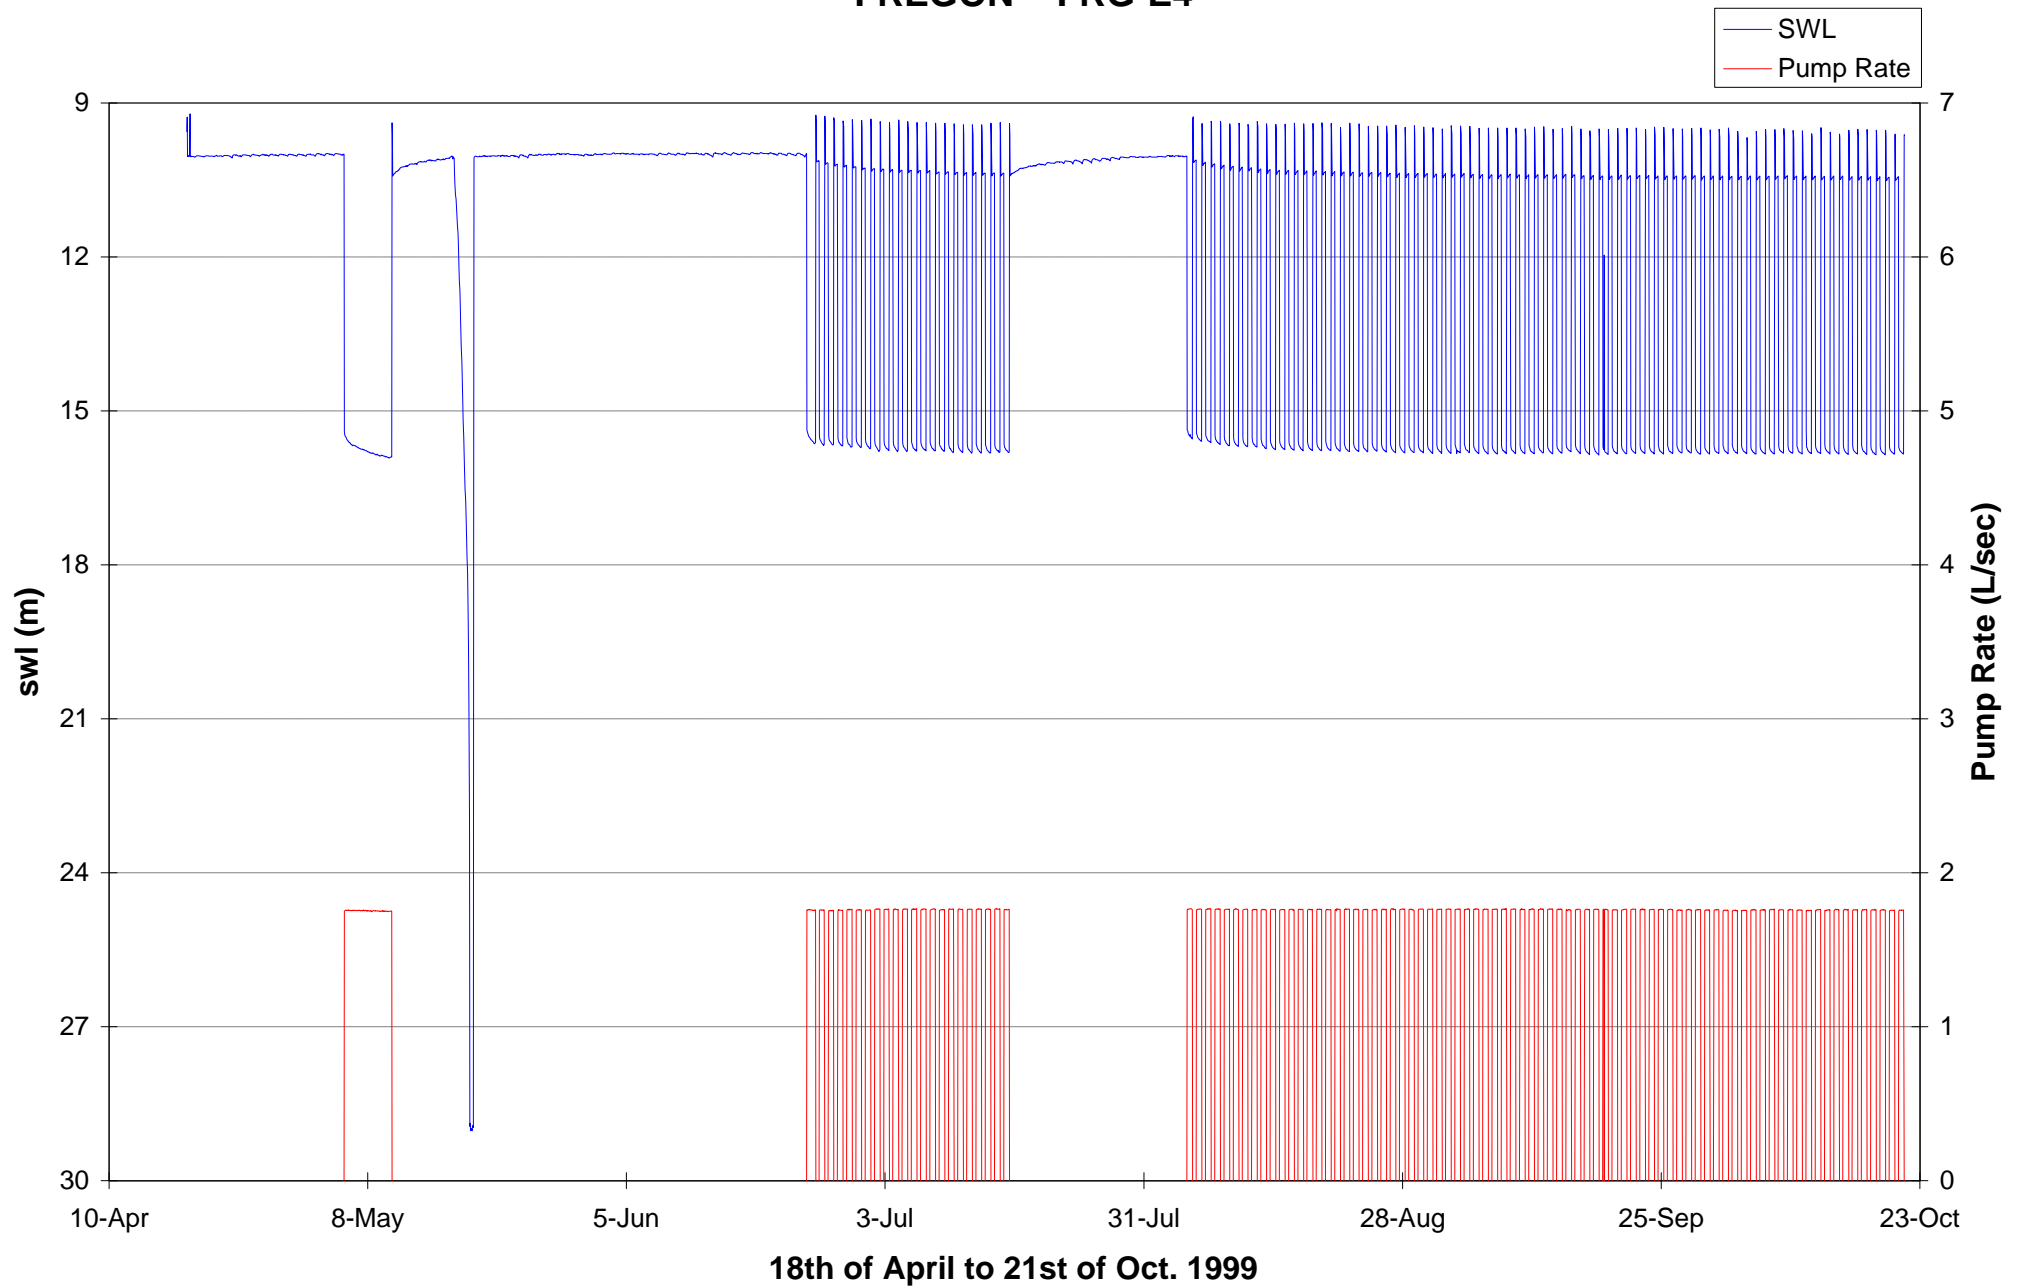
Figure 18 Fregon FRG-E4; Hourly SWL and Pump Rate

Well E4. This well shows strong SWL overshoots when the pump is turned off, as was the case for Mimili M-3 (Figure 18). The same cause, water flow back into the well from the distribution system due to a faulty non-return valve, is suspected. The well copes with the pump rate of 1.8 L/s, which causes a drawdown to 15.8 m, still 4 m above the water cut at 19.8 m. The SWL at 10 m is much the same as it was in 1997 (9.3 m) and actually above the 1971 figure of 11.6 m. There is therefore no evidence of dewatering.

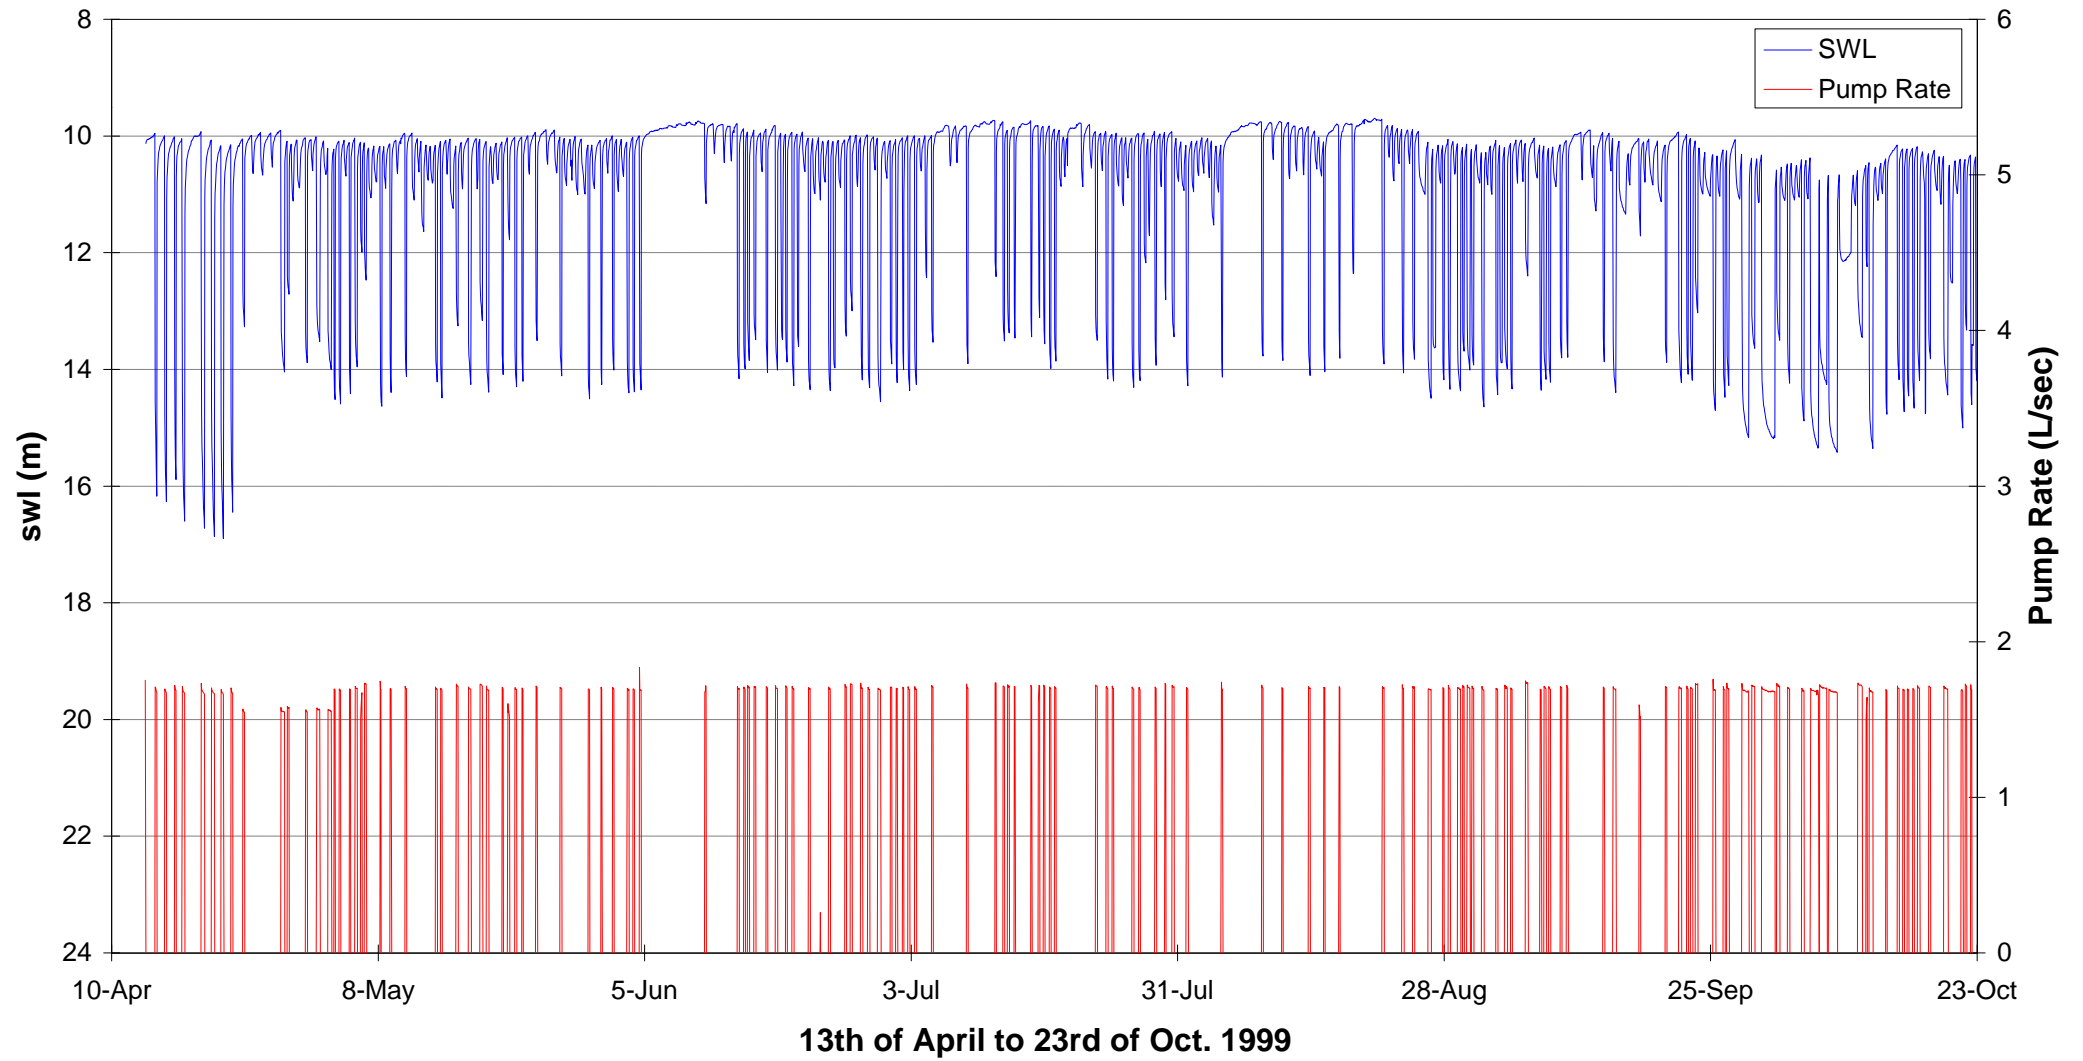
Figure 21 Kenmore Park KP-6; Hourly SWL and Pump Rate

Well 6. As for the previous period the well appears to cope with the current pumping rates, the SWL consistently coming back to a level of about 9.7 m (Figure 21). While there may be a small drop from the original level in 1985 of 6 m, a more critical problem is the difficulty the well has at maintaining the pumping rate of 1.7 L/s, with the drawdown getting quite low in the aquifer, so far as the latter is known. A pumping spell of 34 hours in early October resulted in an increase in drawdown from 3.5 m initially to 4.8 m at the end of the spell. The possibility of dewatering still exists, but is not particularly supported by this period's data.

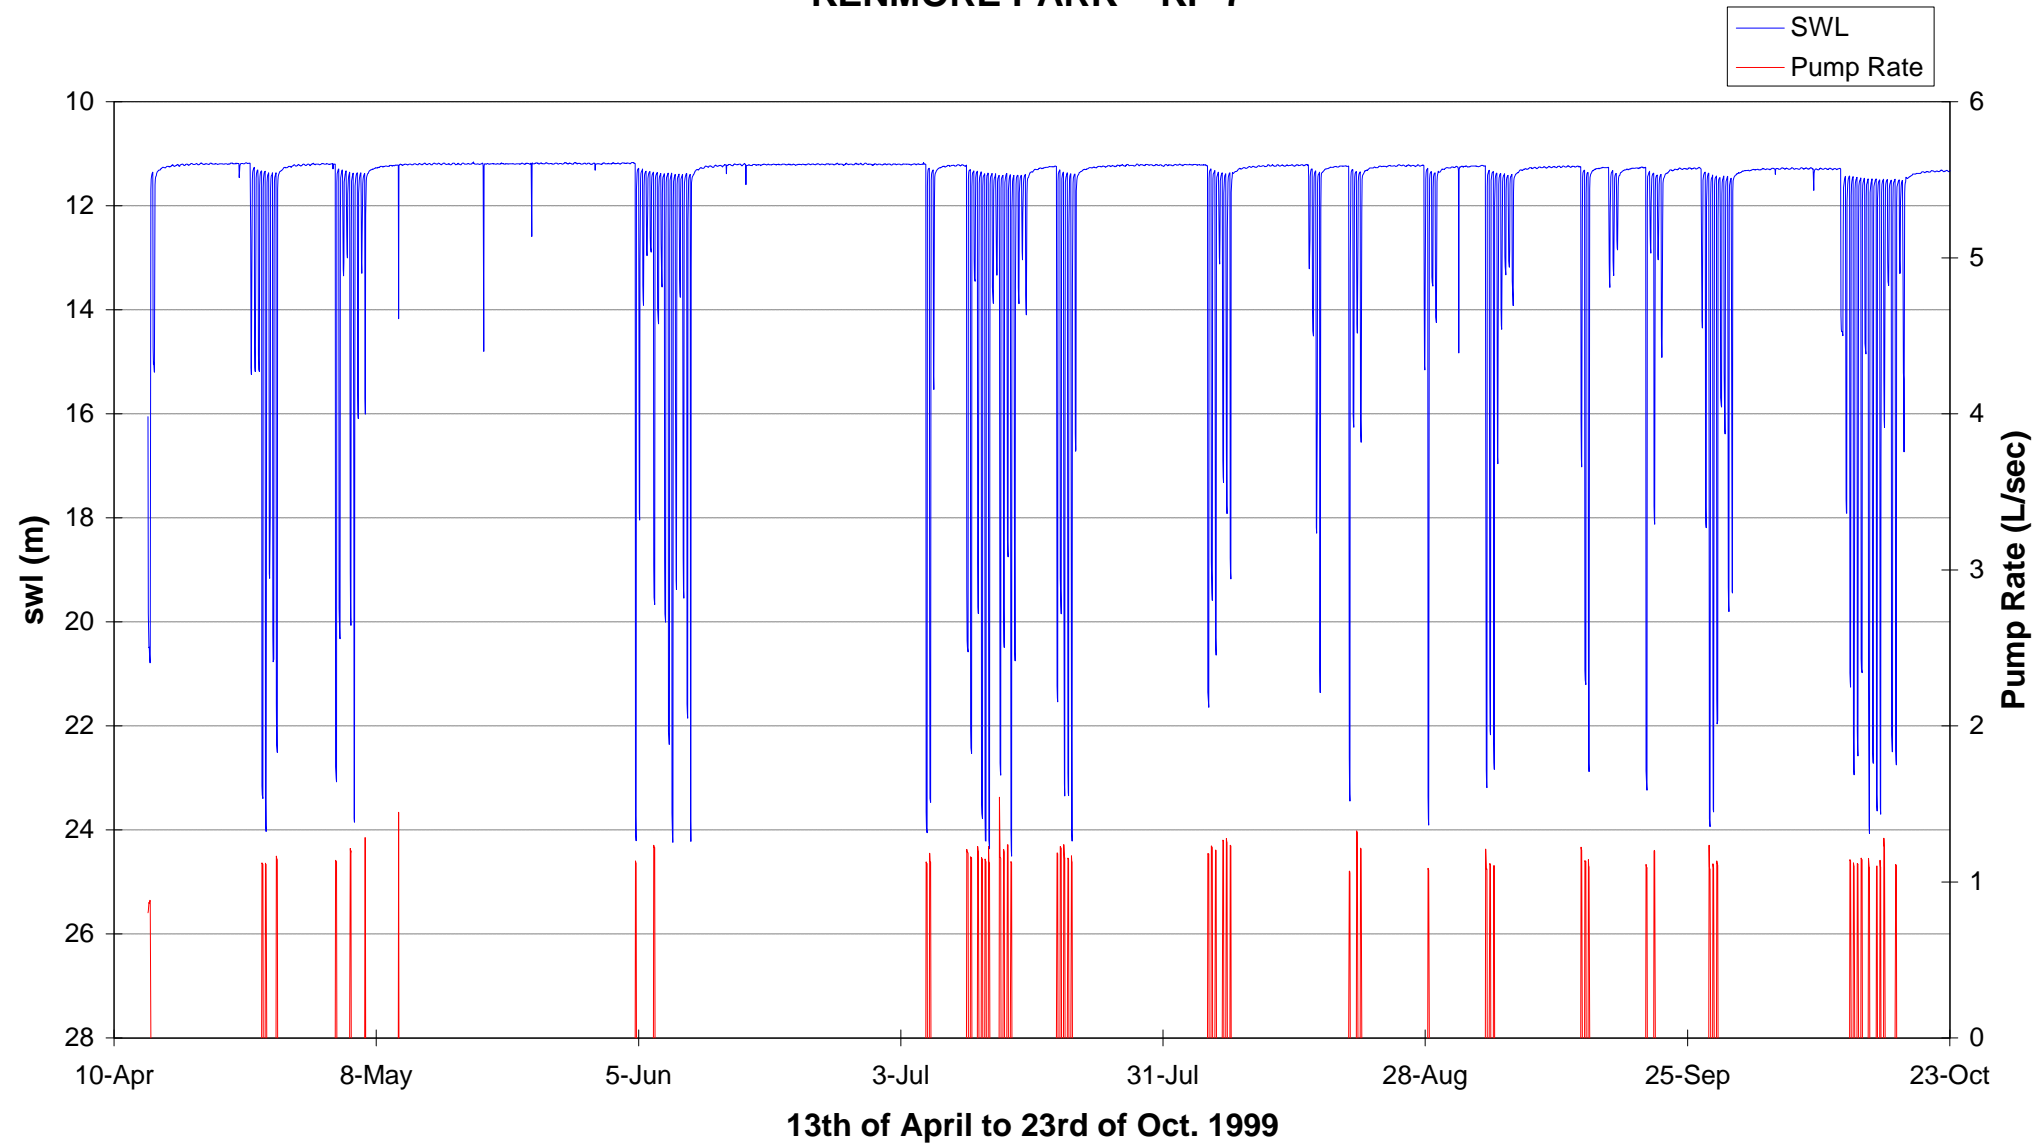
Figure 22 Kenmore Park KP-7; Hourly SWL and Pump Rate

Well 7. As for the previous period there was little pumping of this well, and the relaxed SWL remained constant at 11.2 m (Figure 22). This is a drop of about 0.4 m over 2 years. The large drawdown and short pumping times indicate that the more acute problem is in the transmissivity of the aquifer.

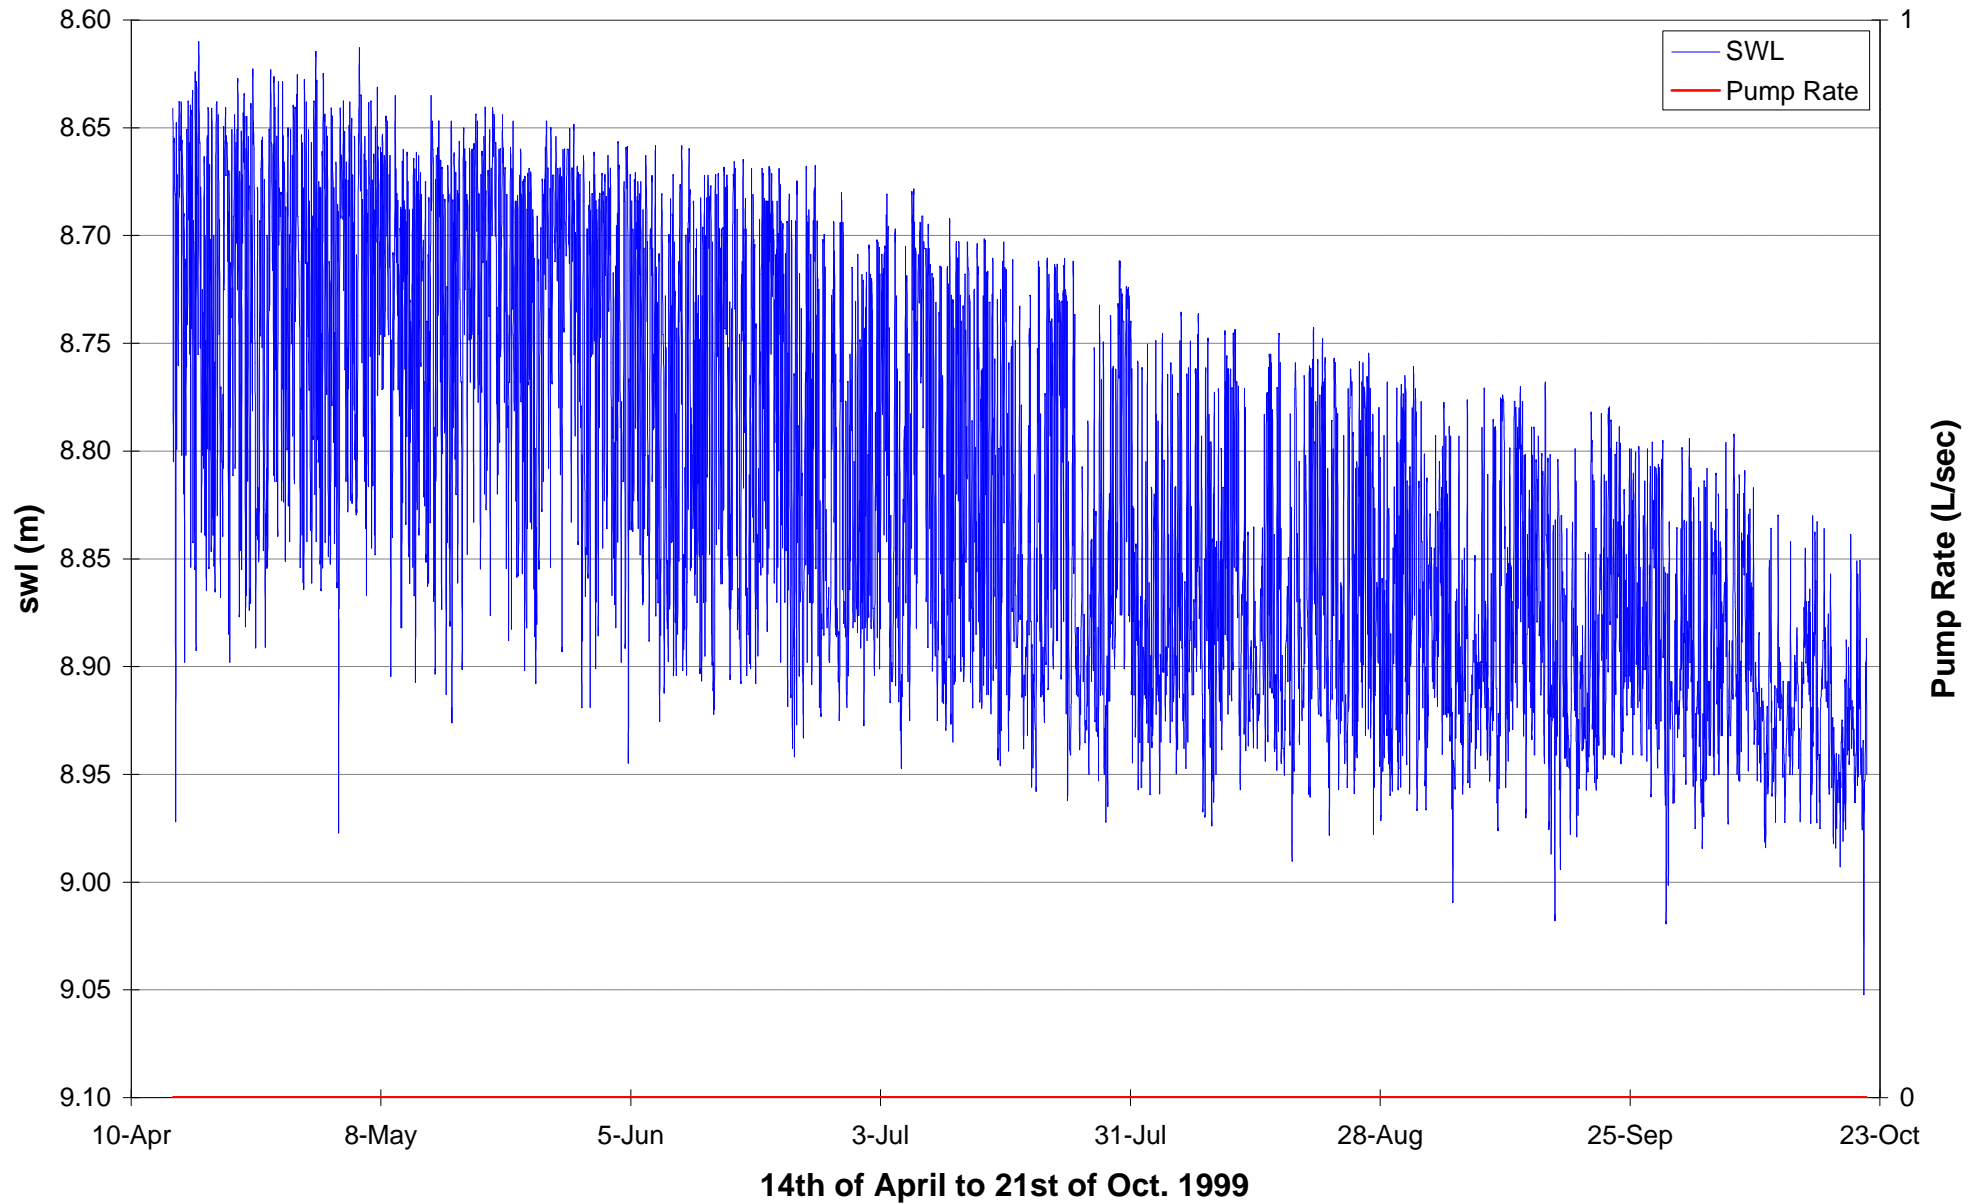
Figure 25 Pukatja E-1; Hourly SWL and Pump Rate

Well 1. This well shows a steady drop of 0.25 m over the period (without pumping), as a result of either pumping in adjacent wells or movement of water downstream, continuing the trend from the previous period (Figure 25). There is no evidence of recharge.

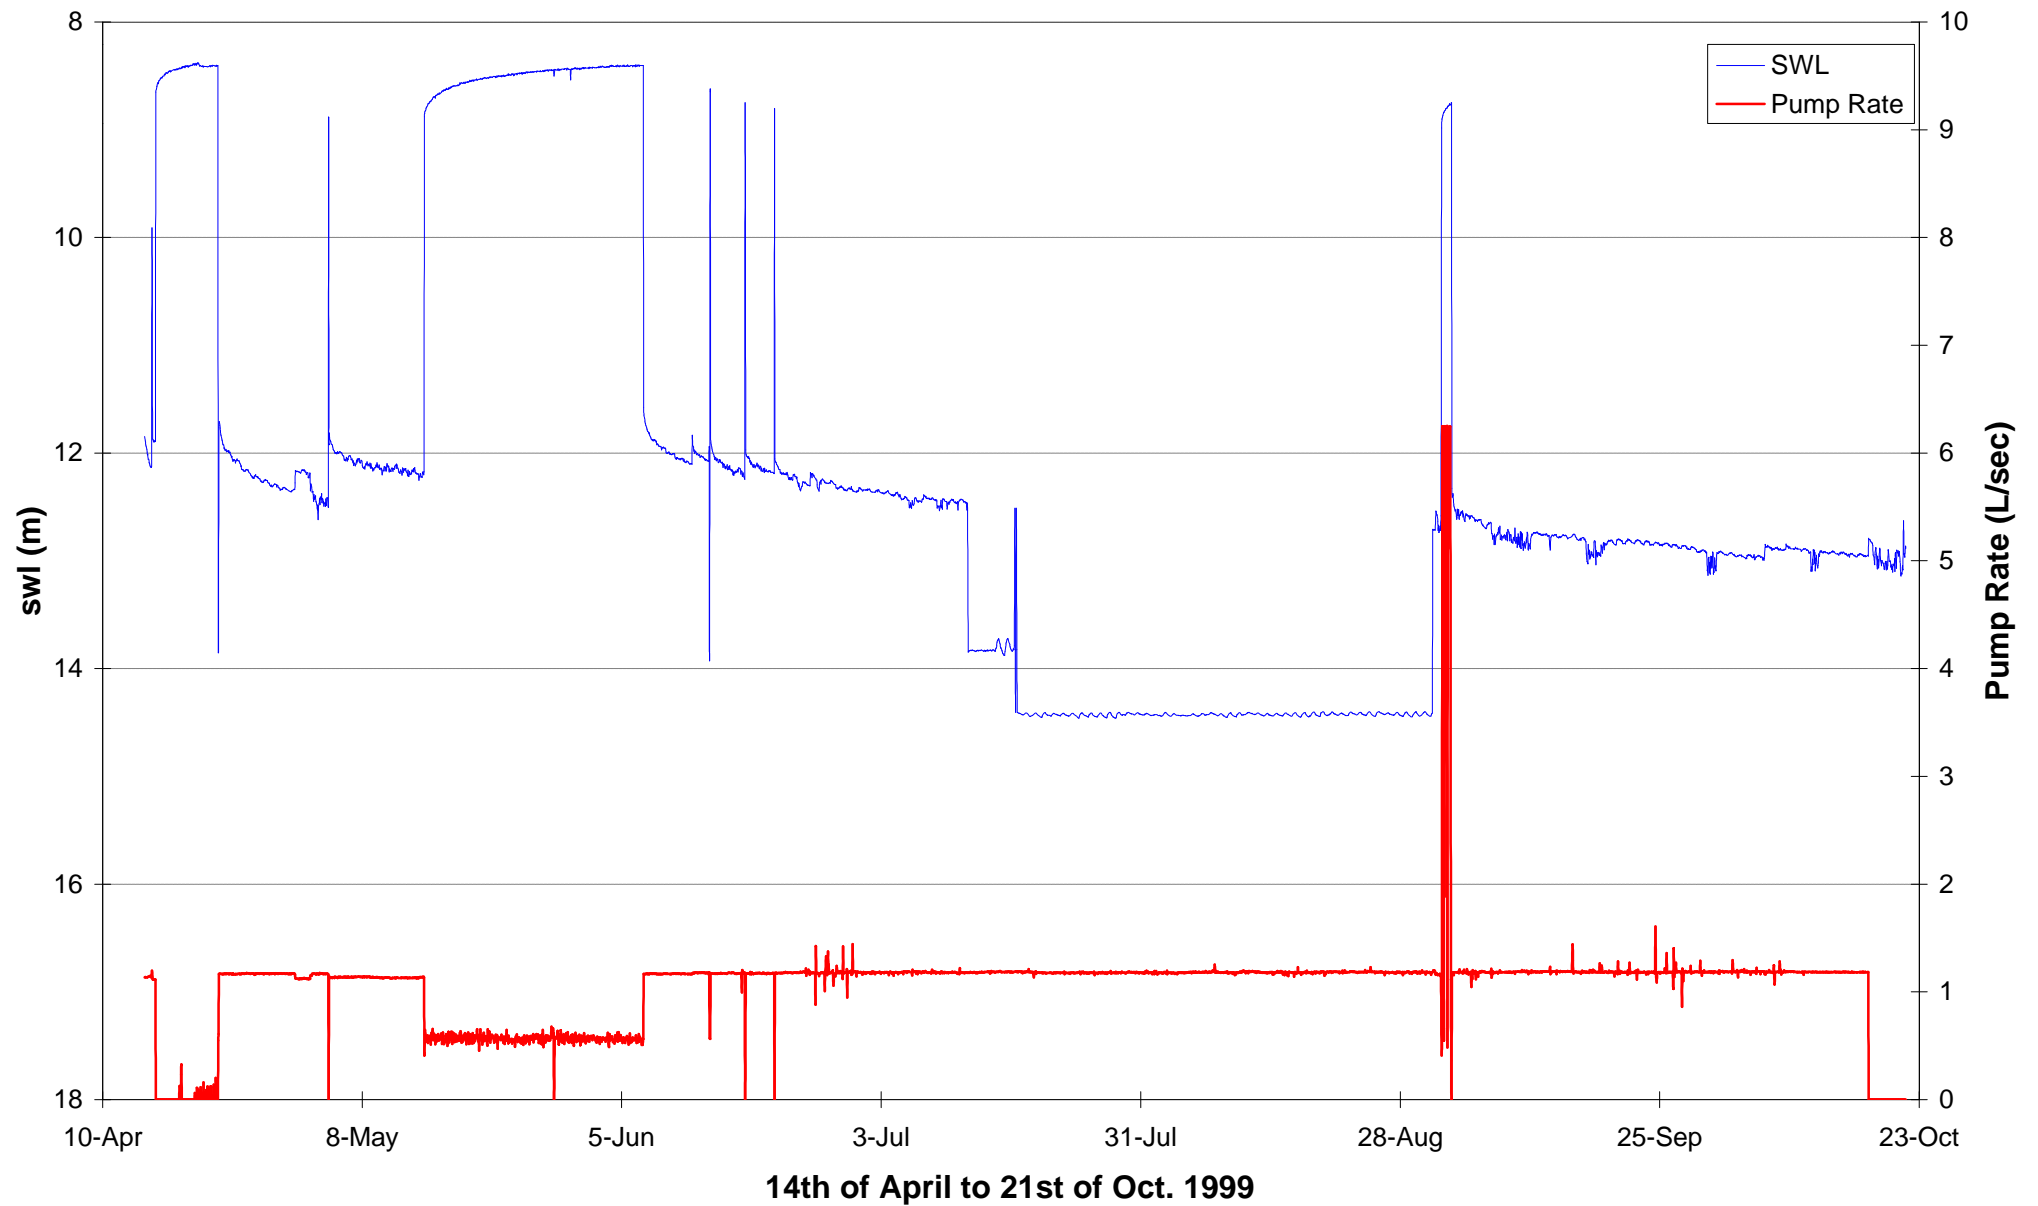
Figure 26 Pukatja E-12; Hourly SWL and Pump Rate

Well 12. The well was pumped well nigh continuously over the period with no sign of aquifer depletion (Figure 26). However, there are some offsets in the SWL data, over the July - August period, that make them suspect in parts. Overall the result seems conclusive, confirming that of the previous period.

Ernabella E12 required the flow meter to be replaced due to the display being unable to be read. The accumulated flow was only able to be retrieved from the last value entered in the bore log book. It appears the output of the flow meter was operating until the 17 October 1999.

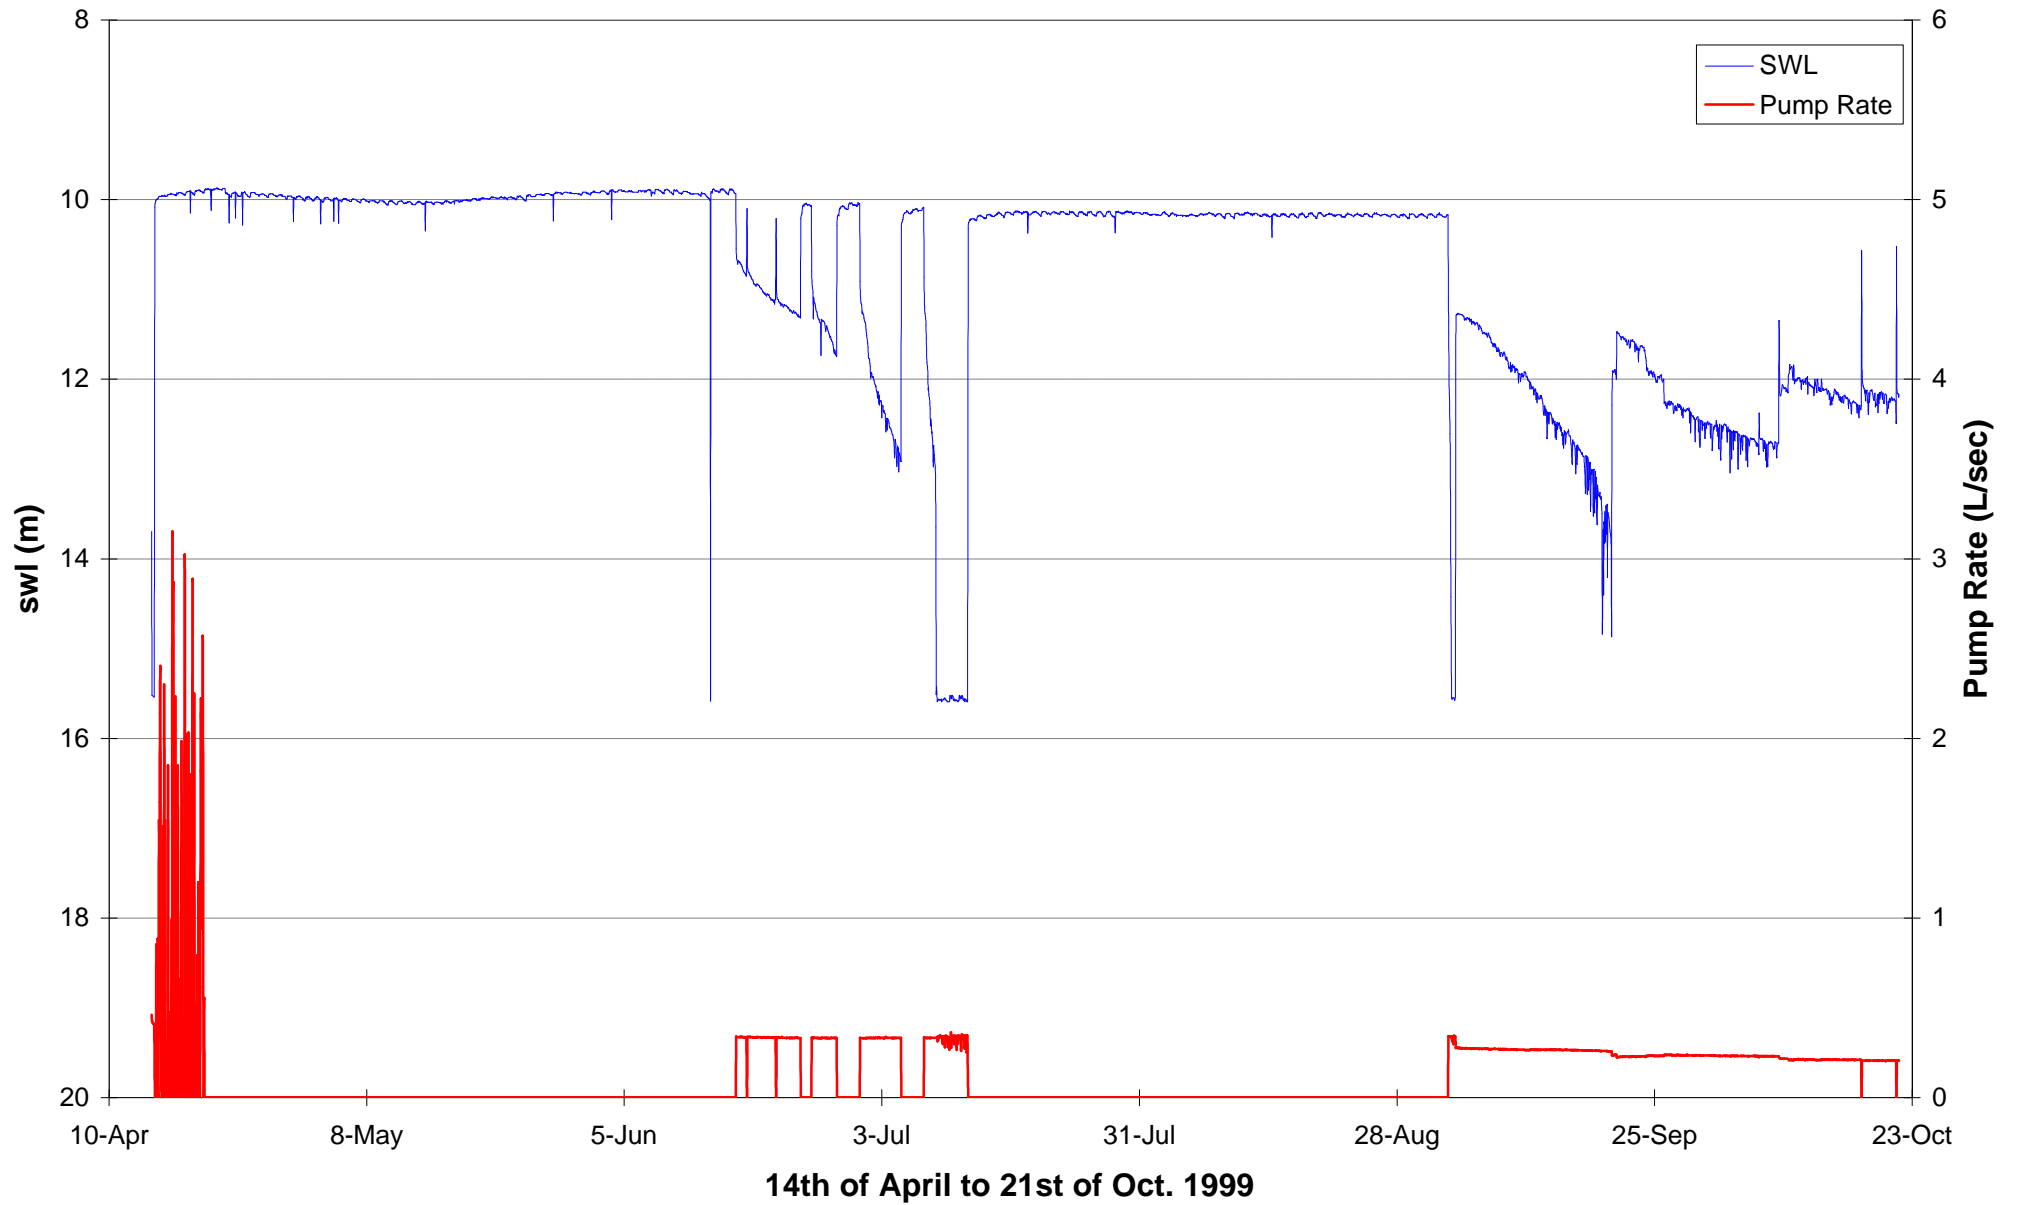
Figure 27 Pukatja E-42; Hourly SWL and Pump Rate

Well 42. The data for this well (Figure 27) are suspect, particularly the high pump rates at the start of the period, which do not correspond to lowering of the SWL, and the sensitivity of the SWL to minor change in pump rate towards the end of the period. However, it does seem that the well is consistently sensitive to pump rate, with low pump rates causing large drawdowns. The relaxed SWL dropped by about 0.2 m this period, consistent with the previous period, but this may relate to a discrepancy between actual and logger SWL levels at the end of this period that required a logger adjustment. Thus there is no clear evidence of a decline in SWL over this period.
