Hydrogeological Report on NW Aboriginal Lands well monitoring – April to October 1999

REPORT BOOK 2000/00007

Lloyd Sampson and Sandy Dodds

Department for Water Resources, Groundwater

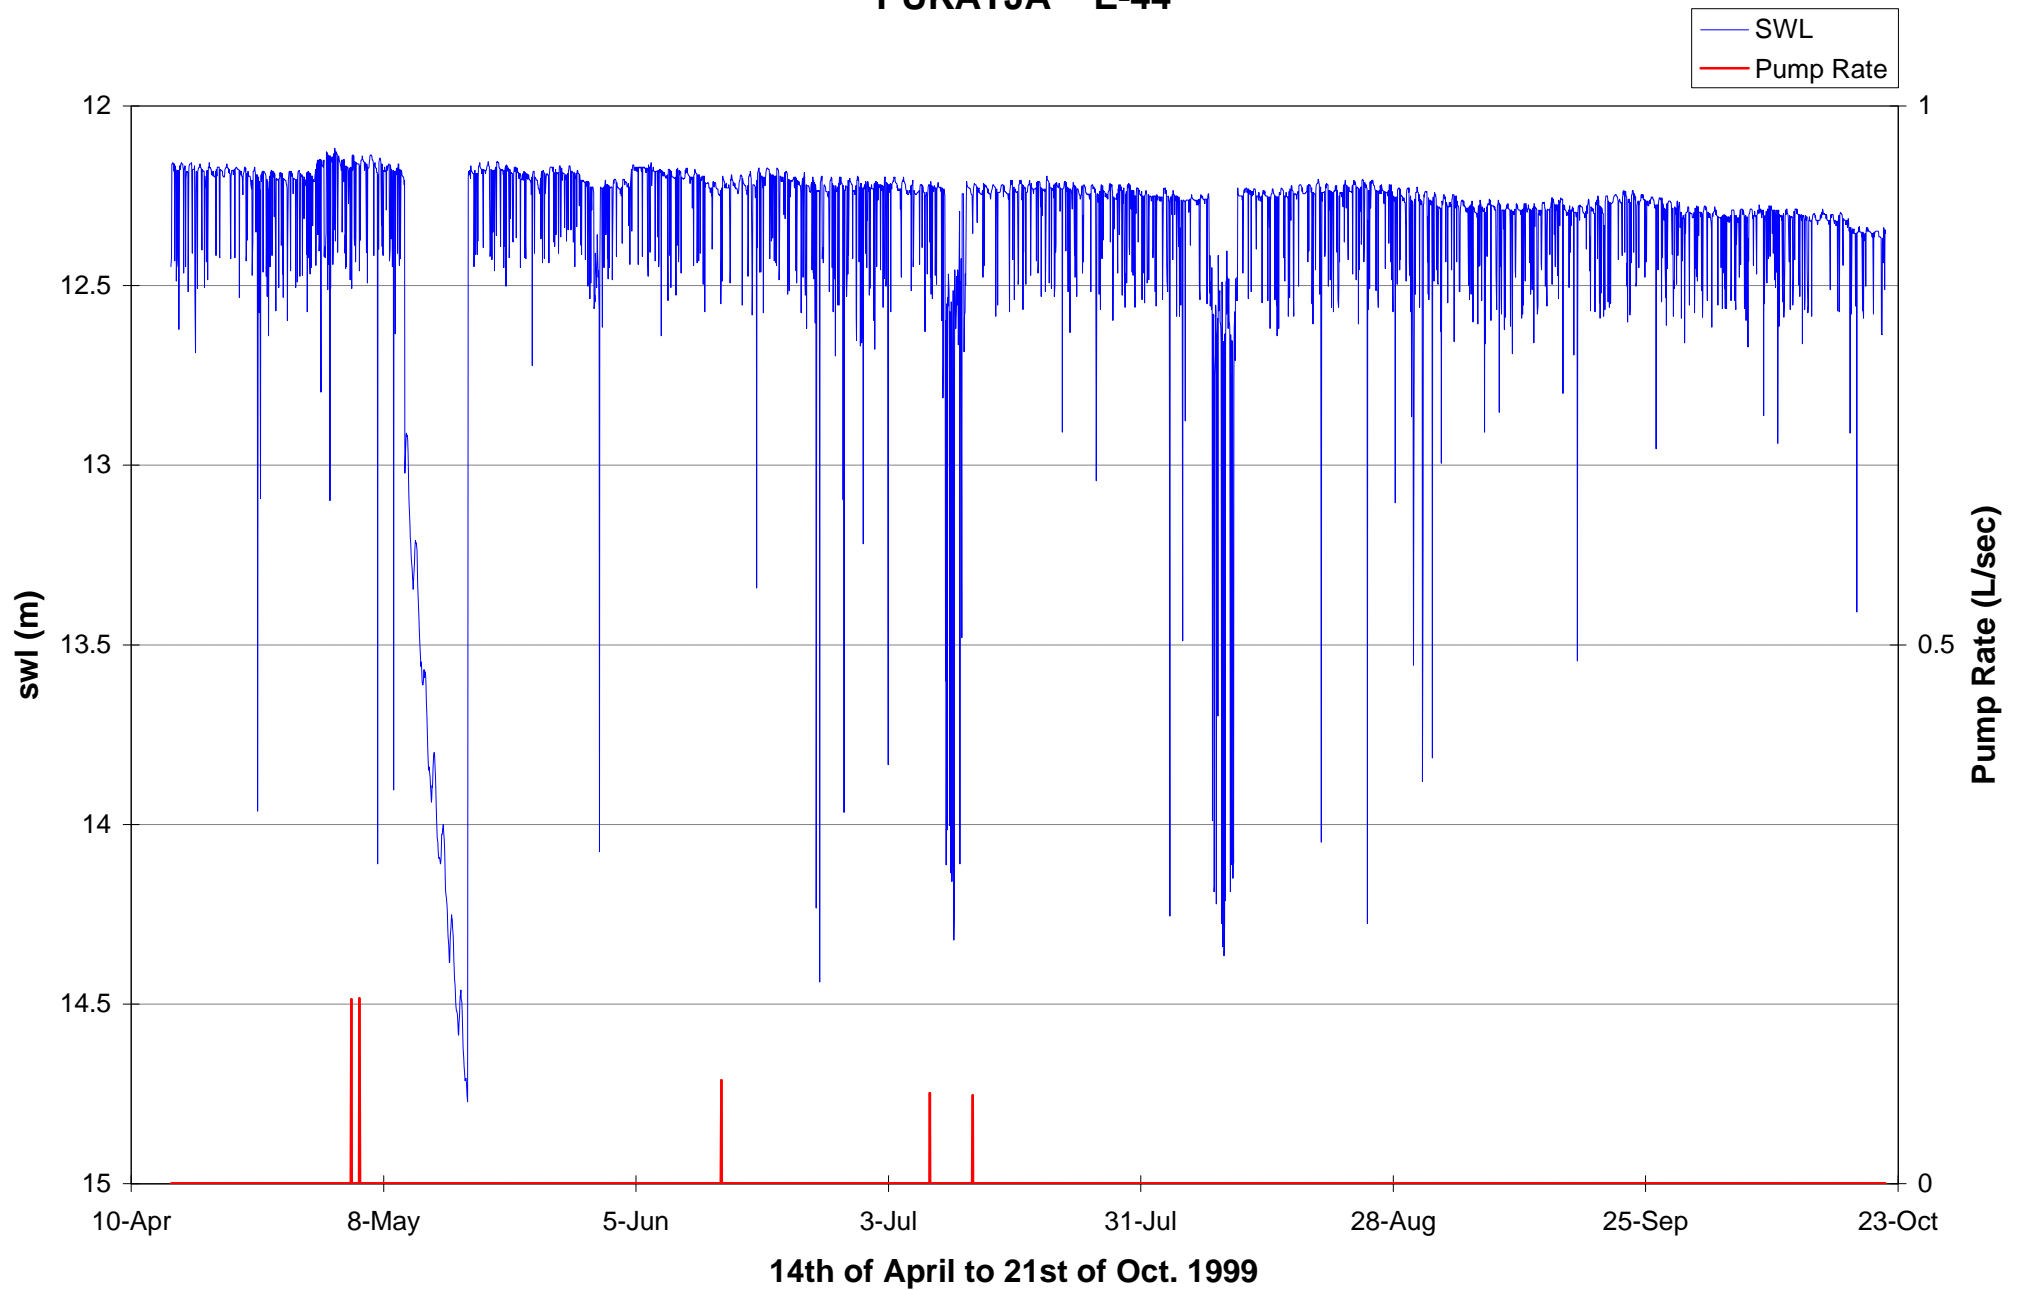
Figure 28 Pukatja E-44; Hourly SWL and Pump Rate

Well 44. This well was hardly pumped at all, yet there are major rapid changes in SWL (Figure 28). Bore E-45 is located nearby, but its pumping regime does not reflect the changes in the water level data. The cause is difficult to understand and needs

further investigation. Apart from this there appears to be a steady lowering of the SWL amounting to 0.2 m over the period.

E44 The SWL data has an anomaly during the period 10 May to 17 May which may be due to a sticking or leaking valve in the 2100P. The flow data is inconsistent with the SWL data in that no flow was recorded when the SWL recorded draw down. This bore is irregularly used and the flow chamber of the meter may need to be cleaned at the next site visit.

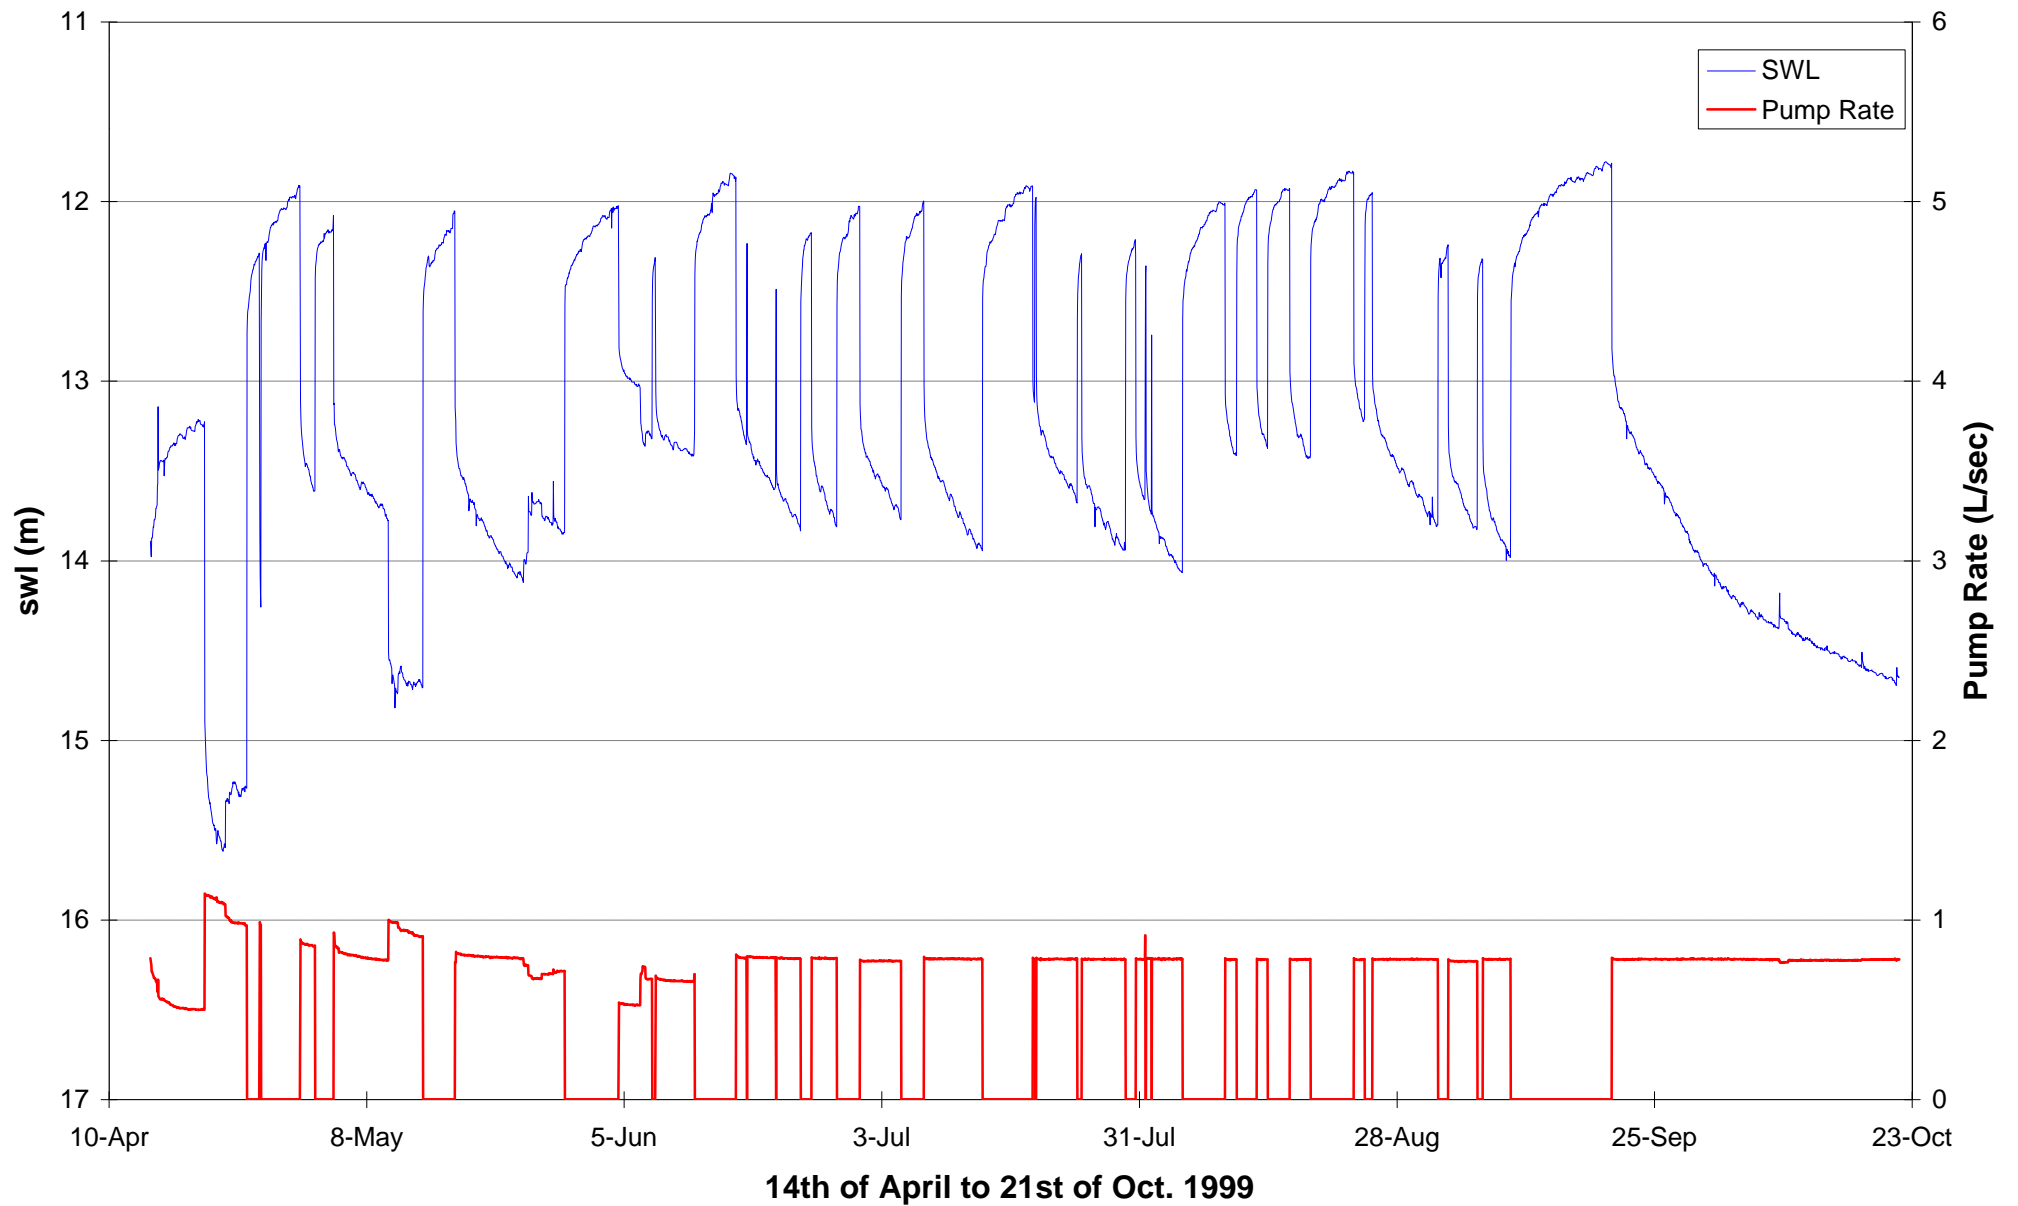
Figure 29 Pukatja E-45; Hourly SWL and Pump Rate

Well 45. The well has been pumped extensively and this, combined with a continual drop in SWL with continuous pumping and the slow recovery when not pumping, makes any establishment of levels or long term changes difficult (Figure 29). However, some indication can be drawn from the continuous pumping over the last month of the period at 0.8L/s, which caused a drawdown of approx 1.8 m. If the aquifer is at 22 m then the well can sustain this production rate for a slightly longer period of time.

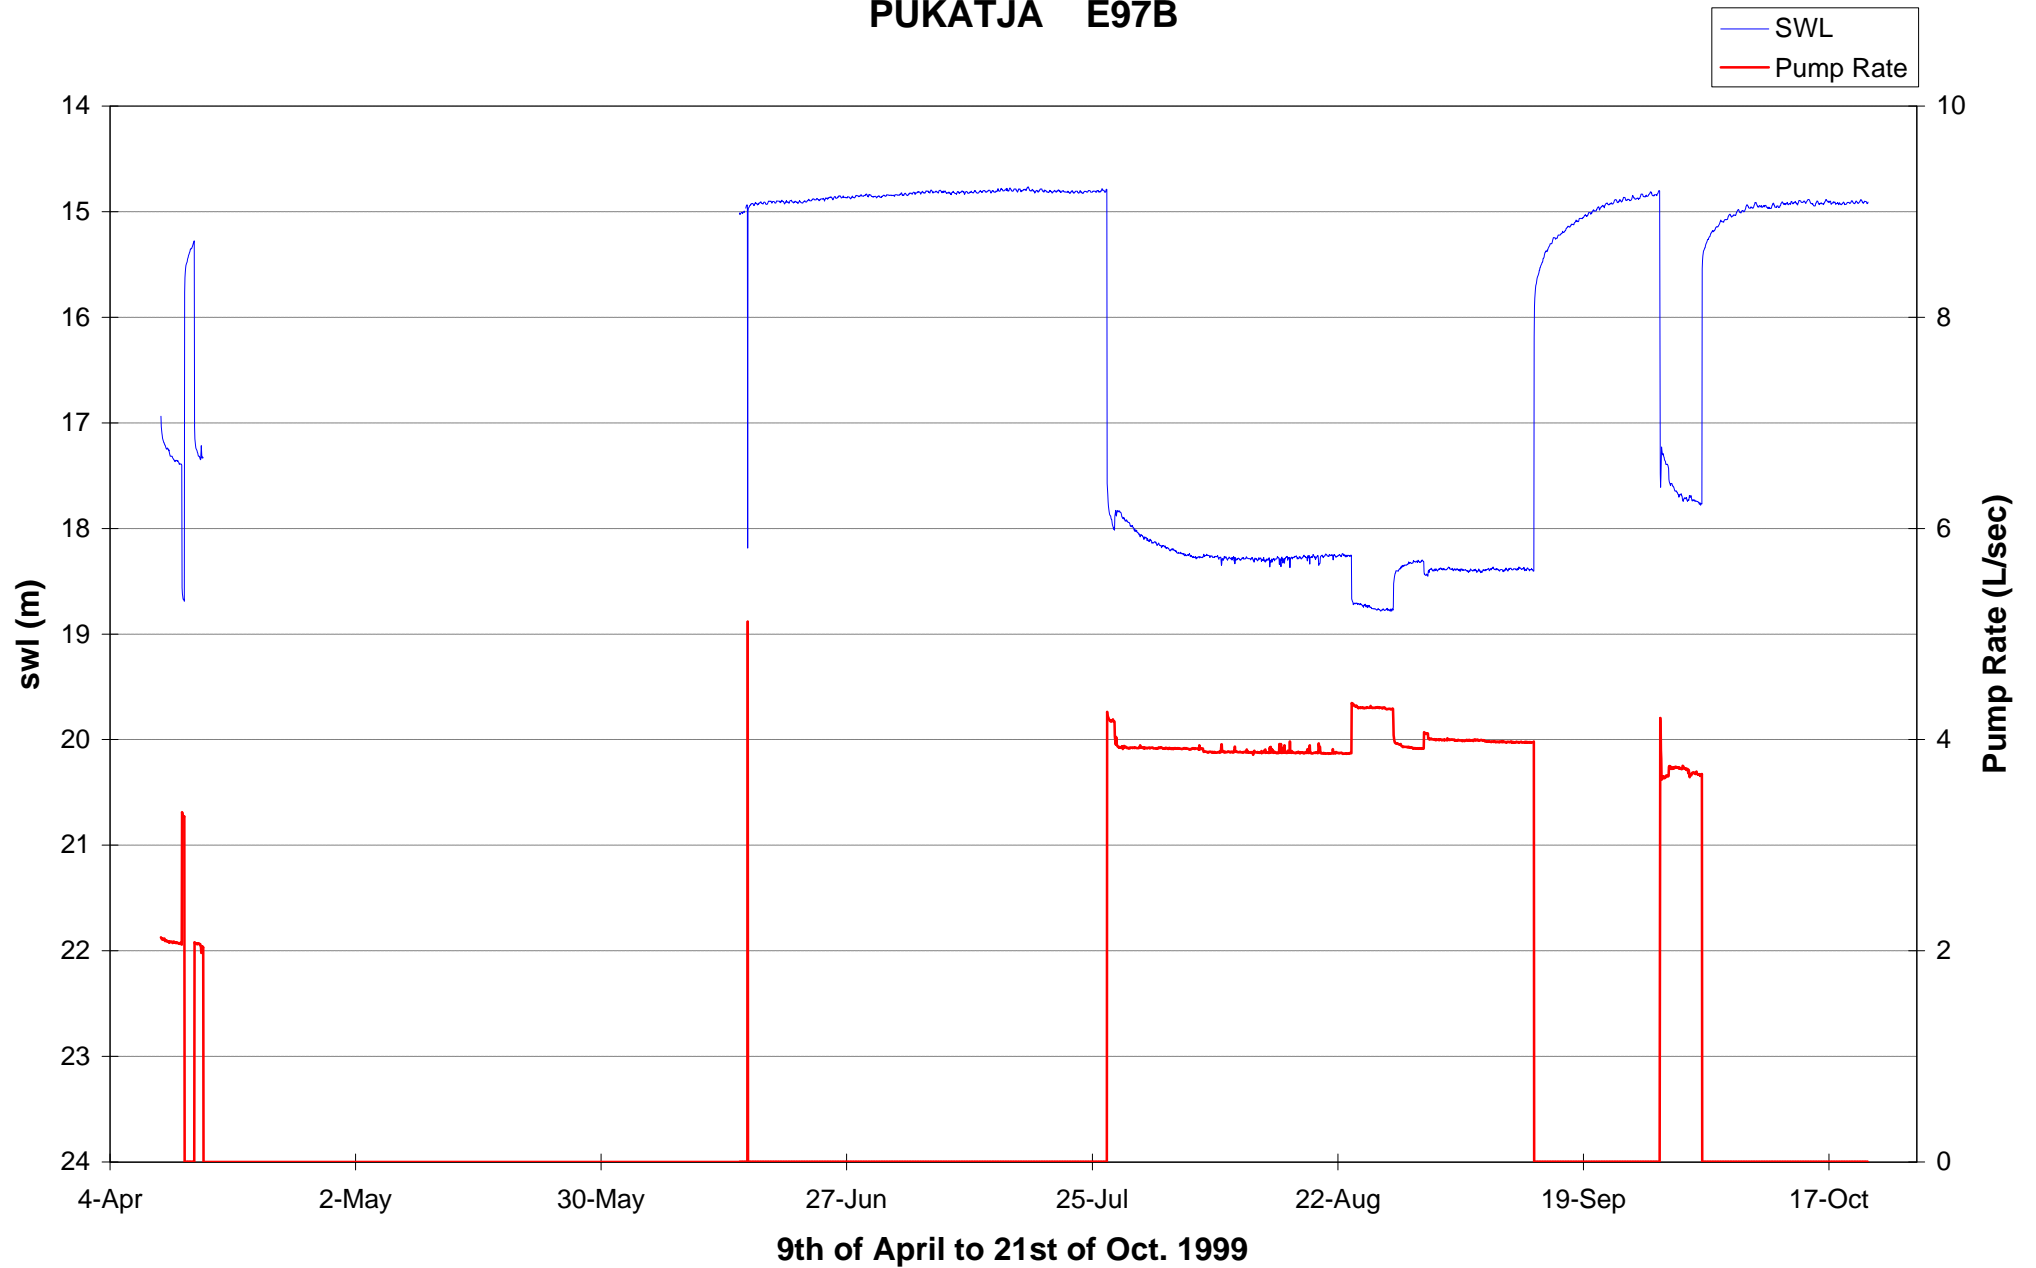
Figure 30 Pukatja E-97B; Hourly SWL and Pump Rate

Well 97B. Equipment failure in May resulted in a reduced data set for this period, but the other data clearly shows that the well is sustaining a pump rate of 4 L/s without much additional drawdown with time (Figure 30). There is no indication of a declining SWL in the long term.

E97B SWL datum reset by 0.425 mm. As for E42 and E44, there was no apparent reason for the offset and was probably introduced at the previous trip when the logger was started while the bore was still recovering. The bore flow meter could not be checked due to a power failure at the site.

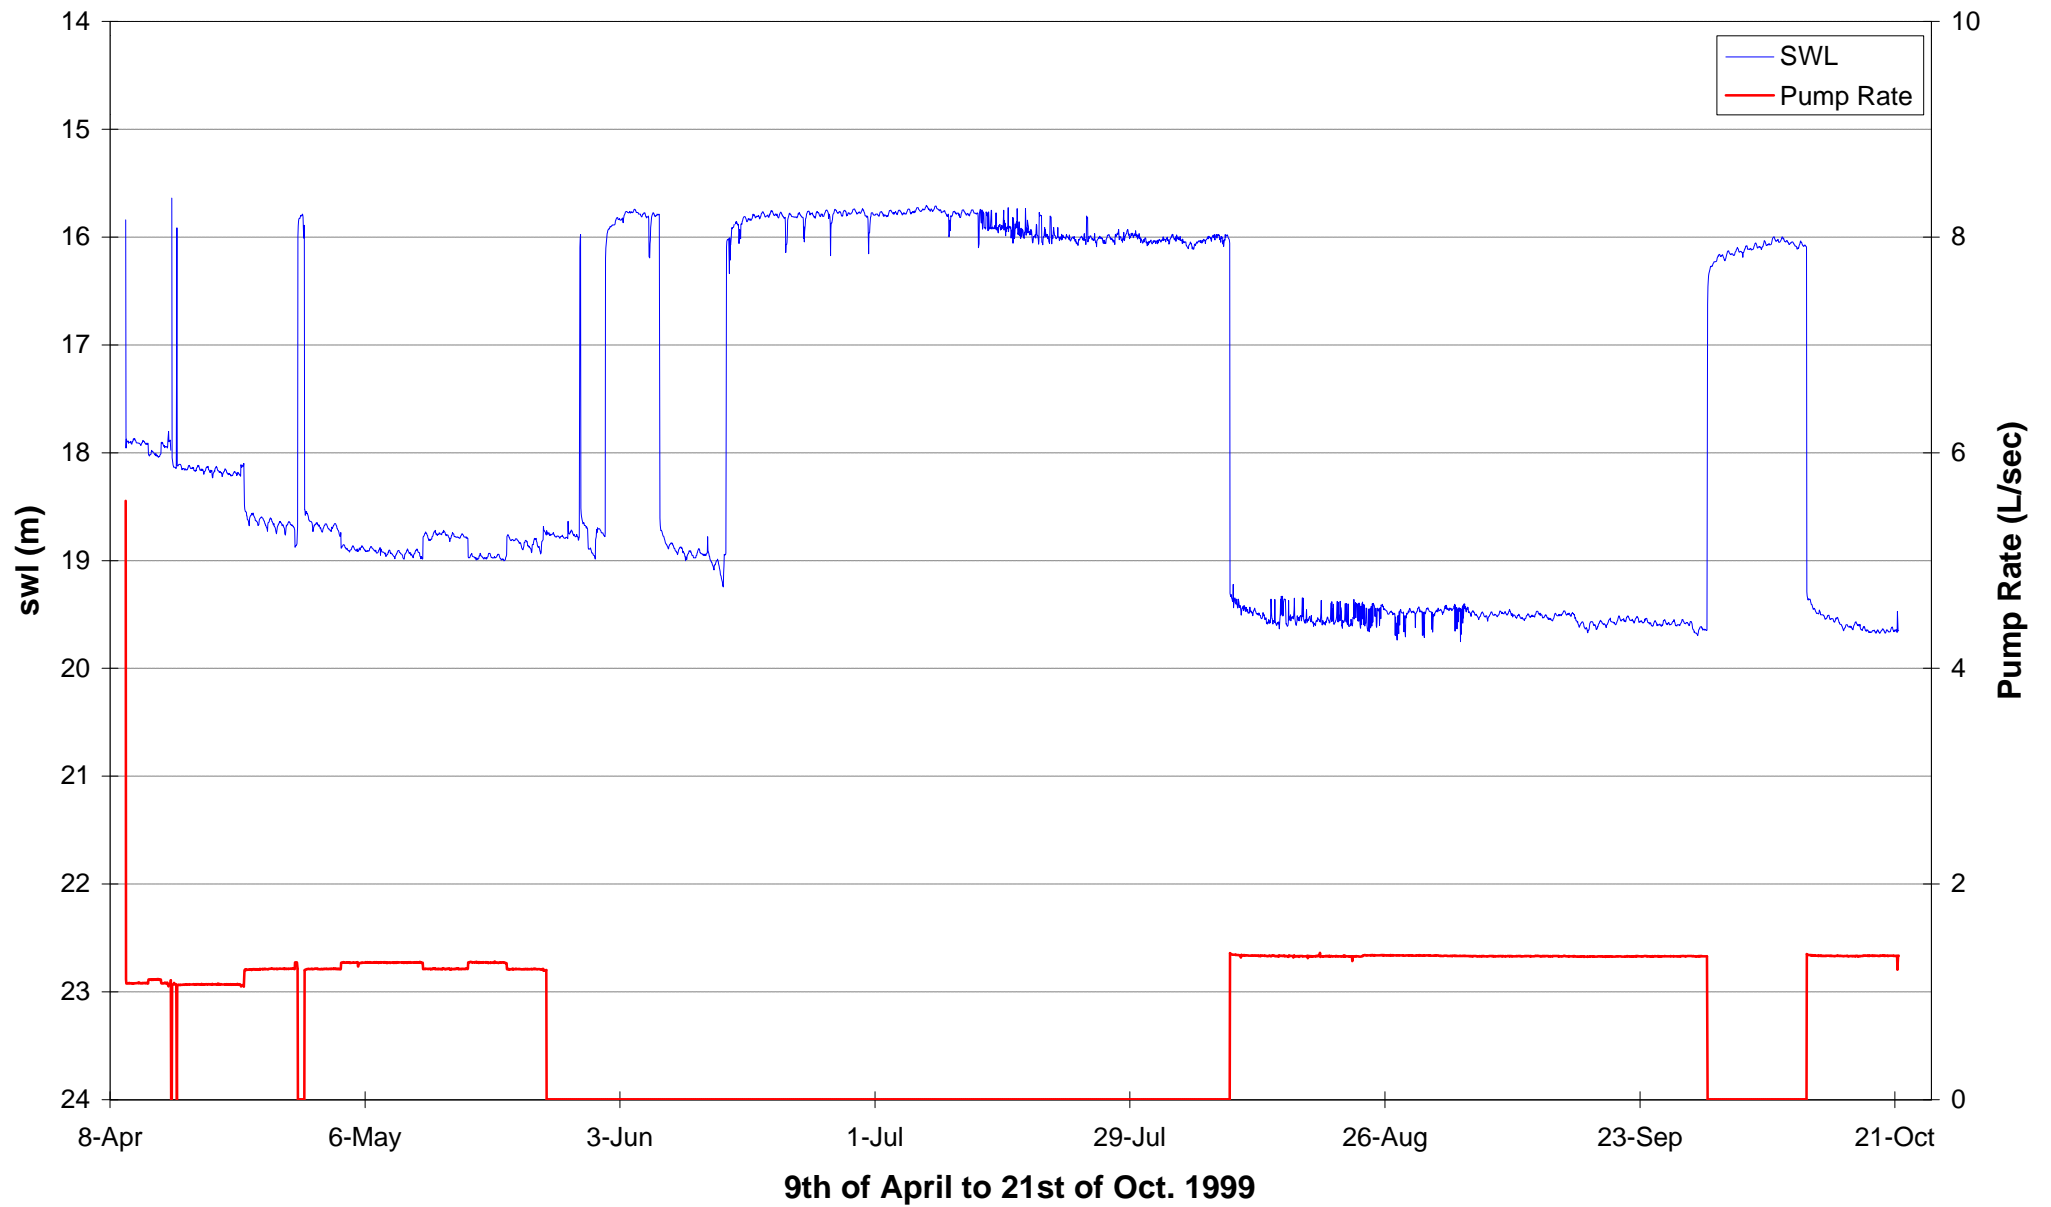
Figure 31 Pukatja E-97L; Hourly SWL and Pump Rate

Well 97L. This well sustained a pump rate of 1.3L/s over several months with no sign of any lowering in the SWL (Figure 31). It is evident that the aquifer can sustain this pump rate. There is some indication of a slight decline in SWL without pumping during July, at a time when E97B was not pumping either. This may support the view that the aquifer is dewatering by natural drainage, but is really too slight to be significant on its own.

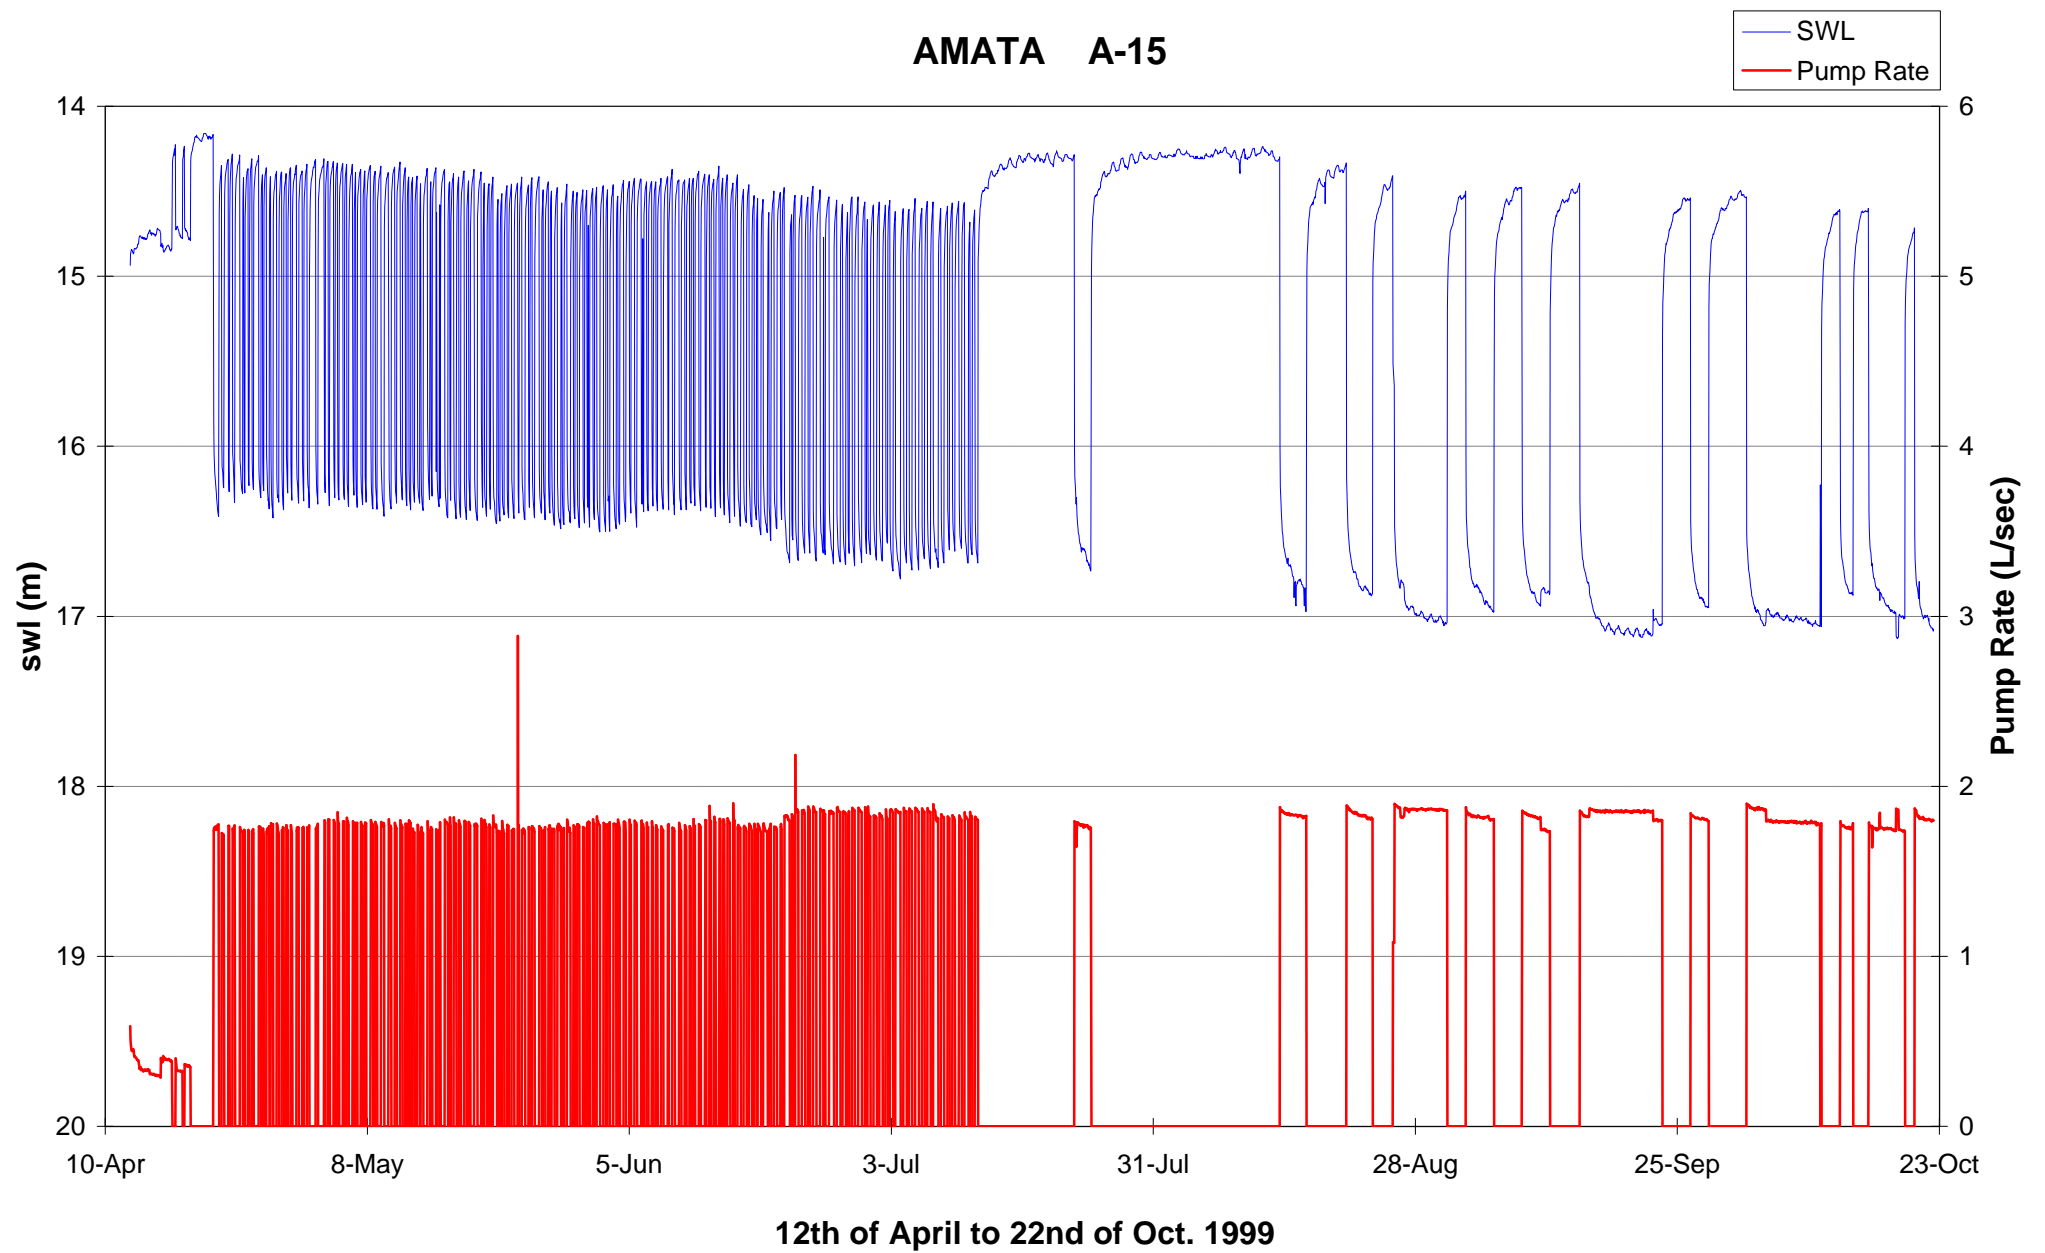
Figure 34 Amata A-15; Hourly SWL and Pump Rate

Well 15. There are possible indications of depletion, but these are obscured by variations in pumping rate and duration (Figure 34). However, taking this period in conjunction with the previous one the evidence of depletion is clearer with a drop of about 1 m in both relaxed and pumping levels over the year. There appears to be adequate available drawdown (14 m) to the aquifer at 30 m (14 years at the current rate of decline).

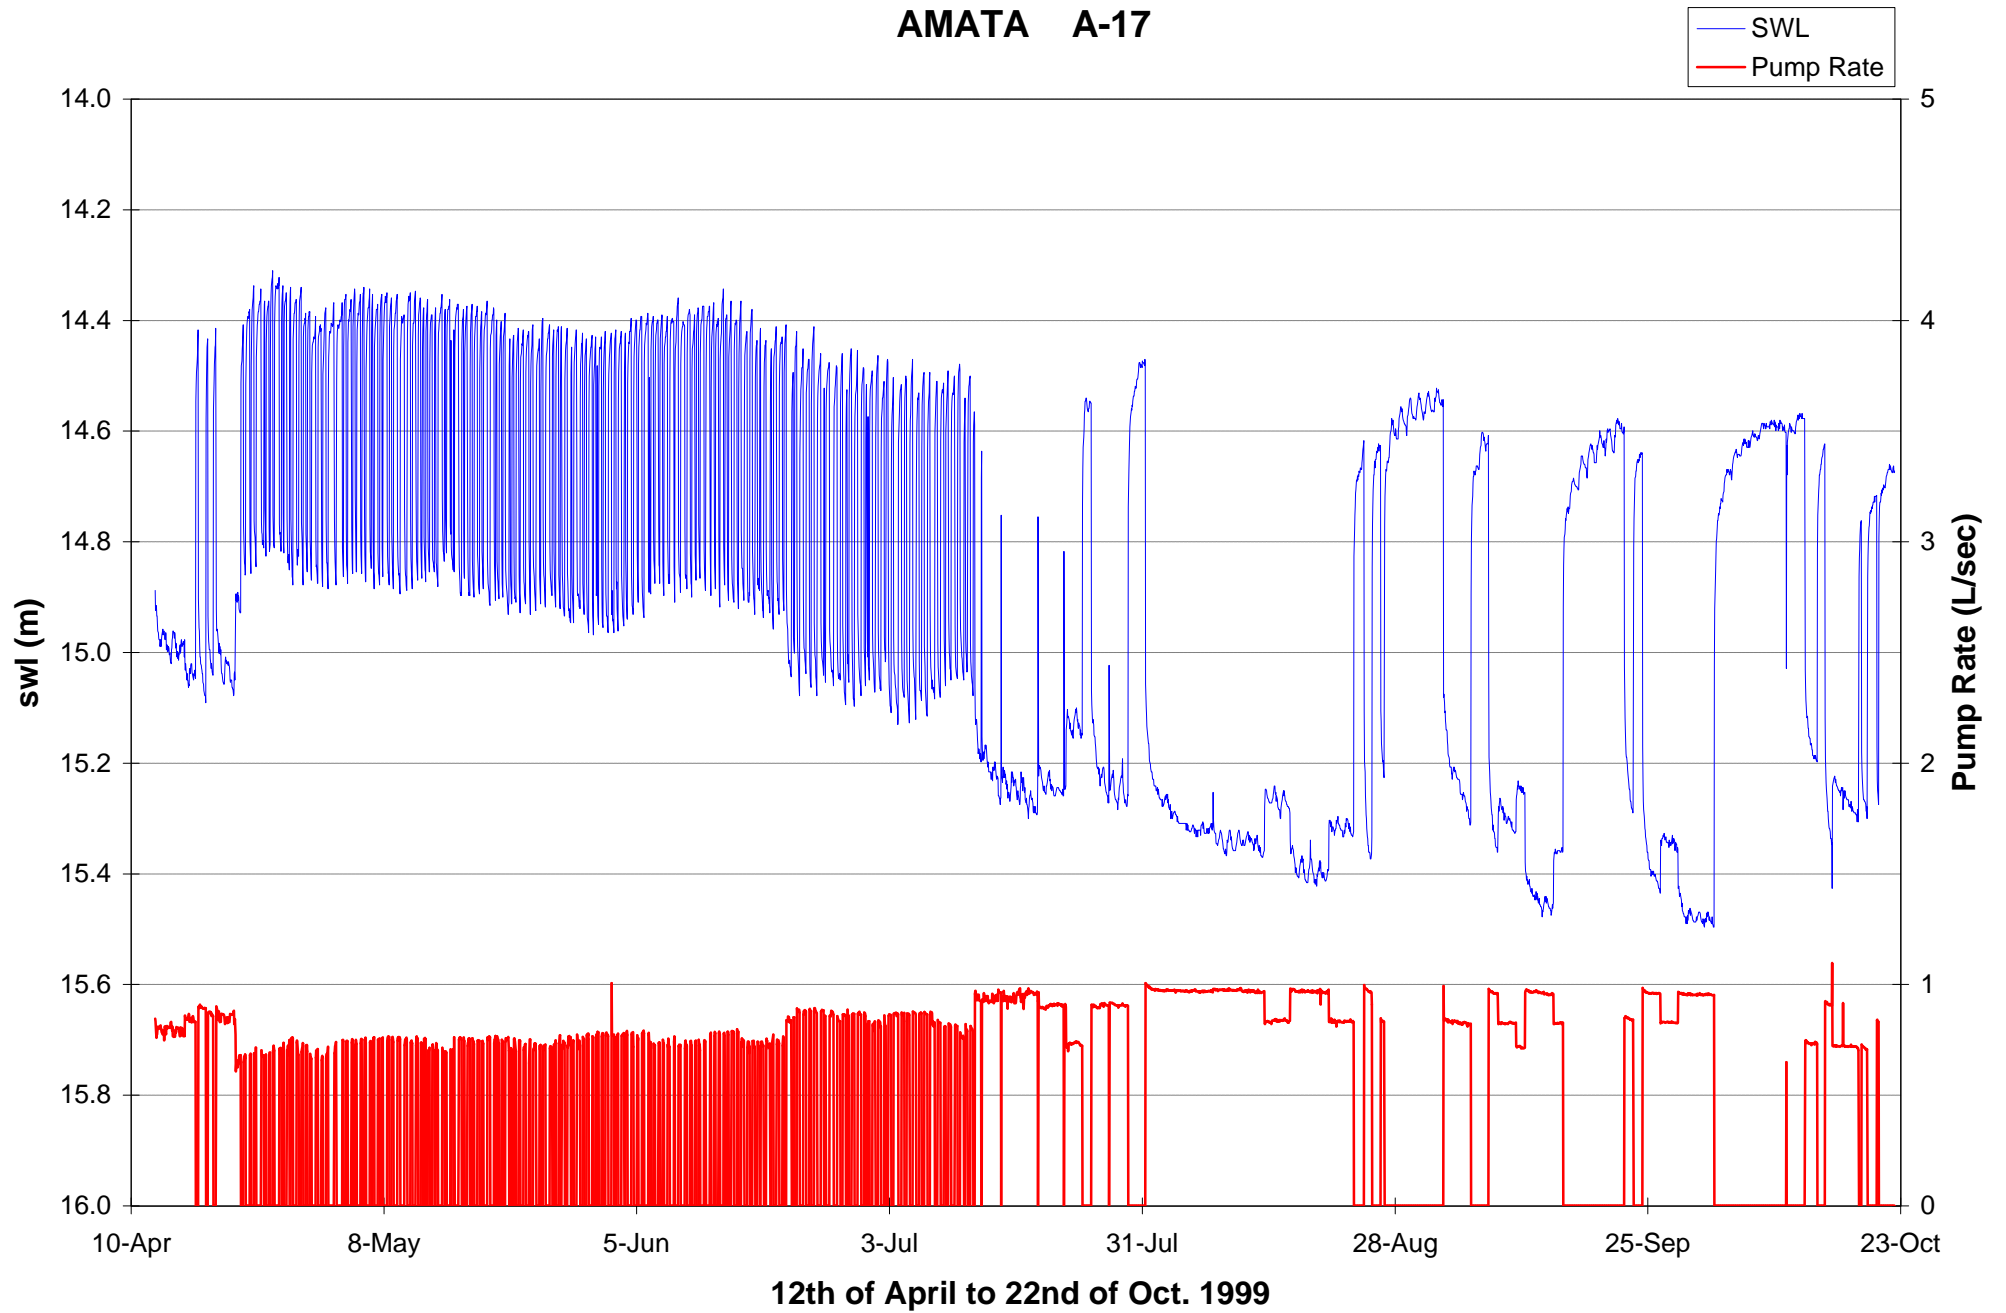
Figure 35 Amata A-17; Hourly SWL and Pump Rate

Well 17. As for 15. The best estimate is a decline in water level of 0.5 m over the year (Figure 35). Again there appears to be a reasonable buffer of 10 m to the aquifer at 25 m, but this is uncertain because of doubts about the aquifer location.

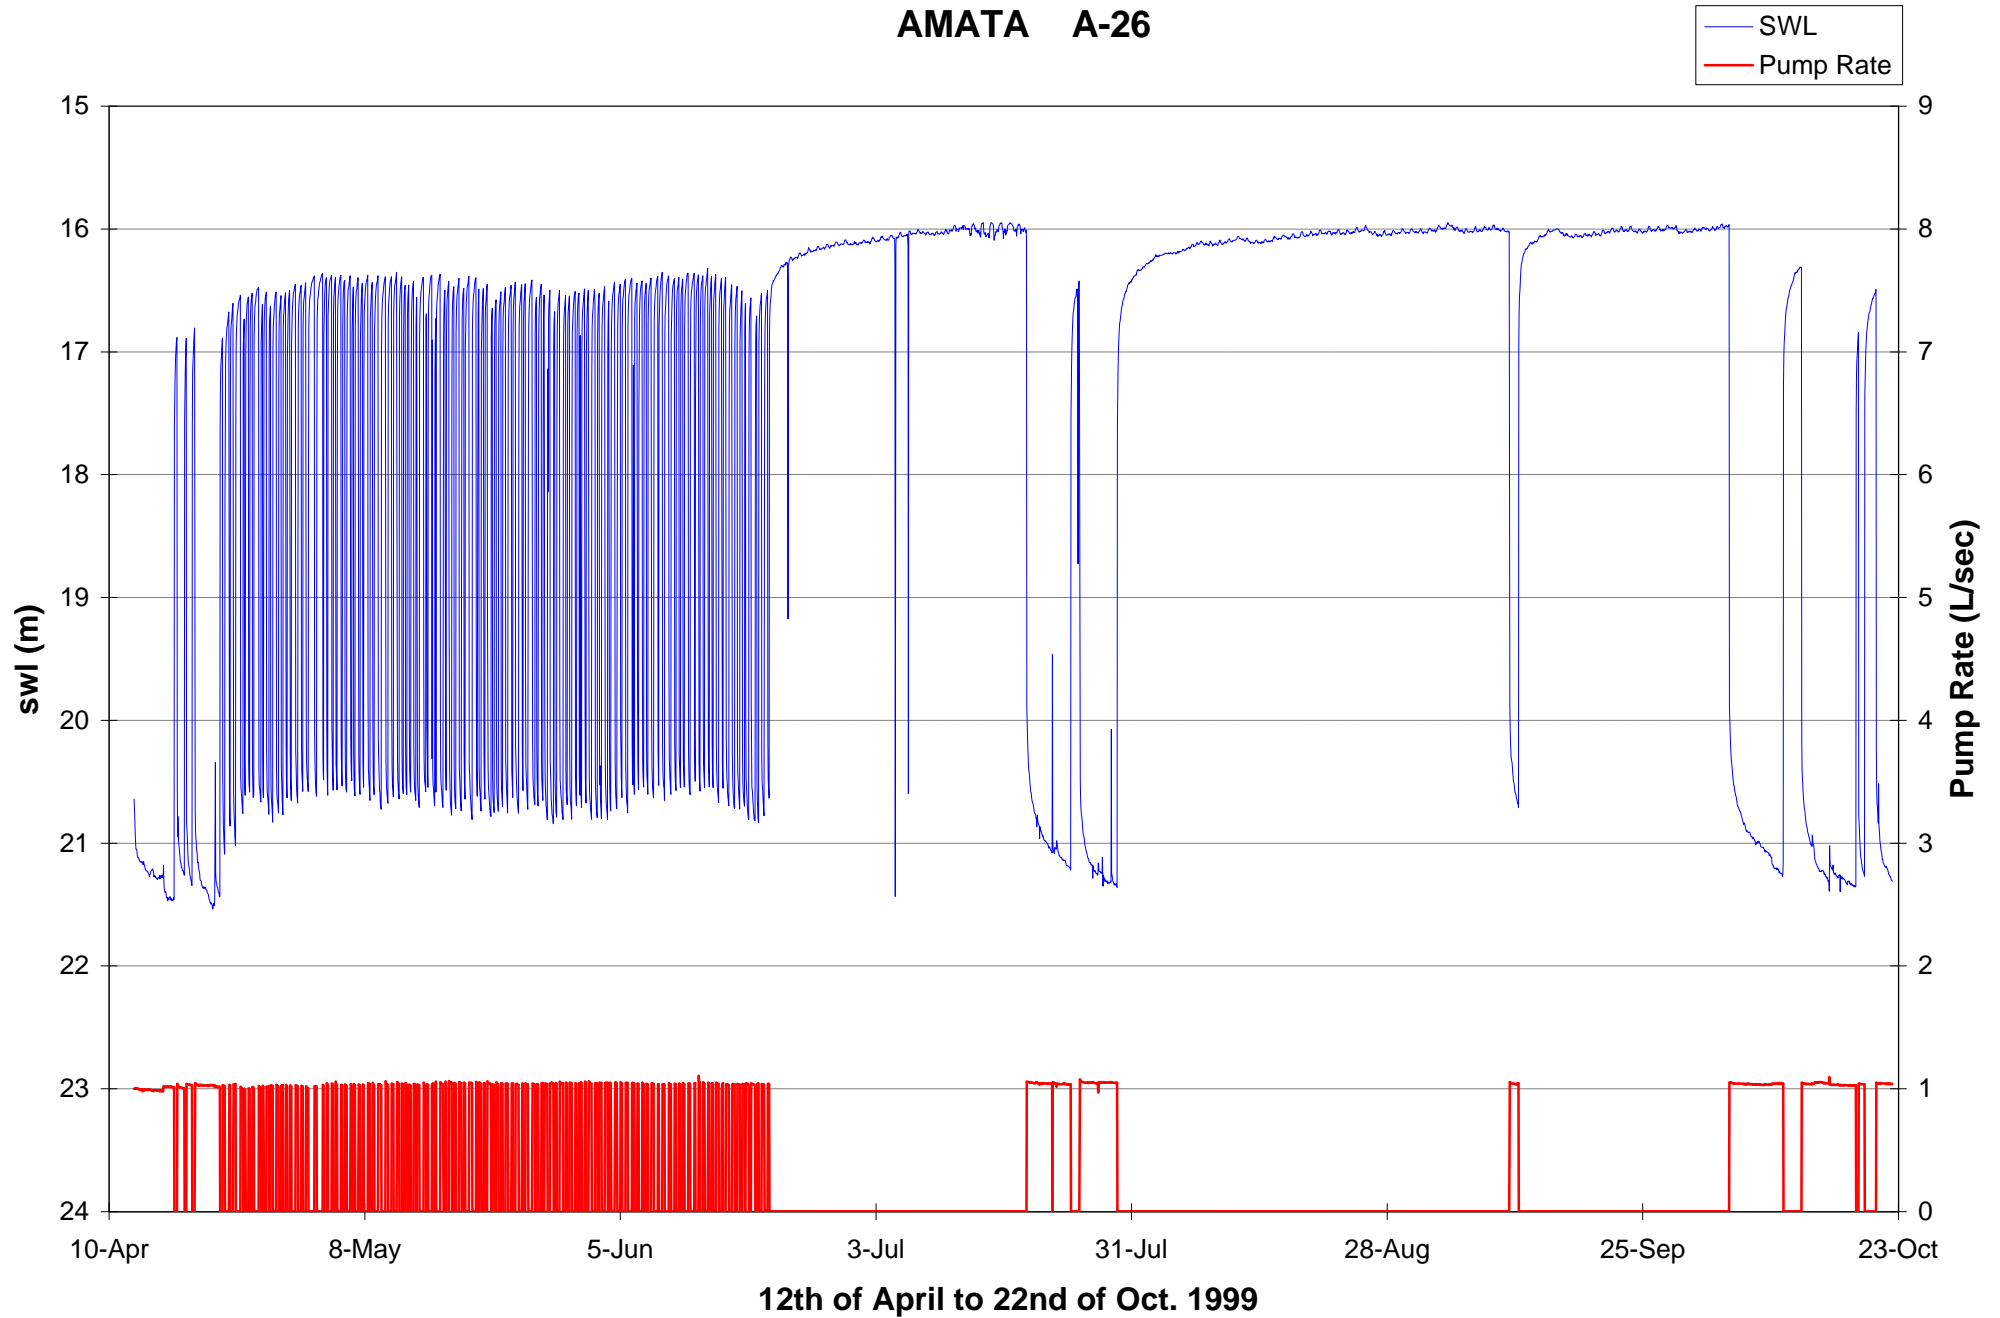
Figure 36 Amata A-26; Hourly SWL and Pump Rate

Well 26. The well was pumped less in this period and had a chance to recover to an SWL at 16 m (Figure 36). This is unchanged over the last year. The well appears to be slow to recover, but is not suffering depletion. There is a buffer of 9.5 m between the pumping SWL of 21 m and the aquifer at 30.5 m. The drop in SWL as a result of continuous pumping is quite severe, but the available drawdown would allow it so long as there is a subsequent rest period to allow the well to recover.

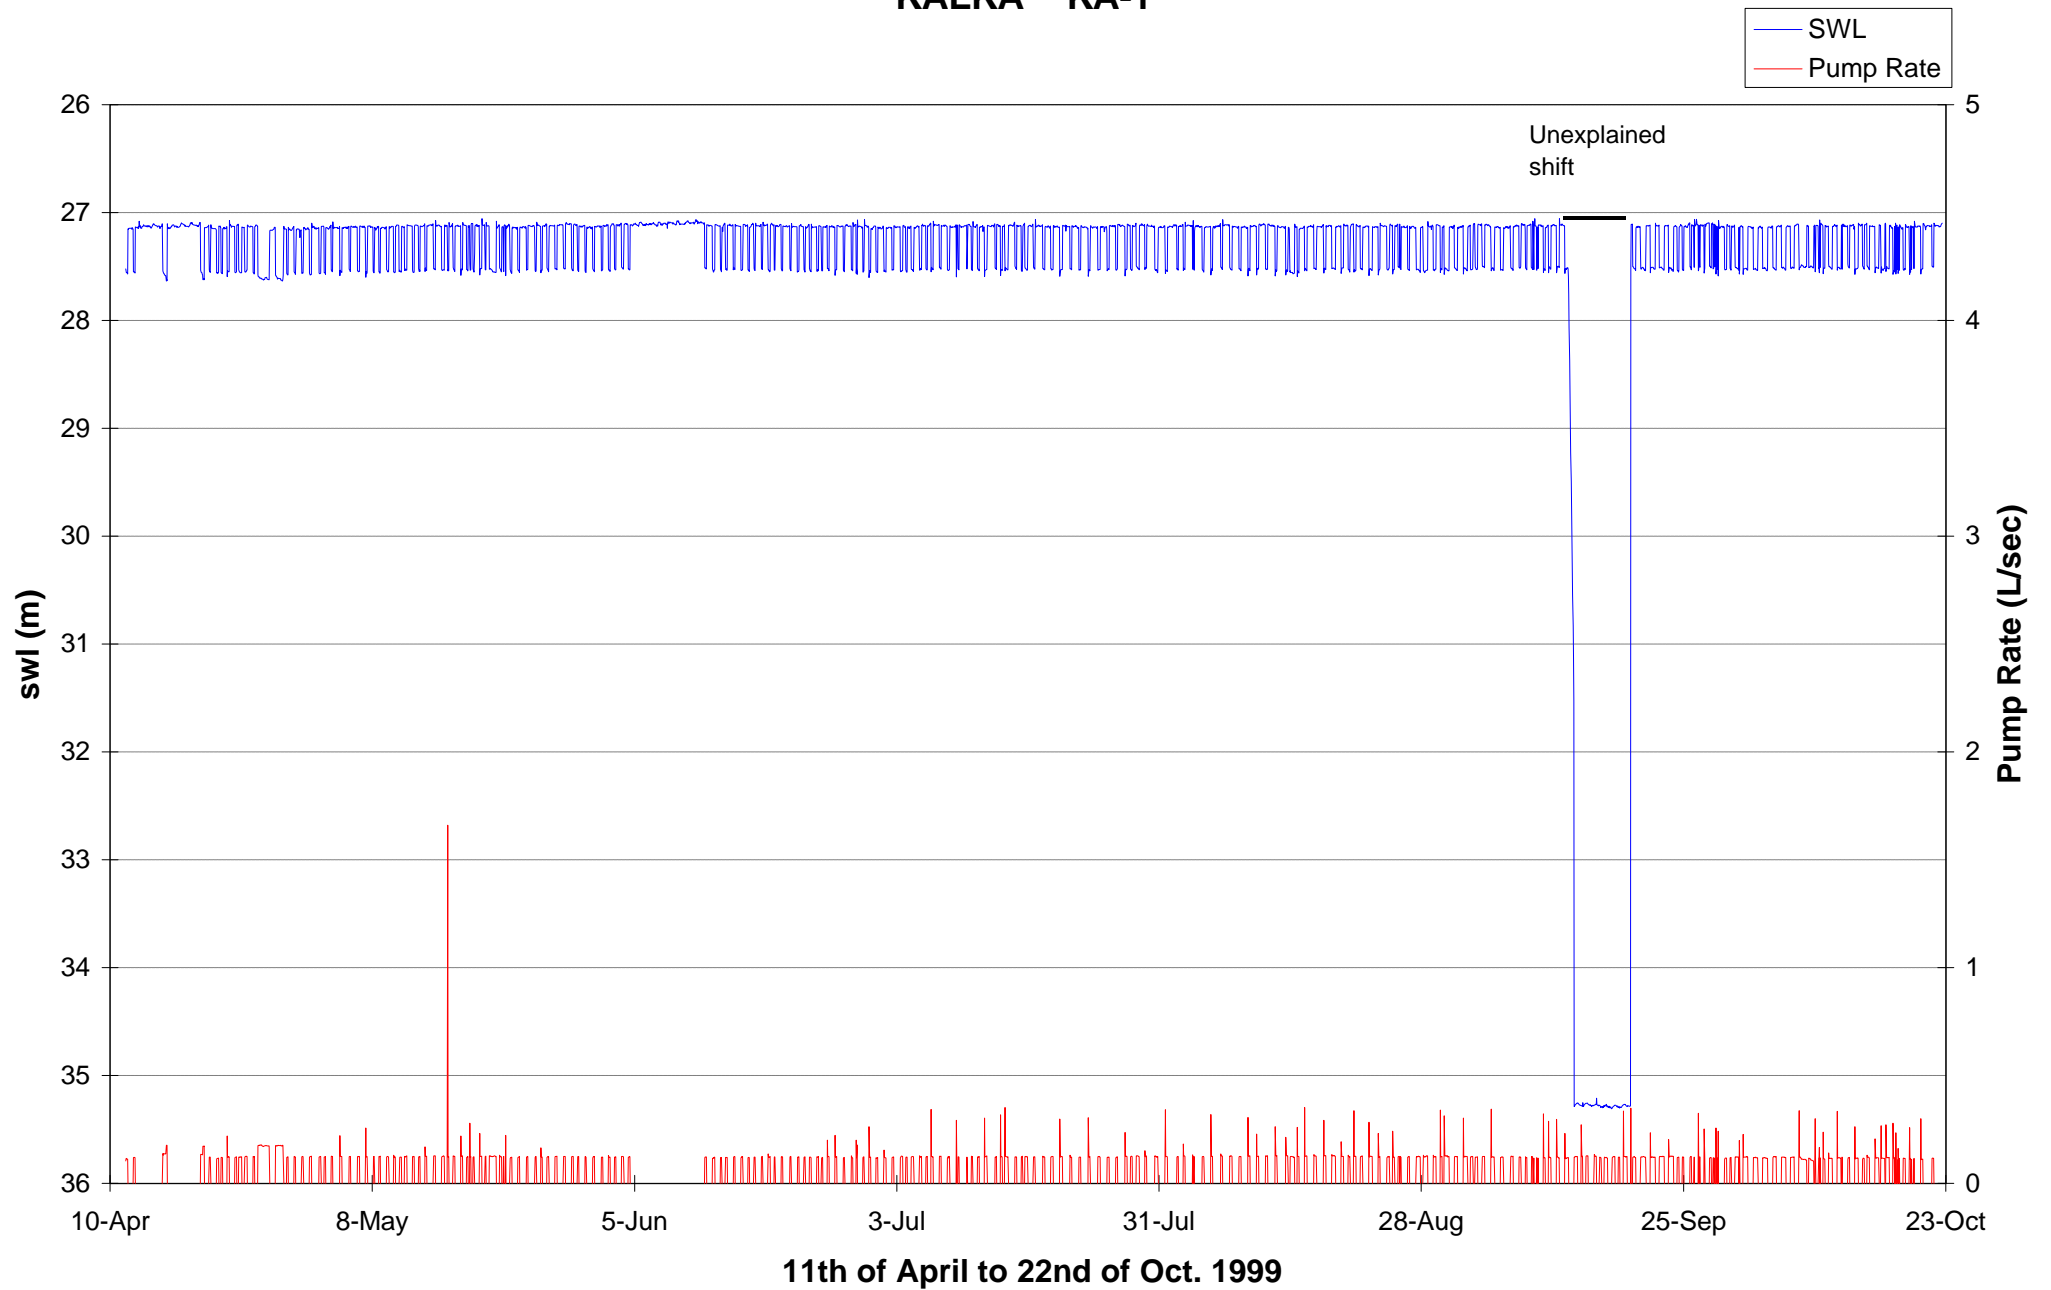
Figure 39 Kalka KA-1; Hourly SWL and Pump Rate

Well 1. No sign of depletion (Figure 39). This well was pumped very lightly. There is a data shift of unknown origin in mid September.
