Hydrogeological Report on NW Aboriginal Lands well monitoring – April to October 1999

REPORT BOOK 2000/00007

Lloyd Sampson and Sandy Dodds

Department for Water Resources, Groundwater

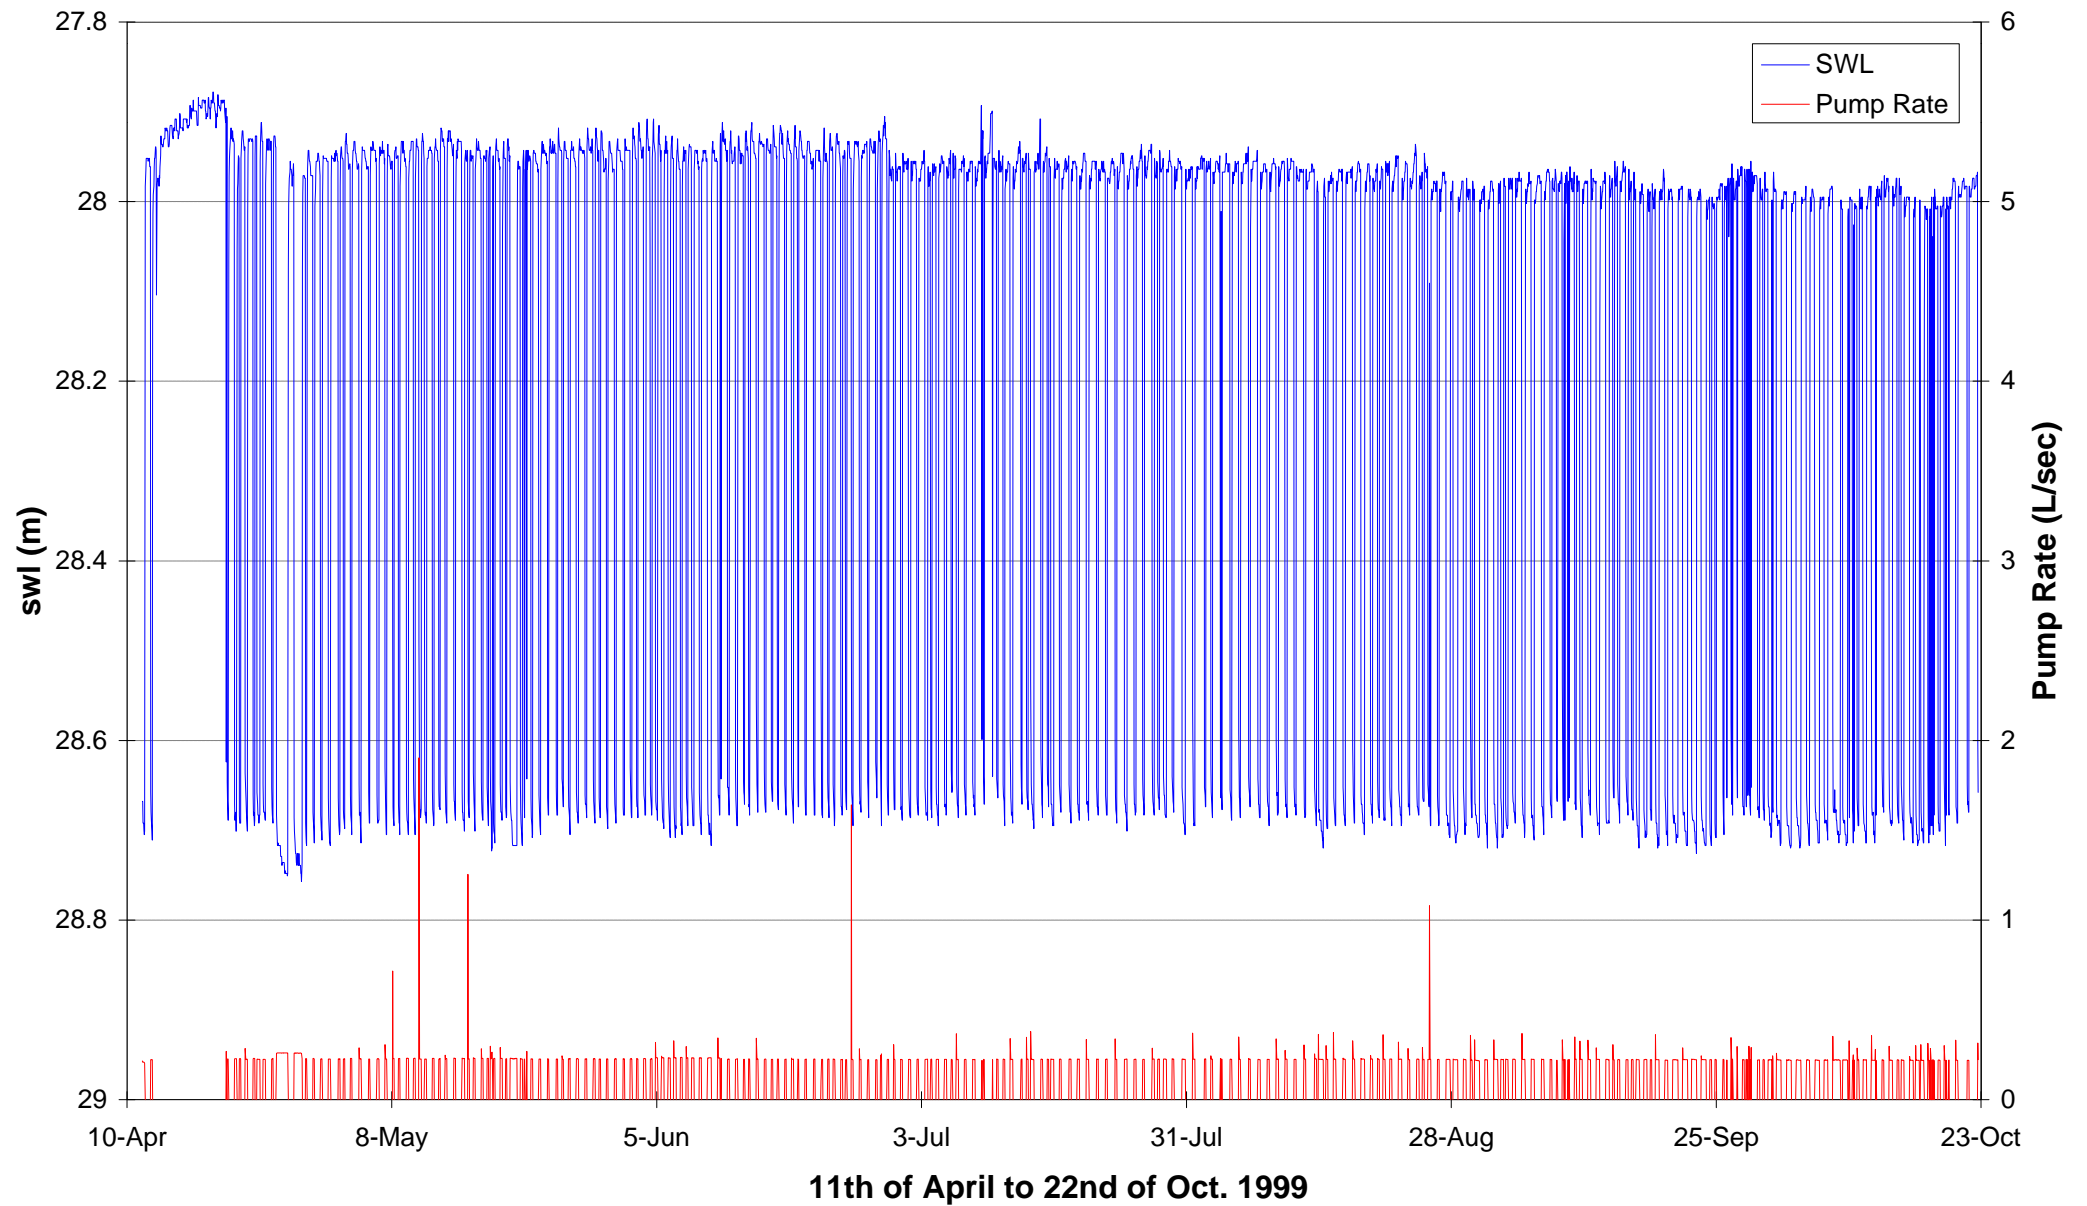
Figure 40 Kalka KA-2; Hourly SWL and Pump Rate

Well 2. The SWL appears to have dropped by 0.1 m to 28.0 m over the period, but with pumping every day it is hard to be sure (Figure 40). The indication is backed up by the previous period's data, with a probably drop of 0.2 m over the year. With the top of the aquifer at approximately 29 m this does not give much leeway, but the aquifer may extend to the bottom of the well at 60 m.

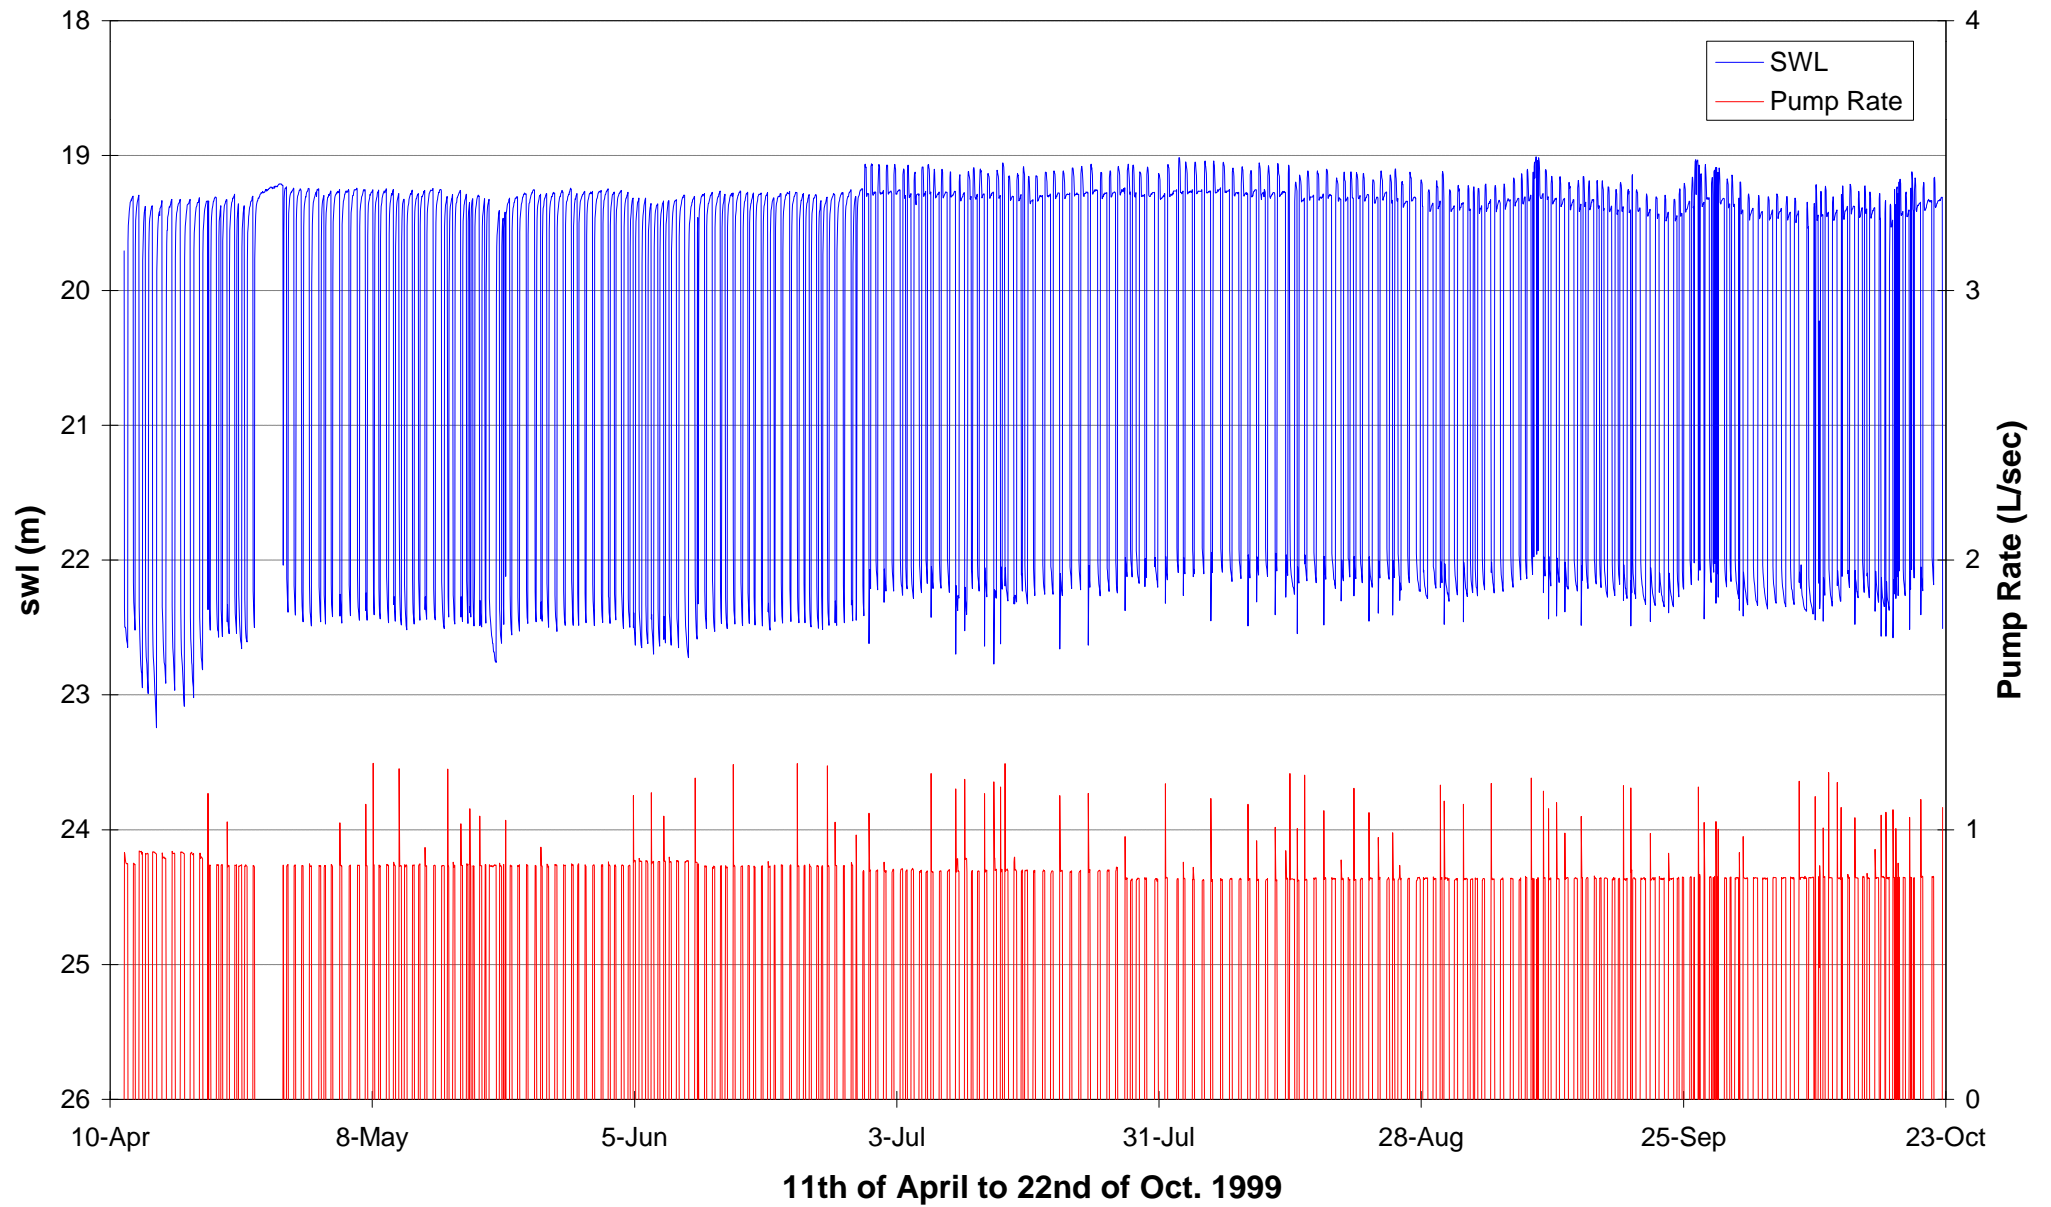
Figure 41 Kalka KA-3; Hourly SWL and Pump Rate

Well 3. As with some other wells, a spike or surge, probably flowback of water from the distribution system because of a faulty non-return valve, started in this well at the beginning of July (Figure 41). This is undesirable from a data point of view and possibly damaging to the well. There is no sign of depletion in this or the previous period.

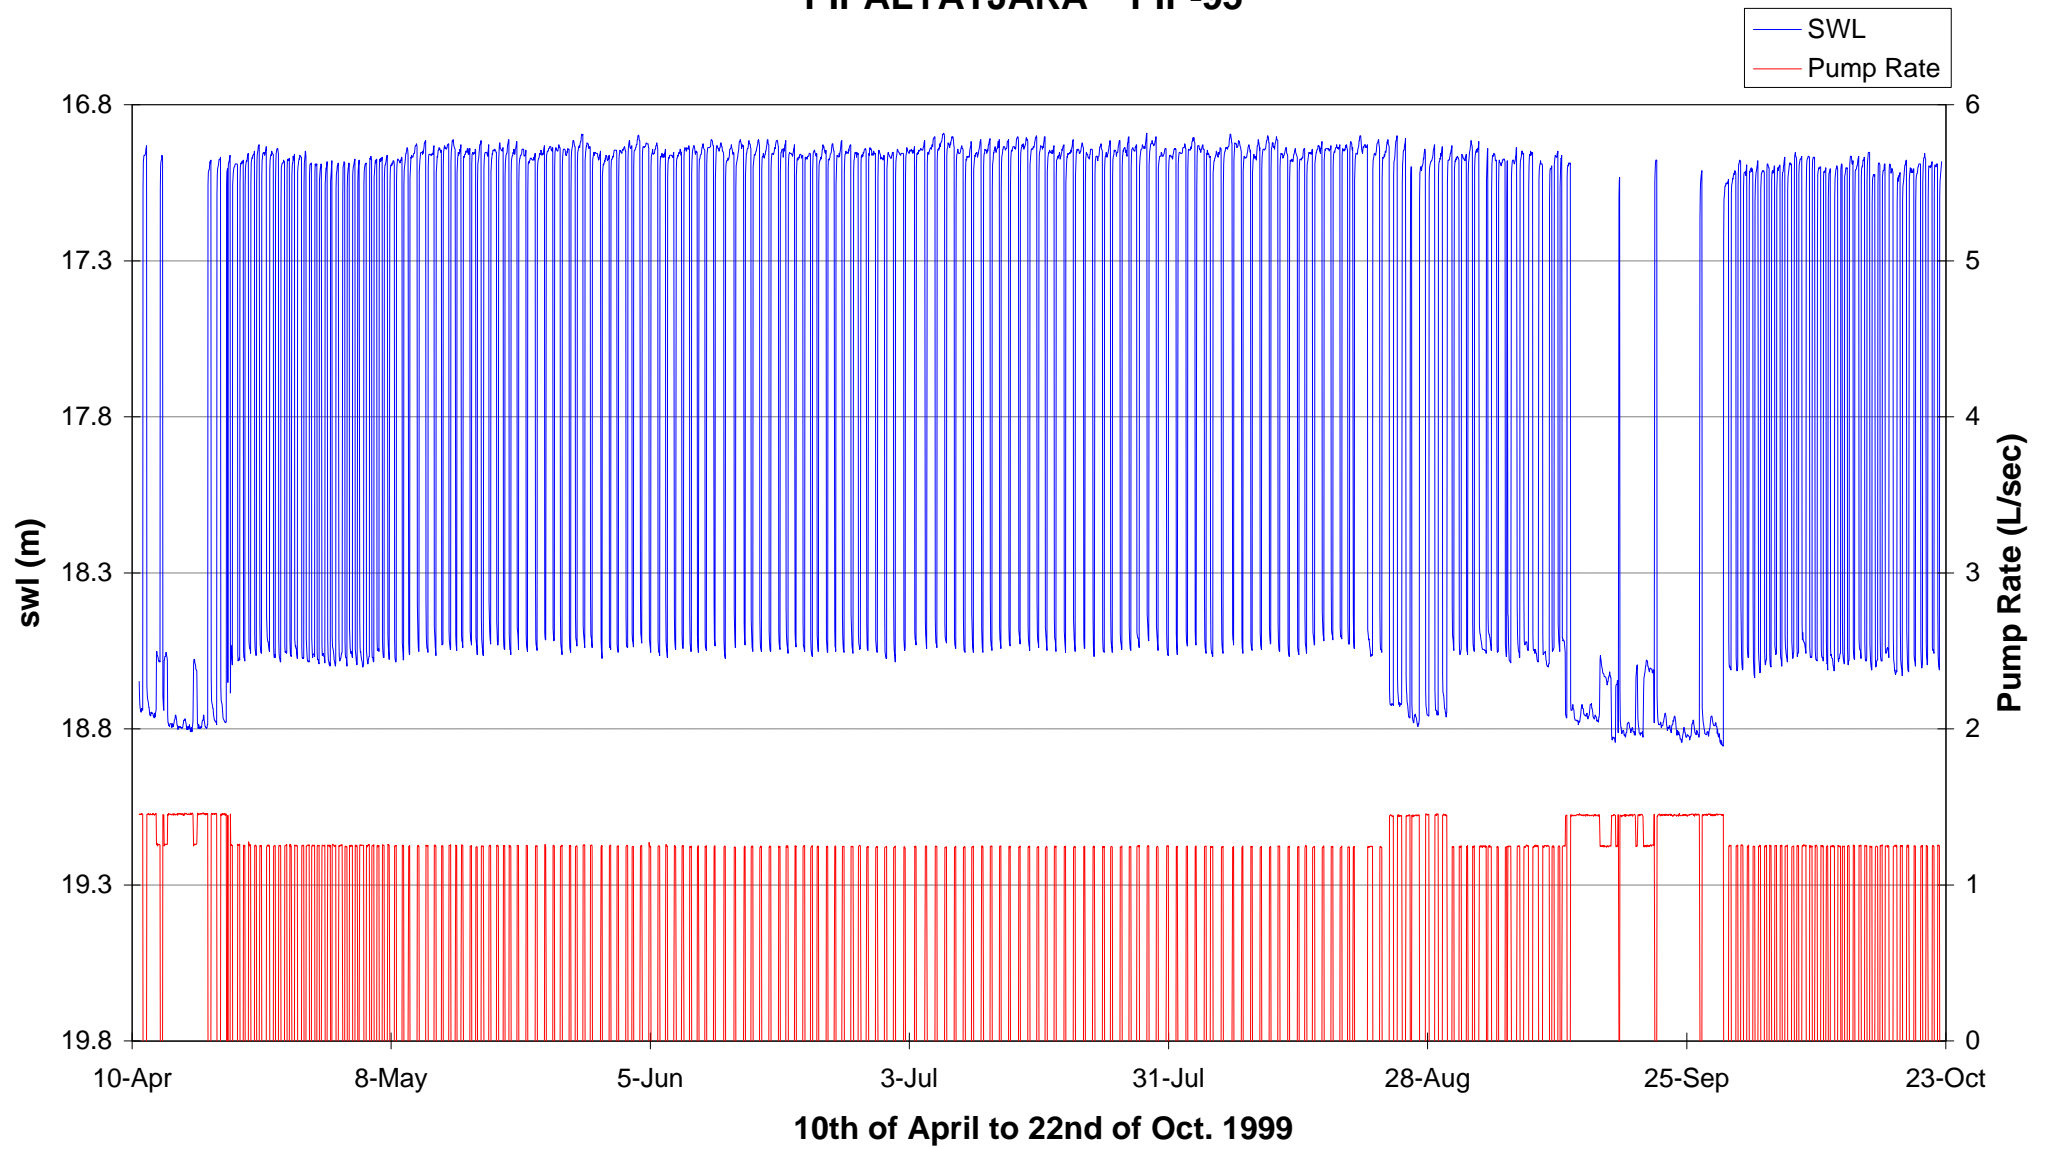
Figure 43 Pipalyatjara PIP-95; Hourly SWL and Pump Rate

Well 95. No sign of depletion, and the data looks good (Figure 43).

PMB95 SWL datum was reset by 0.030 m. The data logger was found to have an intermittent fault with values on channel #2, and varied the battery volts from 12.98 to 4.15. The logger S/N 311193 was removed and replaced with S/N 311207.

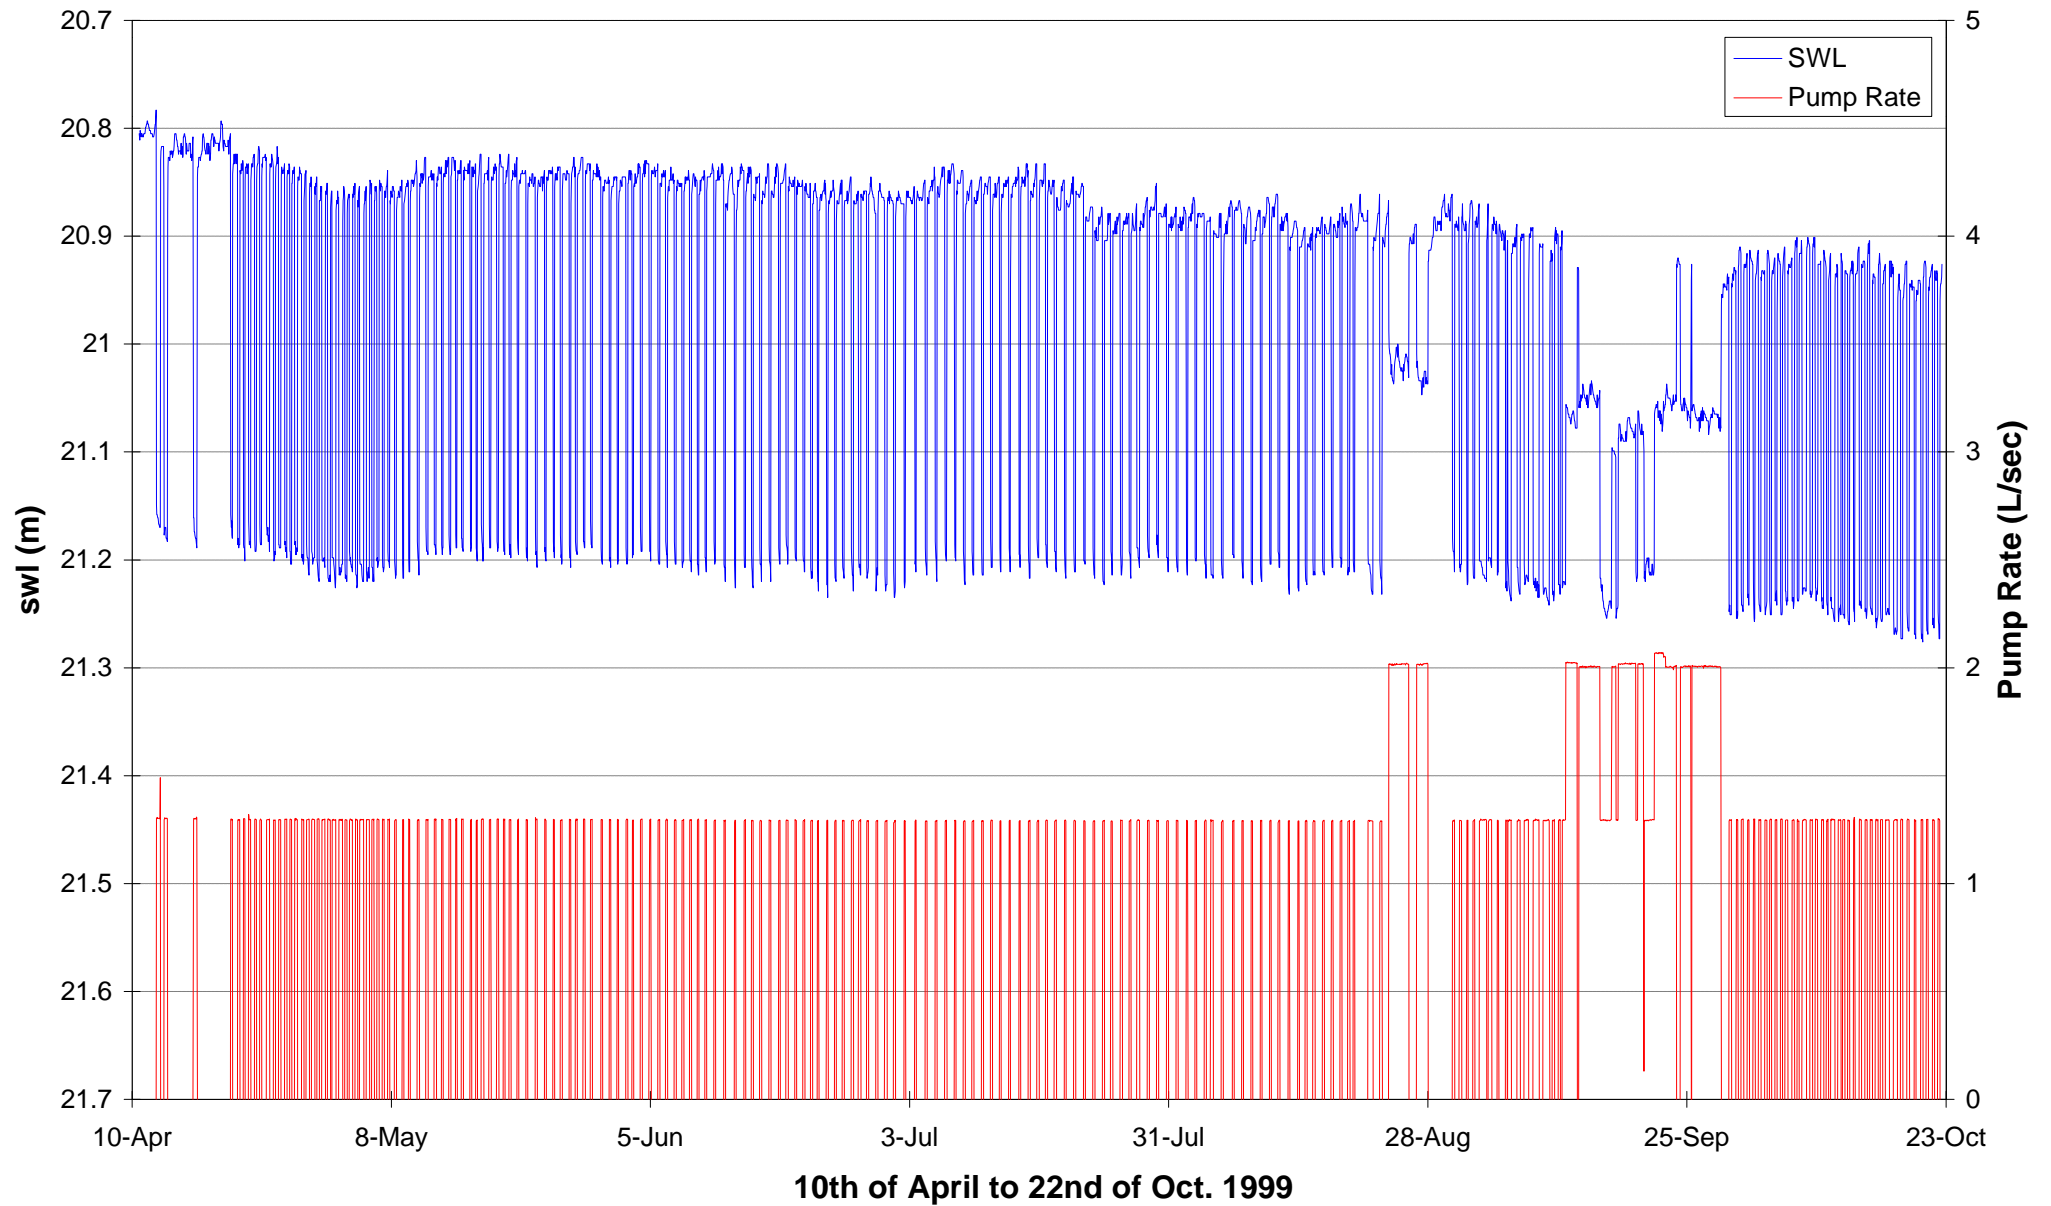
Figure 44 Pipalyatjara PIP-96; Hourly SWL and Pump Rate

Well 96. There was a decline of 0.1 m over the monitoring period (Figure 44). The rate of decline appears greatest at times of longer pumping hours (late April - early May and in October), indicating that the depletion is caused by extraction. With an available drawdown of less than 1 m to the top of the aquifer, this depletion is a matter of concern and may require some relaxation in withdrawal rates. However, the matter is not yet urgent and additional data may clarify the picture.

There are errors in the flow data during late August and mid to late September.
