DEPARTMENT OF MINES SOUTH AUSTRALIA

REPORT ON FOUNDATION TEST FOR HOTEL IN CENTRAL AREA OF NEW TOWN NEAR SALISBURY

A. R. Crawford
Geologist
ENGINEERING GEOLOGY & MINERAL RESOURCES SECTION
GEOLOGICAL SURVEY BRANCH

Date October 1955

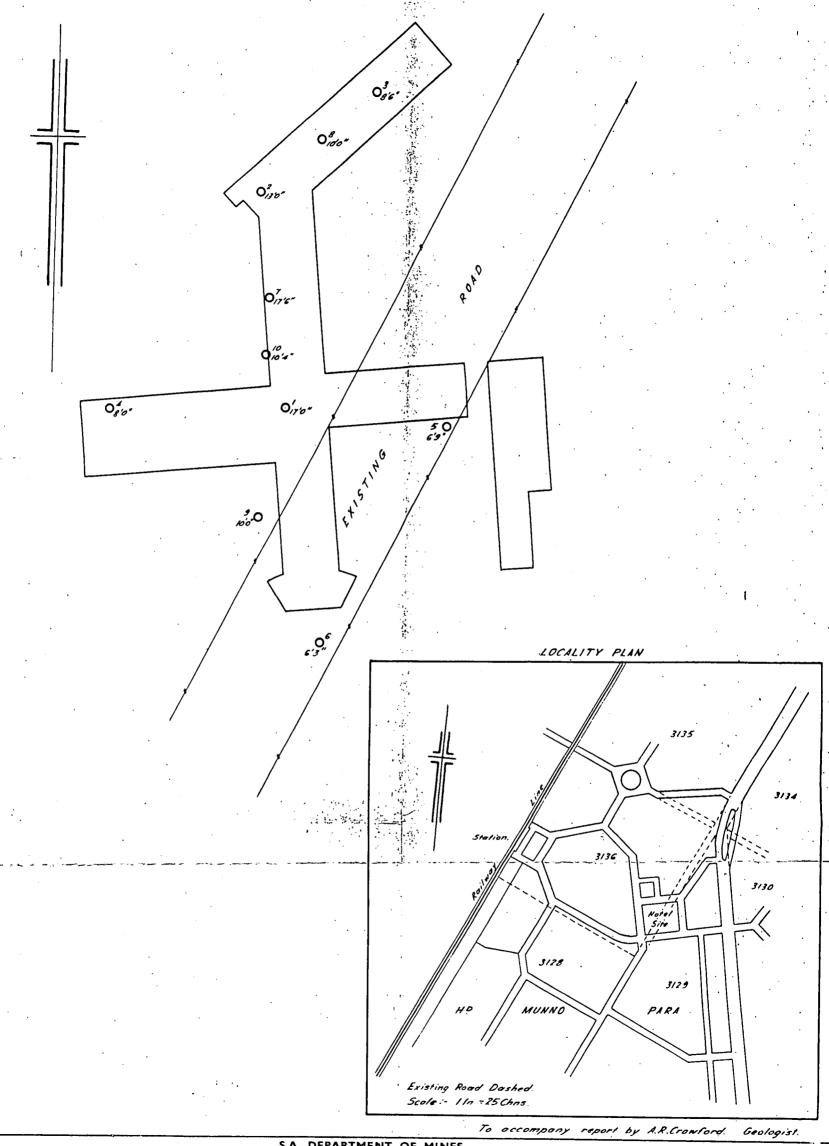
55 - 344

The hotel plan is in the form of a cross with a long axis from north to south and an extra arm attached to the northern end extending north-eastwards (see plan 55-344 attached). The present proposals are for a one storey building to which another storey may be added later.

A first group of six hand auger holes was put down by
Mr. R.C. Mirams, Geologist, on 4th and 5th August. These are Nos.
1-6 inc. and as can be seen from the plan (on which the outline of
the hotel walls is necessarily approximate as no large scale plan
was made available) they were sited to cover the whole area concerned.
The logs of these holes are attached in an Appendix. They showed an
apparent general similarity of conditions around the circumference
of the site (holes 3,4,5 and 6) but somewhat different conditions
in the centre (holes 1 and 2). The four circumferential holes, the
deepest of which was 8'6" (hard clay prevented deepening by hand
auger) showed a general profile of from 6 to 8 feet of red-brown
clay overlying limy clay. The two central holes showed red brown
clay to 10-12 feet, limy clay in the zone from 10-14 feet, and, in
No. 1 hole, red-brown clay below 14 feet, with water at 15 feet
