DEPARTMENT OF MINES
SOUTH AUSTRALIA

GEOLOGICAL INVESTIGATIONS

SMITH CREEK, HUNDRED OF MENZIES
KANGAROO ISLAND.

December, 1956.

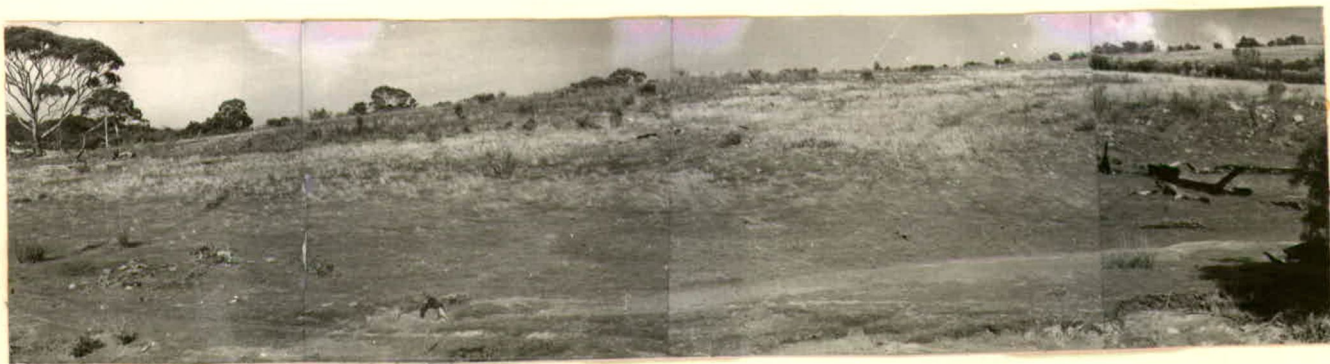
Fig. 3 Left abutment at proposed damsite.

Due to the fact that erosion has not kept pace with uplift at the dam site the rocks below the main foundation area are partly weathered. Diamond drill hole SC2 which is on the left bank close to the creek bed shows that the badly weathered rock is approximately 7 feet deep below the collar of the hole. This is equivalent to 3 or 4 feet below the river bed and rock may have to be removed to this depth to obtain a satisfactory cut-off.

Although no faulting has been observed at the site, a large part of the left abutment is soil covered and some minor faulting may be concealed here. A certain amount of sliding along bedding planes may have occurred.

In the diamond drilling programme the worst core recovery was in hole SC2 on the left bank of the creek in the main foundation area. Some of the core loss may have been due to minor zones of cracking along bedding planes. This cracking is not considered serious and should be adequately remedied by the proposed grouting programme.

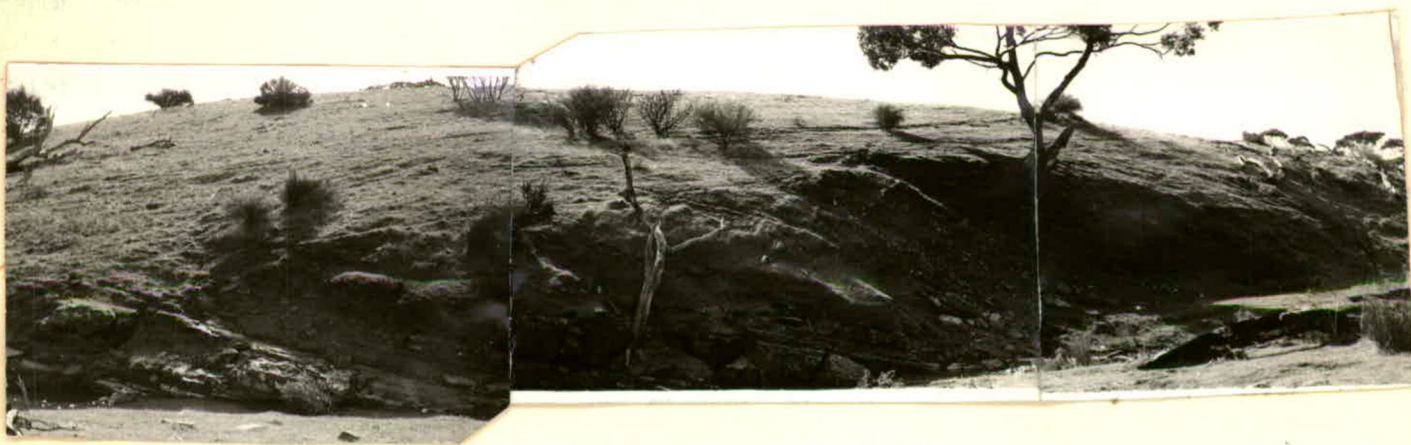
Fig. 4. Right abutment at proposed dam site.

On the right bank information is provided by two boreholes and a test pit. These show the zone of badly weathered rock to extend from 4 to 7 feet vertically below the surface. The zone of soil and completely altered rock is 1½ to 2 feet thick and below this weathering processes have broken the rocks into small angular fragments and partially converted them into clay to the full depth of the zone. Most of this zone will require removal to provide a sure cut-off. Close to river bed level some large blocks of rock, otherwise quite sound, may have to be removed because of their complete detachment from the parent rock by joint cracks.

In the right abutment two holes gave reliable information. The first hole SC2 is close to the creek bed, though some 15 feet above it. At 15 lb. / sq. in. pressure water from this hole broke through to the creek bank, a distance of 10 to 15 feet, laterally along a bedding plane joint or crack.

Hole SC3 at a level 40 feet above the creek bed accepted only 20 gallons of water at pressures rising to 30 lb./sq. in. This indicates that in the higher parts of the abutment the cracks, both sub-horizontal and sub-vertical, are tight and that remedial grouting will not need to be extended under the full length of the dam.

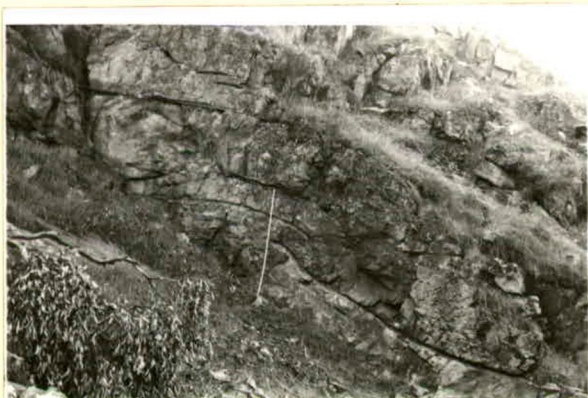
Fig. 5.

Thinner beds of quartzite occur closer to the site. One of these, approximately 10 feet thick, outcrops at creek bed level in the left bank 800 feet north of the site. It would yield a much smaller quantity of aggregate and because of this could only be considered as a source for aggregate for the concreteworks appurtenant to an earth fill dam.

Thick quartzite bed left bank of Smith Creek. Proposed for source of concrete aggregate. Bed also shows slump structures and minor faulting. Photo C. Hays.

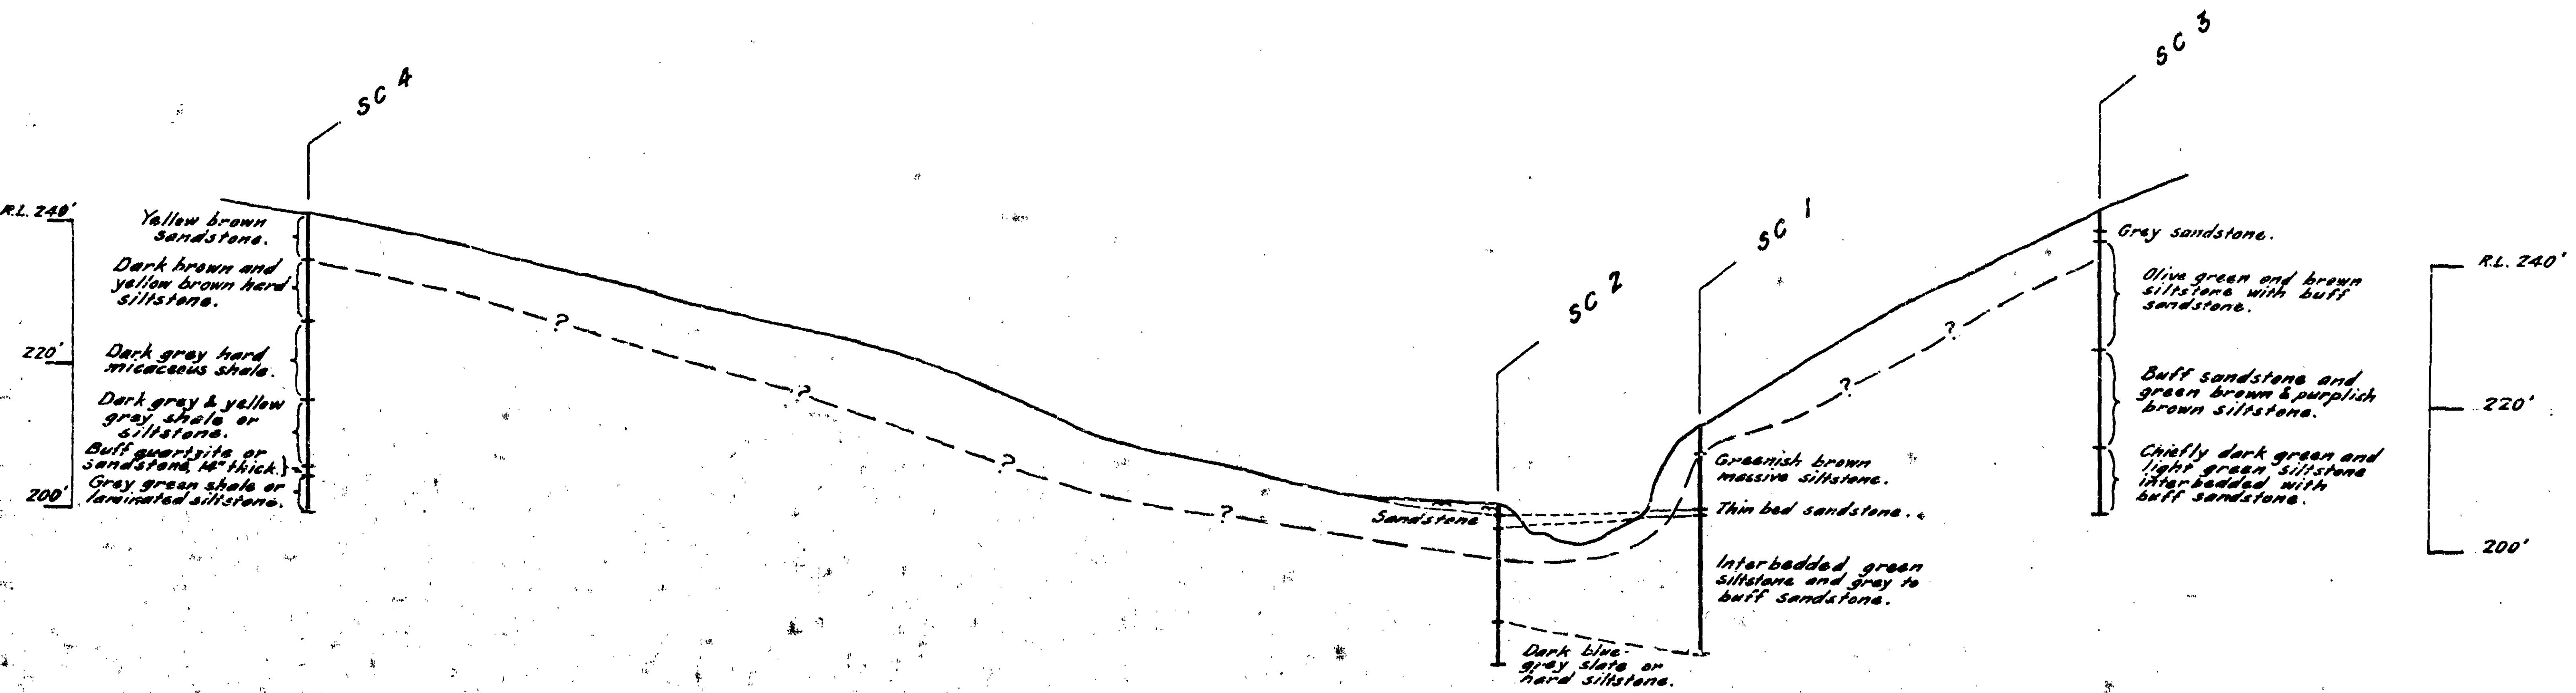
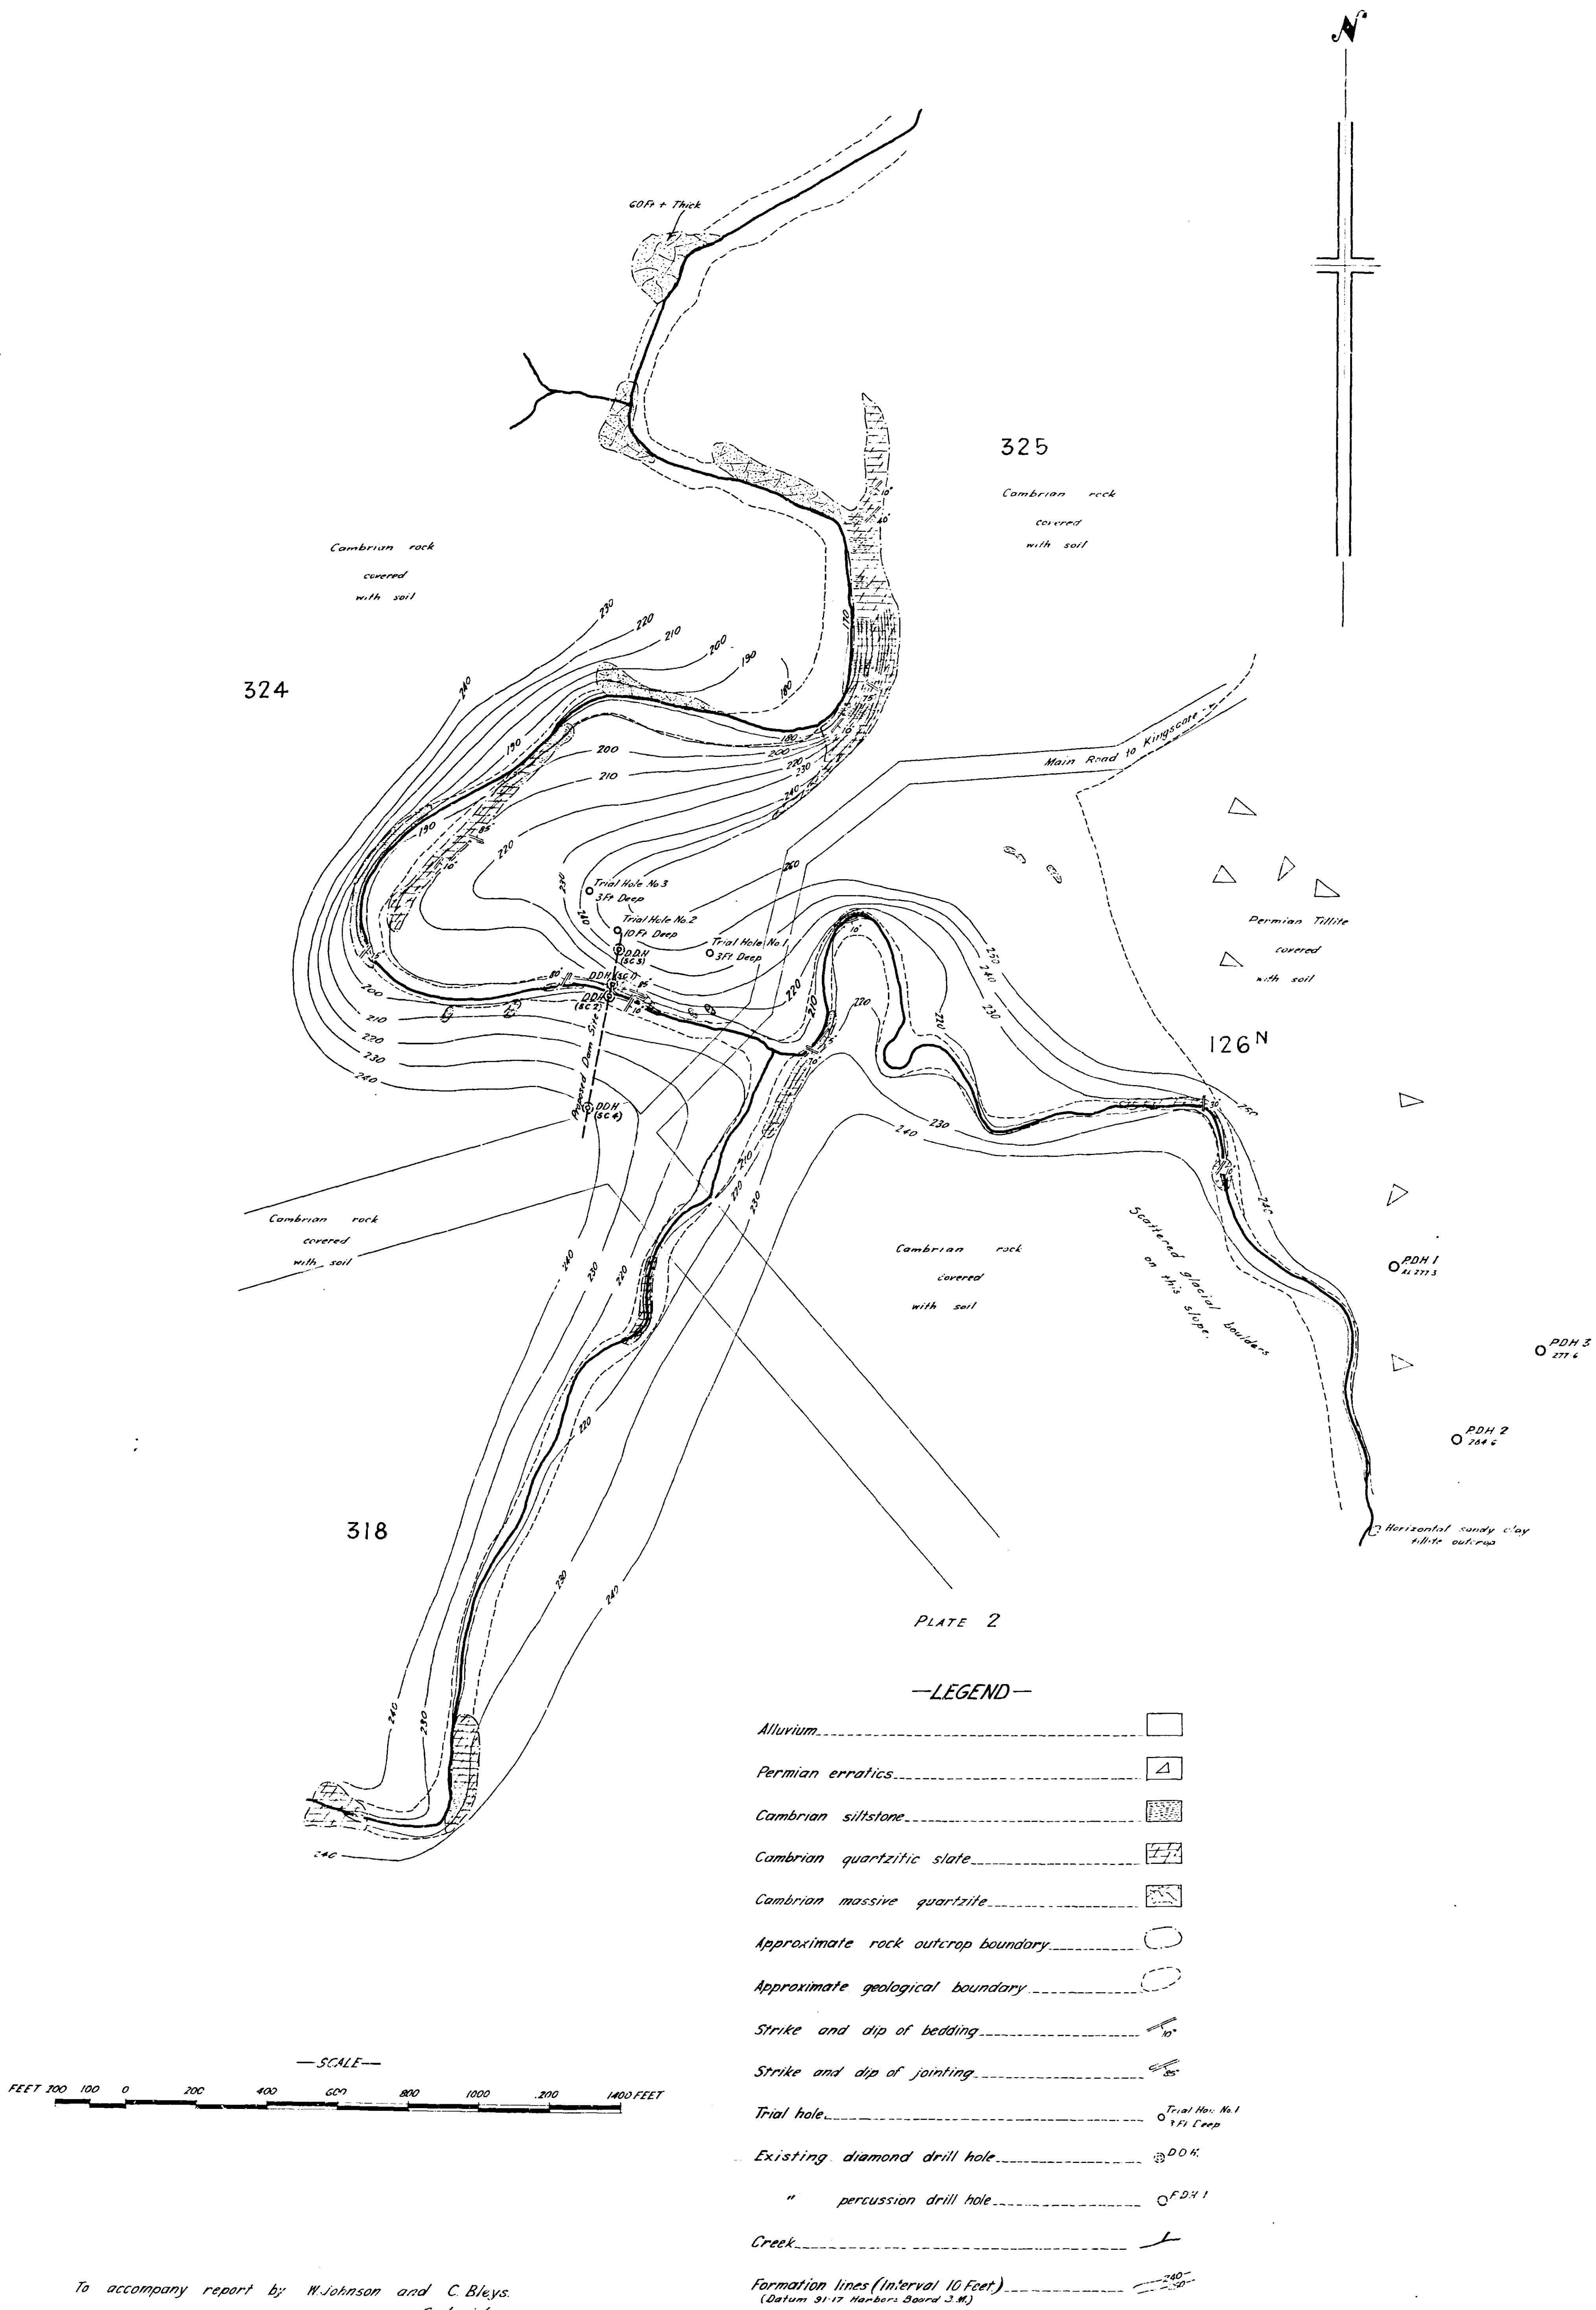
S.A. DEPARTMENT OF MINES
GEOLOGICAL INVESTIGATION
SMITH CREEK DAM SITE
HD. MENZIES KANGAROO ISLAND
CROSS SECTION AT PROPOSED DAM SITE

Zone of badly weathered rock, boundary approximate between bores
