DEPARTMENT OF MINES
SOUTH AUSTRALIA

REPORT ON OCCURRENCE OF SALINE PATCHES

SECTION 231, HD. YANKALILLA

- E. A. WIRTH -

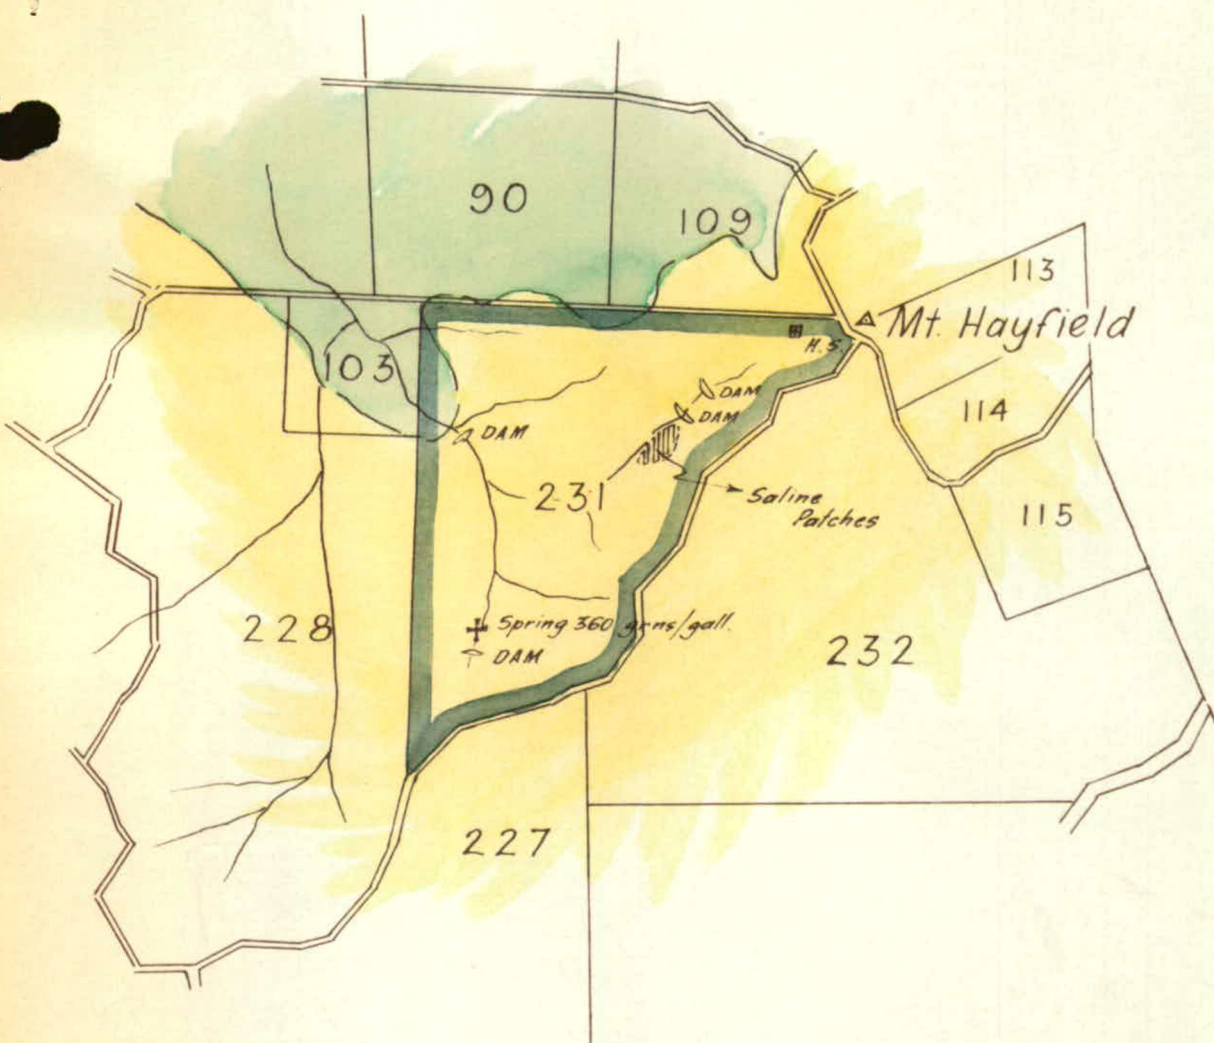
Hd. Yankalilla Sec. 231

Saline patches occurring on the lower slopes of a gully toward the eastern boundary of the property appear to be a direct result of clearing the slopes above. Lateritic clay occurring at shallow depth is almost impervious, and the decreased transpiration following clearing, together with irrigation, has formed a perched water table. This water dissolves salts from the soil and eventually emerges at a lower level, where evaporation raises the salinity to the point where pastures die.

It is suggested that the only effective control is an agricultural one, directed at reducing the soil moisture and eventually eliminating the saline areas. A System of drains would not appear to be effective and is not recommended.
