GEOLOGICAL INVESTIGATIONS, MYPONGA DAM

CONSTRUCTION PHASE

Progress Report No. 2

W. Johnson, B.Sc.(Hons.)
Senior Geologist

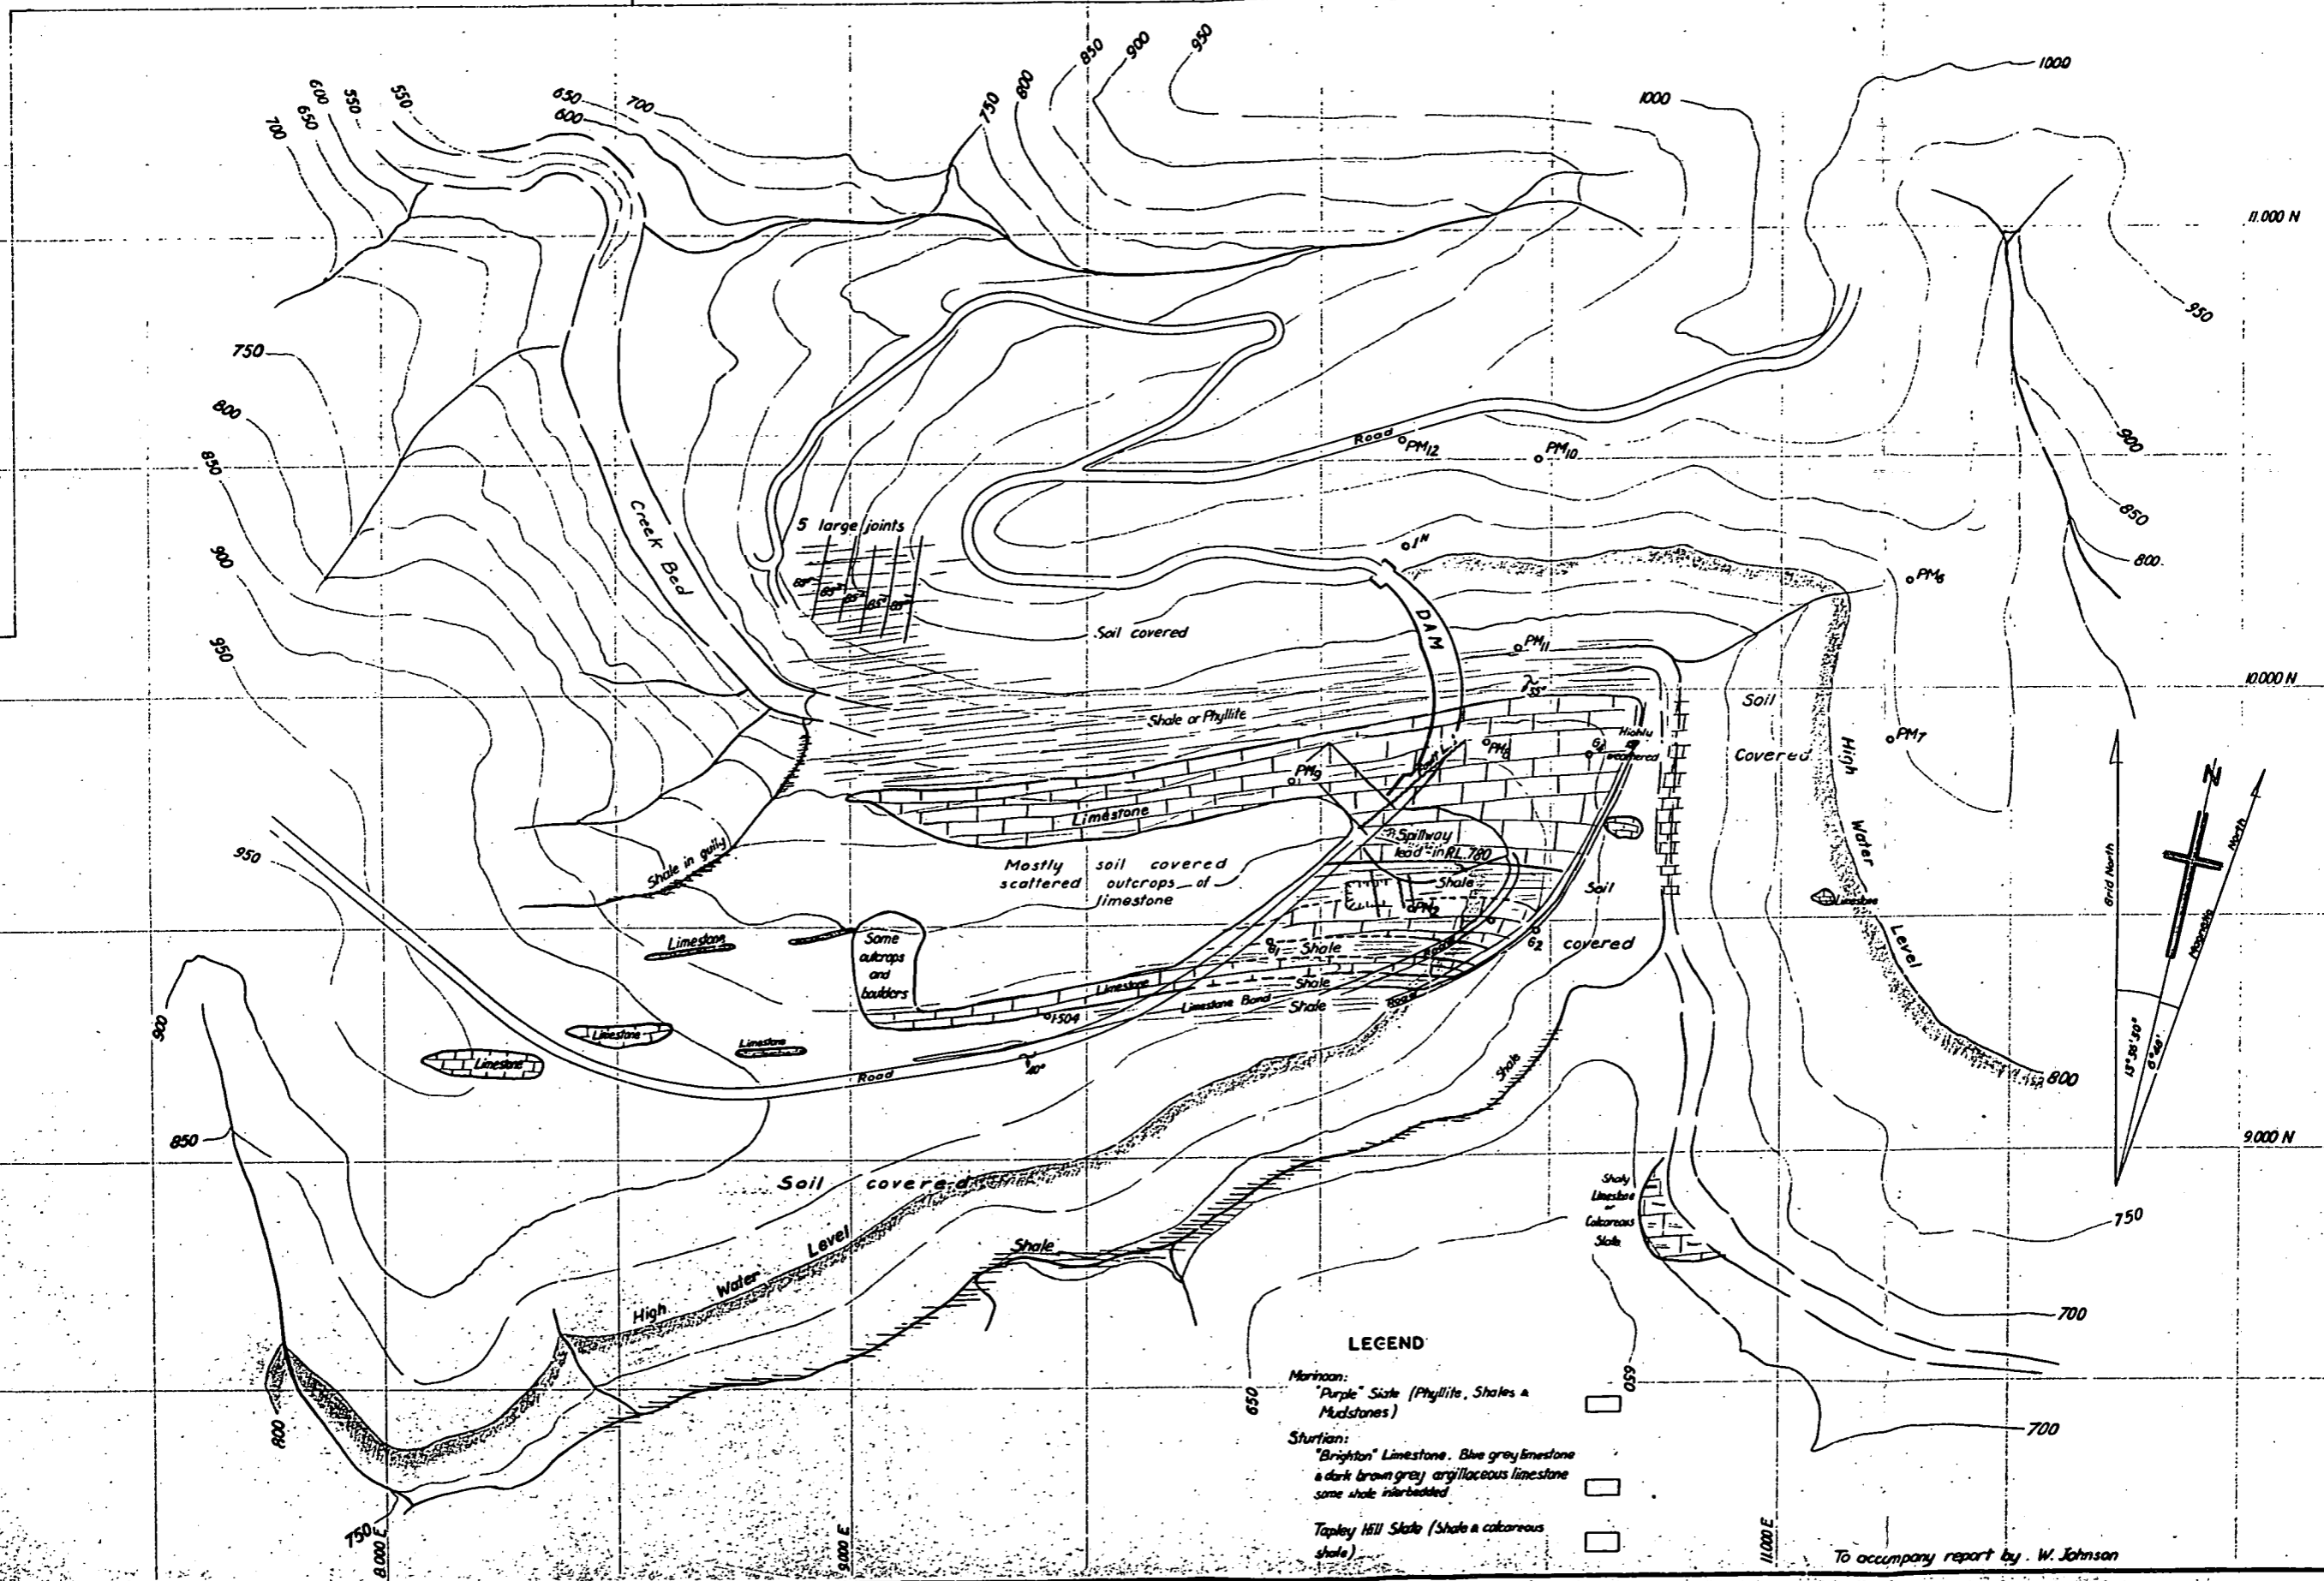
**GEOLOGICAL INVESTIGATIONS MYPONGA DAM SITE
GEOLOGY OF THE DAM SITE & ENVIRONS**

The boundaries of the limestone on the left abutment have been re-mapped and are shown on plan 58-284.

It was possible to define the southern and northern boundaries with some accuracy due to good exposures in road cuttings and other excavations. The northern contact with the stratigraphically overlying phyllite and shales is quite sharp. The southern contact cannot be so easily decided as highly calcareous shales are interbedded with the limestone near its base. However for both stratigraphic and practical reasons the southern boundary of the limestone can be taken as the thin bed located some 330 feet due south of the southern abutment of the dam.

The horizontal width of the limestone, thus defined, on the surface is 550 feet. This is its most important dimension as it gives a limit to the zone that must be covered by the curtain grouting to ensure that no serious leakage will occur from the reservoir. In practice the curtain may need to be extended beyond the southern limits of the limestone to cope with the southerly extension at depth due to its steep southwards dip. This is discussed more fully in the section on remedial measures.

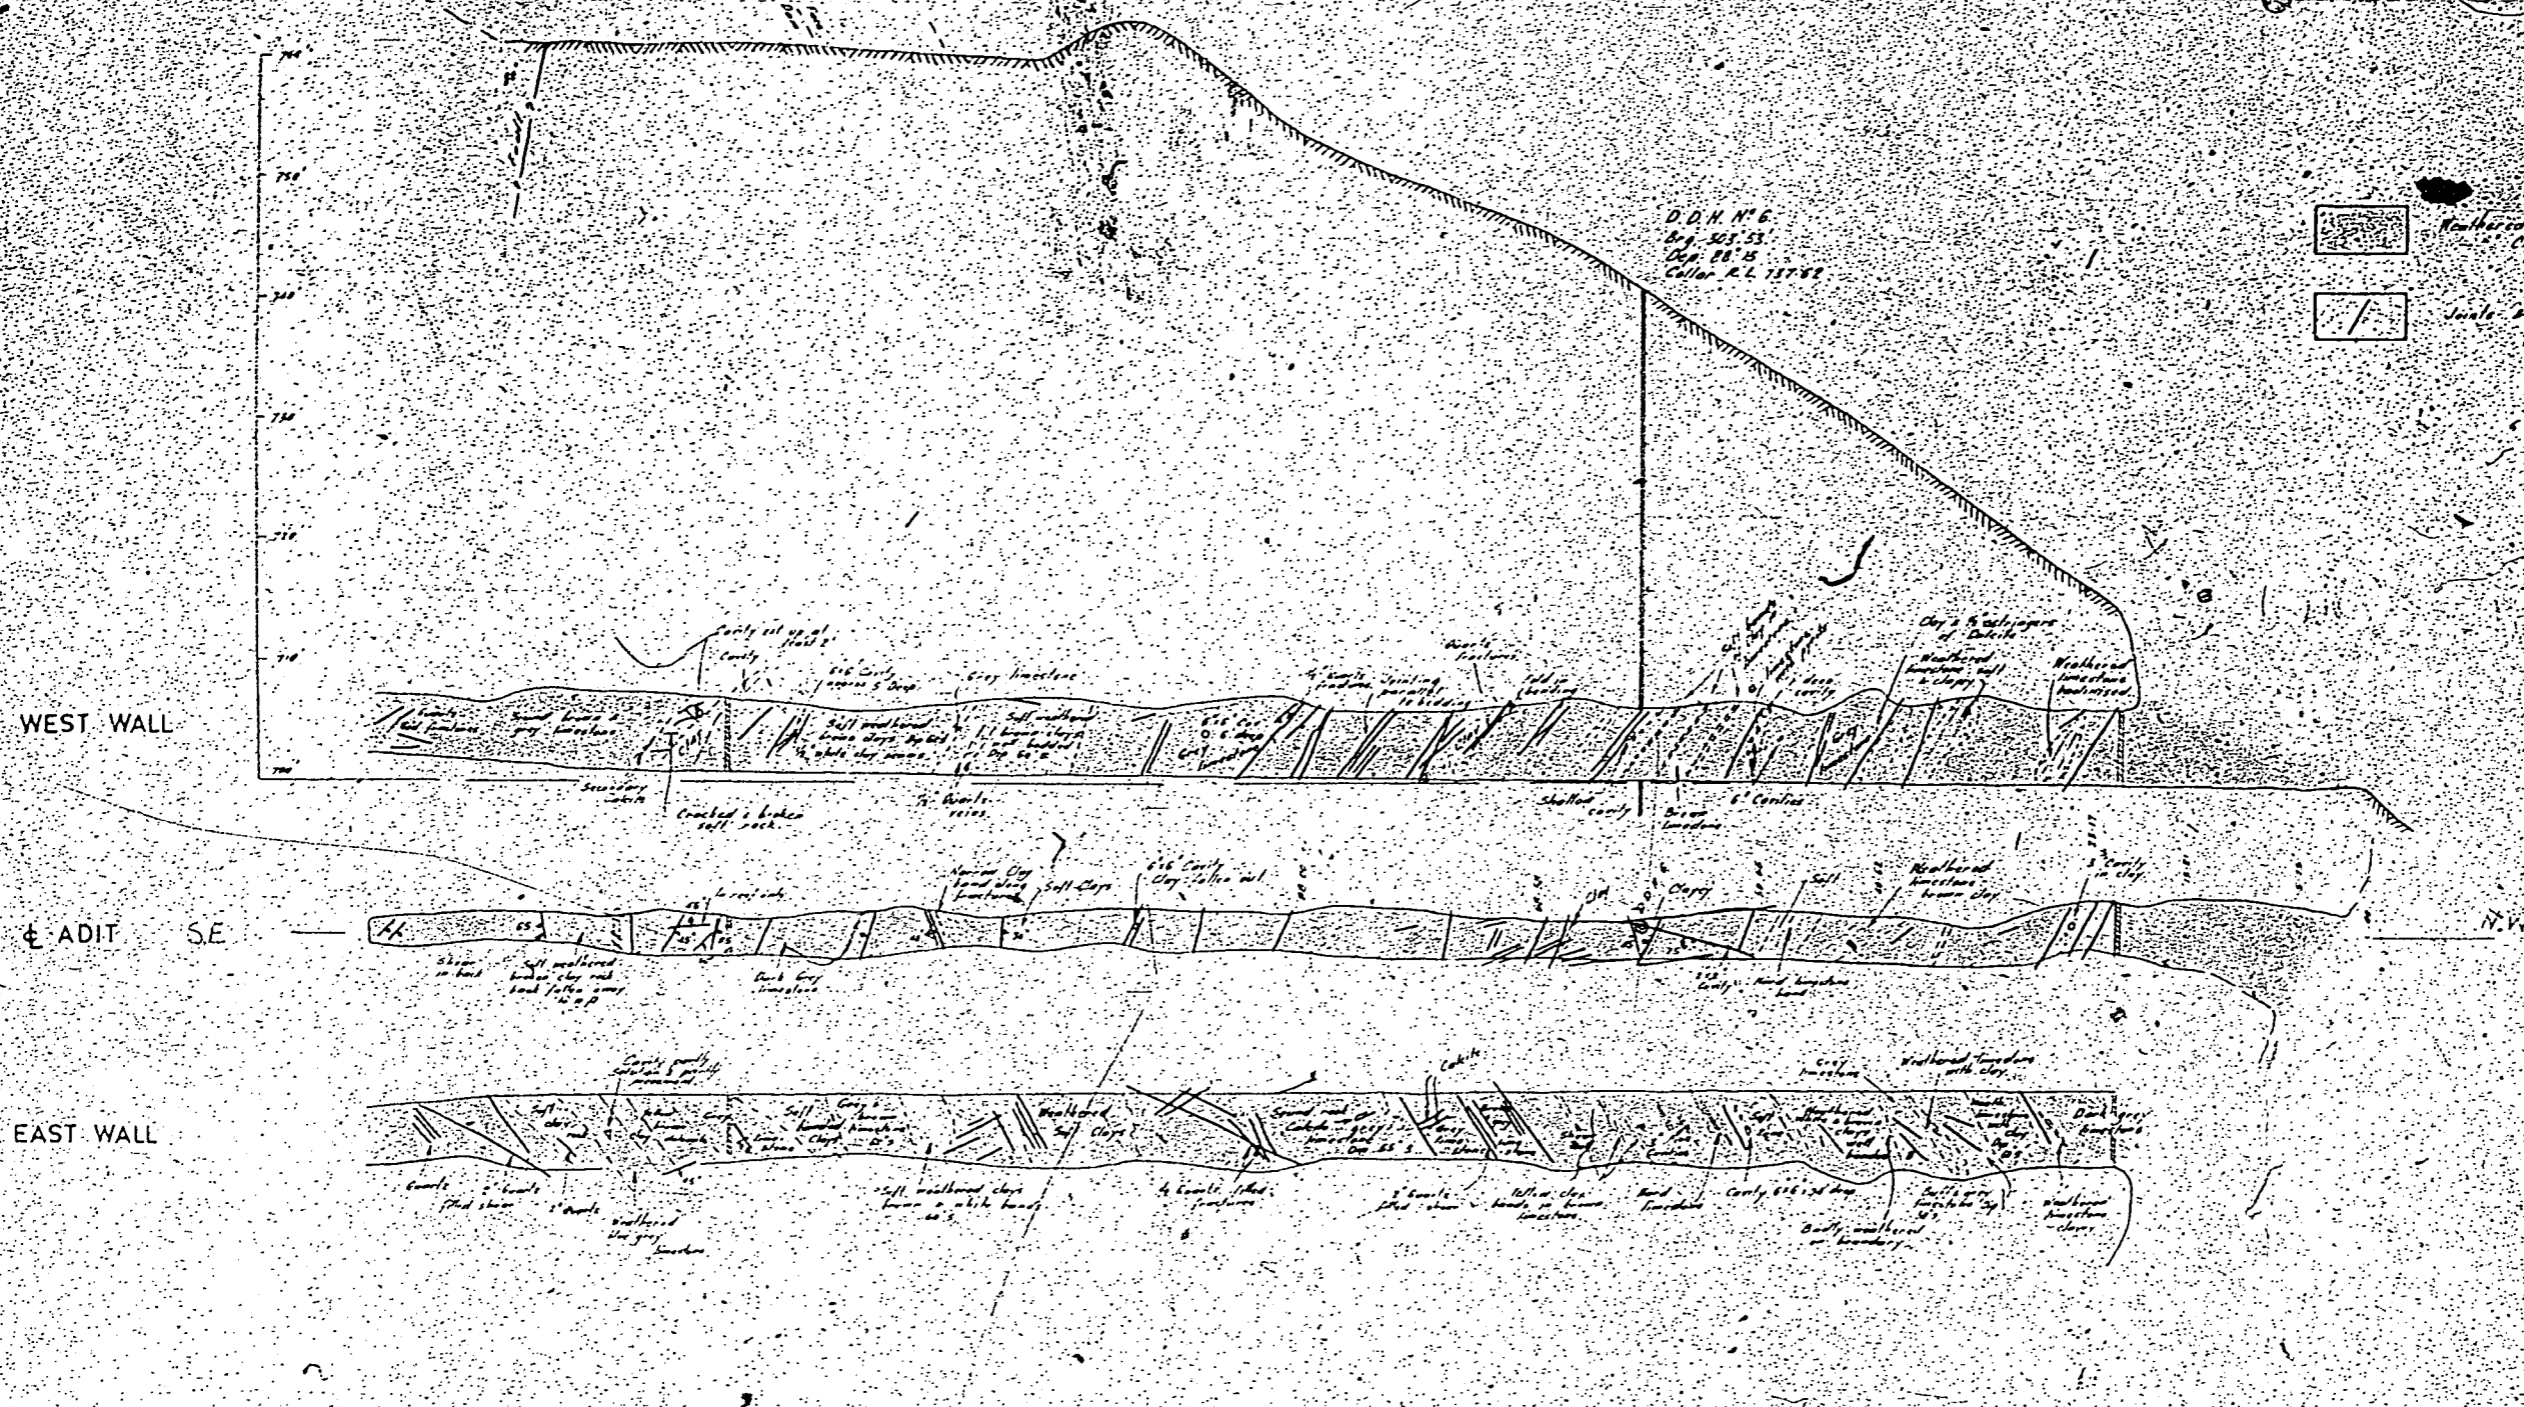
GEOLOGICAL INVESTIGATIONS MYPONGA DAM
 EXPLORATION ADIT AND CROSS-SECTION OF LEFT ABUTMENT

A number of cavities as revealed by the adit are shown on the plan 58-287. With one exception these possess considerable differences from the cavity revealed in the foundation excavation on Blocks T and S.

The cavities penetrated by the adit are practically confined to beds of weathered limestone and are all inclined down the dip of the beds, mostly in a direction normal to the strike, though some have irregular courses. They are pipe-like and lenticular with diameters varying from 2 to 6 inches. Some cavities extend beyond the limit of measurement (6 feet) and some are only a few inches in length. The cavities are definitely due to solution as shown by their pipe like form and the rough irregularly corrugated crusts of secondary calcite and dolomite deposited on their internal surfaces. Some have been partially filled with clay transported by water seeping down along the weathered rock layers. These cavities do not appear to be controlled by the intersection of joints of two different systems or by the intersection of a joint with a bedding plane. They are of relatively small dimensions and should be filled or isolated by an adequate grouting programme.

One other cavity of a different type was observed at a distance of 143 feet in from the portal, adjacent to a badly cracked and decomposed zone. This cavity extended in at least five feet from the east wall of the tunnel along the intersection of two joints or a joint and a bedding plane. It is bounded by roughly planar surfaces on which some secondary calcite has been deposited. The analogy with the surface cavity is obvious and it is possible that differential movement of blocks of rock, bounded by joint planes, along the fault or faults have actually partially formed this type of cavity. Subsequent solution of limestone by water travelling downwards to the permanent water table has no doubt enlarged them.

The adit has shown that weathering of certain beds in the limestone sequence extends to considerable depths. At 156 feet in from the portal or 75 feet vertically below the original surface a bed partially converted to clay over a true thickness of 2 feet was penetrated and drilling has indicated that weathering of similar severity occurs at depths down to 95 feet. The clay fortunately appears to be lenticular and in the adit many of the clay lenses grade into solid, though weathered, rock within the limits of the walls and back. The total proportion of badly weathered rock to sound rock exposed in the adit is 27% in the east wall, 24% in the west wall and 14% in the back, and this includes the zone 30 feet in from the surface which would normally be removed during excavation. The weathered rock seams have been shown to extend to depths well below the present anticipated foundation levels and their effect on foundation excavation and treatment must be considered.

The fault L_1 projected downwards at its surface dip intersects the adit at a point 143' in from the portal. Immediately north of this point the adit penetrated a wide zone of cracked and broken rock, largely converted to clay and showing signs of shearing. It seems more than likely that this is due to the faulting or movement associated with the faulting, though no well defined fault plane, similar to that exposed in Blocks T and S, was observed in the adit. The area excavated to fresh rock in Blocks T and S is small and it is quite likely that larger zones of crushed and weathered rock will be exposed down hill. This is yet another reason for expediting the excavation of the left bank.
