GEOLOGICAL INVESTIGATIONS, MYFONGA DAM

CONSTRUCTION PHASE

Progress Report No. 4

STABILITY AND WATER TIGHTNESS OF FAULTED LIMESTONE  
ON THE LEFT ABUTMENT

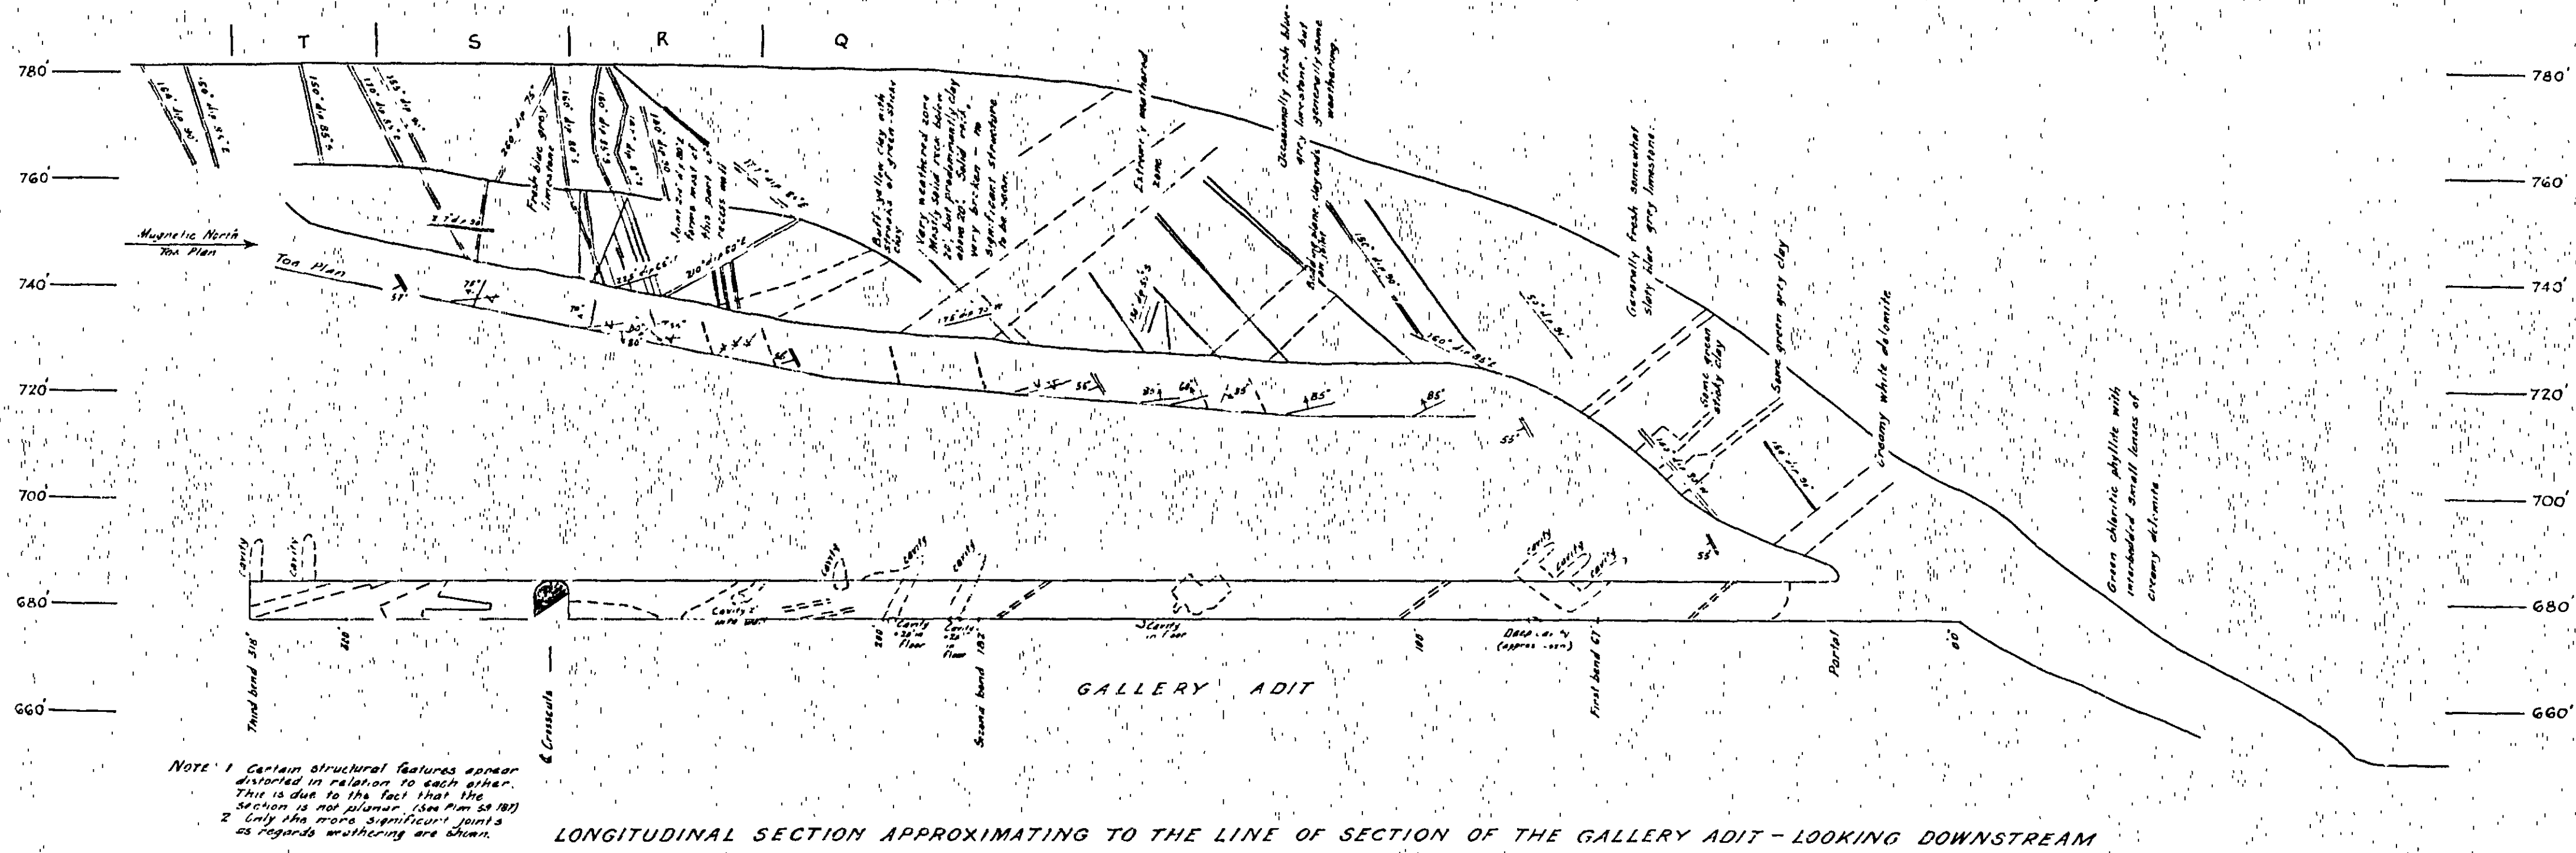
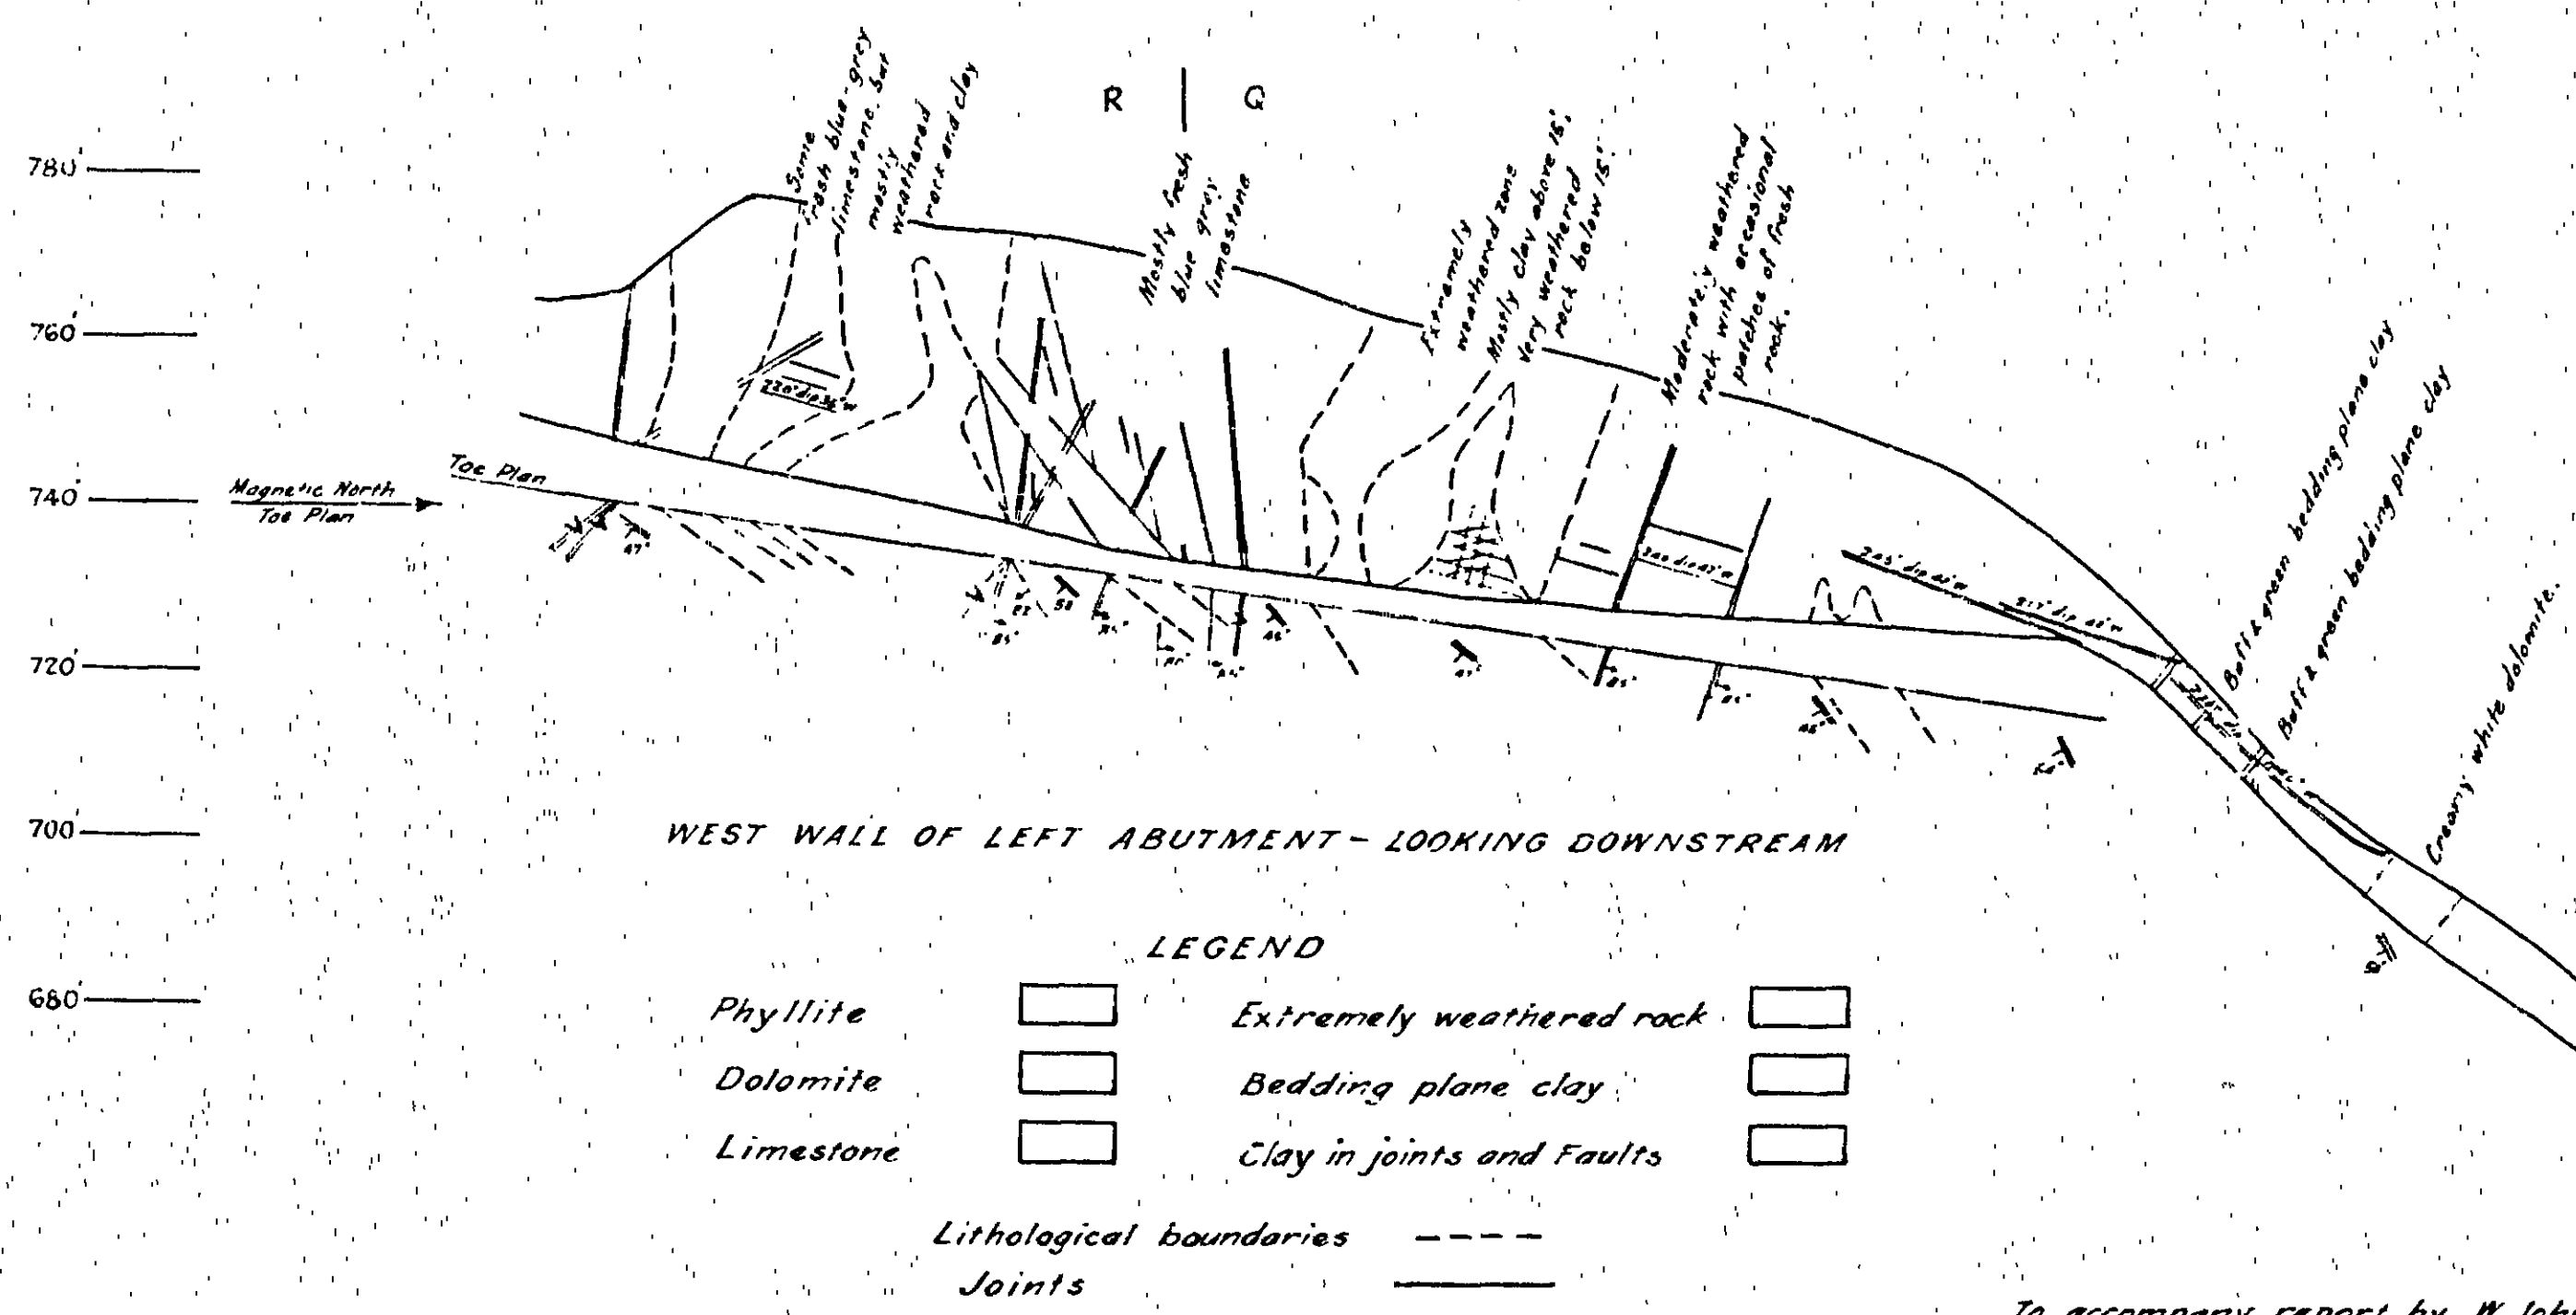
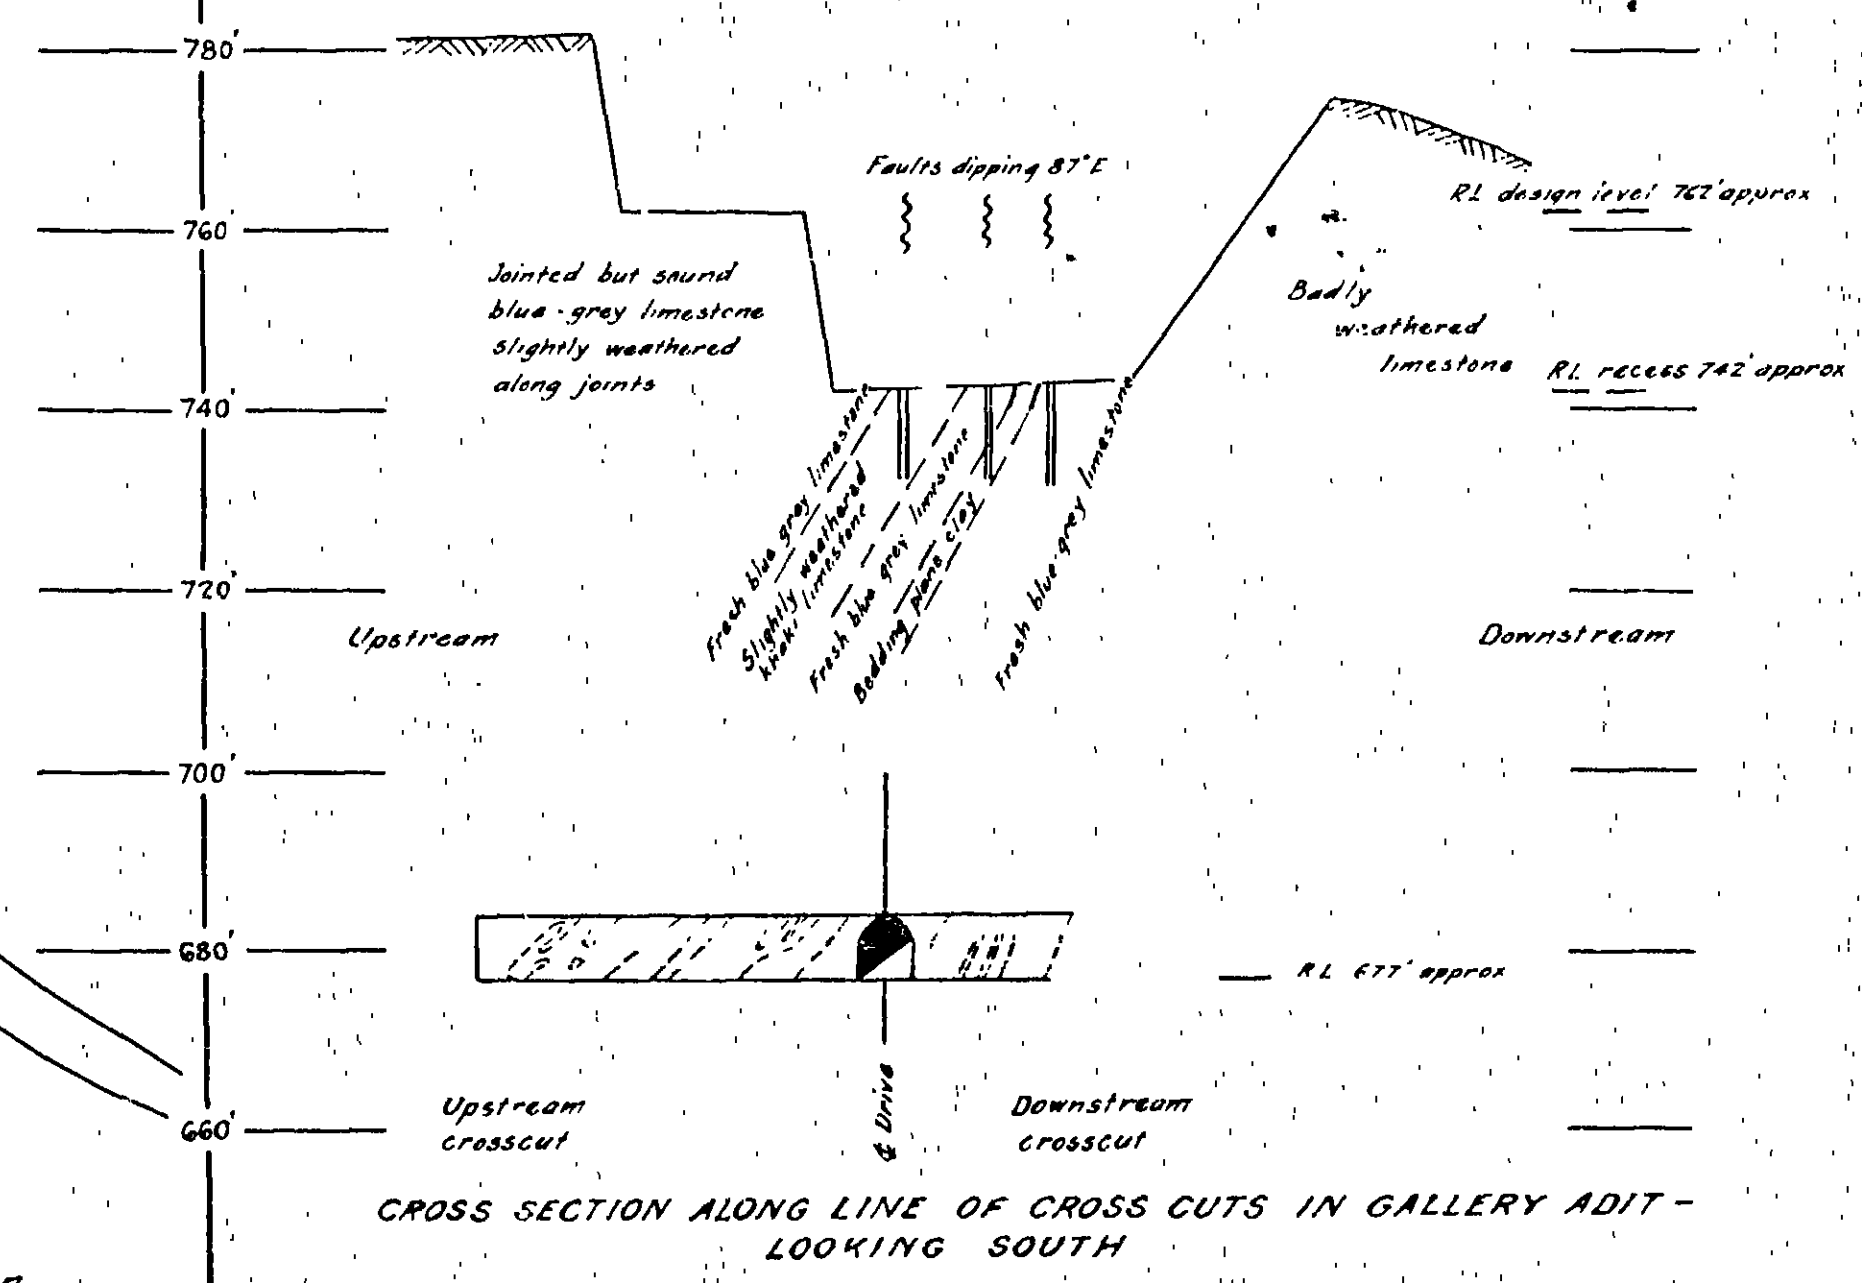
Beyond chainage 360' the gallery adit is in sound massive blue grey unweathered limestone with the exception of the narrow bedding plane fault encountered at ch 490'. The only other discontinuities in the walls back and floor are a very few, largely tight cracks along joints. Apart from the bedding fault at ch 490' it will not be necessary to support the adit with a concrete lining for structural reasons and consideration can be given to leaving the major part of the section between ch 360' and 526' unlined.

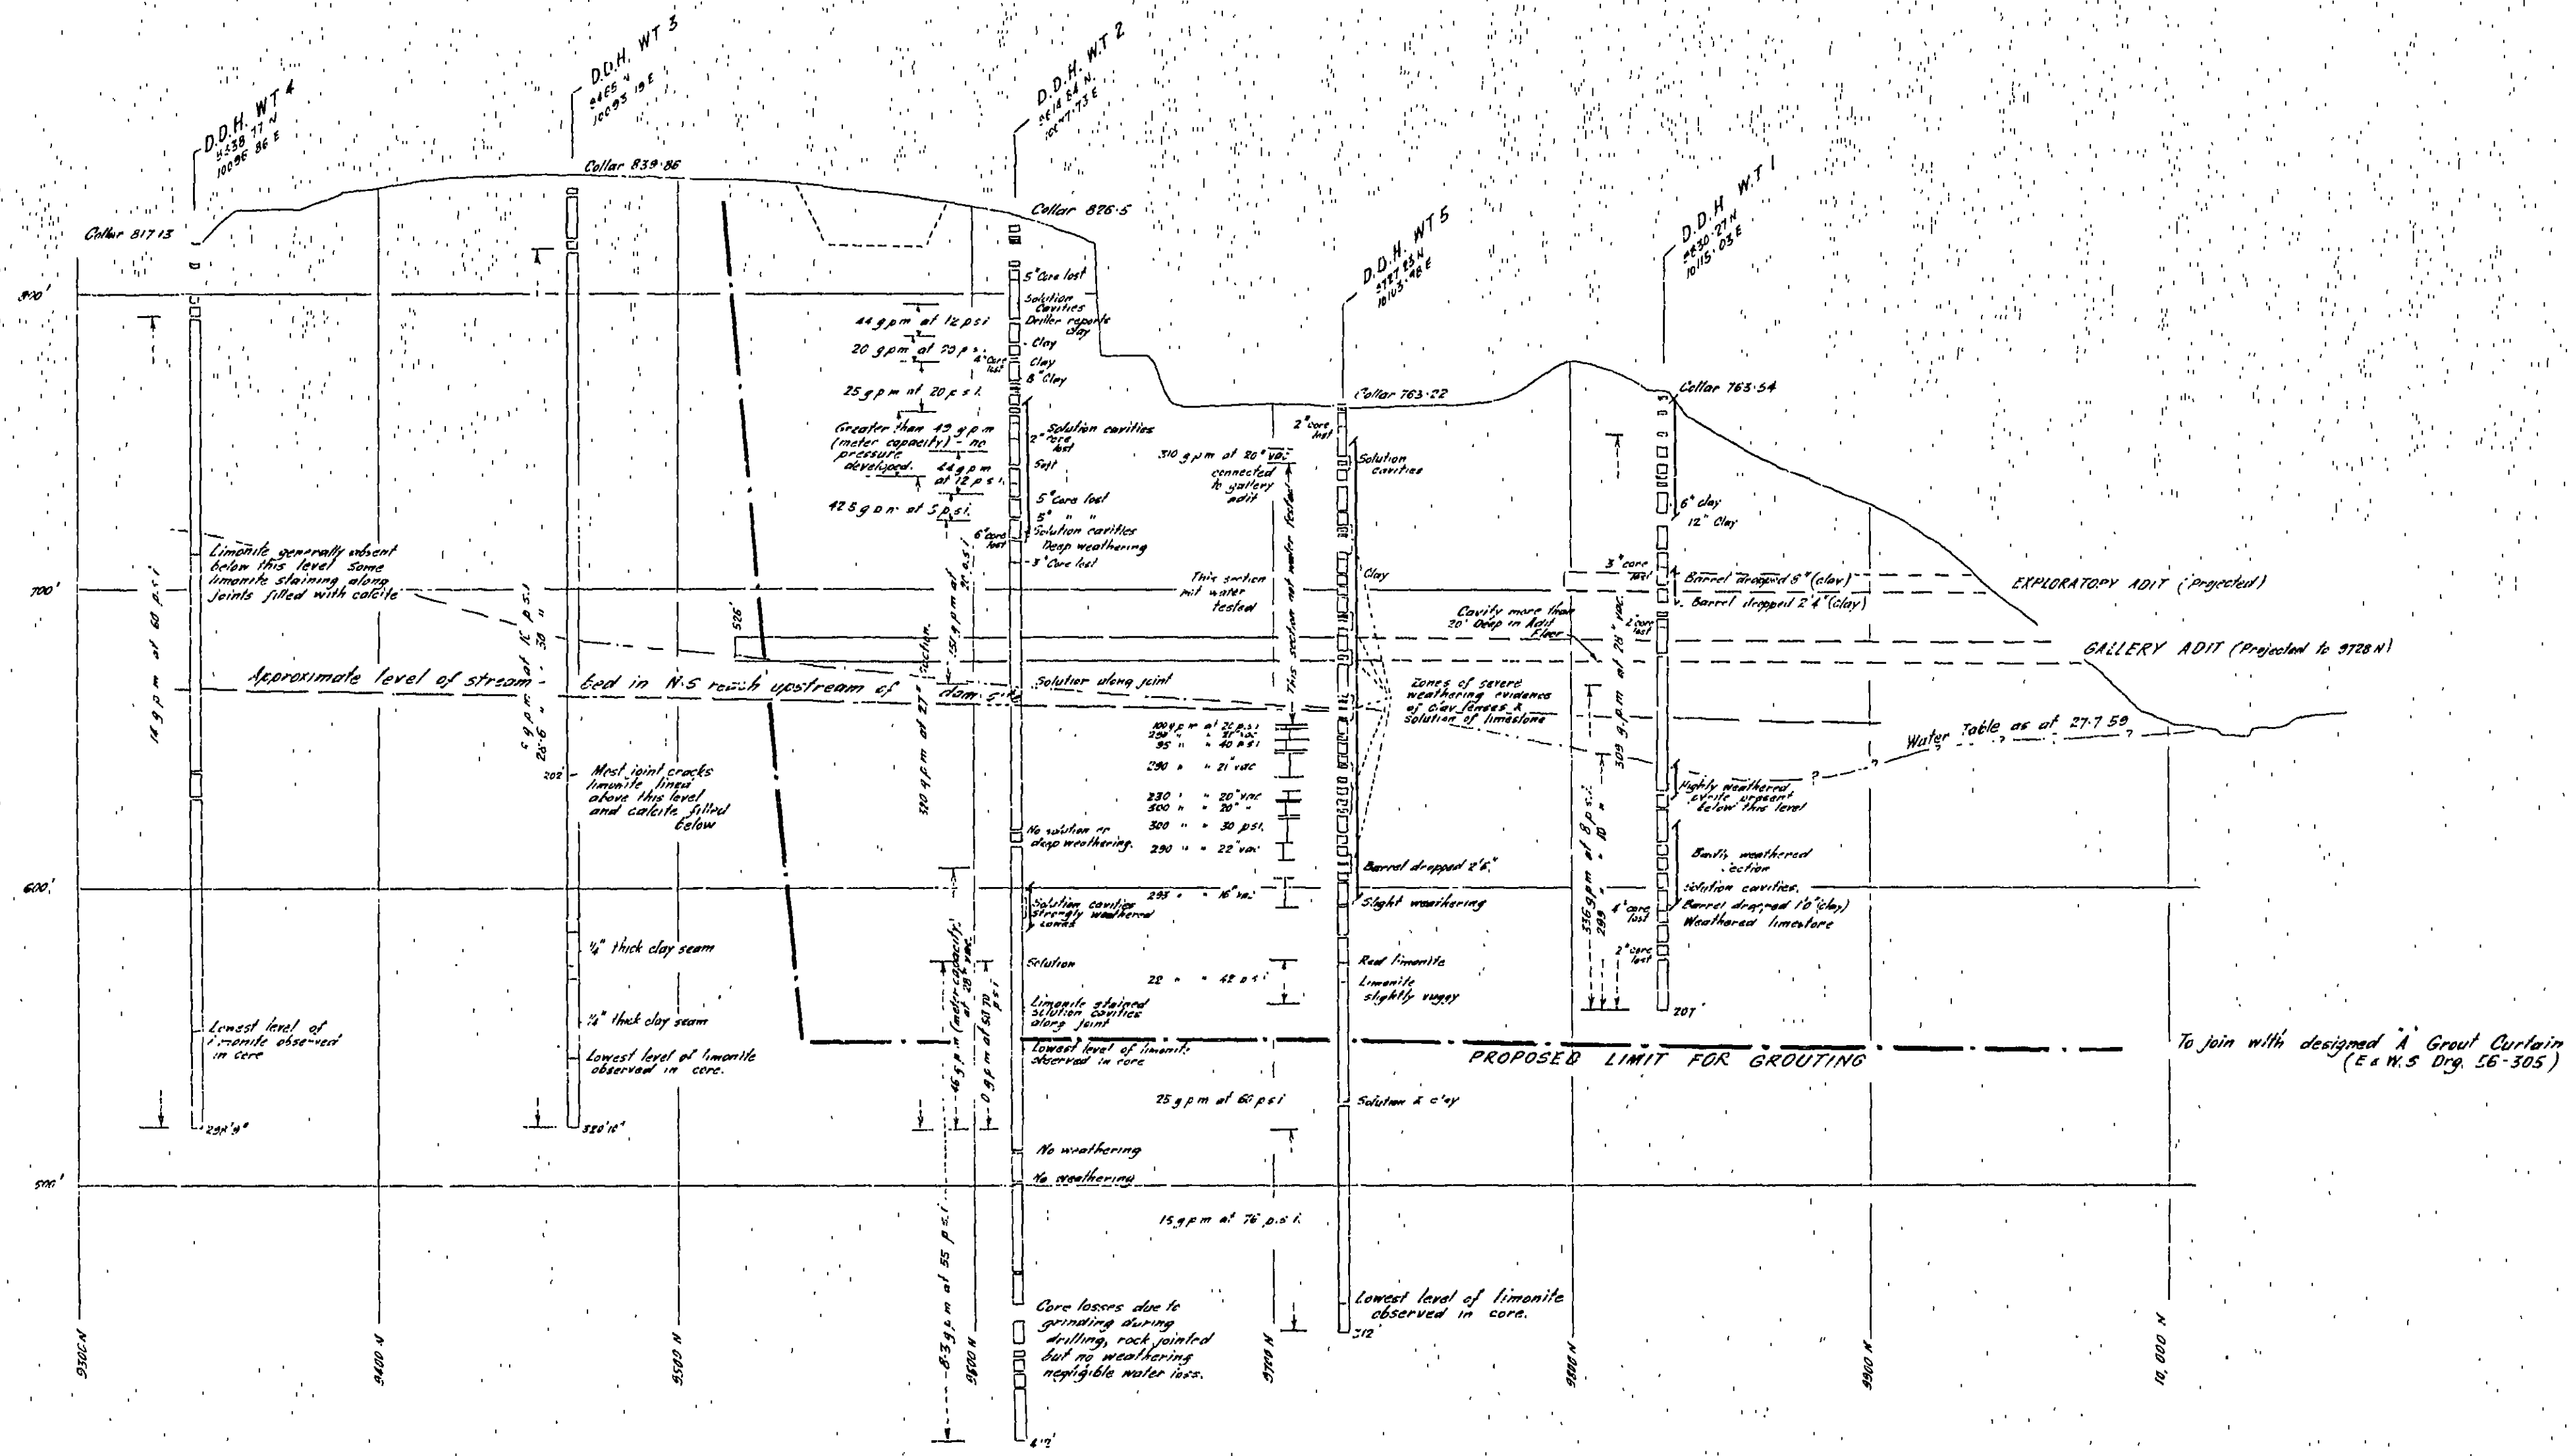
The other holes yield evidence confirming this belief. In WT 5 water losses were negligible below 170 feet to the bottom at 312 feet in a section covering the down dip projection of the Block P major bedding thrust; several bedding plane cavities found in the gallery adit and most of the zones of high water loss penetrated in WT 1. The water loss test at a depth of 236 feet is particularly significant. Here the drill encountered clay seams and open cracks and 3 feet 3 inches of core was lost yet the water loss was only 25 gallons per minute at a collar pressure of 60 pounds per square inch (representing approximately 110 p.s.i. at the crack).

conclusion that the fault zones diminish in size and severity of effect downwards, and that below a level which varies between RL 550 and 575 the cracks are substantially tight and there are no open cavities. This level is taken as the downward limit of the zone of serious potential leakage.

Zones of high water loss ----- 1

Extent of the cavities and cracks has been thoroughly discussed in earlier sections of this report and the limits of the cross sectional area which it is considered necessary to grout are shown on Plans 59-278 and 59-279. It is the area between the limestone/phyllite contact on the north, grid 9525N to the south and RL 550 at depth. Cracks continue below this depth but are much tighter and it is thought that in view of their depth and the long path which leakage would be forced to take that serious leakage below a curtain whose base is at RL 550 is unlikely. Should leakage occur in sufficient quantity to warrant further action it could be adequately remedied by grouting from the gallery adit.
