REPORT ON SITE INVESTIGATION
DAMAGED E.T.S.A. SUB-STATION BUILDING
BERRI
HD. LOVEDAY

28th April, 1960

PLAN SHOWING WALL DAMAGE
E.T.S.A. SUB-STATION, BERRI
HP LOVEDAY

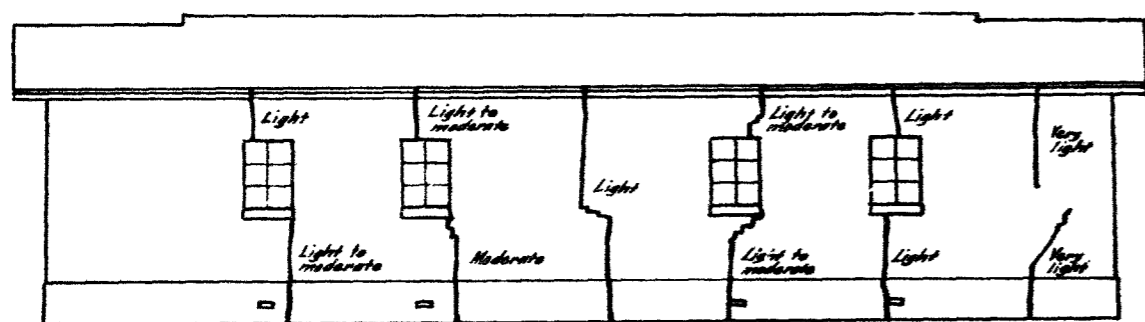
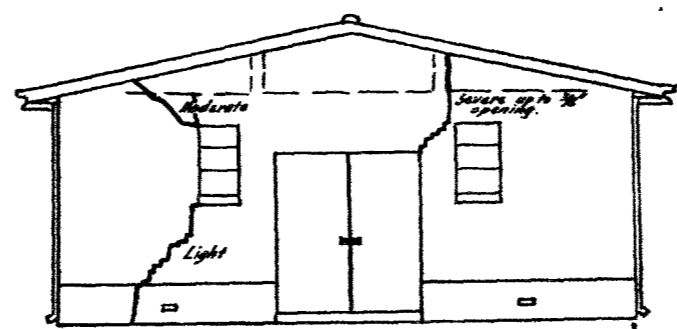
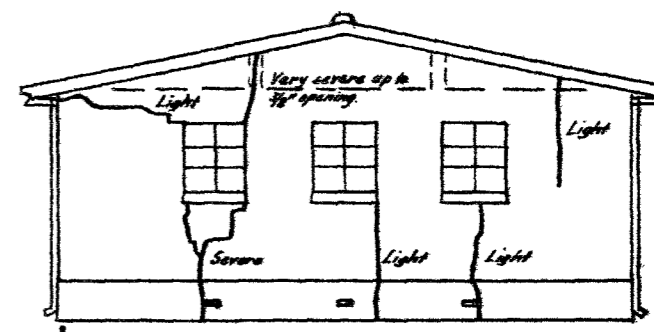
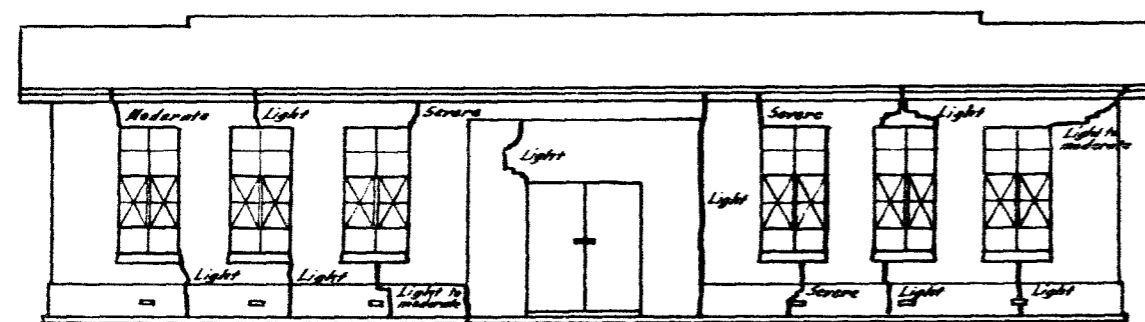
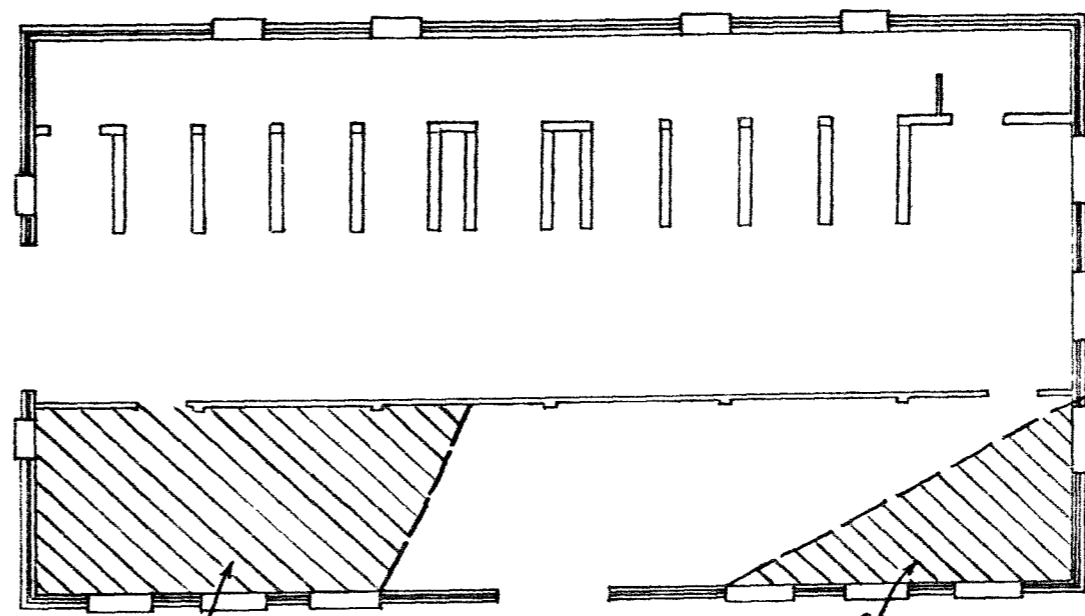
The building, which is constructed of cement brick, is severely cracked particularly in the western portion. The extent of the damage can be seen on the attached plan, where the major cracks have been recorded. The cracking has obviously been caused by foundation settlement, particularly at the corners of the building, the windows and doors of the building providing places of weakness where the walls have failed. No foundation damage could be detected, but such cracks are generally of very small dimensions making detection difficult, and it is also possible that the foundation used for the building could sustain sufficient deflection to suffer the

From an analysis of the cracking in the walls it would appear that the north-west and south-west corners of the building have settled quite considerably, the stresses so imposed being relieved by severe tension cracks through the windows and doors. The eastern portion of the building does not show such severe movement, although tension cracks are still present to a lesser degree. This is due to the type of construction used in these walls, viz reinforced concrete internal walls, and also to the fact that the foundation for this portion of the building is located approximately 2 feet deeper in the soil profile, thus considerably increasing the bearing capacity of the soil.

From the soil profile it is considered that the maximum loading that should be used for foundations located 1 foot below the surface is $\frac{1}{2}$ ton per square foot, provided saturation does not occur. The loading of the building is approximately $\frac{1}{2}$ ton per square foot, and therefore the soil should have just sufficient strength to support the loadings, and shear failure should not have occurred. However as previously mentioned, any saturation of the dune material results in a decrease in strength. The drainage at present provided for the disposal of roof water from the building is obviously inadequate, and flooding of the area immediately adjacent to the foundations is common, particularly at the south-west and north-west corners. The north-east and south-east corners would also be affected to some extent, but a slight slope of the surface would cause the surplus water to be drained away from the building. Consequently it may be assumed that after heavy rains the foundation areas are saturated, causing a loss of strength in the soil within the foundation area.

Although the original failures have been caused by foundation settlement, the severity of the wall cracking has probably been accentuated by the type of material used in the construction. Cement bricks, even when well constructed, are subject to quite significant shrinkage, and it is probable that the original cracking due to settlement has been considerably

The first is to assume that further settlement will not occur, provided drainage precautions are observed. The drainage precautions should consist of ensuring that constant moisture conditions are maintained in the foundation area. All roof water should be carried well away from the foundations in properly constructed drains of adequate capacity. Surface drainage, particularly from the walls of the excavation should be diverted away from the building. A concrete or some other impervious pavement surrounding the building would assist in this respect, and is virtually essential on this type of soil. The pavement should be at least 6 feet wide, preferably wider, and if concrete is to be used the pavement should be bonded to the foundation with a bitumastic compound to permit some differential movement and still maintain a waterproof seal.

The second approach would be to under pin the north-west and south-west corners with a reinforced concrete pad. No strong horizon, suitable for underpinning is present down to a depth of at least 12 feet, so that underpinning will be confined to reducing the load on the soil beneath the existing foundations. The pad would be easily placed into position in the south-west corner, and in this corner the foundation could be jacked up to reduce the foundation drop which has occurred. However the north-west corner of the building apparently presents some construction difficulties in this respect, particularly as the settlement is not confined solely to the corner. Consequently it may not be possible to jack up this corner, and underpinning would be confined to the placing of a concrete slab beneath the existing foundations. Following the underpinning drainage precautions as previously stated should be adopted.

The low margin of safety for the existing foundation due to the loading being the maximum permissible, suggests that it would be advisable to place additional pads at the north-west and south-west corners to decrease the loading at these points.

Repairs to the walls should not be carried out until at least three months after the underpinning and drainage precautions have been completed. This is to enable the soil beneath the foundations to reach a state of moisture equilibrium, and any settlement that may accompany the change in moisture content to occur. If the cracks are repaired before the equilibrium is reached the slight settlement may cause them to reopen.
