DEPARTMENT OF MINES  
SOUTH AUSTRALIA

REPORT ON DRAINAGE

PT. SEC. 914 and 915. HD. ADELAIDE.

TOWN PLANNER  
(Re W. C. Emery)

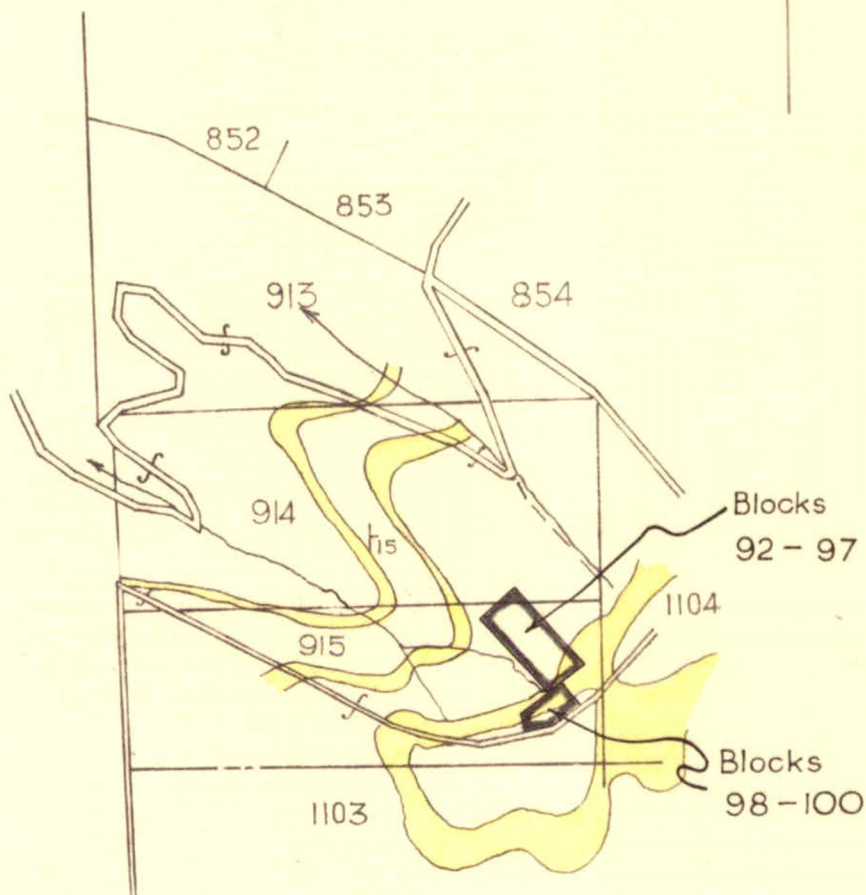
On L.T.O. Plan 7332, new subdivisions are shown which cover the western flank of the north and west orientation spur and the northern slope of the main ridge. The attached geological map shows that the blocks 92 to 97 are underlain by weathered slates which overly a sandstone. Only the southern boundary of block 97 lies on a second sandstone bed.

A large quantity of water has to find its way into the underlying weathered rocks. This may cause landslip especially of the thin clayey cover.

In the blocks 98 - 100, sandstones are at shallow depth and, if septic tanks are installed, the effluent would most likely find its way into the underlying sandstones. If, in addition, gardens are established, the excess water may also find its way into the sandstone and thus the danger of landslip on these blocks is believed to be considerably less than on the blocks to the north-east.
