MOUNT GAMBIER PUMPING STATION
GEOLOGICAL PROGRESS REPORT NO. 2
SEPTEMBER 1965

D.H. Stapledon

14th September, 1965

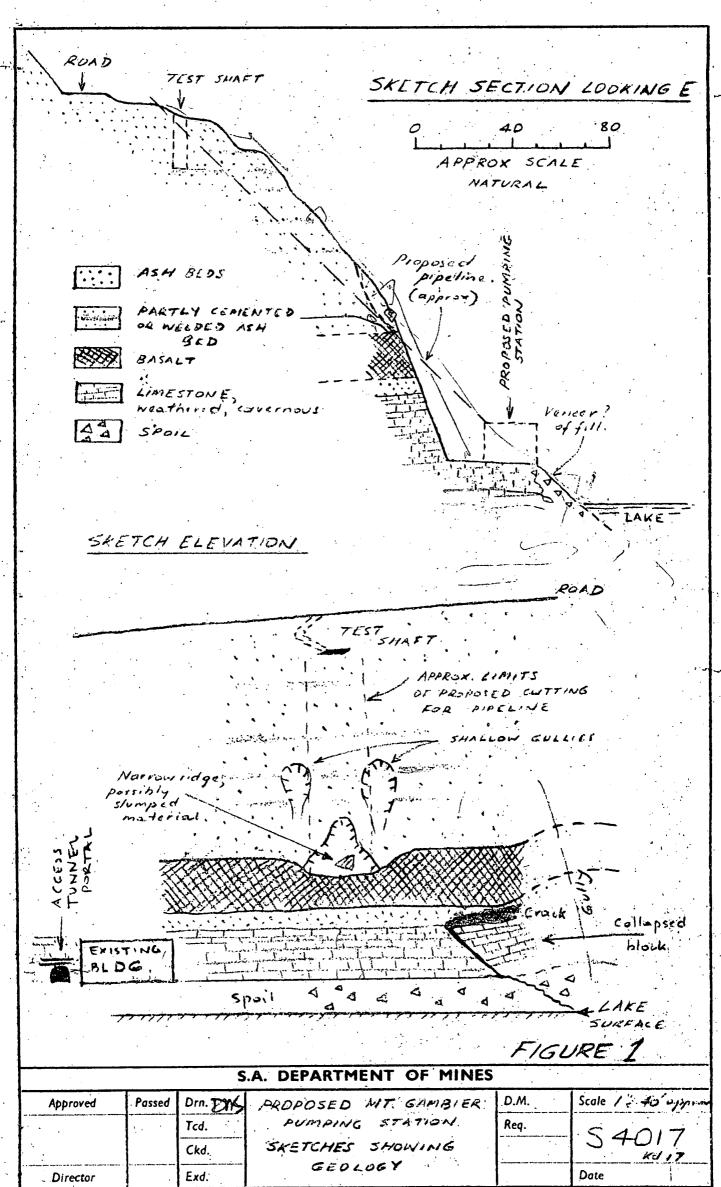
Excavation of the pipeline trench above the site (Fig. 1)

exposed loosely packed, irregularly shaped blocks of accriscous basalt. A pilot trench 2 ft. wide excavated up to 6 ft. into this material has shown that it can be excavated readily by hand methods. This material was shown in Fig. 1 (Ref. 1) as "possible slumped material", concealing the upper surface of the basalt layer. The material now exposed appears to be a pocket of broken up and contaminated lava, extending several feet below the normal surface of the lava flow. Because of its very loose nature it was planned to cut this material back to a slope of 45° above the basalt layer. From the new exposures it appears likely that cutting this material back to 45° may remove most of it, and just expose the basalt layer.

These cracks in the baselt are immediately above the large collepsed block in the weathered limestone underlying the baselt (Fig. 1). There may be some direct connection between this cracking in the baselt and the collepsed block below, but this need not necessarily be so. As pointed out in Report No. I such opening up of joints adjacent to very steep slopes is a part of the normal mechanical weathering process. In addition some opening up of joints would have occurred initially as the lava solidified and cooled, and again during later explosions. The Access Tunnel showed numerous gaping joints.

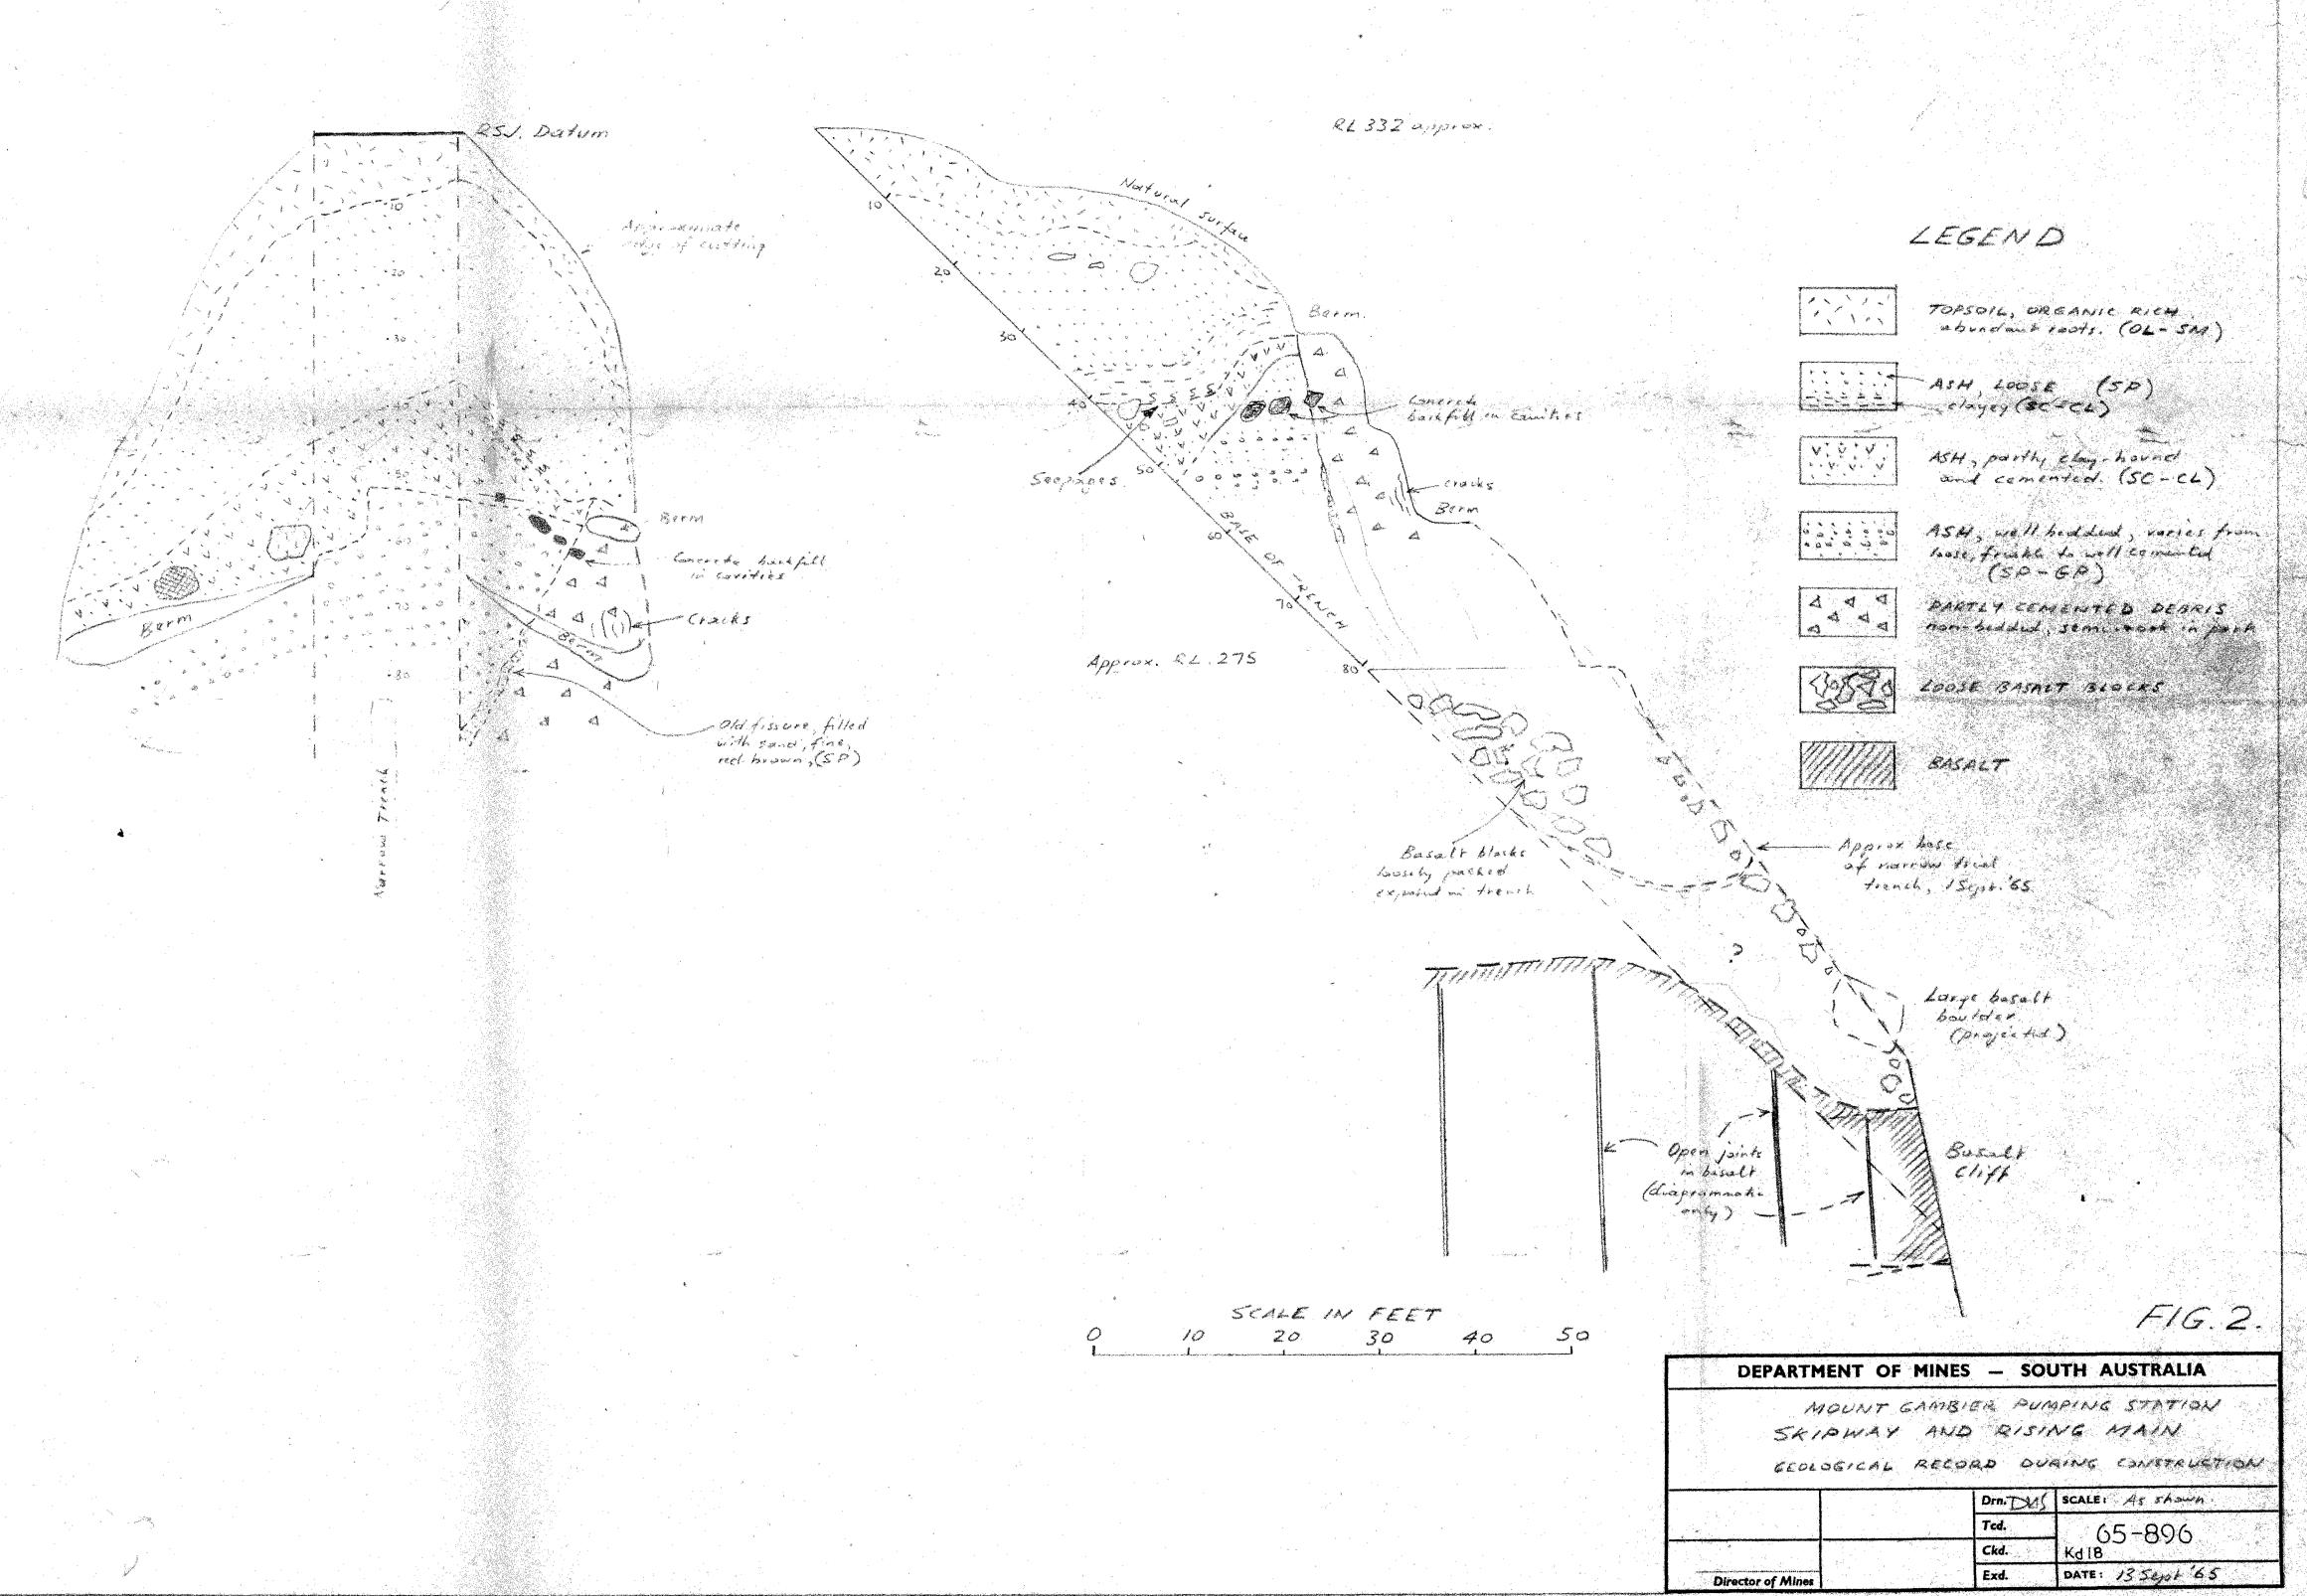
SKETCH ELEVATION EAST FACE

of the eastern wall. Above R.L. 275 the material removed has been mainly baseltic ash consisting essentially of poorly graded sands and gravels. The ash mostly shows poorly defined bedding or layering, as shown on Fig. 2, east face elevation. Much of the material is uncemented, loose, and friable. Some horizons however are partly cemented to form materials grading from very strong soils into weak rocks. The wet strengths of these materials are generally not noticeably lower than their dry strengths.

Excavation of the cutting has removed meat of the nearsurface disturbed material, except on the eastern edge where a
mass of partly cemented ash, probably slide material, lies
steeply against horizontally bedded uncemented ash. At the
boundary of the two materials is an old fissure, now sand filled,
which dips steeply downslope. The surface expression of these
features was noted earlier (Ref. 1) as a probable slide scar.

In the gully immediately to the east of the base of the trench three near-vertical joints are visible. These joints are gaping between 0.2 and 0.5 ft. and are probably partly filled with soil. They appear to strike within 30° of the general direction of the hillside, and occur very approximately at herizontal distances of 5, 15 and 50 ft. in from the face of the pumping station cutting. (Fig. 2, sketch plan).
