BLACKWOOD RAILWAY CUTTING

GEOLOGICAL INVESTIGATIONS, PROGRESS REPORT NO. 1

Client: South Australian Railways

12th August, 1966.

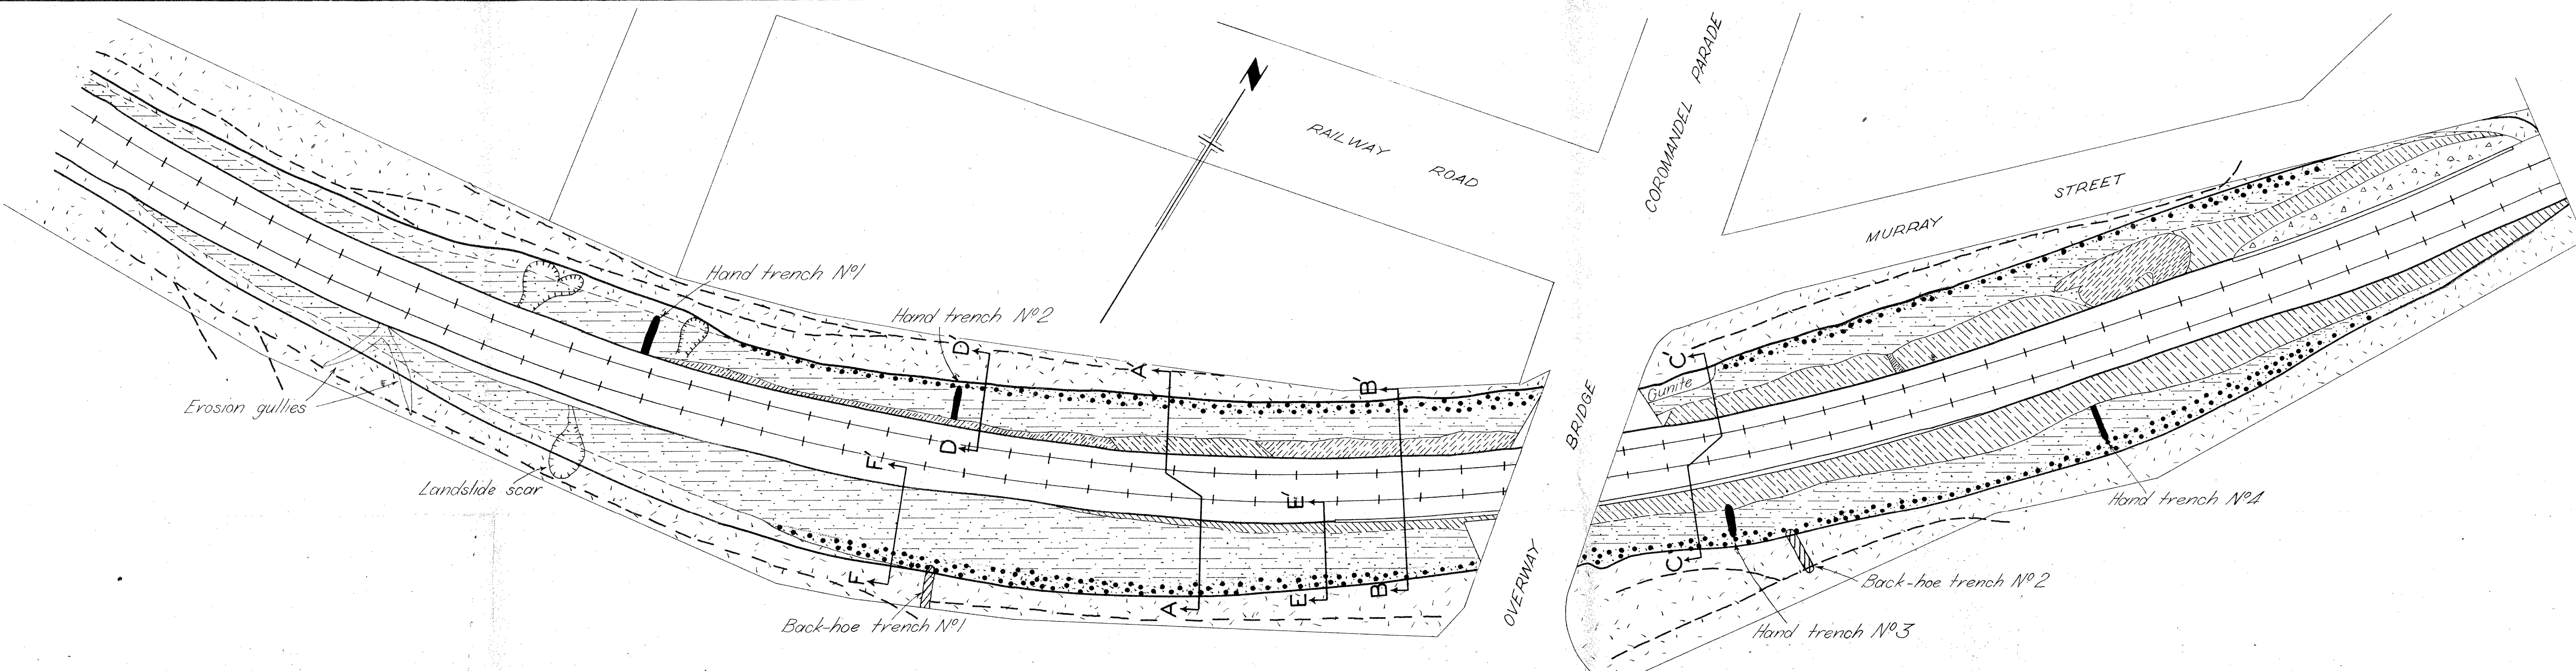
FIG 1

The cutting is located 11 miles from Adelaide on the main line to Melbourne, between the level crossings at Brighton Parade and Coromandel Valley Road (Fig. 1). Recurrent failure of the cutting, mainly during winter, has resulted in minor landslides of up to 30 cub. yards.

The bedrock is stable, and the topsoil is of no consequence in the stability problem. It is evident that initially failure has occurred in the sand and clay horizons, resulting in eventual failure of the overlying laterite.

It is considered that failure of the cutting will continue slowly until stable slope angles (probably 35° to 40°) are attained, unless some form of remedial action is taken. During discussions at the site with Mr. Reed, several possible methods of treatment were considered and are summarised on Fig. 1. A summary of geological conditions in the cutting showing the sections which require treatment is given on Fig. 2.

NOTE - DRAINAGE 1 Surface Lined catch drains along the top of the cutting. Improvement of the existing drainage system should be adequate.
2 Sub-Surface Drainage of the geological materials by a system of spears, located particularly at the sand/clay and clay/bedrock interfaces. Drainage of fill material.
