REPORT ON BUILDING FAILURE AT

BERRI HOSPITAL

B.M. HARRIS  
GEOLOGIST  
HYDROGEOLOGY SECTION

30th October, 1968

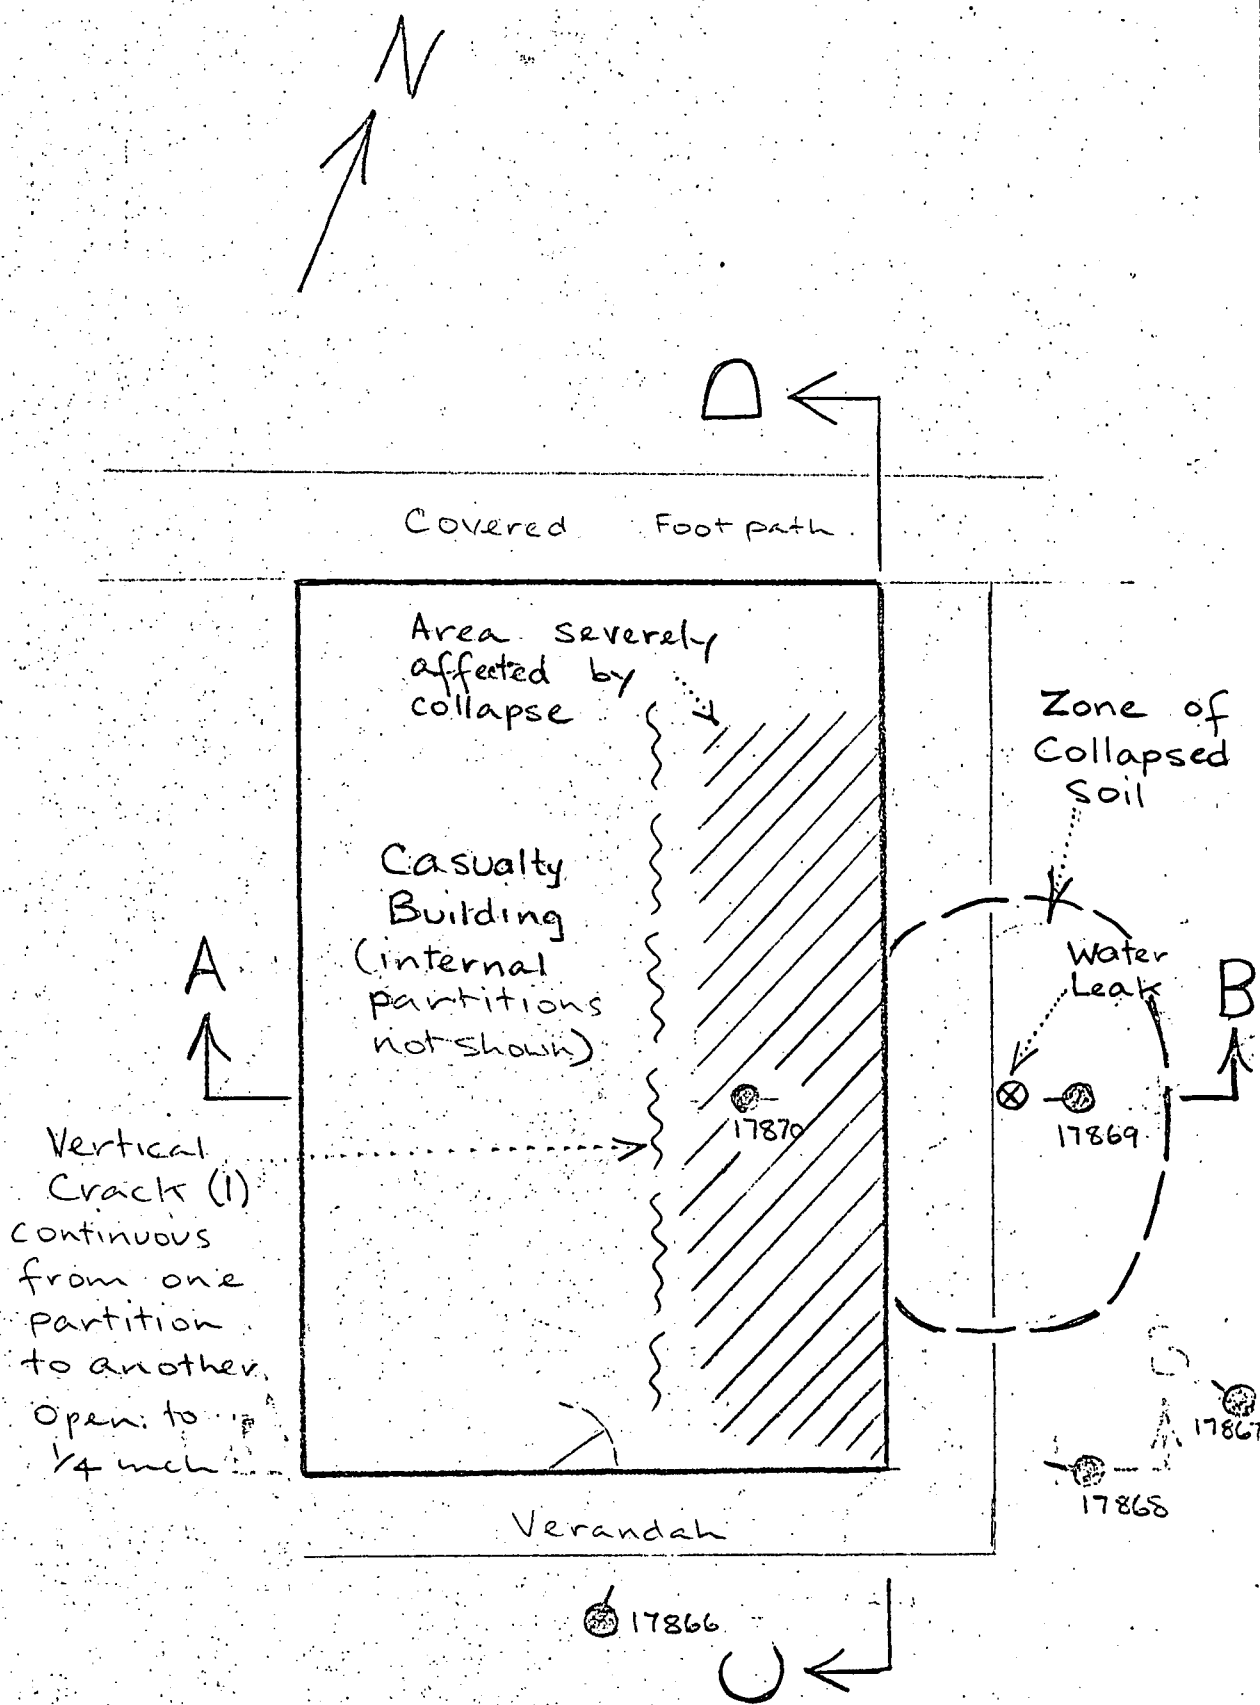
FIG. 1

According to the head groundsman, the failure was first noticed as internal cracks which progressed to the outside of the building. This movement continued for a week resulting in severe damage to half of the building. Figure 1 shows a sketch plan of the building and the positions where photos were taken.

Subsequent investigation by the Architects and the Insurance Company showed a leaking pipe adjacent to the foundations (Figure 1).

Figures 1 and 2 indicate diagrammatically the mechanics of the building failure. It can be seen that the footing failure on the eastern side caused the eastern side of the building to settle and rotate away from the remainder of the building along crack (1). The settlement and rotation was greatest over the zone of collapsed soil, and this caused differential movements in the eastern side (cracks (3) (4) (5) and (6) ). The horizontal crack (2) appears to have been formed as blocks of the eastern wall settled away from the upper part of the wall. The upper part of the wall appears to have received sufficient support from the roof to prevent its failure.

- (a) Precompaction of the soil to a sufficient depth by flooding and rolling.
- (b) Construction on piles or piers seated or in a strong, stable horizon beneath the collapsing soil.

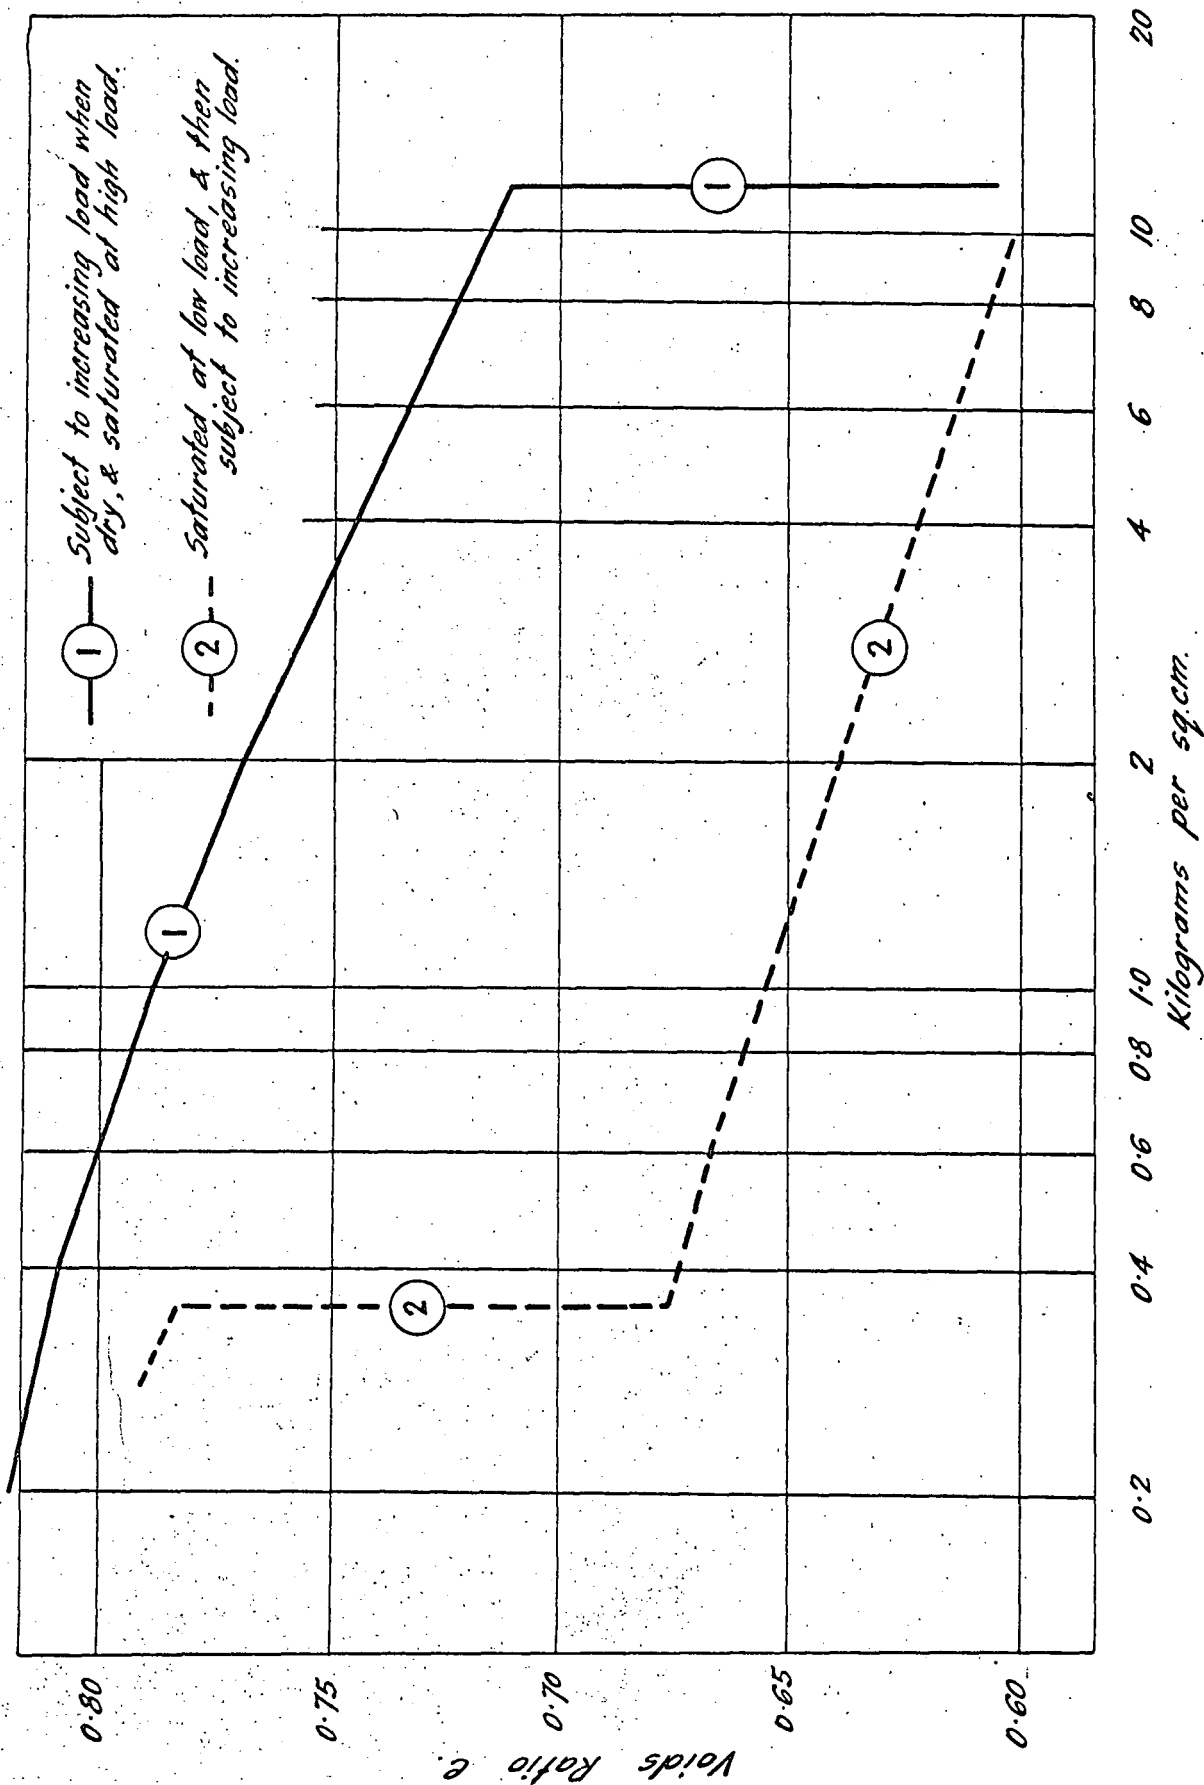
FIG 1

Fig. 1 shows the "collapse" phenomenon which occurs on saturation of these sands.
