NATIONAL ART GALLERY - FOUNDATION FAILURE
GEOLOGICAL INVESTIGATIONS - PROGRESS REPORT NO. 1
MAINTENANCE STAGE

Client: Public Buildings Department

7th November, 1969

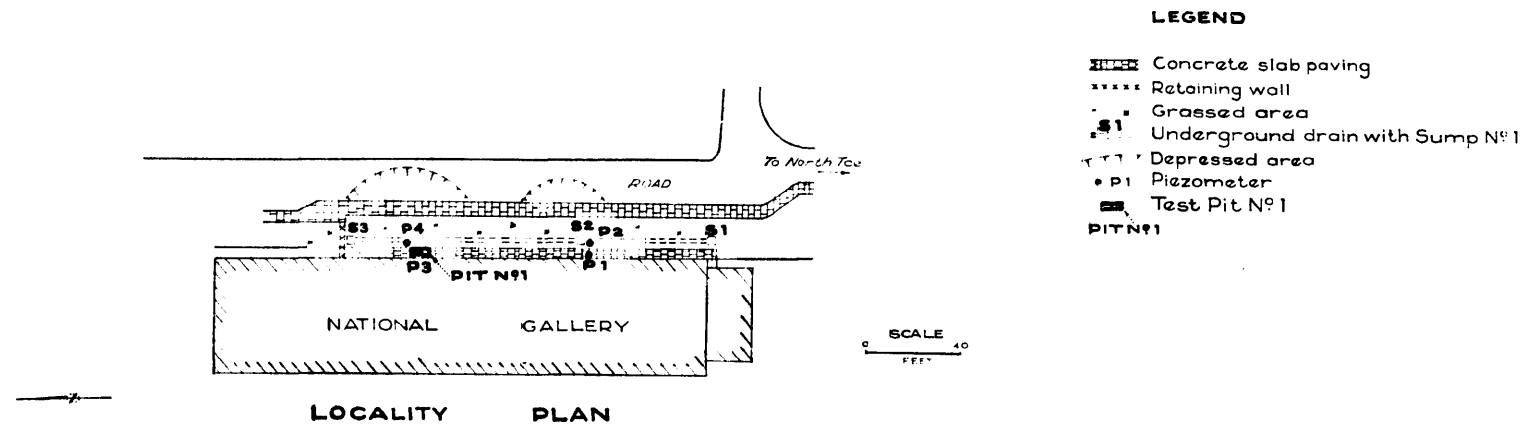
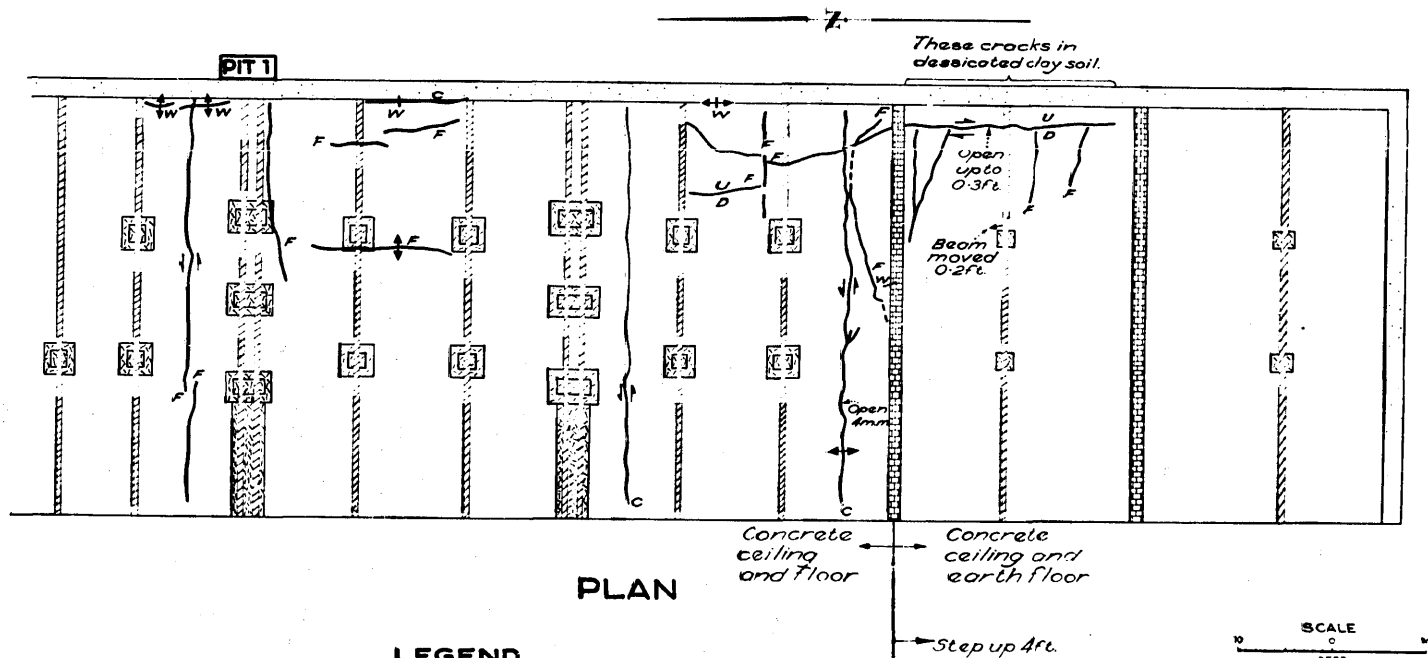
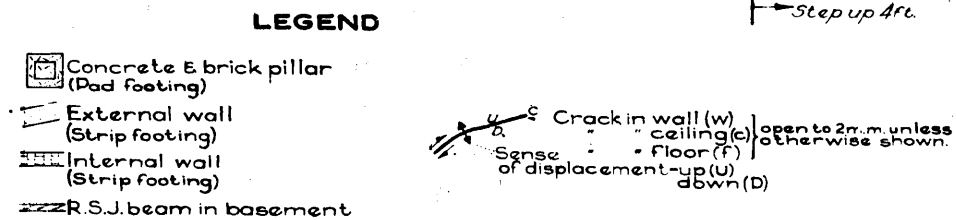
FIG.1

- (1) A preliminary survey of the cracking indicated that movement was due to some failure in the foundations of the eastern side of the building. Later a more detailed survey of cracking in the basement was made (Fig. 1).
- (2) A test pit 5ft. deep (Fig.1) was excavated adjacent to the building foundations, to expose the material adjacent to and underlying the foundations. Geological logs of the pit are shown on Figures 2 to 4.

The clay exposed in the basement beneath the southern end of the Gallery is at a very low moisture content, as indicated by shrinkage cracks open as much as 0.3ft. (Fig.1).

(Fig. 1) indicate that gilgai structures probably occur in this area.

The source of the water is not completely proven, but it is probably the underground storm water drain on the eastern side of the building (Fig. 1). To confirm the interconnection between this drain and the sand layer, the drain was divided into two sections by blocking the pipe at sumps, and then pumping water into the uphill sumps. Leakages of up to 500 gal/hr. occurred from both sections during testing and water was observed to be flowing in the sand layer at the bottom of the test pit, and eventually rose 1 foot in the previously nearly dry pit.

To prevent further leakage from the drain the existing earthenware pipe was excavated and replaced by pipes with watertight rubber seal connections. The connections between the downpipes and the drain were also repaired.

To observe further the groundwater behaviour beneath the footing 2 water level observation points (Fig. 1) were installed adjacent to it. Also 2 further observation points were installed adjacent to the drain (Fig. 1) to detect the presence of water due to leakage from it.

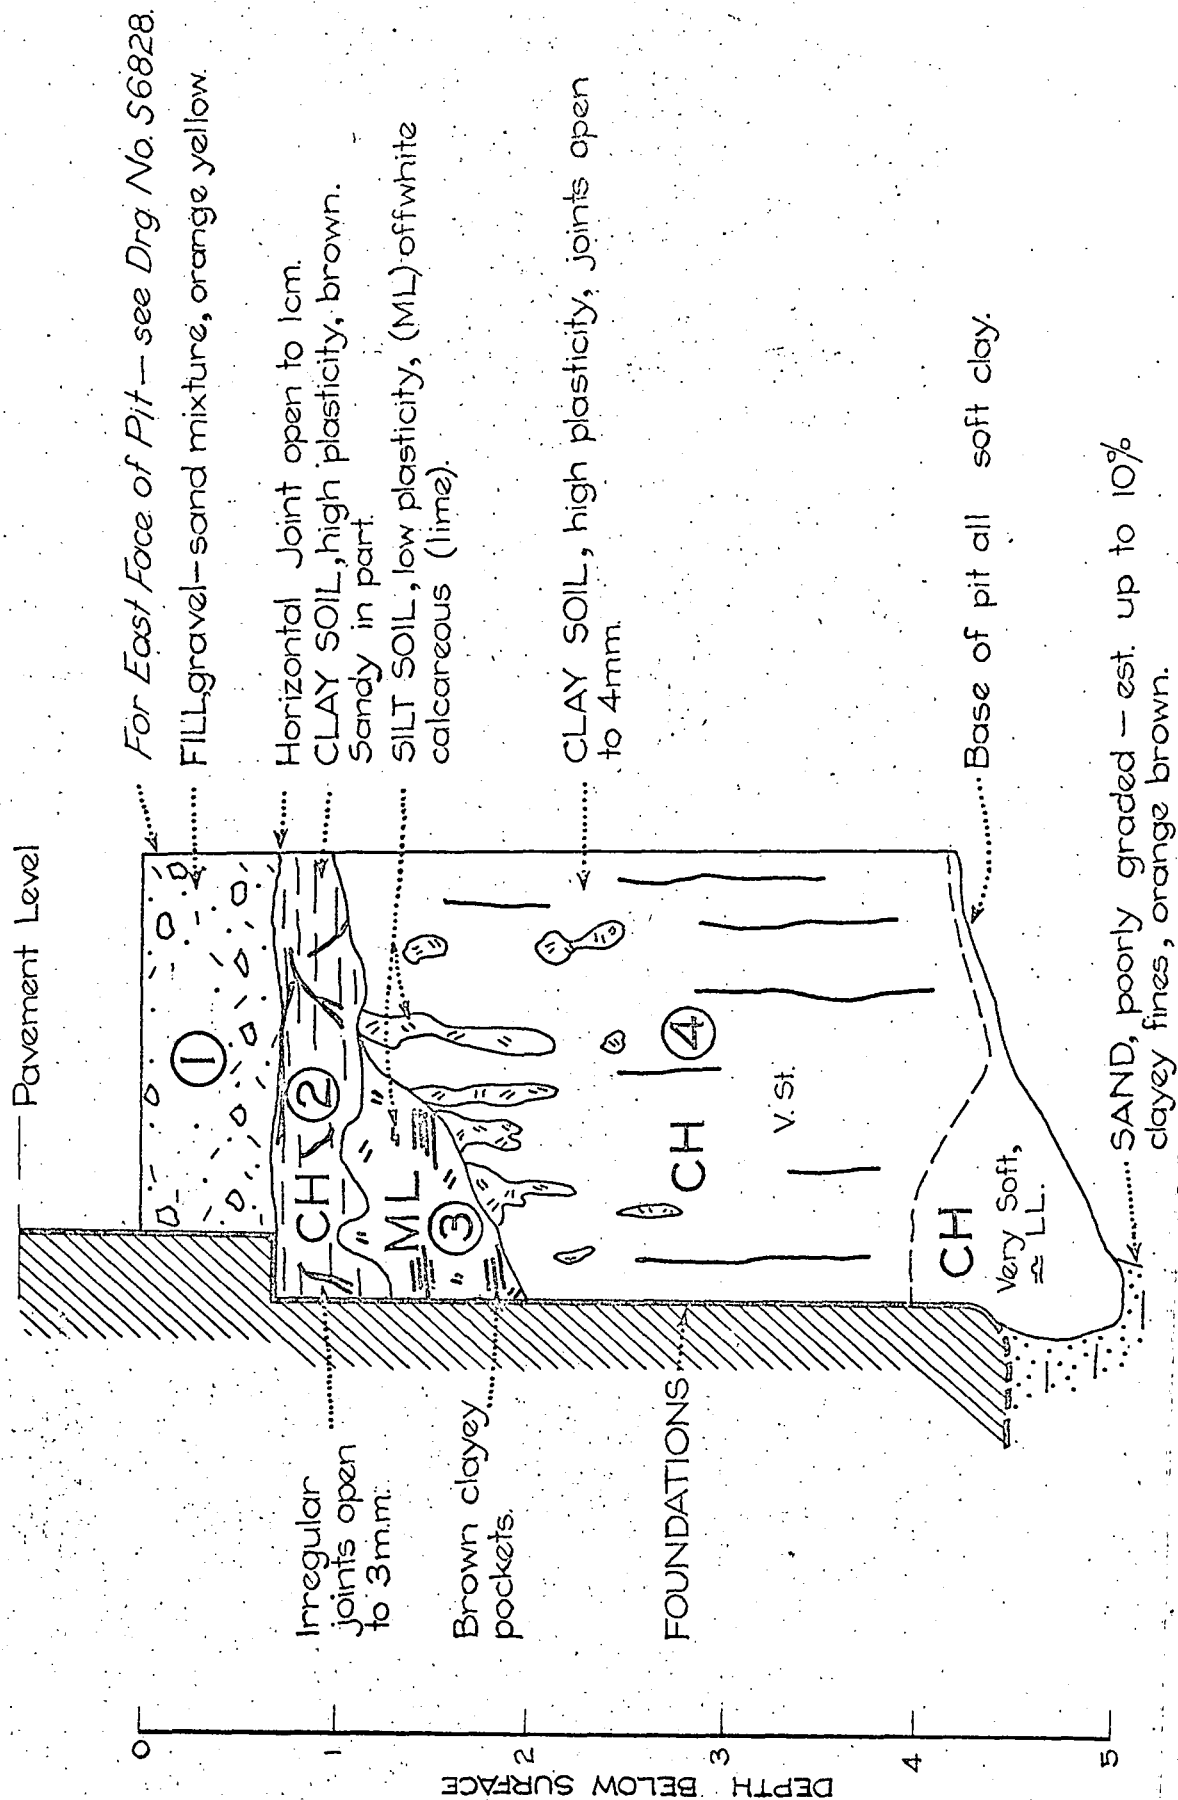
FIG: 2

The test pit indicated that during construction a trench had been dug to the strong clays below the limy layer, a layer of clean fine sand, a few inches thick, placed in the bottom, and the trench then backfilled with a lime-cemented concrete. A beam type concrete foundation was placed on top. The building floors are constructed on R.S.J. beams supported on pillars (Fig. 1). A basement was constructed under the northern end of the building and then, in the past few years, extended further southwards, until at present only a small section under the building is not utilized as a basement (Fig. 1). In this section access can be obtained into a space about 4 ft. high between the floor of the ground floor of the building, and the natural ground surface.
