AROONA DAM - LEIGH CREEK
GEOLOGICAL INVESTIGATIONS - REPORT NO.5
Client: Engineering and Water Supply Department

AROONA DAM - LEIGH CREEK

GEOLOGICAL INVESTIGATIONS - REPORT NO. 5

Rept.Bk.No. 71/111
G.S. No. 4686
D.M. No. 242/71

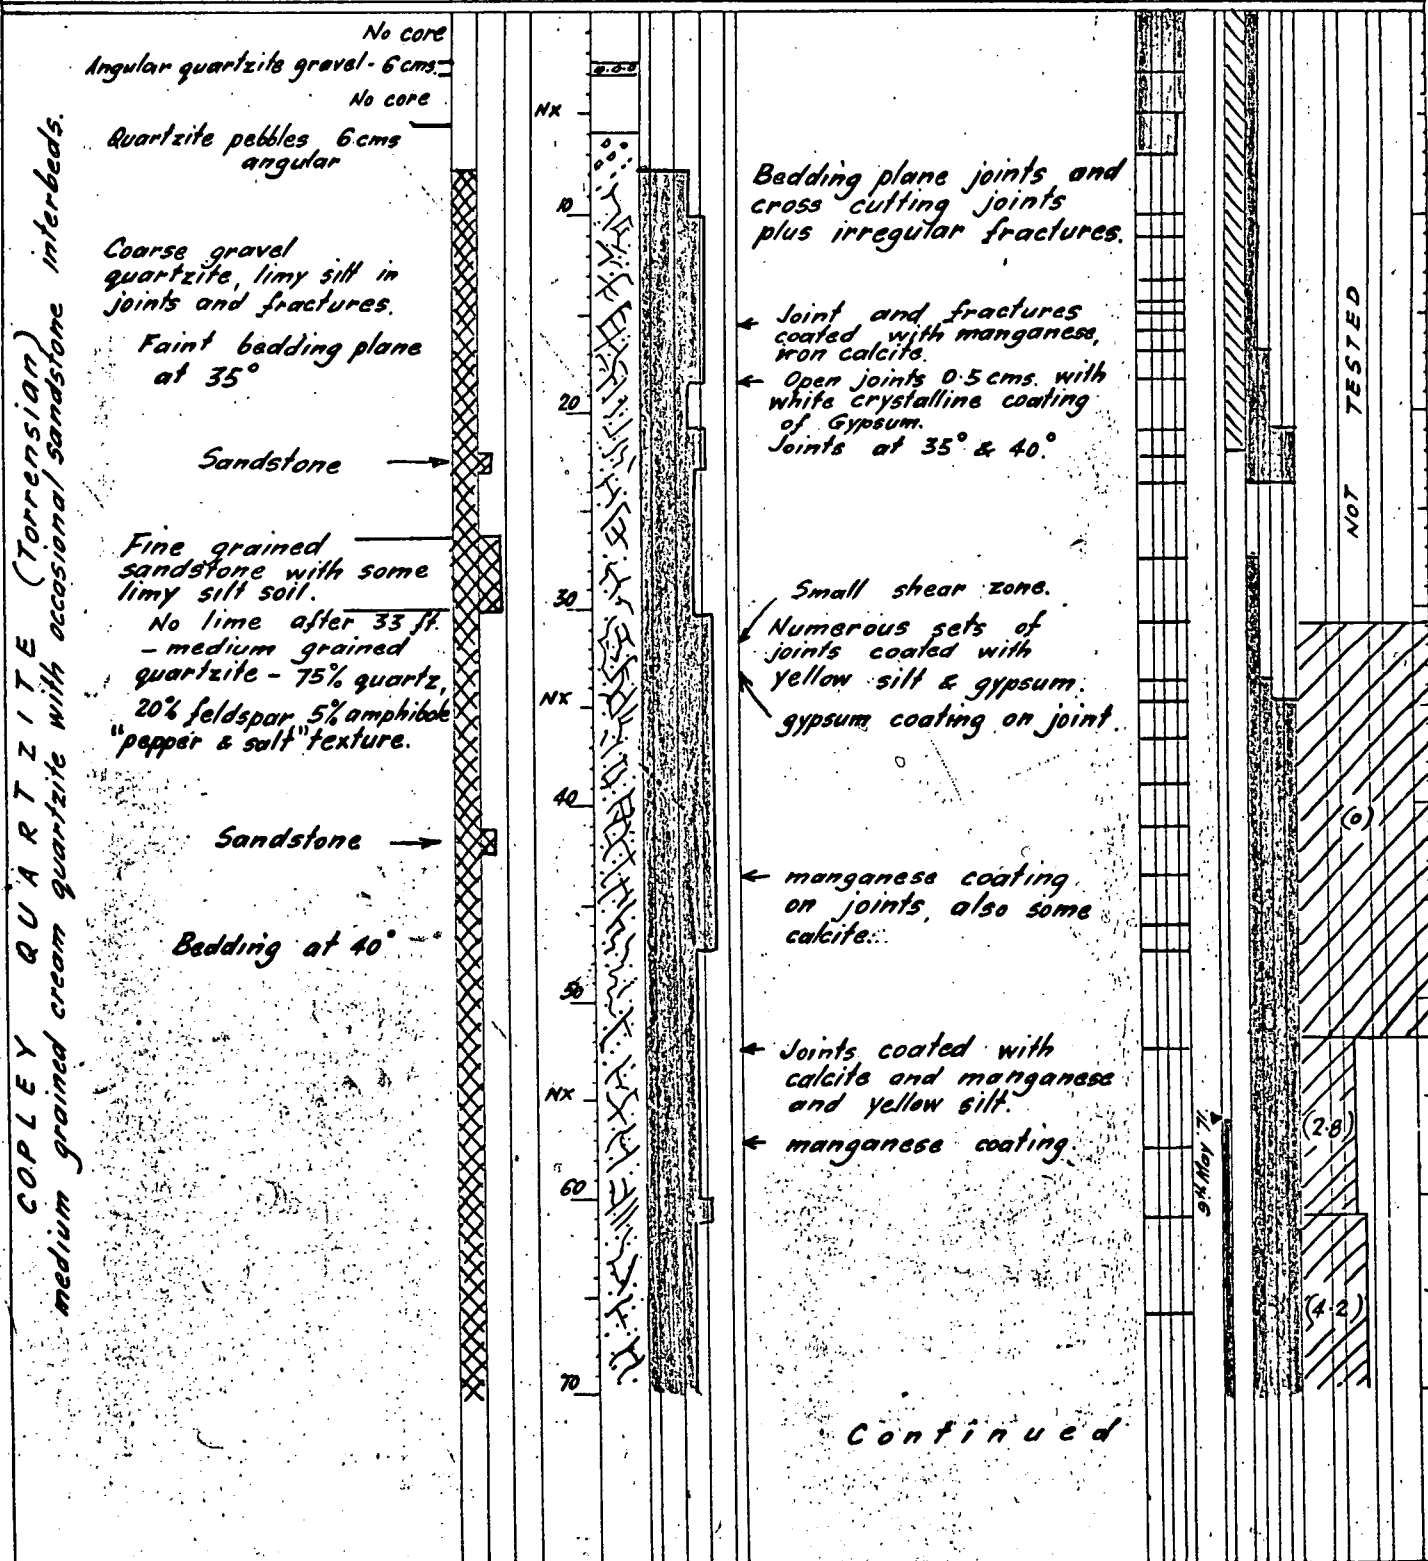
Seepage occurs near the base of the dam wall and at various positions along the eastern bank of the creek downstream of the dam (Fig.1). Water pressure tests in holes DH.1 and DH.2 show that leakages range from a reasonably low 3 Lugeons to over 100 Lugeons with an average of 38 lugeons and 44 lugeons in holes DH.1 and DH.2 respectively. The water loss is directly proportional to the degree of fracturing (Appendix A) and steadily increases down hole DH.1 and also in DH.2 after an initially large water loss nearer the surface. The water loss is greatest where the open joints are coated with gypsum, calcite and manganese. The water gradient across the ridge as measured in the drill holes with the reservoir full is about 1 in 10 (Fig.2), and the calculated value of the hydraulic conductivity is about 10^{-4} cms. per. sec. which is well down in the range of permeabilities of naturally occurring materials, and is equivalent to that of fine sands or a mixture of sand, silt, and clay (Terzaghi and Peck 1966). A similar result was also obtained by W. Johnson (1962) during previous investigations. An increase in groundwater gradient occurs southwards from the left abutment of the dam and this is probably due to a decrease in permeability in this direction, as a result of tightening of joints as the ridge becomes wider and higher and thus less weathered at depth. The flow through the interconnecting joints and cracks in the ridge appears to be slow, but wide spread, and a grouting programme along the ridge should greatly reduce this leakage.

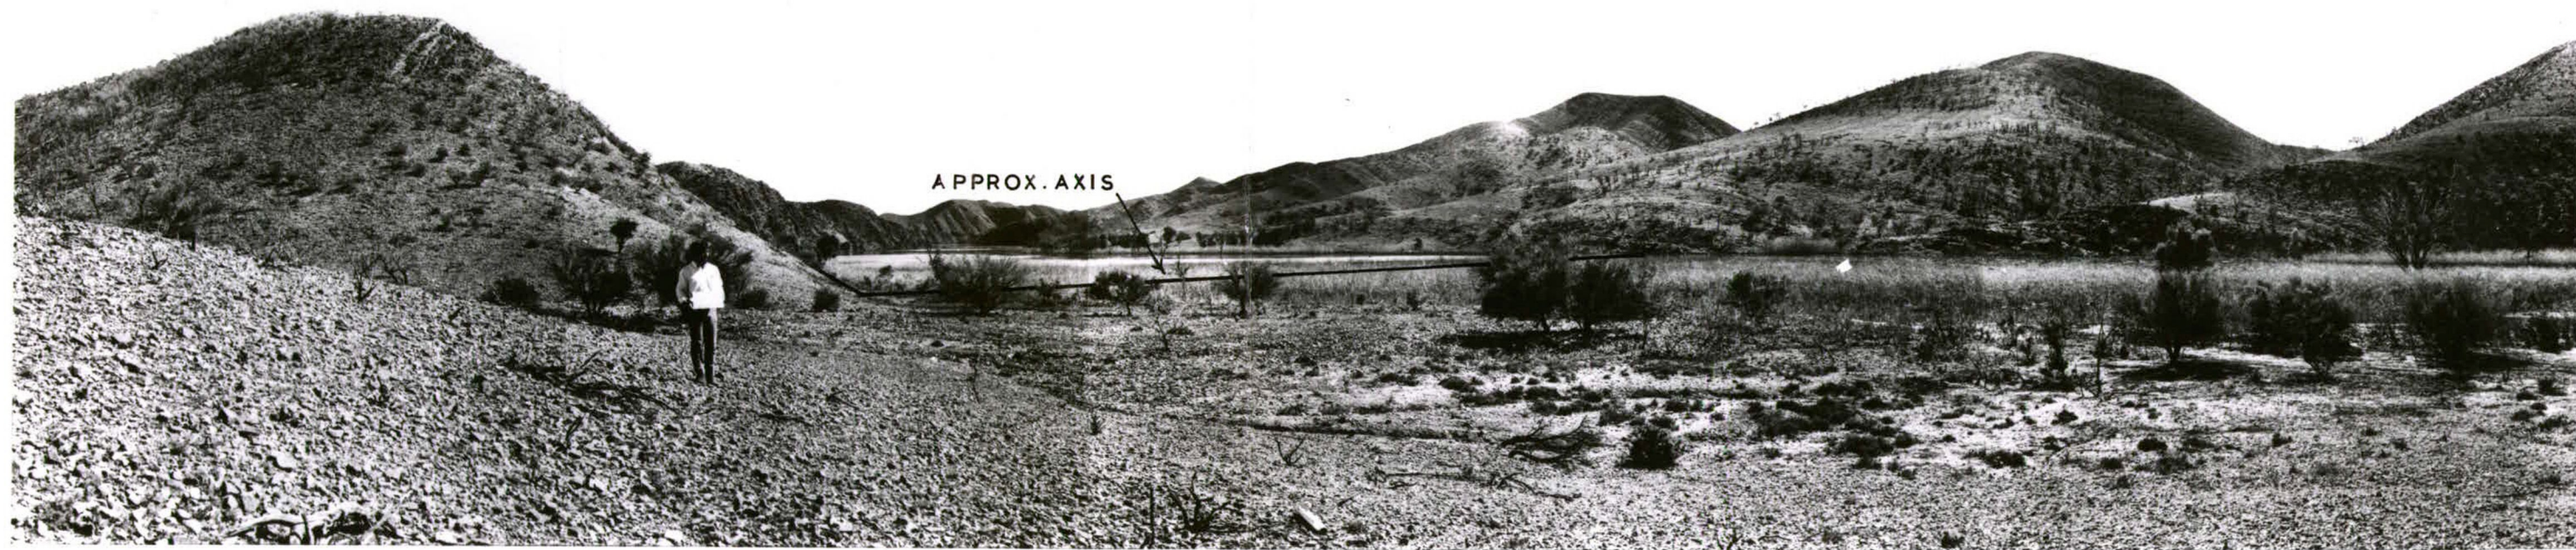
PROPOSED SITE OF UPSTREAM STORAGE DAM
AROONA RESERVOIR

Since the capacity of the reservoir has been decreased by an estimated 450 million gallons in about 20 years by the inflow of silt an upstream storage dam was proposed. A possible site for the dam was chosen mainly on the basis of topography (Appendix B. Photo (a)), but rock exposures on both abutments indicate that adequate foundations for a rock fill dam could be reasonably expected to be obtained. The site is about $1\frac{1}{2}$ miles upstream of the present dam (Fig.2). Two quarry sites (Appendix B. Photos, b & c) for the dam, close to the left abutment, have been proposed. These could be expected to produce blocky quartzite pieces up to 3ft., but mainly 0.5 ft. to 1ft. in size, suitable for use as rock fill. Any other site in the vicinity would produce a similar rock, as the ranges in this area are all composed of quartzite and sandstone. Access to the left abutment

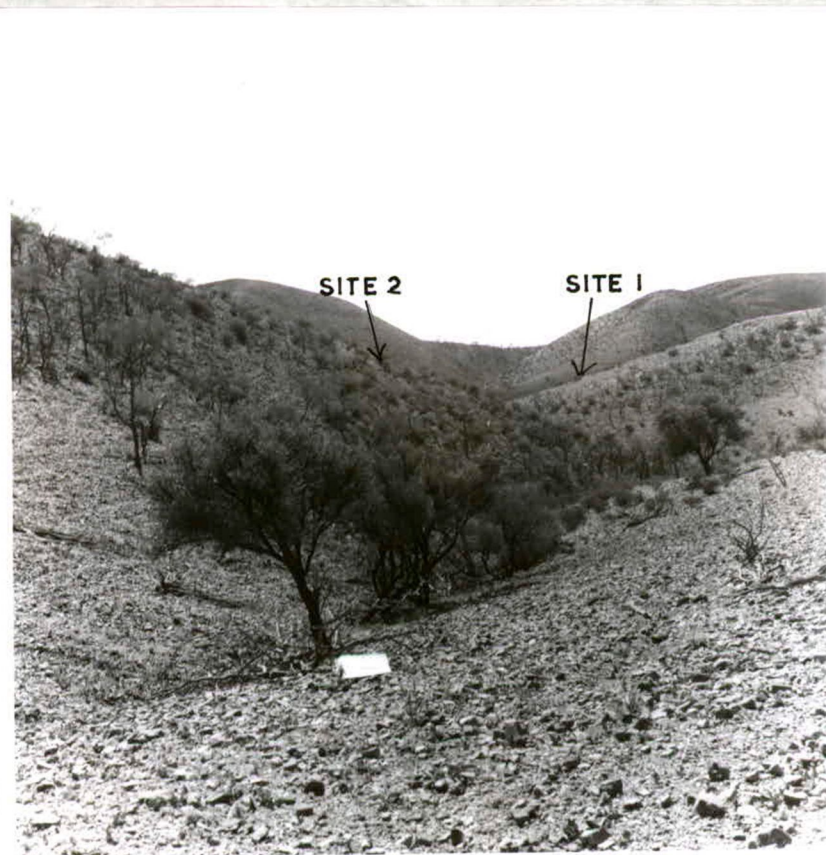
c) Access path and proposed quarry sites

of the proposed dam and the quarry sites, from the existing access road to the Aroona Dam, is relatively good (Appendix B. Photo, c).

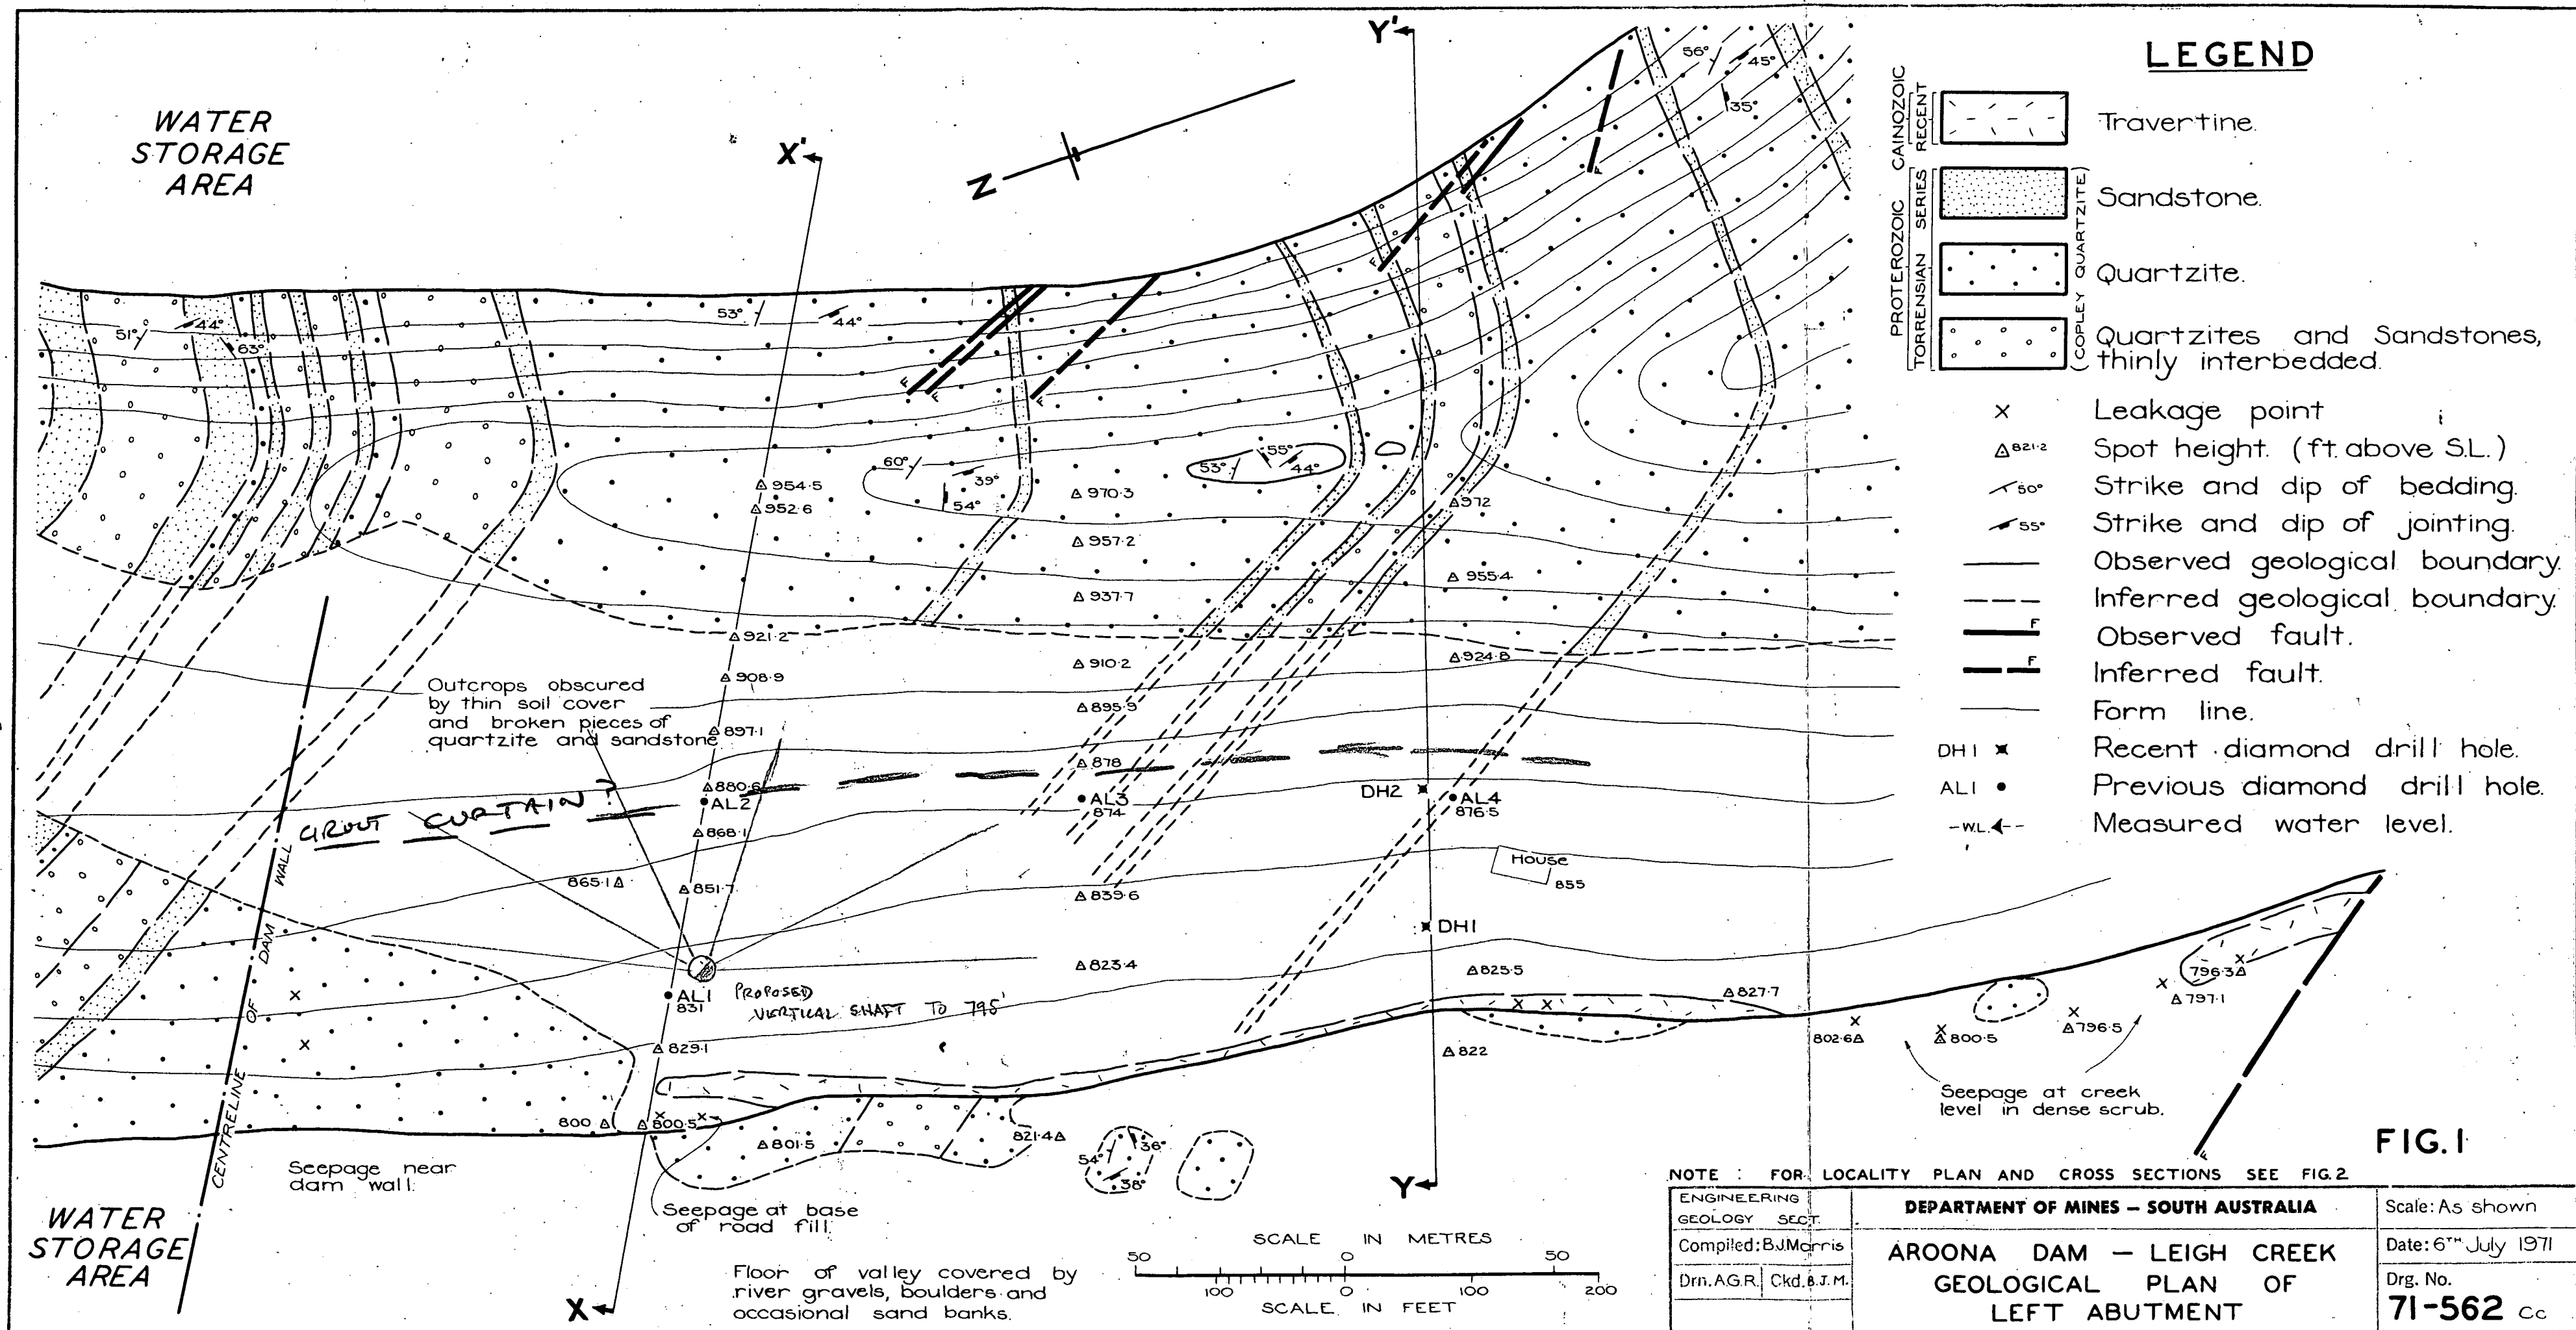
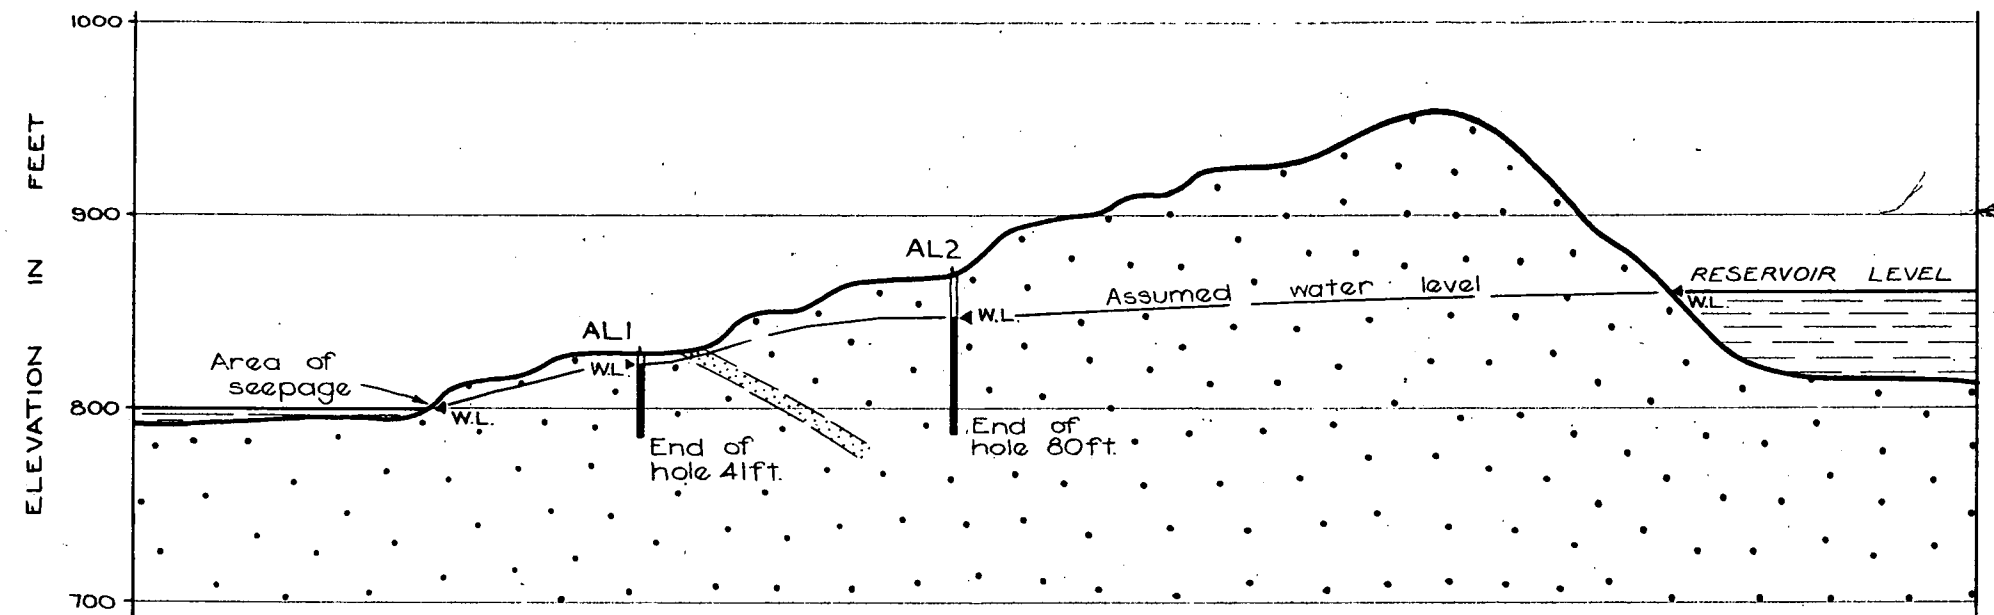
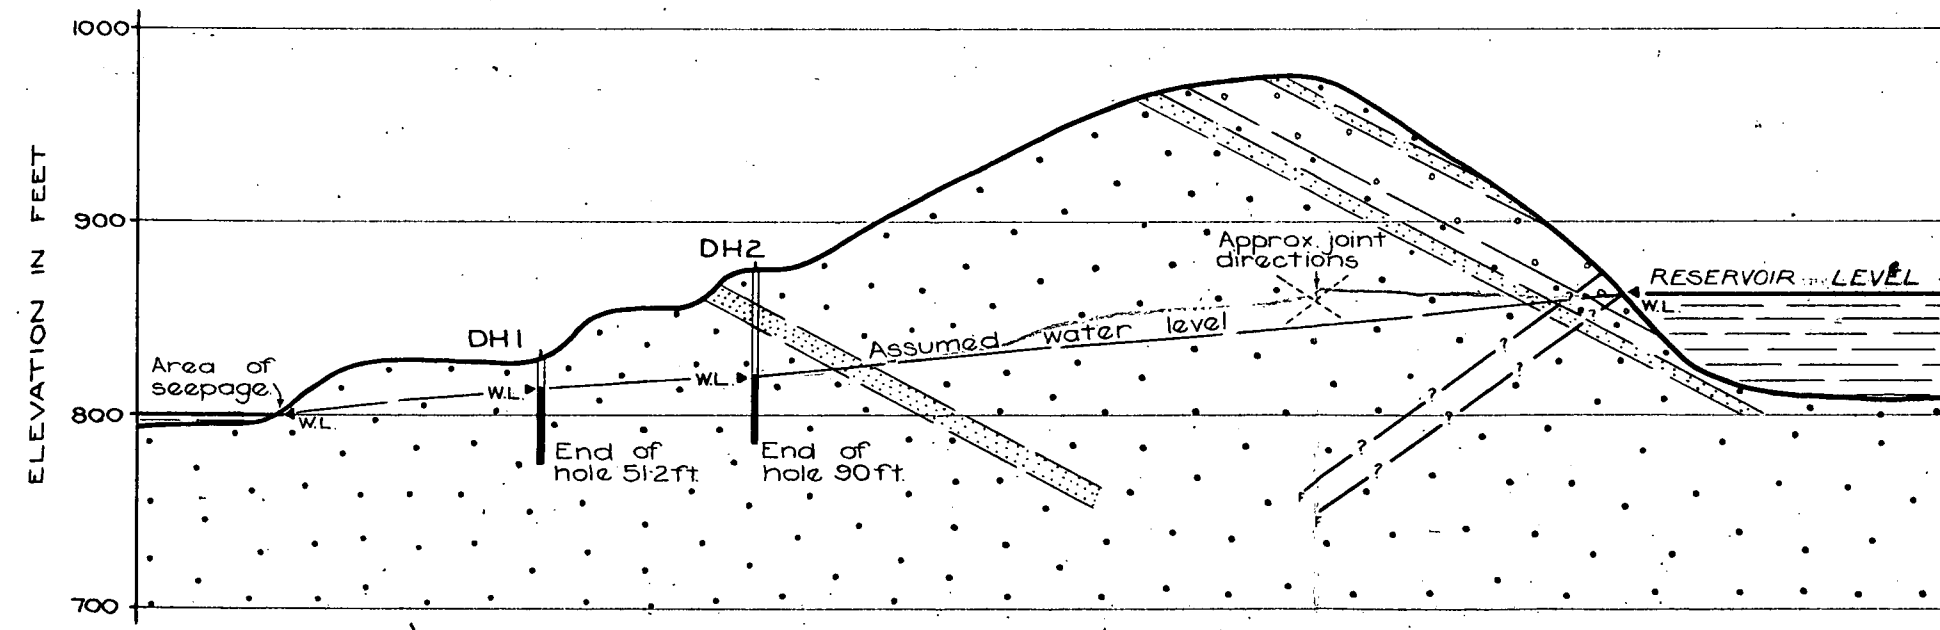
FIG. 2.

Considerable leakage (estimated at about 8 million gallons a month) from the reservoir occurs through the left abutment of the dam, and two diamond drill holes were drilled (Fig.1) to a depth of 51.2ft. (DH.1) and 70ft. (DH.2) and water pressure tested, to determine the frequency of open joints, the occurrence of permeable sandstone beds in the quartzite, the possible occurrence of shear zones, the water gradient through the ridge (Fig.2) and the average permeability of the ridge.

salinity close to that of the naturally occurring ground water which is much higher than that of the reservoir water. This is considered to be due to the slow rate of flow of the water through the ridge. With a hydraulic conductivity of 10^{-4} cms. per sec. water would flow through the ridge when the reservoir was full at about 100ft. per year. On this basis water from the reservoir would take about 7 years to flow through the narrowest part of the ridge, assuming full head for that period. It is considered that the water issuing as seepages is naturally occurring ground water forced to the surface under pressure effects related to the head of water in the reservoir.

- e) leakages could be decreased considerably with construction of a grout curtain in the left abutment downstream of the dam.
- f) a grout curtain along the R.L. 875ft. contour, for 1200ft. downstream of the dam with grouting commencing at R.L. 865ft. in each hole, would greatly reduce leakage.
- g) the grout curtain would have to be between 100ft. and 150ft. deep or to a depth where the leakage is less than 3 lugeons. This depth could be determined by prior water pressure testing in each hole.
- h) grout takes would be large and leakages to the ground surface would be common, especially in the upper part of each hole.
- i) holes should be spaced 20ft. apart with secondary and tertiary holes as necessary.
