DEPARTMENT OF MINES
SOUTH AUSTRALIA

LITTLE PARA DAM
GEOLOGICAL ASSESSMENT OF THE
QUARRY AND WATER TREATMENT WORKS

J.C. BEAL
ENGINEERING GEOLOGY SECTION

Rept.Bk.No. 77/93
G.S. No. 5915
Eng.Geol.No. 77/65
D.M. No. 428/77

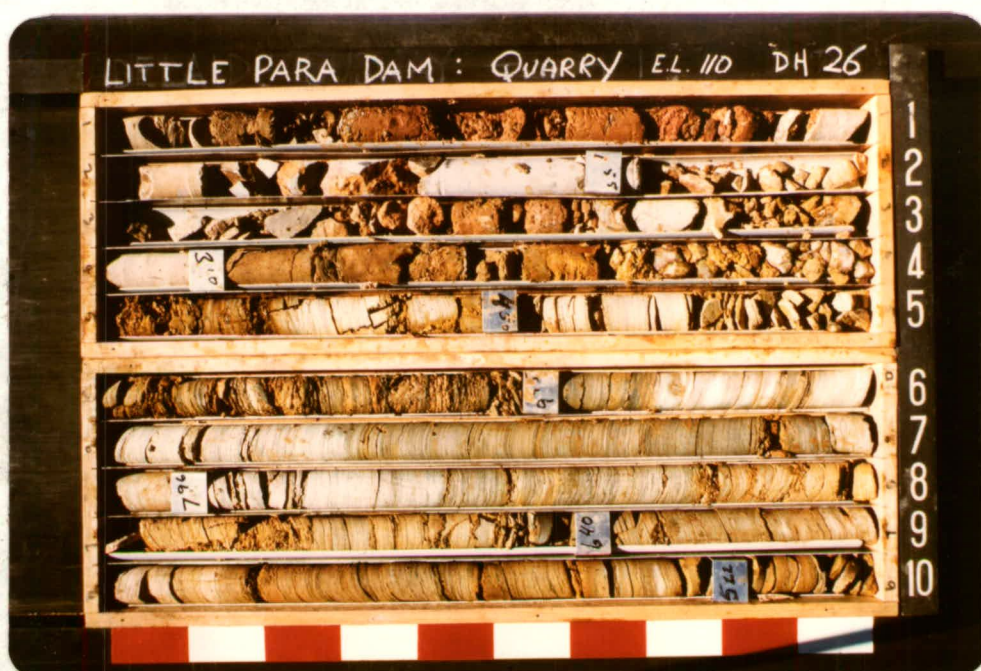
PLATE 1 Drill Core DH26 0.0 m - 10.0 m

The logs of these three cored holes are shown in Appendix I. DH26 indicates acceptable rock conditions at 4.10 metres, DH 27 at 4.30 m and DH 28 at either 1.80 m or 5.0 m depending upon rock conditions exposed after excavation.

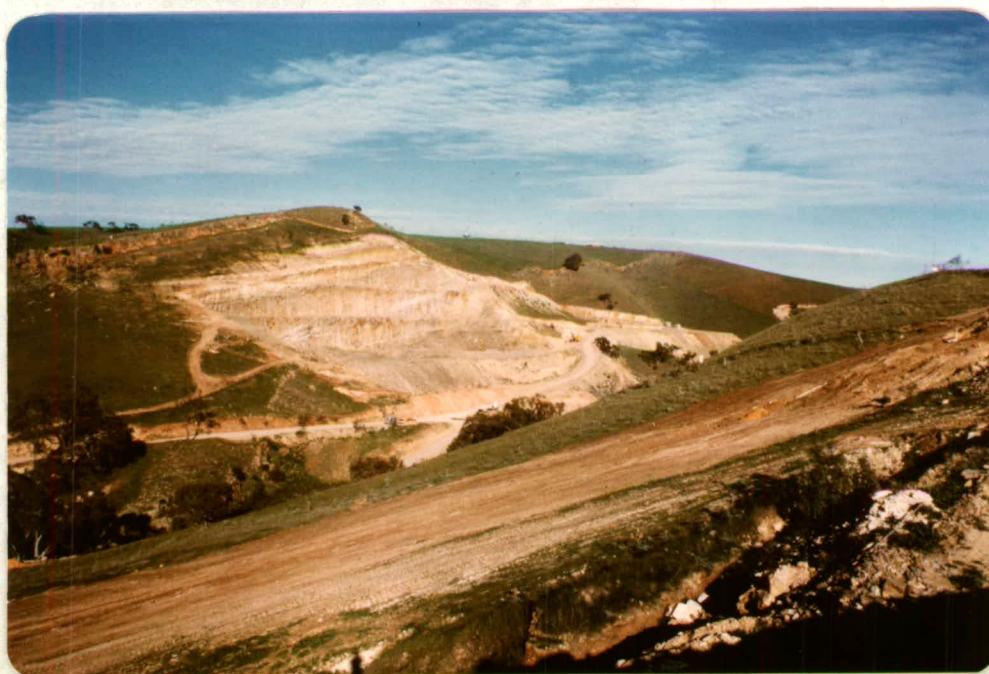
PLATE 4 View of Quarry Showing Berm EL 110

The quartzite and dolomite are acceptable as a foundation for that part of the treatment works to be located on berm EL 120. Air track drilling on the EL 110 berm has proven sound bedrock lying 2.0 - 3.0 metres deep below fill, colluvium and highly weathered bedrock (Refer E.W.S. Drawing TR 245, April 1977).

If the berm level is reduced from EL 110 to EL 107 nearly all the unacceptable material will be removed. It is strongly advised that the water tanks be placed as far back as possible on the EL 110 berm, away from the EL 110 batter. Rock conditions along the edge of the batter may prove unacceptable for bearing structural loads. Fill covering the EL 110 berm outer edge will have to be excavated and the face of the outer edge cleaned up before a final statement as to its stability is possible.

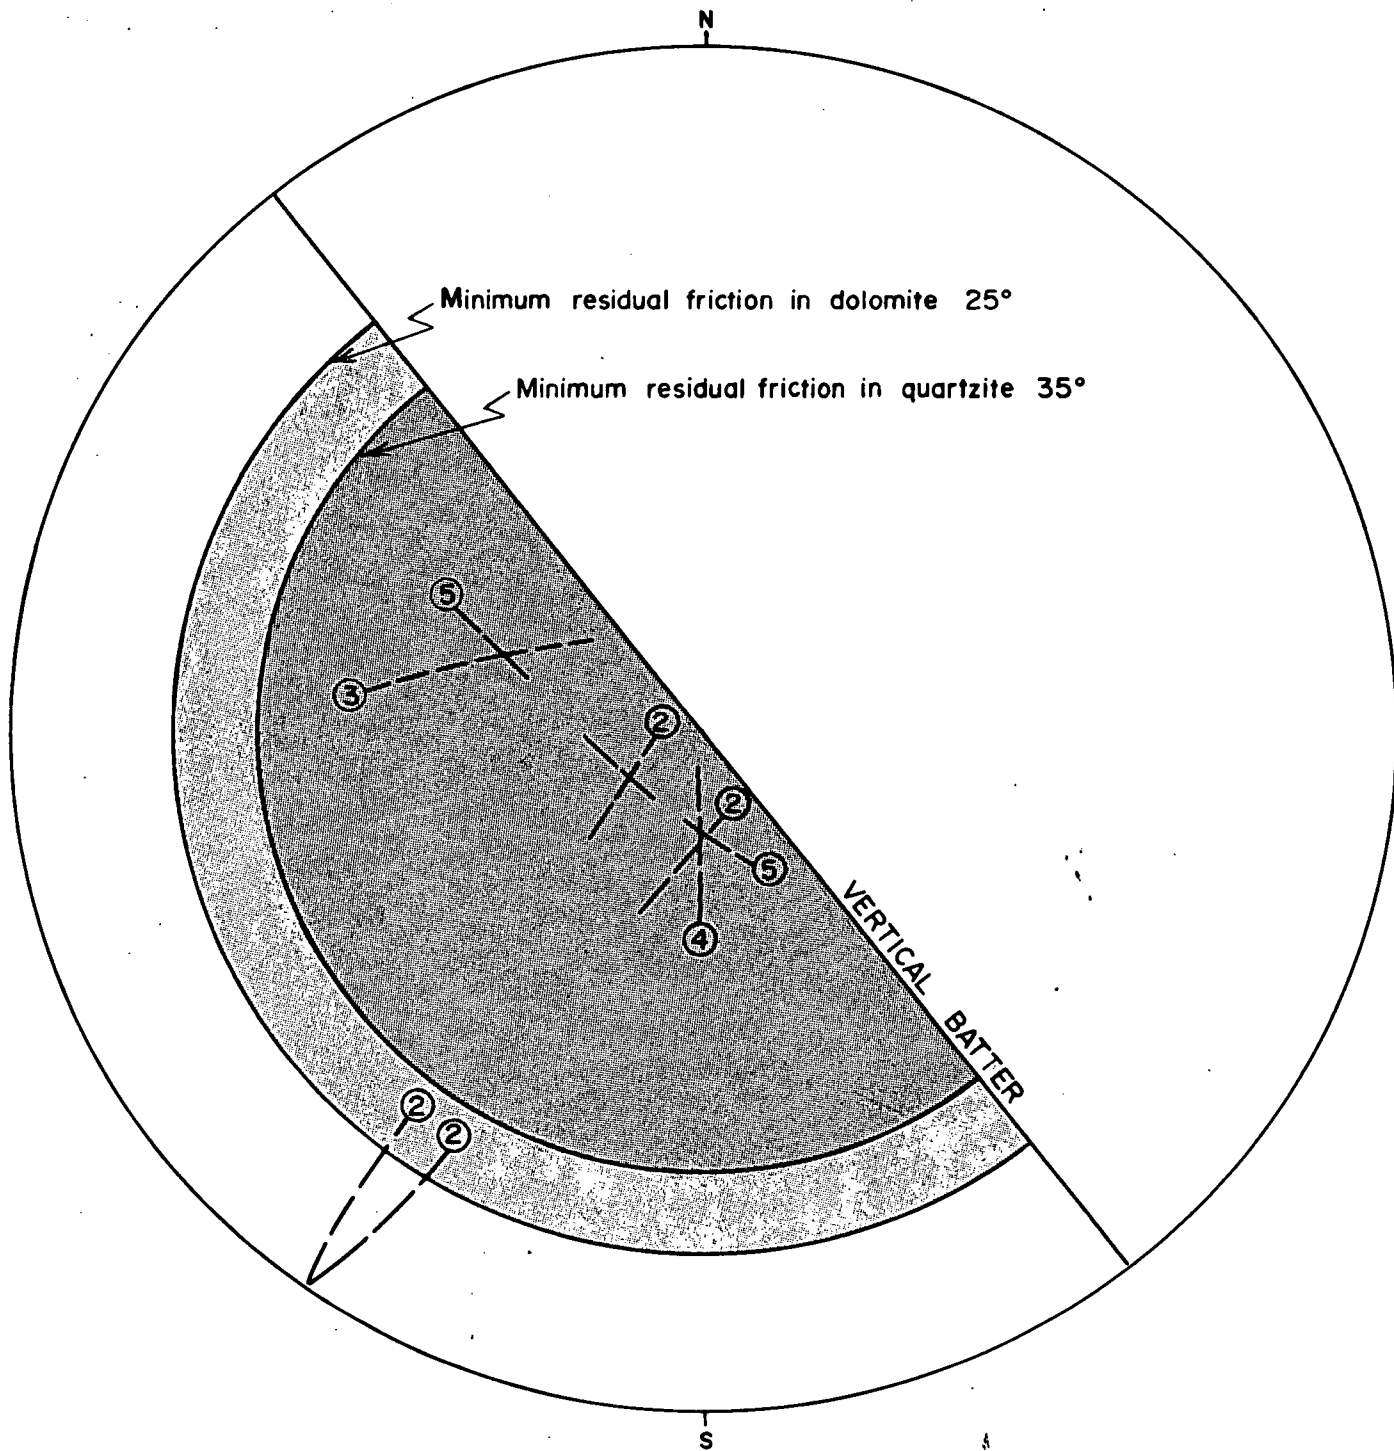
FIG. 6

NO LARGE SCALE INSTABILITY

FAILURE MODE	FRACTURE INTERSECTIONS
Small wedge-blocks	5 and 3 ; 2 and 5 ; 5 and 4

Results of the fracture analysis show that falls of small blocks from the vertical batters of the central and eastern faces of the quarry can be expected. Maximum block sizes of up to 1.0 m x 1.0 m x 0.50 m can be expected to fall intermittently during the life of the quarry. A shallow ditch and cyclone fence should be placed at the foot of batters to prevent falling boulders reaching the treatment works.

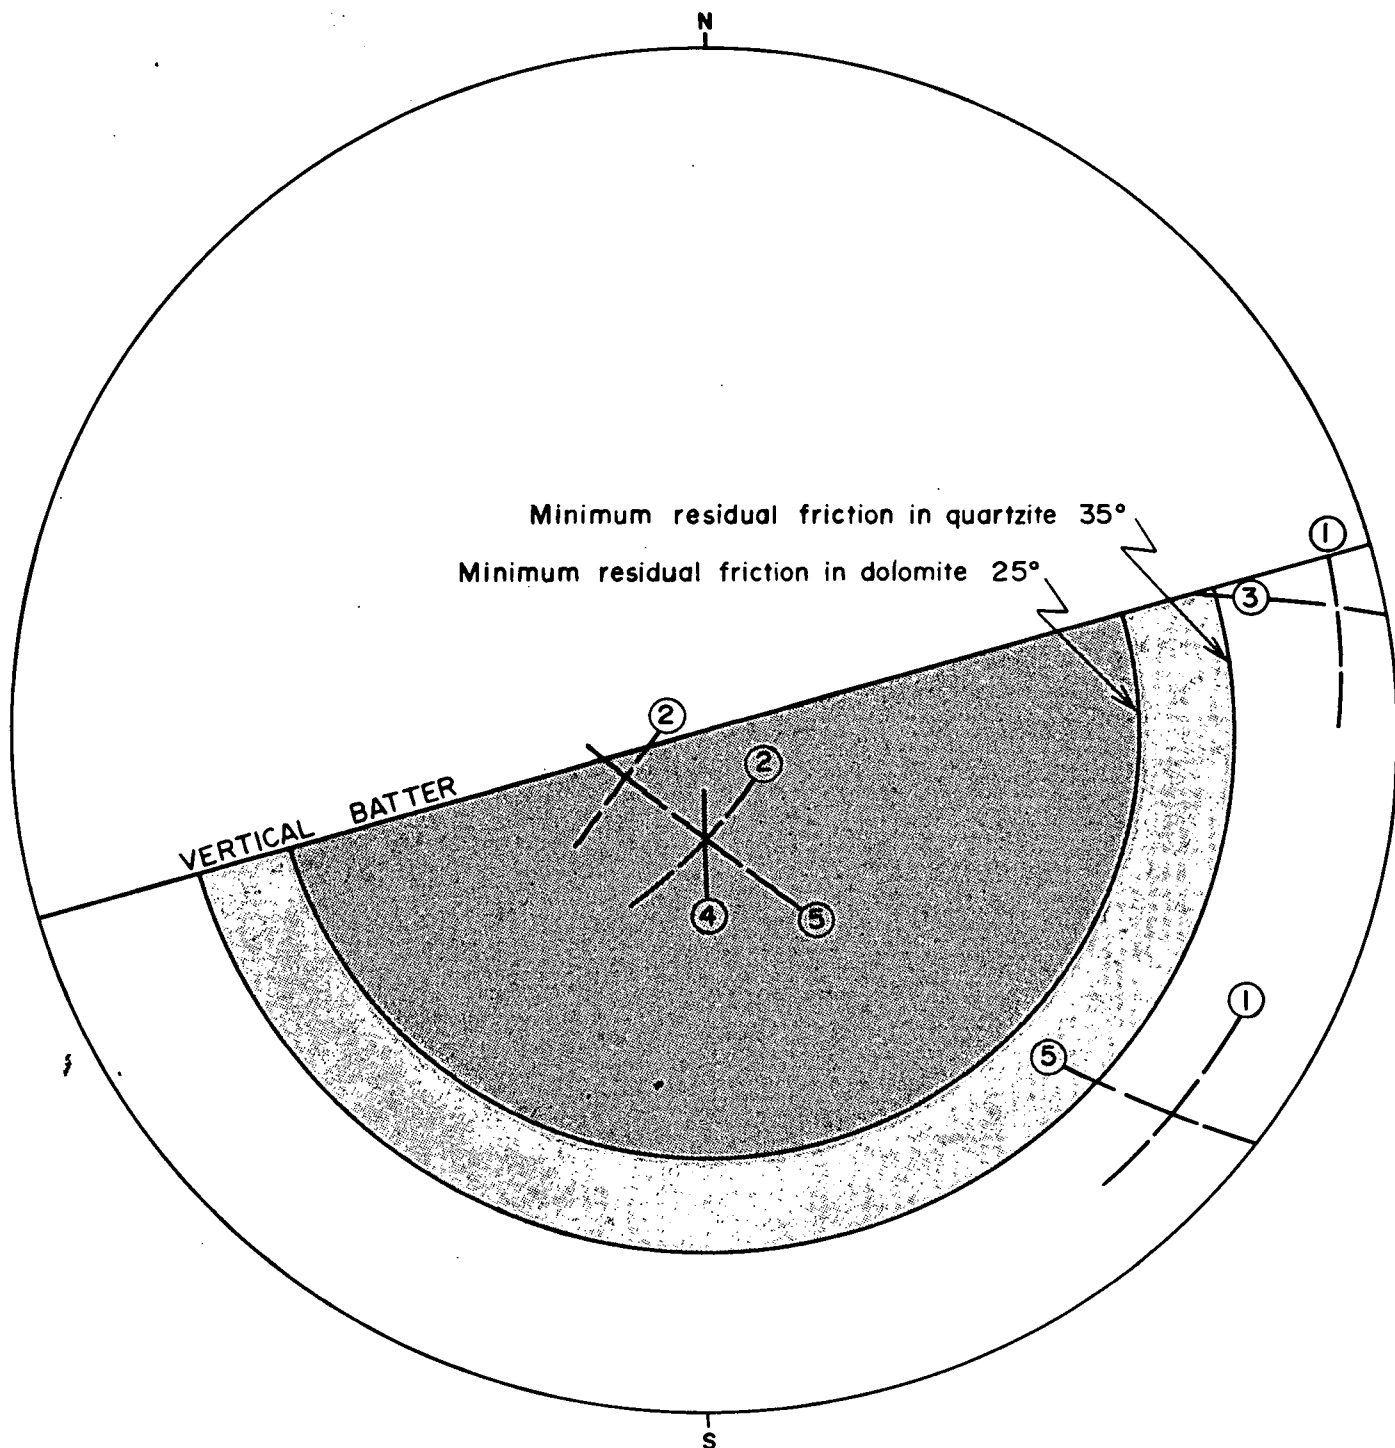
FIG. 7

FAILURE MODE	FRACTURE INTERSECTIONS
Wedge failure of small blocks	2 and 5 ; 4 and 5

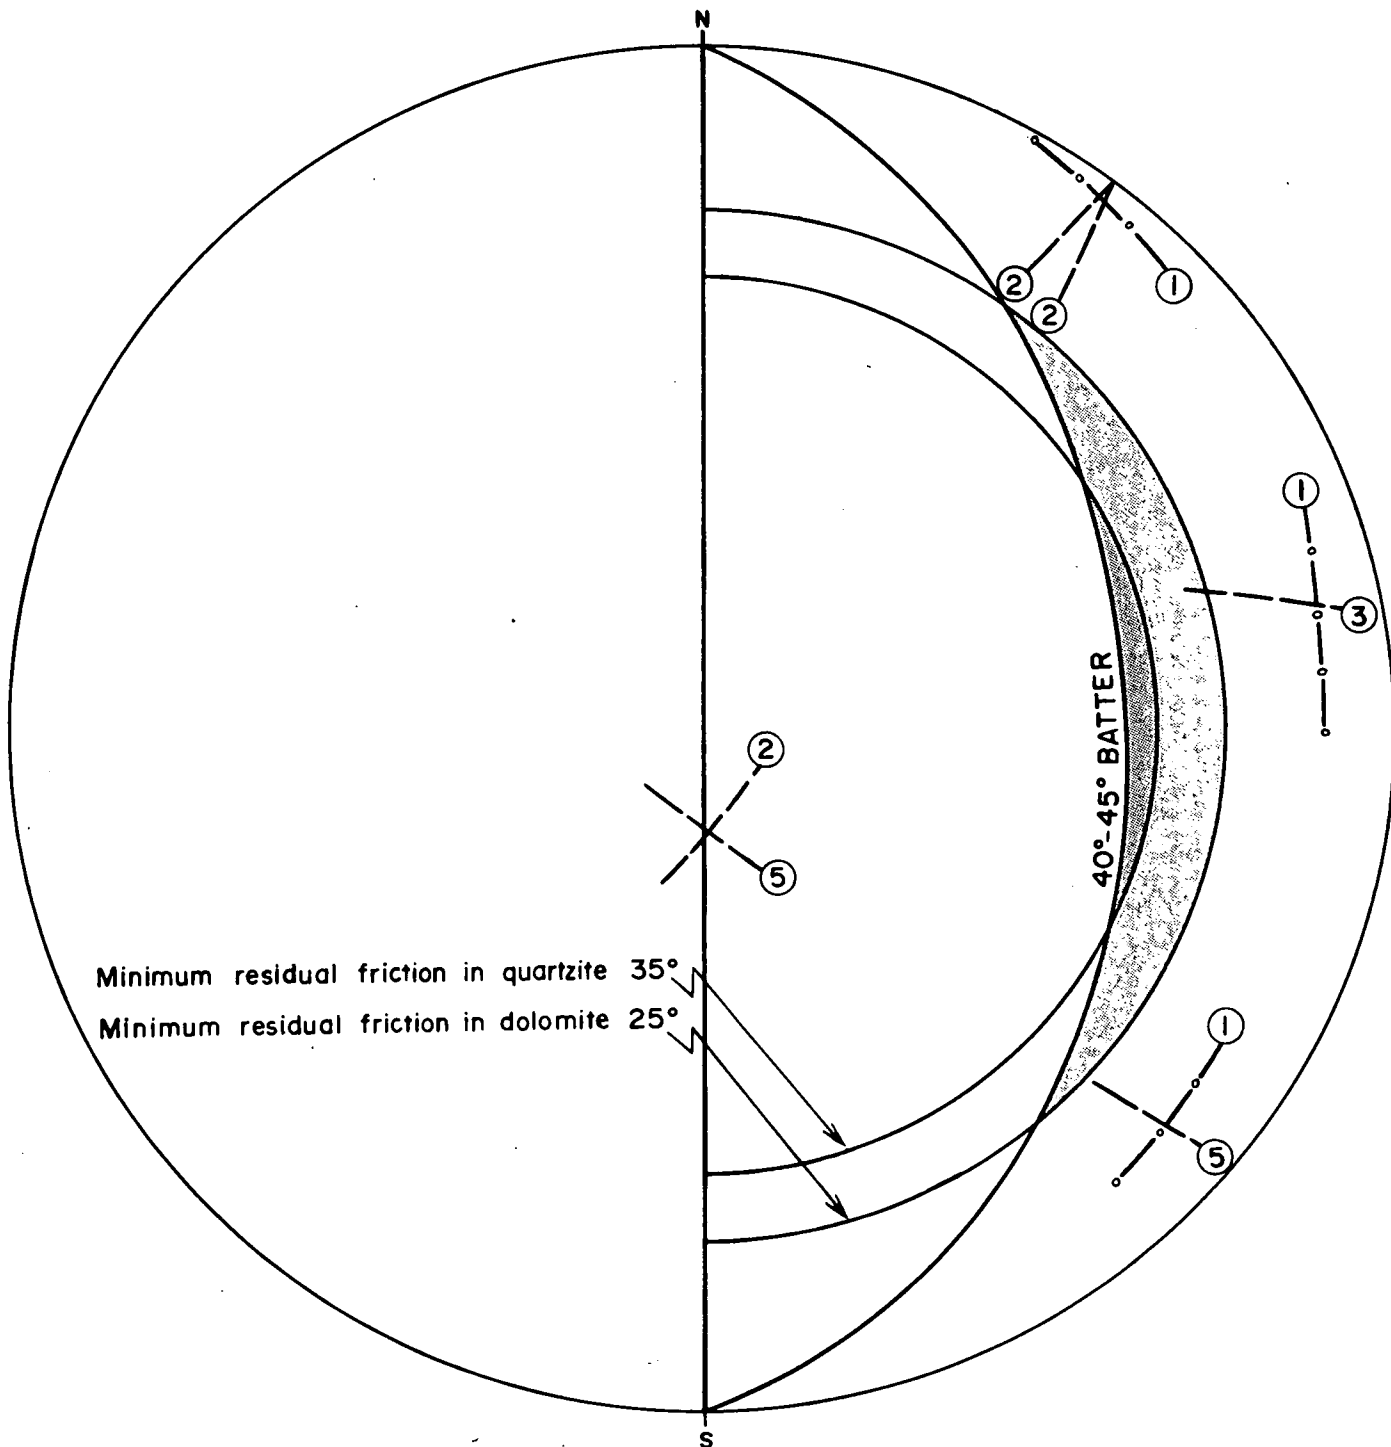
FIG. 8

The western batter (See Regime III Fig. 1) excavated at 40° will also suffer falls of small blocks and a low safety barrier should be placed at the foot of the batter. Because bedding plane angle of friction is greater than bedding plane dip a planar failure of the batter into the excavation, although geometrically possible, is highly unlikely.

All intersections form stable blocks.
