DRAINAGE WELLS IN THE

MURRAY BRIDGE AREA

November, 1977

Rept.Bk.No. 77/138

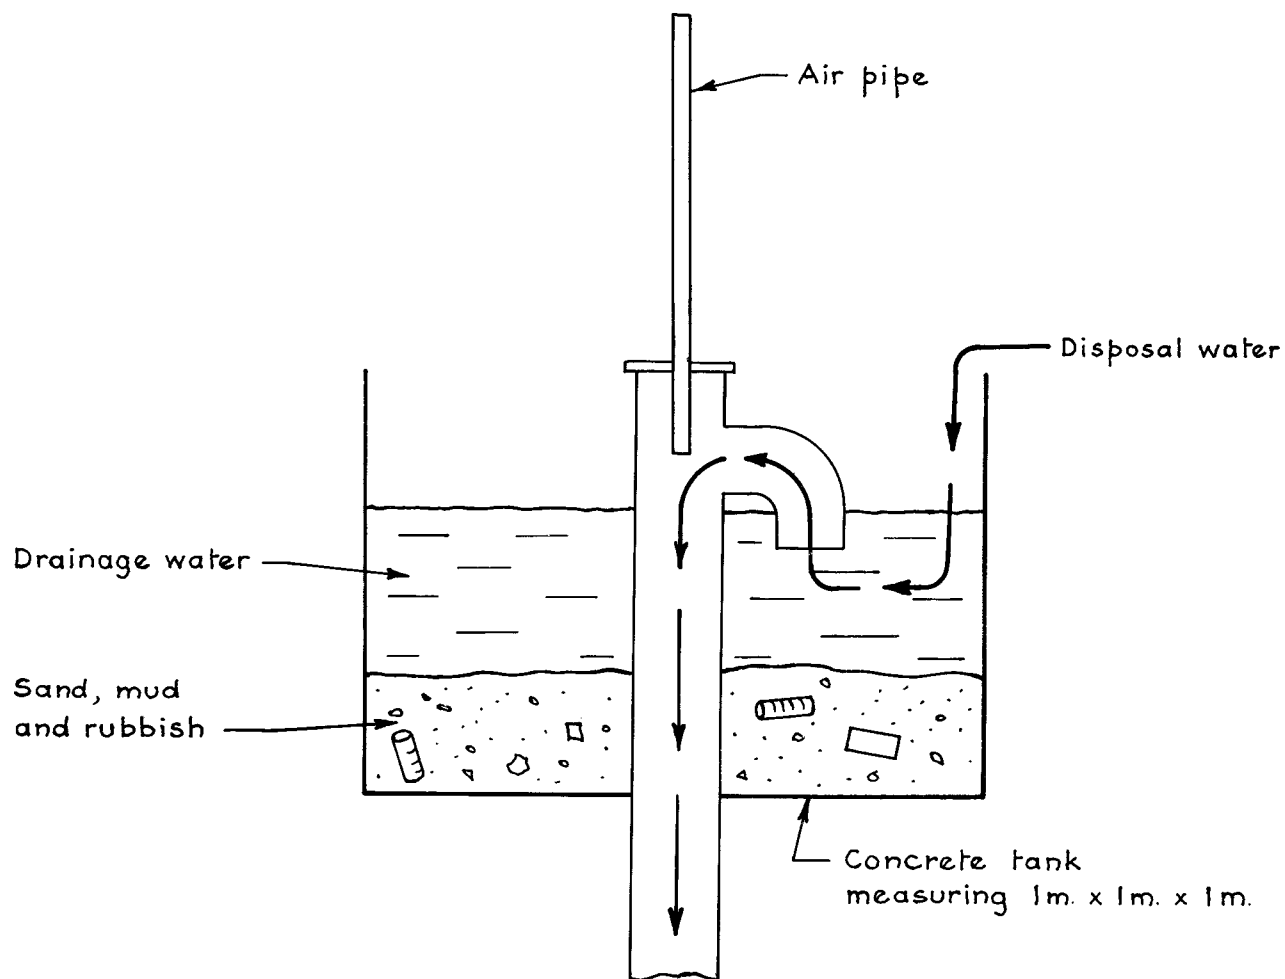
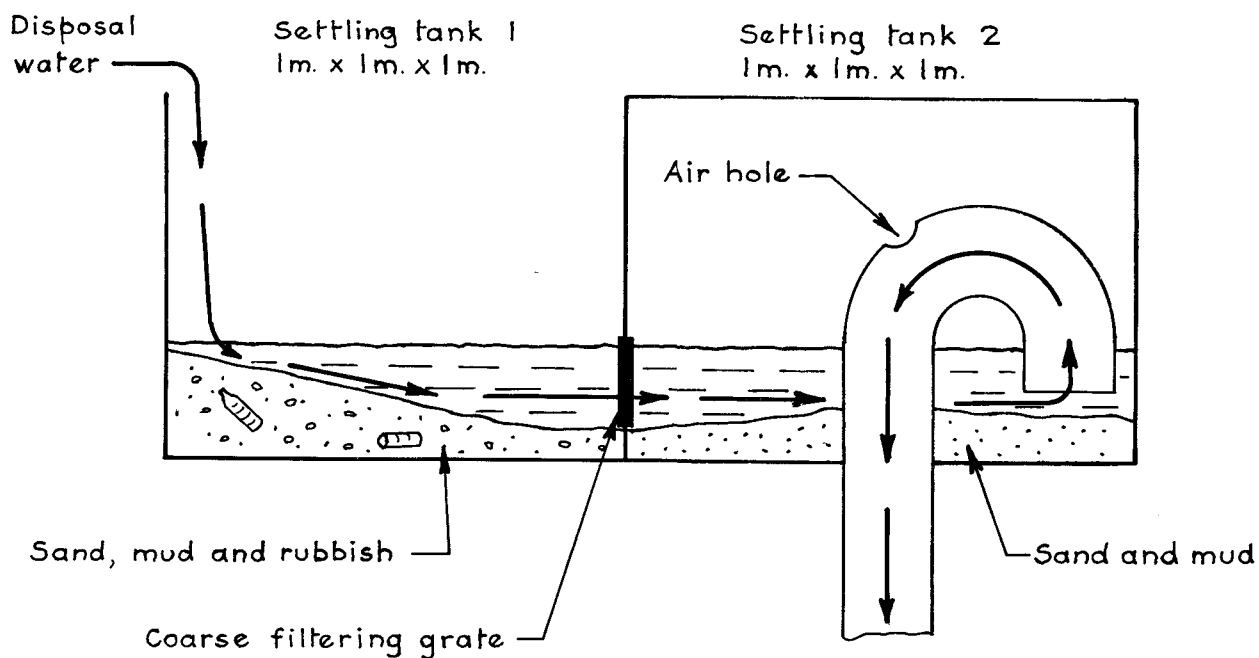
Fig 2

Silt traps currently in use are shown in Figure 2. The most common design is two concrete tanks with a 'gooseneck' fitted to the drainage well. Both designs do not work well when large volumes of disposal water are involved (for example after heavy rains) as the solids are washed into the disposal well. Some type of settling pond is needed to temporarily hold the runoff so that at least the sand and silt settle before the water enters the drainage well. This is quite practical in parkland areas where temporary flooding causes minimal damage and inconvenience. In other areas, it may prove practical to design a series of sieves to fit on the top of the casing so that all materials coarser than silt size are filtered out. These sieves would require regular maintenance but would maintain drainage efficiency. The need still remains for improved silt trap designs.

.....Silt traps currently in use are poorly designed and not adequately maintained. Such drainage wells would require regular, expensive rehabilitation to maintain drainage efficiency.

.....An effort should be made to improve silt trap design and silt traps should be regularly maintained to minimise rehabilitation costs and maximize drainage efficiency.
