DEPARTMENT OF MINES & ENERGY
SOUTH AUSTRALIA

FAILURE IN OVERBURDEN AND COAL, LOBE D, LEIGH CREEK

Rept.Bk.77/141
G.S. No. G.S. 5960
DM. No. 135/75

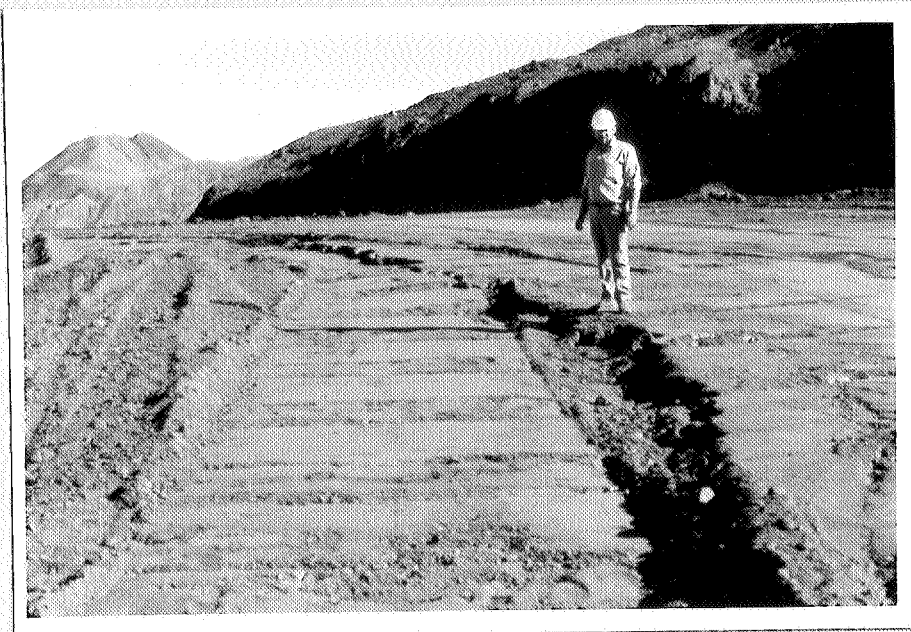
a

1. Tension cracks and slippage in overburden dumps.

Multiple tension cracks extend for 300-400 m in the northern and eastern dumps. Previously, ETSA field engineers had noted individual slippages up to 50 m long in these dumps (Fig. 2). Maximum vertical collapse was 10 m.

- (a) tension cracks showing first signs of failure.
- (b) complete collapse of reworked overburden comprising the dragline walkway.

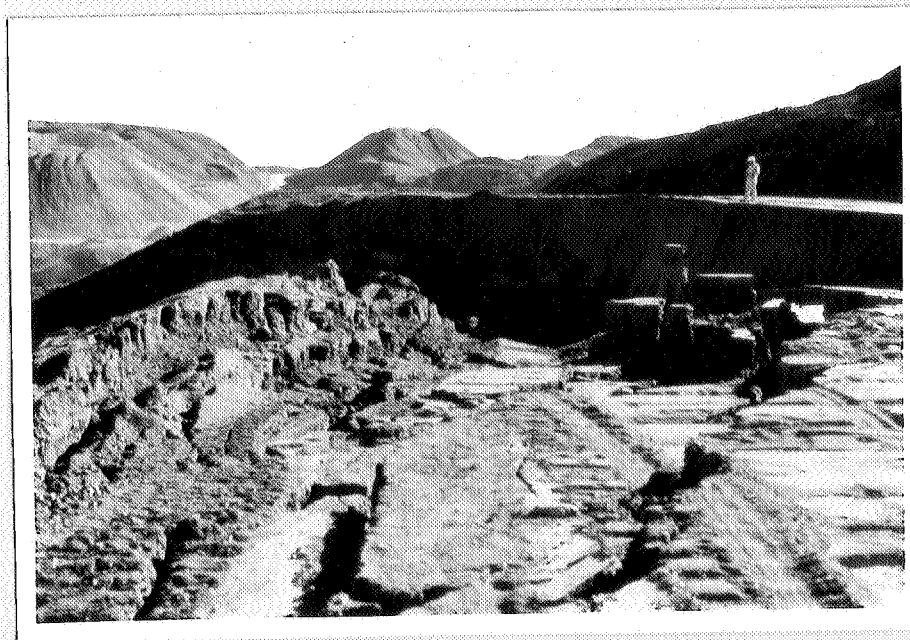
b

The measures suggested were undertaken and successfully retarded such that it was restricted to overburden-collapse only. There was no further buckling of the coal benches during mining thus allowing recovery of the remaining coal. Over a period of one month, the dragline walkway, collapsed completely (Fig. 2), although the debris did not extend beyond the trench. The collapse comprised a series of arcuate failures which may have progressed into the dumps behind the walkway had preventive action not been taken (Plate (b)).

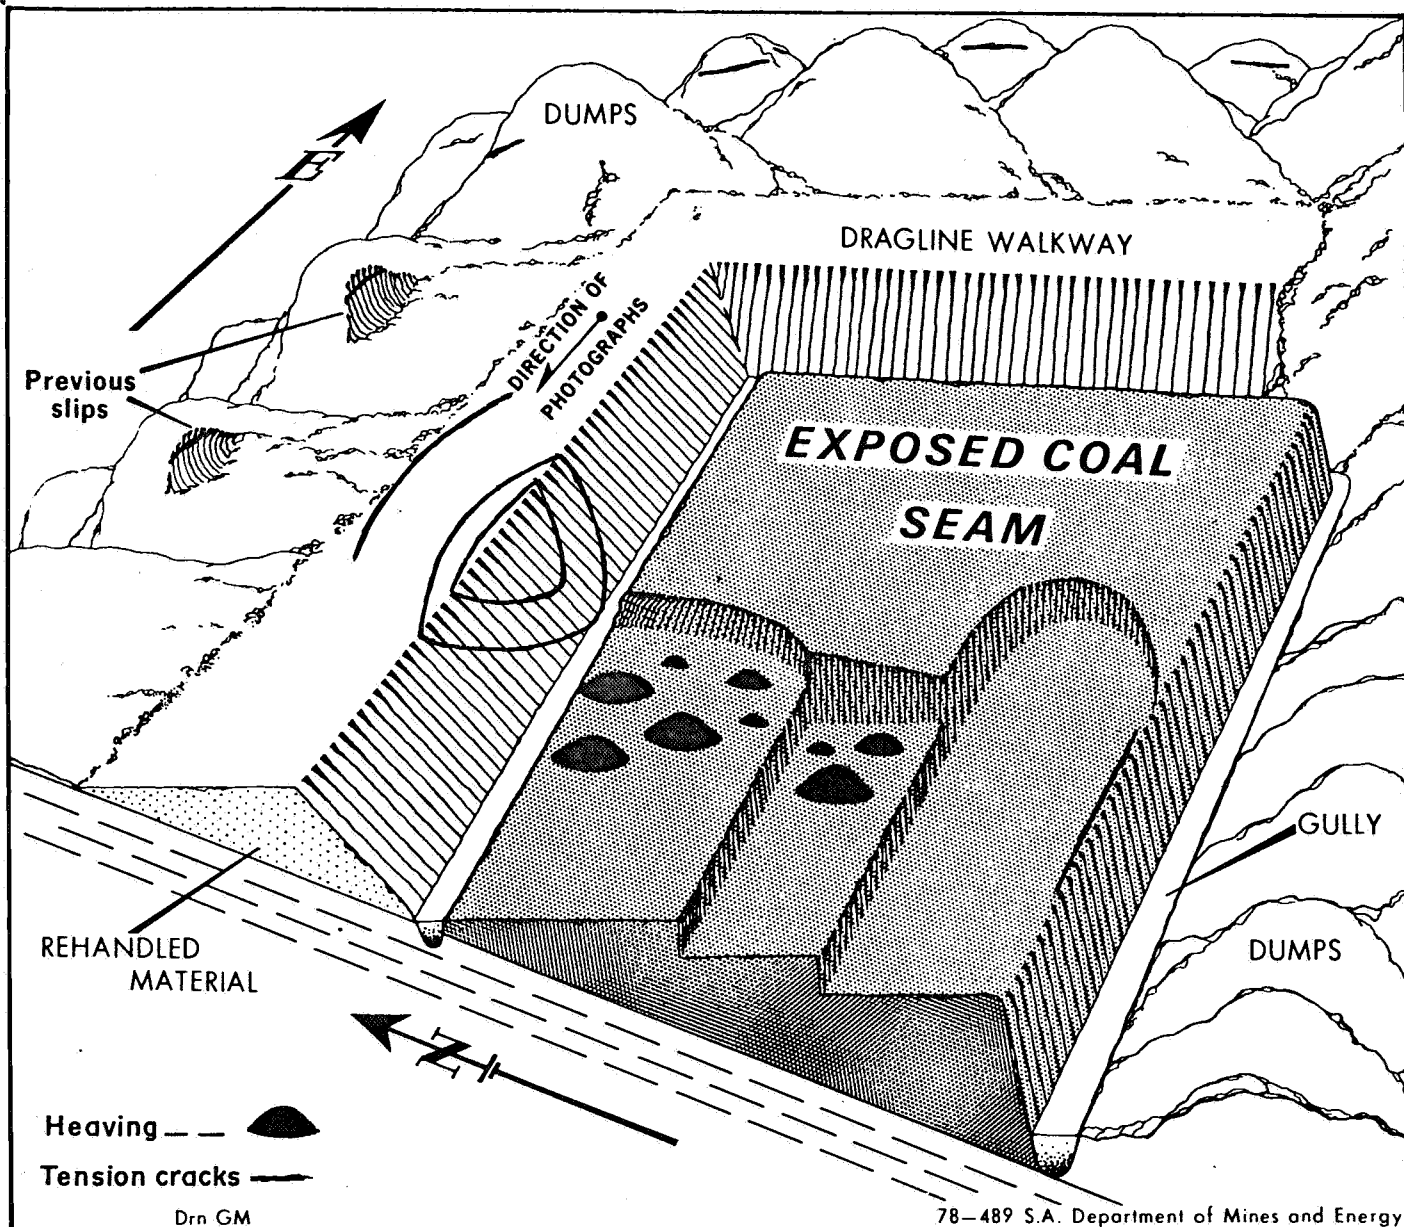
Fig. 2 Diagrammatic sketch of lobe D cut showing signs of failure in overburden and pit floor

In mid-1976 during the final stages of mining Lobe D at Leigh Creek (Fig. 1), overburden removal had been completed and the dragline shifted 10 km south to Telford Basin. While the coal was being mined by normal shovel and truck operation, tension cracks appeared in rehandled overburden comprising the dragline walkway (Fig. 2), and cracks and humps (heaving) appeared in the coal benches.

In the pit floor domes of coal up to 20 m across with vertical relief of 0.2-1.0 m, exhibited brittle fractures and well developed blocky dislocations. Heaving, most pronounced in the northern bench immediately below the shearing in the walkway, diminished with increasing distance from the walkway. Minor cracks paralleled the gully along the southern margin of the unmined block of coal (Fig. 2).

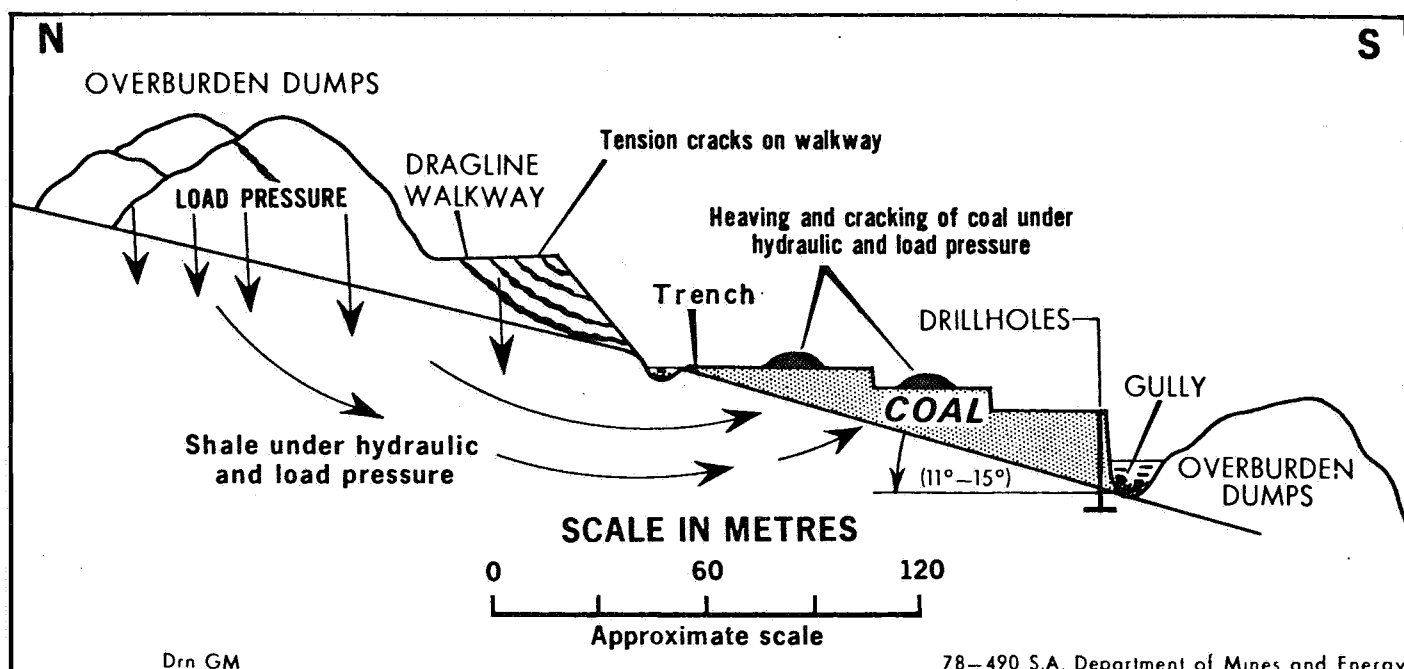
Fig. 3 Diagrammatic north-south section showing cause of failure and preventive measures taken

The main cause of failure was considered to be the inadequate compressive strength of the shales underlying the uncovered coal seam. Once the overburden, up to 50 m thick, had been removed from above the coal, the shales failed to withstand the combined load pressure from the dumps and the hydraulic pressure. Coffey and Partners (1975) attributed earlier failures in Lobes B, C & D to slippage along clay bands which became plastic when wet. In Lobe D, a 150 mm thick clay band occurs 5 m below the lower seam. This, or similar clay bands may have contributed to the instability of the underlying shales.

A trench 2-3 m deep was bulldozed in the exposed shale on the up-dip northern side of the coal in the area most affected by failure (Fig. 3) to encourage shallow collapse of the walkway into the trench and to dewater both the rehandled overburden and the underlying shales, thereby relieving both the hydraulic pressure and reduce the load pressure within the shales.

Additional precautions suggested by Mr. D. Stapledon (Coffey and Partners), included the drilling of a line of holes, 20 m deep, on the southern down-dip side of the coal, 3-6 m apart in the affected area, to dewater any pressured shales or clays between the trench and the gully (Fig. 3). He also recommended that this series of related failures be documented, as it is rare to be able to trace their progressive development from the outset.
