DEPARTMENT OF MINES AND ENERGY
SOUTH AUSTRALIA

REPORT OF INVESTIGATIONS

THE ENGINEERING GEOLOGY
OF THE LITTLE PARA
DAM SITE

October, 1979

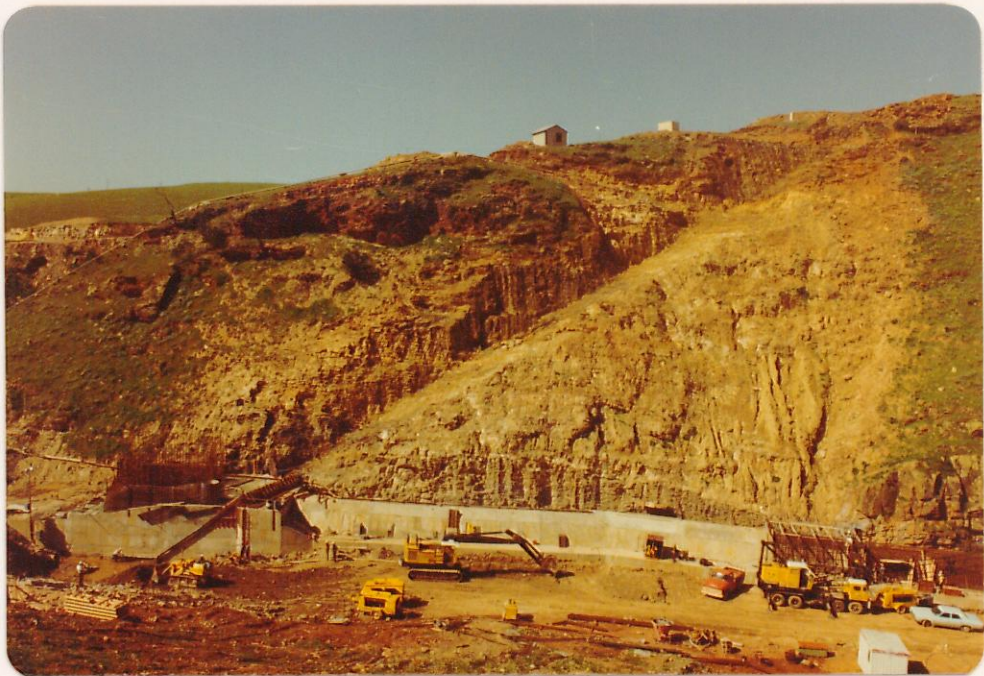
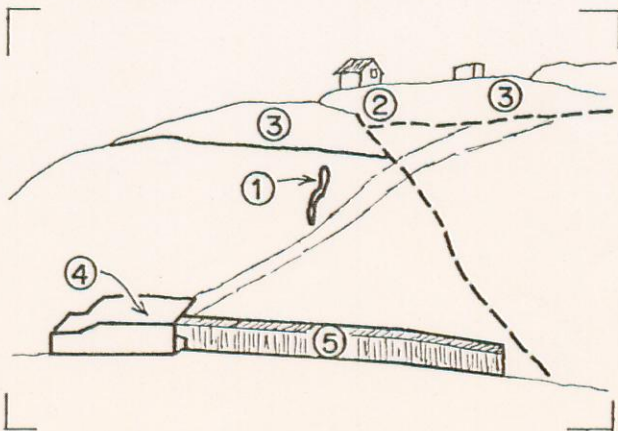
FIG. 10

NEGATIVE NO. 26761 - Sept. 1974
 THE LEFT ABUTMENT AND OUTLET
 DUCT

1. Hillside stress relief fracture.
2. Shear Zone.
3. Displacement of slaty dolomitic siltstone.
4. Base of outlet Tower.
5. Outlet Duct.

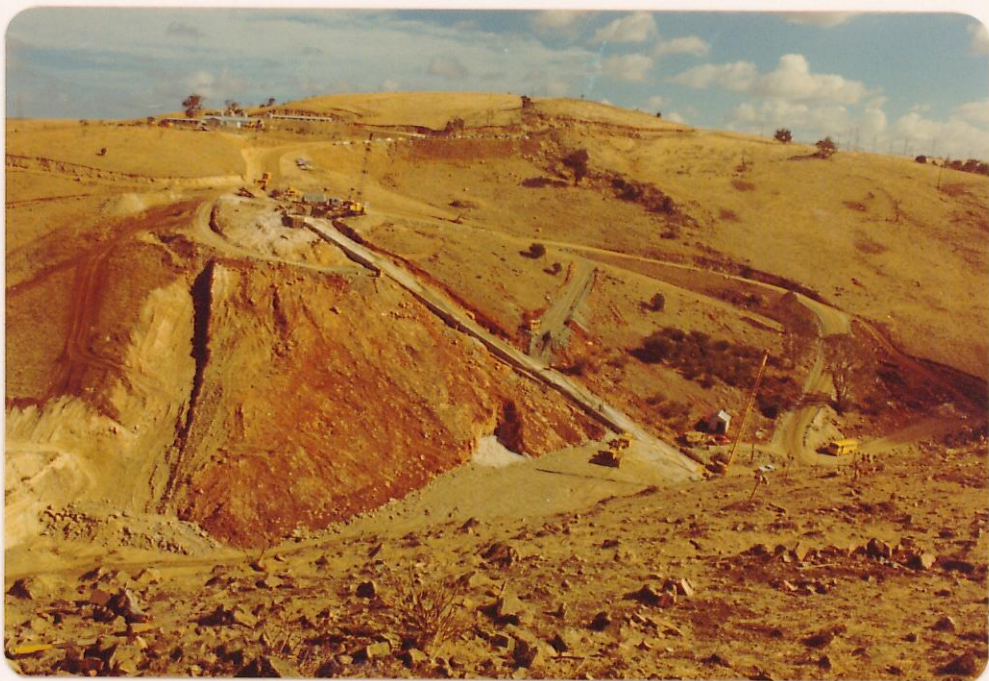
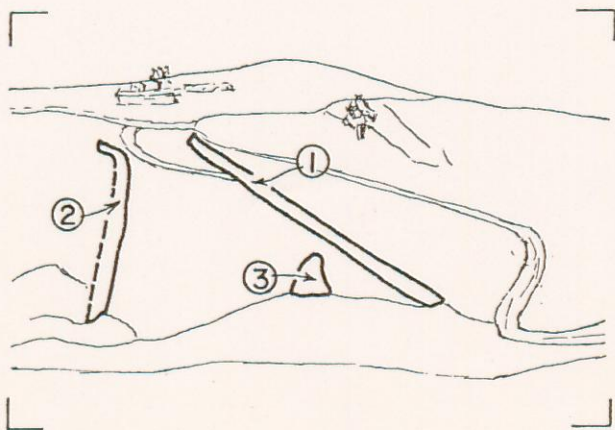
FIG. 11

NEGATIVE NO. 27417 - Dec. 1976
THE RIGHT ABUTMENT
1. Right bank grout cap.
2. Early investigation trench.
3. Excessive excavation along
a minor shear zone back-
filled with Zone 1 material.

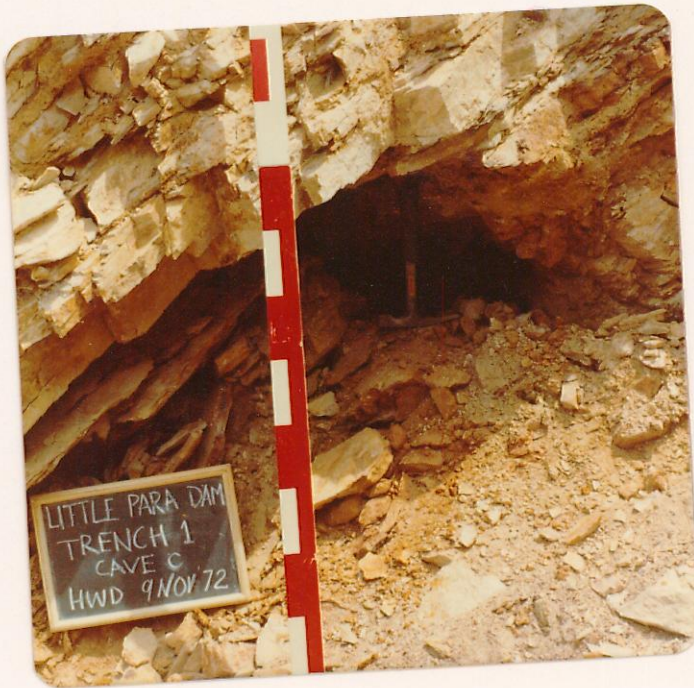
FIG. 13

Seams of completely weathered dolomitic siltstone and associated cavities (Figure 13) occur within the gradational strata between the base of the quartzite and top of the dolomitic siltstone. These strata are referred to in the field as transitional strata and were first exposed in an early inspection trench running down the right abutment. In earlier reports on the site they were variously described as flaggy quartzite, quartz-sericite meta-siltstones or phyllitic dolomite or foliated dolomitic siltstone and indicate the varying nature of the transitional strata. Samples of moderately weathered to completely weathered transitional strata were forwarded to the Soils and Foundations Laboratory Netley, of the Engineering & Water Supply Department. Grading curves from their mechanical analysis (Figure 65) show the weathered samples to be: 10% clay; 55% silt and 35% fine to medium grained sand.

NEGATIVE NO. 23112 - Nov. 1972
CAVITY EXPOSED IN THE RIGHT
ABUTMENT INSPECTION TRENCH
Looking downstream.

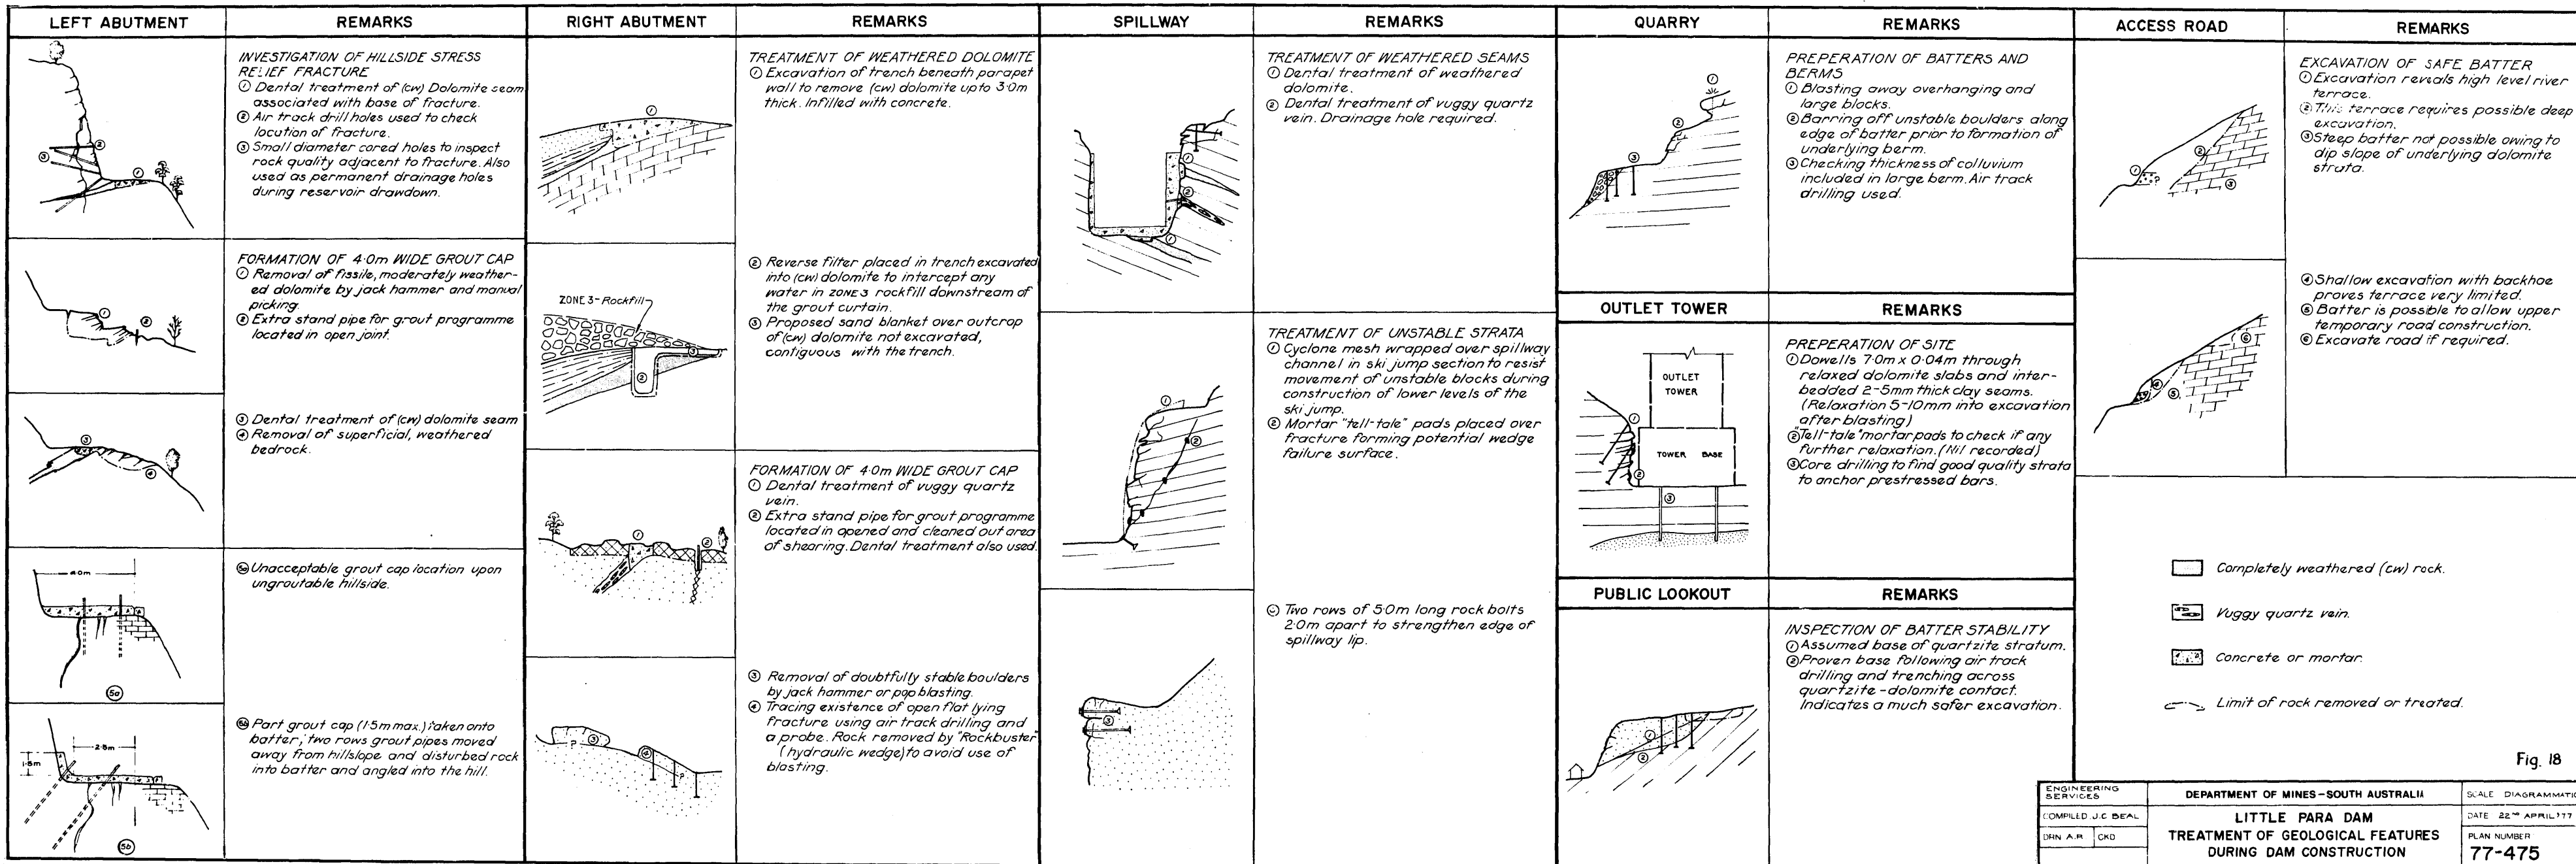
Fig. 18

Although early mapping proved a watertight reservoir an area of concern for possible leakage was on the right abutment adjacent to the dam where completely weathered outcrops of dolomitic siltstone occur immediately upstream of the dam (Figure 19). A weathered seam of dolomitic siltstone passes beneath the right abutment near to the full supply level of the dam and it was thought that impounded water could find a leakage path beneath the right abutment of the dam via these seams. For this reason some thought was given to sealing off any potential leakage path by placement of a clay blanket across the outcrops of the weathered

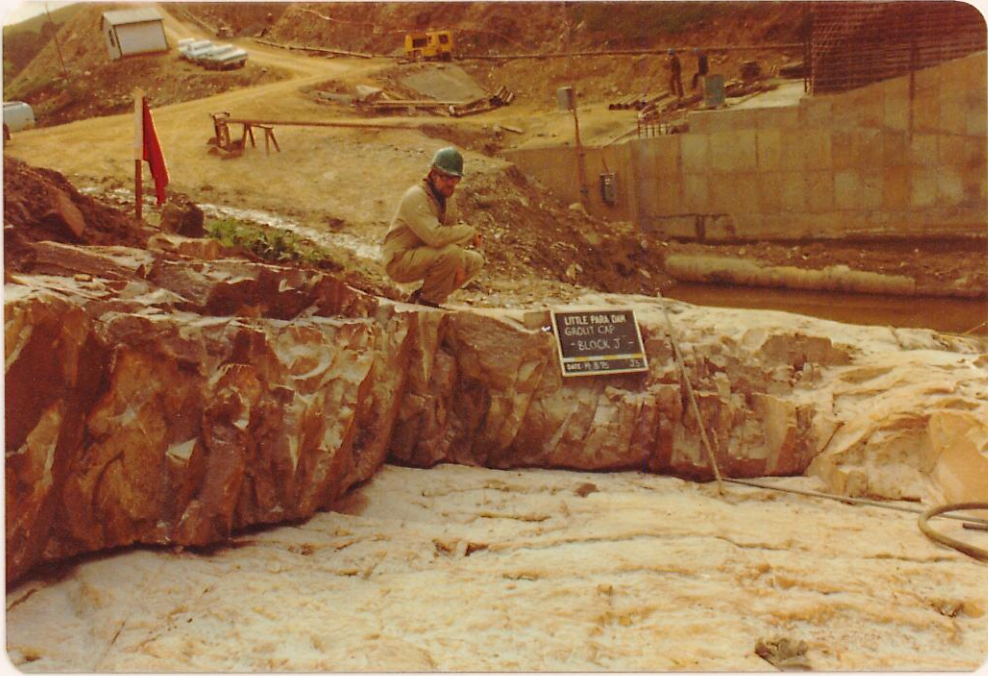
FIG. 22

NEGATIVE NO. 26747 - Aug. 1975
RIGHT BANK GROUT CAP EXCAVATION
Showing open bedding plane
persisting downhill. Overlying
quartzite removed by hydraulic
wedge until phase became tight.
Cofferdam and temporary diversion
pipe in background.

14. Grout cap open joints in quartzite.	GEOLOGY: In upper half of grout cap sluicing reveals trenchlike infilled joints and loose quartzite boulders.	Selective cleaning of open joints with jack hammers advised and removal of loose boulders.

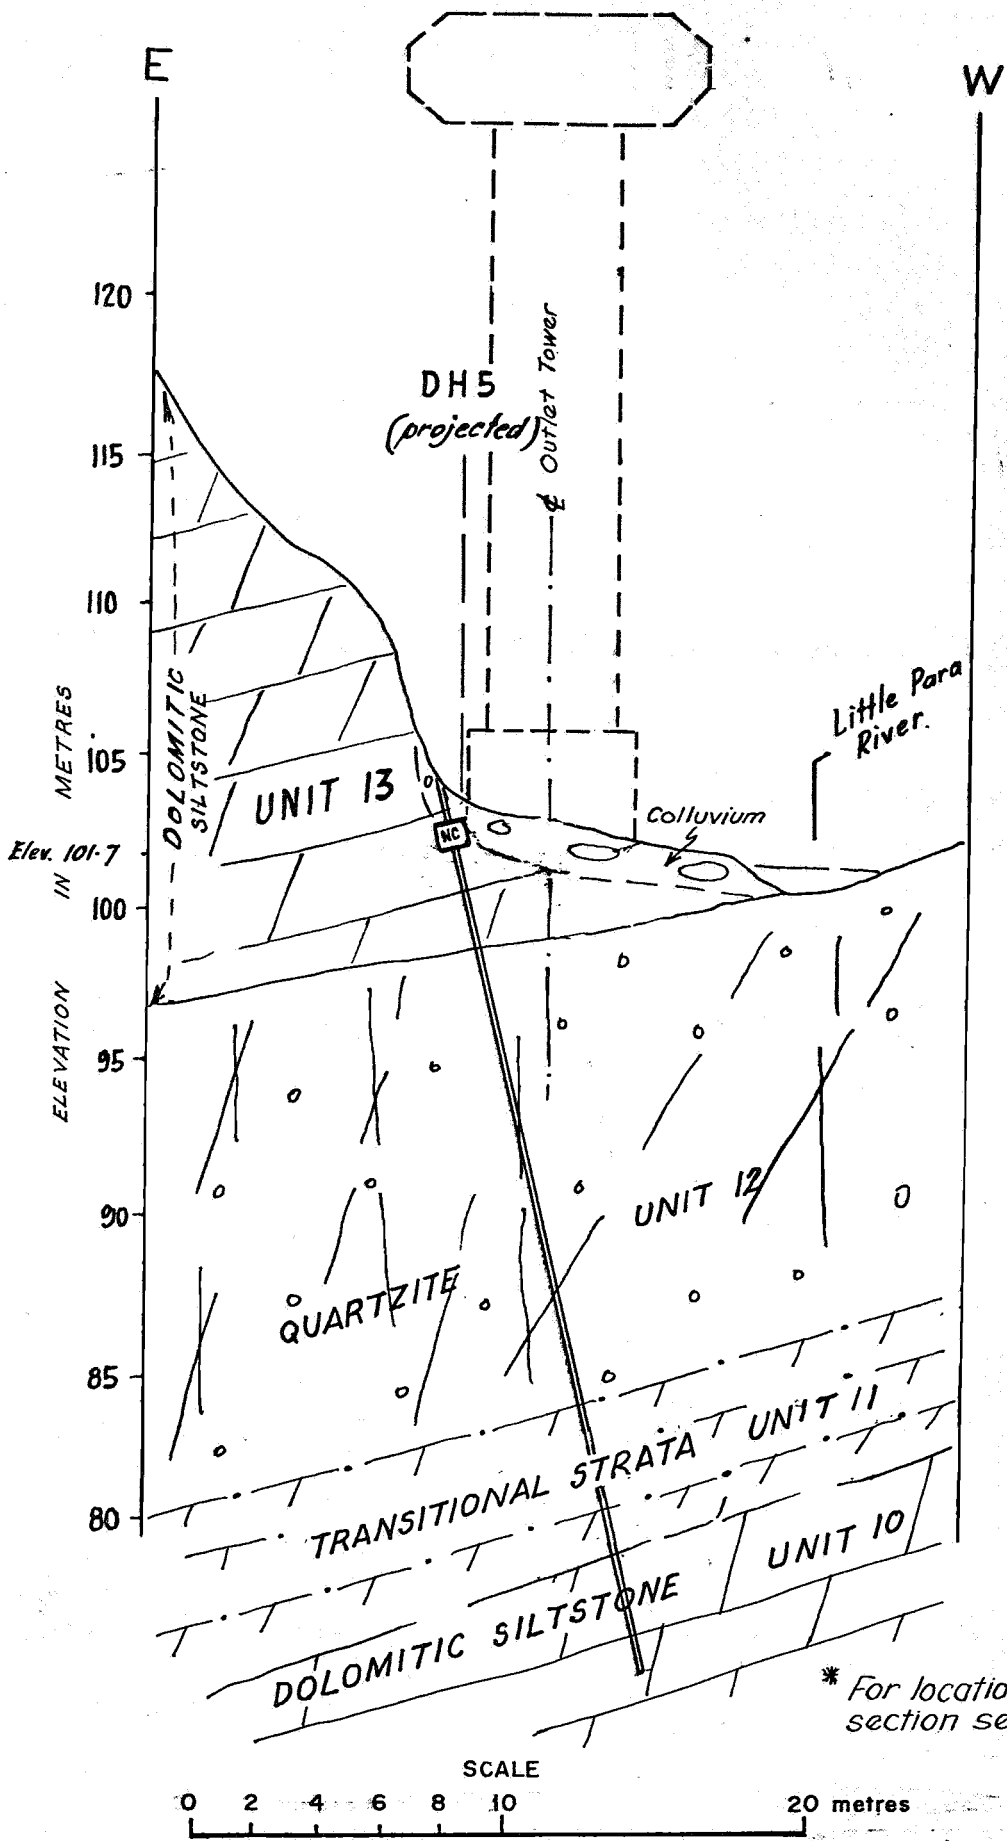
Fig. 23

During excavation of the Outlet Tower Foundations, stress release of strata was seen in dolomitic siltstone in the left abutment. Individual strata moved out 5 - 20 mm into the excavation, this occurring immediately after blasting. Telltale mortar pads and their measurement showed no further movement over the four months the excavation remained open.

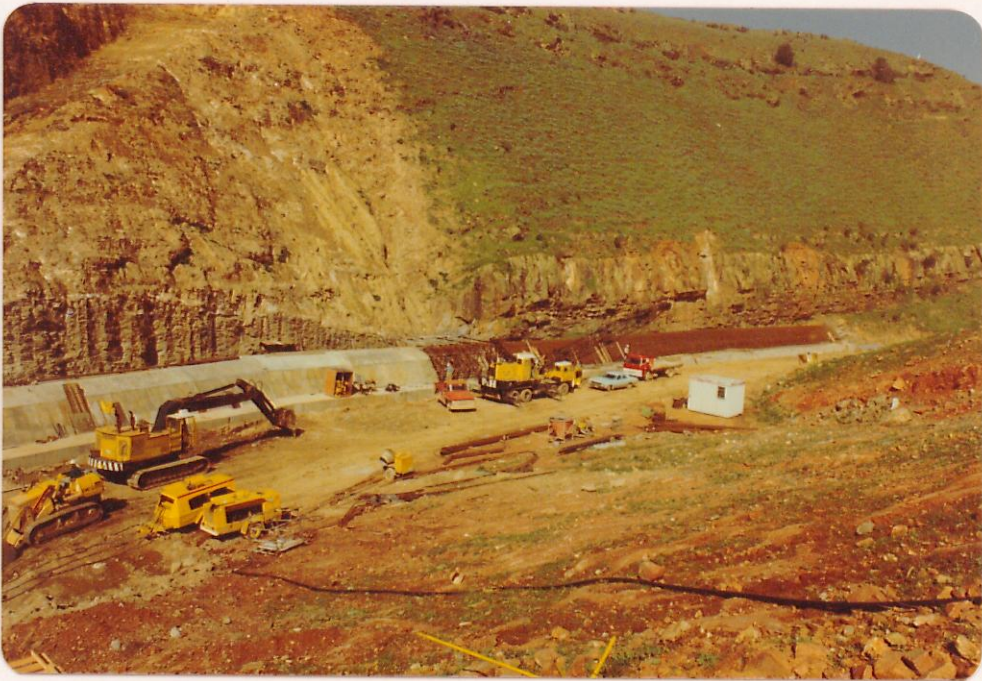
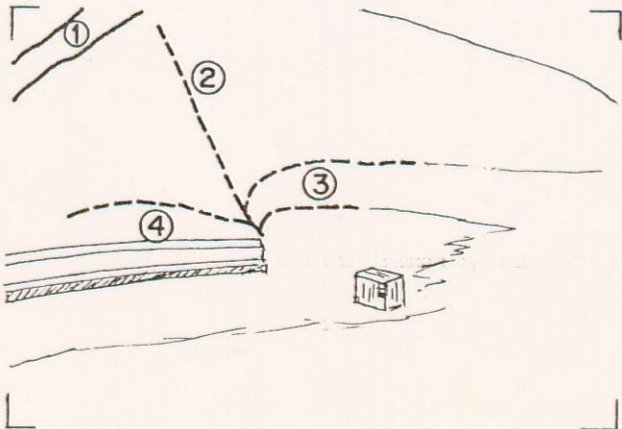
FIG. 24

NEGATIVE NO. 26751 - Dec. 1975
 LEFT ABUTMENT AND OUTLET DUCT
 1. Left bank group cap excavation.
 2. Shear Zone.
 3. Quartzite (UNIT 12) terminates
 against shear zone.
 4. Gently folded dolomitic
 siltstone.

13. Alignment of shear zone behind left bank. Possible hillside failure.	GEOPHYSICAL: Very low frequency (VLF) traverse indicates surface expression of shear zone.	Shear zone exhibits properties of wet tabular body. Zone considered a possible leakage path. Dental treatment where zone crosses grout cap advised.	
		<u>Right Bank</u>

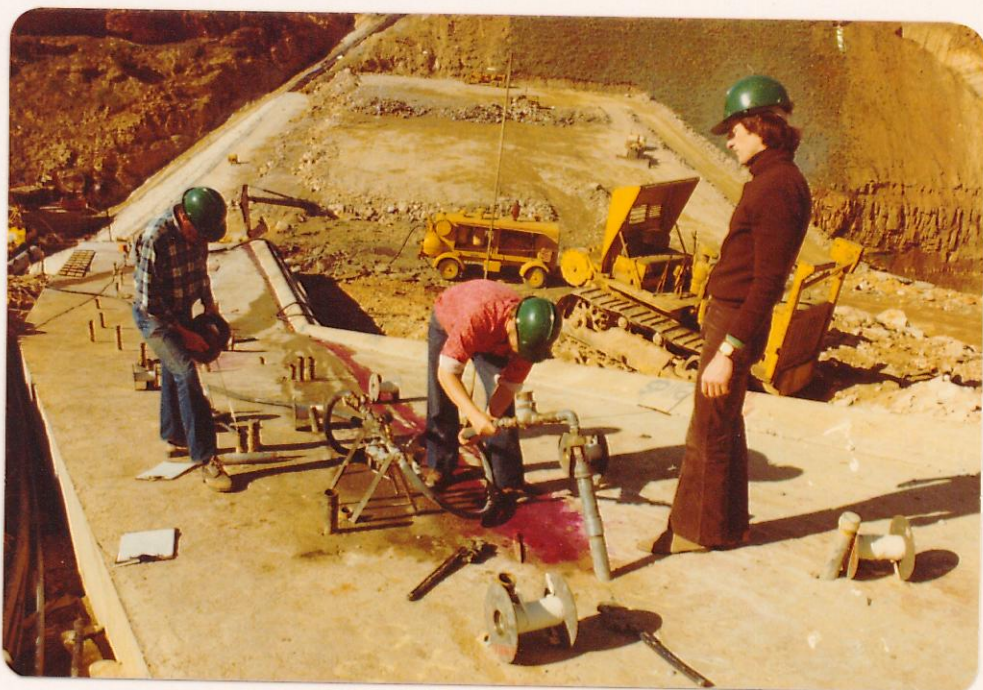
FIG. 31

NEGATIVE NO. 27513
April 1977
Water pressure testing -
Grout CAP BLOCK S
Canvas tape on drum lowered
down observation holes.
Note Rhodamine 'B' dye stain
