FOUNDATION DRILLING AT
ROBE SLIPWAY - LAKE BUTLER

A.F. WILLIAMS
GEOLOGIST

Rept. Bk. No. 79/21
G.S. No. 6140
D.M. No. 86/63
Eng. No. 1979/NA10

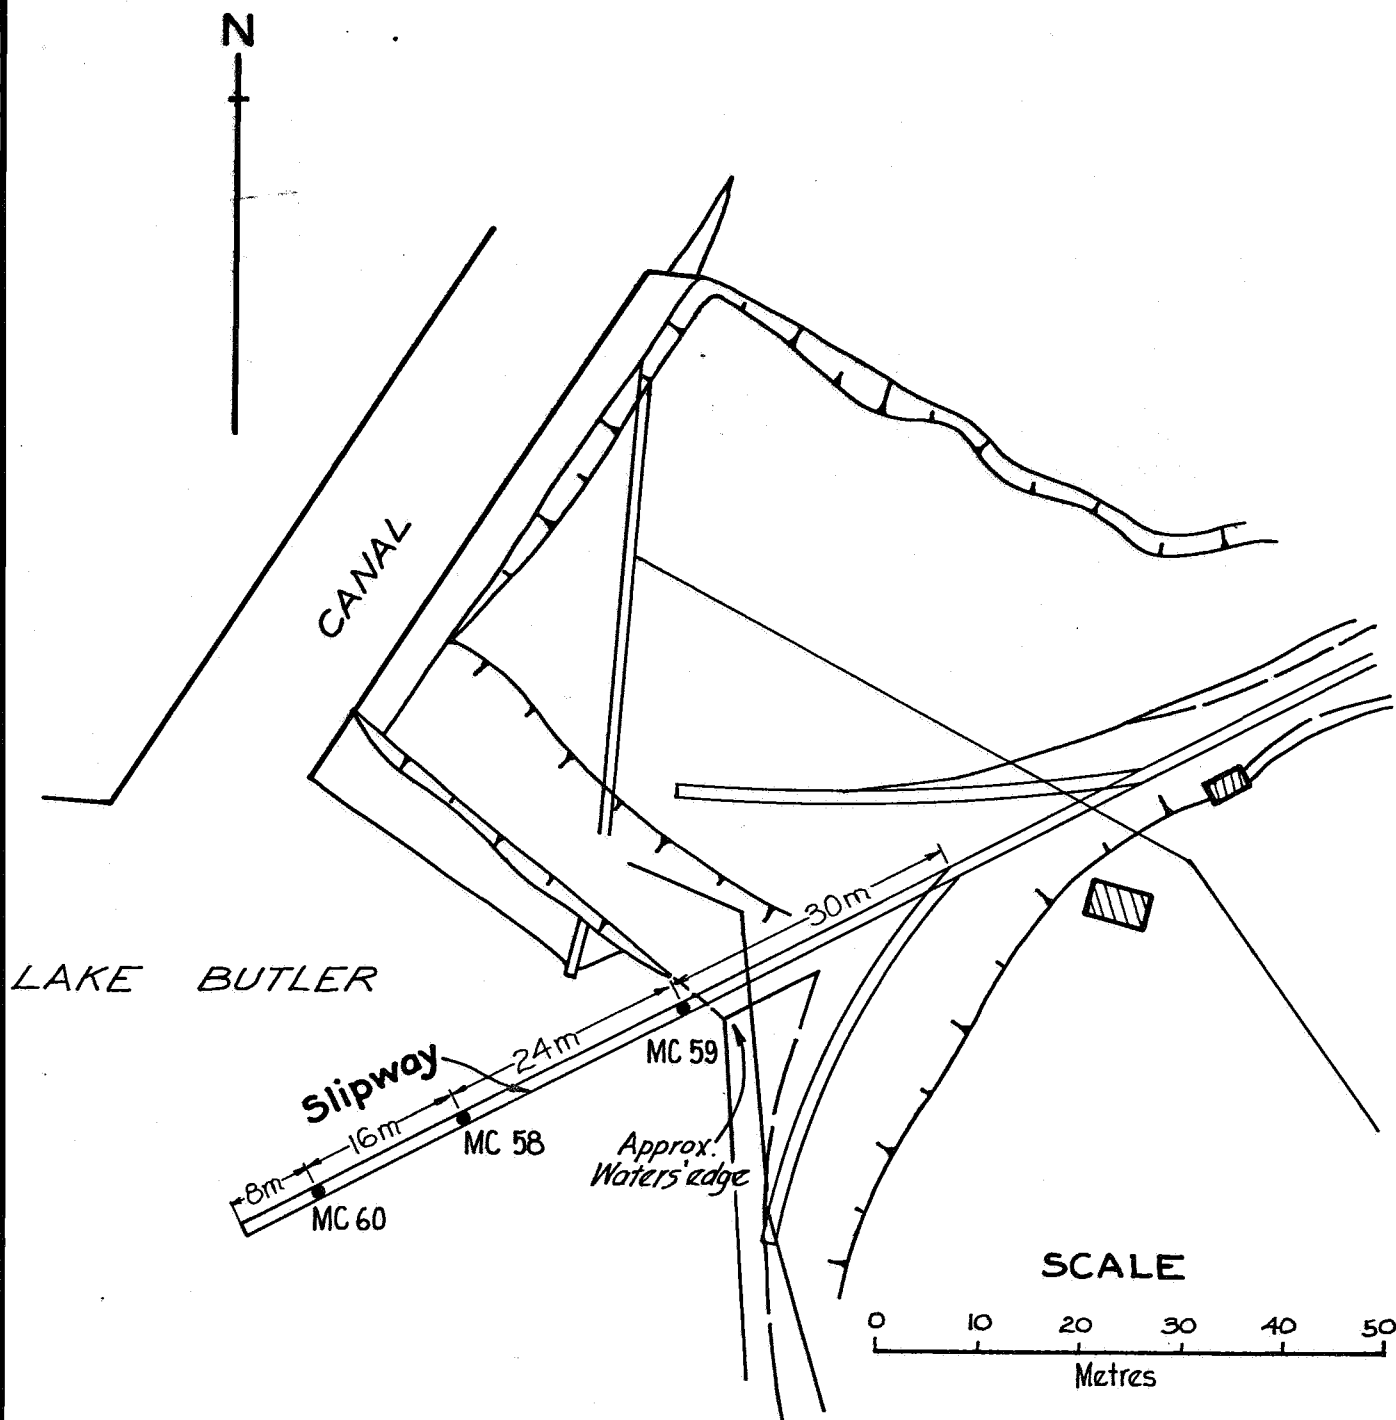
FIG. 2

Three holes were drilled to depths of 10.0, 12.2 and 13.4 m respectively 54, 30 and 70 m from the zero chainage point on the slipway (see Fig. 2).

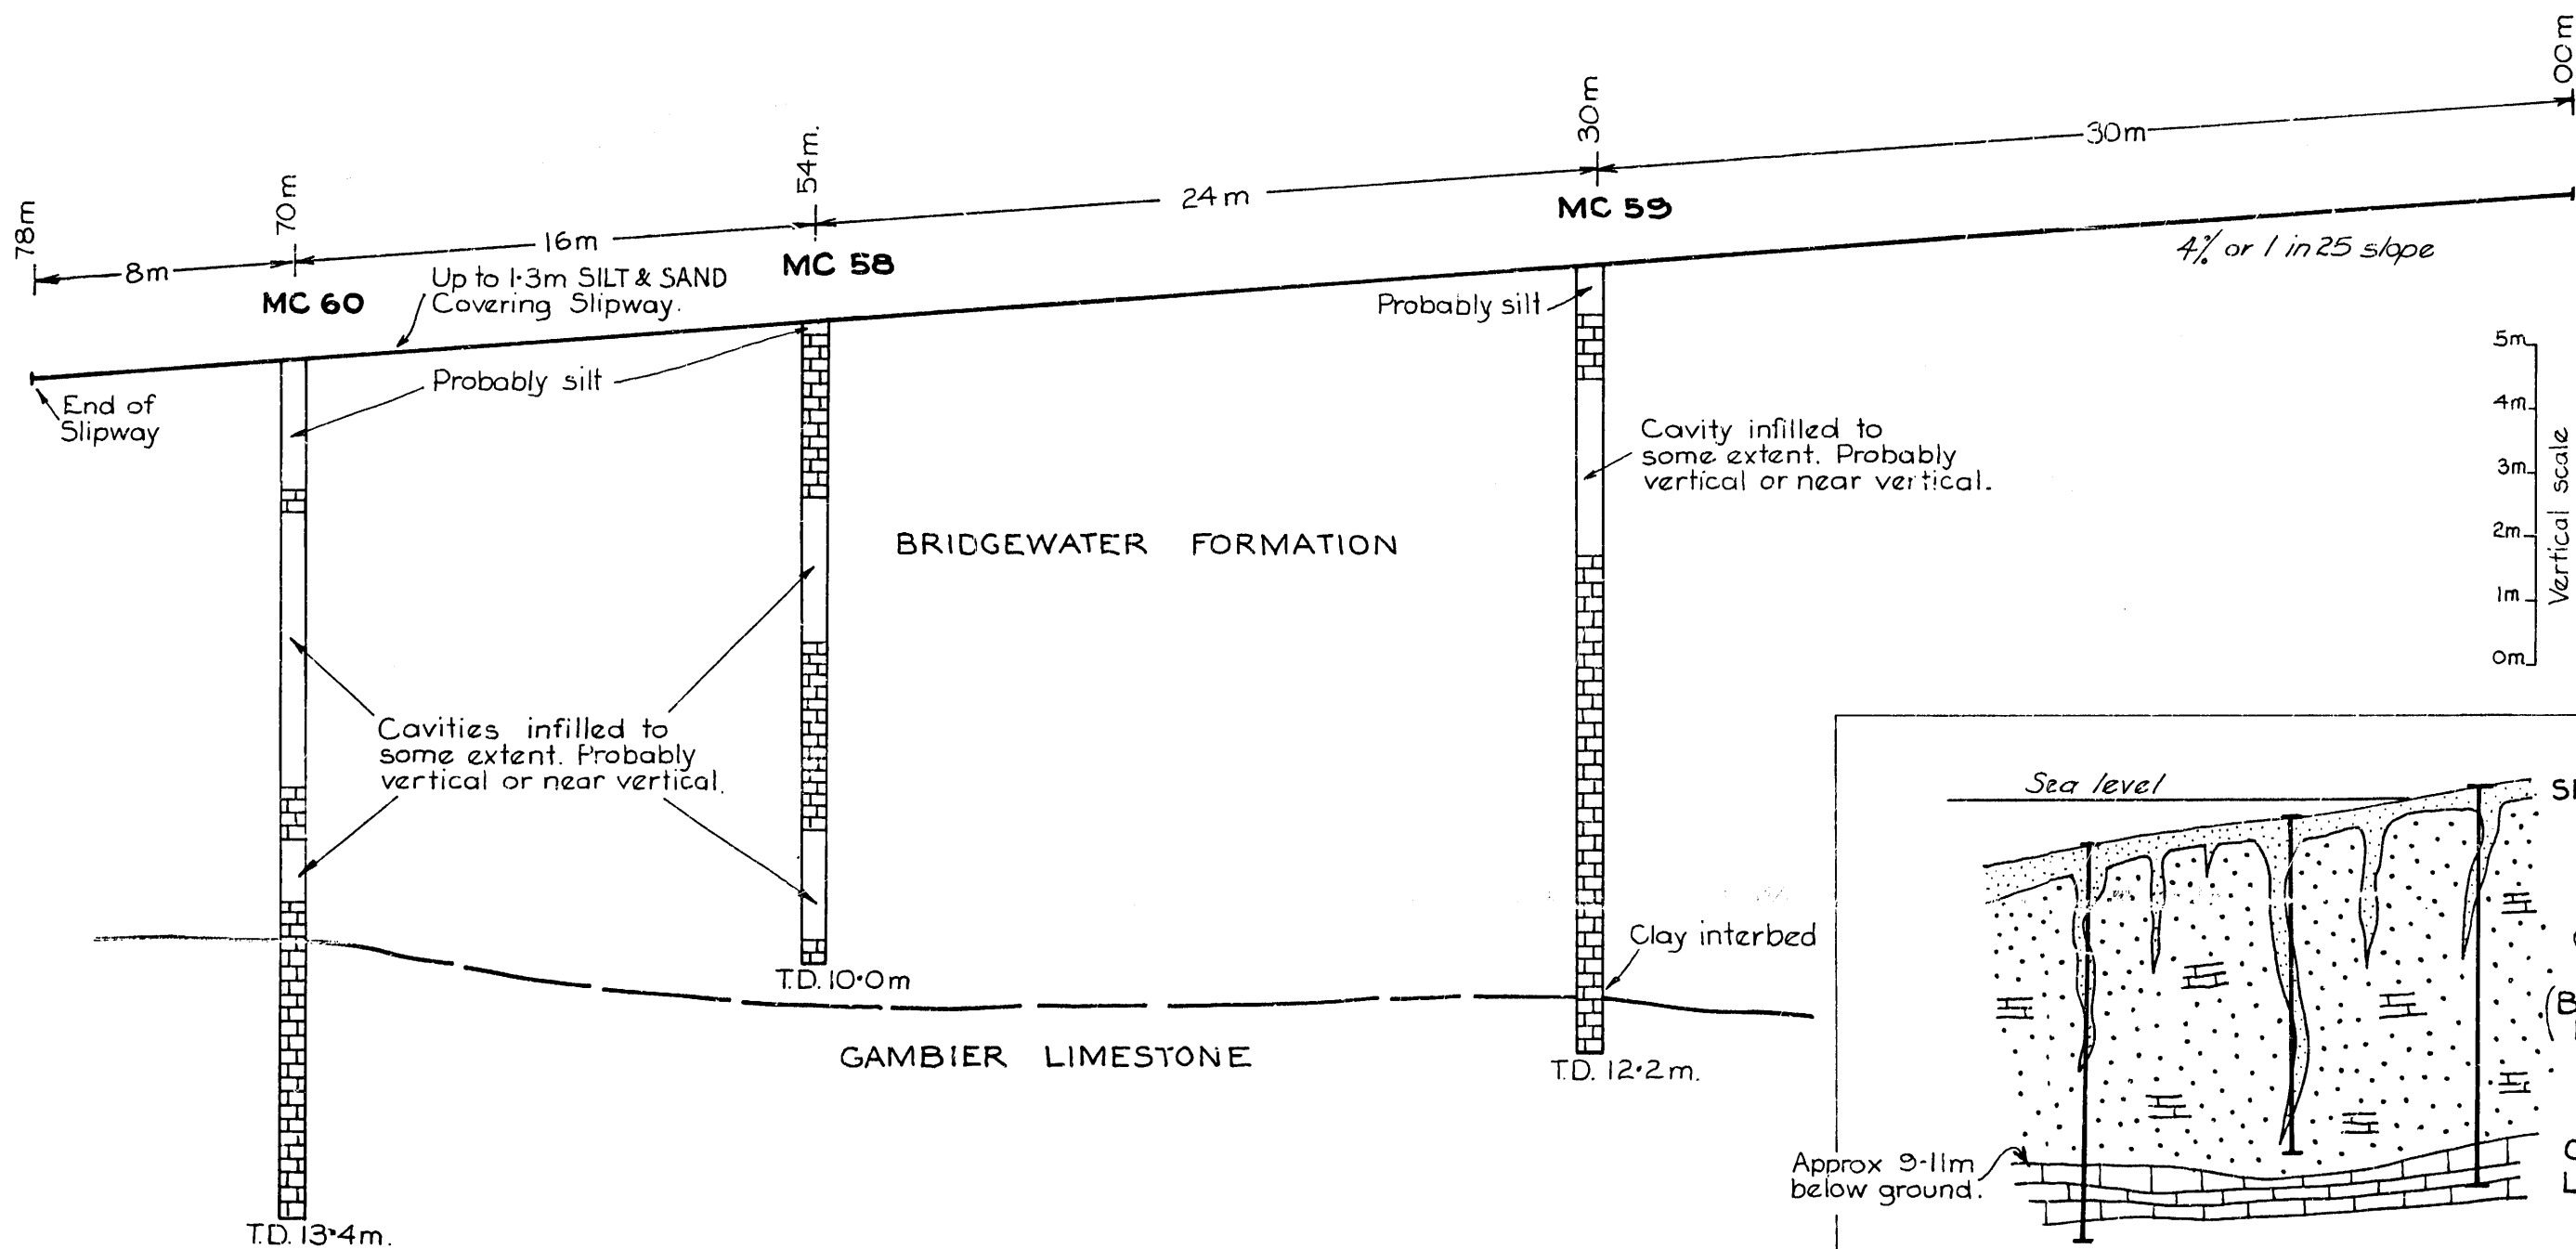
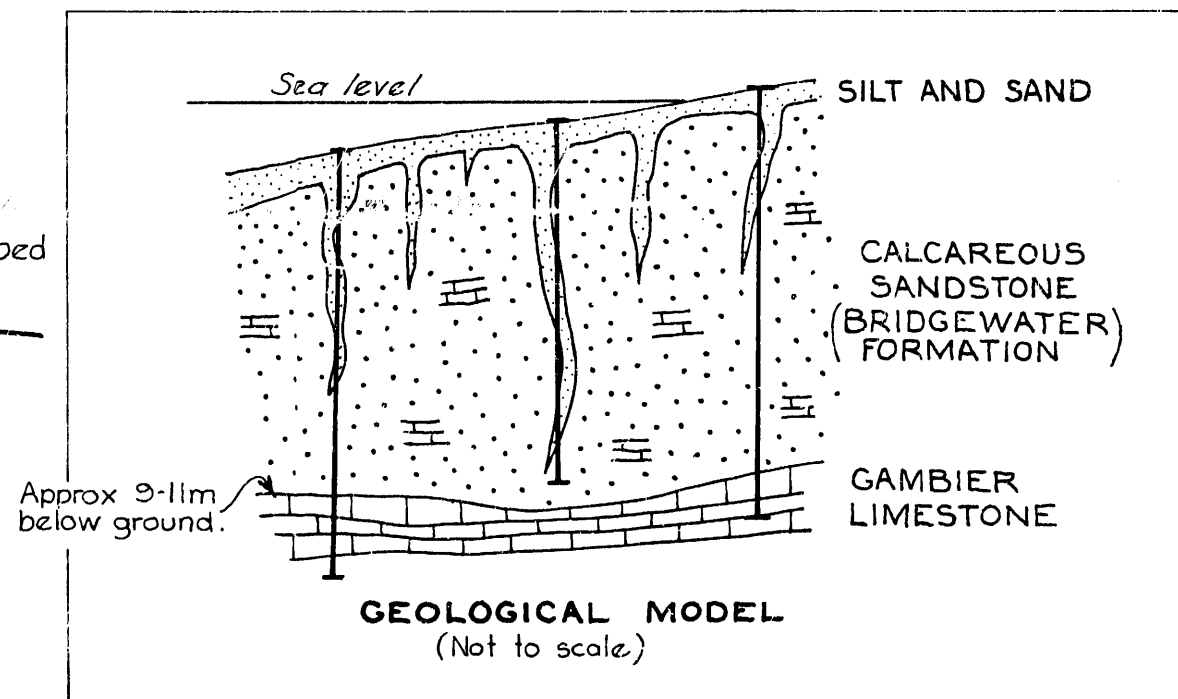
FIG. 3

All holes intersected Bridgewater Formation limestones at or near surface to about 9 m. MC59 and 60 struck Gambier Limestone at 11.4 and 9.0 m while MC59 was not drilled deep

enough to intersect Gambier Limestone, but the contact is expected only 1-2 m below the hole bottom. A geologic section down the slipway is shown on Fig. 3. Logs of all holes appear in Appendix I and a summary of rock properties is given in Table I.

No water returns were obtained in all three holes within the Bridgewater Formation and the driller reported silt in these sections. It is suspected that there are moderate size vertical solution pipes, varying from 0.3 to 1 m in diameter as often seen in road cuttings, occurring through this formation. From the logs they appear restricted to the Bridgewater Formation but it is felt that insufficient thickness of Gambier Limestone has been penetrated to preclude their presence in that formation. They do not appear within the drill holes 9.5 m below the slipway surface.

Lack of core recovery and drilling water returns on all holes drilled indicate the presence of narrow fissures formed by solution effects within the limestone. These fissures may extend to considerable depth and form the main geological hazard on the site. In view of this it is recommended that steel piles be used, designed to effect maximum penetration into the limestone, and that each pile be driven to refusal.
