Amdel Report

No. 1278

REHABILITATION OF BRUKUNGA
PYRITES MINE

July 1978 - June 1979

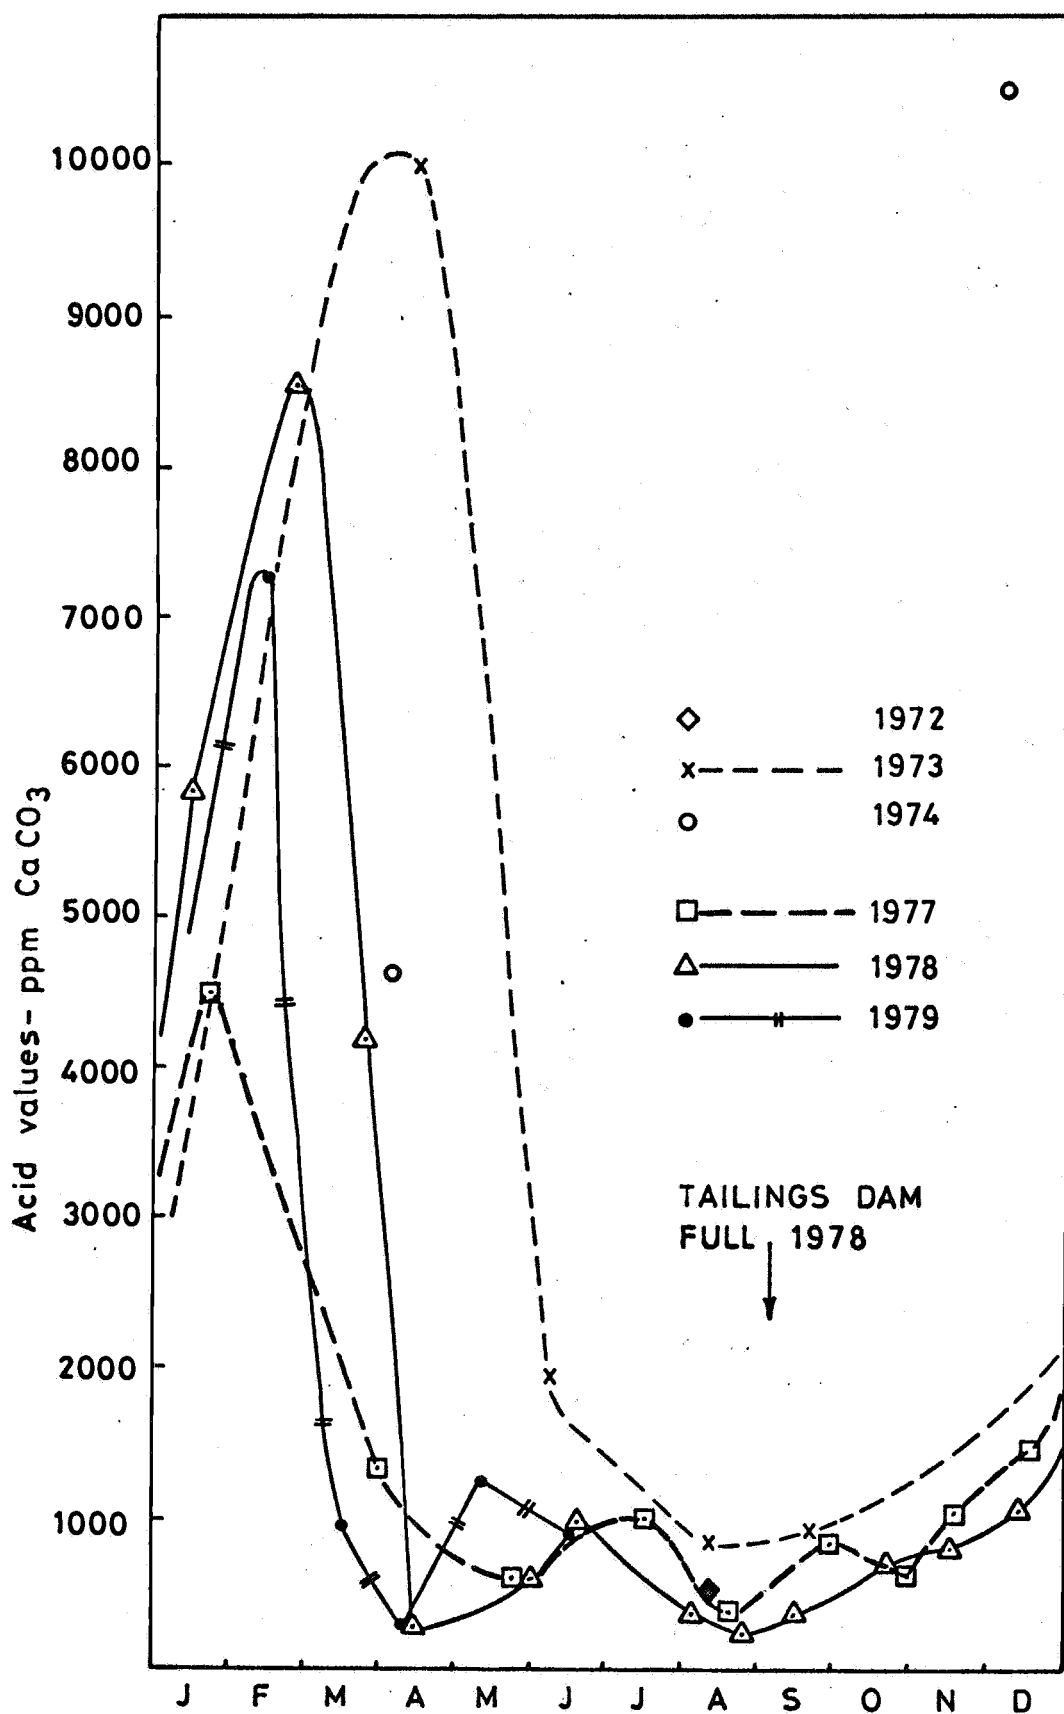
FIG.2: ACID VALUES AT MINE EXIT SAMPLE POINT 11

The acid-values of samples of water taken from Dawesley Creek near the Nairne road bridge about 0.5 km from the southern limit of the mine (sample point 11) indicate large seasonal variations, as shown in Fig. 2. During summer months there was little or no surface flow at the sampling point and very high acid-values were obtained. The data collected in 1977 to 1979 showed that the rains in March and April were sufficient to generate a flow in the creek, and acid-values in samples rapidly fell to below 1000 ppm CaCO_3 .

The effectiveness of the diversion schemes implemented in 1977 is shown in Fig. 2. The high summer peaks of 1977 to 1979 were all significantly lower than the corresponding 1973 samples, and in 1973 the creek flow was sufficient to dilute the acid-values to less than 1000 ppm CaCO_3 only in August/September, compared with the 1977 to 1979 data showing periods of 7 to 8 months with acid values less than 1000 ppm CaCO_3 .

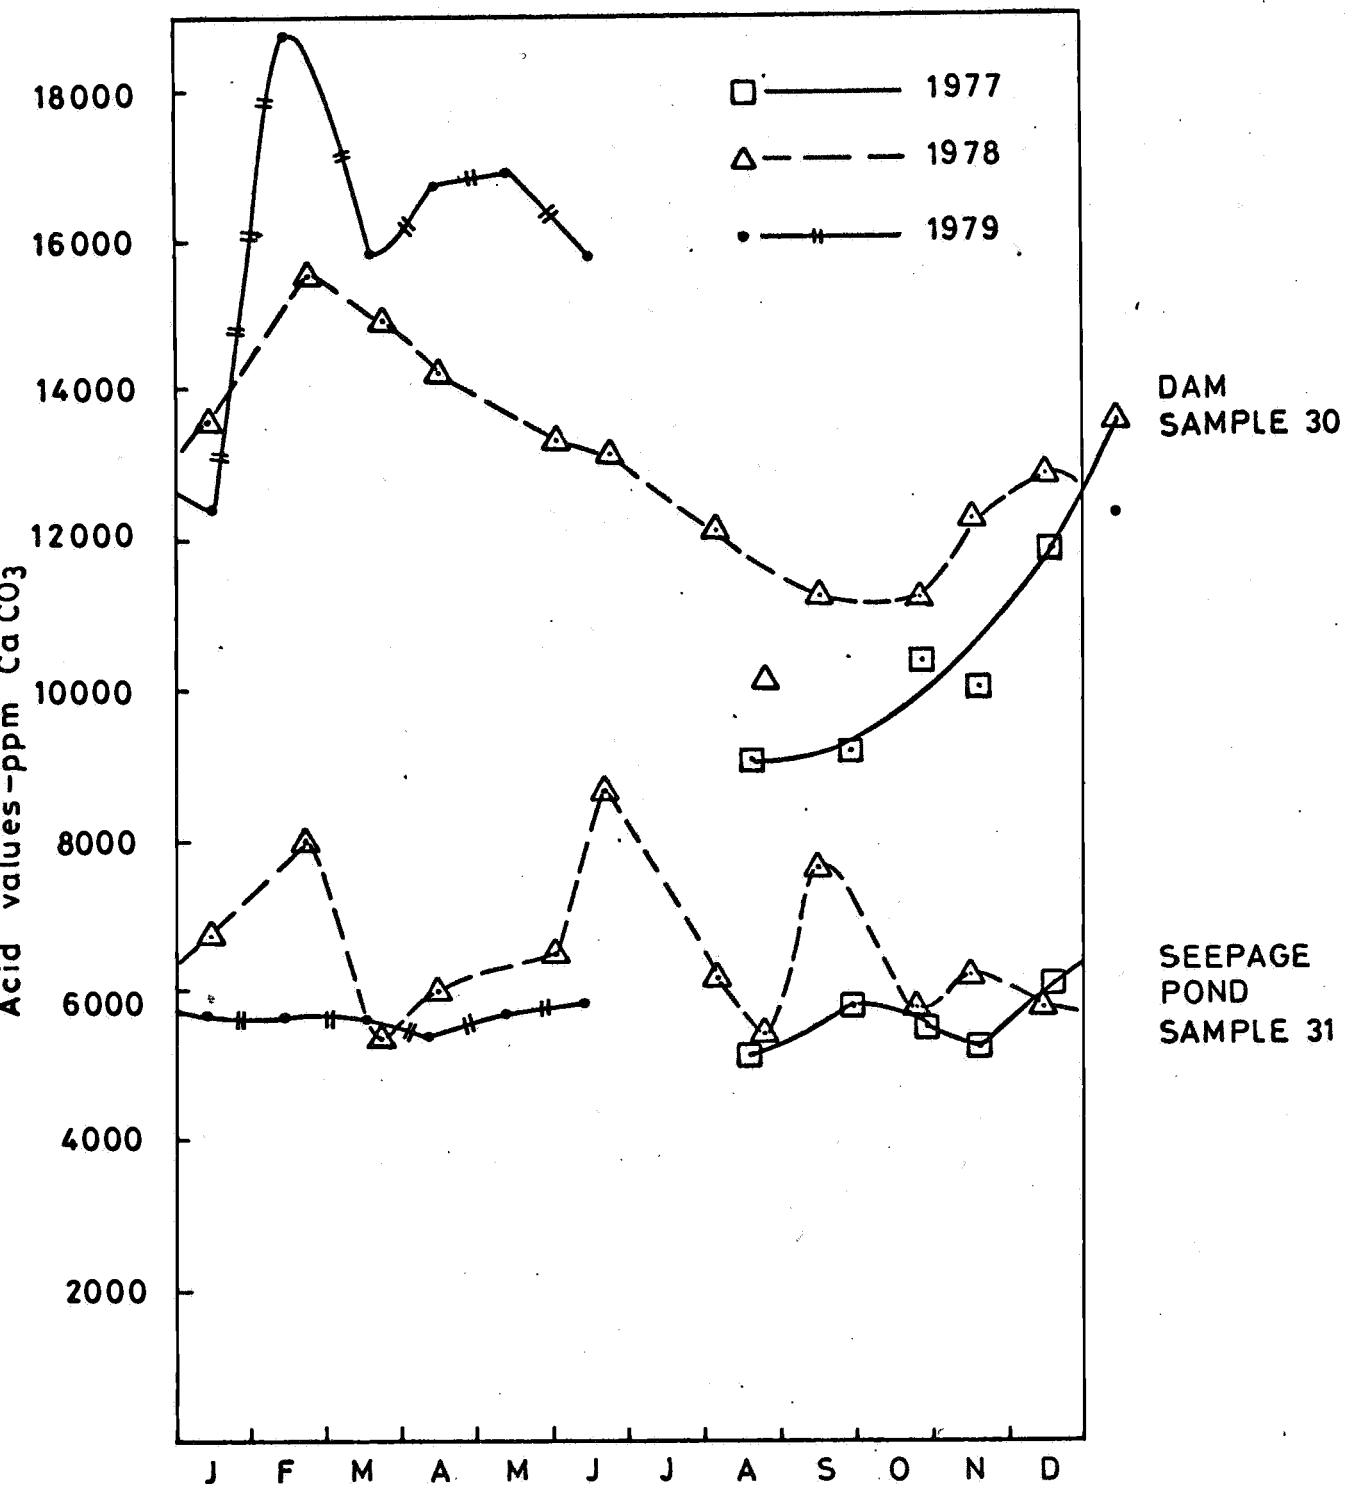
FIG. 3 : ACID VALUES TAILINGS DAM POND
AND TAILINGS DAM SEEPAGE

The acidity of the tailings pond (Sample 30) is shown on Fig. 3 to be increasing each year, and the present values can be compared with values of 5000 to 6000 in 1973. This increase in acidity has not yet percolated through the tailings, however, as the acidity of the tailings dam seepages has remained near 6000.

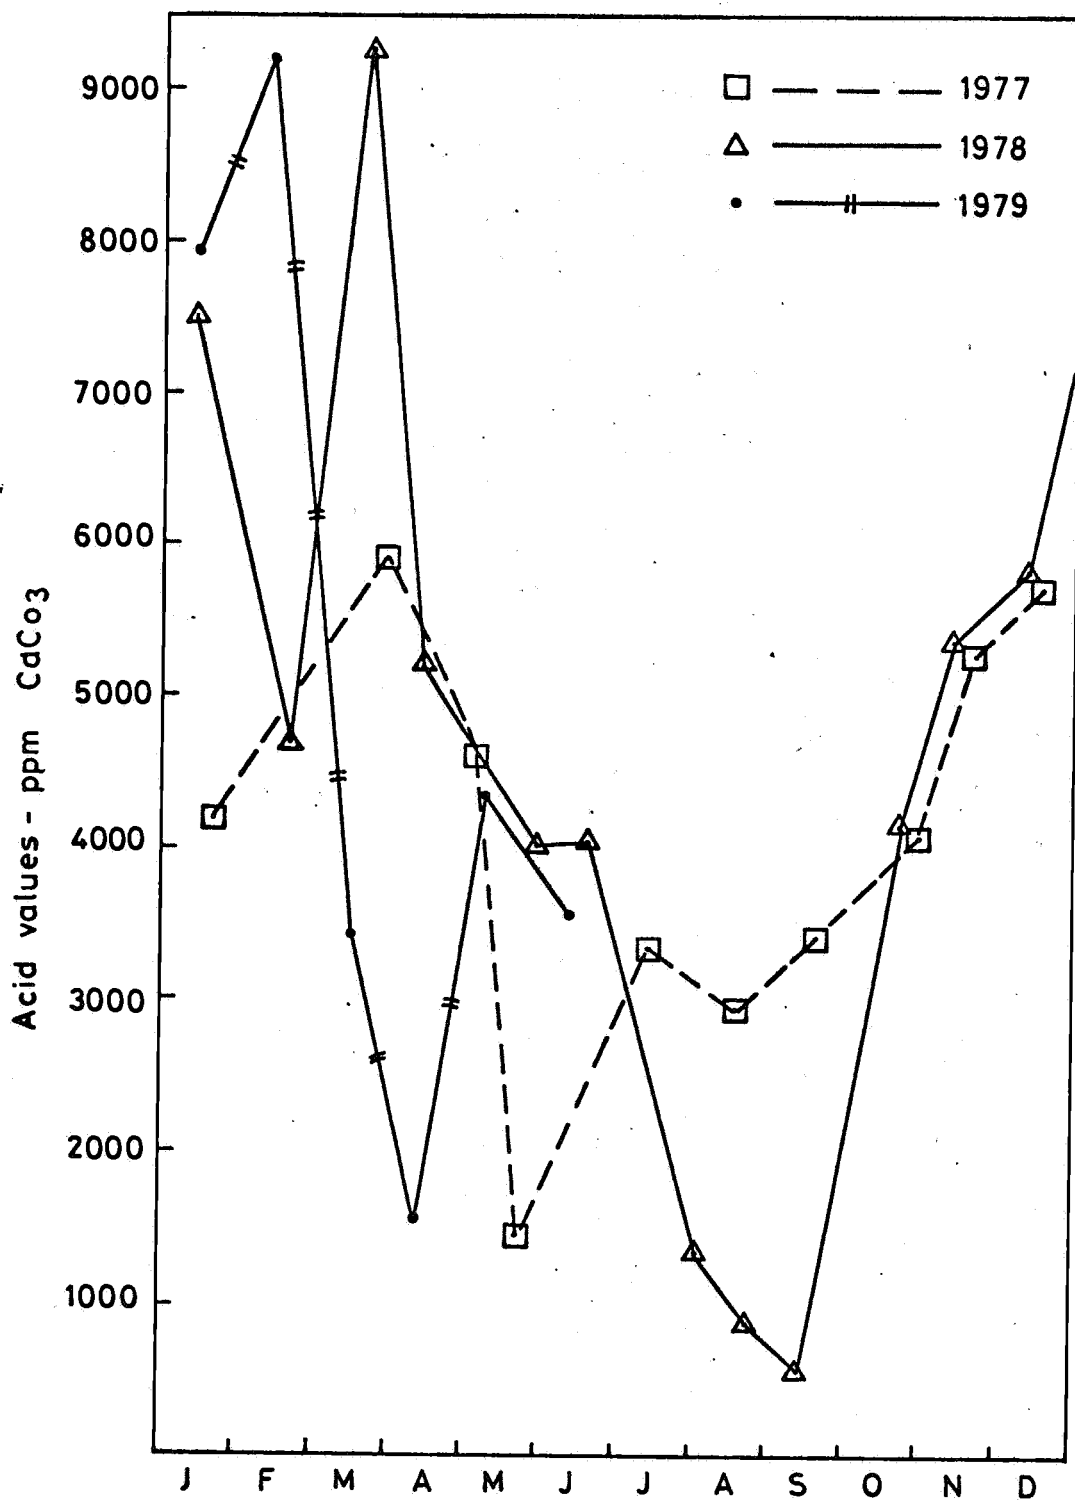
FIG. 4: DAYS CREEK - SAMPLE POINT 16

The acid-values of water samples collected from two points along Days Creek (sample points 15 and 16) are given in Table 4 and the data for point 16 (the junction with Dawesley Creek) is shown in Fig. 4. The samples showed some seasonal variations but all the acid-values were very high and not acceptable, although due to the comparatively small Days Creek flow the effect on Dawesley Creek was usually minor. As the upper reaches of Days Creek (before it enters the mine) were frequently dry, the flow at the junction with Dawesley Creek can be attributed to seepages, which appear in Days Creek near the start of the new drainage channel for Seepage E.

Possible sources for the seepages are Seepage E, the northern mullock heap or the apparently permanent springs near the northern end of the main mine bench. The last source is the most likely, as Seepage E is substantially more acidic than Days Creek.

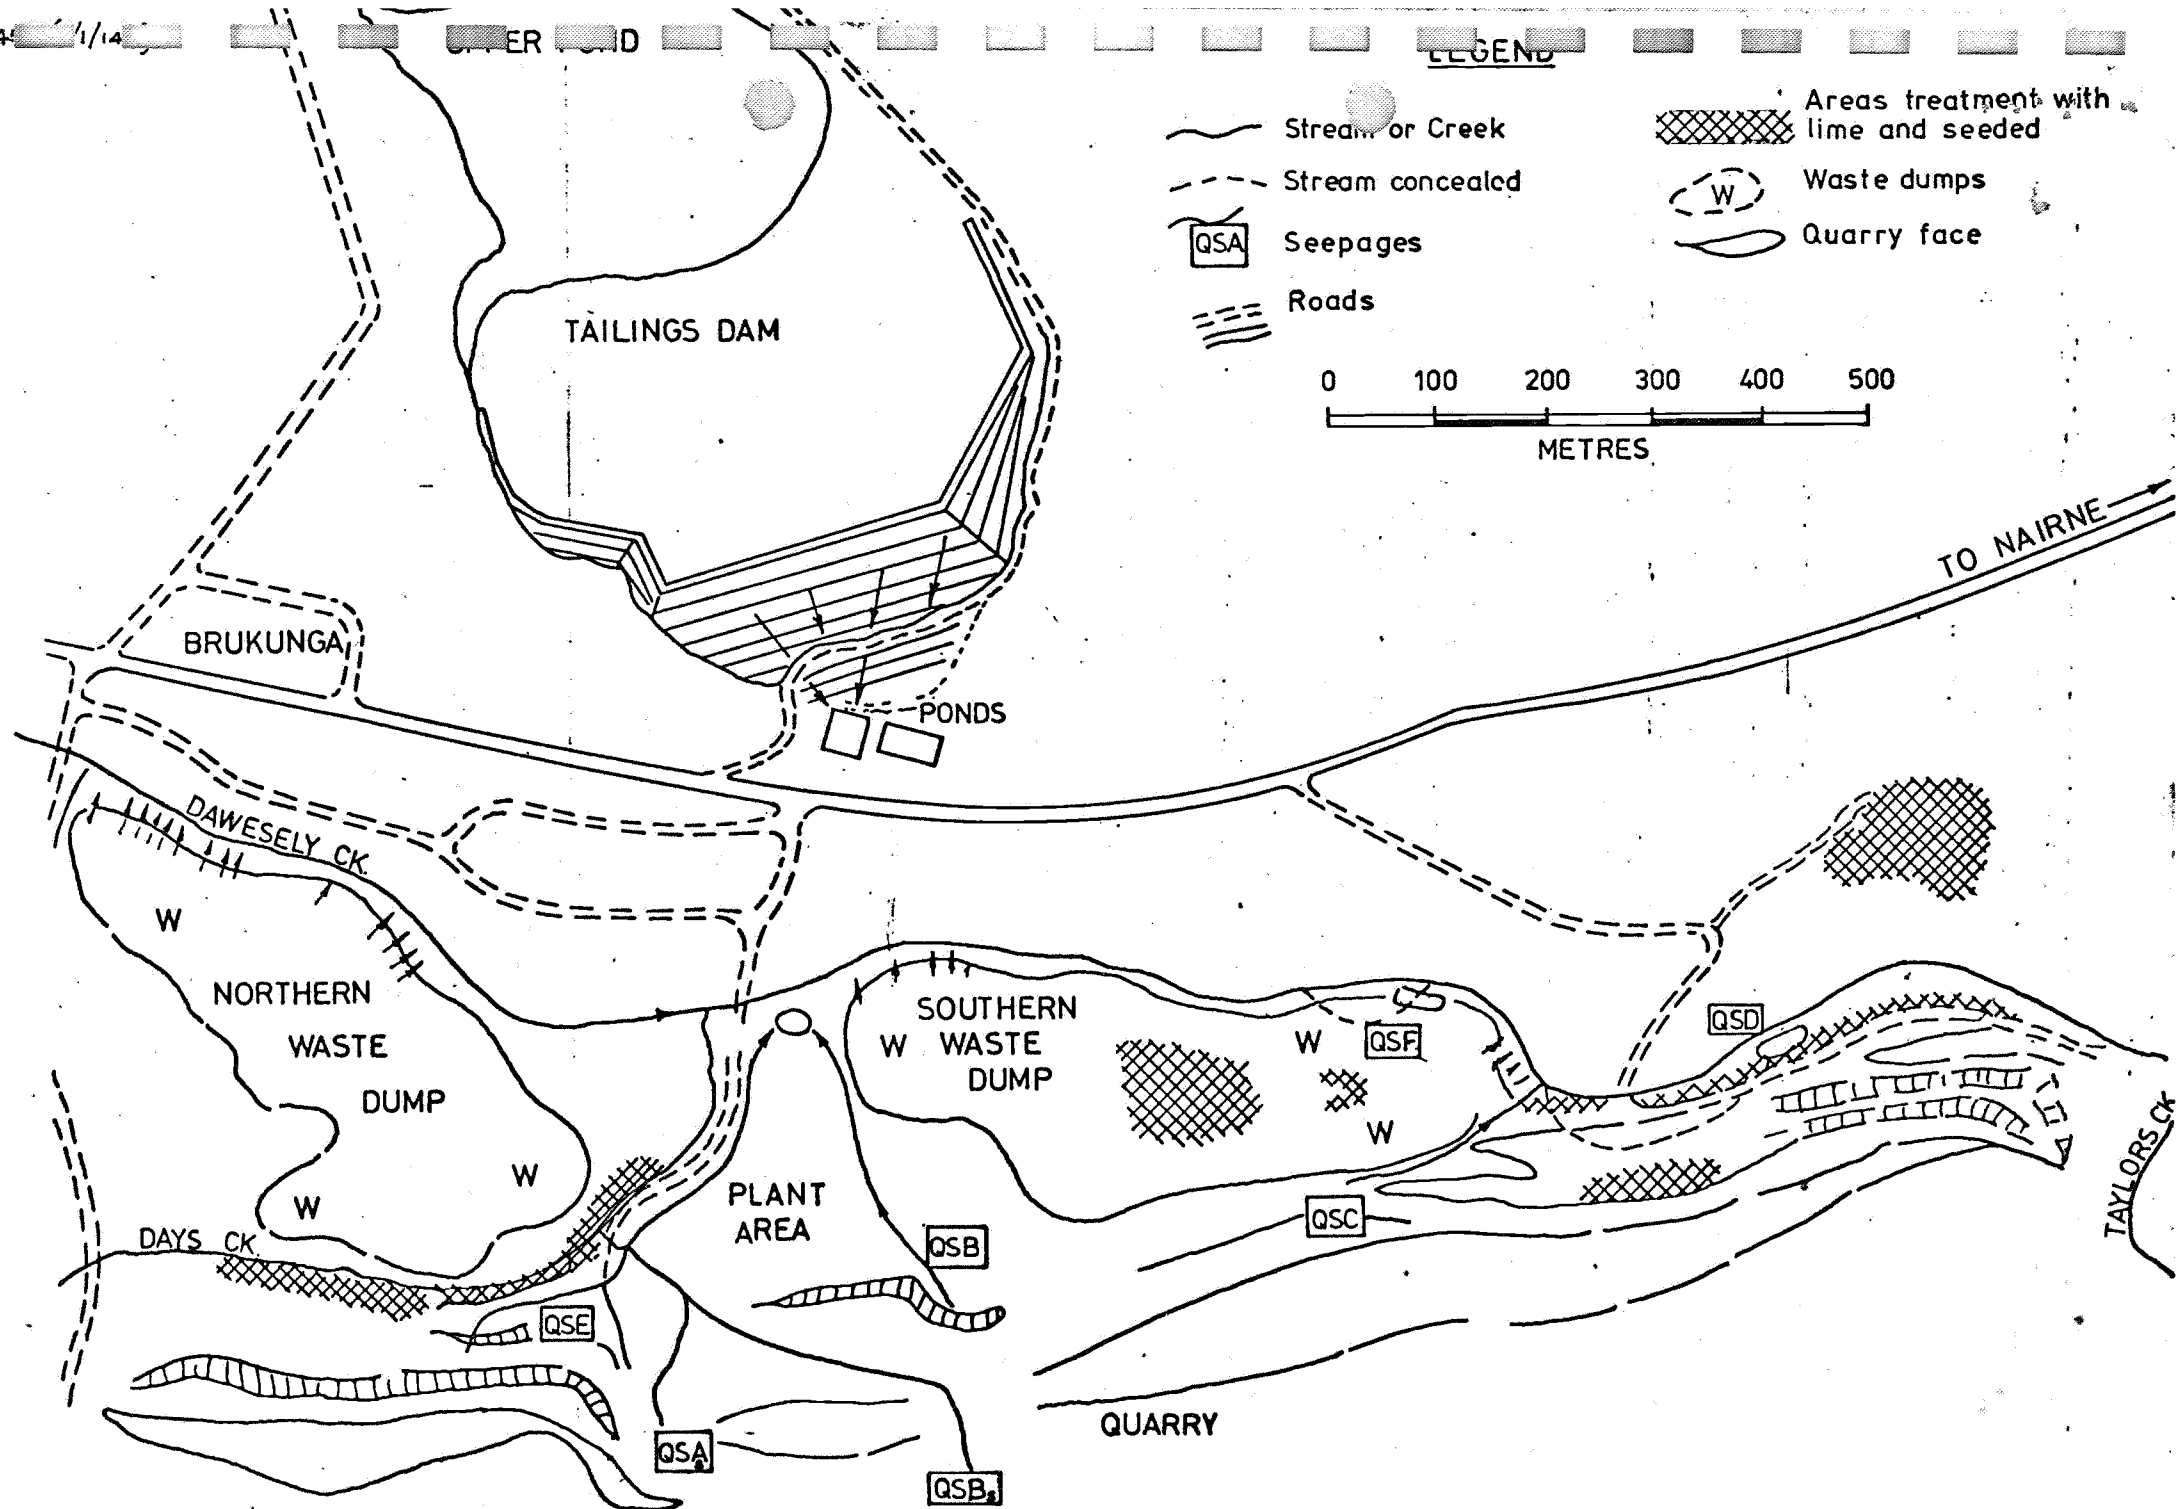
FIG. 5: BRUKUNGA MINE. AREAS OF MULLOCK TREATED WITH LIME.

Following the successful distribution of lime onto areas of the mullock heaps, the areas were treated by hand sowing with fertiliser and seeds to try and establish some vegetative cover. The fertiliser was added at a rate of about 50 kg/ha each of N, P and K as recommended by Dr Roberts, and the following mixture of grasses and clovers was sown:

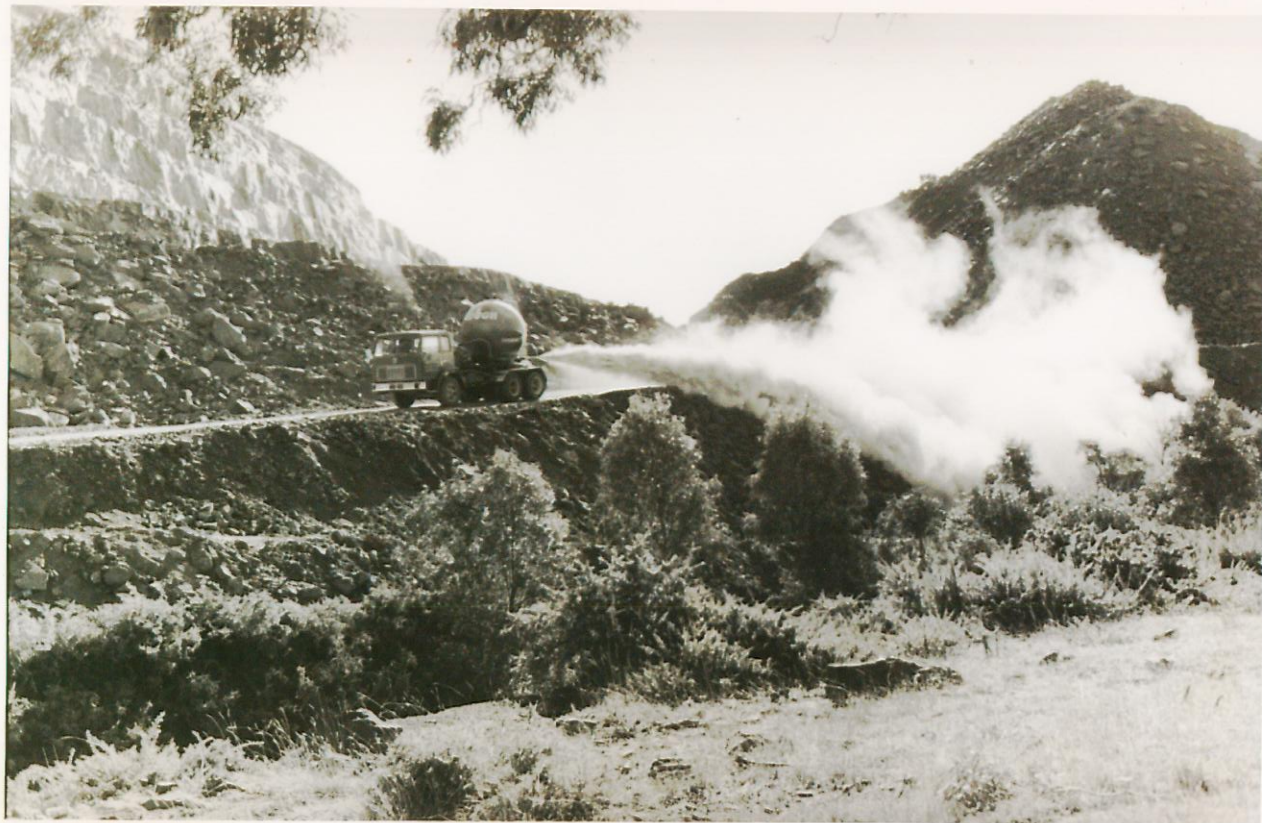
PLATE 1: PNEUMATIC DISTRIBUTION OF LIME

Keough Sands Depot Pty Ltd were approached and agreed to the hire of their pressurised dry sand tanker. Ground, kiln-dried limestone was purchased from Rowley Industries of Murray Bridge. The lime was stated to be about 55% minus 75 μ m and 100% minus 1.5 mm. Three loads of ground limestone were applied to the areas shown in Fig. 5. The lime was fluidised in the tanker and blown through a 75 mm hose at a pressure of about 200 kPa. The hose available was only 40 m long which permitted only areas fairly close to the tanker to be treated. Where firm ground was close to the slope being sprayed, no hose was required (Plate 1).

The results of the tests were quite encouraging as fairly good distribution of lime was achieved. However, the back pressure at the hose outlet was so high that it was only just controllable by two men, and any future work using this technique should employ a smaller size hose, say 50 mm. In order to reach the lower portions of the southern mullock heap, and some areas of the northern mullock heap which are

inaccessible by vehicles, a longer hose, say 200 m, would be required. The lime contains considerable fine dust and personnel should wear dust masks and goggles during spraying. It is also desirable that the wind is blowing away from the Brukunga township during spraying to avoid complaints from inhabitants.
