REPT.BK.NO. 84/36
HAPPY VALLEY FILTRATION PLANT:
PROGRESS REPORT TO NOVEMBER
1983

GEOLOGICAL SURVEY

J.C. BEAL

MAY 1984

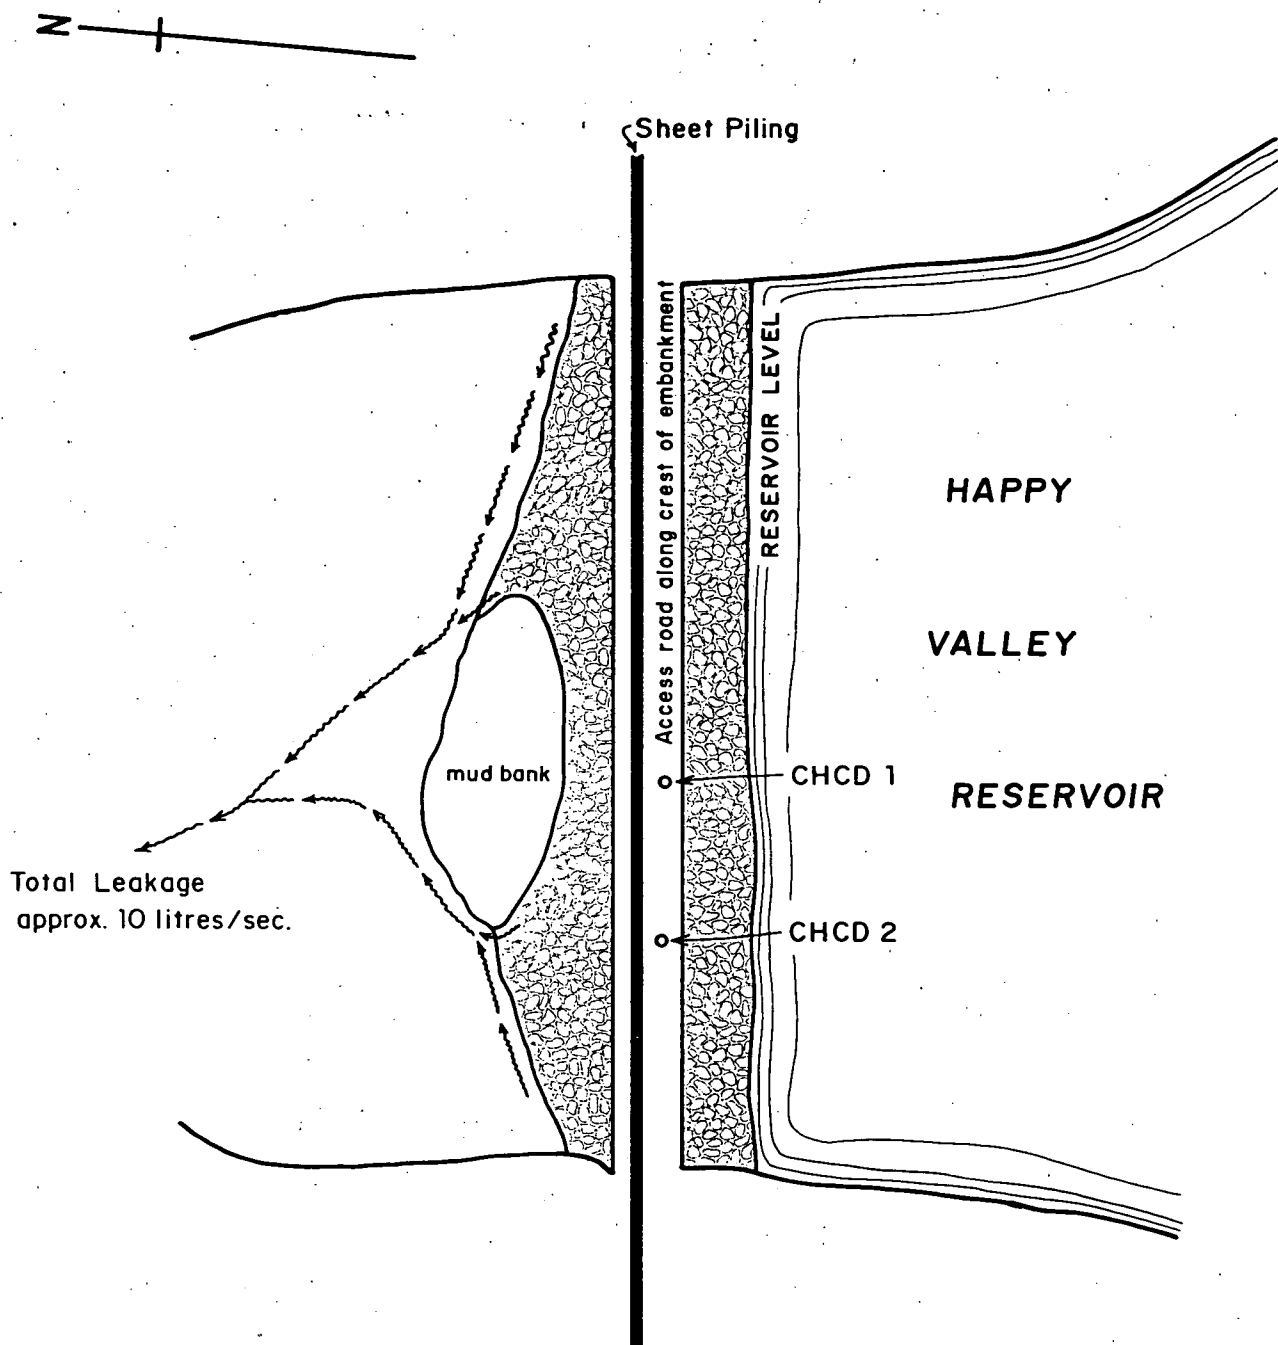
DEPARTMENT OF MINES AND ENERGY SOUTH AUSTRALIA		COMPILED J. B.	WR 5.7.84 C.D.O. DATE
	HAPPY VALLEY FILTRATION PLANT		DRAWN M. B.	SCALE
	DIAGRAMMATIC PLAN OF COFFER DAM		DATE Dec '83	PLAN NUMBER
			CHECKED	S17182

To enable construction of the filtration plant an coffer-dam was constructed across the arm of the reservoir leading to the new Happy Valley outlet tunnel. The coffer-dam consisted of driven sheet piling supported by placed coarse aggregate. After dewatering three or four springs (leakages) occurred from the north face of the embankment and two cable-tool holes (CHCD1; CHCD2) were drilled through the coffer-dam embankment (Figure 3 and plate 1) in an attempt to discover the cause.

As shown in Figure 2 the holes were located opposite the issue of the springs. However the leakages may have originated far removed from their place of issue.

This is likely because a bank of silt & mud was moved towards the centre of the coffer-dam as the embankment material was placed on either side of the piles. This bank could well have diverted leaks until the latter emerged beyond the mud bank.

It is believed that leakage was directly through non-watertight linkage of the piles, occurring as many small leaks which emerged as three or four springs at either side of the above mentioned 'mud-bank'.

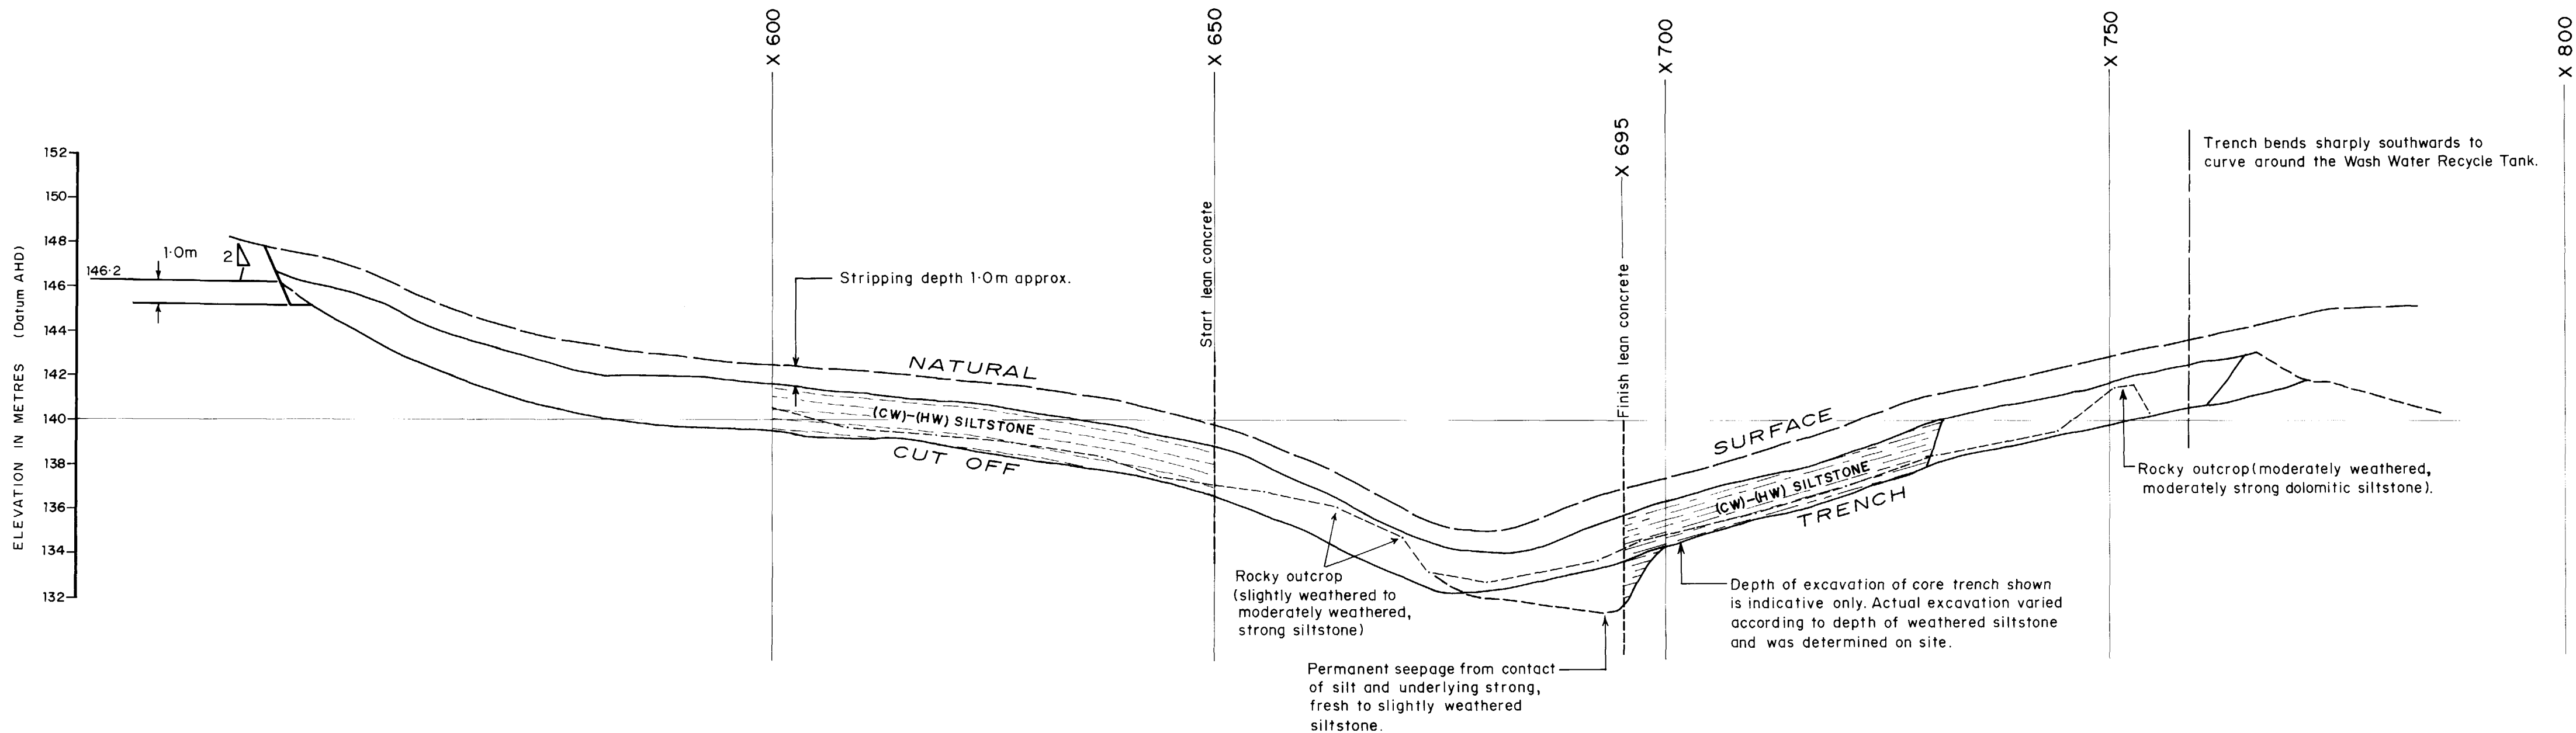
Fig. 5

The cut-off trench (Figures 4 and 5; Plate 3 through to Plate 8) is excavated in steeply dipping dolomitic siltstone which, over the sections X600-X650* (Plate 3) and X705 to Y425 can be broken down by the sheeps foot roller, providing a low permeability foundation for the cut-off trench.

However, siltstone over the section X730 to X755 proved to be stronger than the very soft completely weathered siltstone found between X600 to X650. Over the former section, individual blocks, fist-size and larger, were cleared from the floor of the trench prior to placement of a thin layer of cut-off material whose moisture content, it was intended, should be a little higher than normal to facilitate a better penetration of the small fragments of broken siltstone which covered the trench surface over this section.

Slightly to moderately weathered strong, open jointed siliceous siltstone, occurs over the section X650 to X705, where the roller could not be used (Plates 6, 7 and 8). The trench was excavated to clean, tight bedrock and concrete poured to a thickness which formed a relatively level surface upon which to place the cut-off material.

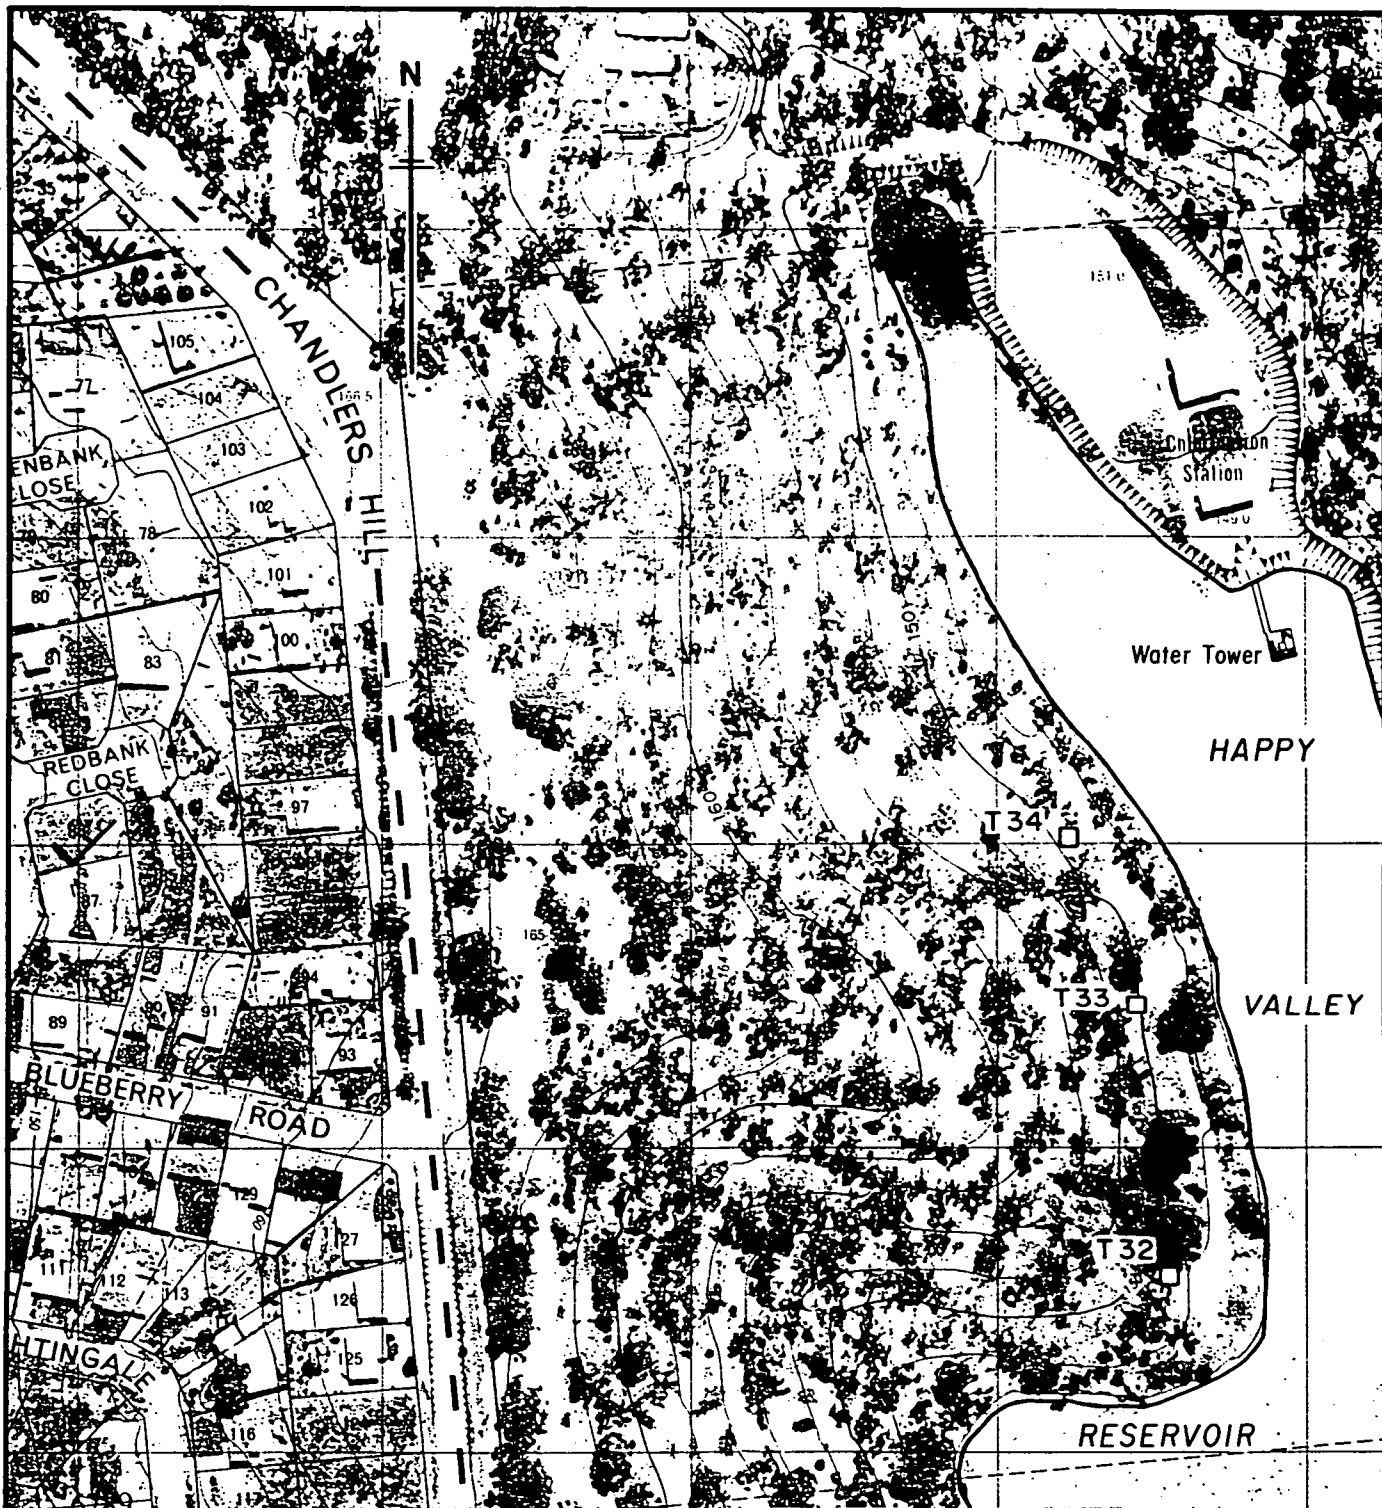
S17183

Three backhoe trenches T32, T33, T34 were excavated at the site of the Filtered Water Storage Tanks in order to assess the stability of batters excavated into bedrock. (see Figure 6).

In trench T32, the bedding agrees with the regional strike of the area, that is, runs approximately N-S, dipping approximately 45°-60° westwards. The dominant fracture dips at approximately 50°-60° towards the east/southeast.

Earlier fracture surveys have shown that bedding may be expected to dip from 40° to 60° westwards. To reduce the risk of rock falls a batter angle of 45° to 50° is recommended. If this is not possible then a vertical batter is recommended and berms should be widened to 10 metres and be excavated for every 13 to 15 metres of batter height. In summary, for westward facing slopes, the chance of slope failure along a dominant fracture plane is considered to be quite high and design of such batters should be conservative.

- (1) Preferred batter angle: for westward facing slopes 45°-50°. (If berms are designed to accept some rock falls then vertical batters are considered acceptable).
- (2) Proposed maximum batter height: 13 metres.
- (3) Preferred orientation of excavated face: NW-SE.
- (4) Strength properties of completely weathered, saturated siltstone be investigated.

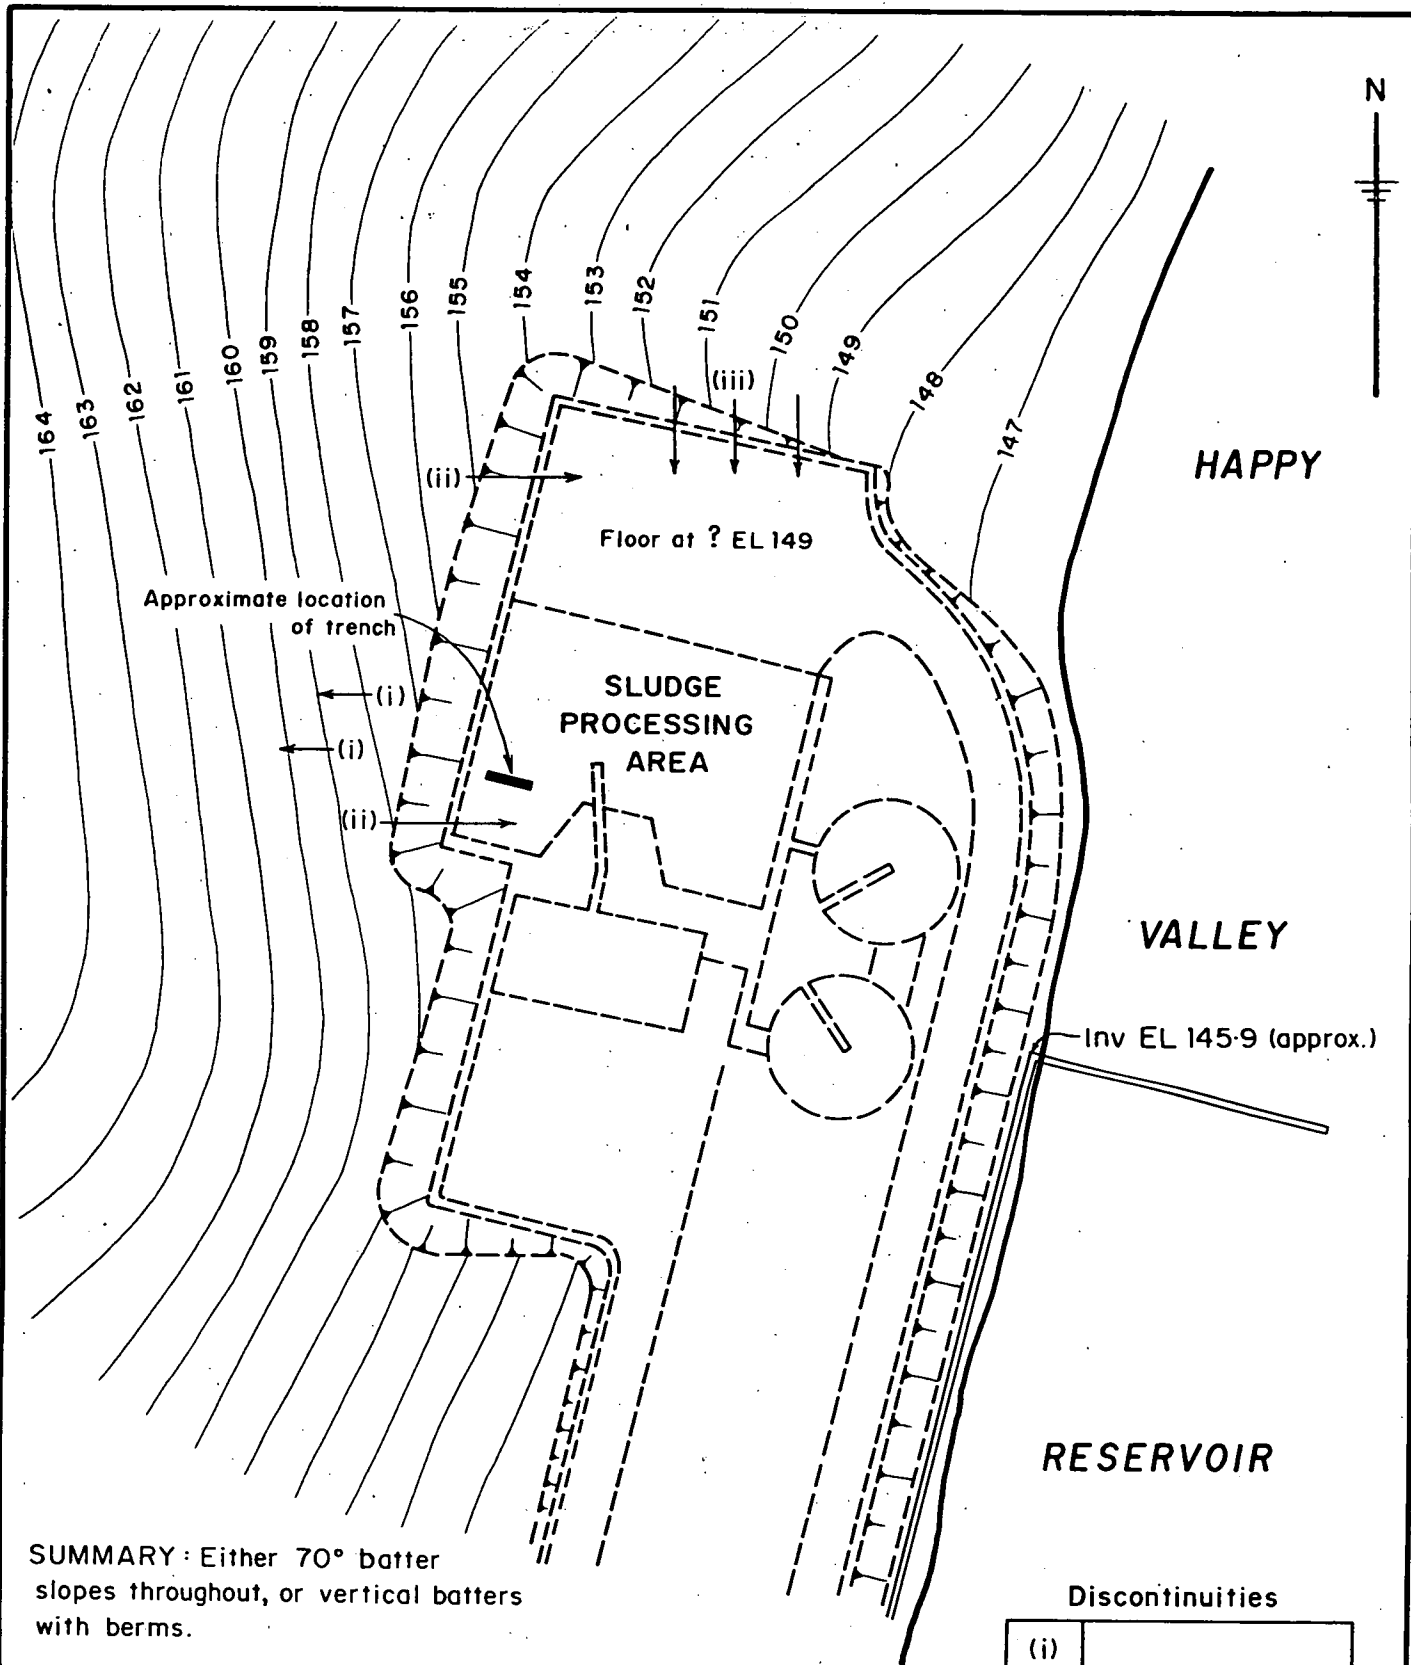
COMPILED J. B.	<i>WR</i> 5.7.84 C D O DATE
DRAWN M. B.	SCALE 1:1000
DATE Dec '83	PLAN NUMBER
CHECKED	SI7184

The pit was excavated through 1.0 m to 1.50 metres of topsoil and 'B' horizon and three metres of completely weathered to highly weathered weak, red-brown siltstone.

- (i) Bedding 170° dipping 45° to west
- (ii) Cleavage 000° dipping 70° to east
- (iii) Joint 090° dipping off vertical either to north or to south.

Groups (i) and (ii) will only daylight along E-W orientated batters facing south. A batter angle of 70° will eliminate the majority of potential rock-slide type falls. Vertical batters are acceptable providing berms of sufficient width to catch falling rock (approx. 5.0 metres or no less than 0.75 times the height of the batter) are excavated where structures are to be built close to batters.

SUMMARY: Either 70° batter slopes throughout, or vertical batters with berms.

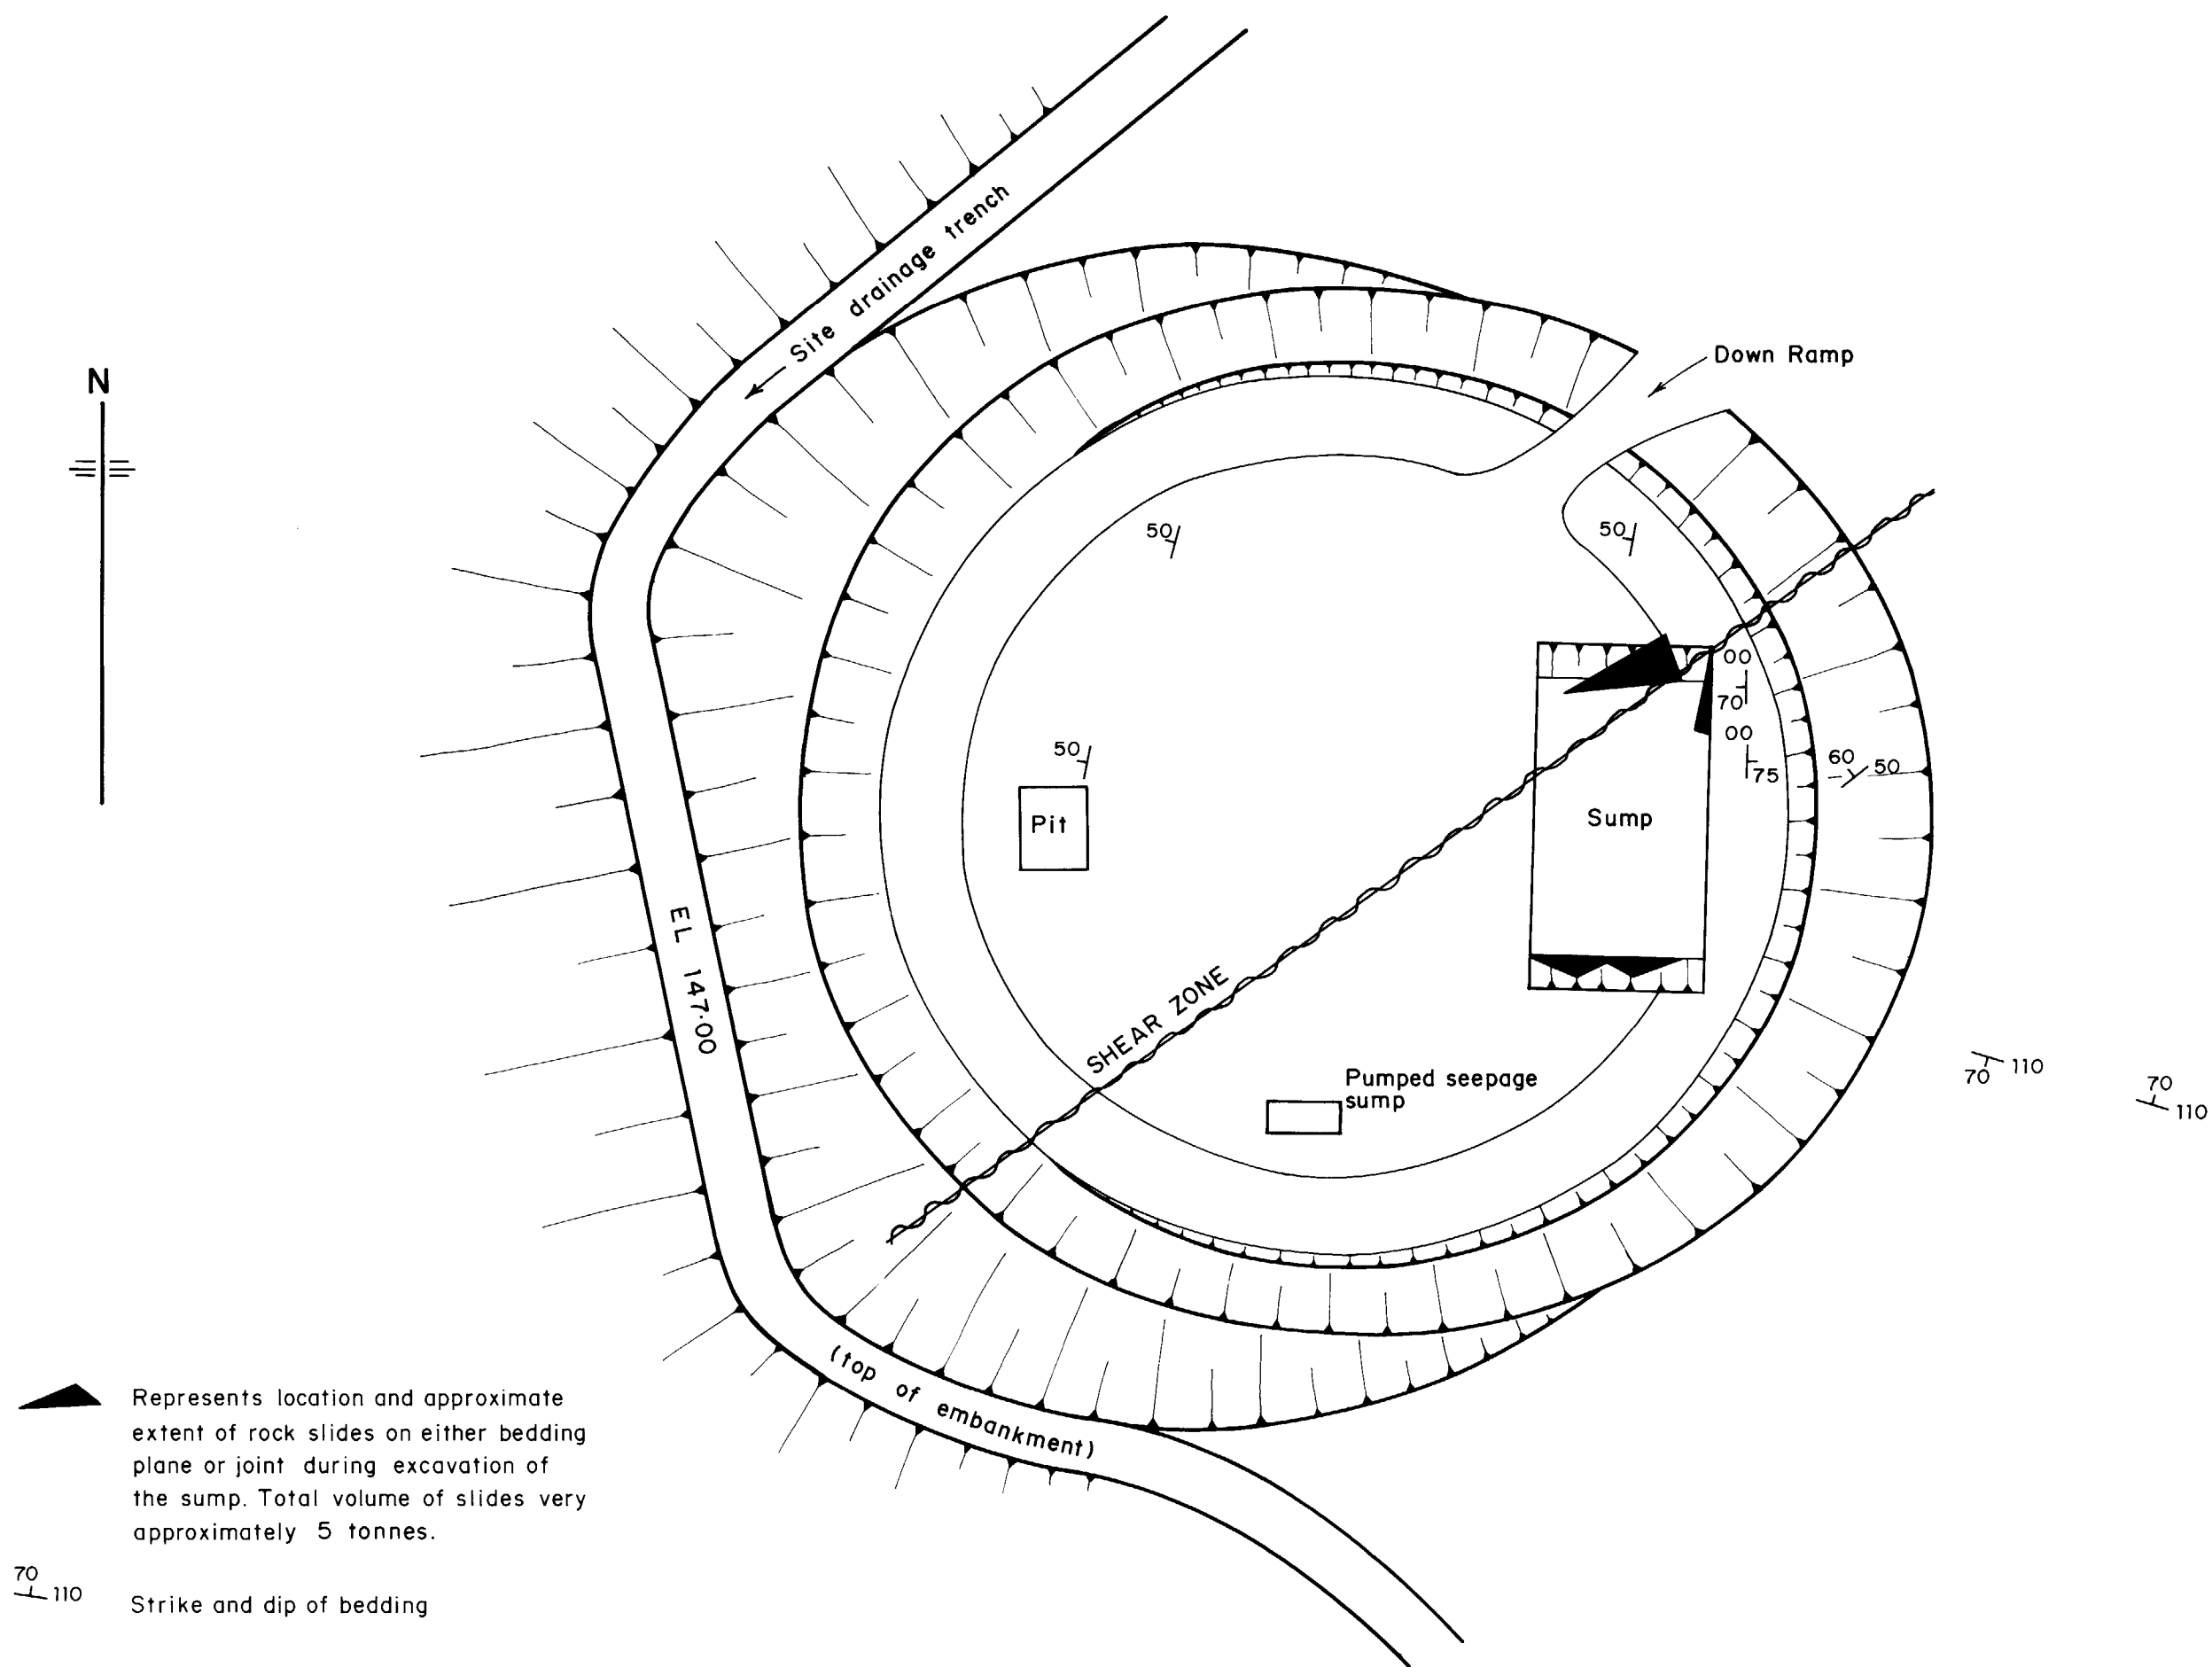
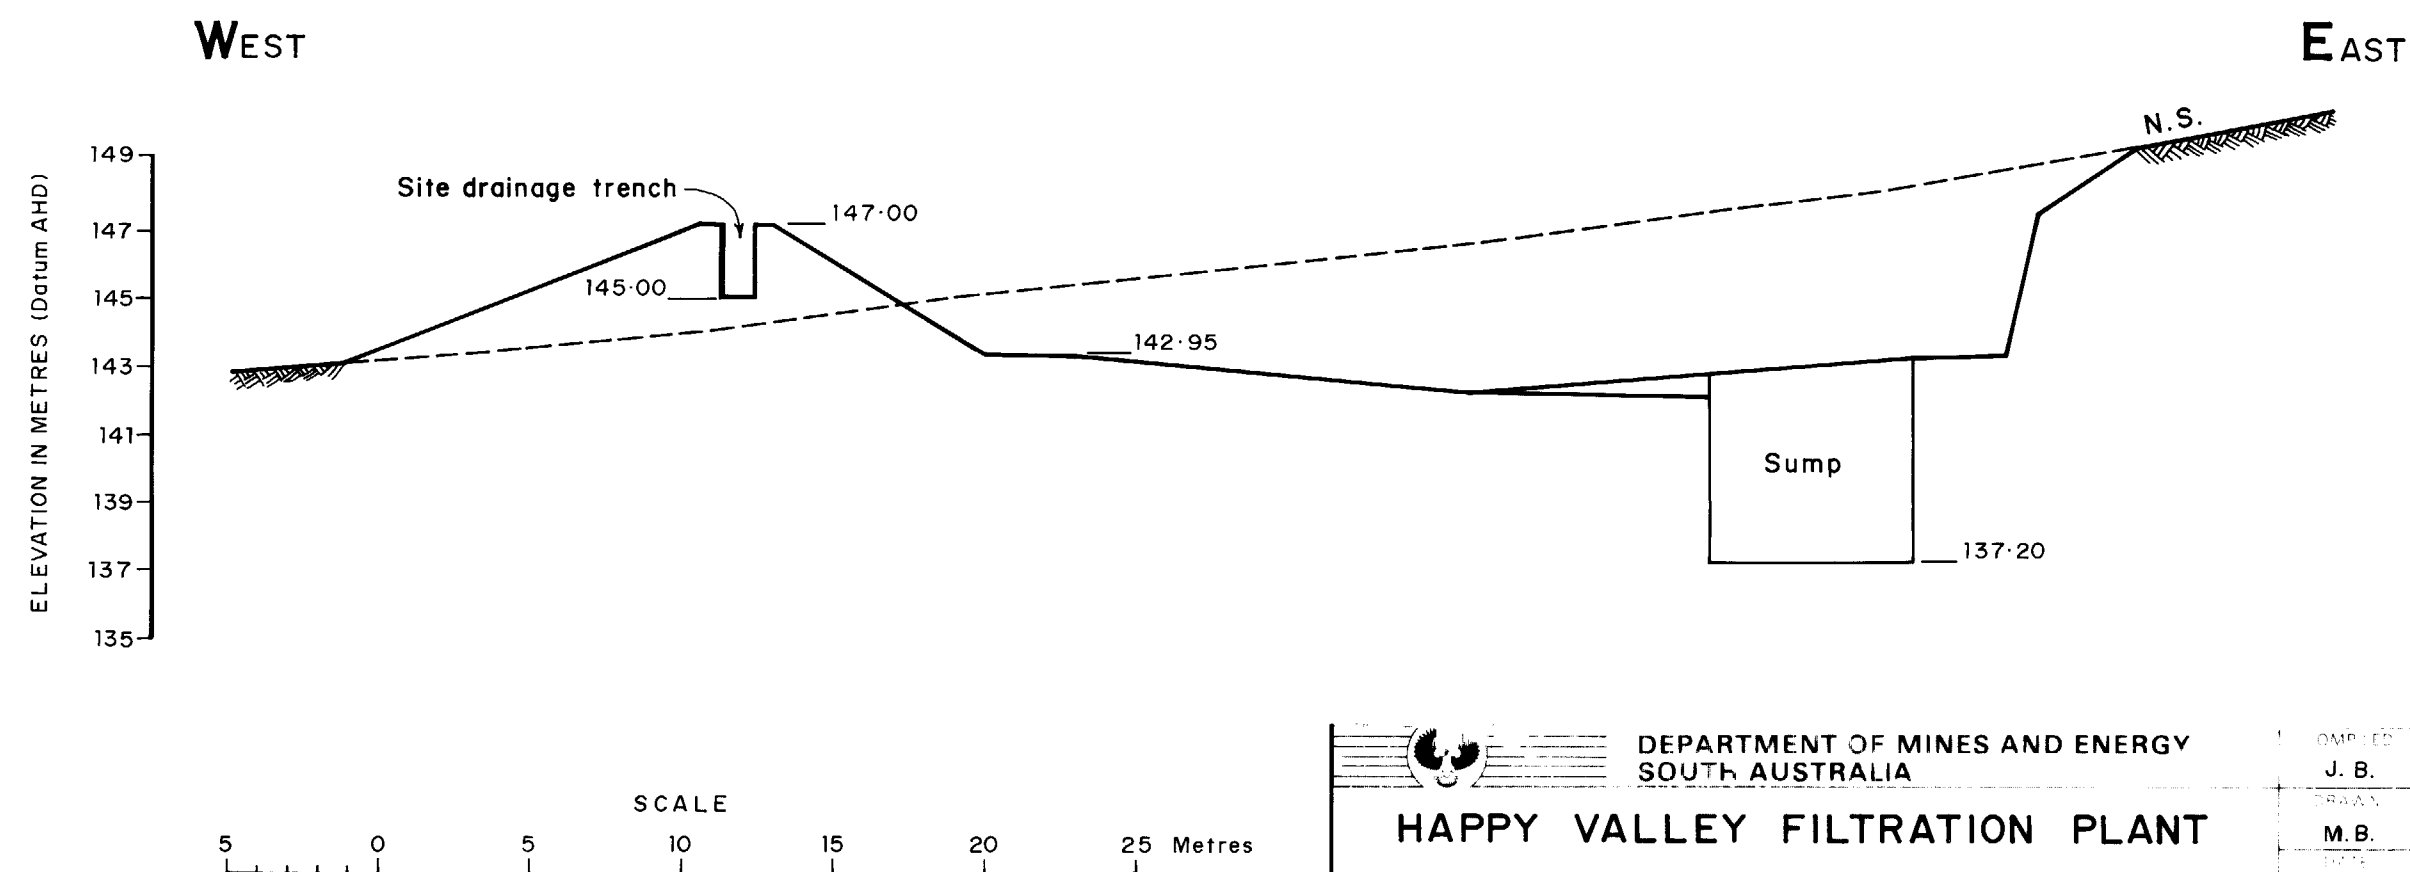
HAPPY VALLEY FILTRATION PLANT
WASH WATER RECYCLE TANK
PLAN AND SECTION

Joint and cleavage planes are well developed, smooth and planar and dip steeply (60°-70°) to the west, south and north (Figure 8).

The two different rock types are separated by a NE-SW striking shear zone, 300 to 500 mm wide dipping approximately 60° southwards (Figure 8).

Two minor rock slides have occurred on the edge of the southern and eastern faces (each of approx. 1.0 tonne). A third rock slide occurred in the northern face (approx. 3-4 tonnes) and was initiated by the weight of the backhoe working adjacent to a backfilled section of the pit. Location of the three slides are shown in figure 8.

The east and west faces have been shored using timbers and struts; the north and south faces have been battered back to approximately 70°. Under-excavation of the east face has resulted in the subsequent removal of 200 to 300 mm of rock from

The site engineer was advised that workers should check for open cracks along the top of the east face prior to entering the pit and also to check for the appearance of cracks or evidence of rock movement in the undercut face.
