REPT.BK.NO. 85/51
STABILITY ASSESSMENT OF REHABILI-
TATION AREA, READYMIX-FARLEY
QUARTZITE QUARRY (RIVERVIEW
HIGHBURY).

J.C. BEAL

OCTOBER, 1985

STABILITY ASSESSMENT OF REHABILITATION AREA, READYMIX -
FARLEY QUARTZITE QUARRY (RIVERVIEW), HIGHBURY

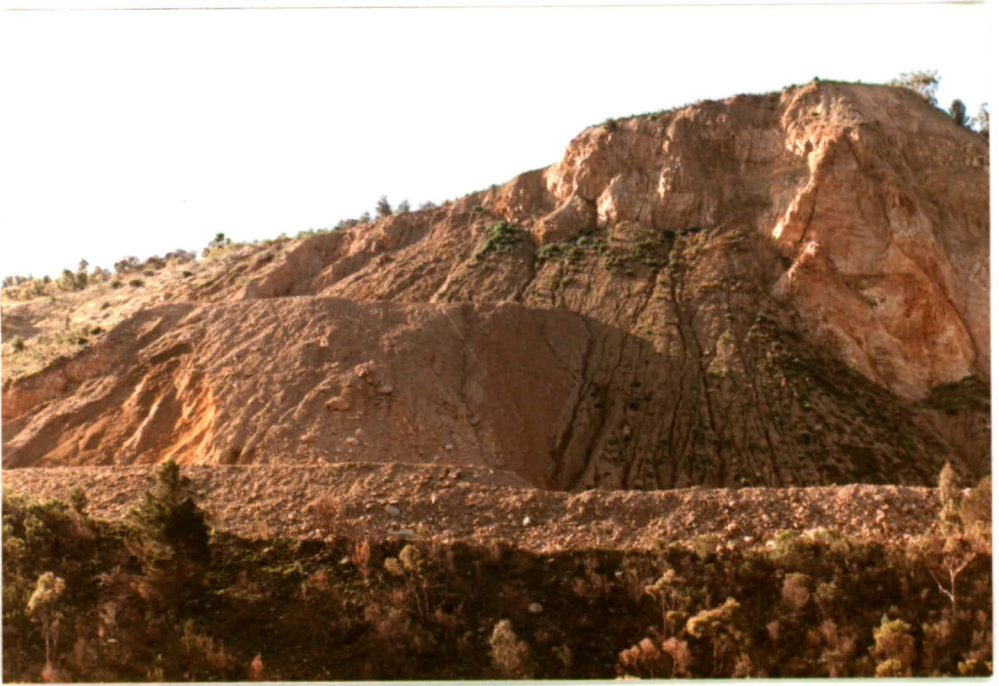
Plate 1.

General view looking North

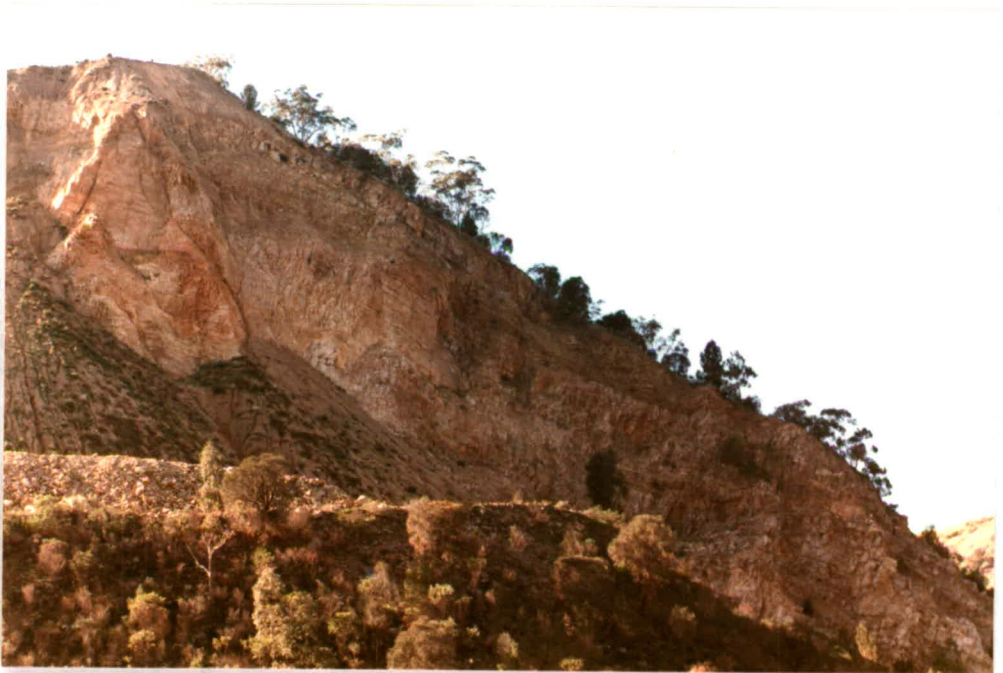
Plate 2

General view looking north-east

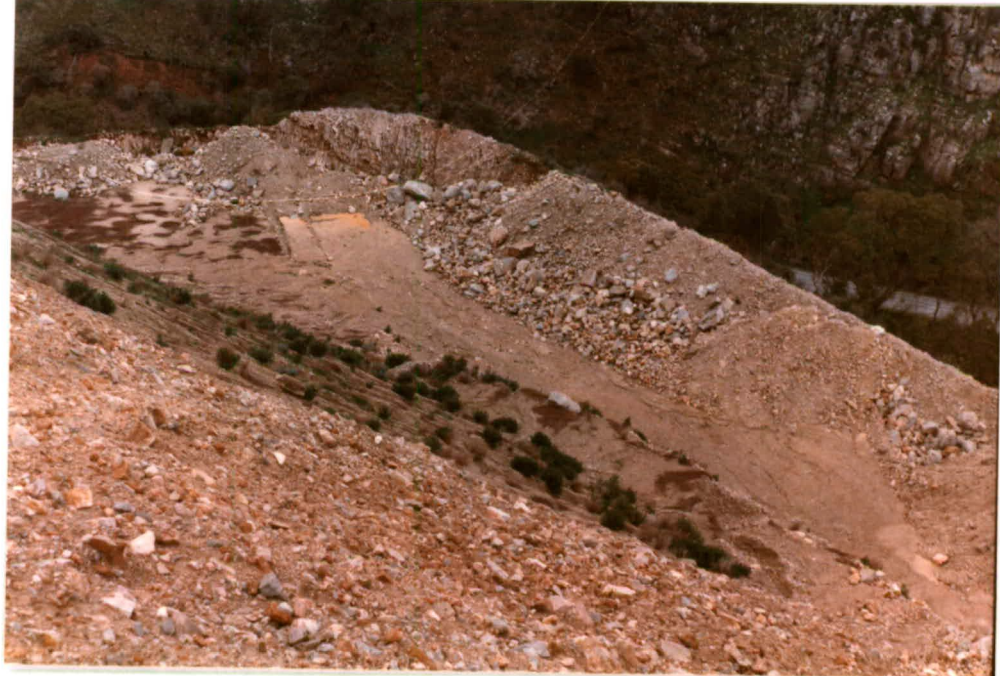
Plate 3

Berm at EL 164

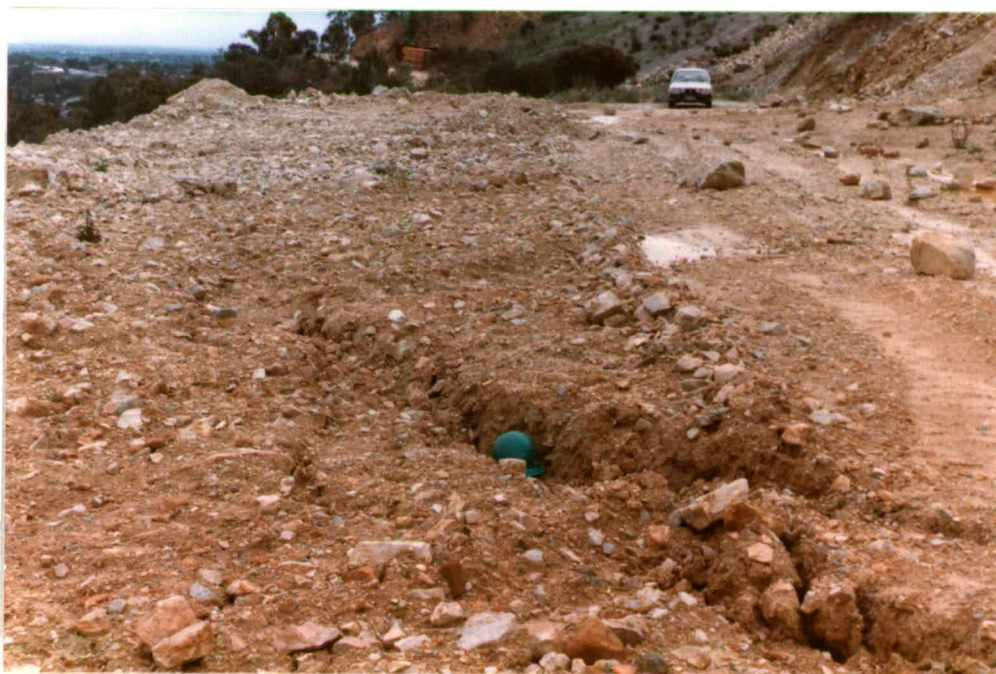
Plate 4

Berm at EL 198

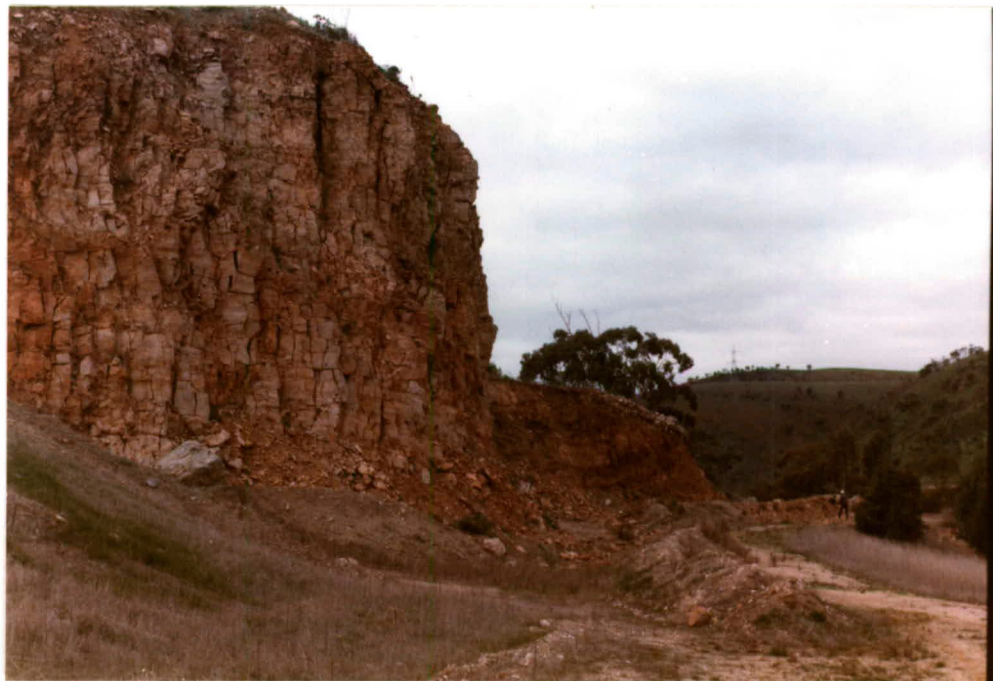
Plate 5

Berm at EL 250

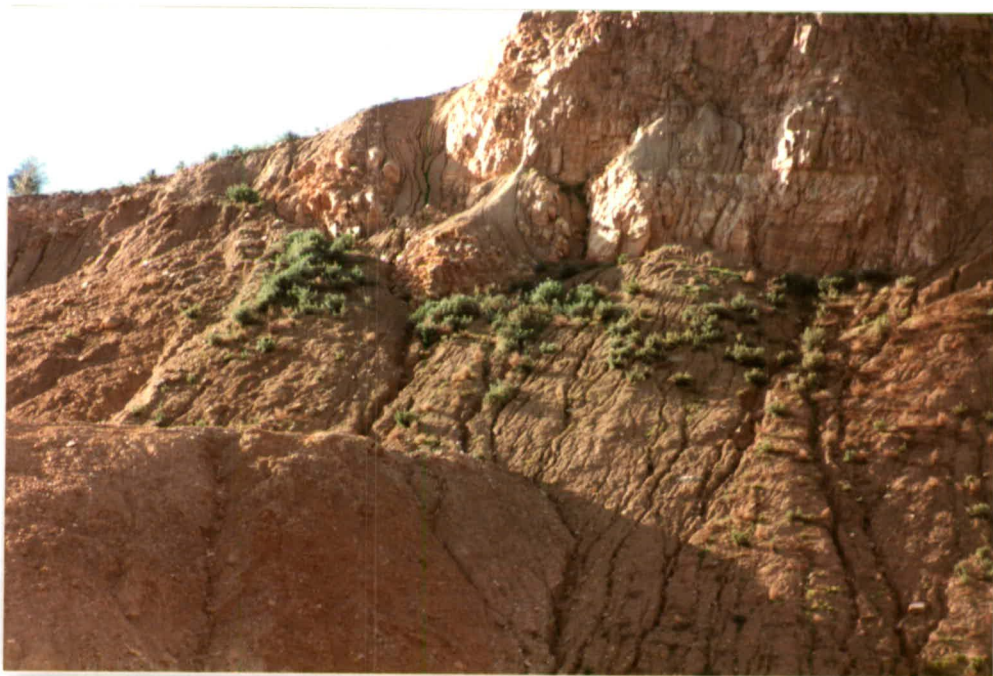
Plate 6

Above berm EL 198

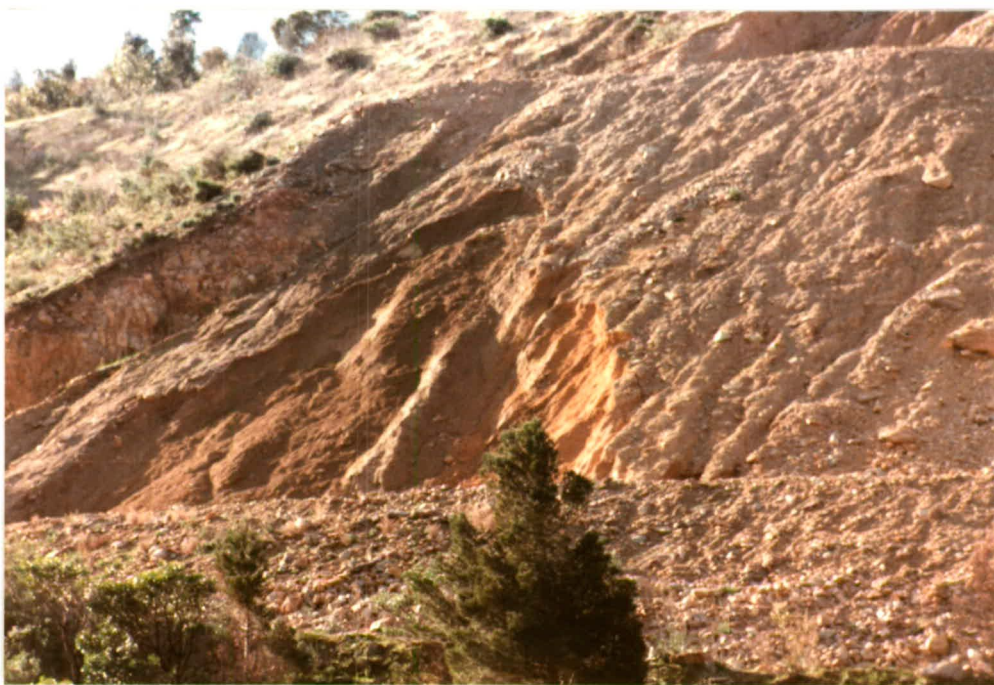
Plate 7

West of rehabilitated slope

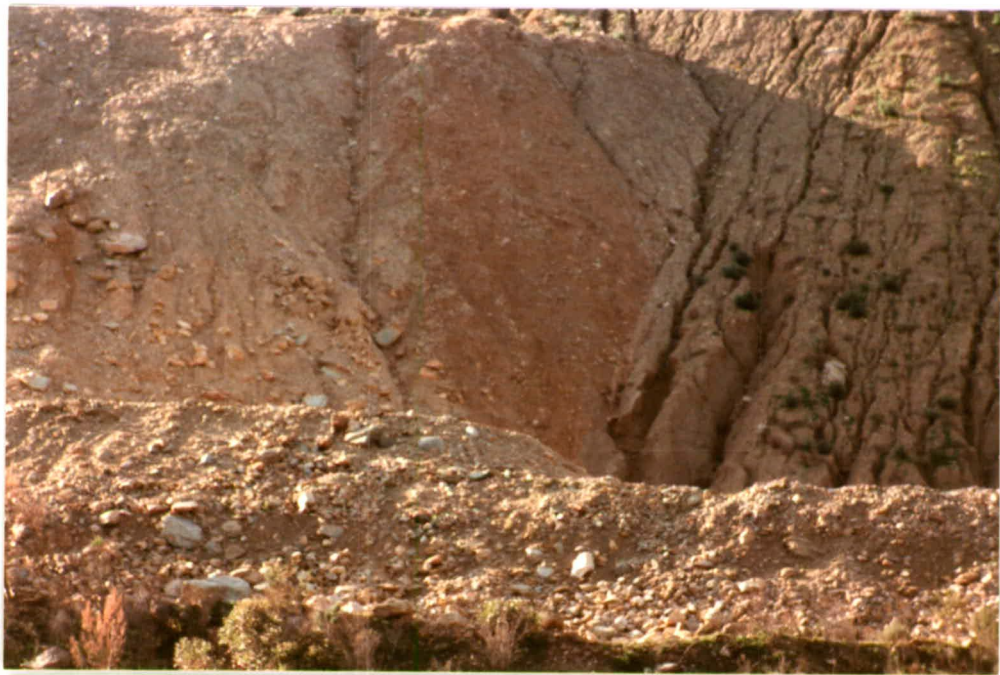
Plate 8

East of rehabilitated slope

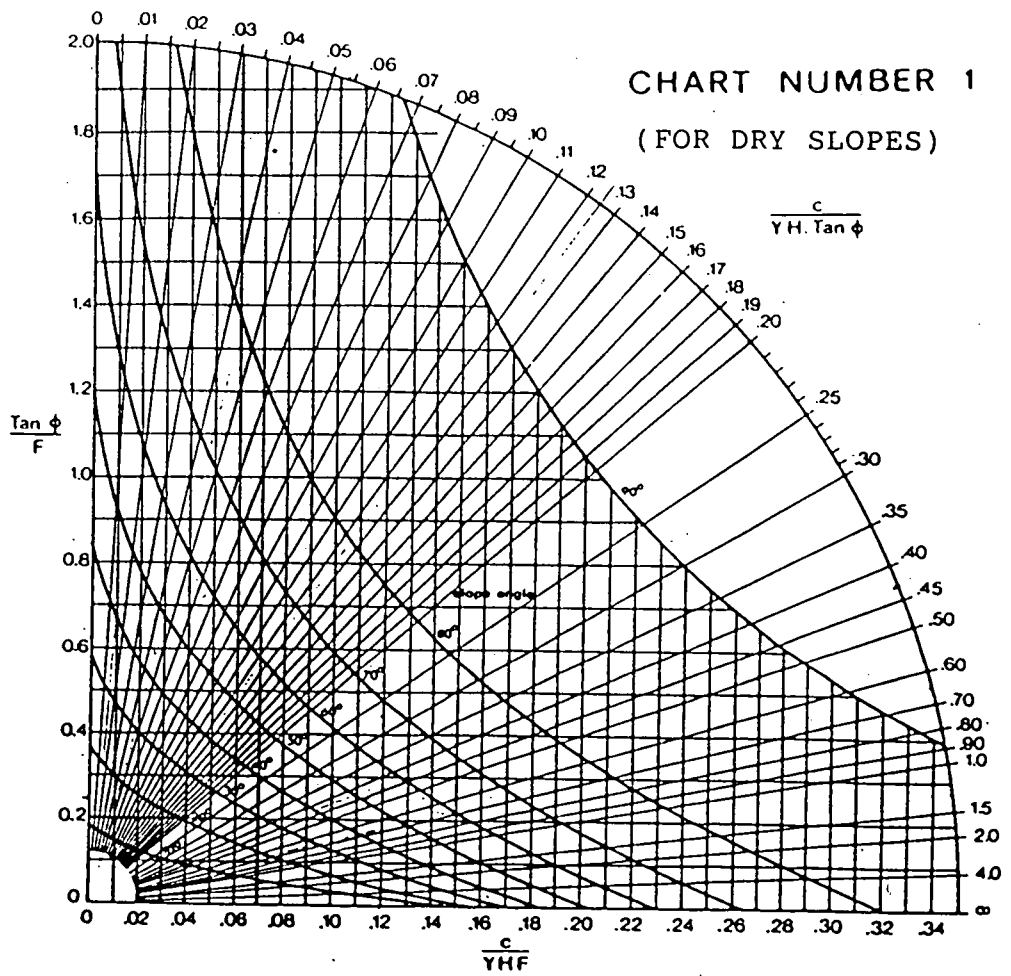
Fig. A-1

The minimum F.O.S. (0.56) was obtained for a partially saturated fill, a slope of 35° and a high friction angle of 40°. An even lower F.O.S. would have resulted had a lower, more realistic friction angle been used and the slope fully saturated.

Slope angle is considered to be more important to the stable - unstable condition of the rehabilitated slope than expected values of cohesion or saturation. The relationship between slope angle and the F.O.S. is shown in Charts 1 and 2, Appendix 1 for dry and partially saturated slopes.

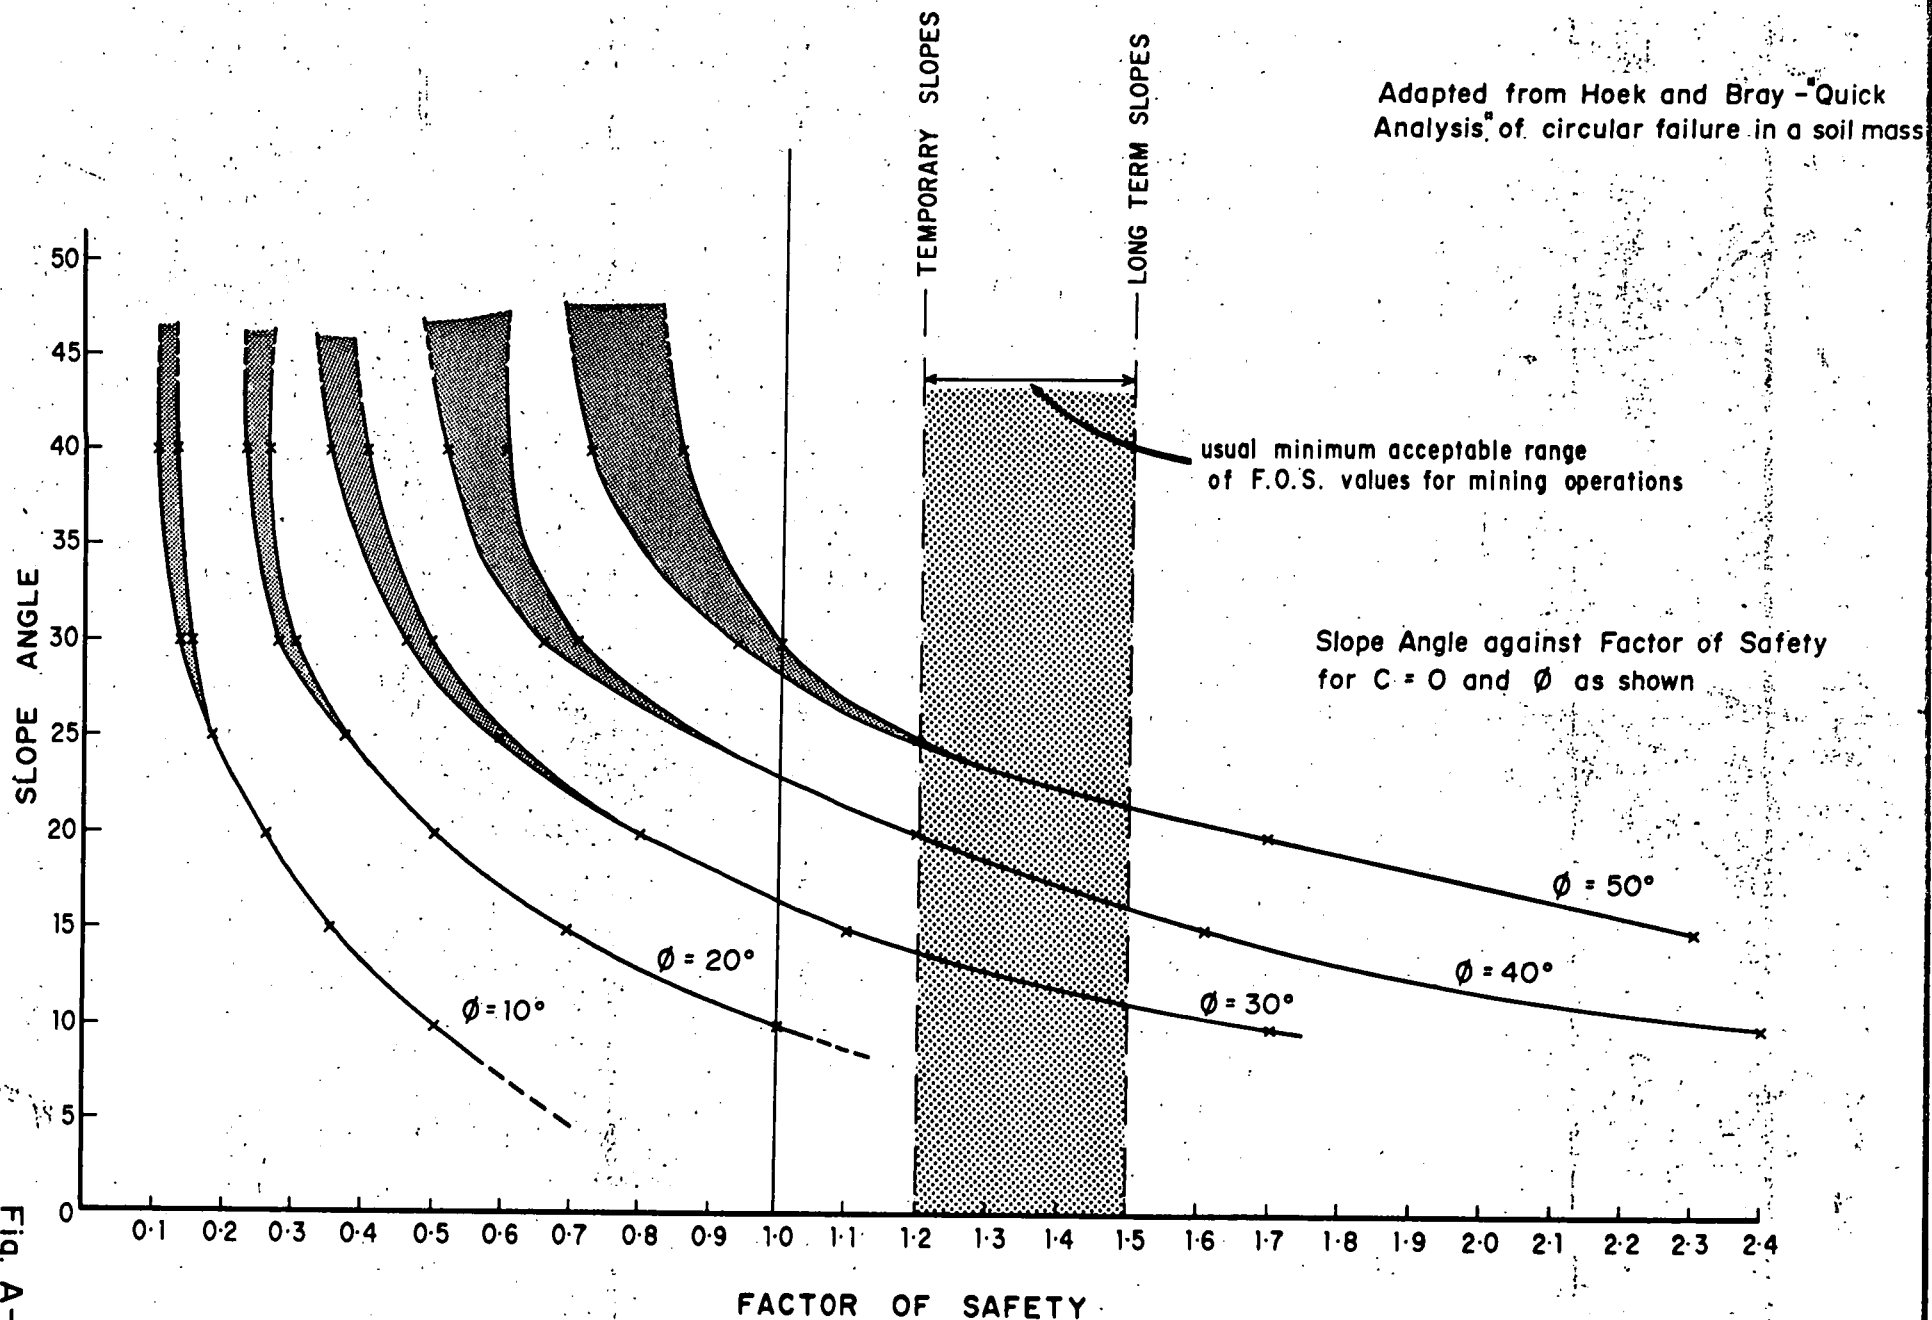
Fig. A-2

A F.O.S. of 1.63 was obtained, based on dry fill, a slope of 25° and a friction angle of 38°. The dry condition is unrealistic and the low slope angle is considered to be economically undesirable.

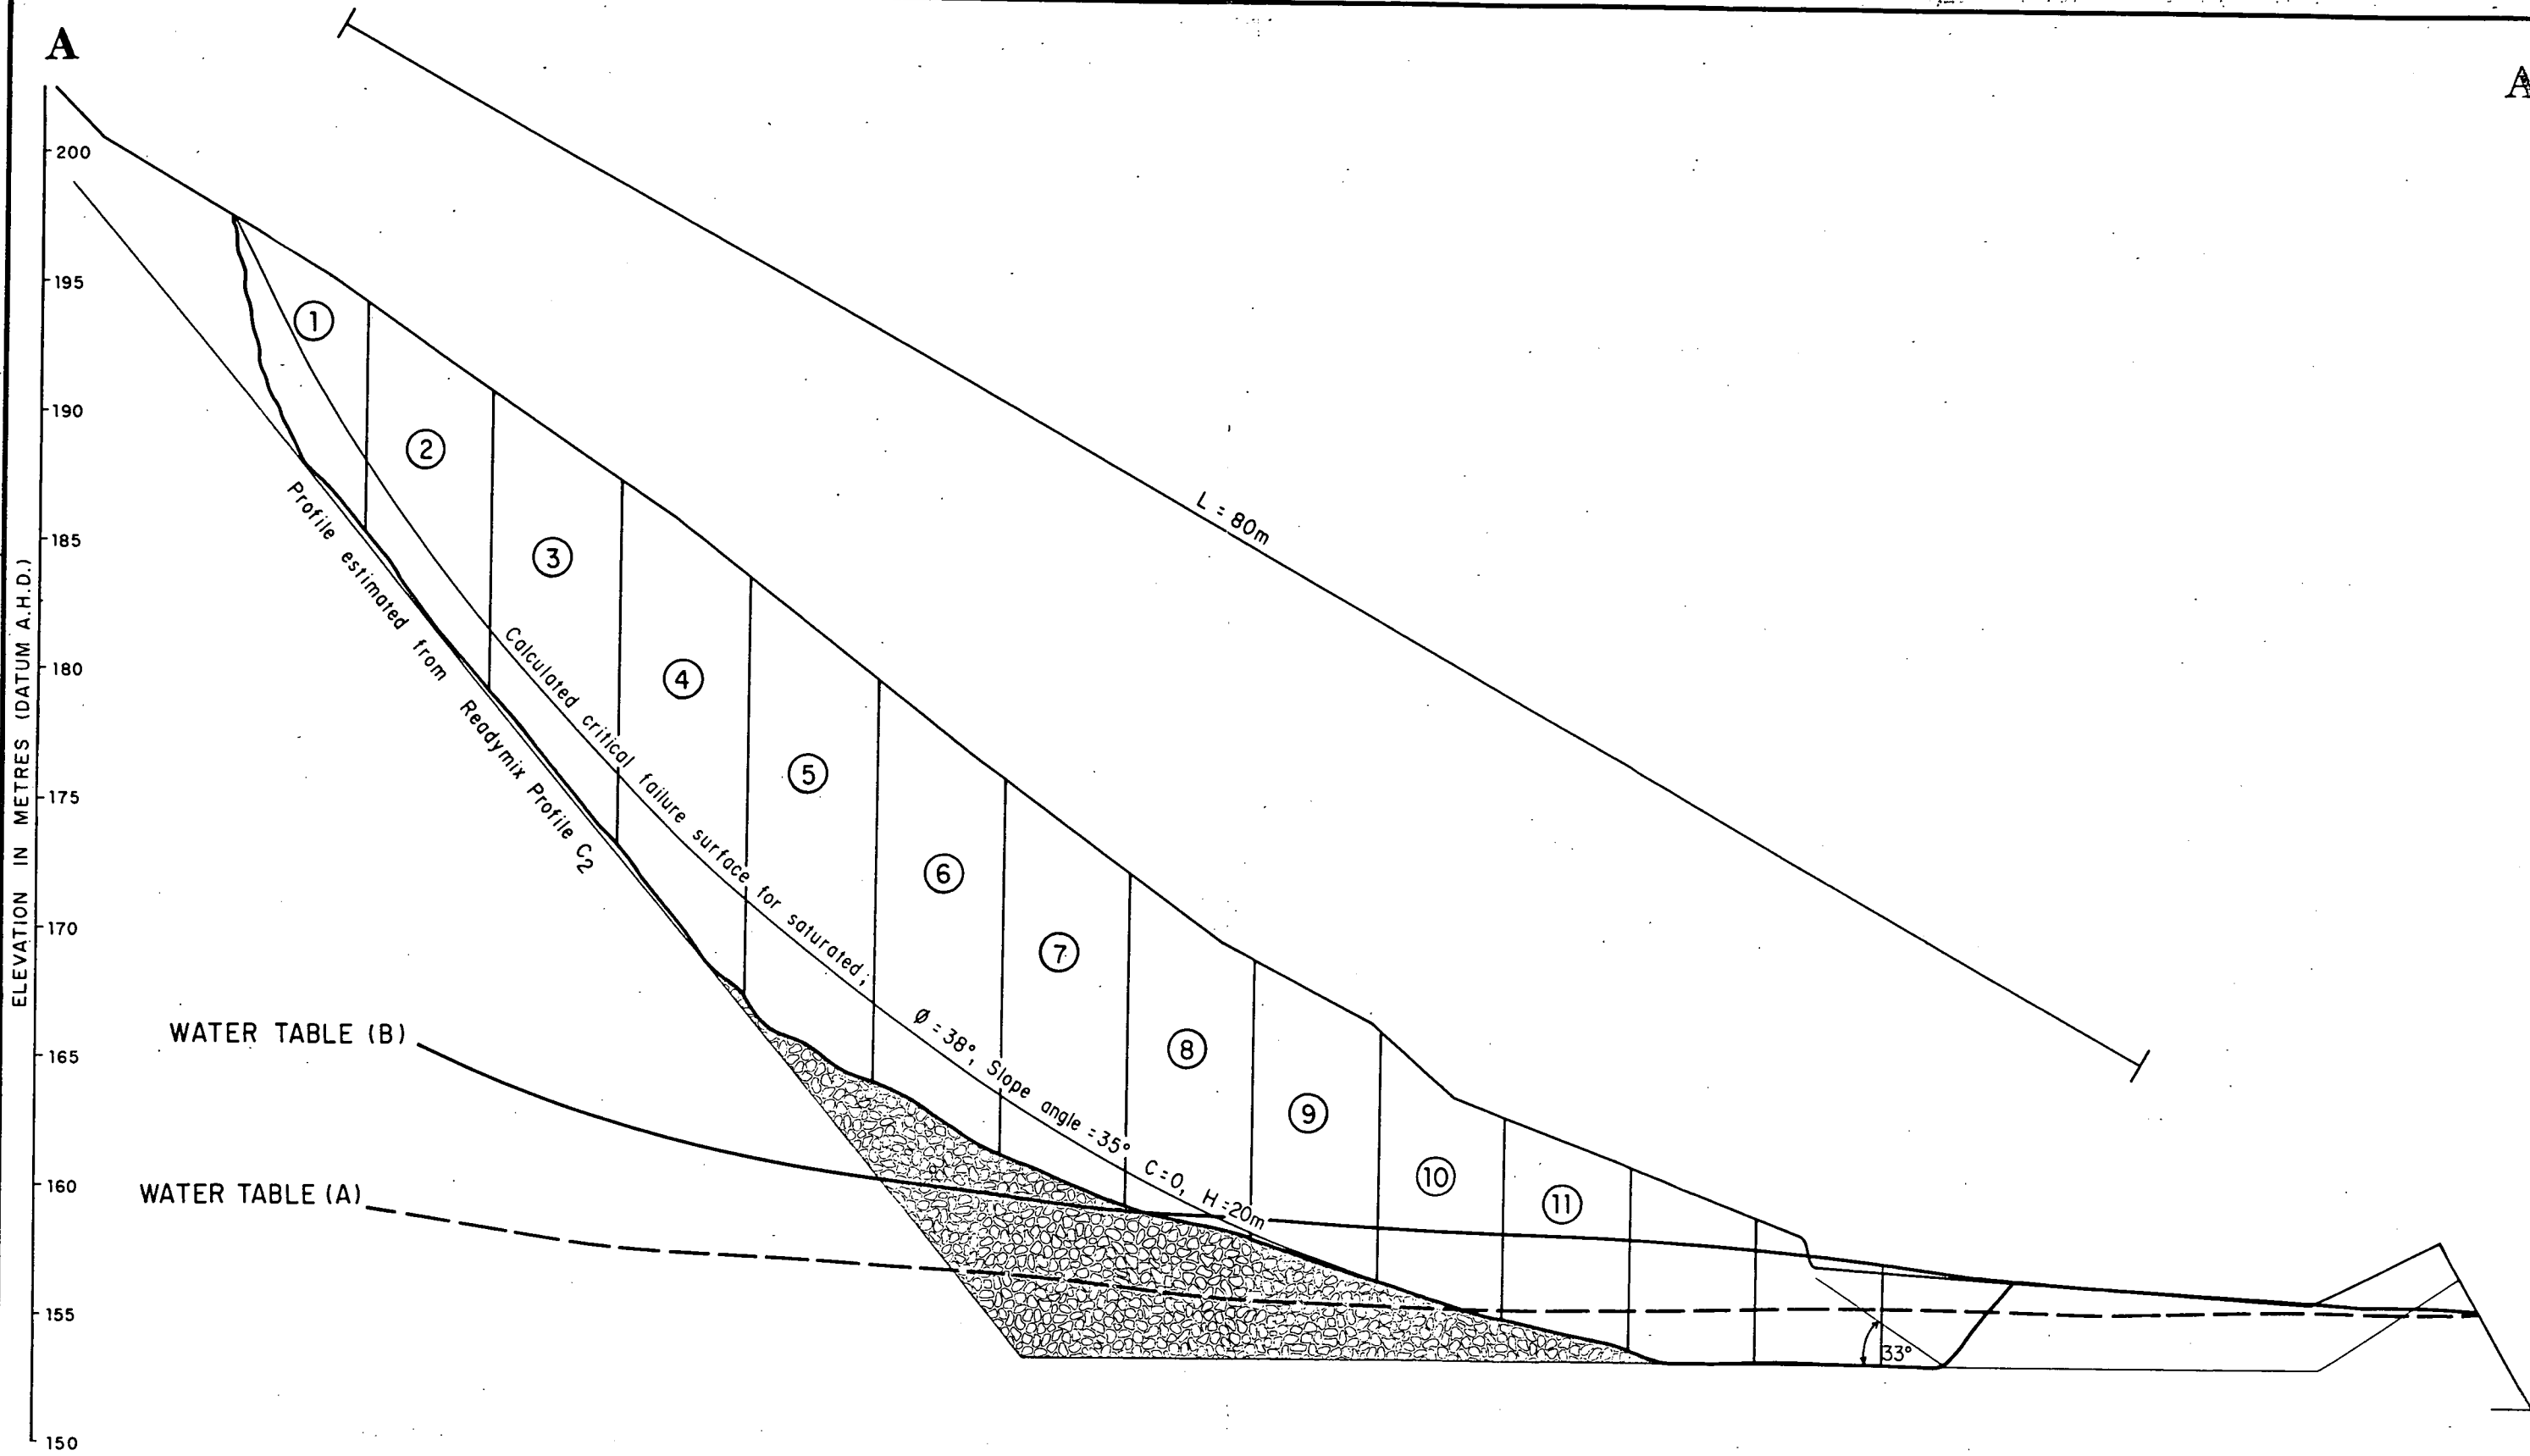
Fig. 4

Table 2:	Dry fill; $c = 0$; $\phi = 35^\circ$; slope angle = 35°	F.O.S. = 1.12
Table 3:	Toe Saturated to water-table, level A. (Figure 4)	F.O.S. = 1.06
Table 3:	Toe saturated to water-table, level B. (Figure 4)	F.O.S. = 0.9
Table 4:	Toe-fill to water-table, level B. (Figure 5)	F.O.S. = 1.3
Table 5:	Toe-fill with compaction and water table at level B. (Figure 6)	F.O.S. = 1.5

Quarry waste not affected by failure surfaces

From this analysis it can be concluded that maximum slope stability for failures passing through the toe can be achieved by placing a free-draining toe to approximately EL 164 with some compaction of the toe-fill.

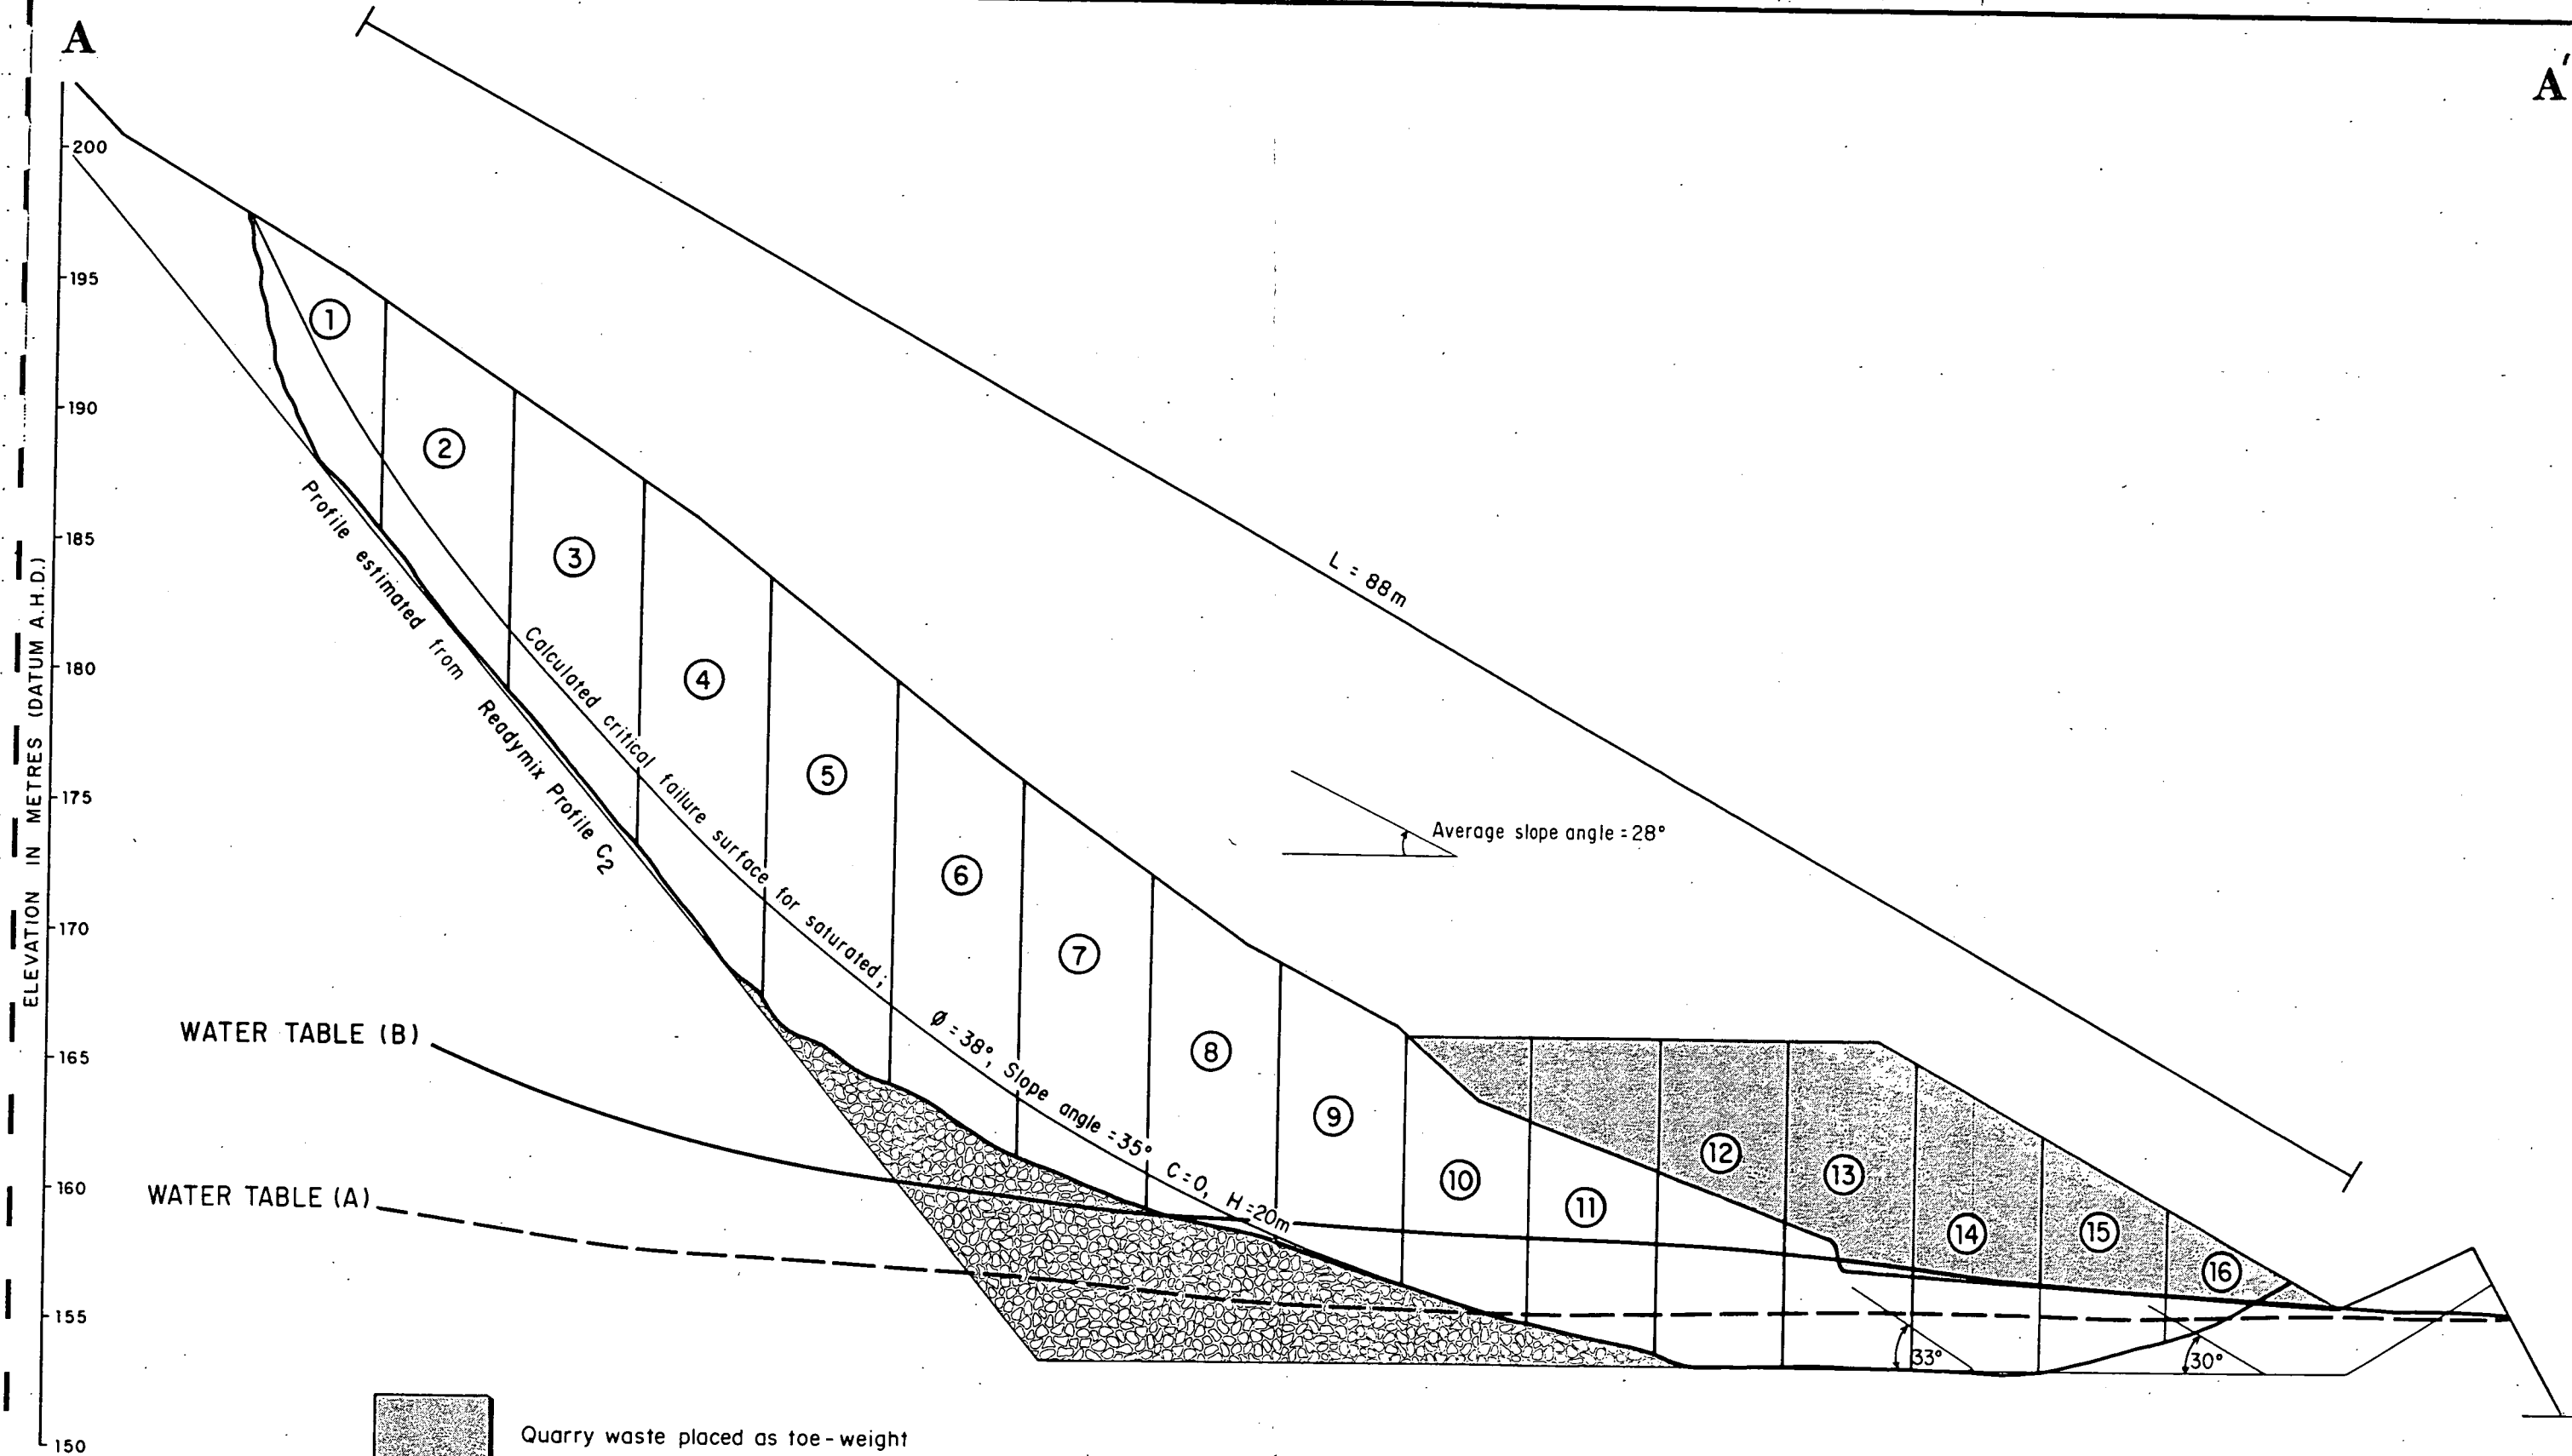
Fig. 5

Quarry waste placed as toe-weight

Quarry waste not affected by failure surfaces

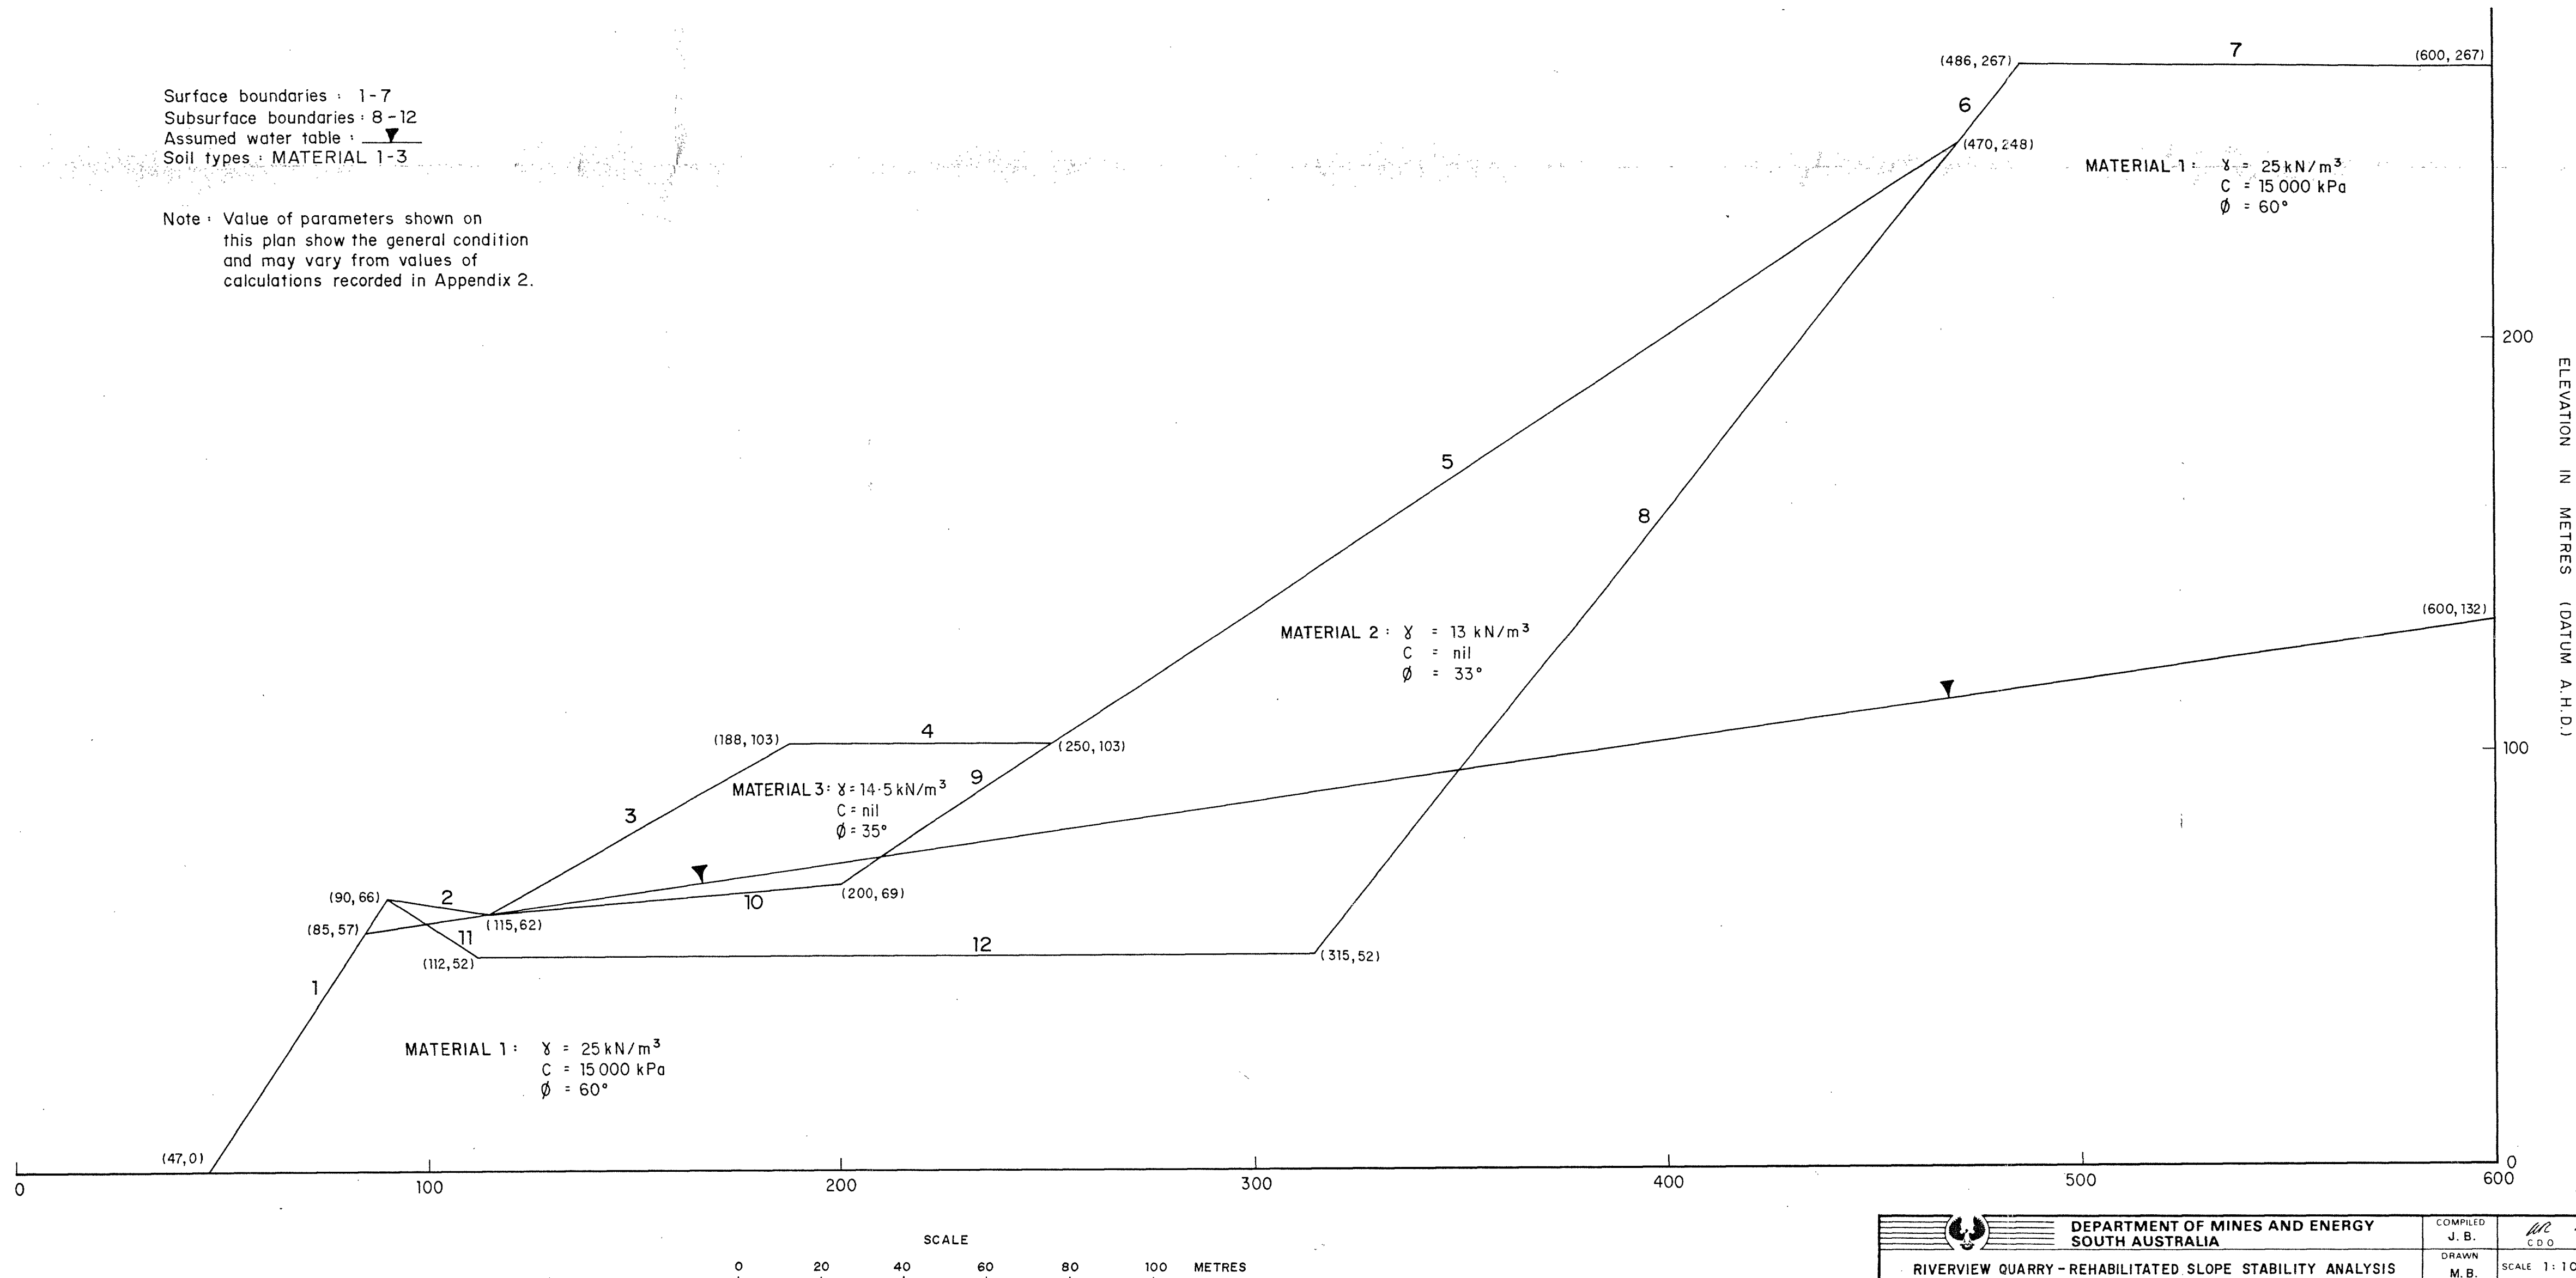
Fig. 6

The programme repeatedly locates slip-failure surfaces and identifies the slip-circle associated with the minimum F.O.S. which in the cases examined range from 0.956 to 0.984, again underlining the unstable nature of the waste-fill. The slip circles in question are located above both water-table and toe-fill.

The analyses show that the placement of a toe-fill at the base of the rehabilitated slope will increase the existing F.O.S. of approx 1.0 to a maximum F.O.S. of 1.4 for failures passing through the toe of the slope. For higher seated failures a F.O.S. of approximately 1.0 prevails for both the wet and dry condition.

It is advised that placement of further quarry-waste onto the rehabilitated slope in the area under discussion cease and that the existing slope be allowed to stabilize prior to vegetating. A standing period of two wet seasons is suggested. During this period measures should be taken to drain storm water away from the rehabilitated slope.
