FREGON WATER SUPPLY -
1987 DRILLING

GEOLOGICAL SURVEY

R.E. READ
GROUNDWATER AND ENGINEERING

SEPTEMBER, 1988

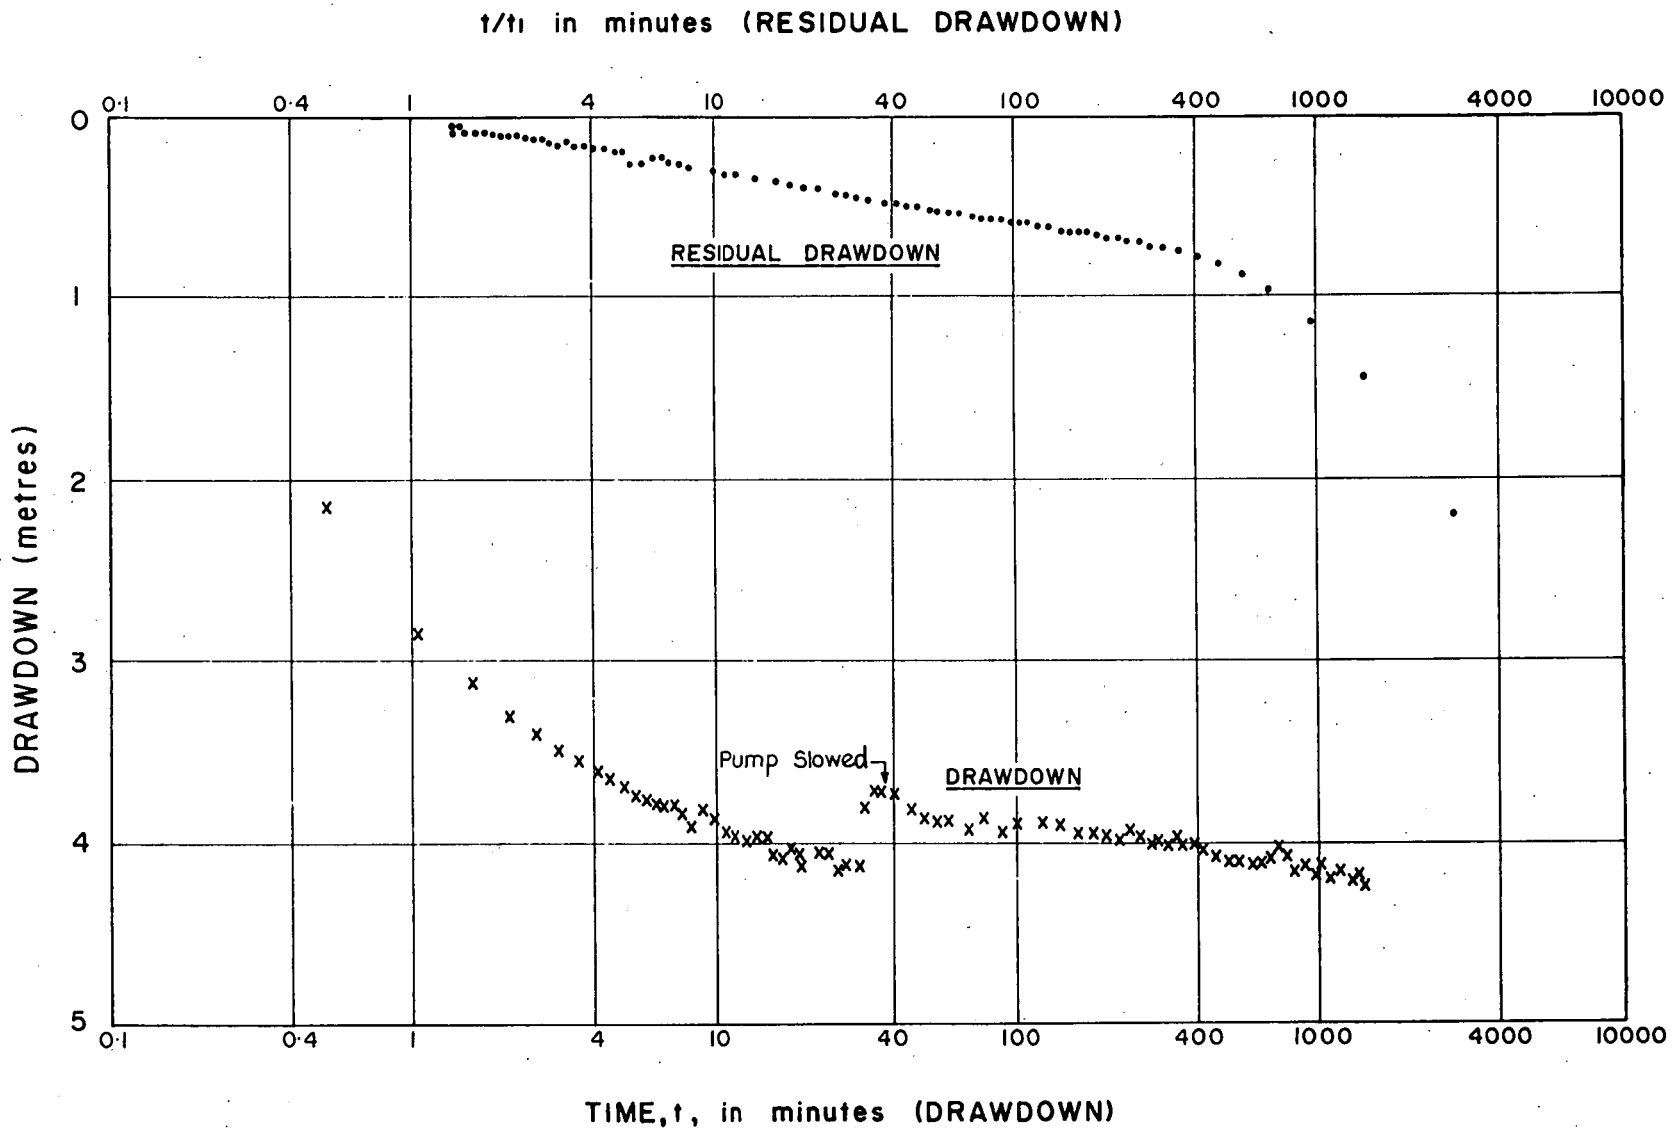
Figure A-1

The semi-log plot of drawdown (Fig. A-1) appears to follow a straight-line with ' Δs ' of 0.2 m.

The t/t_1 plot of recovery appears to be following a straight-line passing through the origin with ' Δs ' of 0.28 m.

From the above, 2 year drawdown is estimated to be about 5 m or 15 m from the surface. The top of the aquifer as recorded by the driller was 18 m, suggesting that safe yield is higher than the test rate.

Unlike 5344 WW 31 where the response suggested delayed yield 5344 WW 47 had a response characterisitic of radial flow. However the ' Δs ' of the straight line corresponds to a transmissivity of 190 m²/day which is very high for fractured crystalline rock.

Therefore it is considered that the long-term yield is about the test-rate, around 2.5 L/s.

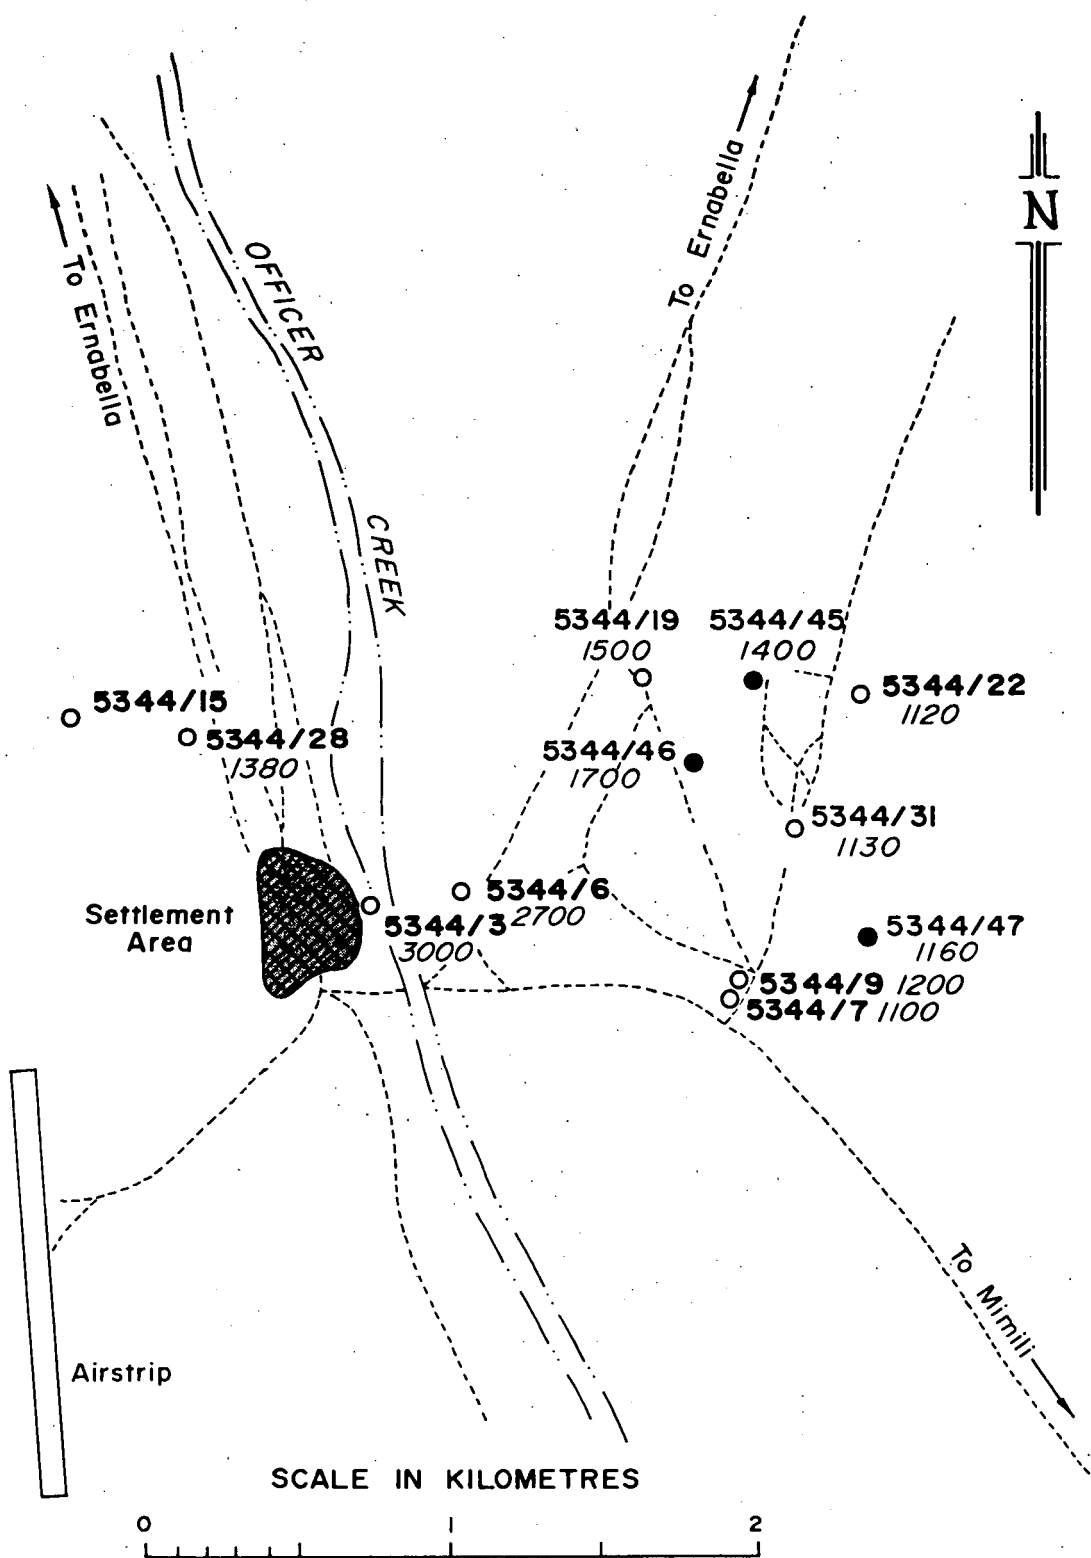
Figure..... 2

The aquifer is relatively thin and there is little evidence of vertical stratification of salinity. Salinity changes markedly over relatively short horizontal distances (Fig. 2). By contrast salinities of pumped wells have remained remarkably constant (Table 2). These facts suggest that the aquifer is divided into poorly connected compartments which restrict horizontal movement of the saline water.
