Improvement in groundwater supplies at the communities of Kalka, Amata, Mímili and Kenmore Park, Anangu Pitjantjatjara Lands, South Australia

DWR 2001/014

September 2001

Report DWR 2001/014

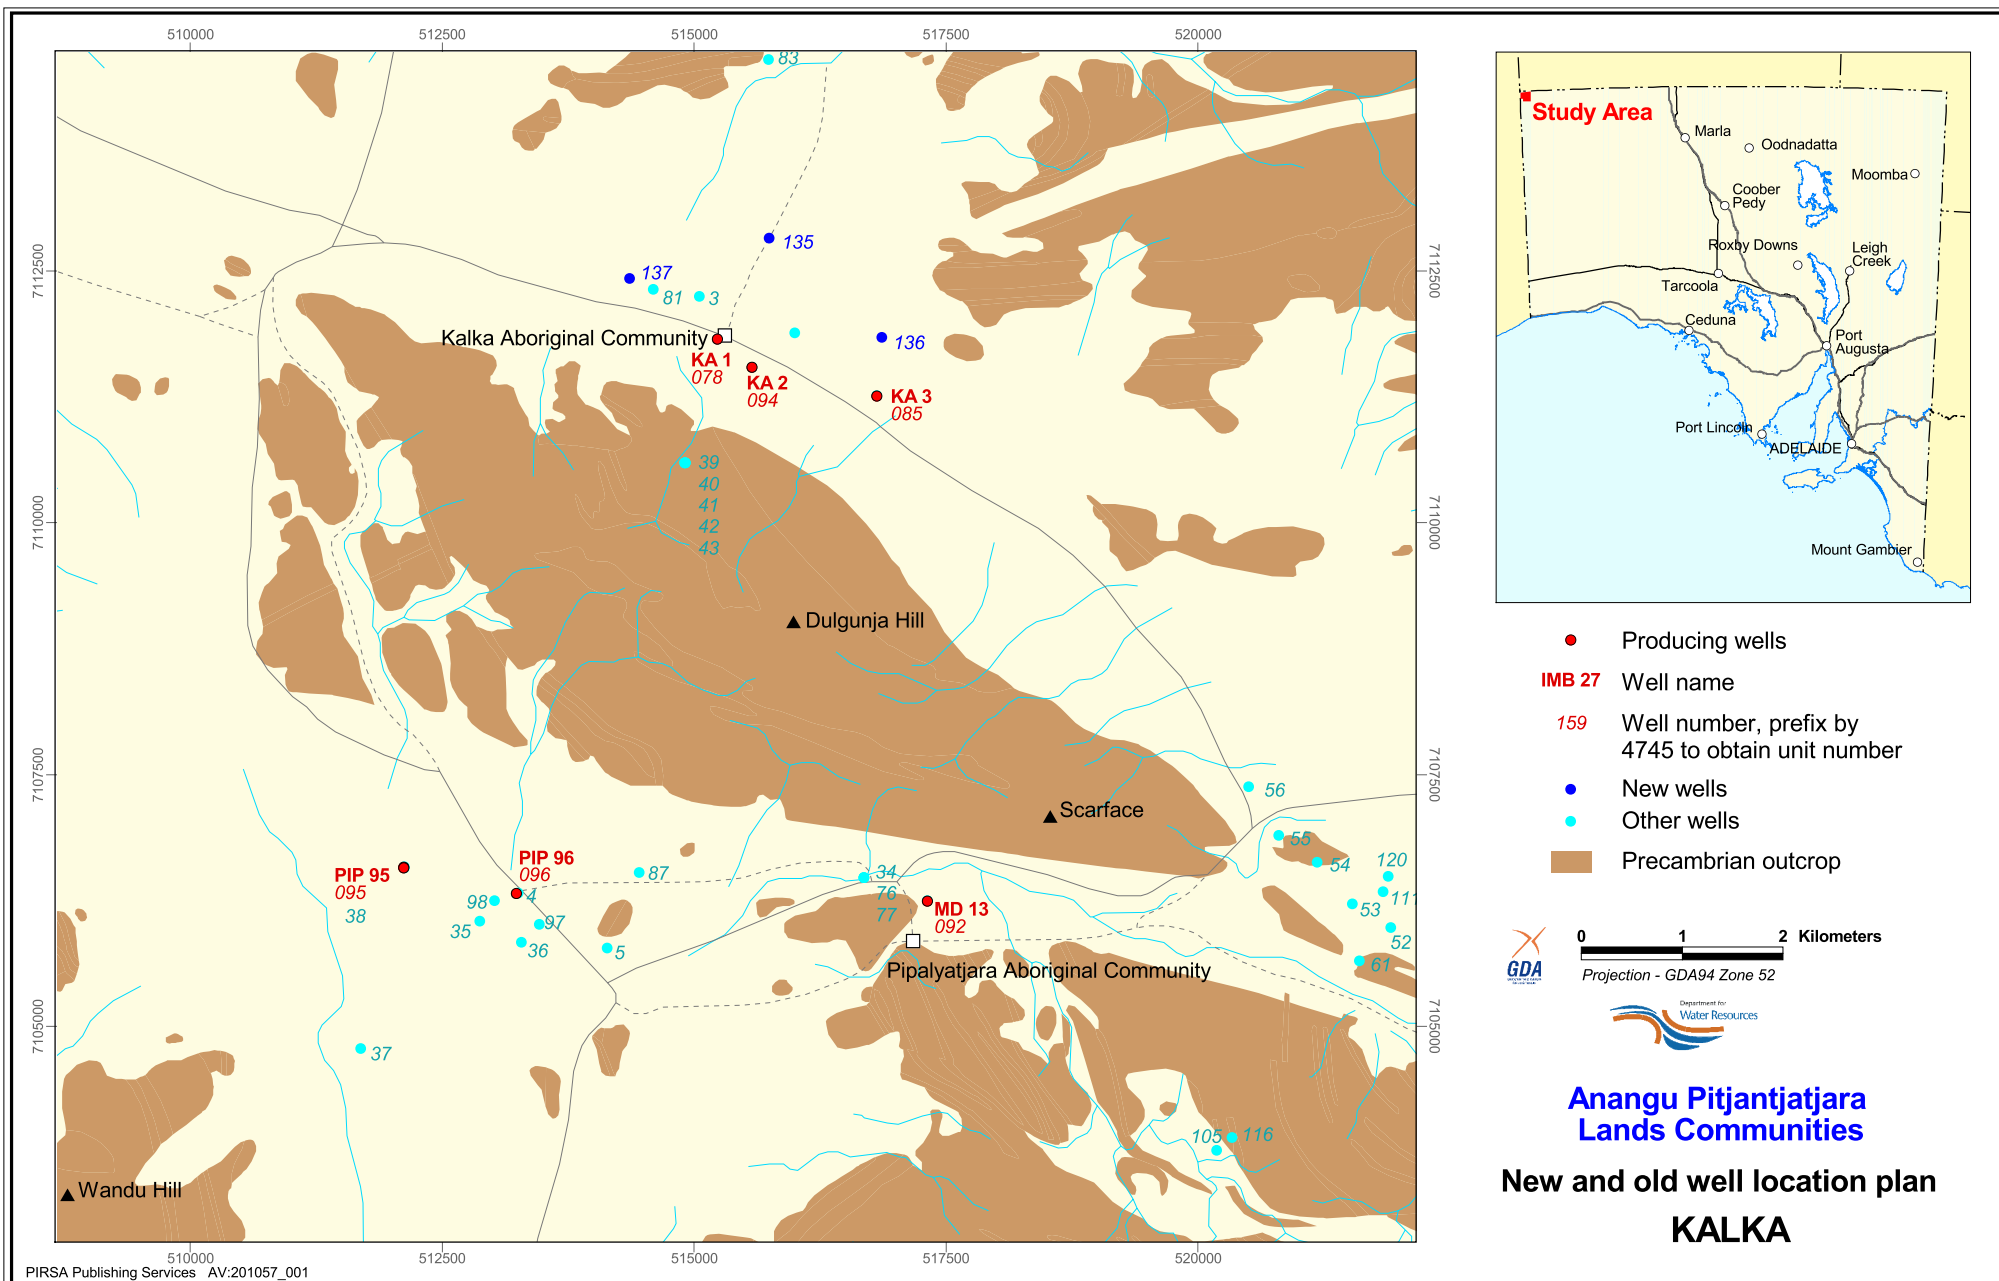
Figure 2

All three existing wells (Fig. 2) are located in a wide east-trending valley that flanks the community to the north. Several ephemeral creeks flow into this valley, but there is no creek line along the valley or leaving it, nor are there any extensive evaporative pans, suggesting that the incoming water is absorbed into the sub-surface. The wells have shown no sign of recharge or dewatering of the aquifer. However, the maximum monthly rainfall since monitoring began has been 88 mm, which is probably not enough to cause recharge.

Three drill sites were selected and drilled in the valley (Fig. 2), aimed at deeper parts of the valley and preferably near inflowing creek systems. Two of these were successful, producing conservative long-term yields of 0.63 and 7.1 L/s of good quality water. All the water comes from weathered gneissic gravel, sometimes transported, under 20 m or so of finer Quaternary sediments. Basement is gneiss. The third well produced only a seepage of water, despite intersecting weathered and highly fractured gneiss from 27 to 43.5 m, a depth at which the water table should have been intersected. It appears that the aquifer at this point is not connected to a recharge supply of groundwater. This indicates a lack of lateral connectivity of aquifers in this area and, indeed, the existence of total barriers to groundwater movement.

Kalka's water supply seems assured by the new well, but monitoring of its water level (on a six-monthly basis) would be advisable. Should the well be equipped, then the installation of monitoring equipment would provide valuable data, whether the well is being pumped or not. It would be interesting to find out more about the aquifer in this location, perhaps by application of geophysics to assess the dimensions of the channel, however, this can only be justified unless additional water supplies are required.

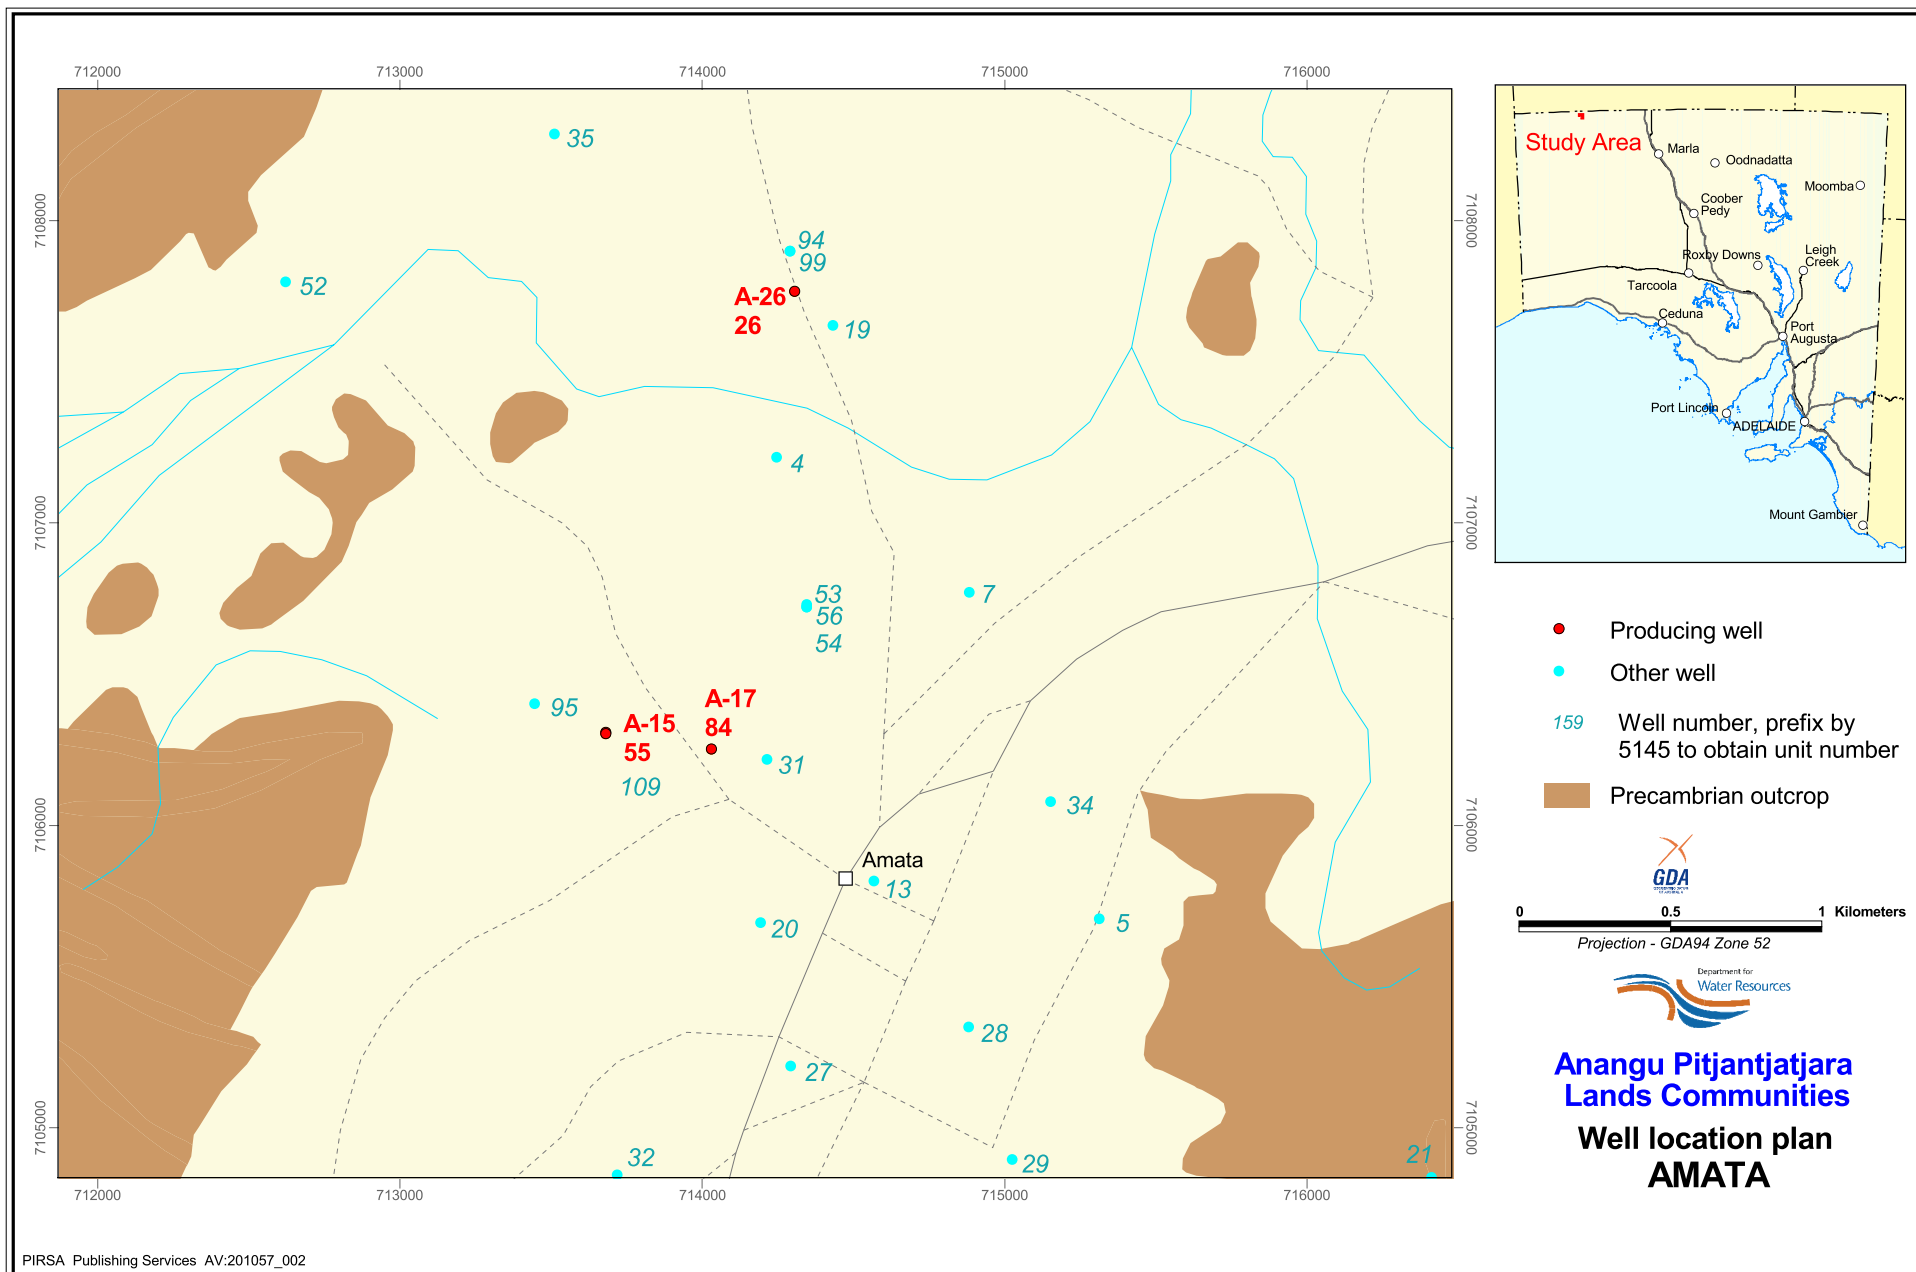
Figure 3

The community has a satisfactory water supply from three wells, A-15, A-17 and A-26, (Fig. 3) any two of these wells could supply the normal requirements of the community. However, the casing and screens in all three wells were highly corroded and partially blocked, with a build up of sediment at the foot of the well. After initially considering redrilling all three wells, it was eventually decided that rehabilitation would be attempted.

Attempts to rehabilitate A-15 resulted in the screen being destroyed and the well being abandoned. A new well was drilled a few metres away, the position was selected on the basis of convenience for movement of the infrastructure. The resulting well has a long-term yield of 5.1 L/s, considerably more than the original well. The water comes from a fractured gneiss aquifer.

Well A-17 was fully flushed and rehabilitated with new PVC casing. Well A-26 could not be rehabilitated, since there was immovable infrastructure positioned over the well, preventing access by the drilling rig. It was therefore only flushed out, and the casing remains fragile.

While some of the work at Amata was unsuccessful, the work has resulted in an increase in the water supply available through well 5145-137 and improved the condition of well 5145-84 (A-17). Unfortunately, the casing in well 5145-19 (A-26) could not be rehabilitated and flushing the well will be of limited value. The aquifer is performing very well, with major recharge over the past 18 months, indicating that the conclusion expressed by Dodds and Sampson (2000; RB2000/027) that only a drought of 20 years or more would be likely to cause a water shortage, is verified. Rehabilitation or replacement of well 5145-19 is desirable but not urgent.

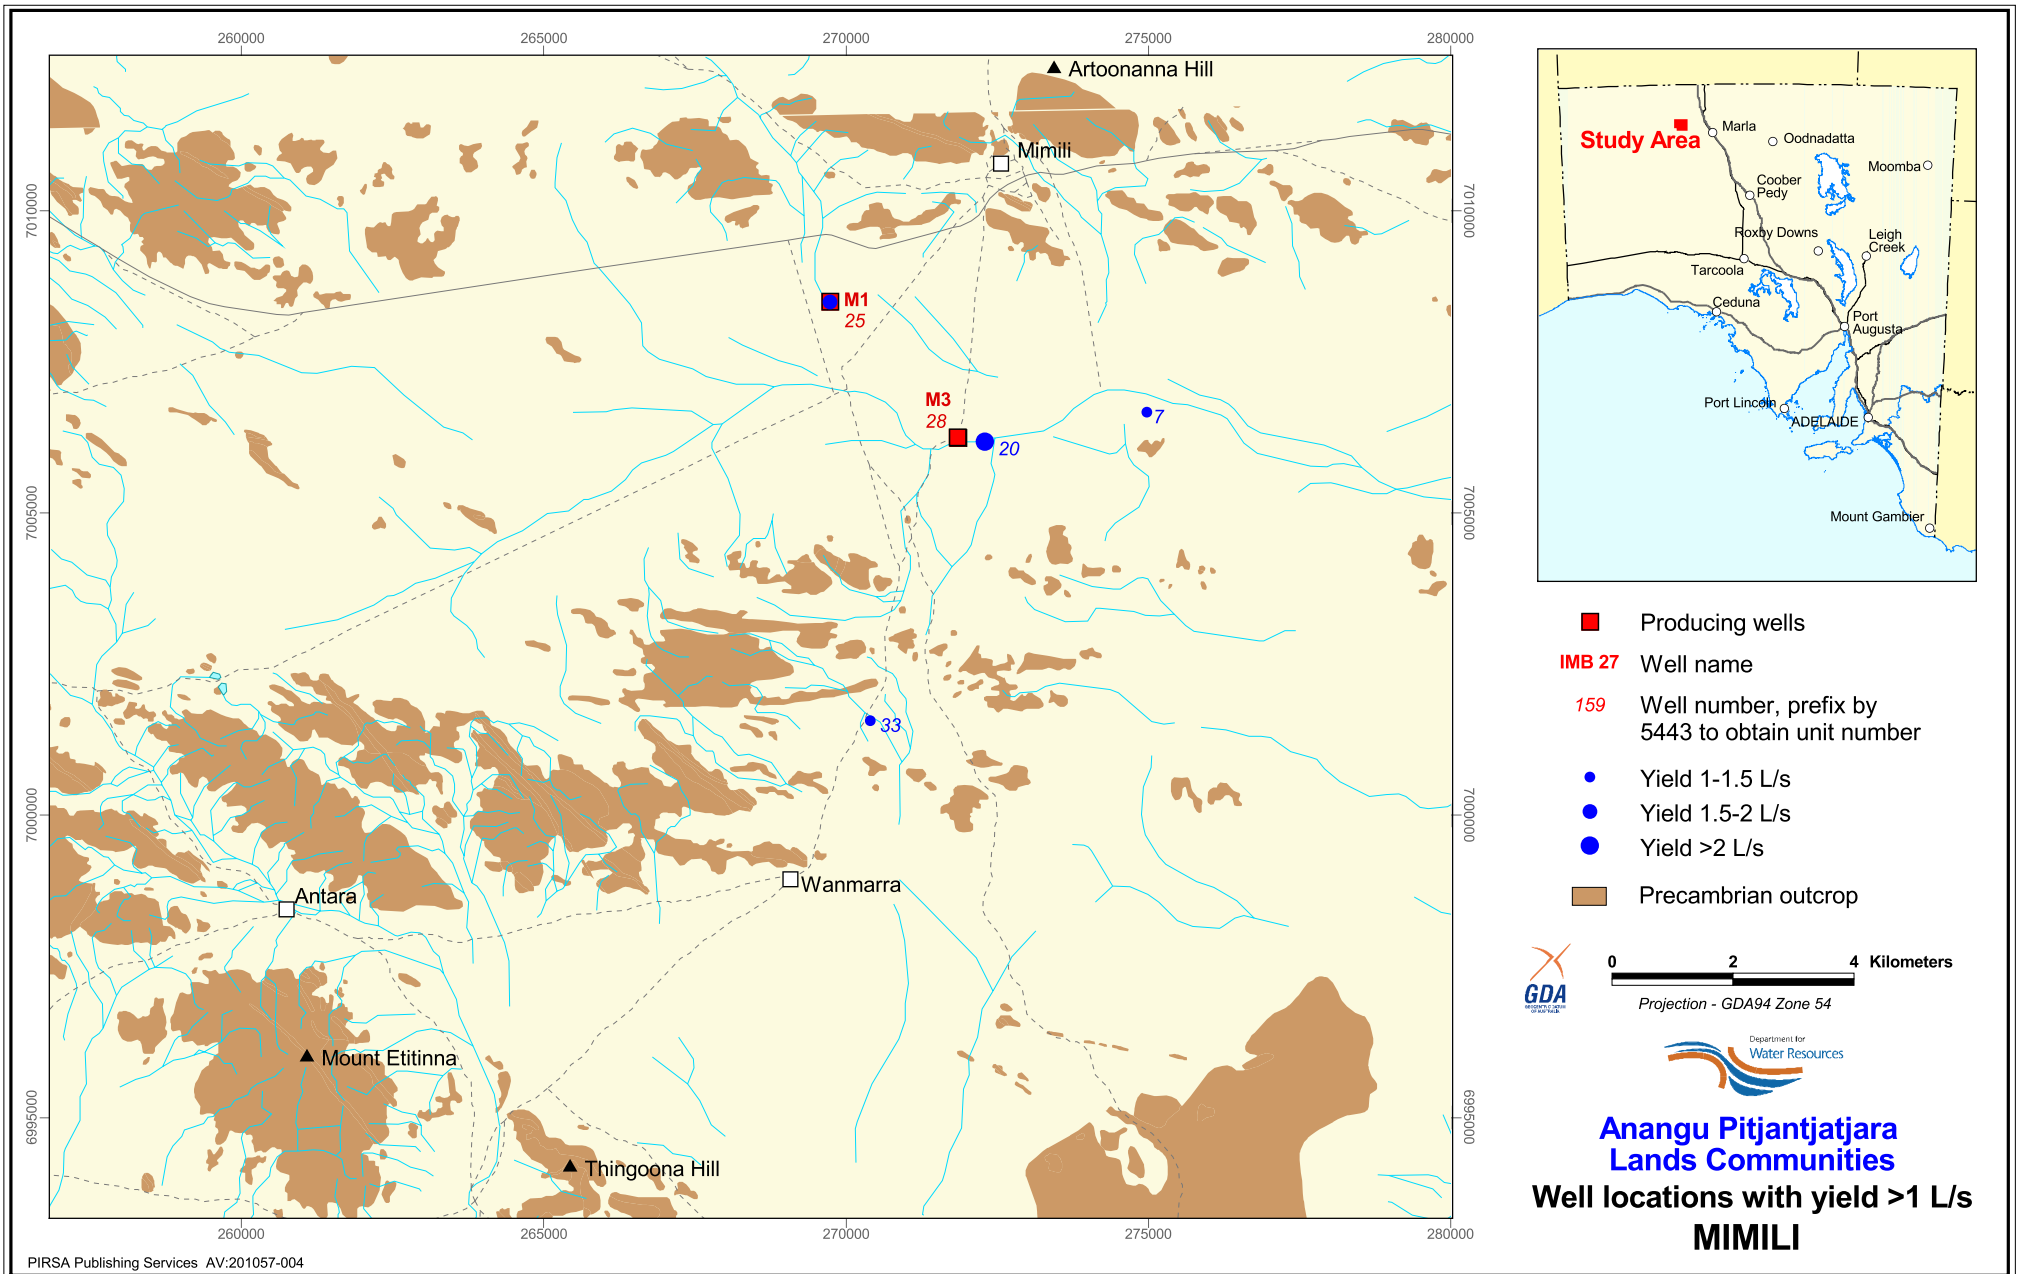
Figure 4

The community has an adequate water supply coming equally from two wells, M-1 and M-3 (Fig. 4), either of which could supply the community's needs in the short term. Neither well shows signs of dewatering or recharge, however rainfall has not been heavy at any time since monitoring began, so there has been no source of recharge water. A third well is considered desirable to ensure the community water supply.

The other two sites, chosen on the basis of surface features, were drilled without success. One yielded saline water (over 2000 mg/L) and was abandoned at 25 m, while the other yielded only a seepage of water (Fig. 4).

The situation at Mimili is unchanged, with the community still dependant on two wells for its water supply. The difficulty in finding additional supplies has been reinforced, and the solution of concentrating further search efforts near existing wells is recommended. A minimum separation of 200 m is suggested to ensure that wells do not interfere with each other. Some use of geophysics could help in locating new wells more precisely, however this could only be justified if the crew and equipment were already in the area for other work. Six well sites have subsequently been selected for possible future drilling; three near each of the current town water supply (TWS) wells.

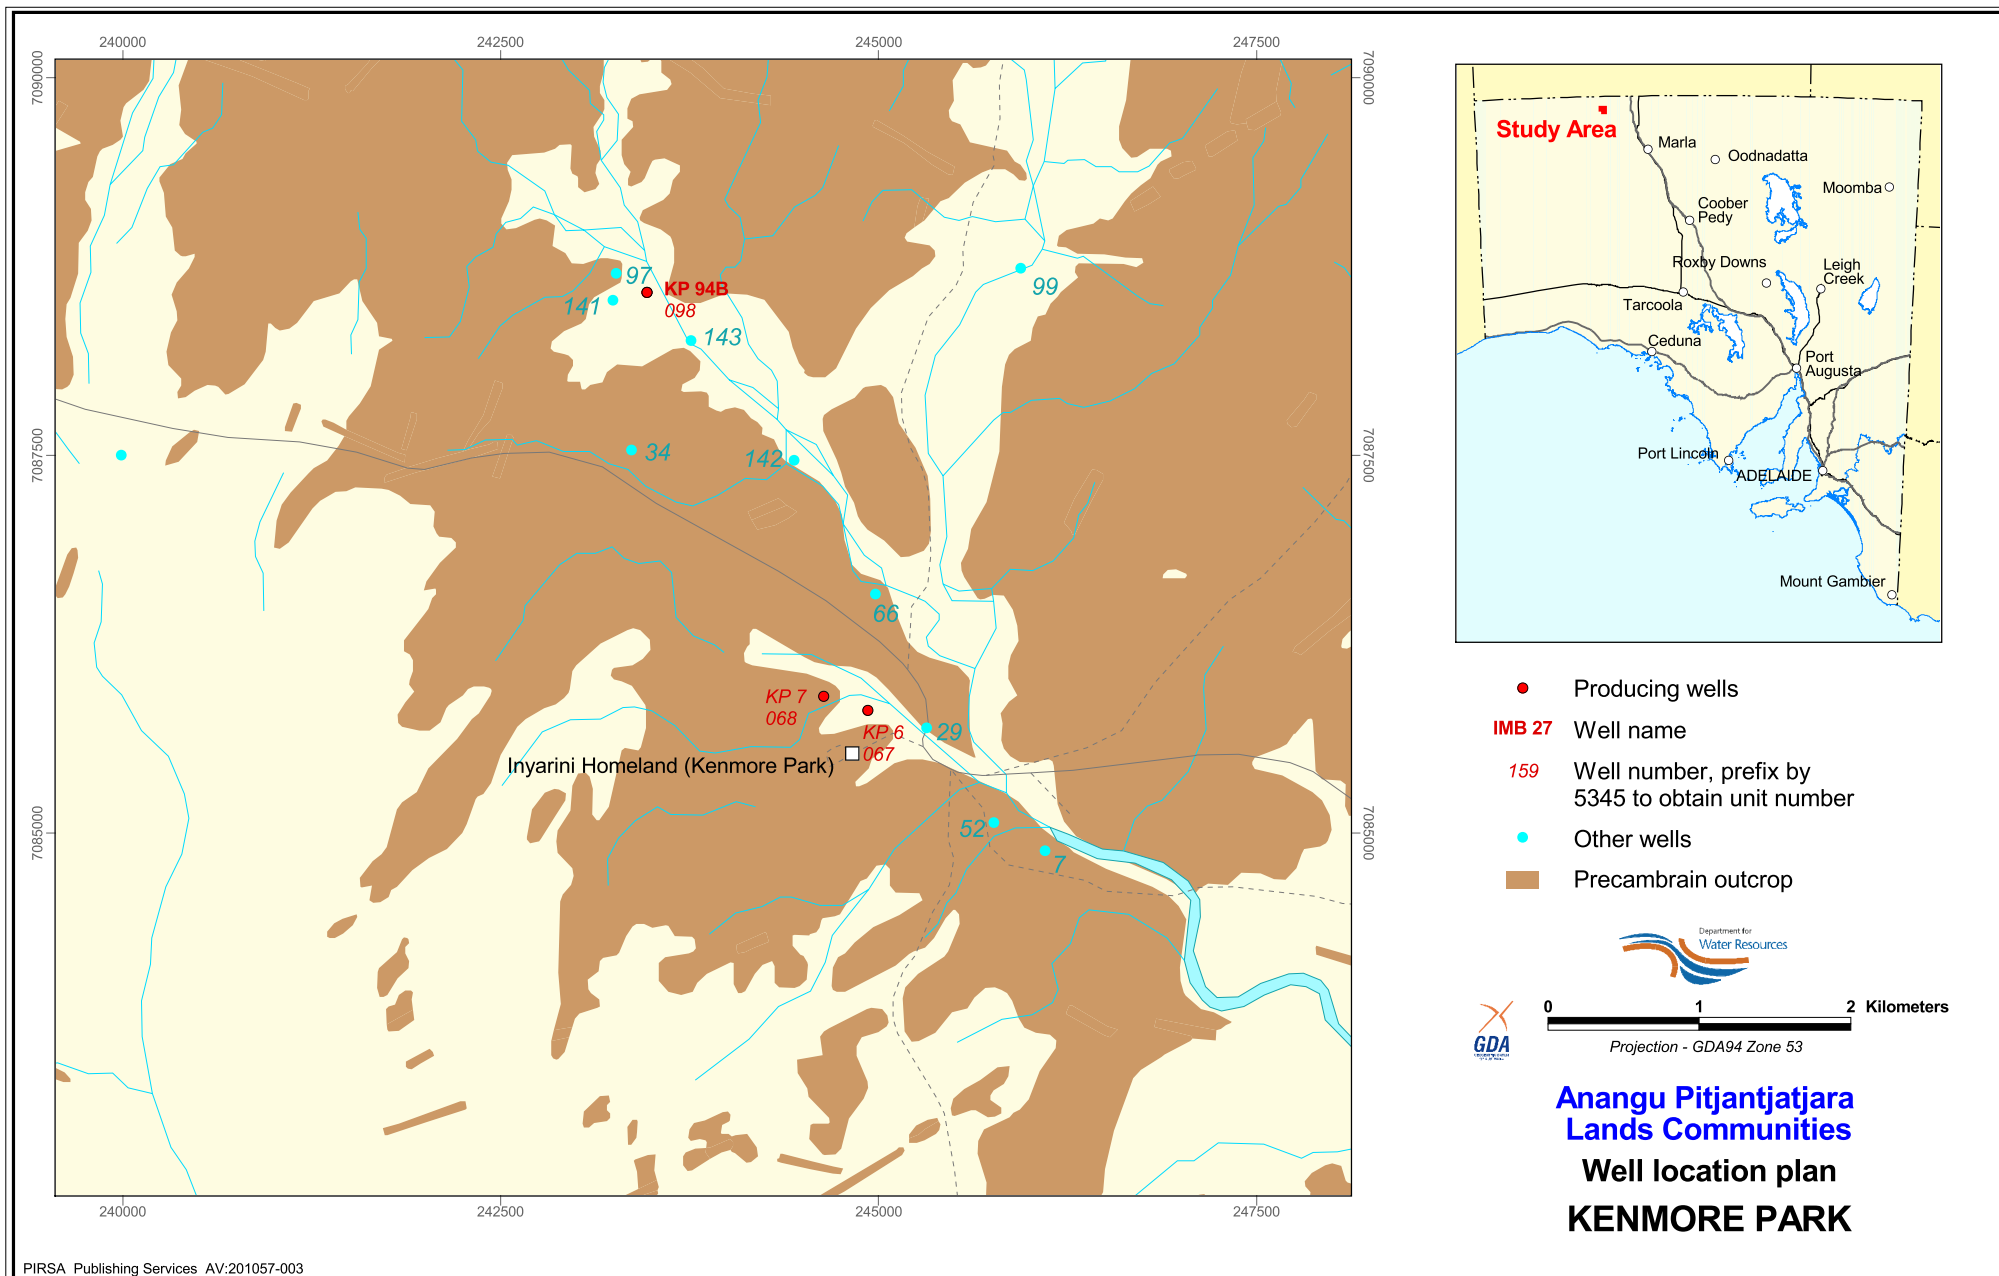
Figure 5

Three wells supply water to this community: KP-6, KP-7 and KP-94B (sometimes referred to as KP-98 after the well unit number, 5345-98) (Fig. 5). The first two have been regularly pumped and monitored and, while not providing generous supplies, have sufficed to serve the community. KP-94B was little used before last year, 2000. While it was previously assumed that this was due to an unreliable supply, the real reason was that the pump had to be manually turned on and off at the well site, some 4 km from the community. Increased use in the last year, and a more detailed study of the well's testing and performance, indicate that the well can supply at least 1 L/s in the long term, and could be a major contributor to the community's water supply.

The search for additional supplies in this area concentrated on the vicinity of KP-94B, where favourable structures are indicated by outcropping formations. Three wells were drilled, but produced only minor quantities of water. All the wells encountered gneiss at shallow levels and found little weathering or fracturing of the rock. One well was terminated at 12 m, since the water found was saline. The area along the main road west of Kenmore Park was also considered, despite high nitrate values recorded in some earlier wells. Well 5345-34 had reasonable quality water in unknown quantities, and was pump tested. The supply proved to be minor.

While no additional water supplies have been found for Kenmore Park (and the difficulties of finding such supplies highlighted), a reassessment of existing supplies has shown that the water supply may be sufficient unless there is an increase in demand. If the need for water increases, or if one of the wells shows signs of stress, the supply from 5345-98 (KP-94B) could be reassessed by more stringent pump testing and by monitoring its use and water levels. It is likely that this well can supply more than the 1 L/s currently recommended as the maximum yield.
