Hydrogeological report on water well monitoring in Aboriginal lands — April to October 2000

A.R. (Sandy) Dodds and Lloyd D. Sampson

Report DWR 2001/005

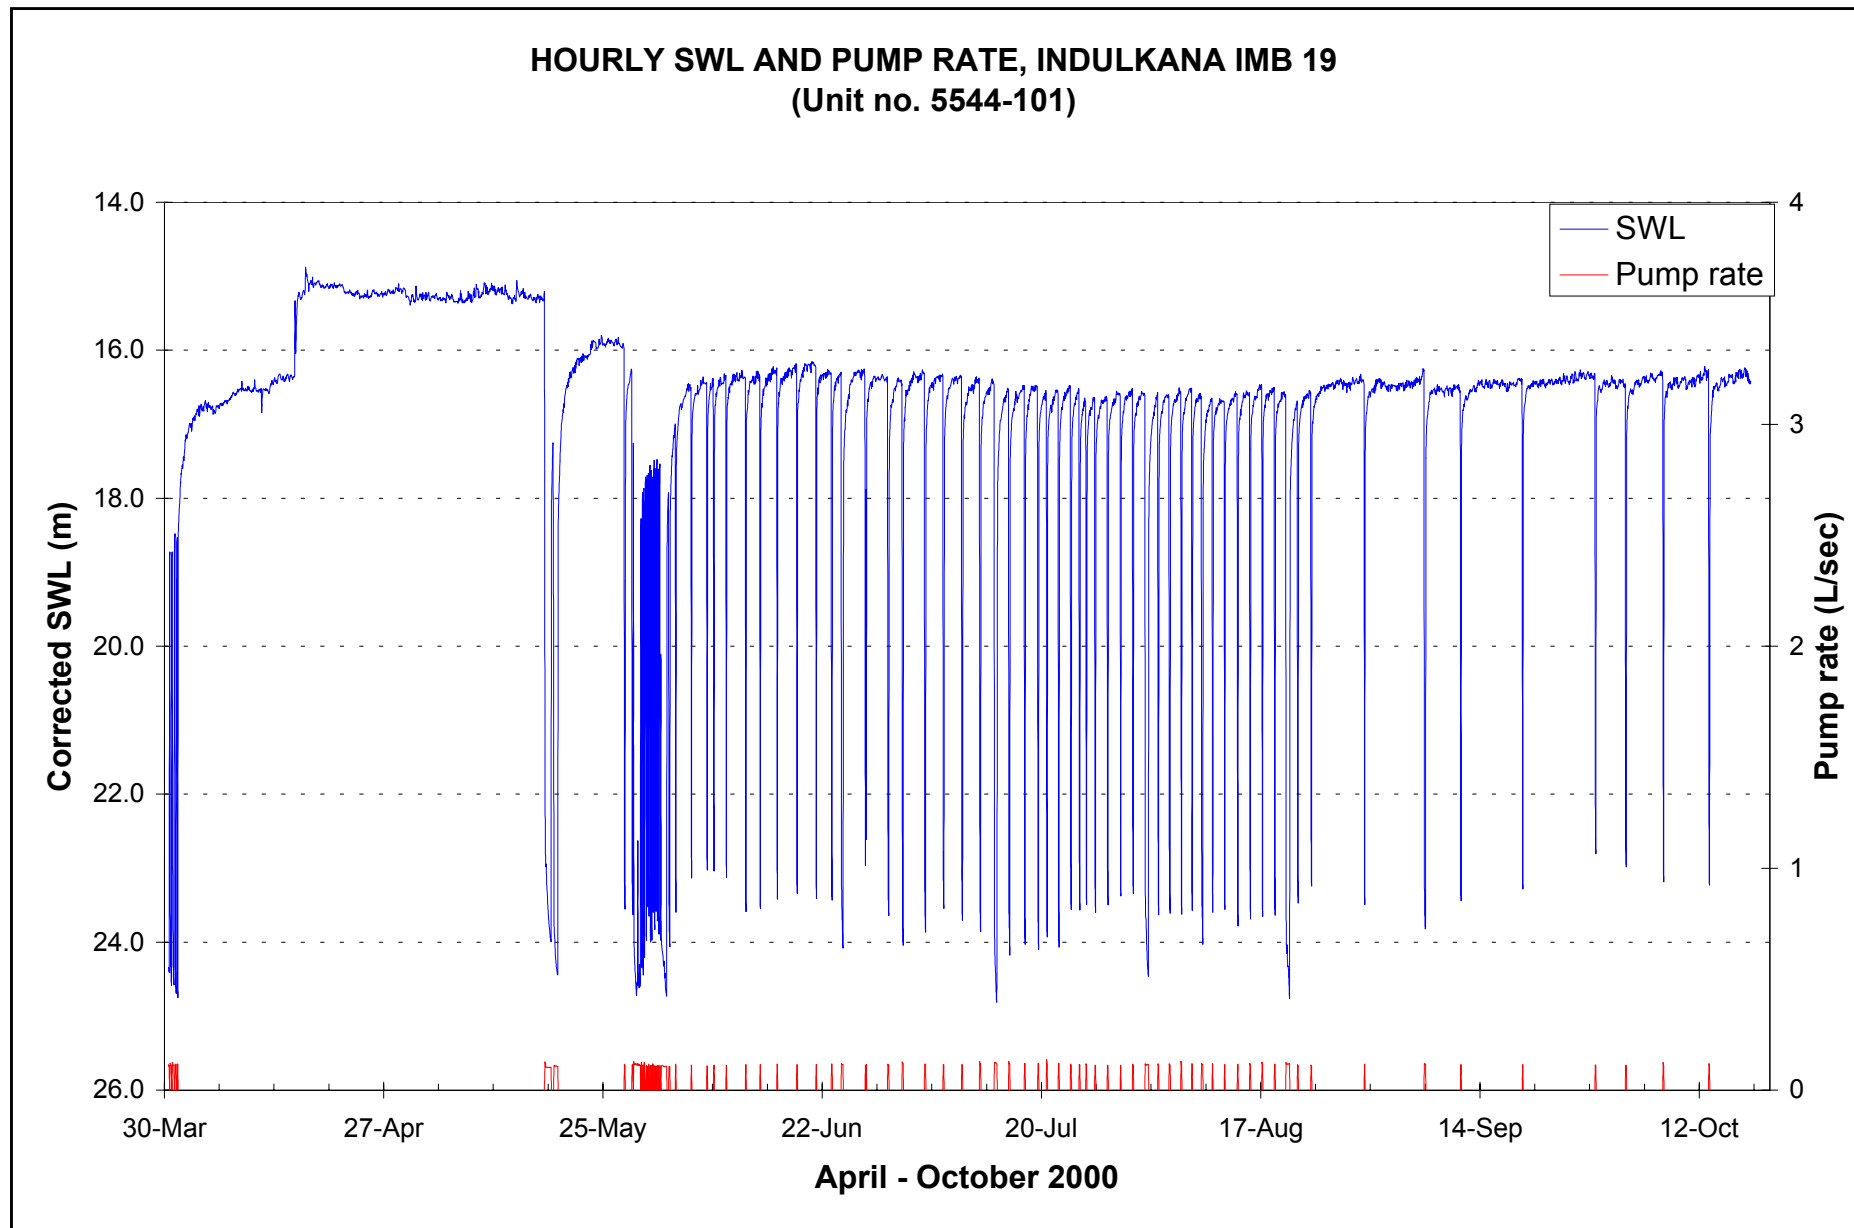
Figure 1.4

As observed in the previous monitoring period (October 1999 to April 2000), the water level in IMB 19A recovered quickly when rested after an extensive pumping period. This is shown in April 2000 with the water level recovering to 26.8 m which is above that at the time of drilling (28 m).

The complex relationship between SWL, pumping rate and recharge make the assessment difficult, but the data suggests that there was recharge to this aquifer resulting from the February 2000 rains. The SWL unit failed during the monitoring period (Fig. 1.5); some data in April to May 2000 and all data after August 2000 being erroneous.

- IMB 19A** Data logger was downloaded and memory cleared and flow totaliser reset. The data indicates the 2100P failed during the logging period but subsequently recovered, however, the 2100P battery was not holding charge and was replaced. The logger was re-started with the 0.015 m correction to the SWL datum.

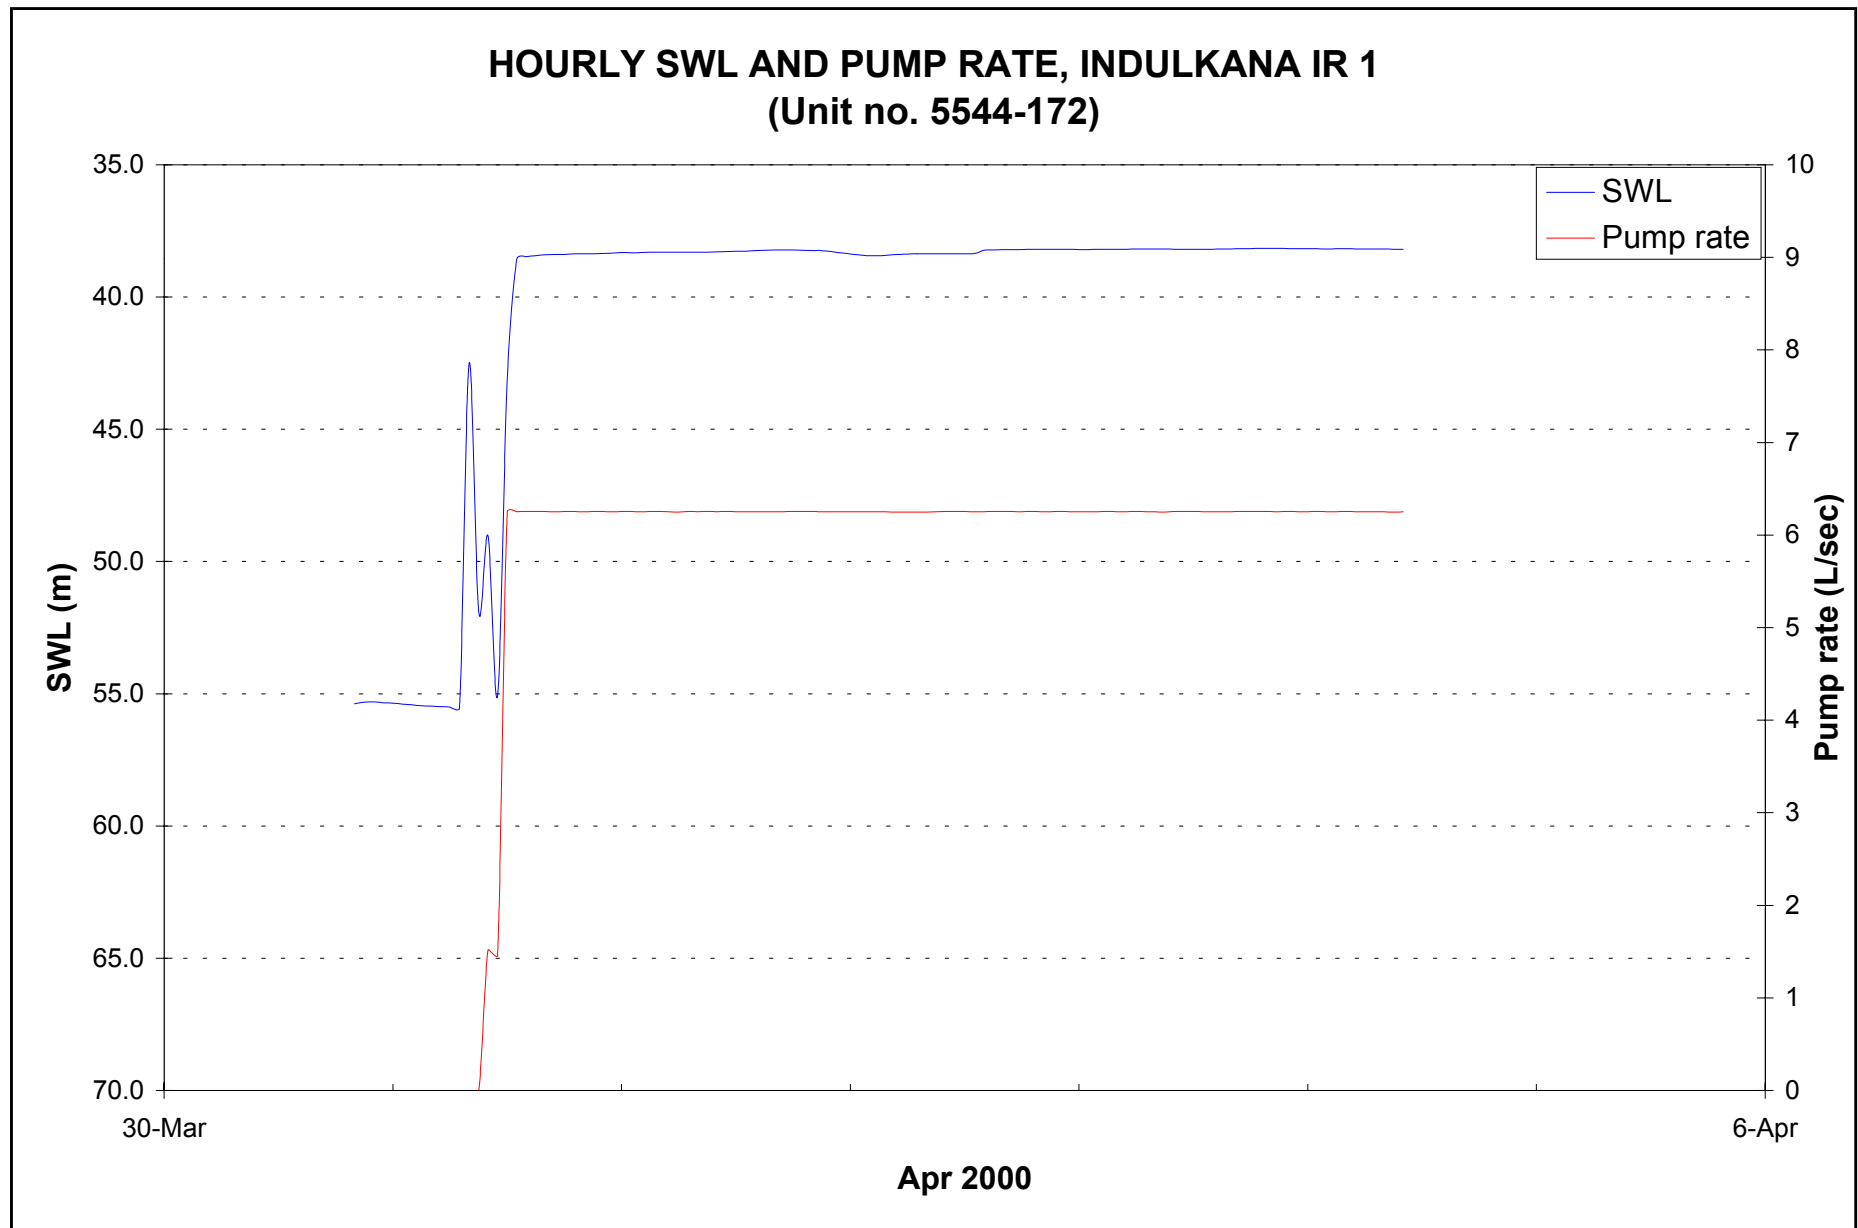
Figure 1.9

The data loggers for IR 1 both failed and have resulted in a lack of data. The SWL has dropped from 37.5 m at the time of drilling to 38.4 m in April 2000 and 39 m in October 2000, which suggests the fall is a result of pumping (Fig. 1.9).

- IR 1** Unable to communicate with the logger, memory module was removed and was not able to download using an alternative logger. The logger S/N 311170 was replaced with S/N 311404. All inputs were calibrated and the logger restarted with a new datum.

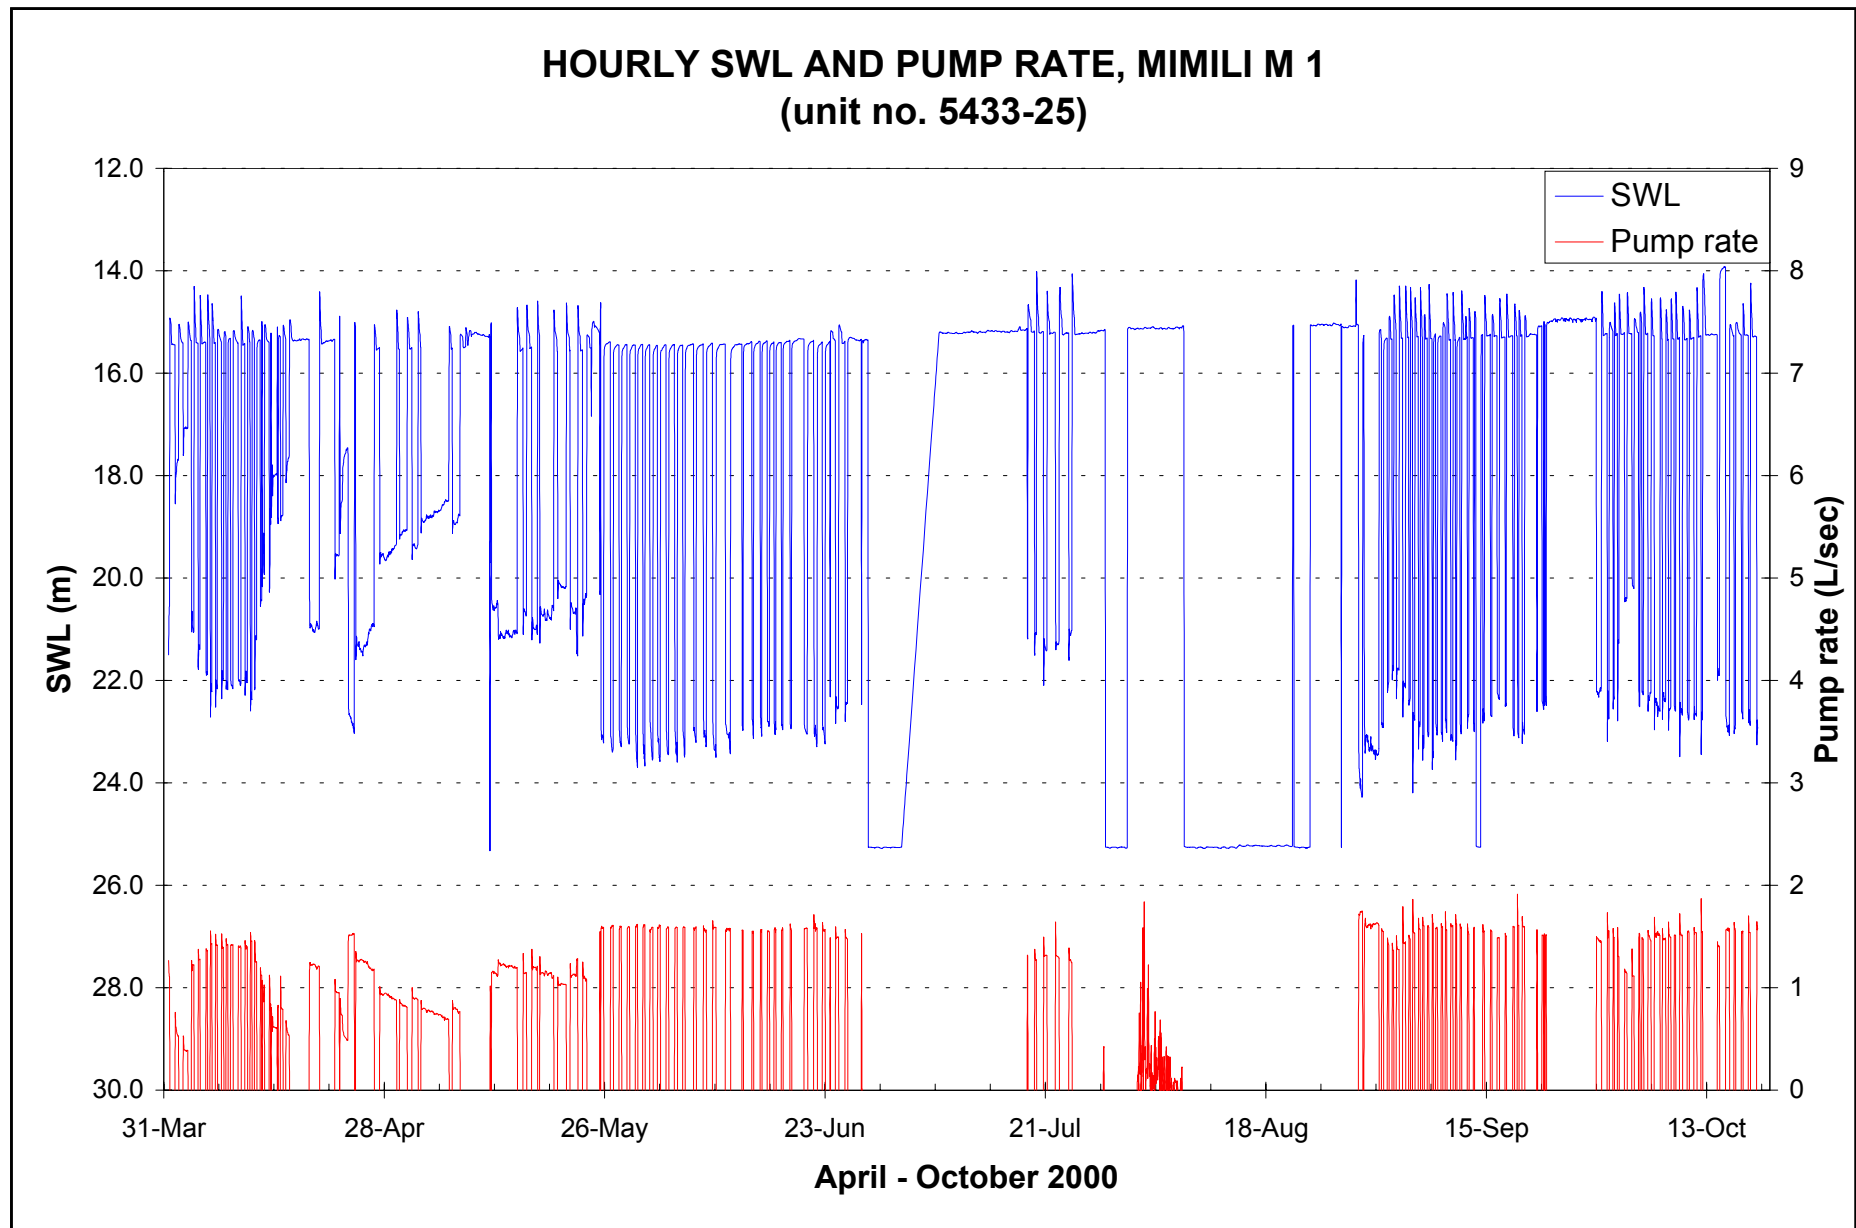
Figure 2.3

Although the SWL unit had temporary failures in June and August 2000, the unit appears to have recovered (Fig. 2.3). However, the overshoot in the SWL, when the pump turns off, suggests that water is flowing back into the well from the distribution system through a faulty non-return valve. Pumping rates for the well were erratic, when compared to the previous monitoring period.

- M 1** The bore was pumping on arrival, was isolated and allowed to recover. The logger was downloaded, memory cleared and flow totaliser reset. There was a significant period of invalid data but the 2100P seems to have recovered. The logger was restarted with a correction 0.047 m to the SWL datum.
- M 3** The bore was pumping on arrival, and was isolated and allowed to recover. The logger was downloaded, memory cleared, flow totaliser reset and the rain gauge accumulator reset. Data indicates that the 2100P failed at various stages during the logging period and was replaced. The logger was restarted with a correction of 0.034 m to the SWL datum.

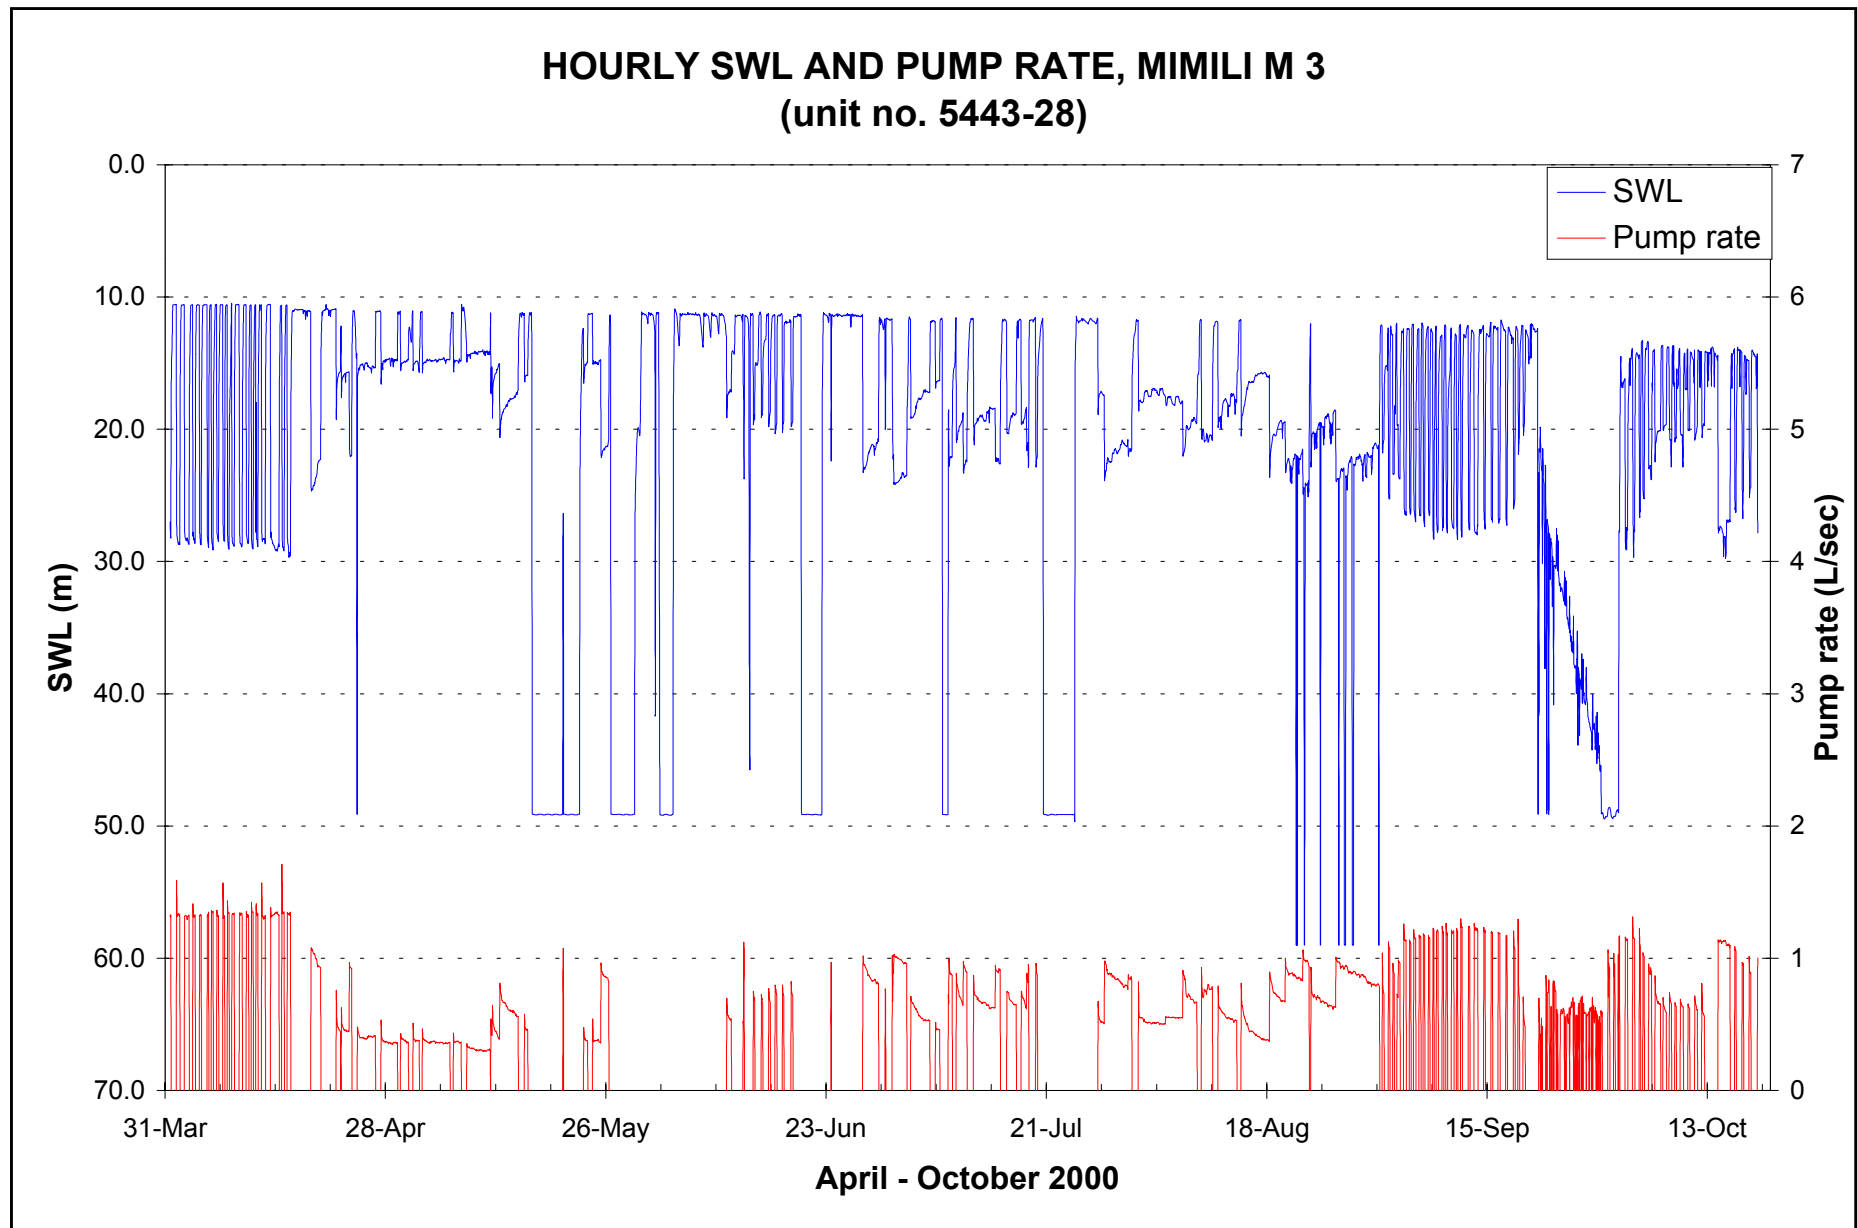
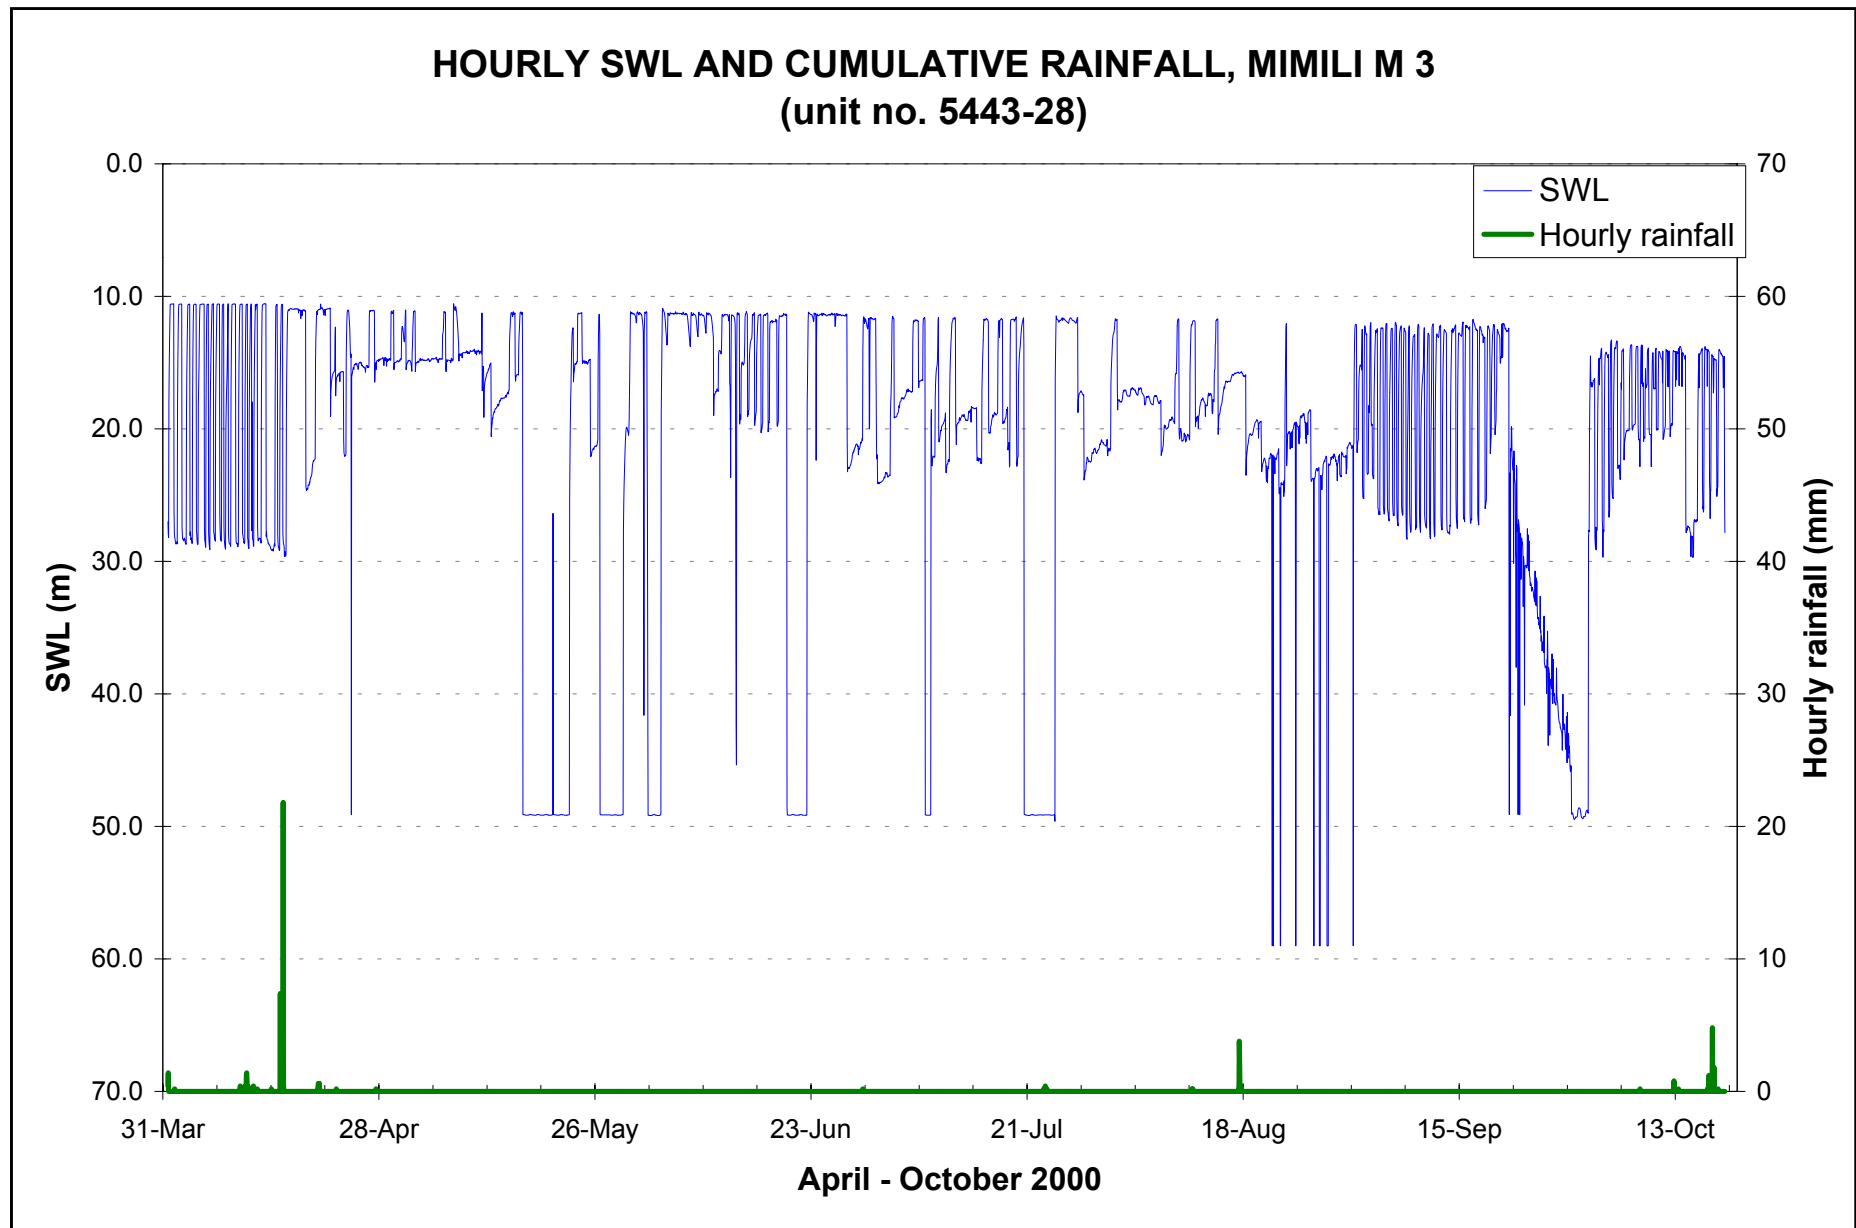
Data collected for M 3 over this monitoring period is inaccurate due to a failed SWL probe, however, a manual SWL measurement was taken at download time. The reading indicates there was no further water level drop (Figs 2.4–2.5).

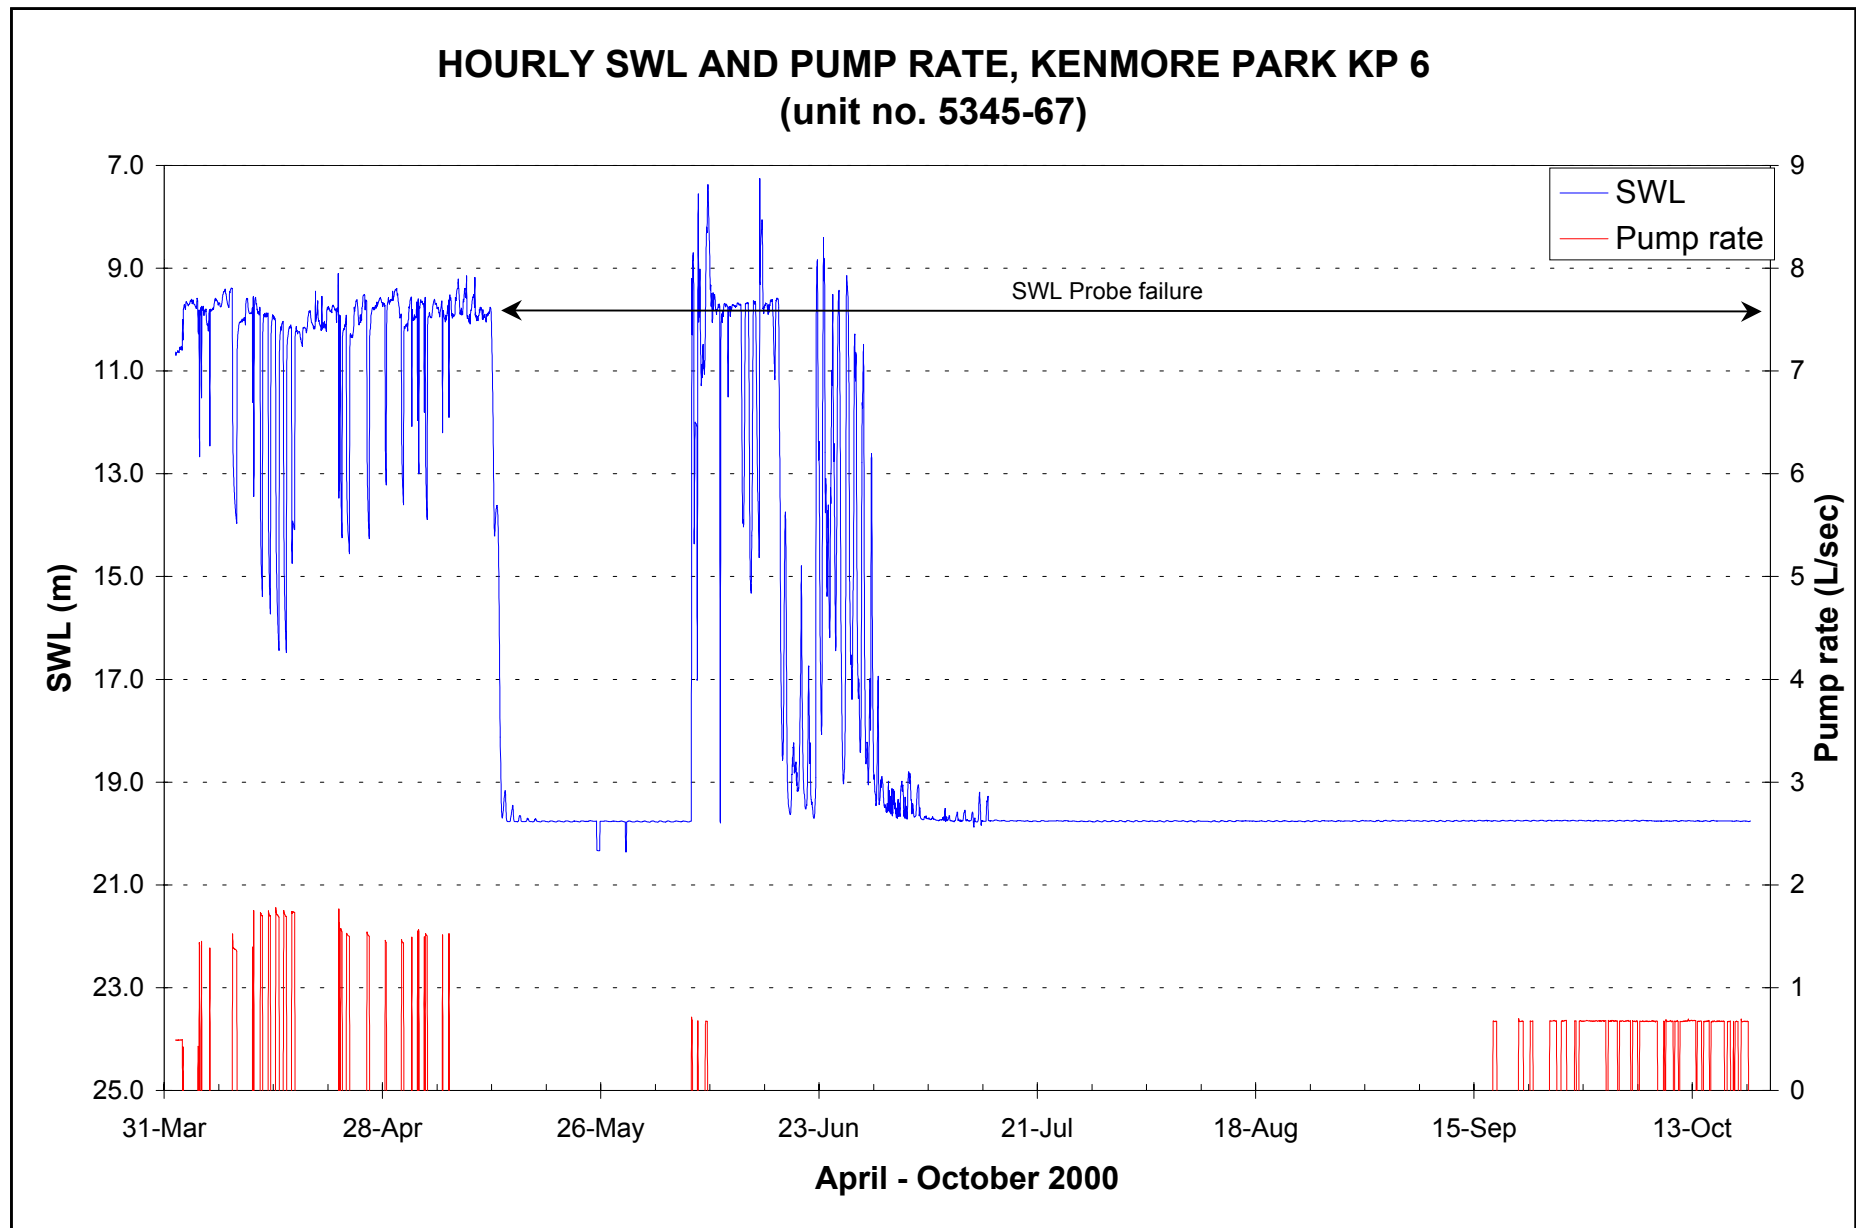
Figure 4.3

The SWL measurement unit in KP 6 failed temporarily in May 2000 then completely in late June, and the water level data is not reliable. However, the final manual measurement water level of 9.93 m, suggests that the water level is being maintained (10.3 m last period, October 1999 to April 2000), showing no recharge effects or aquifer depletion.

Water production was 60% lower than the previous period and an even smaller proportion of that of earlier years. It is not clear if the intermittent use of KP 6 is due to the fact that the well struggles to produce its own supply (Fig. 4.3). The well was pumped at the start of the period and, towards the end of the period, it was pumped for 40 hours at 0.67 L/s when the SWL unit failed.

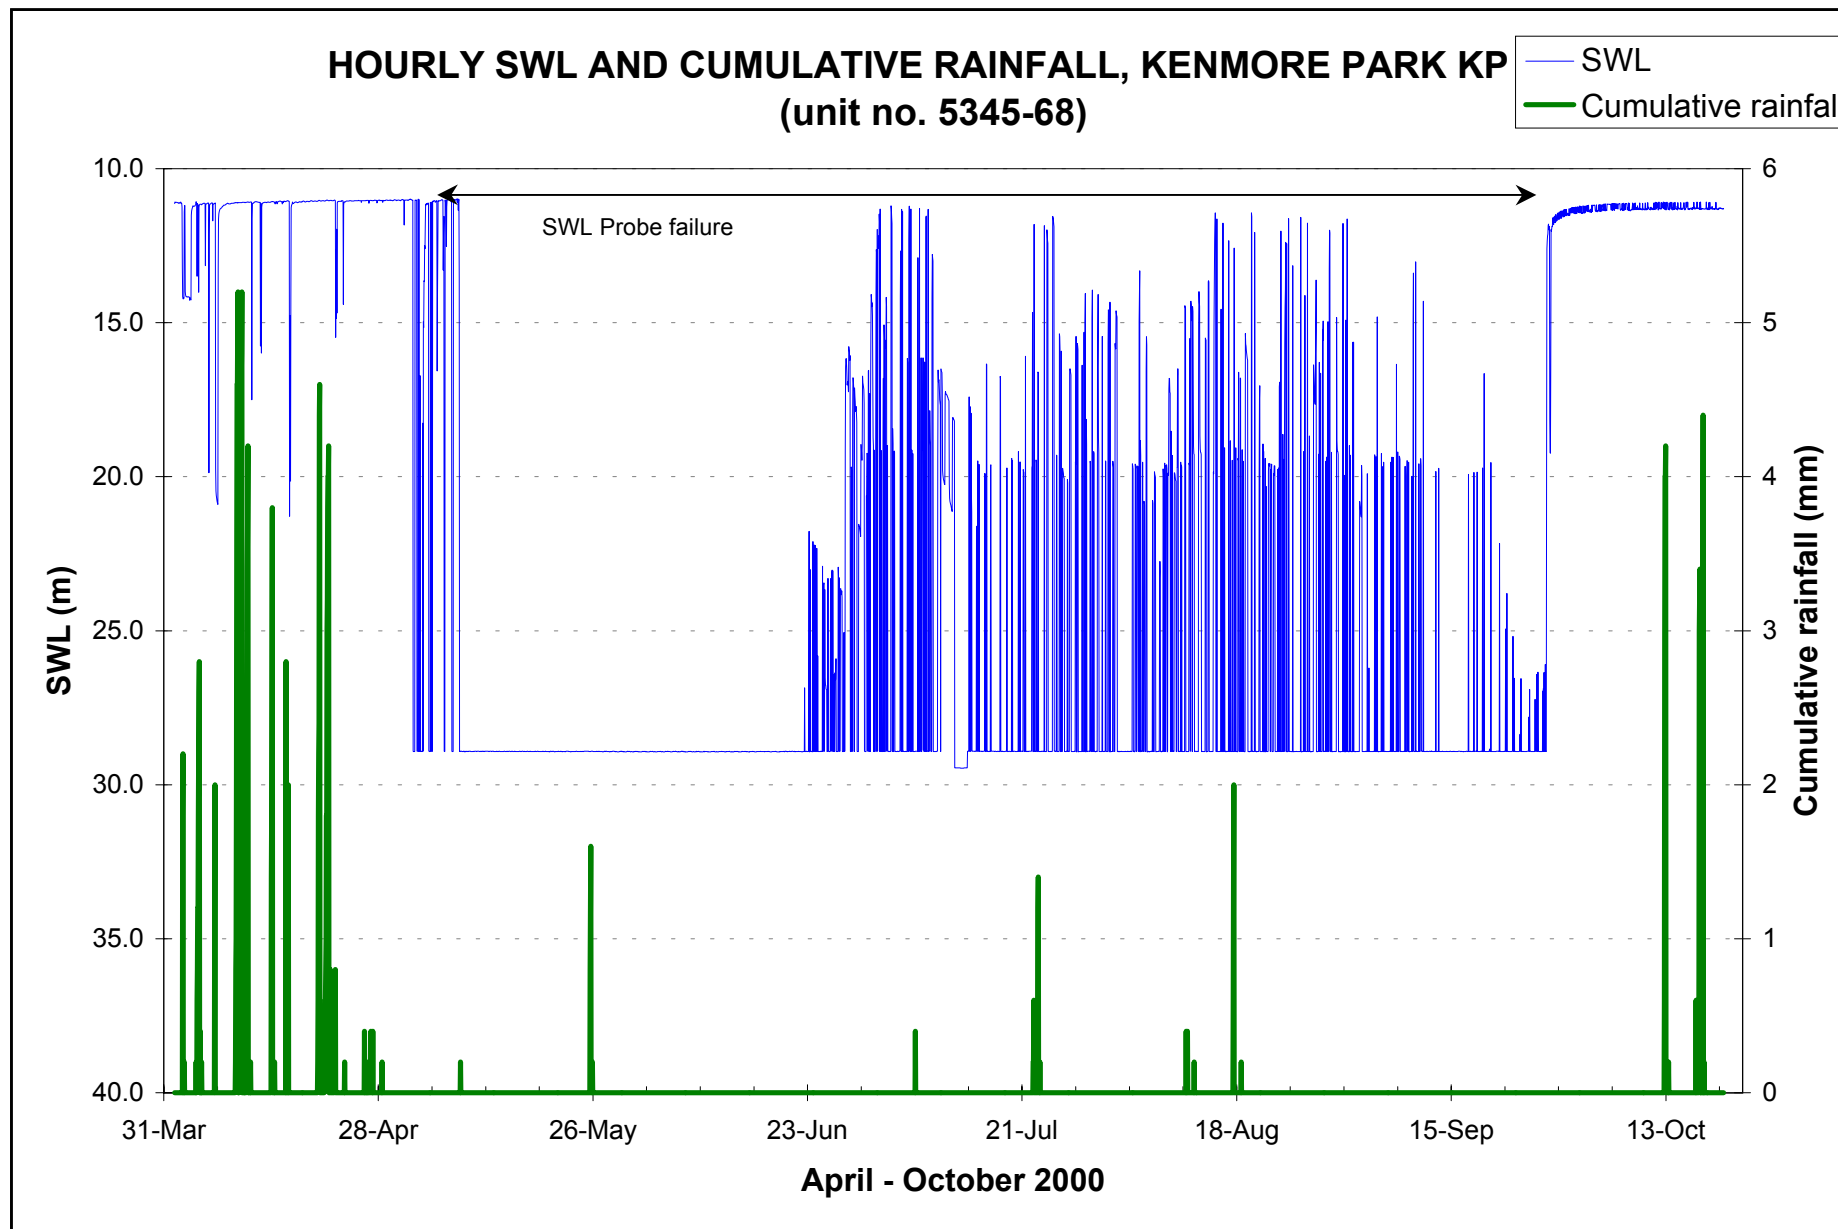
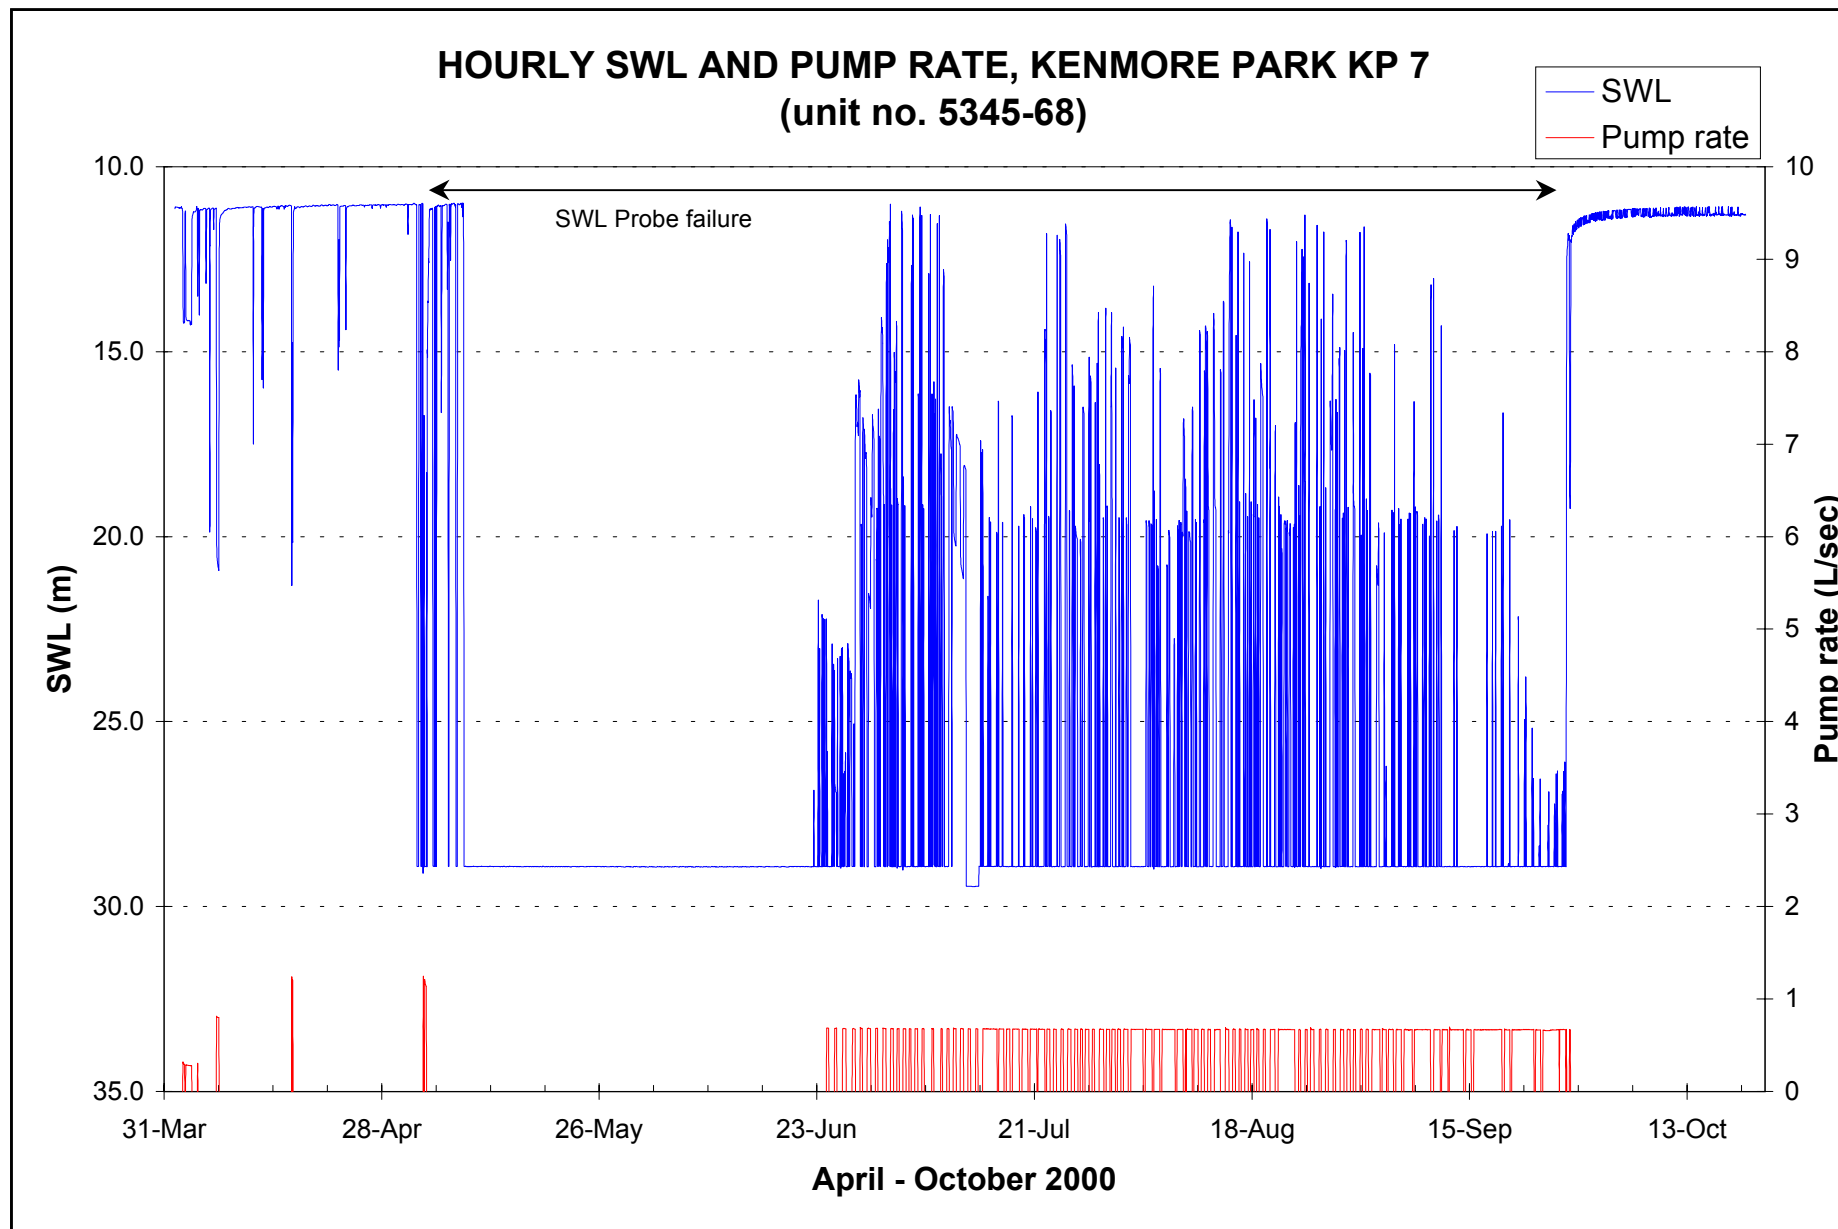
The SWL probe in KP 7 failed in early May 2000 causing anomalies in the readings for the monitoring period. The manual SWL reading taken in October 2000 shows that the watertable was constant for the period at 11.09 m, compared with 11.1 m prior to the failure of the probe. Overall the SWL has remained consistent at about 11 m since 1997.

It is likely that the rise in SWL mentioned in the previous report can be attributed to recharge in March 2000, however the rise did not continue into April (Fig. 4.4). This well was pumped harder during this period (16 kL/d) than at any time since 1997; an average increase of about 80% (Fig. 4.5).

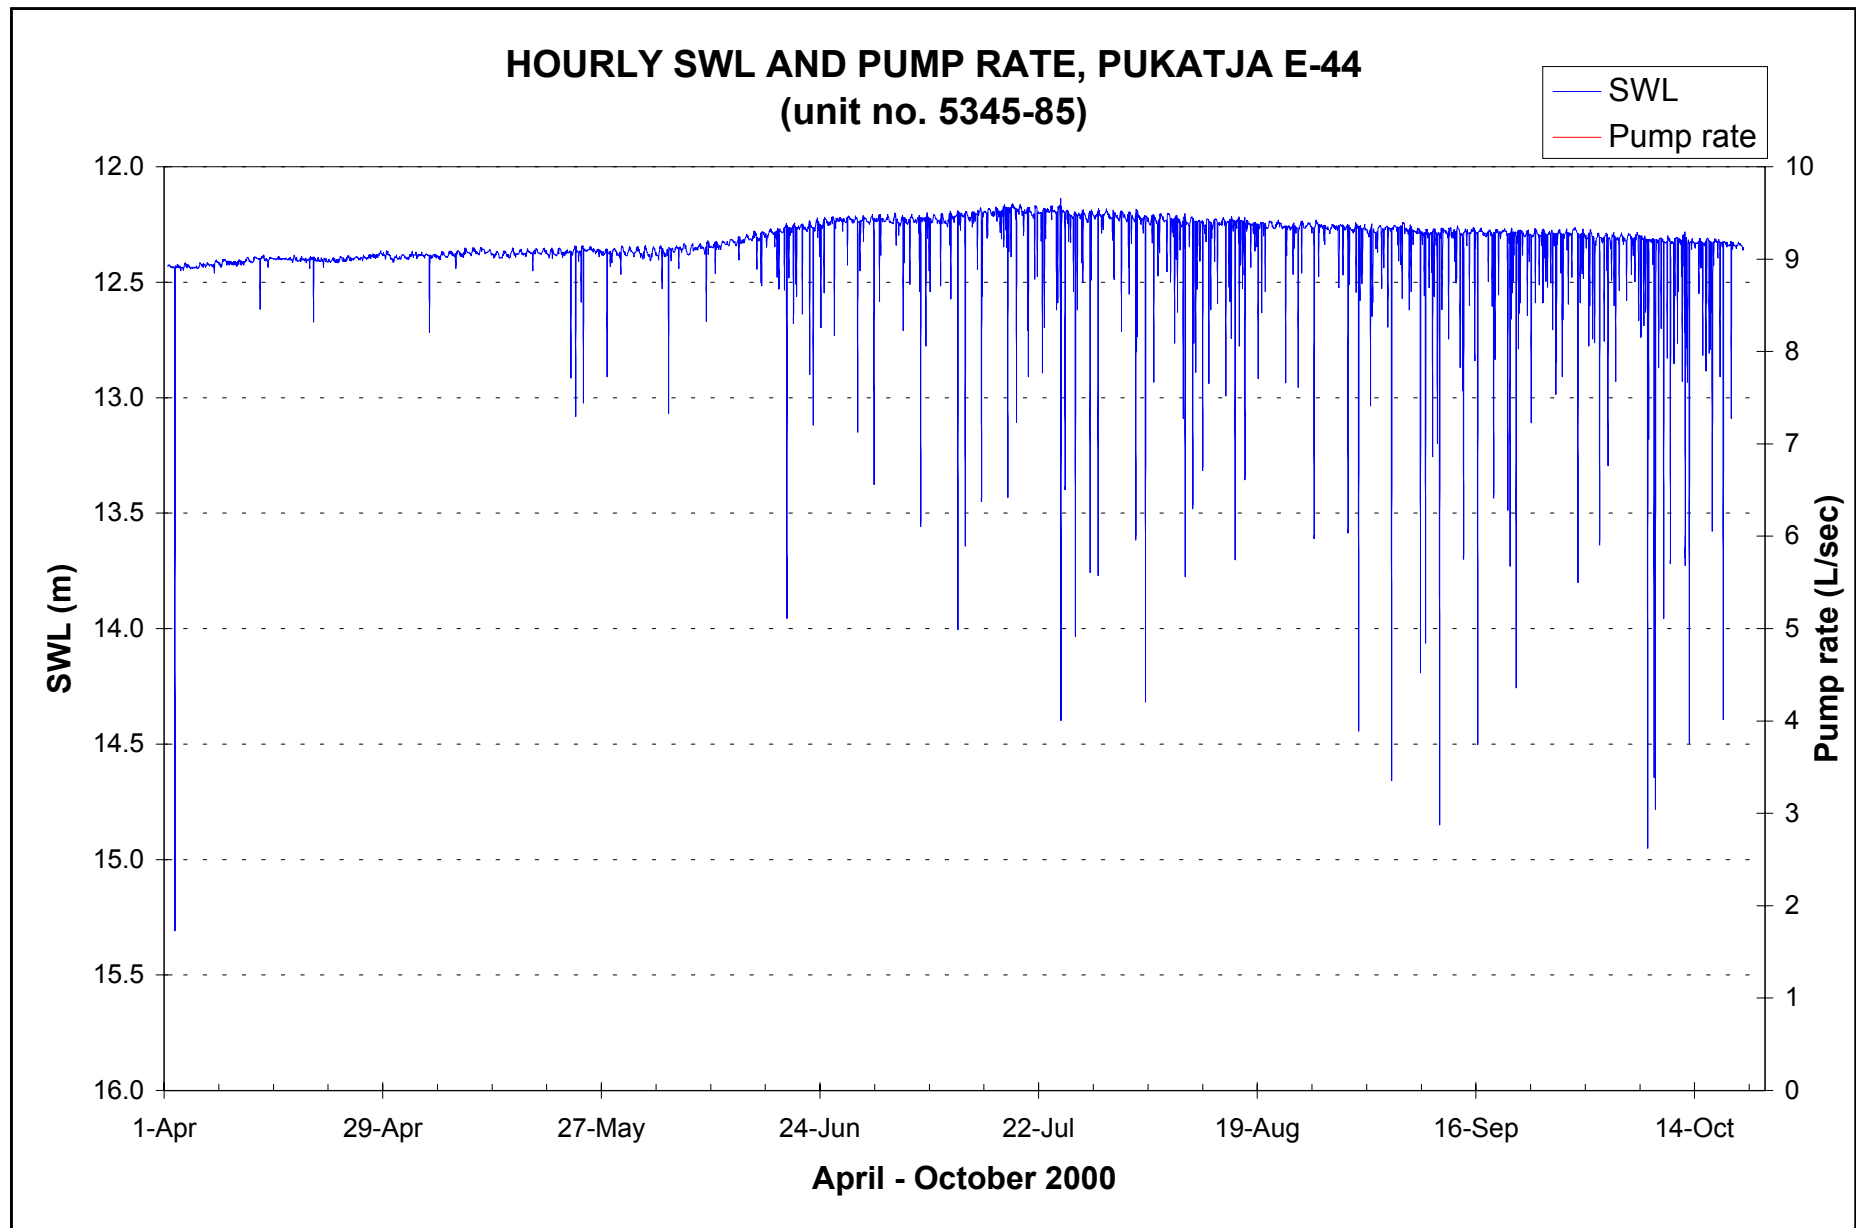
Figure 5.6

Similar to the previous two monitoring periods (April 1999 to April 2000), E 44 was not pumped, however, there are significant spikes in the water level readings. The SWL probe appeared to be functioning and a difference of only 0.013 m existed between the logger and actual SWL in October 2000 (Fig. 5.6). The cause of the spikes is still unknown.
