Hydrogeological report on water well monitoring in Aboriginal lands — April to October 2000

A.R. (Sandy) Dodds and Lloyd D. Sampson

Report DWR 2001/005

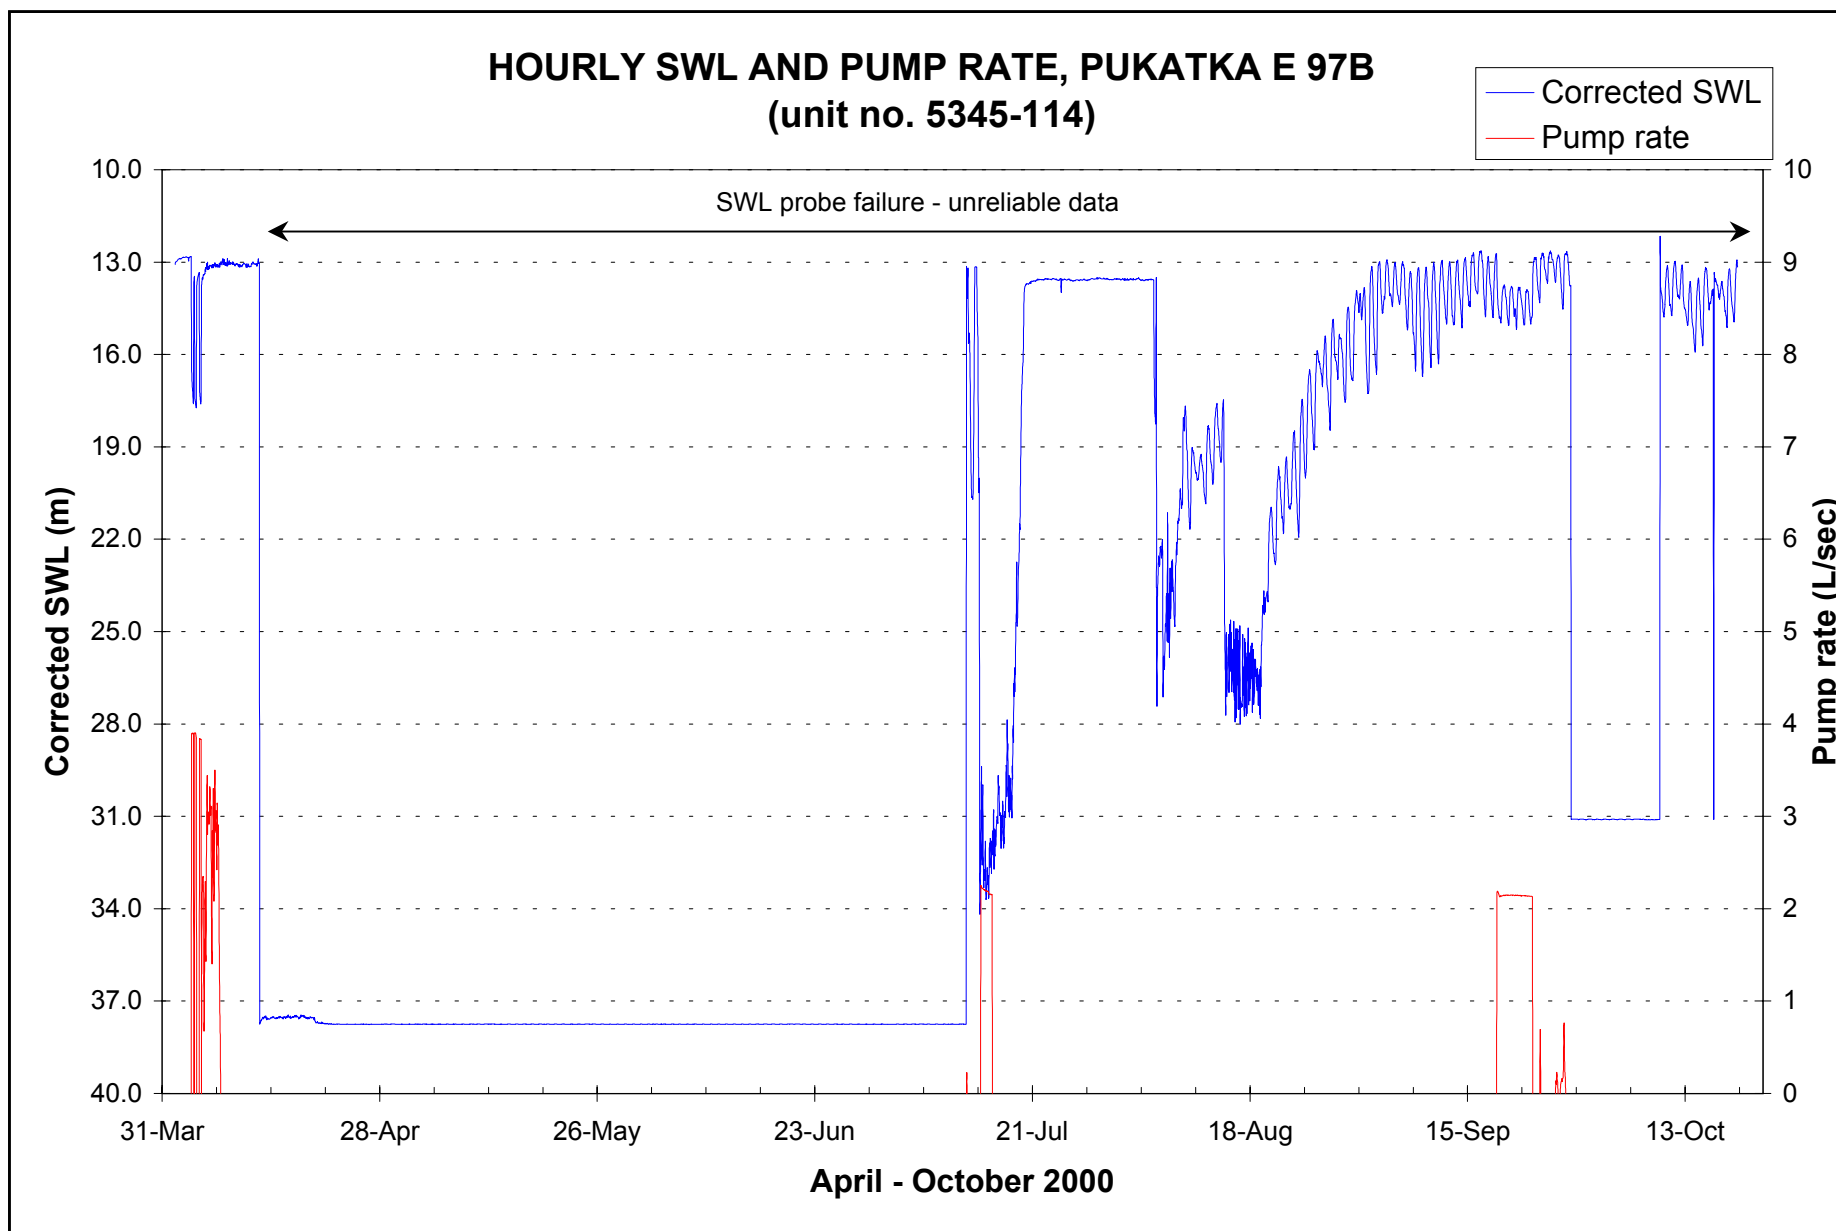
Figure 5.8

E 97B was not extensively pumped during this monitoring period (Fig. 5.8). A defective SWL unit limits the information on the aquifer behaviour. The water level has evidently dropped from a high of 12.3 m in February to about 13.6 m in July. This compares favourably with the level of 13.55 m at the time of drilling but a longer history and reliable data will be needed before confident predictions of sustainability can be made.

- E 97B** Data downloaded, cleared memory and reset flow totaliser. Data shows two major pump failures from the 12 April to 13 July and 28 September to 9 October. The logger was restarted and the SWL datum reset.
- E 97L** Data downloaded, cleared memory and reset flow totaliser. Data showed evidence of a faulty check valve in the 2100P which was replaced with S/N 212117. The logger was restarted and the SWL datum reset.

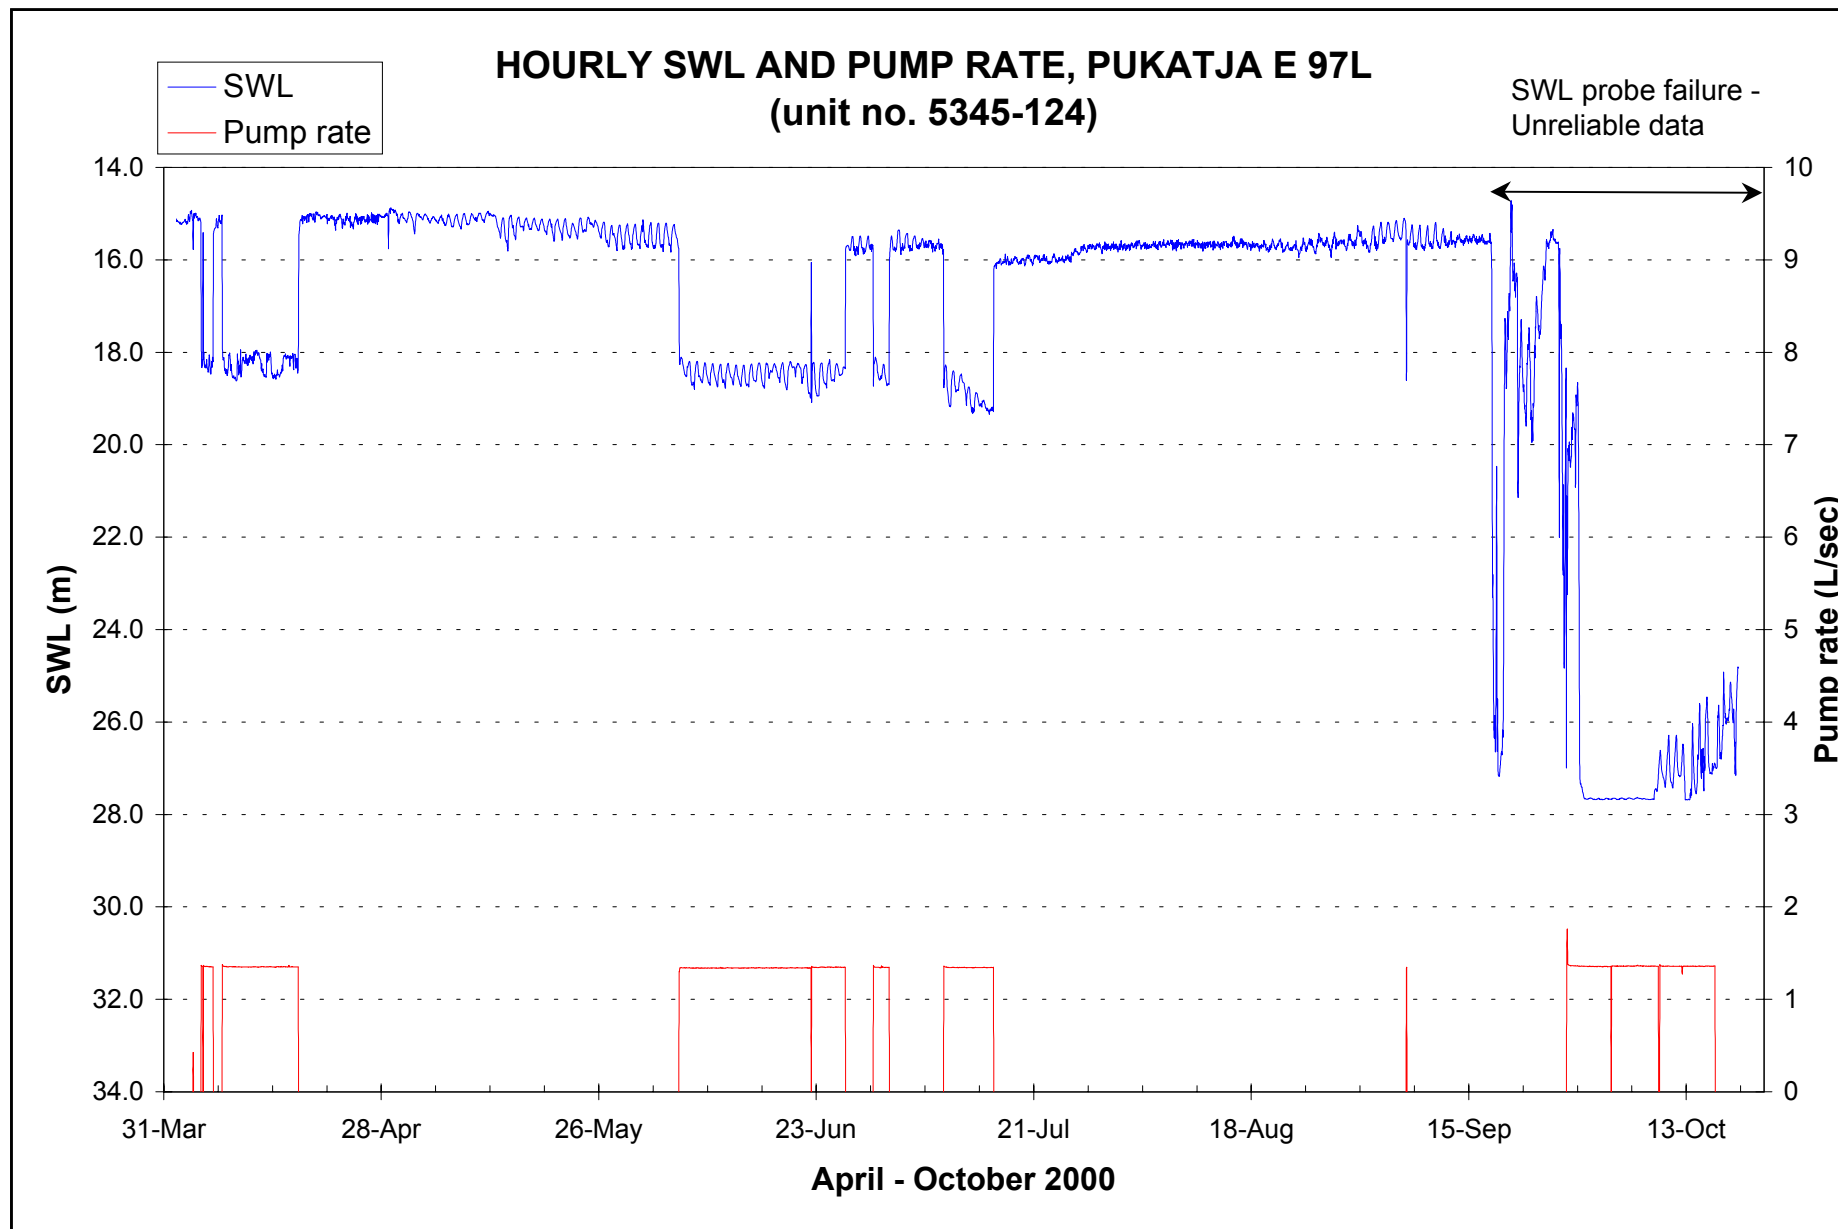
Figure 5.9

The SWL unit in E 97L was defective at the end of the monitoring period, but valid data was collected up to late September 2000 (Fig. 5.9). The non-pumping water level has risen from 16 m before recharge in February, to 15 m in August 2000. This is slightly below the level at the time of drilling in 1997.

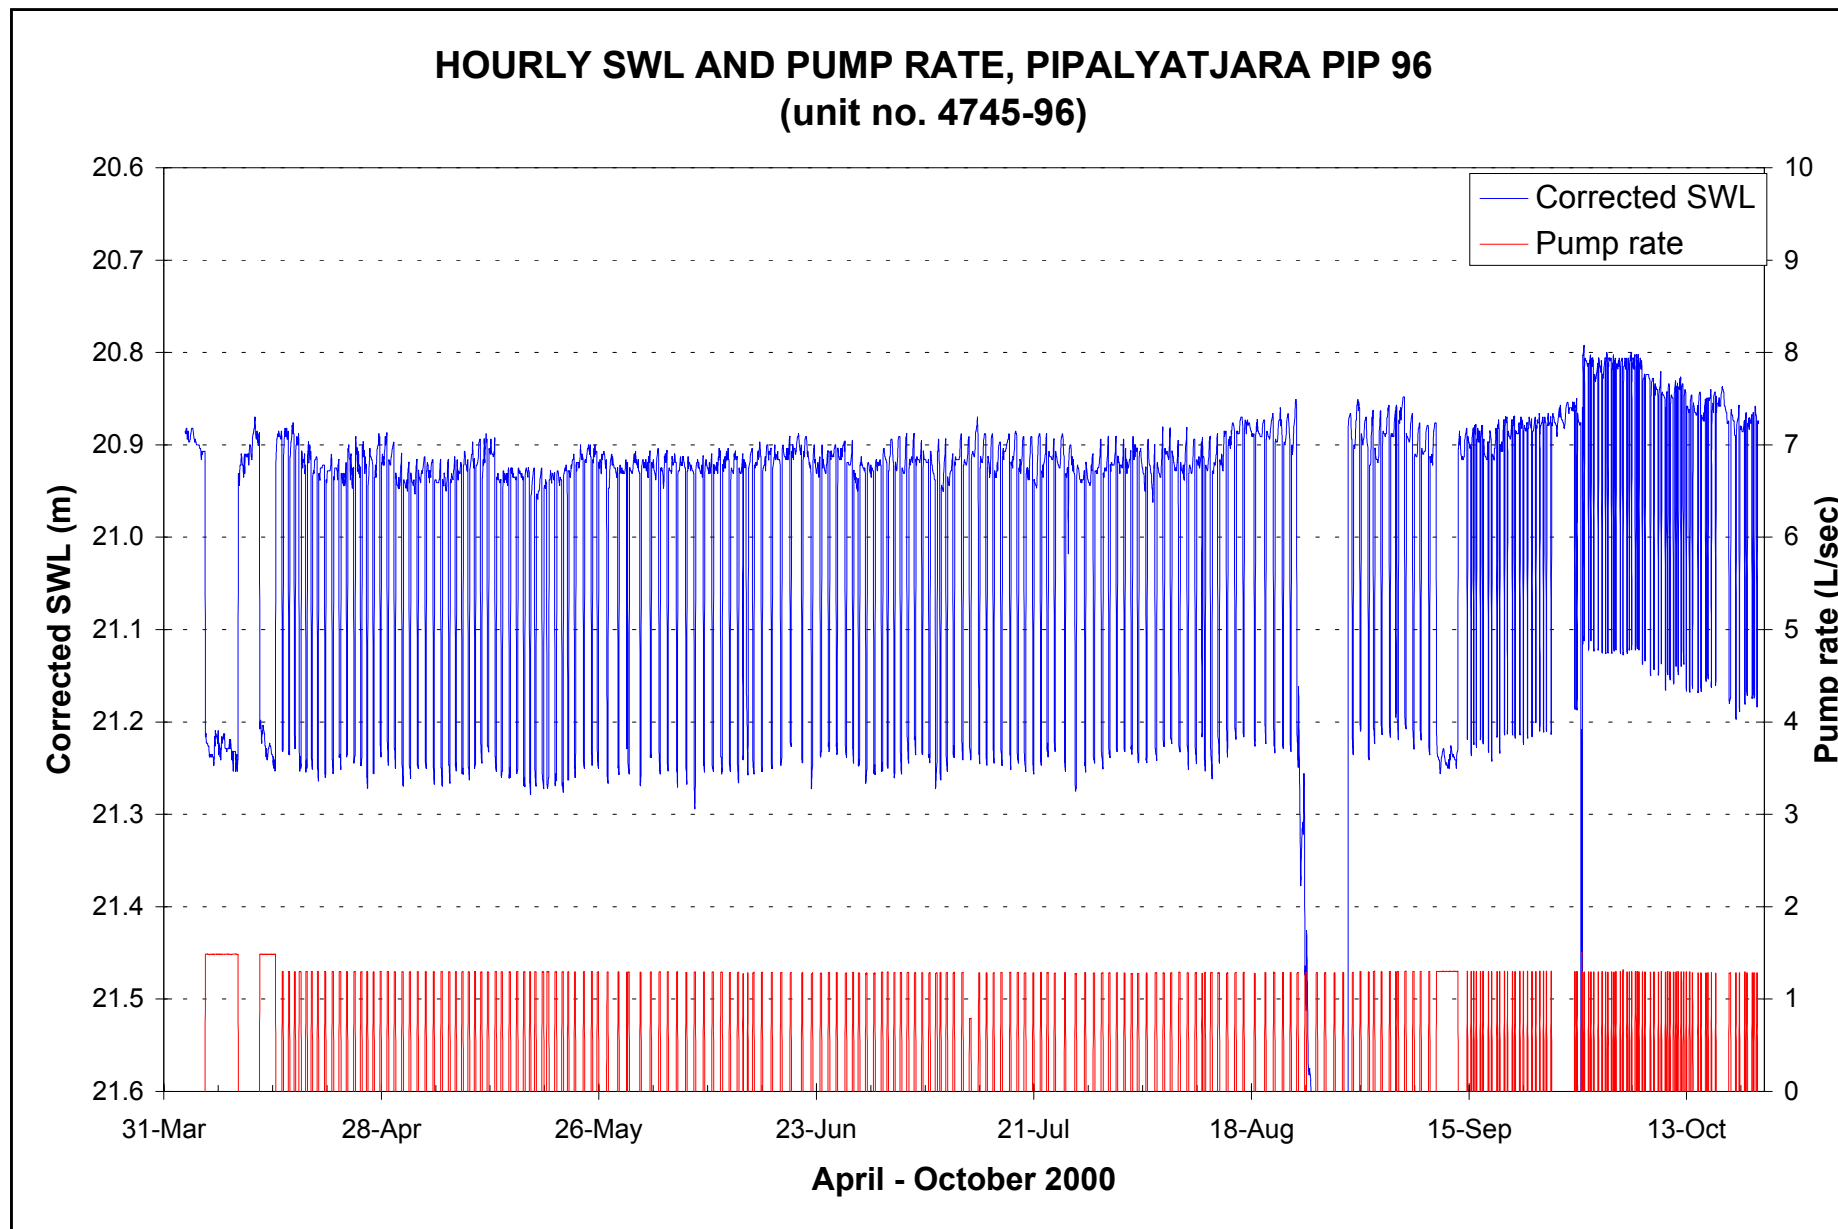
Figure 8.4

In PIP 96 a difference of 0.107 m existed between the logger and the actual water level at the time of download. This correction was applied as a constant to all readings after a shift in the data on 29 September 2000. Allowing for adjustments, SWL has remained constant over the monitoring period. Over the last two years, the water level has dropped by 0.2 m. Production from the well increased by 76% over the previous six months (Fig. 8.4). There is no sign of depletion of the aquifer.

PIP 96 Data downloaded, cleared memory and reset flow totaliser. The logger was restarted with a correction to the SWL datum of 0.107 m. This anomaly in the SWL data reading may be caused by battery problems. B. Hewitson replaced the 2100P battery on 30 September.

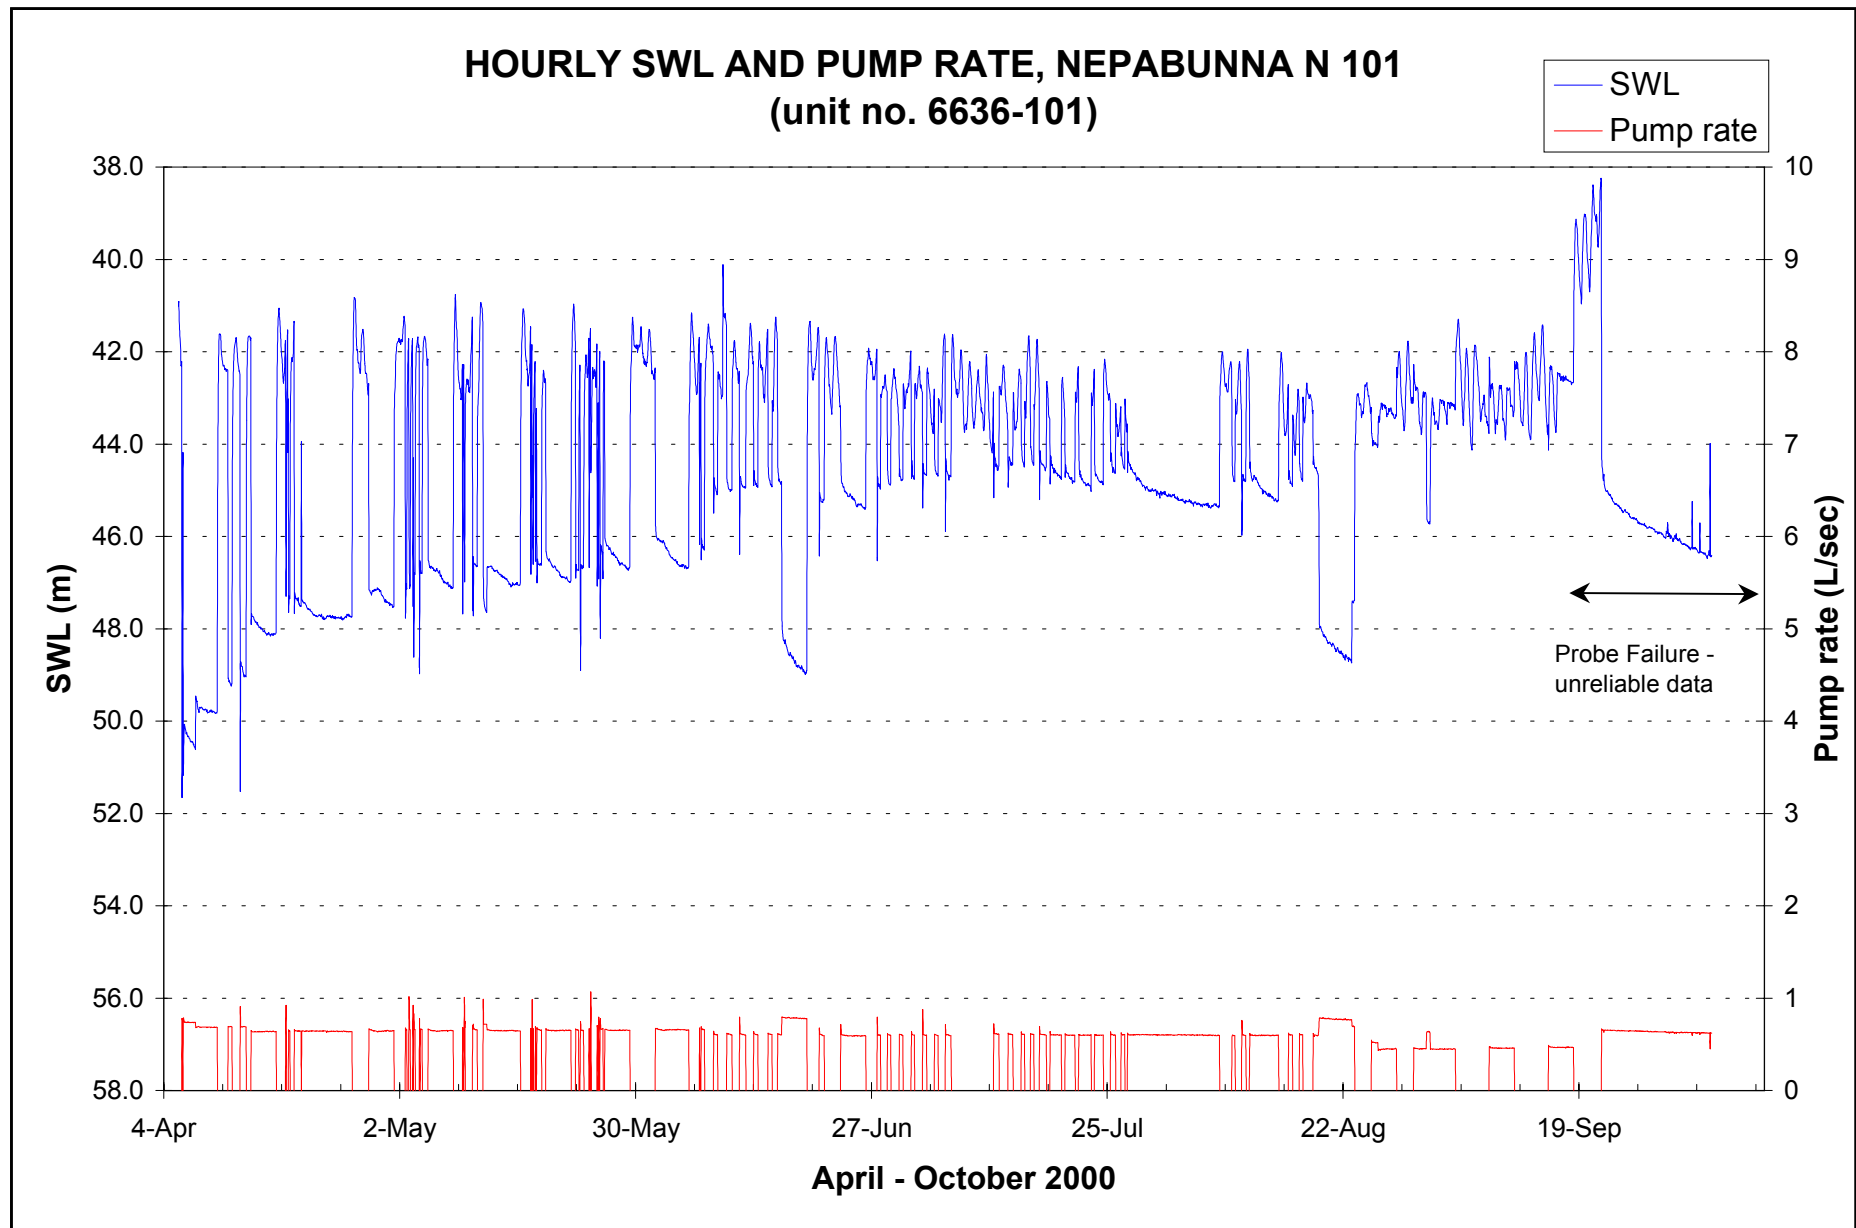
Figure 9.3

In N 101 the increase in SWL, commencing in the previous monitoring period, continued with the SWL peaking at 40.8 m in May 2000 before falling to 41.5 m in September 2000. The peak of 39 m suggests there was a faulty water level probe, which has been replaced. Over the latter half of the monitoring period, the water level probe shows an increase in the amount of noisy data during lengthy pumping and non-pumping periods. Variations of up to 1 m occur in the readings. The cause is not understood, but should become clearer with the acquisition of more data.

N 101 Data downloaded, memory cleared and flow totaliser reset. The 2100P was replaced with a modified unit S/N 210435. The logger was restarted with a new SWL datum.

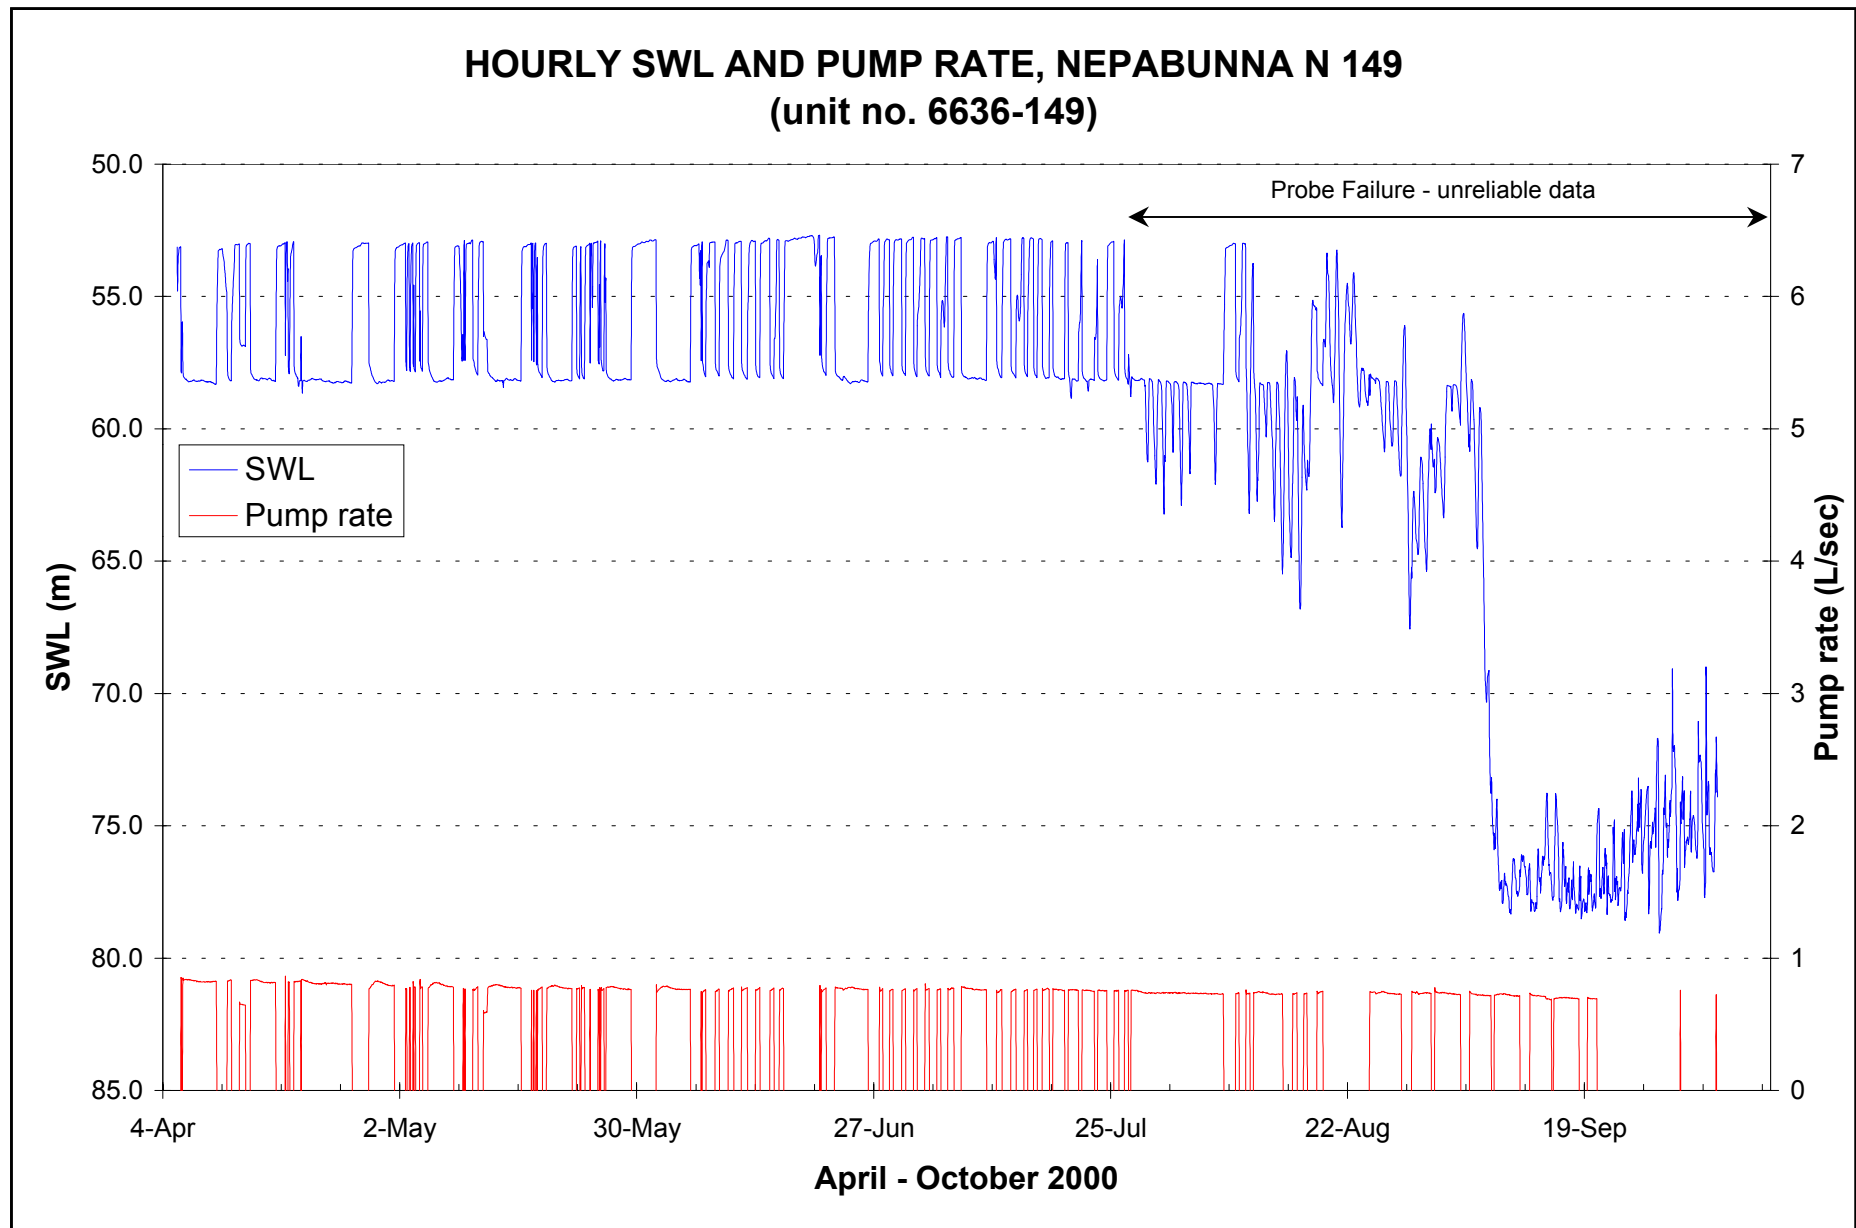
Figure 9.4

In N 149 the SWL rose marginally to 52.9 m, recovering the 0.5 m drop that occurred during the period of extensive pumping February to March 1999. The water level is similar to the level it was at the start of monitoring in December 1999. The water level probe failed in July and has been replaced.

The pump rate for N 149 continued to decline, from 0.8 to 0.7 L/s. Pumping rates for the well were 0.97 L/s in December 1999. The water level has fallen consistently throughout the period to 58 m when the pump is operating (Fig. 9.4), despite the decrease in pump rate that would normally be expected to result in a lower well loss component, indicating a gradual decrease in the production capacity of the well. The well was drilled and constructed in 1983 and may need to be cleaned.

N 149 Data downloaded, memory cleared and flow totaliser reset. The 2100P was replaced with a modified unit S/N 210493. The logger was restarted with a new SWL datum. Note, the rain gauge accumulator was not reset.
