# **The City of Mitcham**

# **QUARRIES**

1999

#### MITCHAM QUARRIES EXECUTIVE SUMMARY.

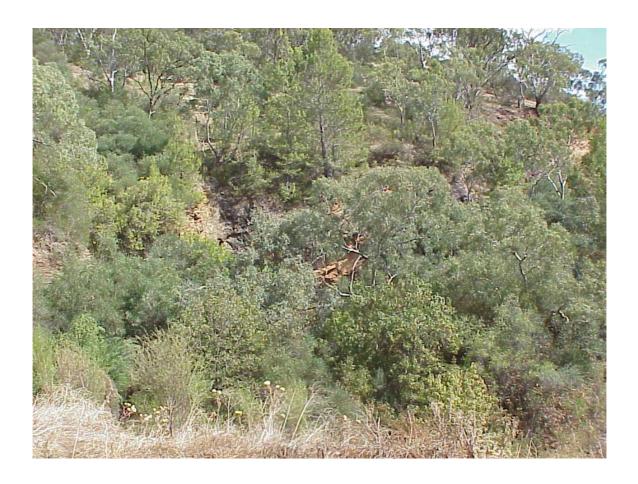
# ROGERS QUARRY (Reserve C1, adjoining 1093)

1. < 2.5m	Italiii	9		
2. 2.5m to 10m				
3. 10m to 20m				
4. > 20m	4		Sheer walls to quarry face	
Stability - Top	Ratin	g		
No loose material/Stable	1			
Some loose material

3. Loose material				
4. Loose material/Unstable				
Stability - Bottom	Ratin	g		
No loose material/Stable		•	Unable to assess the floor of the quarry wall as access is not possible due to dense	
			weed growth.

2. Slight fire risk			
3. Accessible in case of fire			
4. Fire trap	4	Minimal access high fuel loading make area a fire trap and potential hazard	
Visitation public access	Rating	William a decess riight fuel leading make area a me trap and potential mazara

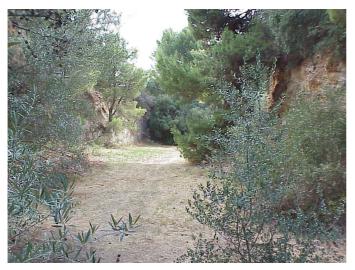
Fig - AQ1

1. < 2.5m 2. 2.5m to 10m 3. 10m to 20m 4. > 20m	2		Fairly uniform cut	
Stability - Top  1. No loose material/Stable 2. Some loose material 3. Loose material	Ratin 2	g	Some loose material on the top of quarry trees holding top together	
<ul> <li>4. Loose material/Unstable</li> <li>Stability - Bottom</li> <li>1. No loose material/Stable</li> <li>2. Some loose material</li> </ul>	Ratin	g		
<ul><li>3. Loose material</li><li>4. Loose material/Unstable</li><li>Gradient</li><li>1. Gentle gradient/Walkable</li></ul>	Ratin	g		
<ul><li>2. Slightly steeper/Unwalkable</li><li>3. Sheer</li><li>4. Overhanging</li></ul>	<b>✓</b>			
Proximity to houses 1. Isolated 2. Aware of housing 3. Visible	Ratin	g

2. Minor		
3. Interesting feature	✓	Some good features such as ripple rock and quartz stress fractures
4. Significant feature		
Vegetation	Rating	
Total exotic	<b>√</b>	Pines Olives and exotic woody weeds all present

Comments	Actions
Fencing and Signage				Addiono
Is quarry area fenced?	Yes ✓	No	Private property on each side of quarry fenced	
Is fence in good repair?	Yes	✓	Fences to be checked for safety	
Is fence appropriate?	<b>√</b>	No		
Is quarry signed?	Yes	✓	There are signs indicating No dumping of rubbish. No quarry warning signs visible	
Is signage appropriate?	Yes	No ✓	Suggest that signage be looked at	
Description of Quarry Small quartzite quarry/ slate			,	
Quarry Height	Ratin	g

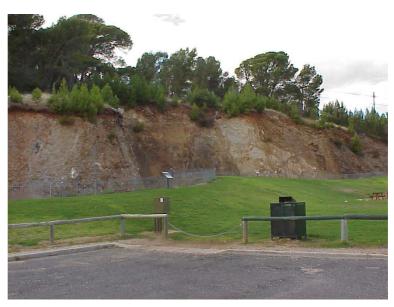
1. < 2.5m				
2. 2.5m to 10m				
3. 10m to 20m	3			
4. > 20m				
Stability - Top	Ratin	g		
No loose material/Stable			Once allow the investor the same habited forces because to delice the suspension

2. Some loose material	2		Some slips obvious in the area behind fence loose material on the quarry face	
3. Loose material				
4. Loose material/Unstable	Dotin	~		
Stability - Bottom  1. No loose material/Stable	Ratin	g		
Some loose material

3. Loose material	3		Loose stone has fallen and is obvious Bunding as installed is working well	May have to clean out fallen material at some time, work plan required.

Comments	Actions
Fencing and Signage				
Is quarry area fenced?	✓	No		
Is fence in good repair?	✓	No		
Is fence appropriate?	✓	No		
Is quarry signed?	✓	No		
Is signage appropriate?	Yes	<b>√</b>	Sign required to indicate that persons visiting the area should stay behind the fence as	S
		<b>√</b>	there is a danger of falling stones	
Description of Quarry				
			arry site that has been made into a car park, lookout and recreation area.	
			then a rubbish dump for many years.	
Quarry Height	Ratin	g

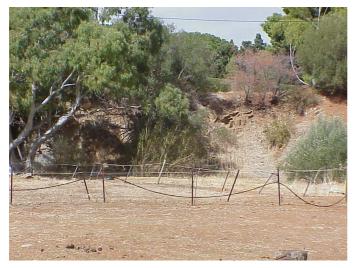
## SCOTT'S QUARRY (248)

1. < 2.5m		3		
2. 2.5m to 10m	2		Quarry face obscured by vegetation from Blythewood road area	
3. 10m to 20m			, , ,	
4. > 20m				
Stability - Top	Ratin	ng		
No loose material/Stable				
Some loose material	2		Some loose material and a slope down to quarry face	
Loose material

Comments	Actions
Fencing and Signage			Johnnenes	Addolis
Is quarry area fenced?	Yes	<b>√</b>	Some fence next to Blythewood	Fence along Blythewood road to replaced as soon as possible
Is fence in good repair?	Yes	<b>√</b>	Fence in poor condition	
Is fence appropriate?	Yes	<b>√</b>	Needs repairs and upgrading	
Is quarry signed?	Yes	<b>√</b>		Quarry to be signed as soon as possible
Is signage appropriate?	Yes	<b>√</b>		
Description of Quarry				
Small guarry on Blythewood Roa	ad opp	osite	the Mitcham cemetery not visible form road but is in close proximity to footpath area.	
Quarry Height	Ratin		in the second of

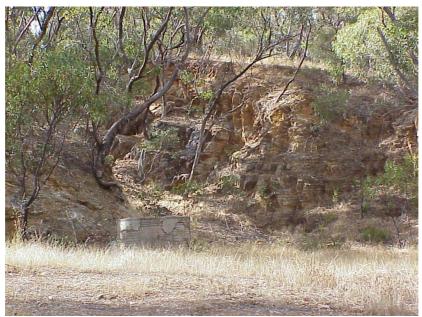
## **LOCAL GOVERNMENT QUARRY** (1143)

1. < 2.5m 2. 2.5m to 10m	3	)	2.5 to 1.5 max-face			
3. 10m to 20m		)				
4. > 20m						
Stability - Top	Rat	ina				
No loose material/Stable	1.00	9	Thin soil crust

Randall Park Local Gov Q	uarry		Comments	Actions		
Fencing and Signage						
Is quarry area fenced?	Yes	No ✓	Small quarry	Investigate fencing along top of Quarry face		
Is fence in good repair?	Yes	No				
Is fence appropriate?	Yes	No		Standard of fencing – Dept Mines – low exposure		
Is quarry signed?	Yes	No ✓		Establish signage – appropriate to area		
Is signage appropriate?	Yes	No				
Small 3 pipes quarry – soft sand "3 pipes what were they used fo	r"		rippie ieature east rim.			
Quarry Height	Rat	ing	0.5 to 4.5 months as

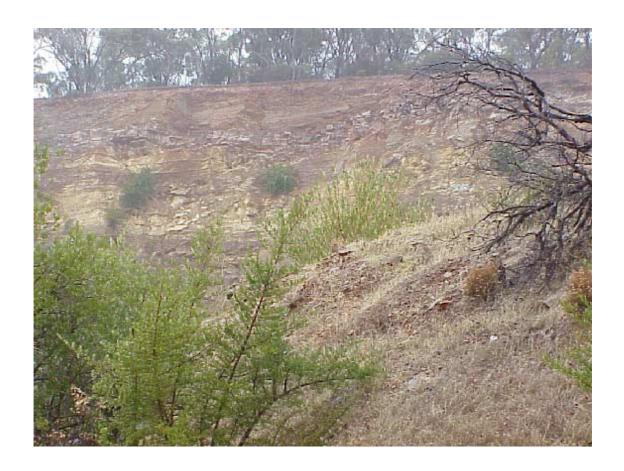
# O' DEA QUARRY - PYM STREET BELAIR

Comments	Actions
Fencing and Signage			Comments	Actions
Is quarry area fenced?	Yes	✓	No Fence obvious steep quarry face	
, , , , , , , , , , , , , , , , , , , ,				
Is fence in good repair?	Yes	✓		
Is fence appropriate?	Yes	✓		
Is quarry signed?	Yes	✓	No signage on Quarry	Quarry to be signed as soon as possible
Is signage appropriate?	Yes	✓		
Description of Quarry				
Very large quarry adjacent to old	l railwa	y tun	nels	
There is a bike track leading to to	op edg	e of c	quarry no fencing	
Council reserve	1_		T	
Quarry Height	Ratin	g

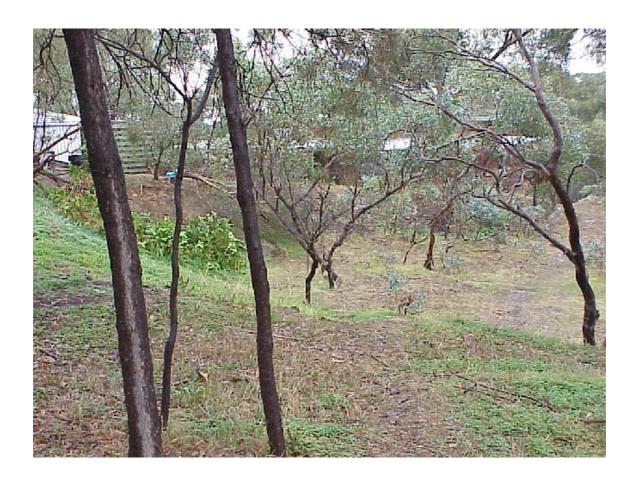
Willunga street quarry		Comments	Actions
Fencing and Signage			
Is quarry area fenced?	Yes		
Is fence in good repair?	Yes		
Is fence appropriate?	Yes		
Is quarry signed?	Yes		Quarry to be signed as soon as possible
Is signage appropriate?	Yes		
Description of Quarry	•		
The small clay pit that is behind	l the Willunga	street Kindy at Eden Hills.	
The quarry is mostly filled in lea	ving a slight	depression with gently sloping areas.	
The walls of quarry are no more	e than 2 metre	es high .Area used as dumping ground	
Quarry Height	Rating

1. < 2.5m	1		
2. 2.5m to 10m			
3. 10m to 20m			
4. > 20m			
Stability - Top	Rating		
No loose material/Stable	1		
Some loose material			
Loose material			
4. Loose material/Unstable	- ·		
Stability - Bottom	Rating		
<ol> <li>No loose material/Stable</li> <li>Some loose material</li> </ol>	1
