Mine & Rehabilitation Annual Compliance Report

2013

Mine Name	Penrice Quarry & Mineral (PQM)			PEPR#	(2011/021)
Owner	Penrice Soda Products Pty Ltd			Tenements	
Operator	Penrice Quarry & Mineral (PQM)			PM 86	PM 120
Site Contact	Name	James Rowe		MPL 118	MPL 75
Email	james.rowe@penrice.com.au	Ph	08 8563 8822	ML 6233	RL109
Site Location Details: PQM is located approximately 2.5 kilometres north of the township of Angaston					
Report Details					
Reporting Period	1st January 2013 – 31st December 2013 inclusive		Date of Preparation		
Ownership Statement: This document represents a true and accurate account of the compliance status of the site at date of preparation.					
Name	James Rowe	Signature		Date

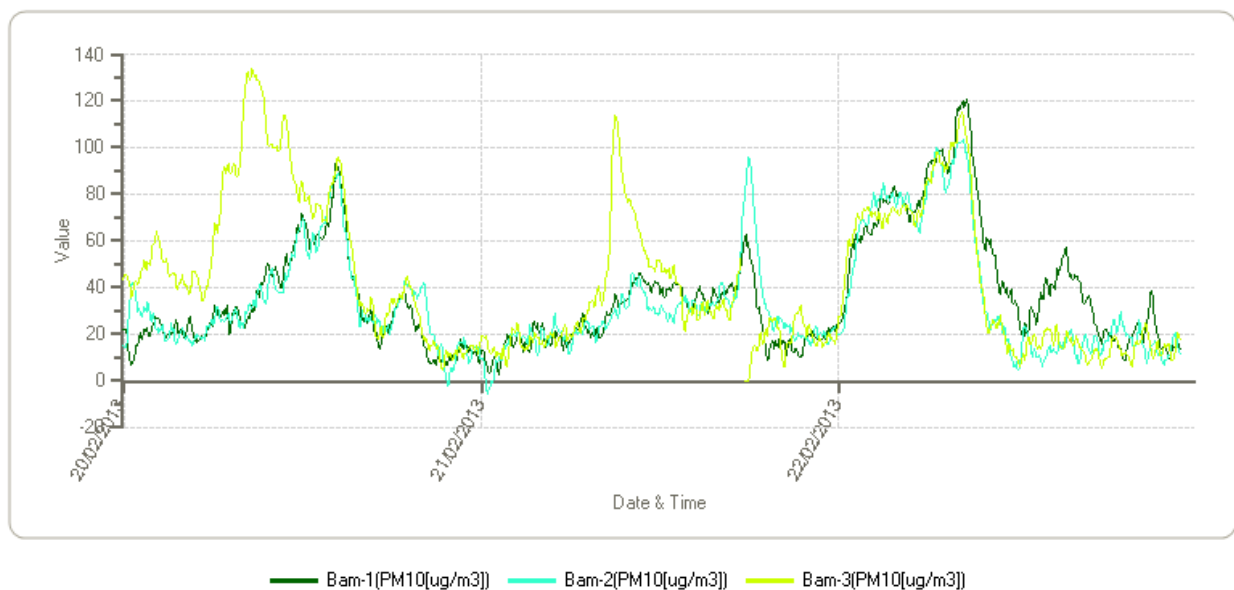
Figure 1 - PM₁₀ real time monitoring data

On the 20th and 22nd of February there was large amounts of smoke in the area coming from bushfires which effected the PM₁₀ readings at the BAM monitors. DMITRE, EPA and CCG members were notified of the exceedence and photos of the smoke were supplied. Figure 1 below shows the real time PM₁₀ readings over this period. The predominant wind direct for this period was South Easterly (figure 2). The Dust Management Plan was implemented both days.

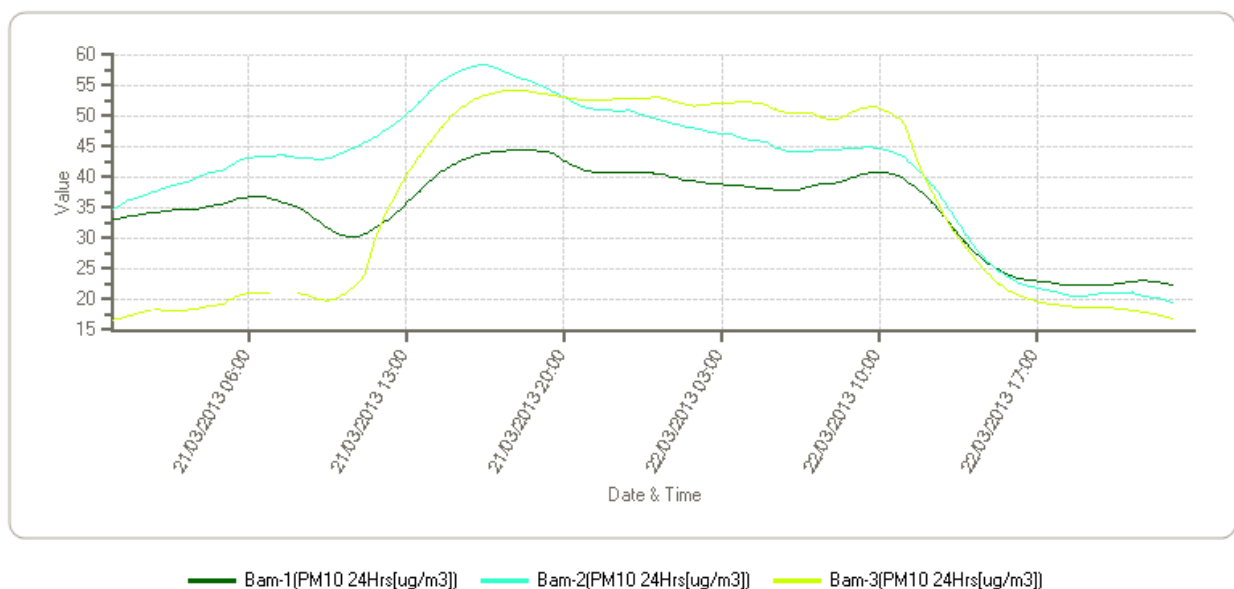
Figure 3 - PM₁₀ 24 hour average

On the 21st of March there were dust storms in the Barossa area with speeds up to 70km/hr (Nuriootpa station 023373, BOM website) and the direction predominantly from the WSW (figure 4) all three units show consistent 24hr readings for dust coming onto and leaving site through out this period (figure 3). DMITRE, EPA and CCG members were notified of the exceedence. The Dust Management Plan was implemented.

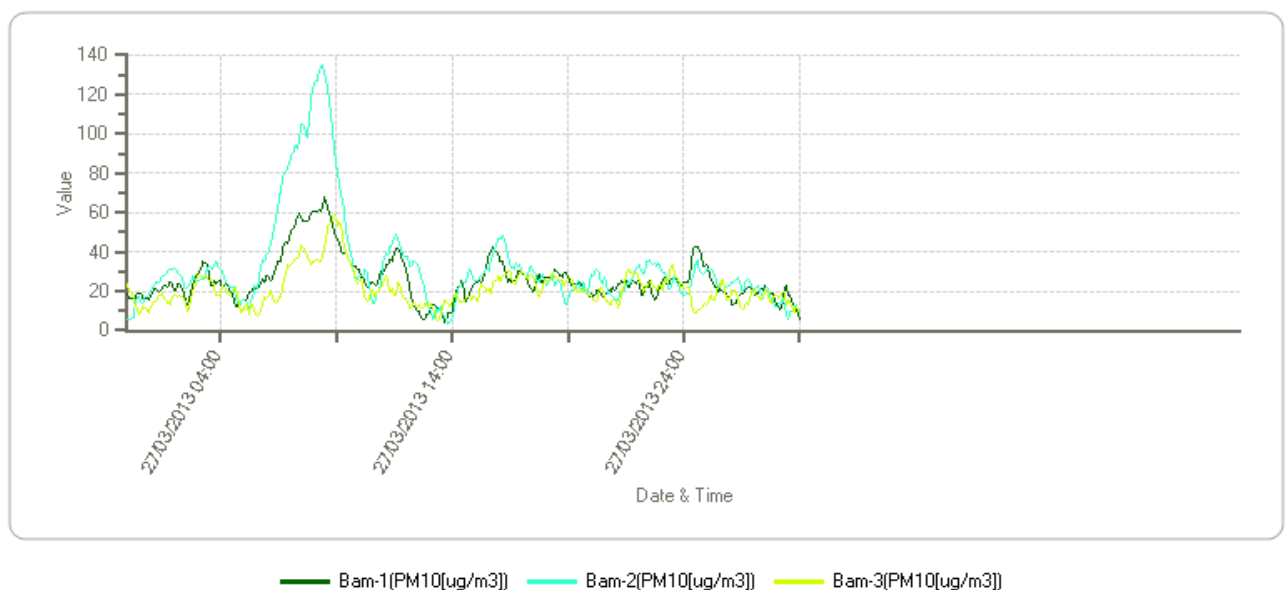
Figure 5 - PM₁₀ real time monitoring data

On the 27th of March there were WNW winds of up to 65km/hr (Nuriootpa station 023373, BOM website) apart from one spike at Bam 3 of 280 $\mu\text{g}/\text{m}^3$ all three units had consistent readings through out this period (figure 5). On the day there were public road works being undertaken on Penrice Road (south of the quarry boundary) which is believed to have affected the readings as the predominant wind direction at Bam 2 for the day was SW (Figure 6). DMITRE, EPA and CCG members were notified of the exceedence. The Dust Management Plan was implemented.

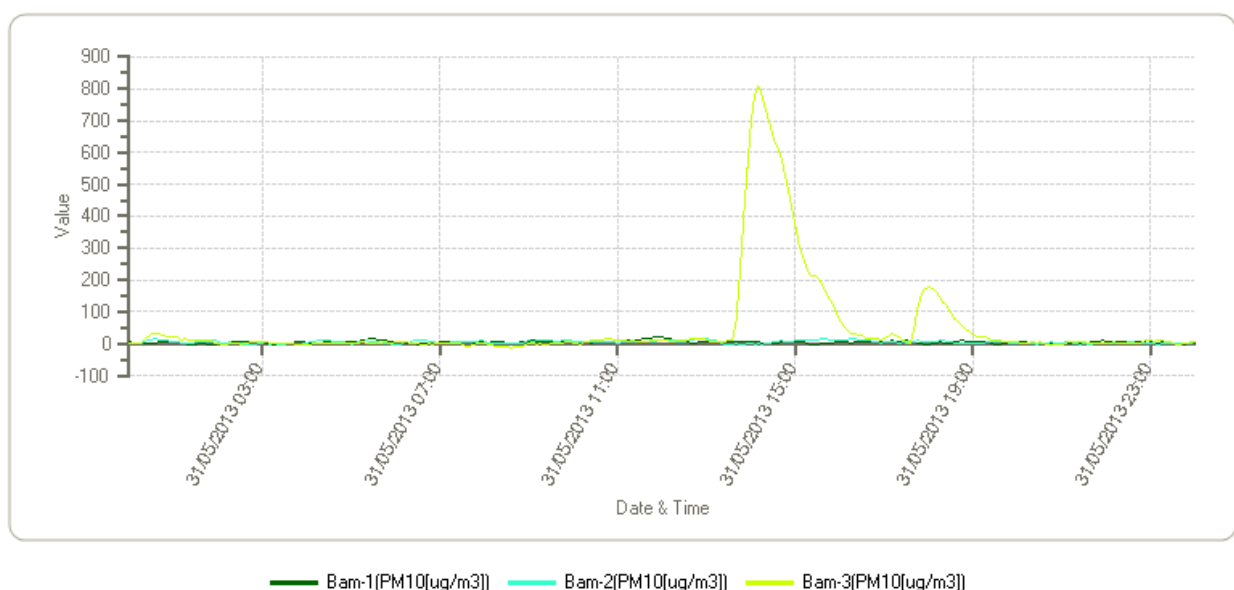
Figure 9 - PM₁₀ real time monitoring data

On Friday the 31st May there was an exceedence at BAM 3 with the real time reading up to 800 $\mu\text{g}/\text{m}^3$ (Figure 9). This is thought to be an incorrect reading as there was rainfall all day with a total of 4.8 mm for the 24 hour period. Lear Siegler were contacted and the root cause was found to be water egress into the air conditioner, the extra drainage plug was removed which fixed the problem.

31/5/13	High Pm 10 reading	High reading PQM 3 monitor	⇒ High reading of 600 plus resulting high Pm 10 24r. ⇒ This is not possible due to very high rain fall all day (4.8 mm)	Report to DMITRE & EPA: 1.Faulty BAM unit seek technical support from Lear-Siegler 2. Root cause water egress into air conditioner Removed extra drainage plugs to fix problem	1. MS 2. JR	Complete Complete	Complete Complete	Y Y	CCG	
13/6/13	Telstra data issue	Notified DMITRE EPA	Telstra data issues	Report to DMITRE & EPA: 1.Favourable damp conditions had to turn off Telstra sim 2. Working with PSP IT Dept. and Lear-Siegler To resolve issue	1. MS 2. JR	Complete Complete	Complete Complete	Y Y	CCG	
16/8/13	High Pm 10 reading	High reading PQM 2 monitor	⇒ High reading 61 PM 10 24r. High northerly wind Issue with SMS activation system, management did not receive alarms	Report to DMITRE & EPA: 1.Main Agg material spray with water and extra foam and Fine mill plant shut down 2. Trucks stopped working in several areas	1. BP 2. JR	Complete Complete	Complete Complete	Y Y	DMITRE

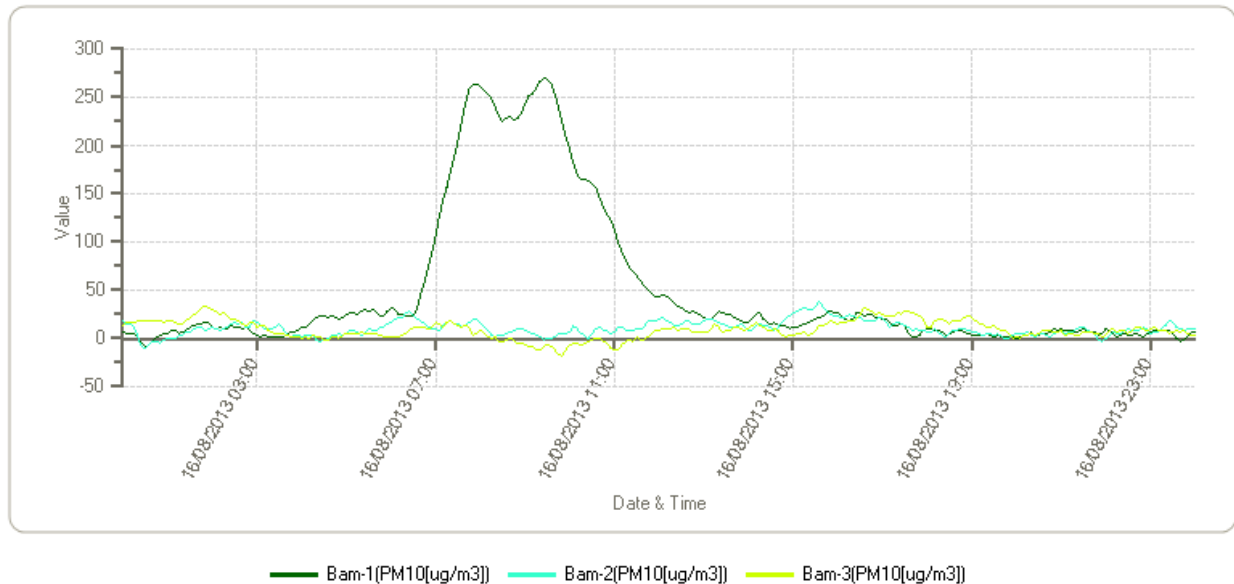
Figure 10 - PM₁₀ real time monitoring data

On the 16th August there was a PM₁₀ exceedance at BAM 1 with real time reading reaching 270 µg/m³ (figure 10). The maximum wind speed was 67km/hr and the dominant wind directions are shown in figure 11 below. The SMS alarm system was not working and therefore no alert was given for the exceedance, as soon as this was realised Lear Siegler were contacted and the system corrected.

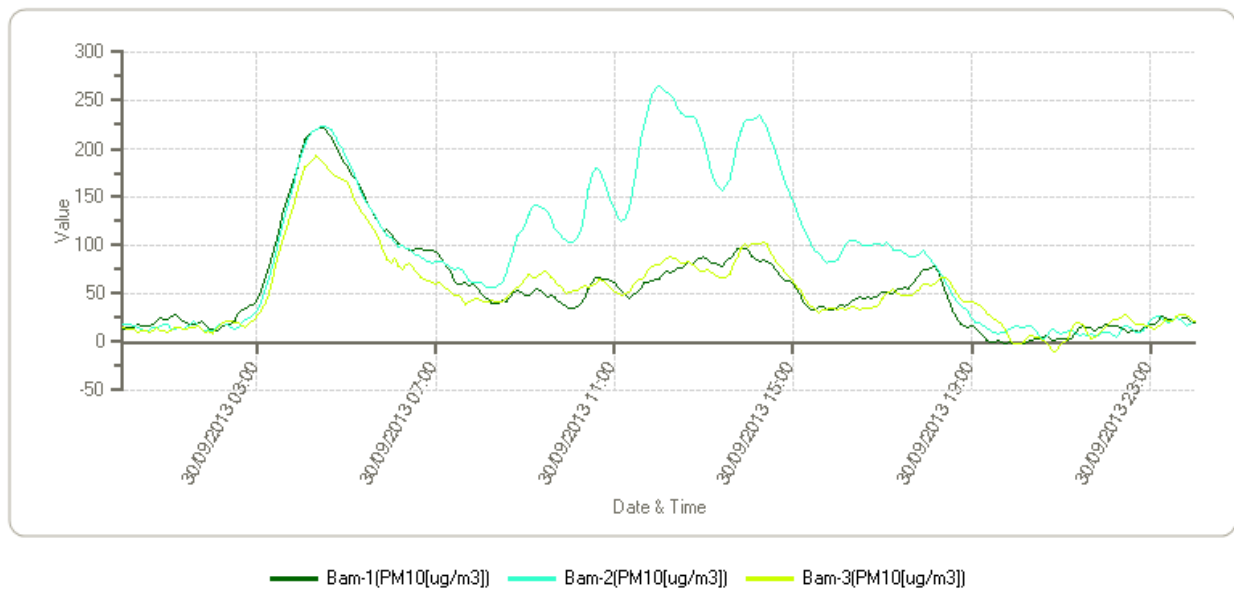
Figure12 - PM₁₀ real time monitoring data

On Monday the 30th September there were extreme weather warnings and conditions for the Barossa area with NW wind speeds up to 91 km/hr (Nuriootpa station 023373, BOM website). At 5am all three units had readings around 200 $\mu\text{g}/\text{m}^3$ see figure 12. The Dust Management Plan was implemented with all water trucks running and the Aggregate Plant remained off for the whole day. Wind direction during this period was predominantly NNW as shown in figure 13. With plant shut down and water trucks working continuously Penrice still contributed to the amount of dust going off site see figure 14. DMITRE and EPA were notified of the exceedence. A meeting was held between Penrice and DMITRE to discuss whether the PEPR conditions in criteria 1.2 can realistically be met when there are extreme weather events.

30/9/13	High Pm 10 reading	High reading PQM BAM 2 & 3 monitors	⇒ High reading of 200 plus resulting high Pm 10 24r. ⇒ PM10 data of over 100ug/m3 recorded at 6pm Sunday the 29 th whilst nobody was onsite	Report to DMITRE & EPA: 1.Root cause, extreme weather alerts for the state, 94km/hr gusts at the quarry. High PM10 levels when nobody was onsite.	1. BP 2. JR	Complete Complete	Complete Complete	Y Y	CCG DMITRE

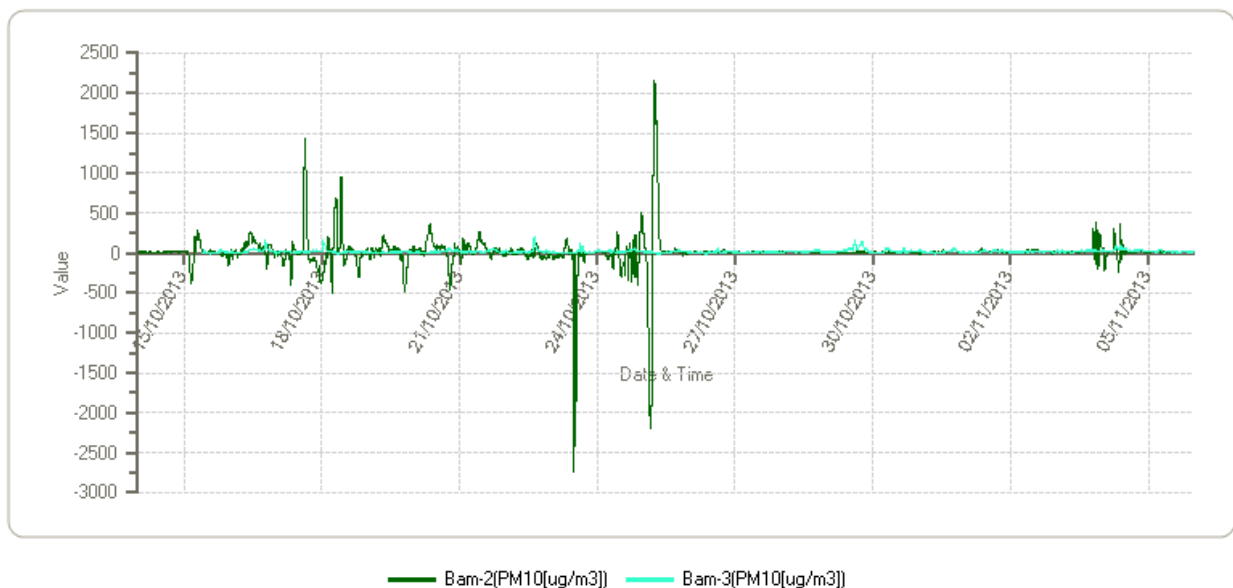
Figure 15 - Bam 2 irregular readings

There were irregular readings at BAM 2 (Figure 15) from the 14th October, Lear Siegler were contacted to advise on why this might be happening. 17th October a Lear Siegler technician came to site to try and repair BAM 2. The technician returned to site to calibrate all three units on the 23rd October. BAM 2 gave consistent reading with the other two units after it was calibrated until the 5th of November when the irregular readings started again. The unit was removed from site and sent to Lear Siegler for repair. The

unit was returned and reinstated on the 12th of December and appears to be working correctly again. DIMITRE were notified and updated throughout this period.
