POLYMETALS
MINING LIMITED

WHITE DAM GOLD MINE

Compliance Report

1st October – 31st December 2012

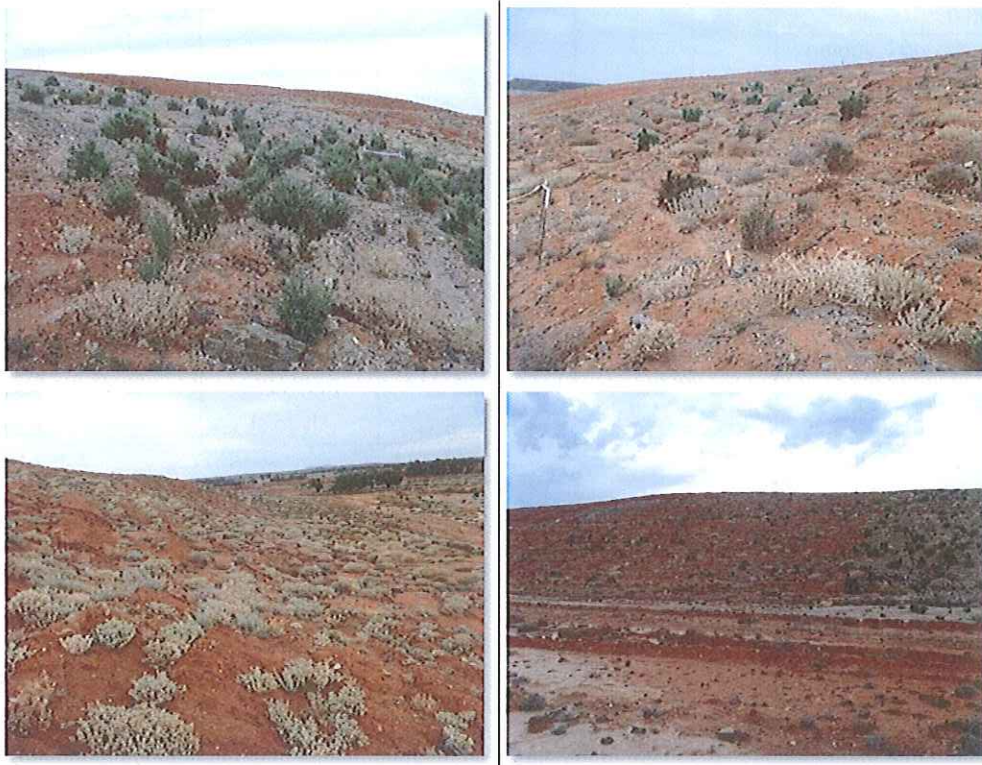
Plate 1: Photographs of Rehabilitation Trial Area on Hannaford WRD (@ November 2012)

with topsoiling. A trial area on the waste dump had also been established to assess the likely rehabilitation outcomes and success for a number of treatment options (refer **Plate 1** below). Such options included rehabilitation using natural volunteer colonisation for plant establishment, hand seeding using certain selected plant species within both topsoil and mine waste planting medium.

Both the Hannaford and Lloyd's waste dump reshaping to final batter profiles plus topsoiling was completed in the previous reporting period (with the exception of a minor area of the Hannaford WRD used for bioremediation plus access) and the monitoring program of rehabilitation has continued. Plantings have been completed to supplement natural colonisation.

- *Evidence (by using closure and rehabilitation criteria in the current approved PEPR/MARP) of the effectiveness of rehabilitation:* This is being progressively undertaken. Photo points have been established and monitoring protocols developed. Closure and rehabilitation criteria are being addressed in the Closure Plan.

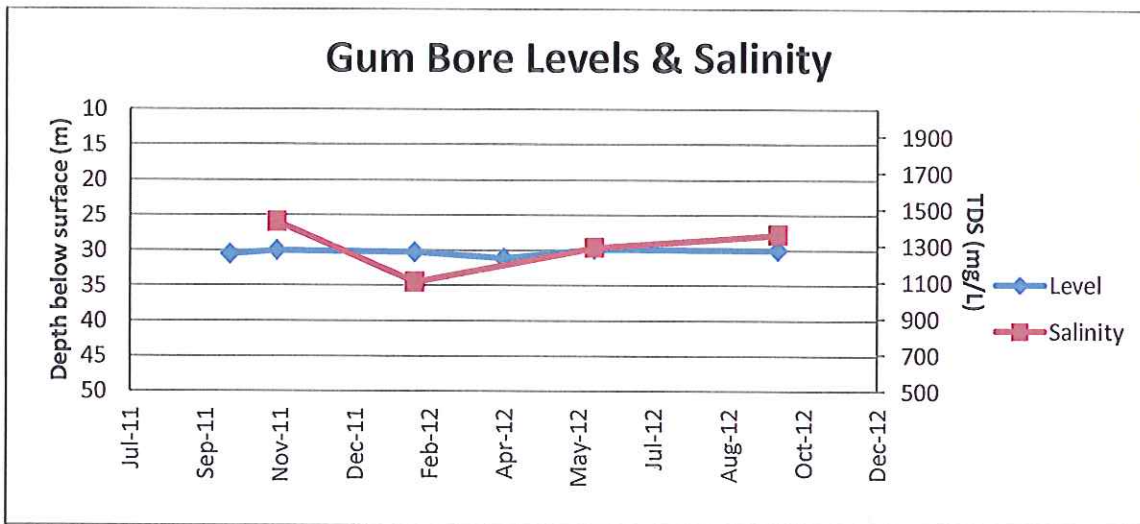
Figure 4: Gumbore Levels and Salinity

Figure 4 below indicates that there has been minimal change to water levels in this bore during the reporting period when compared with previous levels. There has also been little change relative to pre-mining levels. Similarly, salinity levels have shown minimal fluctuation over the reporting period (again compared with previous levels), and remains well below the 3000mg/L TDS criterion.

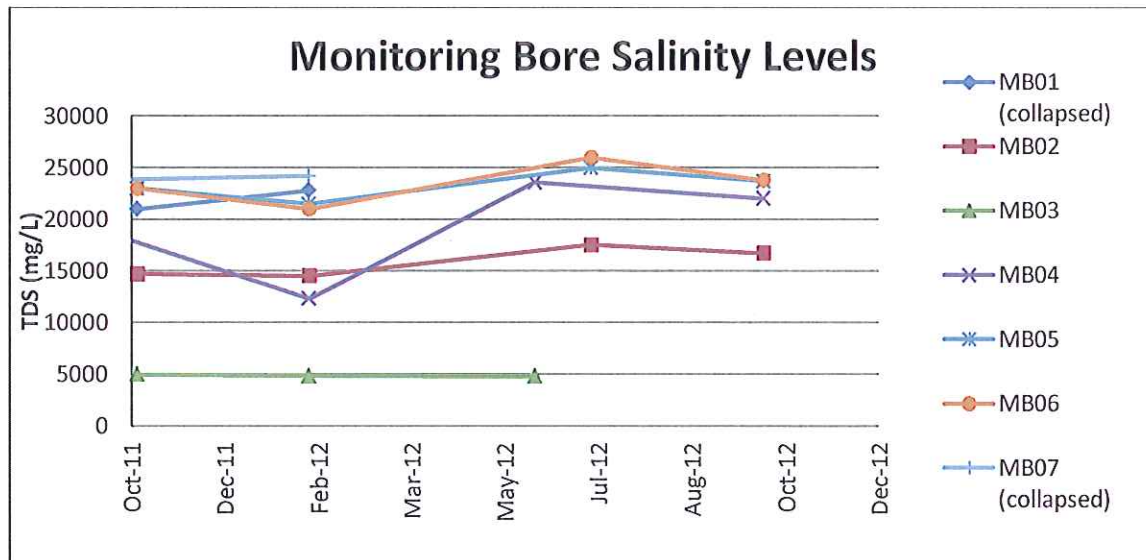
Figure 5: Monitoring Bore Salinity Levels

Figure 5 below shows salinity levels at monitoring bores at the time of last sample (October 2012). Bores are sampled quarterly (when accessible), available data is shown for below for approximately the last two reporting periods. This shows minimal change to salinity levels and within expected natural fluctuations.

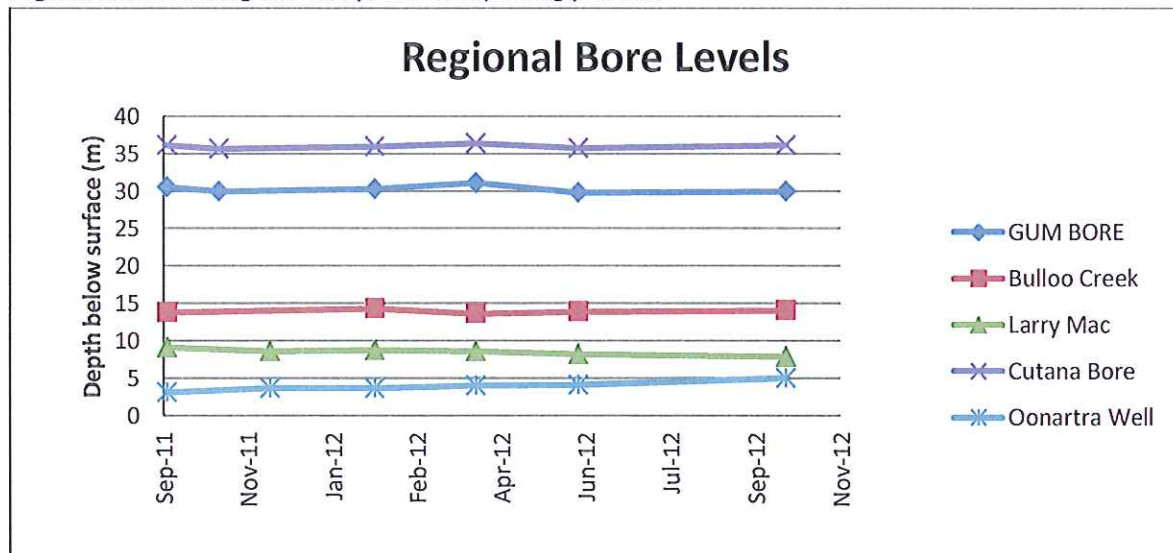
Figure 6: Regional Bore Level Monitoring

Monitoring bore MB05 has shown a substantial level reduction however this has shown no significant effect on other bores in proximity nor regional bores (see regional bore levels Figure 6 below).

Figure 6 below indicates that there has been minimal change to bore water levels throughout all regional bores during this and previous reporting periods.
