# **Quarterly Compliance Report**

## **1<sup>st</sup> January to 30<sup>th</sup> March 2018**

Penrice Quarry & Mineral

May 2018

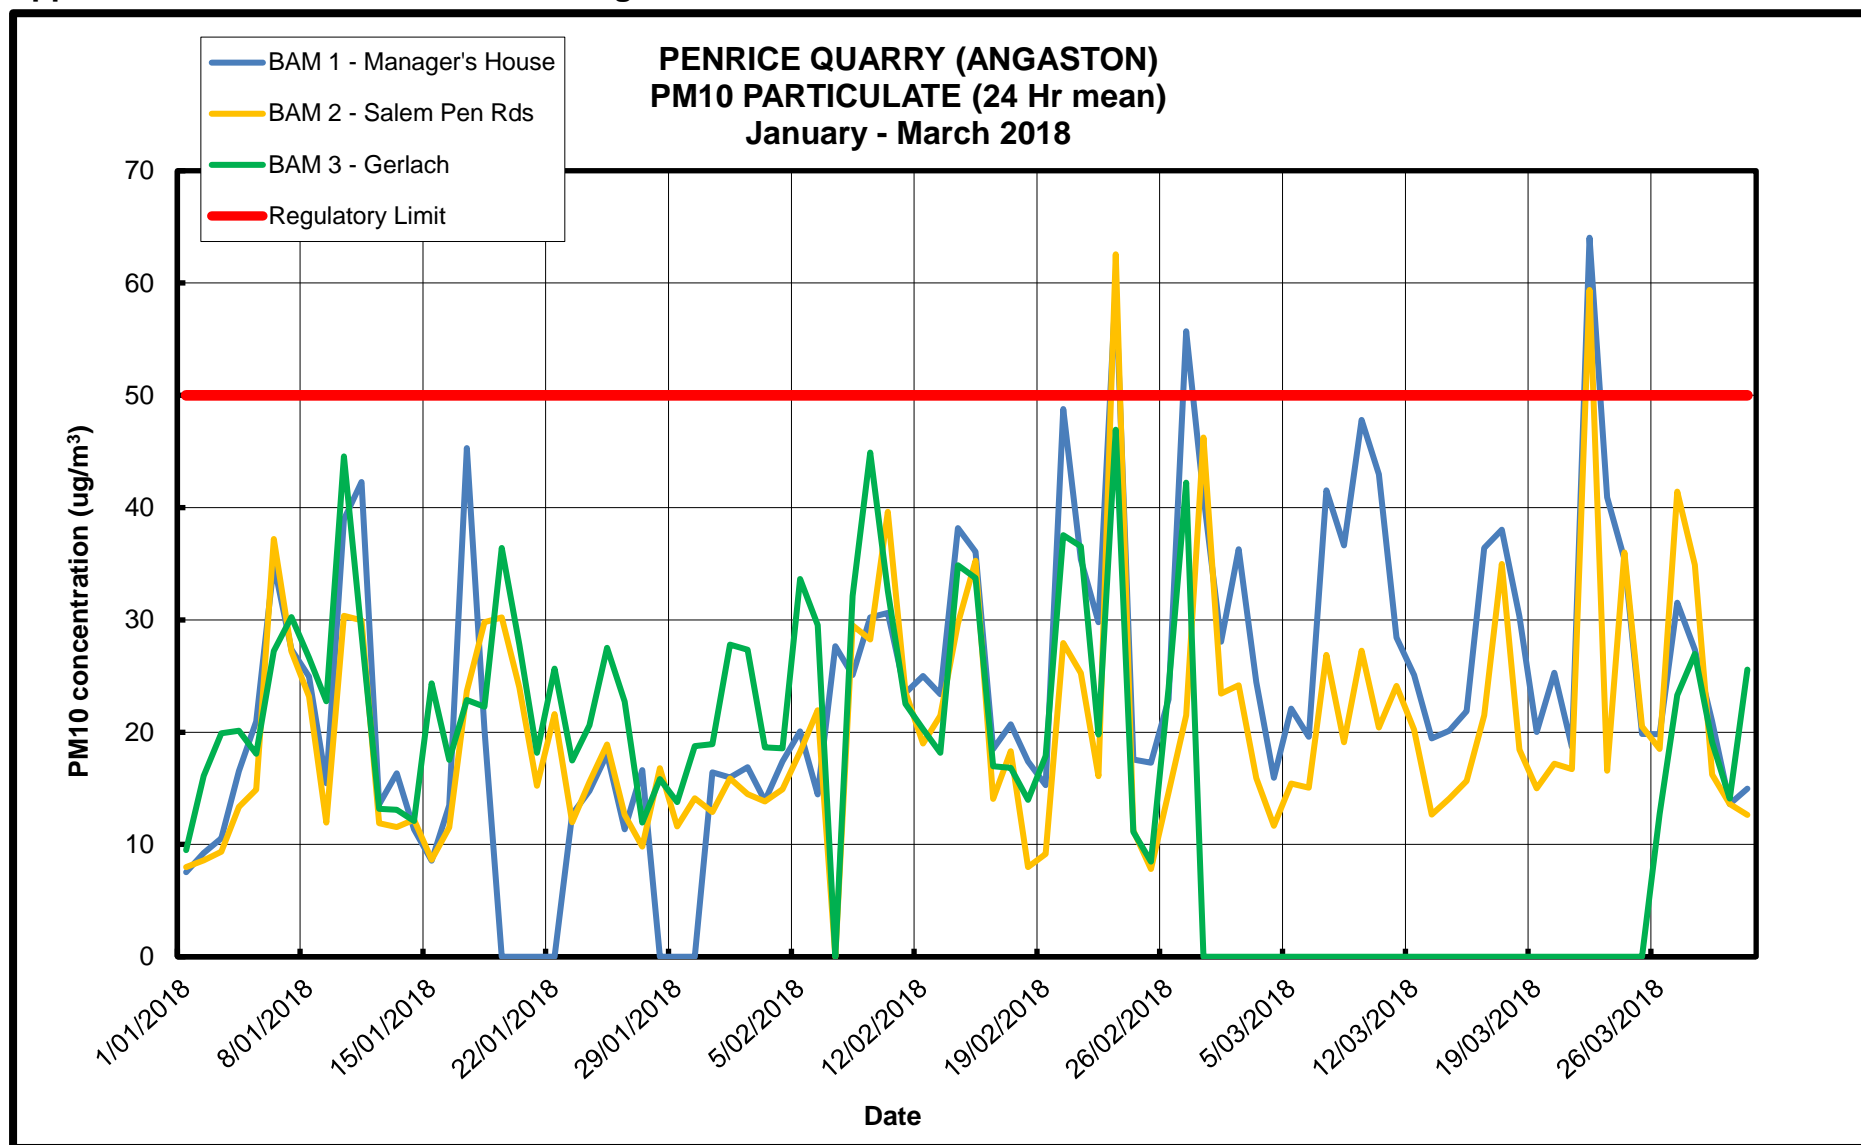
## Appendix B – BAM Monitors 24hr Average PM<sub>10</sub> Concentration

- All BAM units were calibrated in February and will again be calibrated in May.
- Three PM<sub>10</sub> 24-hour (rolling average) exceedances was recorded during the quarter:

- 11/01/18 – BAM1- High PM<sub>10</sub> readings as a result of Quarry operations, with a Northerly wind direction and hot conditions. Actions and controls during the day include starting water truck and stockpile sprays at 5:30am, no production at Aggregate plant or mobile crushing plants, stopping Load and Haul activities and concentrating water trucks in south eastern sales areas.

- 23/02/18 – BAM1 and BAM 2 – High PM<sub>10</sub> readings as a result of regional visible dust coming onto site and Quarry operations contributing, with a Northerly wind direction and hot conditions.

- 22/03/18 – BAM1 and BAM 2 – High PM10 readings as a result of regional visible dust coming onto site and Quarry operations contributing, with a Northerly wind direction and hot conditions. BAM reading started rising from 10:30am resulting in shutting down aggregate plant, relocating mobile crushing, reducing load and haul activity and maintaining both water trucks throughout the day.
- There was one 24-hour daily average exceedance (midnight to midnight) on BAM 1 that occurred on the 27<sup>th</sup> February, but did not trigger the rolling 24-hour average. On this day, it was again hot conditions with a Northerly wind direction. Operations were modified to reduce dust generating activities.
