Quarterly Compliance Report

1st January to 31st March 2019

Penrice Quarry & Mineral

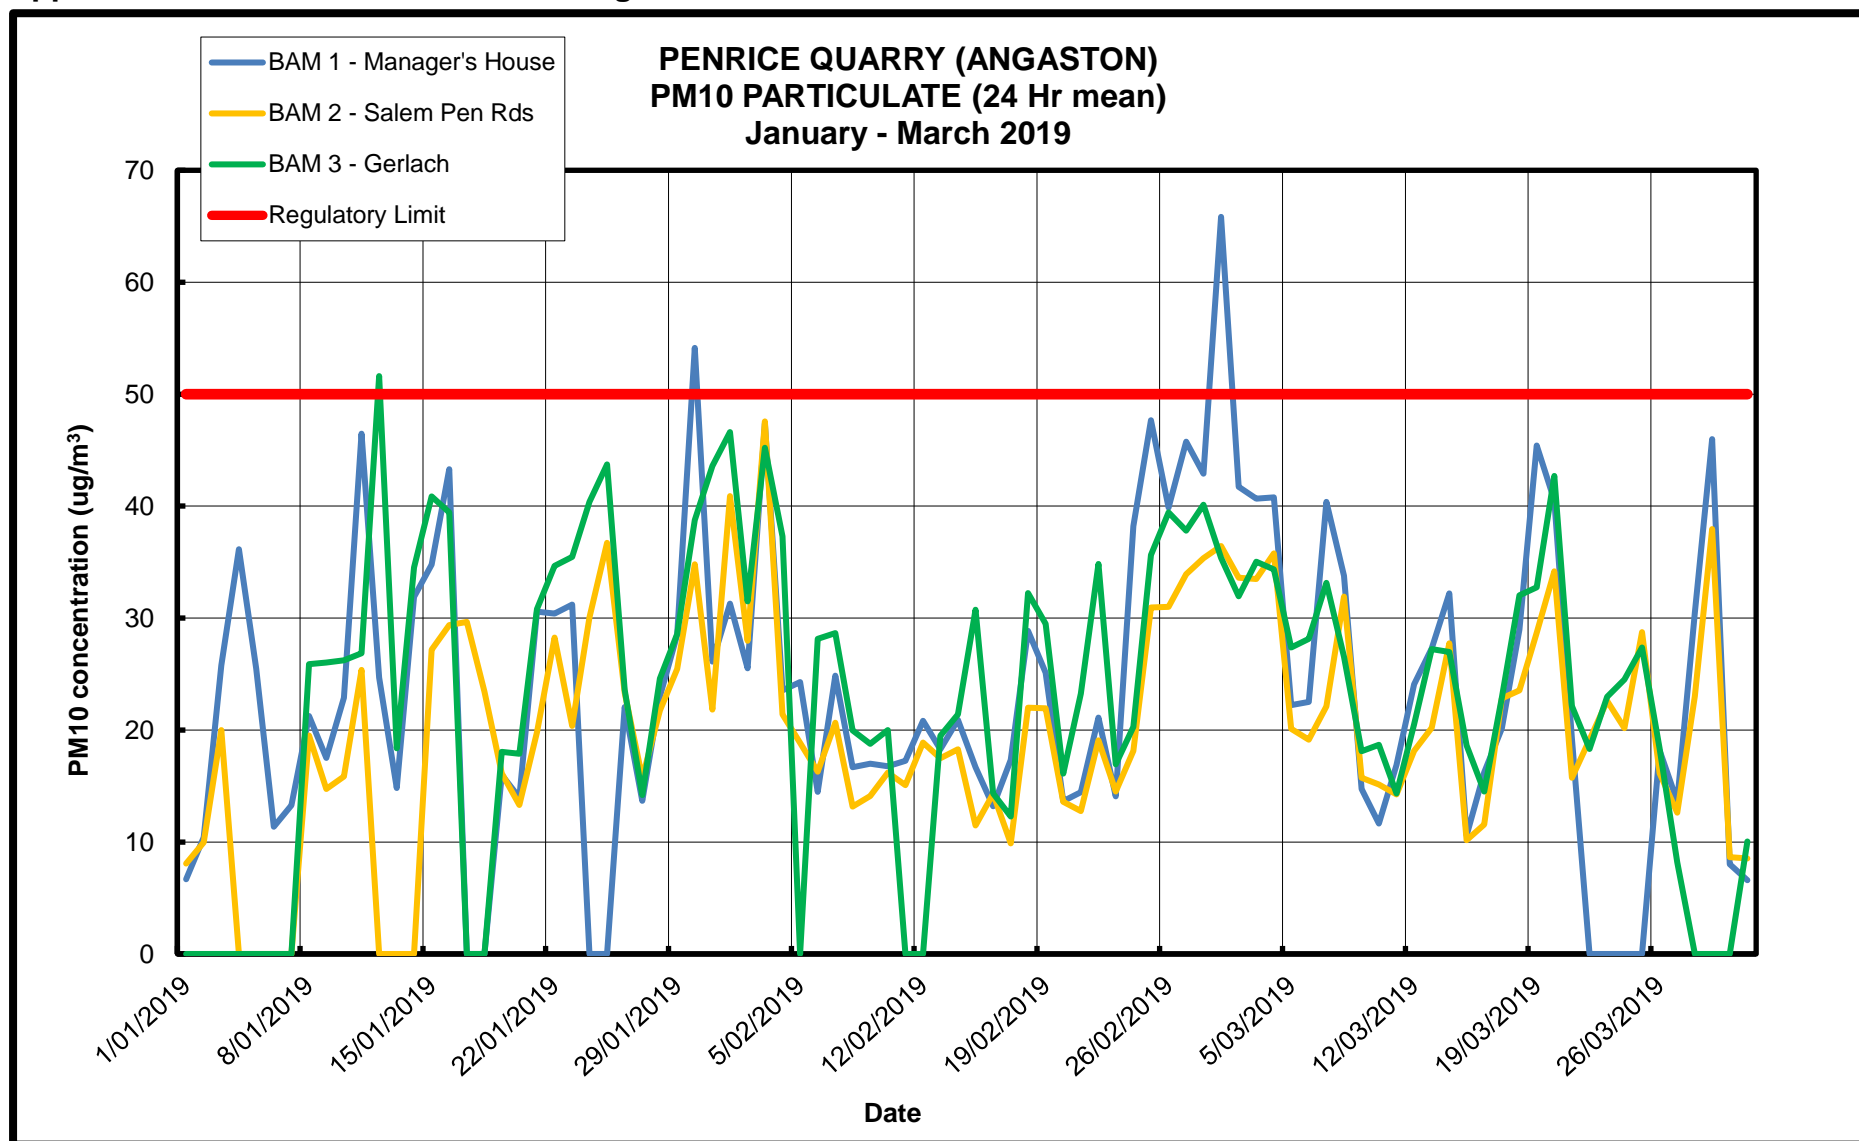
Appendix B – BAM Monitors 24hr Average PM₁₀ Concentration

- BAM unit data showing the 24hr daily mean (mid-night to mid-night) for the reporting period is attached in Appendix B. Four daily mean exceedances were recorded during the quarter.
- BAM unit availability for the period as follows, with BAM locations shown in Appendix A, Site Locations:
 - BAM 1 – 91%
 - BAM 2 – 92%
 - BAM 3 – 83%
- BAM unit calibrations and maintenance is continuing on a quarterly basis and was last completed on the 17th January 2019. The lower availability on BAM3 was a result of a filter tape issue over the Christmas and New Year period.

- Nine PM₁₀ 24hr (rolling average) exceedances were recorded during the quarter and reported to DEM and EPA. In each case, the Trigger Action Response Plan (TARP) is enacted as per the sites Dust Management Plan (DMP), which includes stopping dust generation activities including production, increasing usage of the water trucks, and redirection of haul road traffic. Brief details of each exceedance are listed below highlighting date, BAM location and wind direction:
