# WHITE DAM GOLD MINE

# Quarterly Compliance Report

1<sup>st</sup> October to 31<sup>st</sup> December 2013

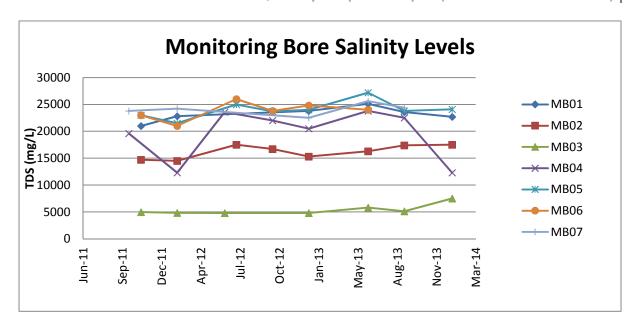
**Figure 4: Monitoring Bore Salinity Levels**

As previously reported, monitoring bore MB05 has shown a substantial level reduction from baseline but the level has stabilised since last reporting period. As is noted below, there has been no observable effect on regional bore levels.

In previous reporting periods MB01 and MB07 were inaccessible, and were then believed to be collapsed. However during the recent reporting periods, samples were able to be taken and field sampling indicated that salinity levels remain stable.

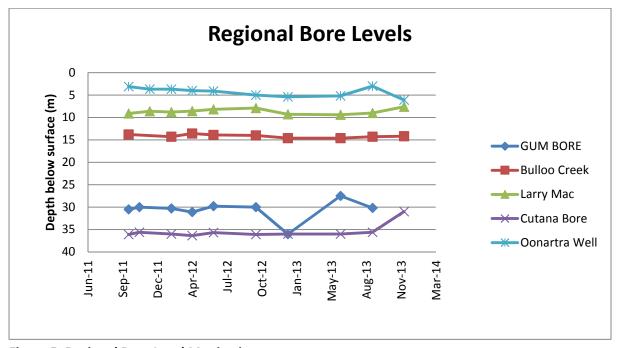
**Figure 5: Regional Bore Level Monitoring**

**Figure 5** below indicates that there has been minimal change to bore water levels throughout most regional bores during this and previous reporting periods.

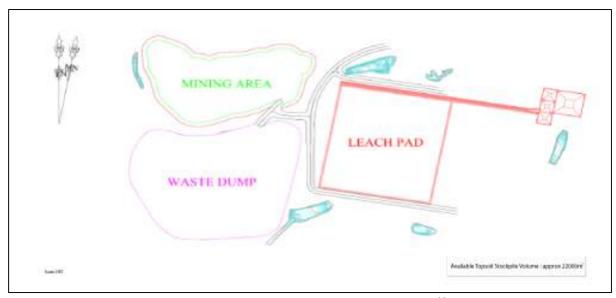
Figure 6: Topsoil stockpile inventory within the White Dam project site<sup>11</sup>

Topsoil Stockpile Name	Original Volume	Cumulative Usage	Remaining
TSP1	7261	7261	depleted
TSP2	2005	2005	depleted
TSP3	2749	inaccessible	inaccessible
TSP4	19518	19518	depleted
TSP5	9034	nil	9034
TSP6	1145	nil	1145
TSP7	6984	nil	6984
TSP8	2994	nil	2994
TSP9	9836	8336	1500
TSP10	779	779	depleted
TSP11	2000	2000	depleted
TSP12	2248	2248	depleted
Total	66553	42147	21657
