ILUKA RESOURCES LIMITED

TECHNICAL REPORT

JACINTH-AMBROSIA PROJECT

Mining and Rehabilitation Compliance Report 2012

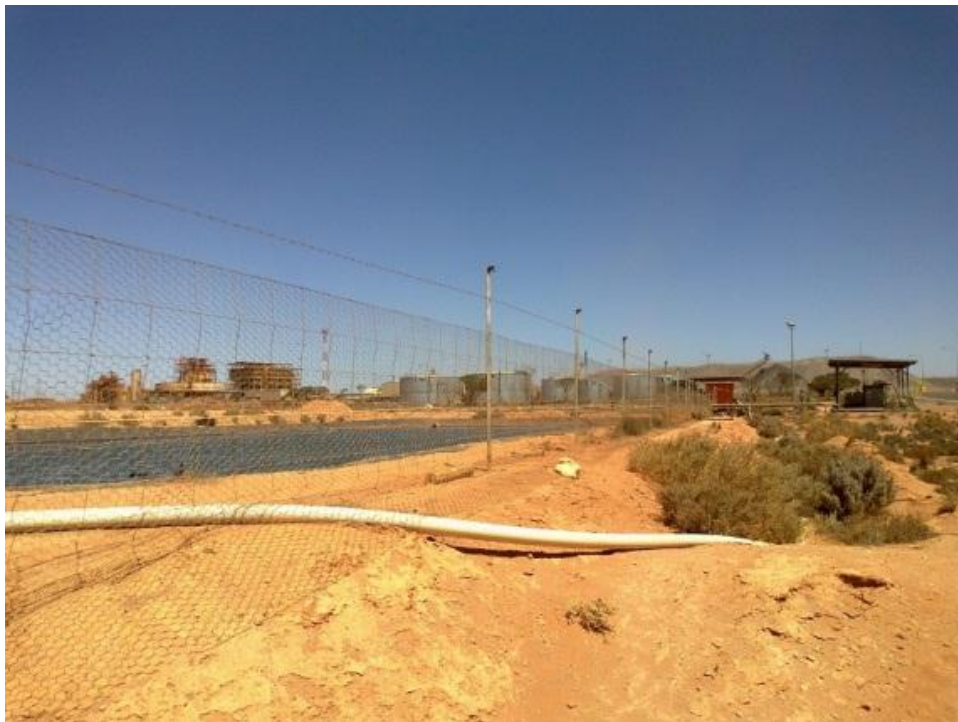
- As in previous years, road kill represented the greatest impact to fauna and mostly involving wombats.
- Drowning events declined in 2012, down 38% from 2011. This is attributed to fencing upgrades and other activities completed in 2012:
 - Addition of chicken wire to existing cyclone fencing around process water dams;
 - Installation of gate self-closing mechanisms to mitigate issues with fauna access to water bodies through gates left open;
 - Ongoing repairs to electric fencing;
 - Installation of additional fauna escape matting;
 - Implementation of a daily borefield and bore-line inspection including checks of Turkey Nests;

Figure 13 – Chicken wire upgrade to existing process water pond cyclone fencing

A review of bird control measures (e.g. bird diverters, bird netting) was completed in 2012 and an audio deterrent system is proposed for trial at the Jacinth process water dam. Netting systems were deemed impractical given the size of the process water bodies in question.

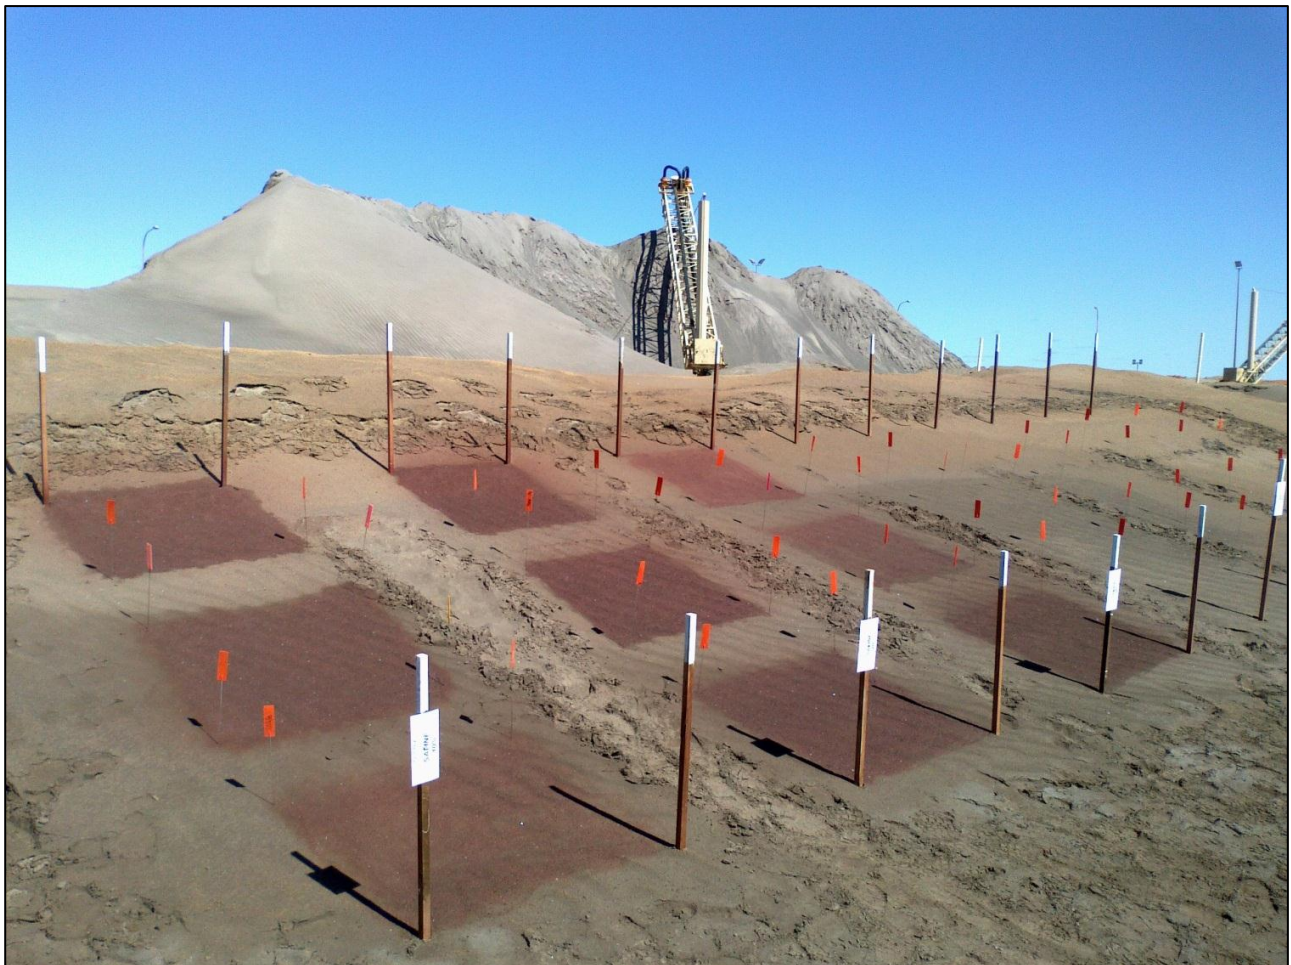
Figure 26 – Sealant demonstration assessing dilution rates, application rates and frequency

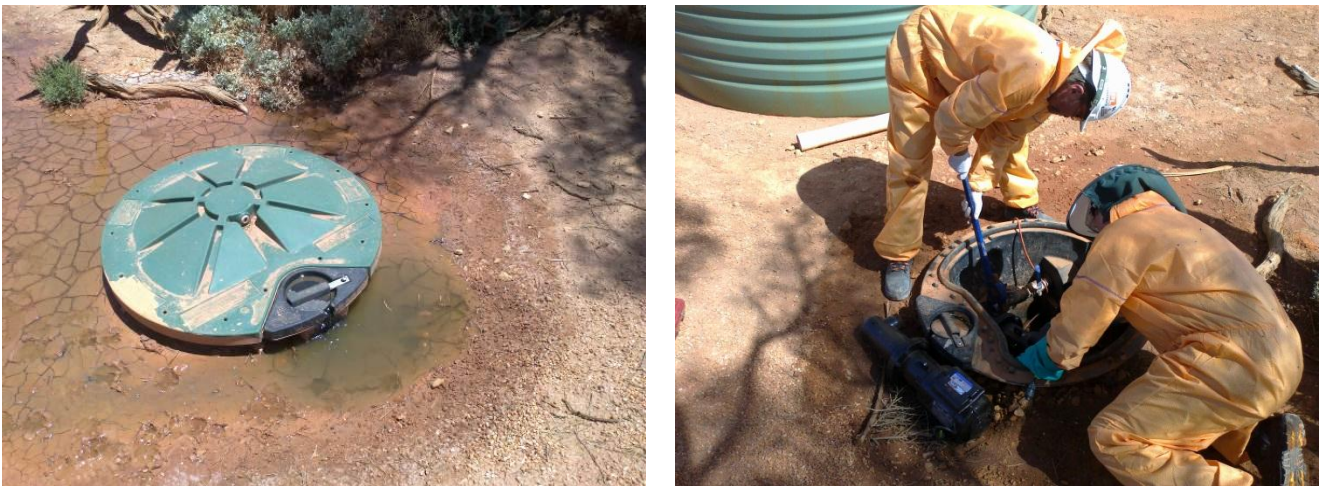
Figure 29 – Septic overflow from receiving tank and replacement of macerator pump

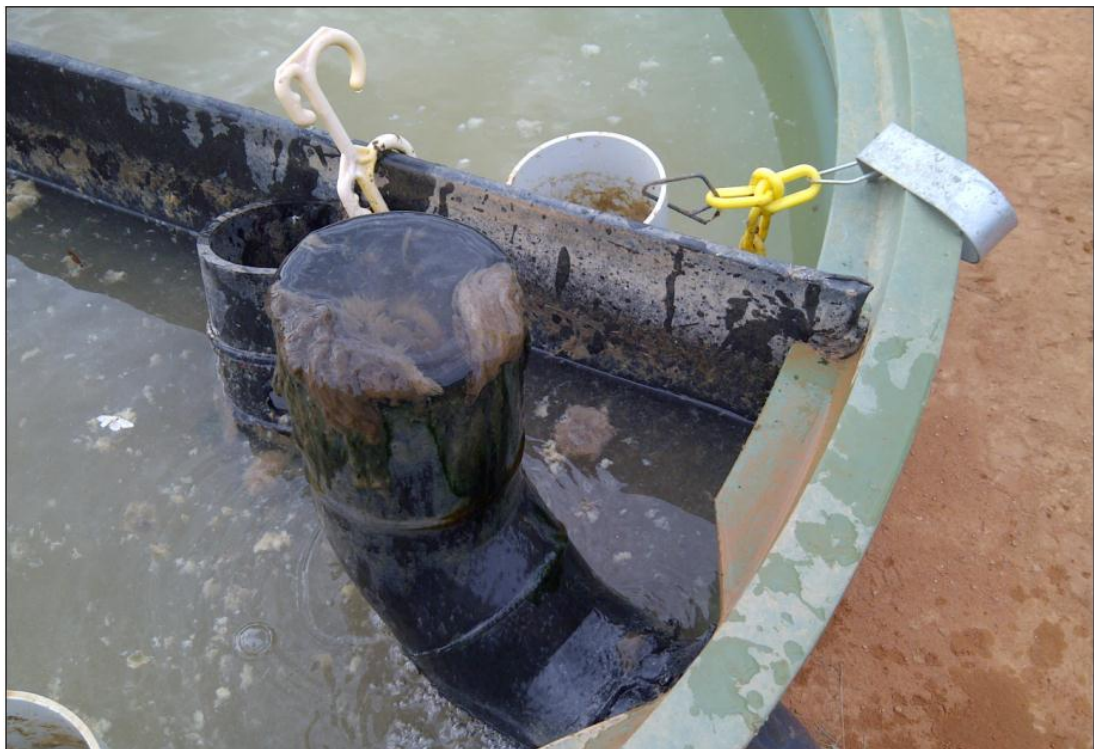
- Jacinth village overflows – humus build-up in draw-off pipe between humus tank and chlorine contact tank (Figure 30). Blockage causing water backflow and overflow of the humus tank. No repeat incidents recorded following implementation of daily plunging and purging program.
- Mine system pump failure – stocking of replacement macerator pumps as critical spares, implementation of weekly pump inspection and installation of trash screens to capture debris and eliminate pump fouling/blockage.

Figure 30 – Plunging and purge of humus draw-off pipe to reinstate normal flow

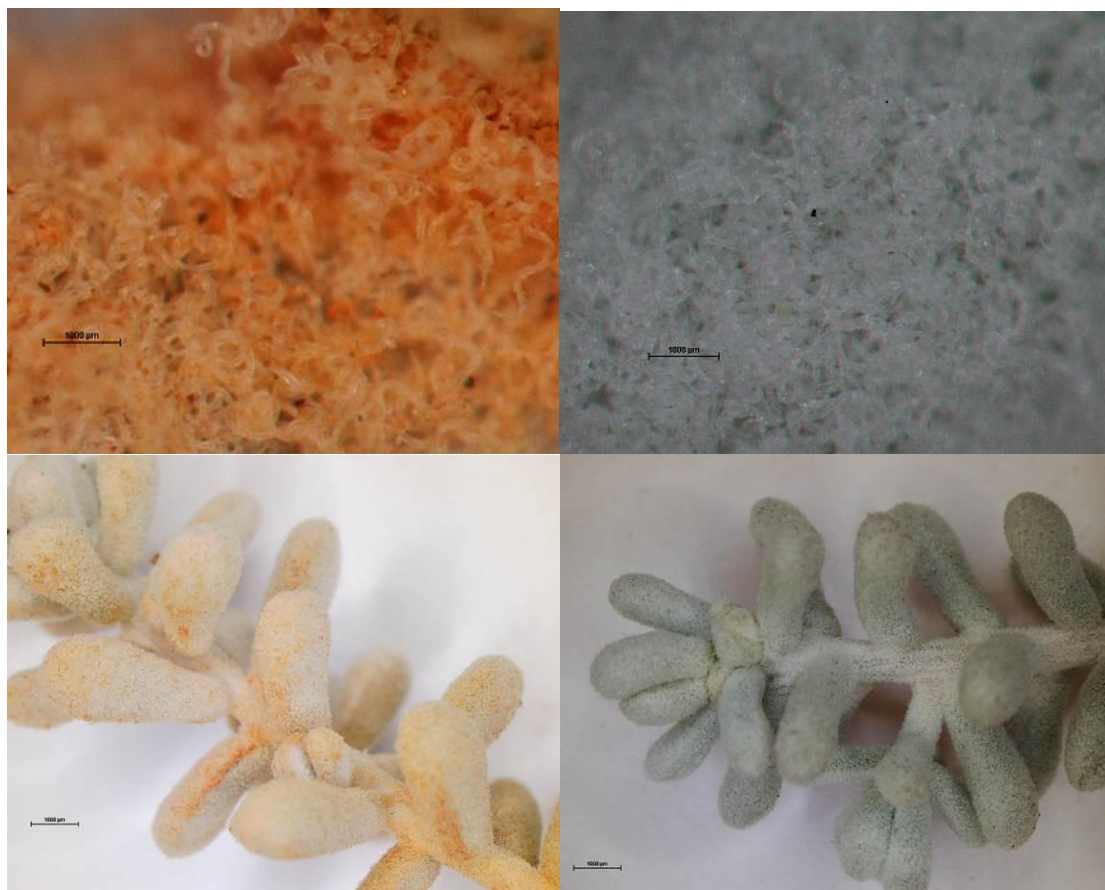
Pearl Bluebush (*Maireana sedifolia*) is one of the most widely distributed species at J-A. The leaves and stems of this species are covered with a thick layer of fine hairs, referred to as trichomes (Figure 1). Dust from light to medium wind events appears to be deposited on top of these hairs and readily washed off in rainfall events. Dust from heavy wind events appears to penetrate the hairy layer and is captured and held by the plant (S Doudle, observations 2009-2011, Figure 1). Other local species with dust trapping trichomes include: *Acacia papyrocarpa*, *Rhagodia* species (Table 7) *Maireana trichoptera*, *Maireana integra*, *Maireana erioclada* (stems only), *Eriochiton schleroionoides* and *Sclerolaenea patentiuspis*, *S. obliquicuspis* and *S. diacantha*.

Figure 1. Hairs of Pearl Bluebush coated with dust on the left and without on the right at 80x magnification above and 8x magnification below
