ILUKA RESOURCES LIMITED

JACINTH-AMBROSIA PROJECT

Mining and Rehabilitation Compliance Report 2014

31st March 2015

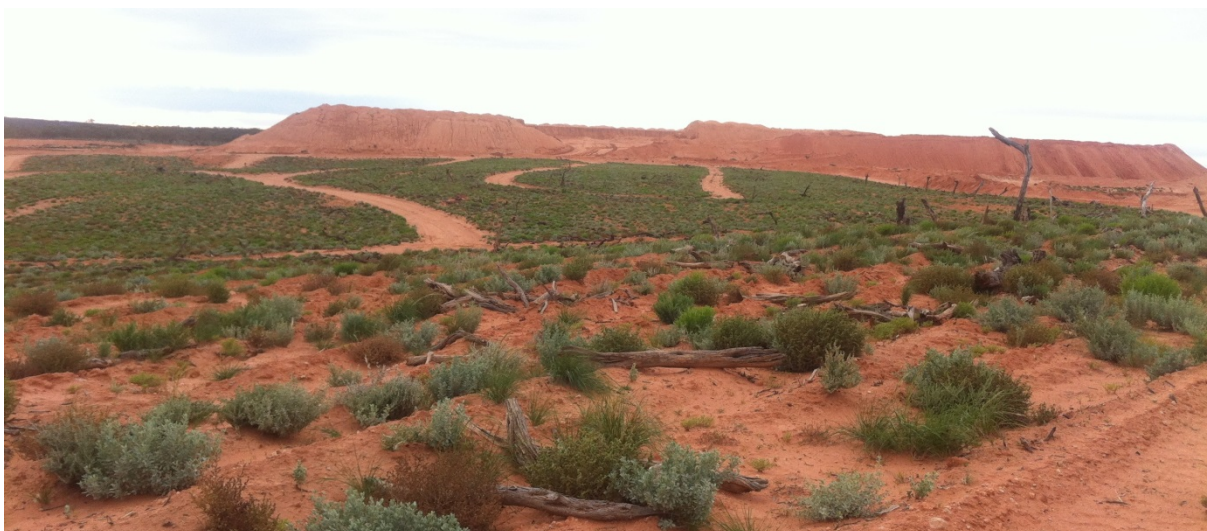
Plate 7 Rehabilitation in Cell 1 East with prolific plant growth evident

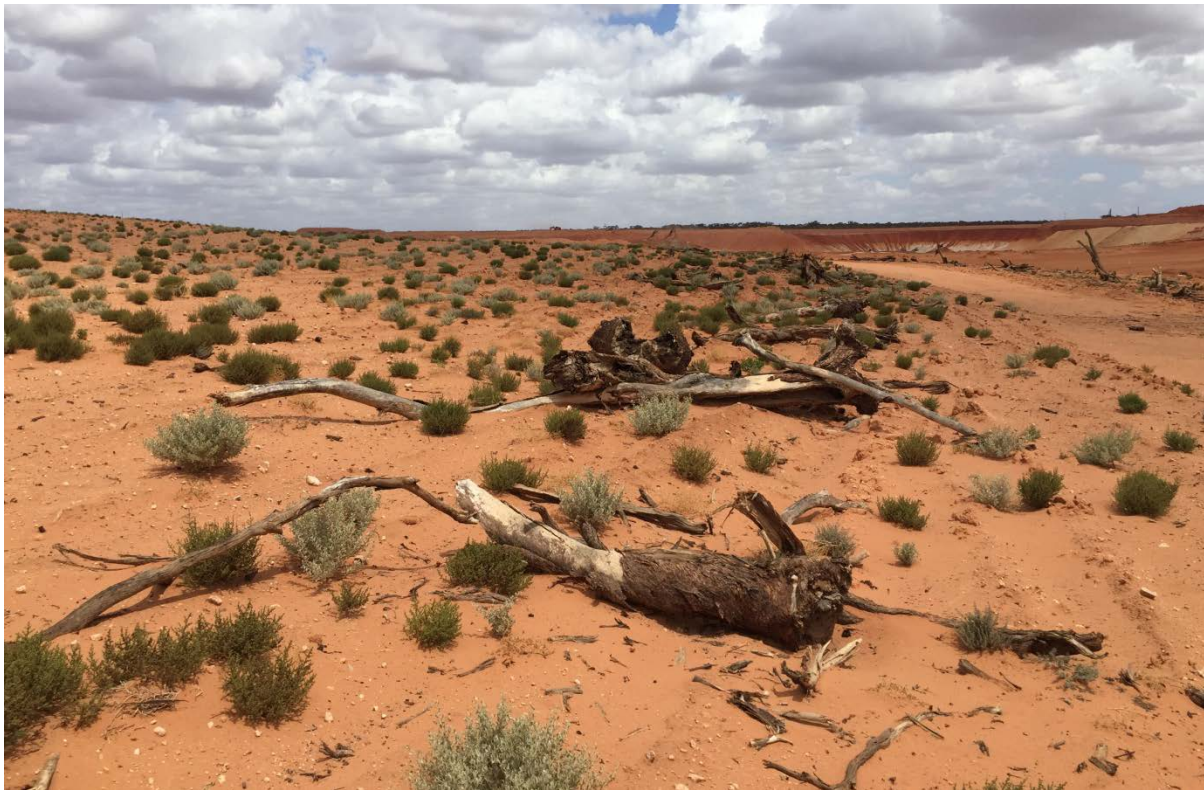
Plate 8 Rehabilitation of Cell 1 West

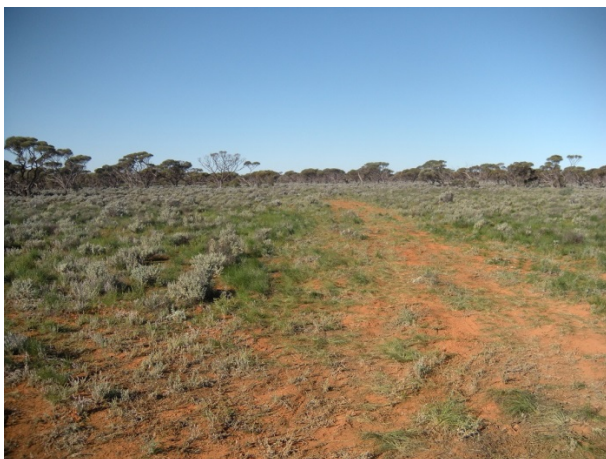
In 2014, Iluka rehabilitated two areas of vegetation clearance breaches associated with a non-approved wind mast installation (Plate 9) and drill-rig access track installation (Plate 10 and Plate 11) that occurred beyond mine lease boundaries in 2013 (refer Iluka J-A 2013 MARCR). Rehabilitation outcomes were reported to the DEWNR Native Vegetation Council.

Plate 9 Wind mast clearance area rehabilitation, 2014

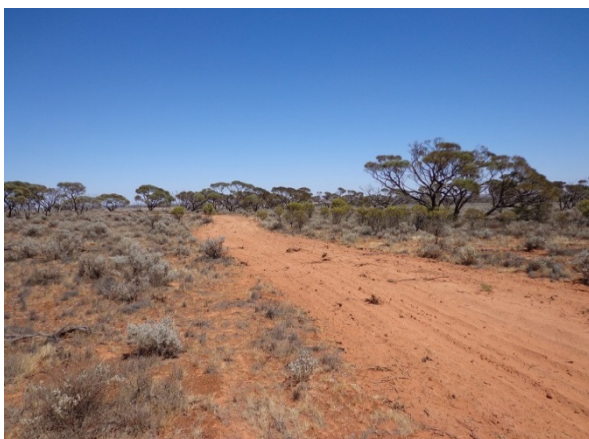
Plate 10 Access track rehabilitation, 2013

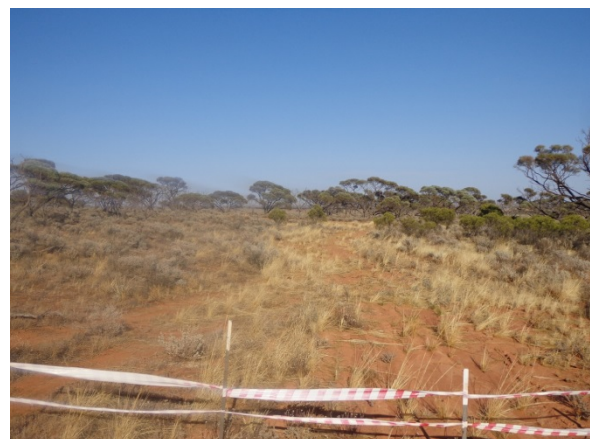
Plate 11 Access track rehabilitation, 2014

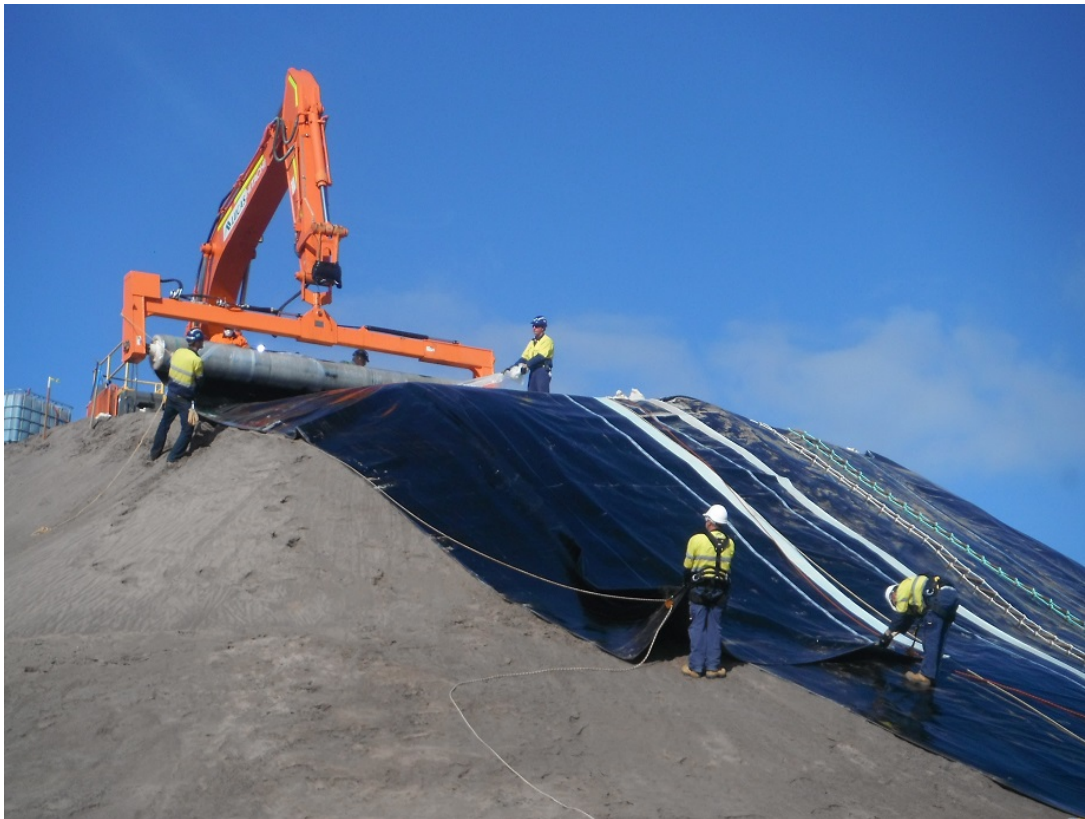
A trial installation of a bituminous geo-membrane (BGM) cover for long-term HMC stockpile containment was completed in July 2014 (Plate 13 and Plate 14). Bitumen geo-membrane, designed as a heavy-duty liner for dams and similar applications, was selected on the basis of its weight and durability in extreme heat and wind conditions prevalent at Jacinth. As indicated by the manufacturer, the BGM material had not previously been used for this type of application but offered a unique alternative to HDPE and other materials which had been dismissed as unsuitable for site conditions.

Plate 13 BGM installation

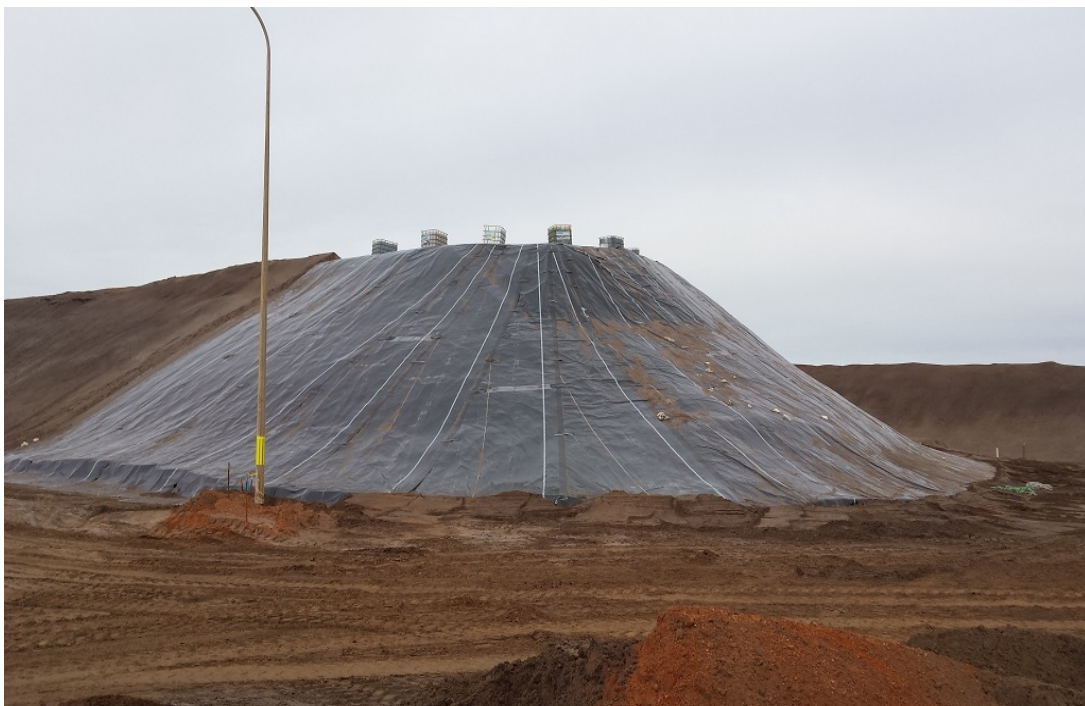
While trial outcomes supported the proof-of-concept of BGM for stockpile containment the continued long-term use of this product was dismissed due to the difficulty of installation and recovery, membrane failures due to wind uplift, and unfavourable cost-benefit compared to traditional water cart and sealant application.

Plate 14 Completed BGM trial

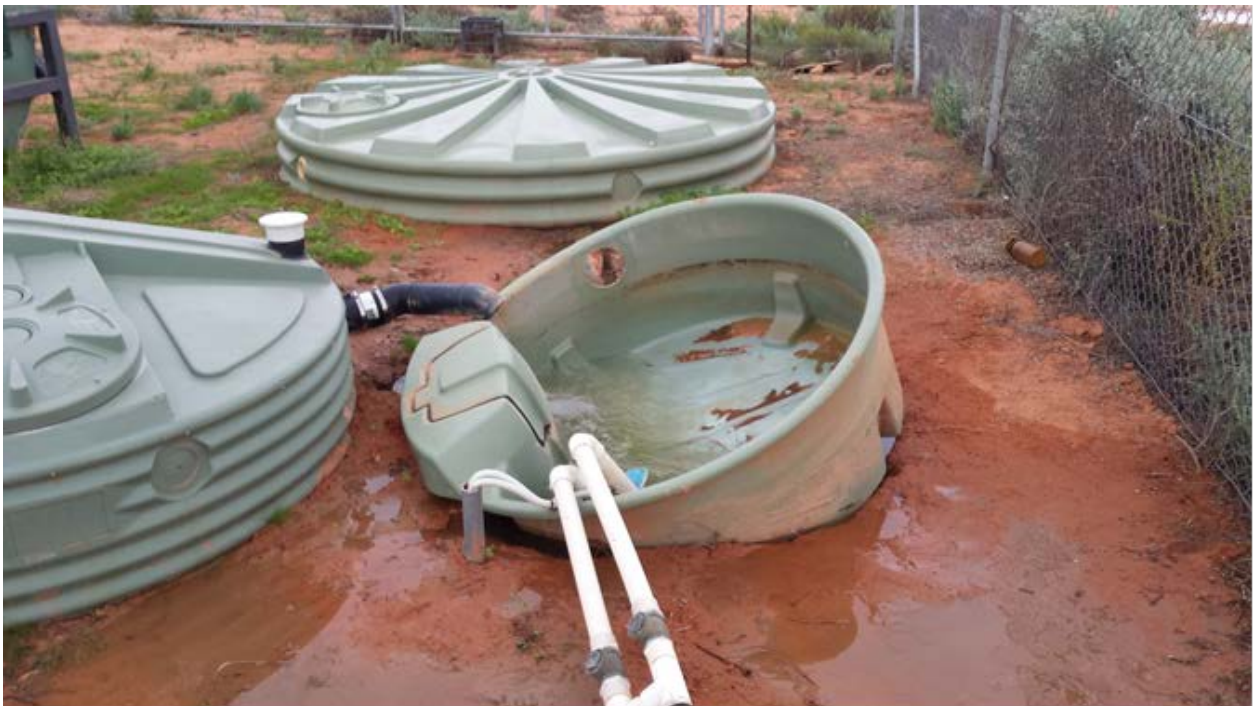
- Jacinth village: humus tank overflowed (approx. 100 L) on to unsealed ground, causing the final transfer tank to lift out of ground. Cause was due to scum build up in primary tank 3 weir box and the humus draw-off pipe / tank, which then caused flow restrictions and back-up of water in the humus tank. The overflow from this tank ran down slope towards the transfer tank (Plate 15).
- Mine Site: effluent pump seized due to unknown blockage, causing 50 L of effluent to spill onto bare ground. High level alarm was activated and the site control room and maintenance team responded immediately to rectify.

Plate 15 Overflow of wastewater from the humus tank at Jacinth village
