Engineering Geology of Little Para Dam

W.R.P. Boucaut and J.C. Beal

Report of Investigations 54 Geological Survey of South Australia

Report of Investigations 54

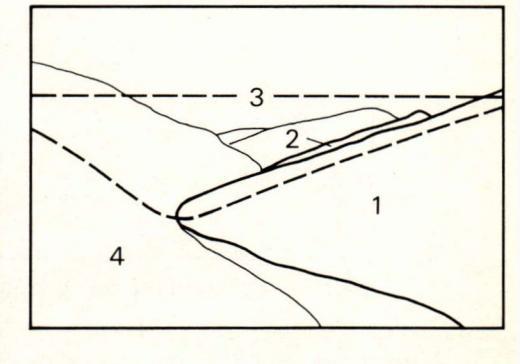
Plate 2

The dam site before construction, looking down-stream in July, 1973 (T13066).

- 1. Quartzite stratum (Unit 12) forming dip slope on right abutment. 2. Spoil from exploration trench.
- 3. Dam axis.
- 4. Dolomitic siltstone (Unit 13) of left abutment.

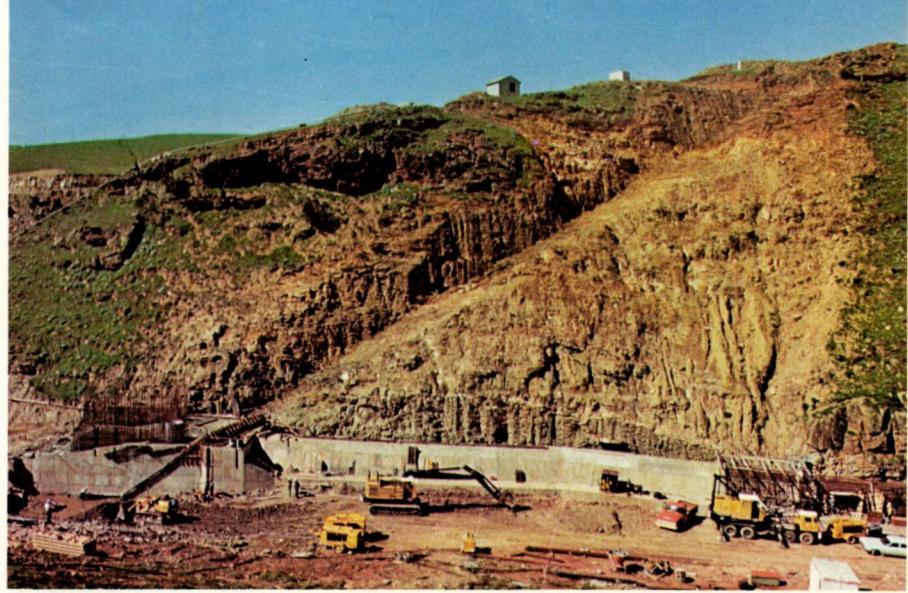
Plate 3

Left abutment and outlet duct during construction in September, 1974 (T24372) 1. Hillside stress relief fracture.

- 2. Shear zone.
- 3. Slaty dolomitic siltstone displaced by shear zone.
- Base of outlet tower.
 Outlet duct.

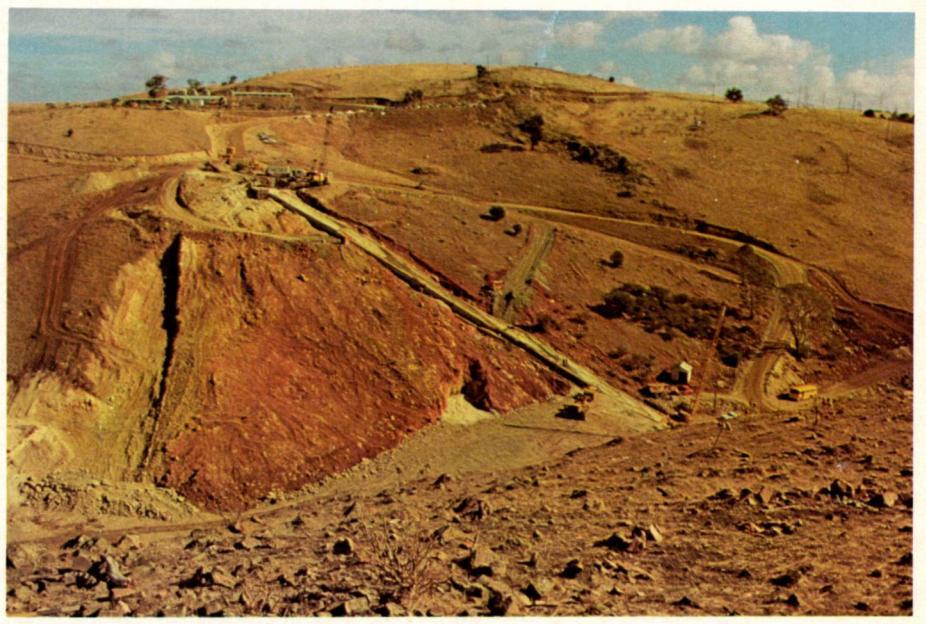
- Plate 4
 Right abutment in December, 1976 (T24373).
 1. Right bank grout cap.
 2. Early investigation trench.
 3. Over-excavation along a minor shear zone backfilled with zone 1 material.

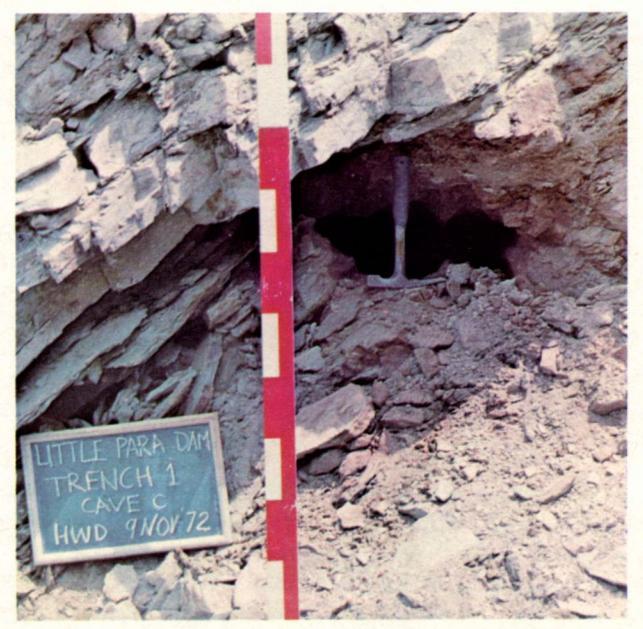
Plate 6 Cavity exposed in right abutment inspection trench—November, 1972 (N23112). Note: Scale marked in 10 cm increments.

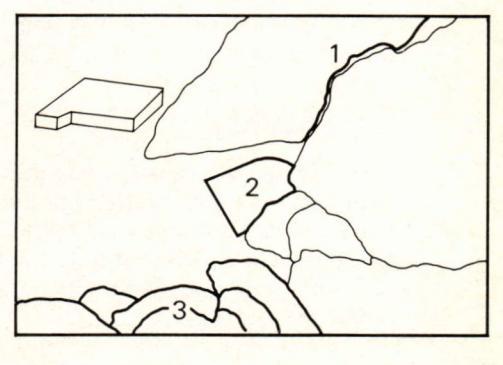
Plate 8
Left bank grout cap excavation—March, 1974 (T24376).
1. Hillside stress relief fracture.
2. Dental concrete in excavation seam of weathered delements effective (1111)

- dolomitic siltstone (Unit 13).
- 3. Shows slabby nature of dolomitic siltstone.

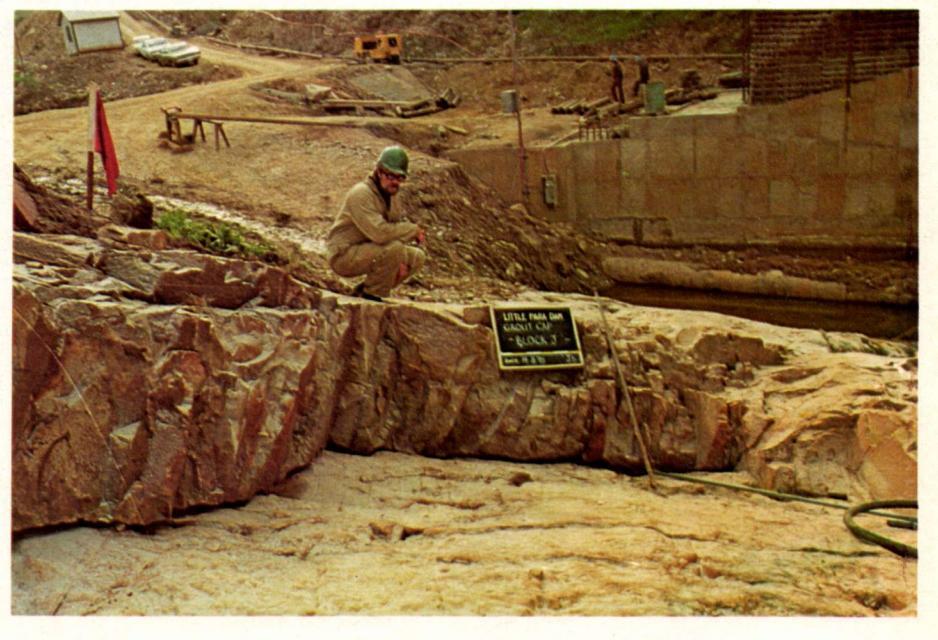
Plate 9

Open bedding plane on right bank grout cap exca-vation. Overlying quartzite was later removed by hydraulic rock splitter. Background shows tempo-rary coffer dam (left) and diversion pipe in front of outlet tower base (T24377).
