UNDERGROUND WATER INSPECTION - SEC. 219 HD. MYPONGA

PROPERTY OF E. S. U. MANLEY - MOUNT COMPASS

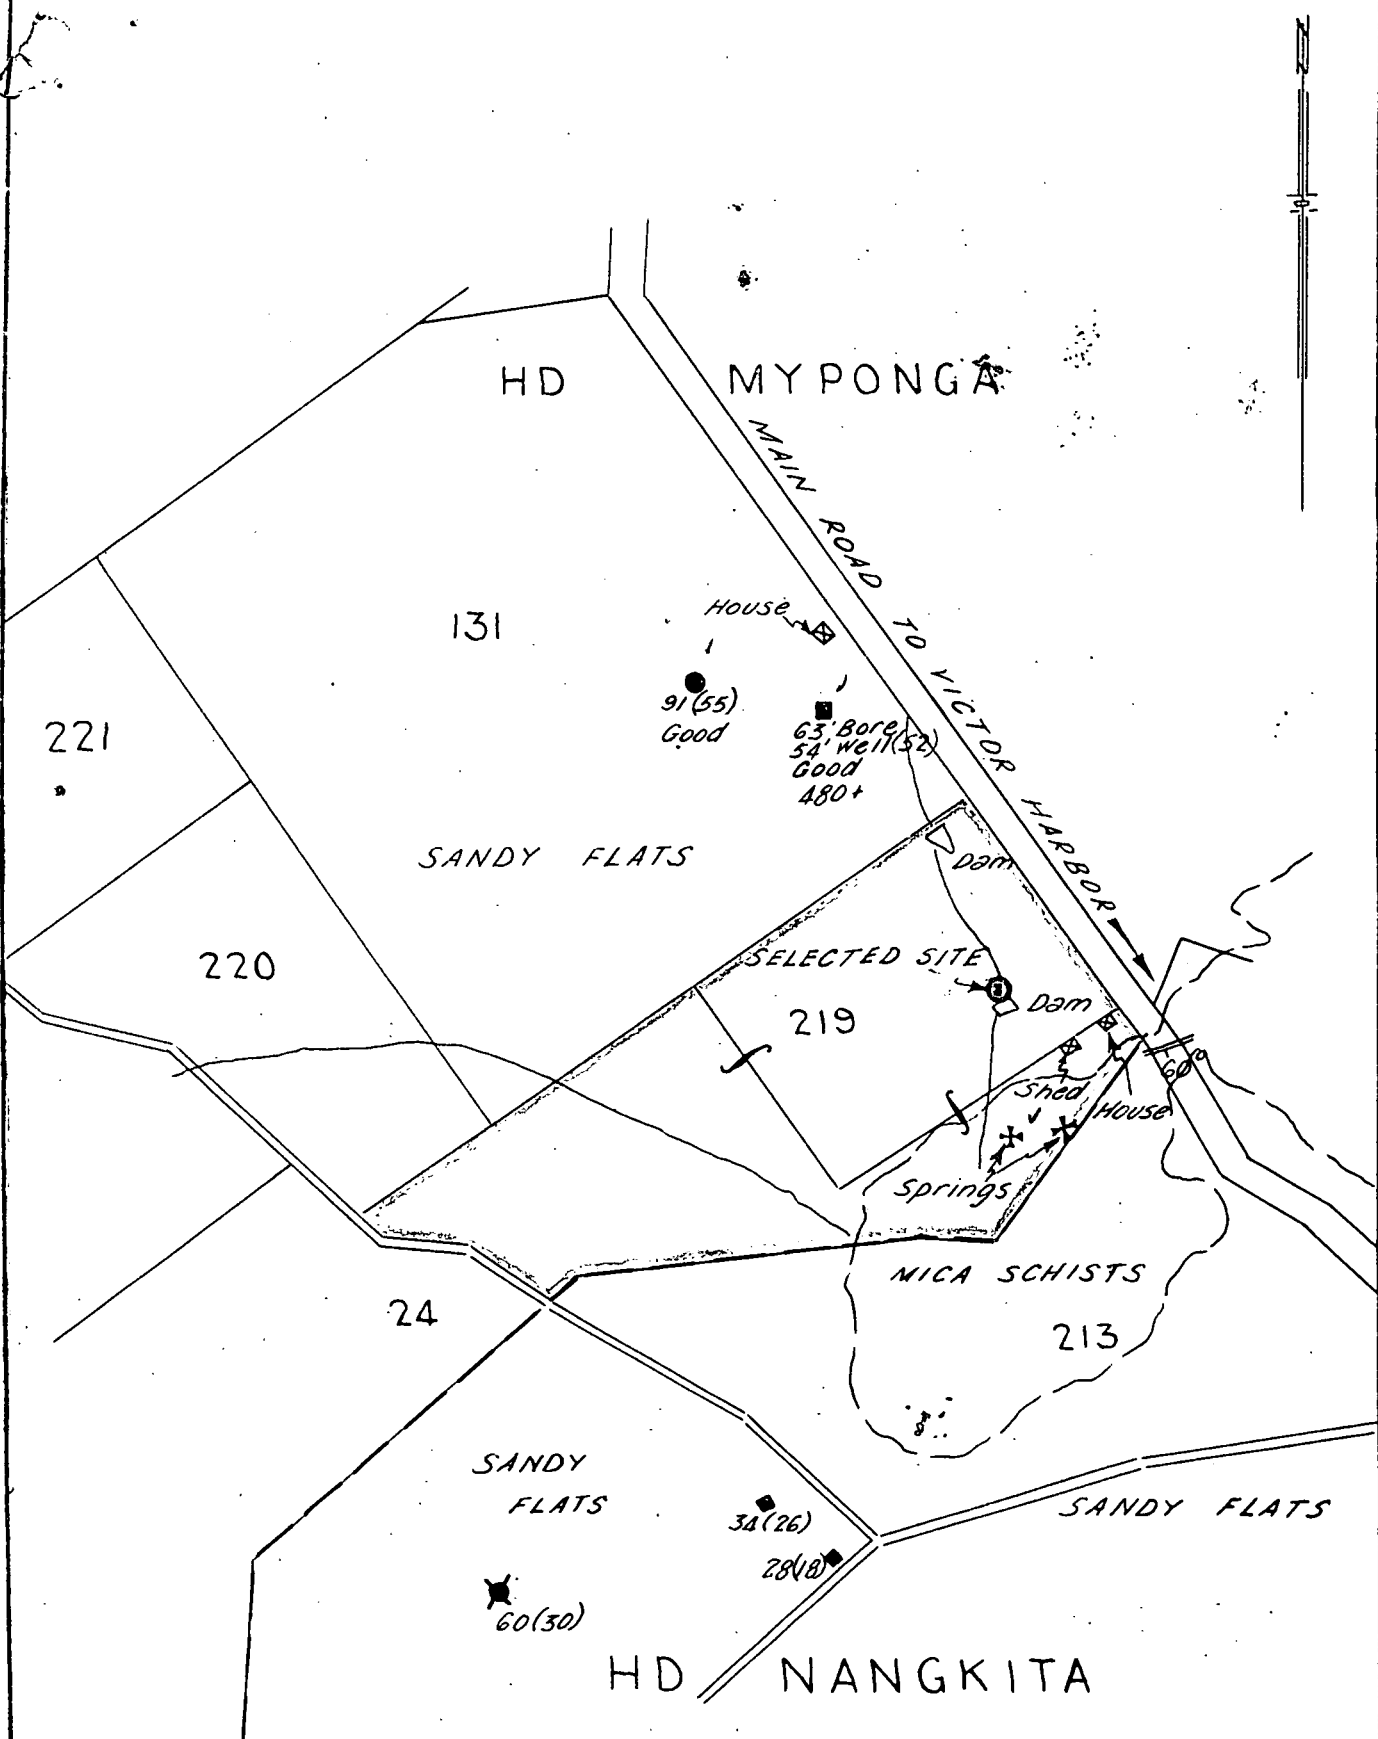
The most promising bore site on the property is one adjacent to the dam in the northern corner of the property. The thickness of unconsolidated sediments on the property is probably at a maximum at this point diminishing towards the basement outcrops on the southern margin of the property. The prospects of obtaining adequate supplies within these sediments is dependent largely on their overall thickness so that bore sites located south of the above mentioned site appear to offer poorer prospects, though in the absence of bore records in the area it is impossible to delineate areas in which supplies will be available.

Because of the location and elevation of the storage dam in relation to the area to be irrigated, it is desirable to locate the bore as near as possible to the dam. A bore located beside the dam (selected site) does not have the prospects of one located in the northern corner of the property, but would permit direct pumping to the storage dam.

The property owner expressed a preference for this site and in view of the prospect of rapid drilling it is recommended that this site (selected site on map) be drilled first. Depending on results obtained, further drilling at the site in the northern corner may be considered.
