## DEPARTMENT OF MINES.

# REPORT ON GROUNDWATER PROSPECTS Section Pt. 6028. Hundred Talunga - Miss M. Hynes

This section was inspected on the 10th February, 1954.

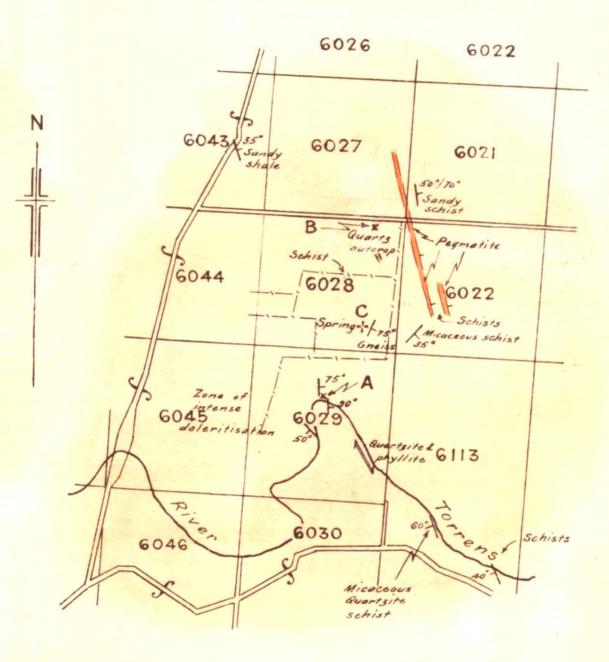
Approved	Possed	Den. R.R.	UNDERGROUND WATER	P M Re	20 Chns. to 1 In.
Director	C.D.	Exc.	HP TALUNGA SEC. 6028		Ha 8

Along the northern boundary the watercourse is some little distance away, and local intake into rocks underlying the section would be consequently reduced. However, at the point "B" on the attached plan, it is possible that the rocks may be rather less hardened than elsewhere and this is considered the least doubtful location on the whole section, for the construction of a bore. The site has been indicated

It is considered that the spring at "C" probably owes its existence to the hard gneiss in which it occurs. Such a rock would afford little access for the downward percolation of rainwater soakage and the spring has apparently been caused by such soakage riding on top of the hard rock and moving laterally till it appears at the sloping hill surface, rather than working down to depth. In fact the existence of the spring is considered a discouraging factor, unless its flow is in itself enough for requirements, which seems unlikely.

Drilling on or near the hill top cannot be recommended and a bore at site "B" appears to offer the best chance of success, but there is some doubt both as to the quantity and perhaps the quality of the water obtainable and also the permanence of any large supply, if such were obtained. A bore at site "A" should obtain good quality water, but

Drilling conditions are expected to be hard, and costs might be £2. 10. 0 to £3. 0. 0 per foot, including casing. If undertaken, drilling should not be discontinued at a shallower depth than 200 ft. for site "A", and 250 ft. for site "B", in the case of failure at lesser depths.
