# DEPARTMENT OF MINES. SOUTH AUSTRALIA.

# REPORT ON GROUNDWATER PROSPECTS. SECTION 463. HD. JULIA CREEK. M.T. & D.P. CARTER.

The Property was inspected on 2nd June, 1954.

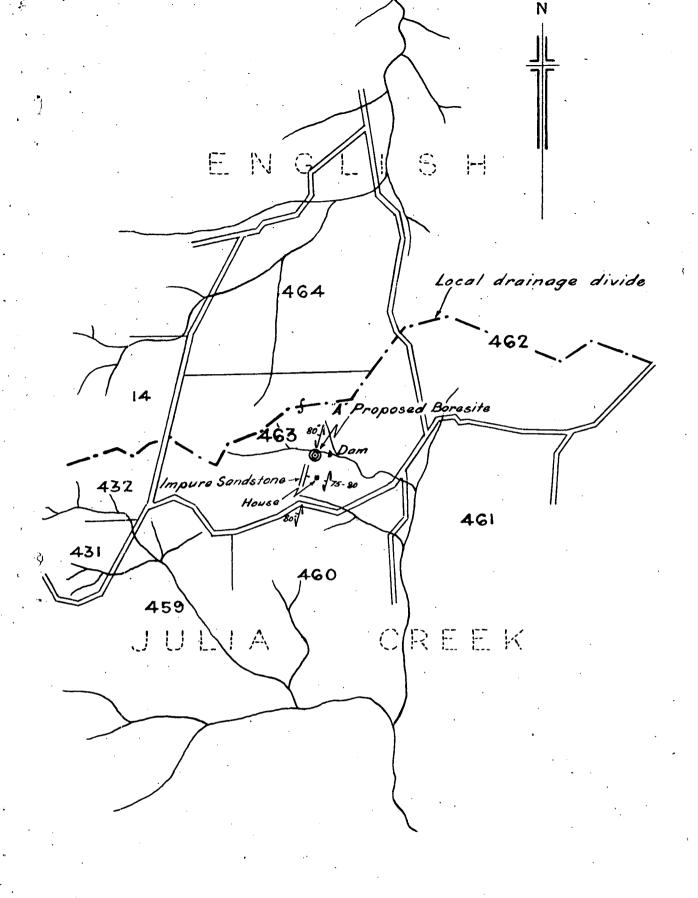
To accompany report by J.J. Jenkin.

A site has therefore been indicated on the attached plan, where limited supplies of probably stock quality water may be obtainable, but it is emphasized that its selection has been influenced by the possibility of penetrating a sandstone bar, the existence of which at the site has not been definitely established.

It seems likely that collection and storage of surface runoff in a dam or dams might be a better means of ensuring the required supply, and it is recommended that consideration be given to this, rather than to the drilling of a bore. It is suggested that before constructing a dam, at least five auger holes be put down to test the depth and extent of the clay.

The holes should be about a foot deeper than the proposed depth of the dam, four being placed at the corners and one in the centre of the site.
