DEPARTMENT OF MINES  
SOUTH AUSTRALIAIron-Ore Deposit  
Near Gladstone.  
(Sect. 182, Hd. Yangya)

D. S. BUIST

Iron-ore Deposit near Gladstone  
(Sect. 182, Hd. Yangya)

12th October, 1955.

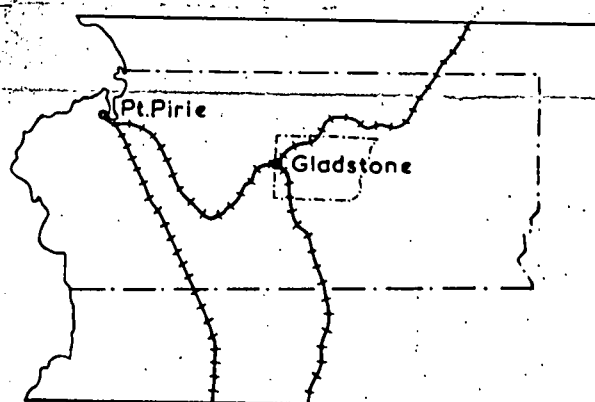
55-331

Mineralised rock was observed (a) where the creek bed enters the workings at their south end and (b) on the western side of the workings (see accompanying sketch-plan). Apart from these two localised areas, no more ironstone was noted.
