REPORT ON GROUNDWATER PROSPECTS

SECTION 97, HD. WANILLA

A. E. Gameau

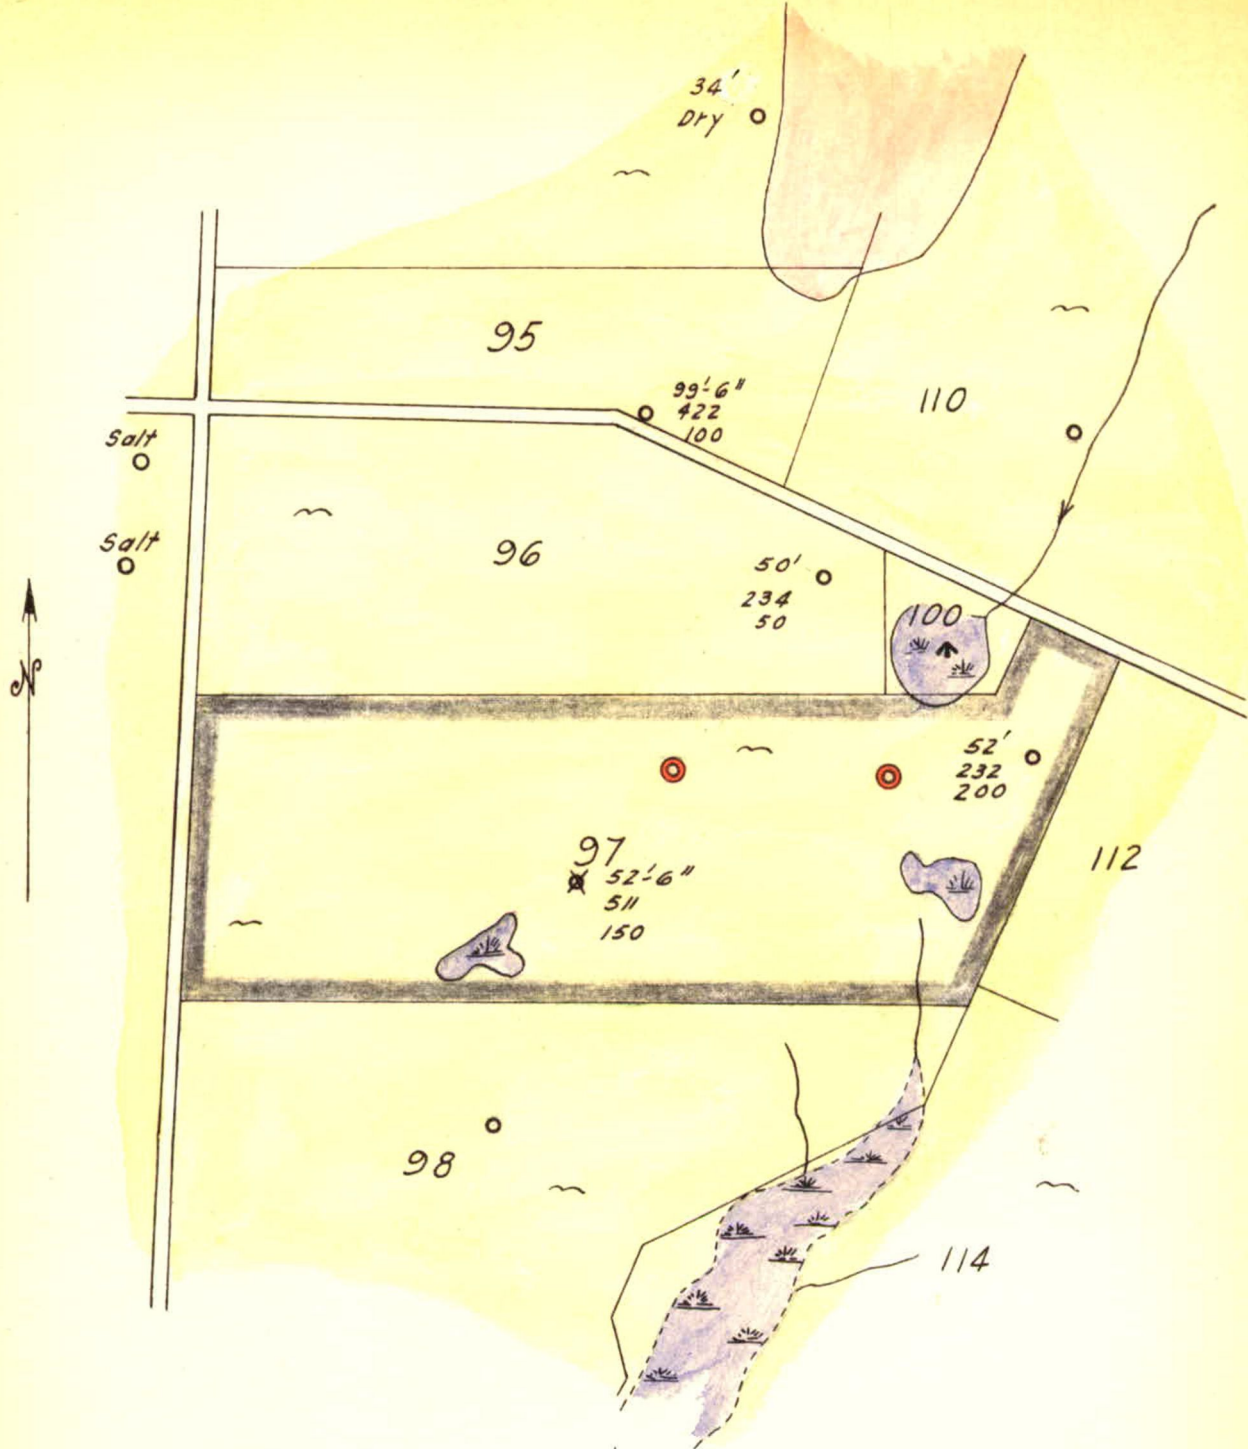
For this reason it is considered that better quality water may occur at higher levels and accordingly two sites have been suggested, and shown on the accompanying plan. Water is expected to occur at a depth of 40-50 feet and the supply may not exceed 100-200 gallons per hour. The water may not be suitable for use on plants, but as additional stock supplies are required in the western part of the property, drilling is probably warranted.

The supply from an existing bore in the western part of the property has failed because of sand trouble. Cleaning out and installation of a screen may restore the original yield. However it was found difficult to develop a supply from this bore when drilled and therefore it is probably preferable to drill a new bore.

Water suitable for stock should be obtained from sand at a depth of 40-50 feet at the site suggested. A sand screen may be necessary to develop the supply, which is not expected to exceed 100-200 gallons per hour. It is doubtful whether water suitable for irrigation will be obtained but as additional stock supplies are required, drilling is recommended. Stock water may also

be obtained by drilling in the gully along the western boundary of the section, as indicated on the plan.
