Department of Mines  
South Australia

REPORT ON SUITABILITY OF PROPOSED SUB-DIVISION

PT. SECTION 874, HD. ADELAIDE

Town Planner's Office

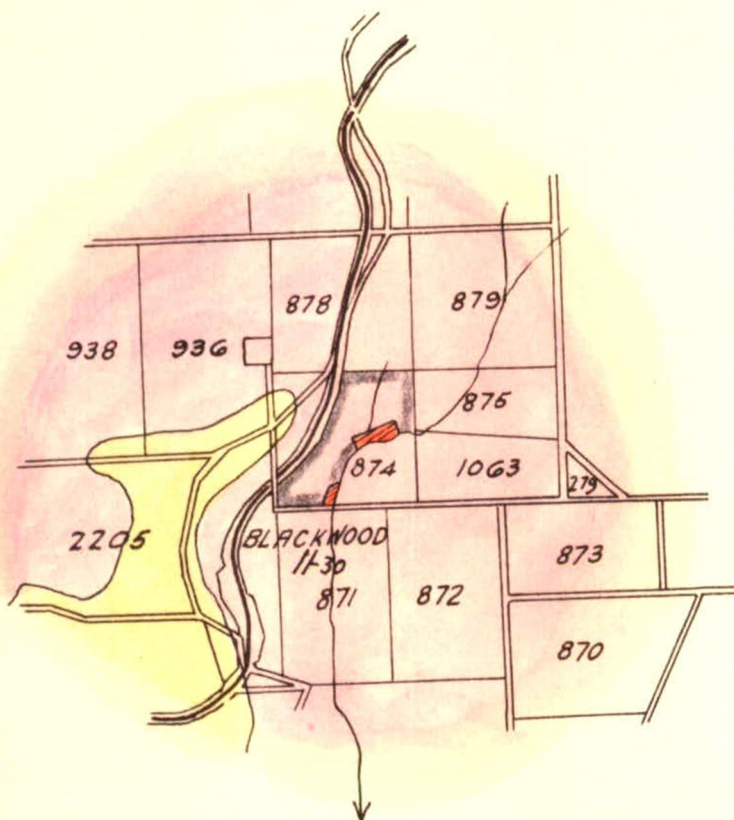
| Approved | Passed | Drn. | <b>DRAINAGE INSPECTION</b><br><b>PT. SEC. 874 Hd. ADELAIDE</b><br><b>TOWN PLANNER</b> | D.M. | Scale 40 ch. to 1 in |

An area along the creek including allotments 114-117 and 118-124 is considered to be unsuitable for subdivision because of the possibility of waterlogging.

Area considered suitable for subdivision

The area generally appears to be suitable for sub-division, provided it is adequately drained. It is considered that the allotments should have a larger area, particularly where the slopes are steep. It is therefore suggested that the area of allotments 59-63 and 78-113 should be subdivided into larger allotments, preferably of  $\frac{1}{4}$  acre area.
