MIDDLE RIVER DAM - KANGAROO ISLAND
FEASIBILITY STAGE GEOLOGICAL INVESTIGATIONS
PRELIMINARY REPORT - SUMMARY OF RESULTS
~~DECEMBER~~ 1964

by
D. H. Stapledon
Senior Geologist

and
S. Robson
Geologist

8th December, 1964.

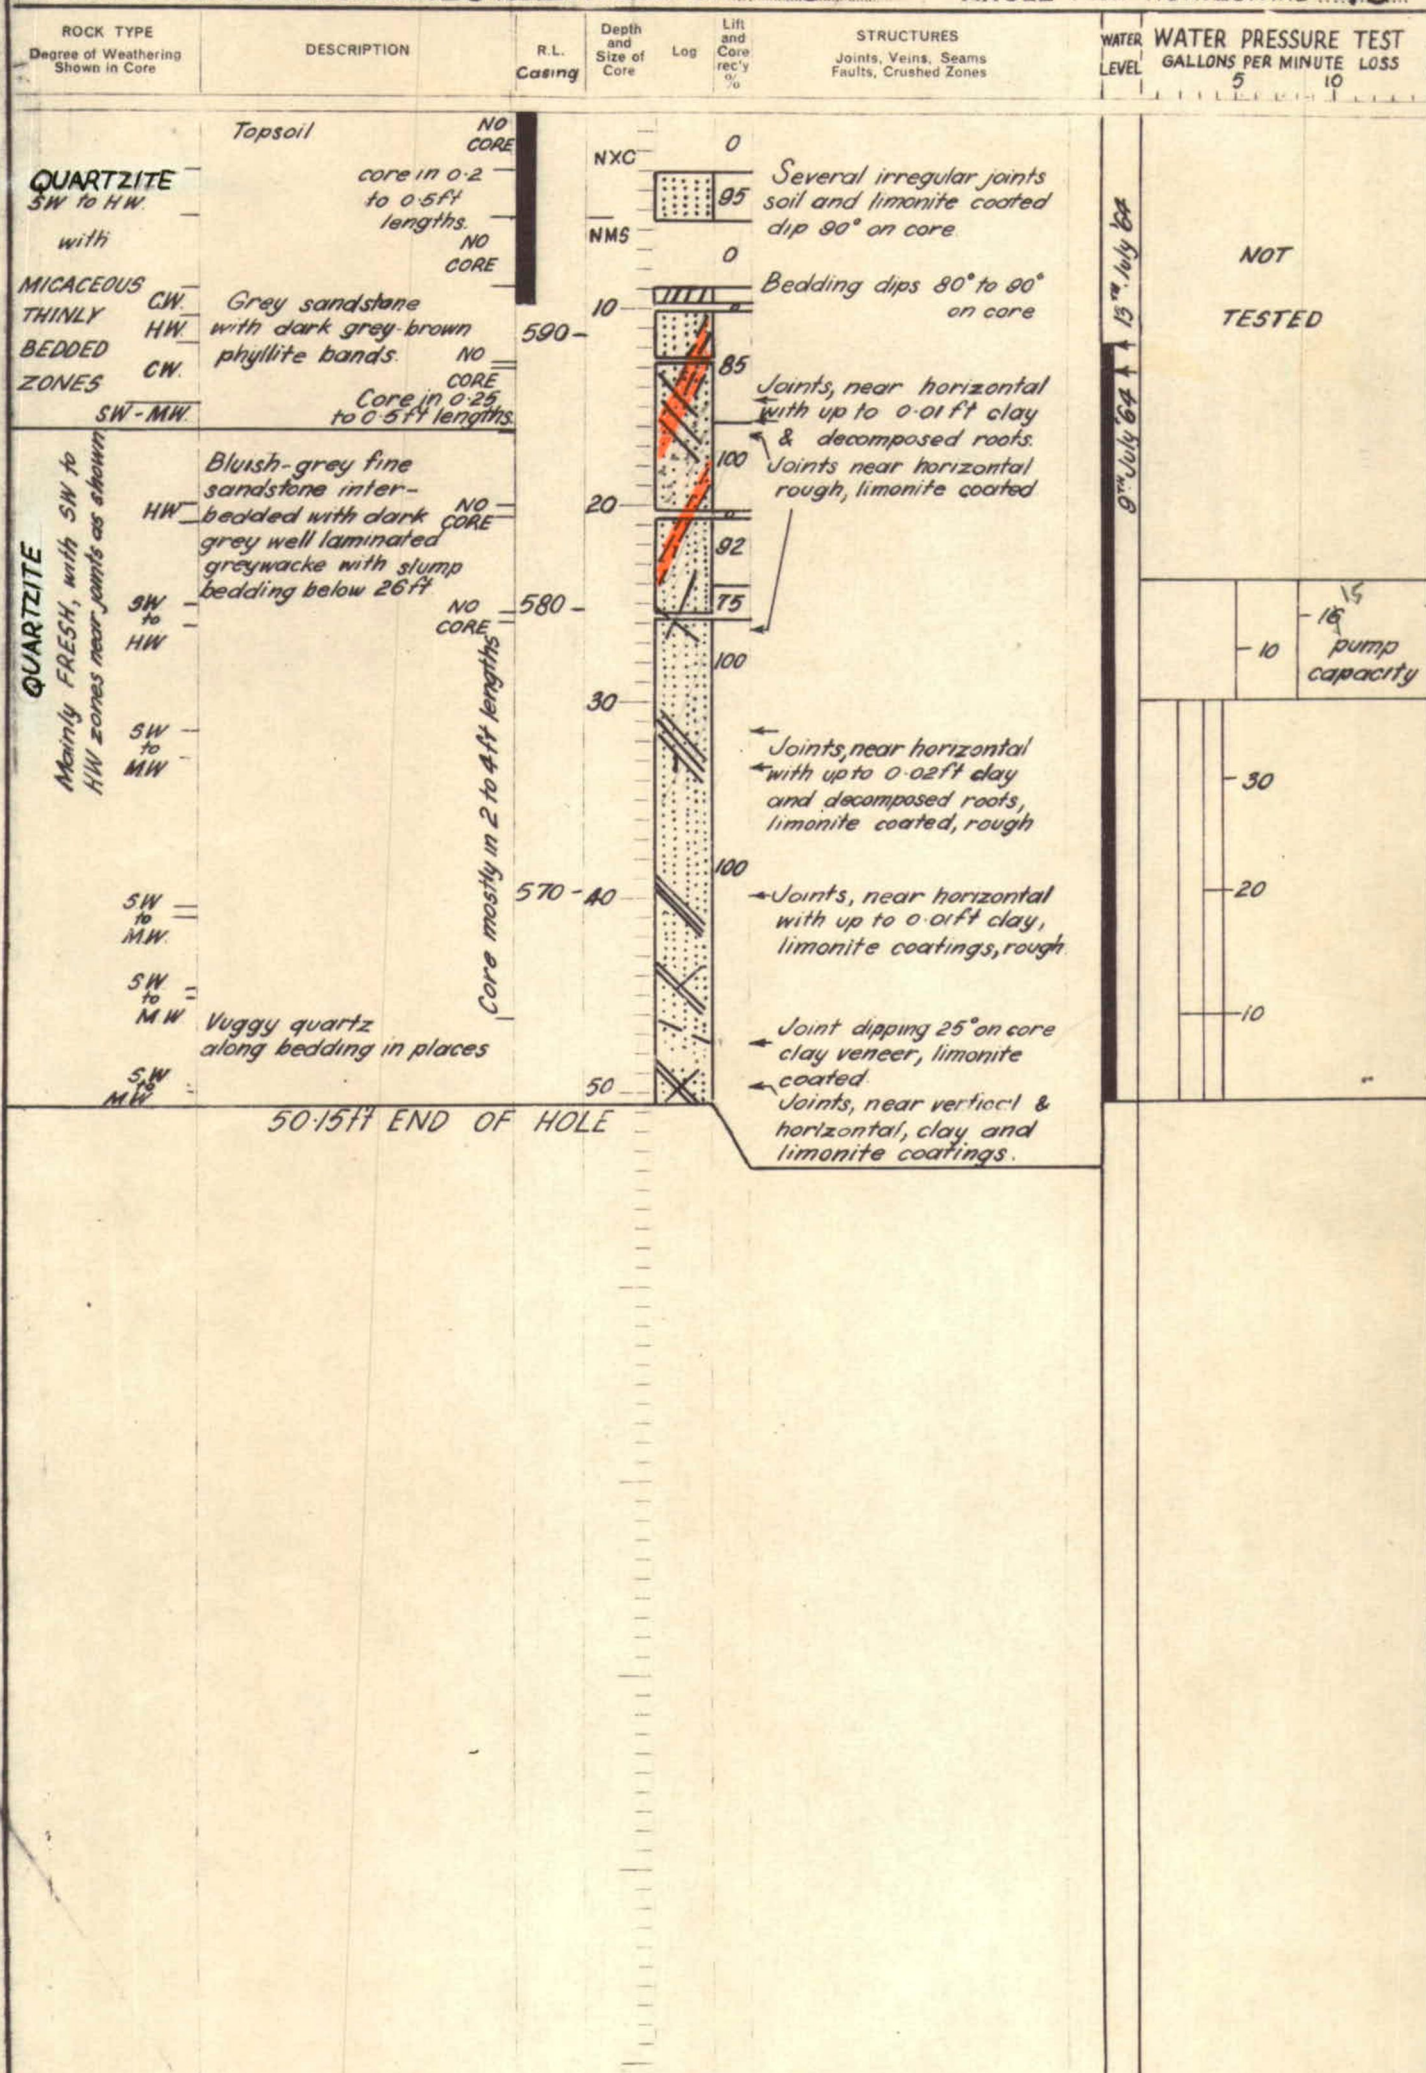
Hole No. 1

All of the holes were tested for permeability by the single packer method. Except in Hole 1 at the top of the right abutment, 10 and 20-foot sections of the rock below the main weathered zone were almost watertight when tested at pressures of up to 40 lbs./sq.in.

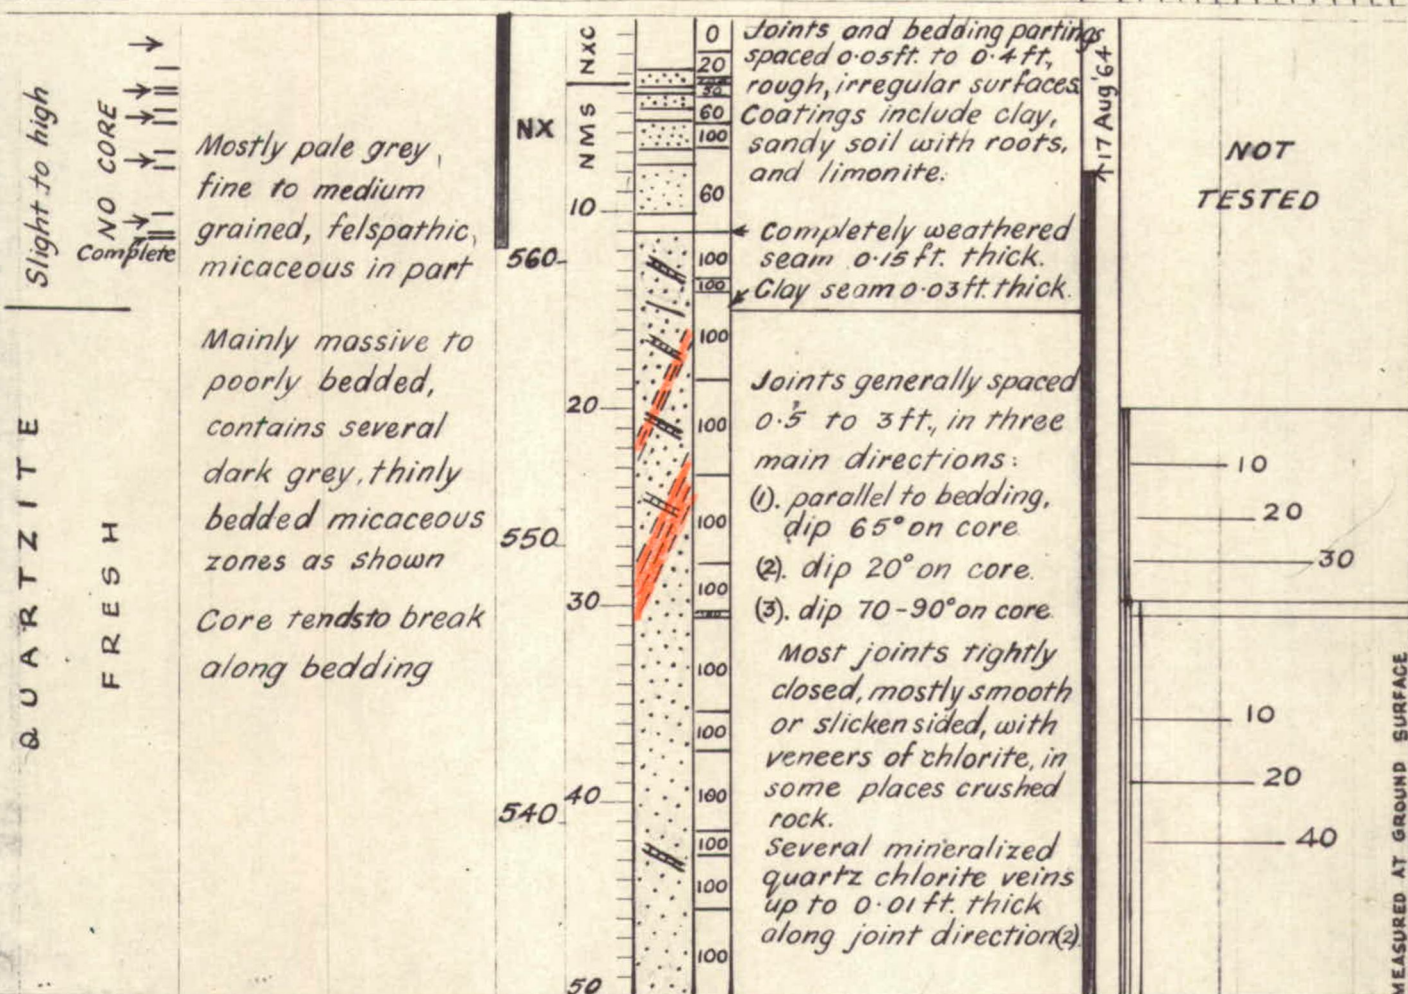
Hole No. **4**

A steeply dipping zone of weathered rock exposed in the trench on the left bank was intersected in the uppermost 10 to 15 feet of Hole 4. It appears to be a localised zone about 10

feet wide in which joints are spaced 0.5 feet or less, with the result that the effects of mechanical and chemical weathering probably extend locally deeper than in the average rock.

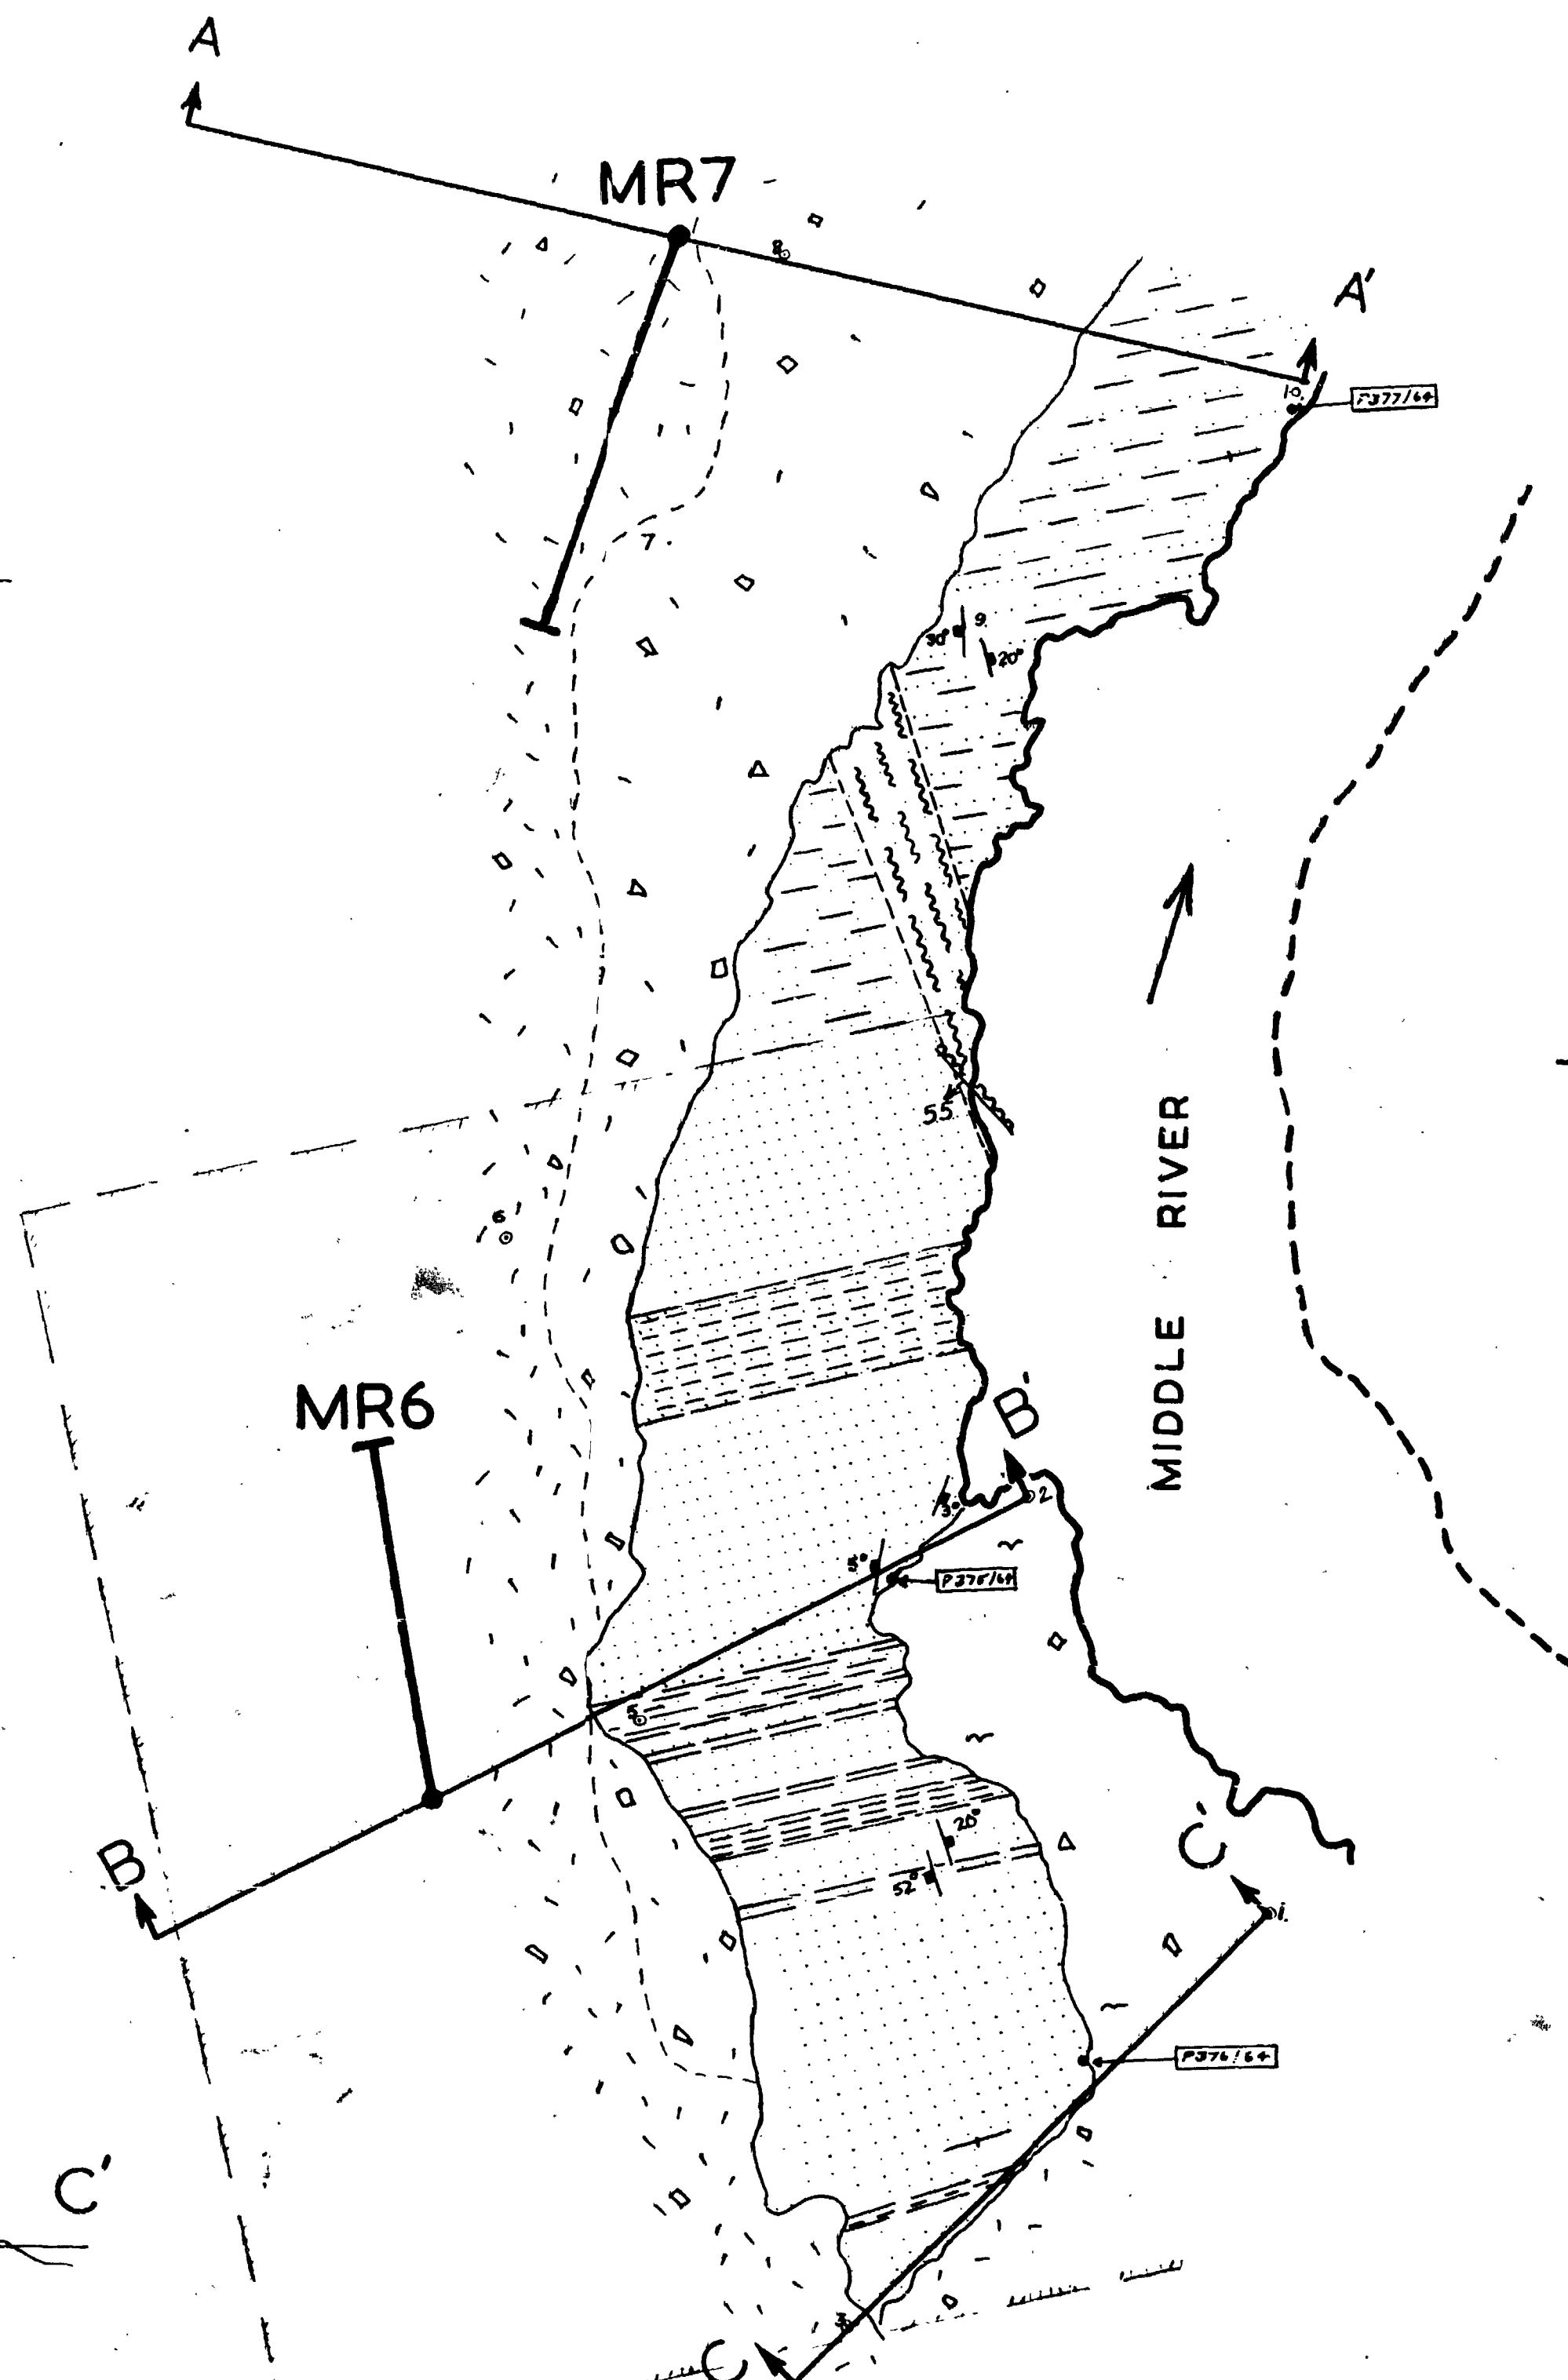
MIDDLE RIVER DAM, KANGAROO ISLAND
QUARRY SITE NO. 1
 GEOLOGICAL SKETCH PLAN AND SECTIONS

Quartzite which appears suitable for crushing for coarse aggregate is exposed in a 30 to 50 foot high face about $\frac{1}{2}$ mile downstream from the site (Fig. 3). The rock is generally massive or poorly bedded, and except in some localised thinly bedded zones, should provide coarse aggregate up to three inches in size.

Preliminary estimates on the basis of the surface geological mapping and sketch sections on Figure 5 indicate that at least 10,000 c. yds. of material could be obtained from this source.

It is considered that adequate quantities of suitable quartzite exist along the sides of Middle River gorge, within $\frac{1}{2}$ mile of the dam site. An extension of proposed concrete aggregate quarry, shown in Figure 3, may prove to be best source.
