**DEPARTMENT OF MINES  
SOUTH AUSTRALIA**

SOUTHERN FREEWAY - LAND FOR QUARRYING  
GEOLOGICAL INVESTIGATIONS - PROGRESS REPORT NO. 1

Sections 124, 125 and 137, Hd. Noarlunga

Client: Highways and Local Government Department

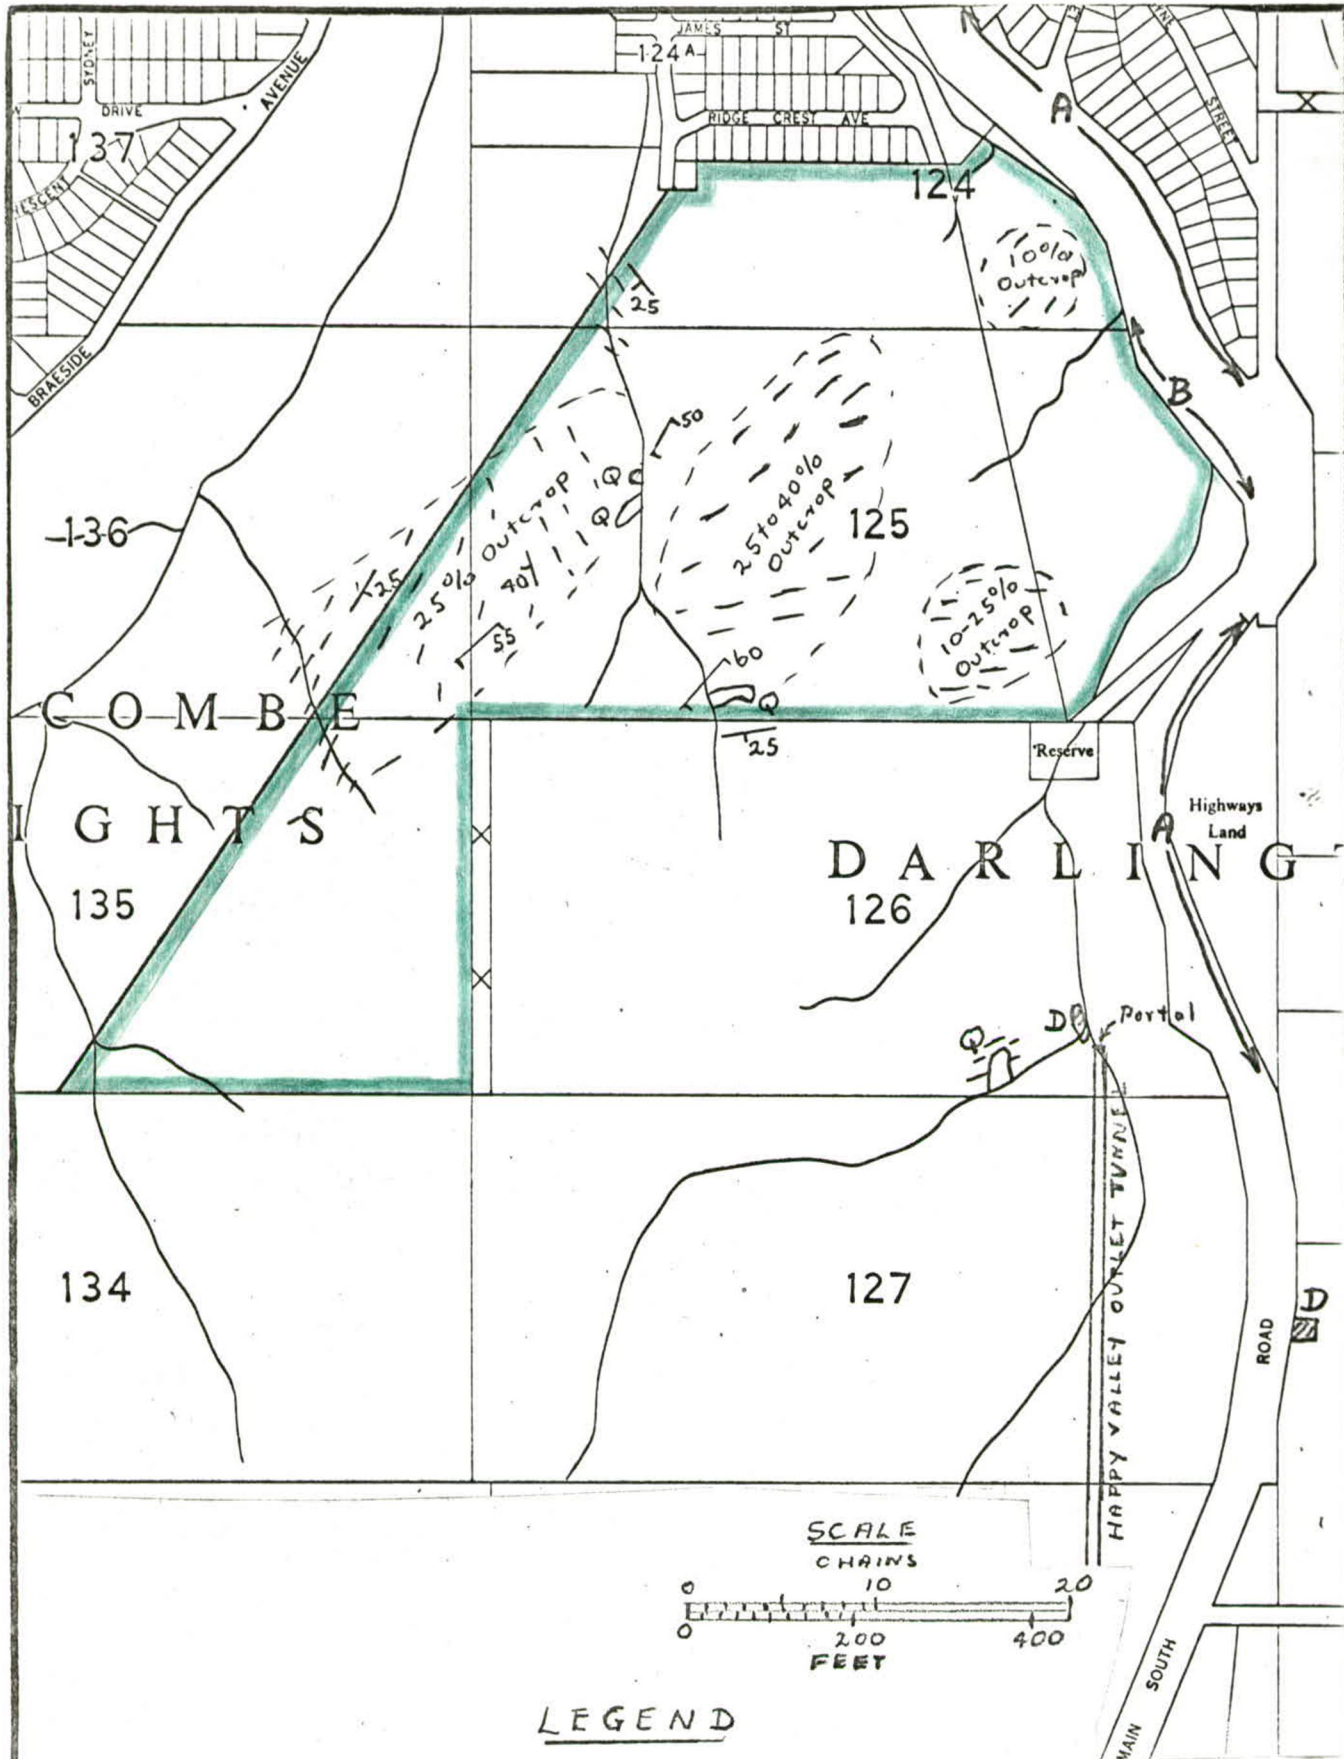
FIG 1

The proposed area is immediately west of the existing Main South Road (Fig. 1). The Happy Valley Outlet Tunnel runs close to the area and the pipeline from this tunnel is located along the eastern boundary (Fig. 1).

An inspection has been made of surface exposures in the area including excavations for the pipeline, the Main South Road, and for several small quarries which have already been excavated in the area (Fig. 1). Usually less than 100 cu.yds. of material have been removed from these quarries. The geological records of rock conditions in the tunnel during construction, and material in tunnel spoil dumps have also been examined.

There is a poorly to well developed cleavage in the slate. It strikes about northeast-southwest and dips  $55^{\circ}$  to  $75^{\circ}$  E. Surface outcrop tend to follow the strike of the cleavage. Outcrops generally are of more "massive" bands of rock in which the cleavage is poorly developed and the small quarries in the area have all been developed to follow one of these "massive" bands. The areas of no outcrop (Fig. 1) would appear to correspond to bands in which the cleavage is

Material excavated from the tunnel has been dumped at two locations near the downstream portal (Fig. 1). The fresh slate in these dumps would be similar to that which would be excavated in the proposed quarry area, and these dumps could be examined in further detail, and tested to determine their suitability for various engineering purposes.
